MISSION REPORT / RAPPORT DE MISSION

Vat Phou and Associated Ancient Settlements within the Champasak Cultural
Landscape (N481)/Vat Phou et les anciens établissements associés du paysage
culturel de Champassak (République démocratique populaire lao) (N 481)
15-21 February 2012/15-21 février 2012

**Report on the Joint World Heritage Centre/ICOMOS/ICCROM Reactive Monitoring
Mission to Vat Phou and Associated Ancient Settlements within the Champasak
Cultural Landscape (Lao People's Democratic republic)**

15-21 February 2012

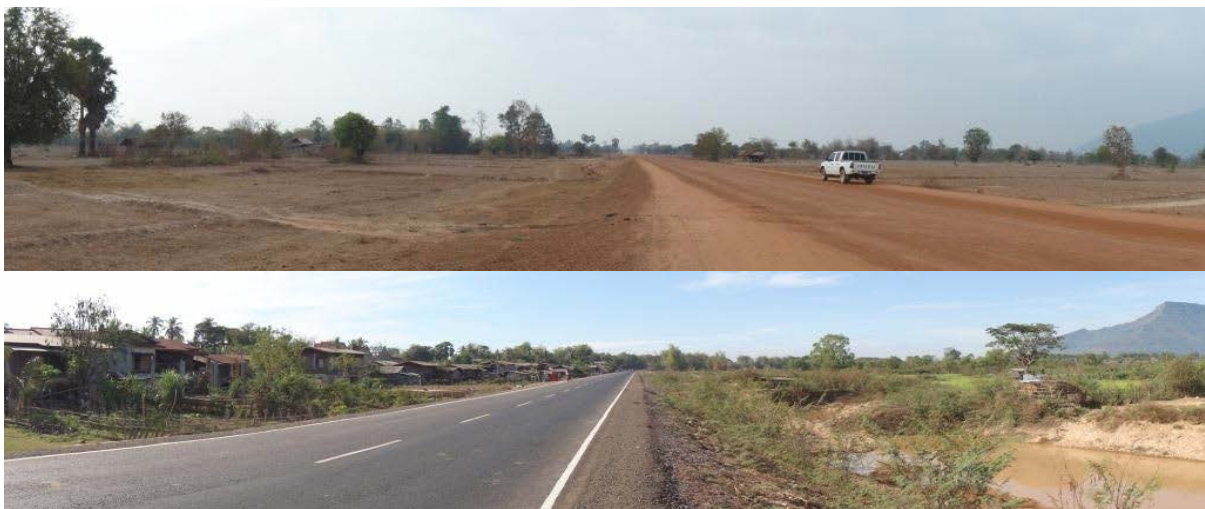
14A under construction (above) and as constructed (below)

impact of the completed road (and associated bridges) on the cultural landscape. There was also concern that the road, designated a regional road, could well develop into a national four-lane highway. This concern was not specifically expressed in the aforementioned letter from the World Heritage Centre, but later shared by those knowledgeable about the project. At the time of the Reactive Monitoring Mission, all work had been stopped on KM 29 + 050 to KM 34 + 261; a section of Route 14A that includes three partially constructed bridges. The remaining part of Route 14A has been largely finished

(3) In regard to the visual impact of Route 14A, it would seem best to refrain from planting a linear screen of trees on either side of the road as this would serve to emphasize the dramatic cut of the road through the cultural landscape – and would be especially visible from the platforms of Vat Phou.

(4) The railings of the three bridges between *Ban Sikheut to Junction of Vat Phou Road near Ban Phonsaoe (KM29 +050 to KM 34 +261)* should be treated with a colour that reflects one of the dominant colours of the natural landscape (rather than white).

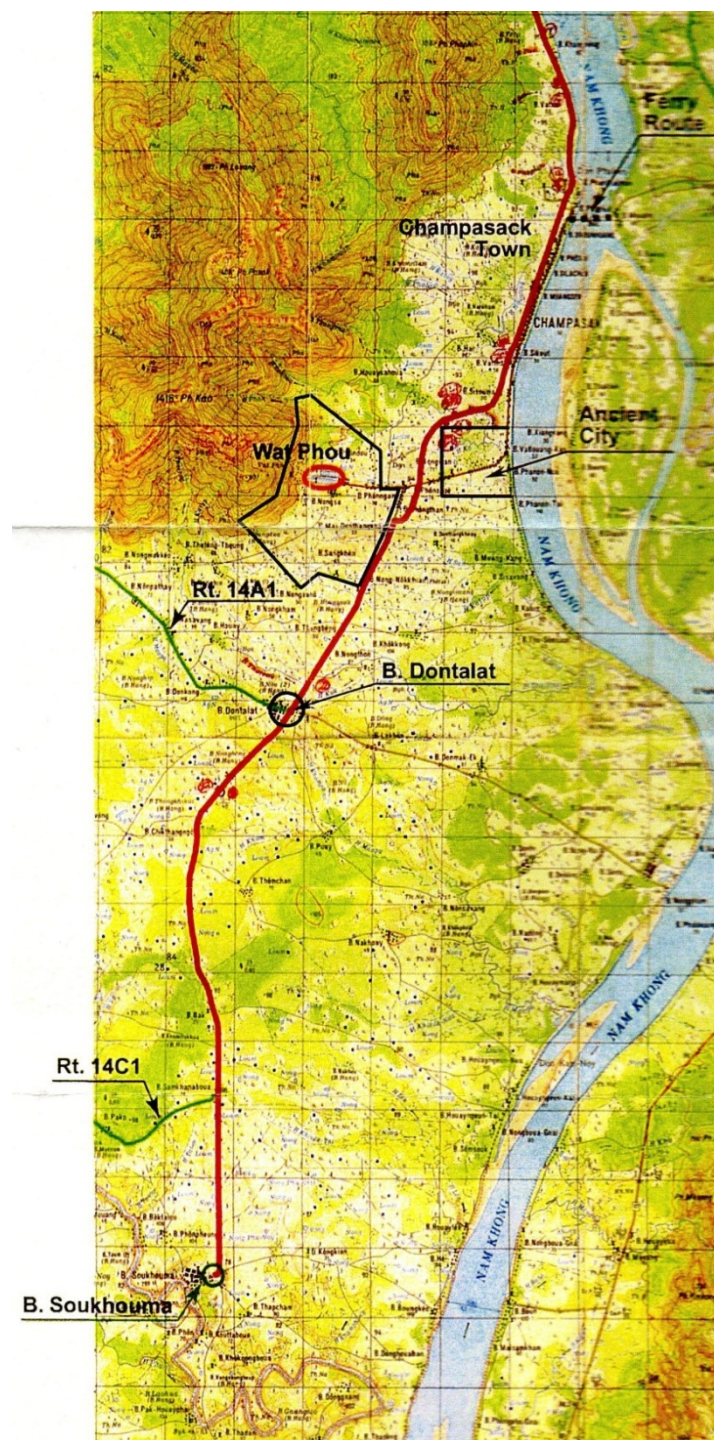
Map showing Route 14A

The mission notes that Route 14A has direct impact on Zone 1 [Champasak Heritage and Cultural Landscape Protection Zone] and Zone 3 [Archaeological Research Zone] – and indirect impact on Zone 2 [Sacred Zone] and Zone 4 [Monumental Management Zone]. (See Annexe 6 for map showing zone boundaries within the property).
