### **OF THE INSTITUTE FOR THE PROTECTION OF CULTURAL MONUMENTS OF REPUBLIC OF SERBIA ON THE STATE OF CONSERVATION OF THE MONUMENTS IN KOSOVO INSCRIBED IN THE LIST OF THE WORLD HERITAGE IN DANGER**

#### **MEDIEVAL MONUMENTS IN KOSOVO (SERBIA) (C 724)**

Belgrade, January 2014

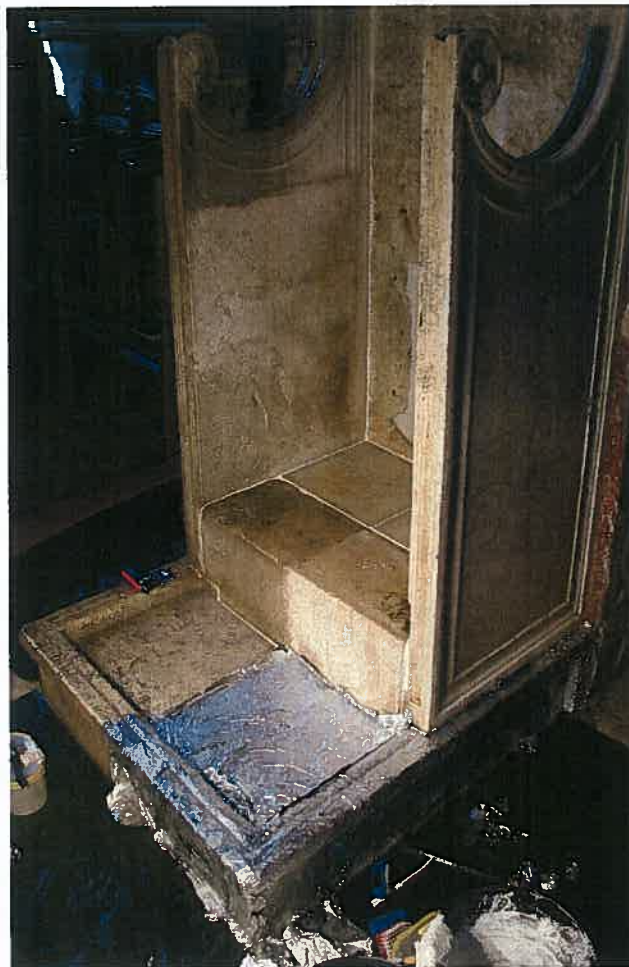
*The stone throne during conservation works*

In September and October 2013, conservation and restoration works were conducted on the stone throne in the monastery church. Soot and grime covering the stone surface were removed in both chemical and mechanical ways. The unstable stone part were cleaned and fixed. The missing stone elements on the throne were reconstructed with polymer modified mortar. The finishing layer hue was adjusted by adding natural pigments to the mortar, so that it corresponds to the original stone in colour and texture.

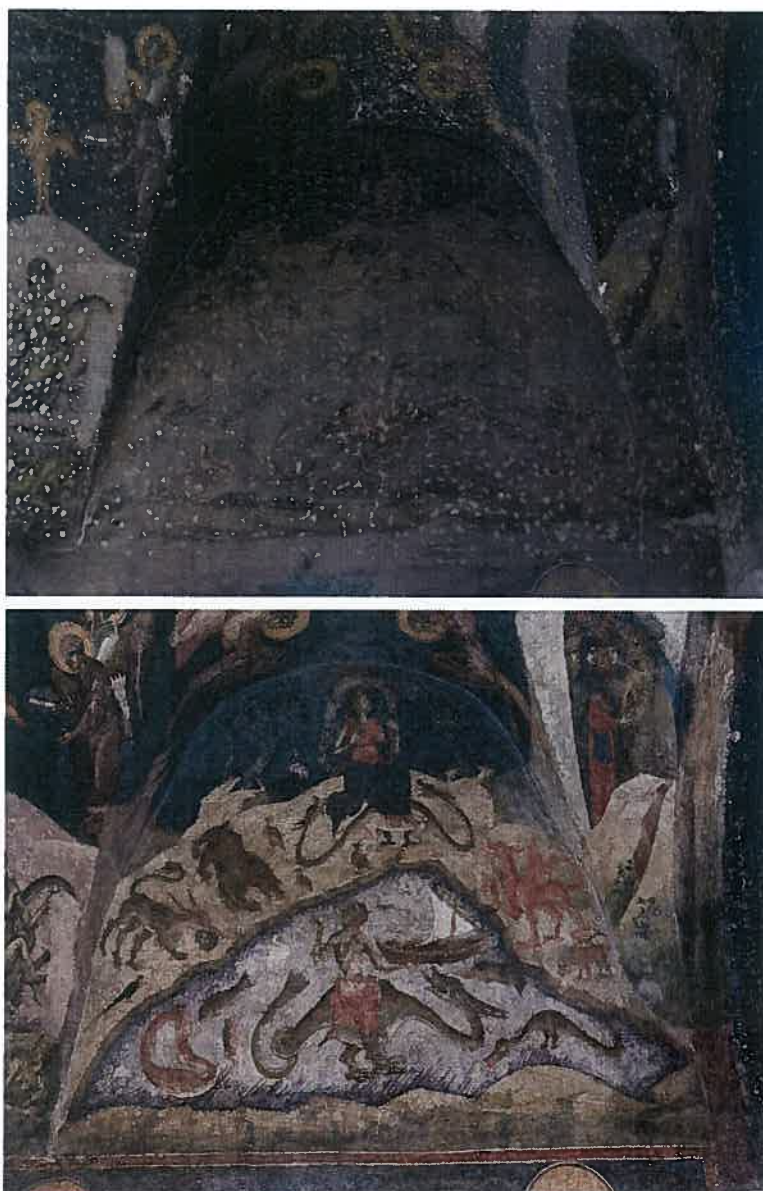
*Detail of wall paintings before and after the conservation works*

In the September-December 2013 period, conservation works were conducted on the frescoes in the church exonarthex. All the wall paintings surfaces were cleaned from thick layers of dust grime and efflorescence. While removing a more recent layer of mortar, about 4 square metres of frescoes were discovered. The places where the plaster detached from the wall were injected and the major damages sealed. All the treated surfaces were retouched with reversible water colours.

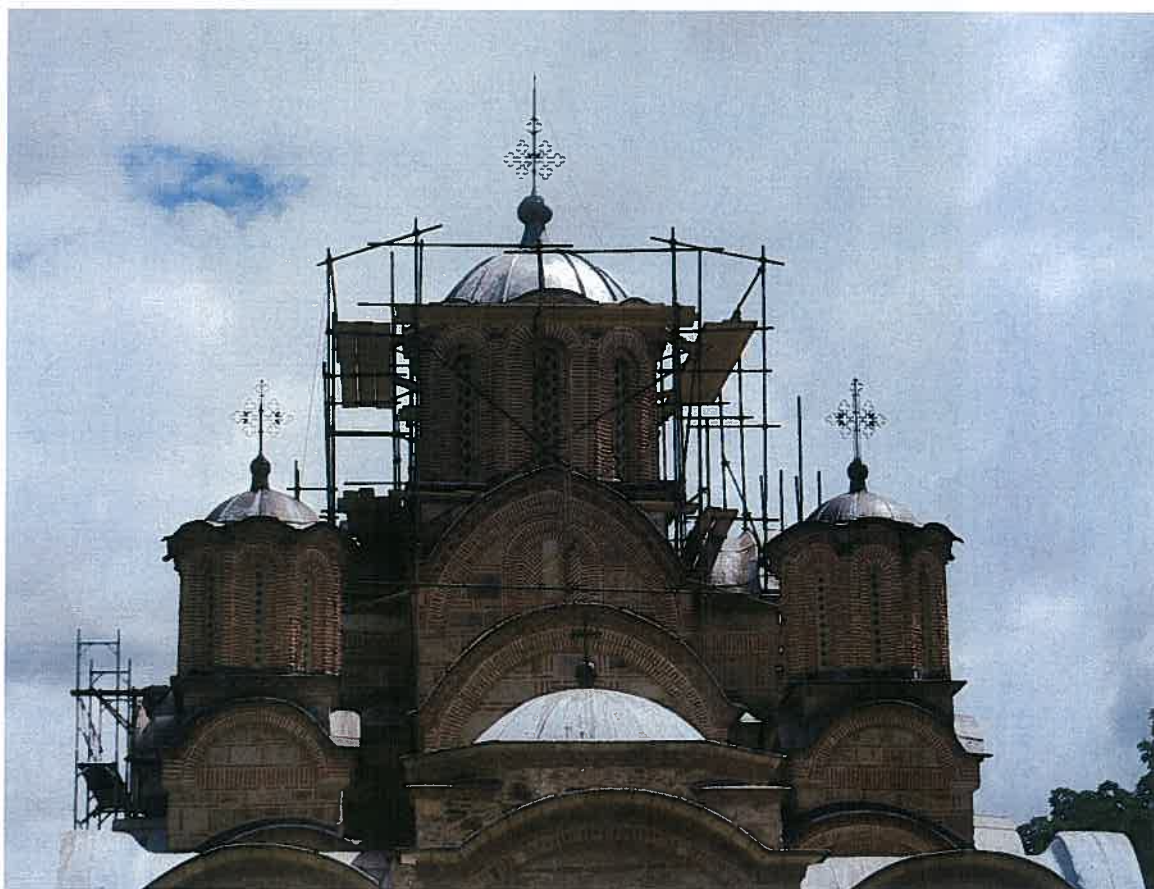
*Monastery church during works*

According to the Institute's Project of Conservation Works on the Holy Virgin Church at the Gračanica Monastery, the UNESCO Venice Office publicised a call for bids for conducting the works. Since the available funds could not cover all the works set in the Project, in the period from late April to July 2013, the church roofing (save the exonarthex) was done. The damaged lead sheets were removed, the base was repaired where necessary and new 3 mm sheets were placed. Minor damage on the dog-tooth cornices was repaired.

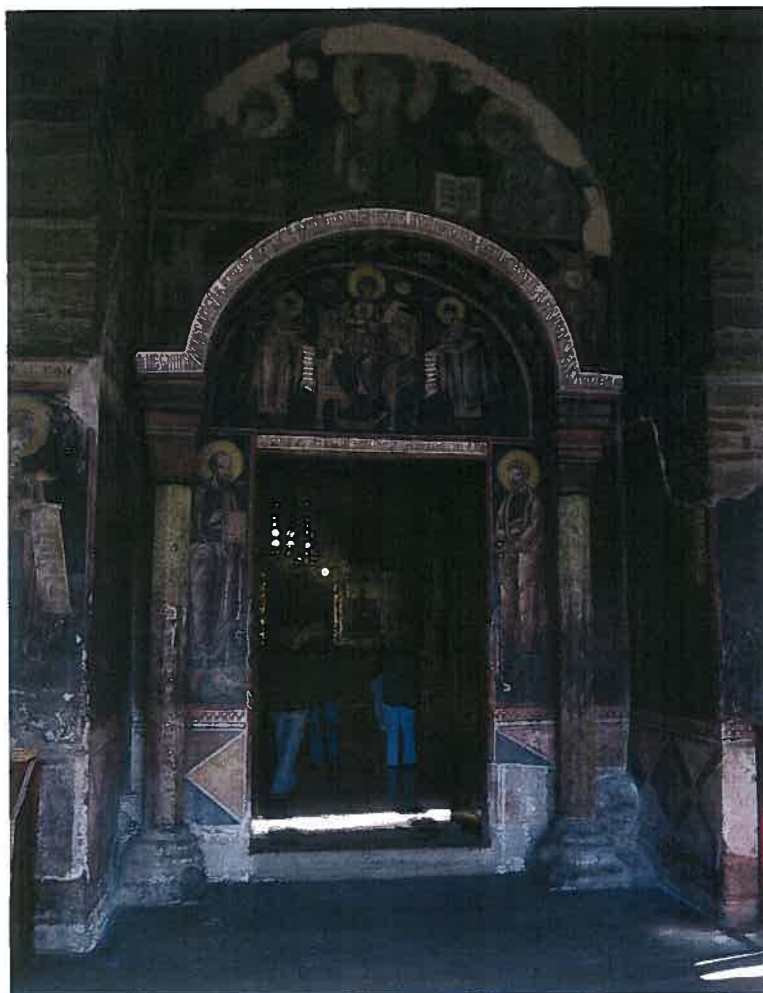
In September and October 2013 the Institute conducted the conservation works on wall paintings in the church exonarthex. After inspecting the surfaces and establishing the condition, there were interventions performed on the weakened sections of the wall paintings above the interior portal, where it was found that parts of the paintings were

*Interior portal after the conservation works*

detached and could fall down. The works aimed at consolidating the said areas. On the pilasters flanking the portal, partial paint fixing was done on the painted layers, seams placed where needed, as well as partial injection reinforcement. All the wall paintings surfaces were cleaned from a thick layer of soot and dust.
