Historic Area of
Istanbul (No 356)

UNESCO MISSION TO ISTANBUL
NOVEMBER 1993

TO REPORT ON THE PRESENT STATE OF THE HAGIA SOPHIA MONUMENT
AND MAKE RECOMMENDATIONS FOR ITS PRESERVATION AND RESTORATION

MISSION REPORT

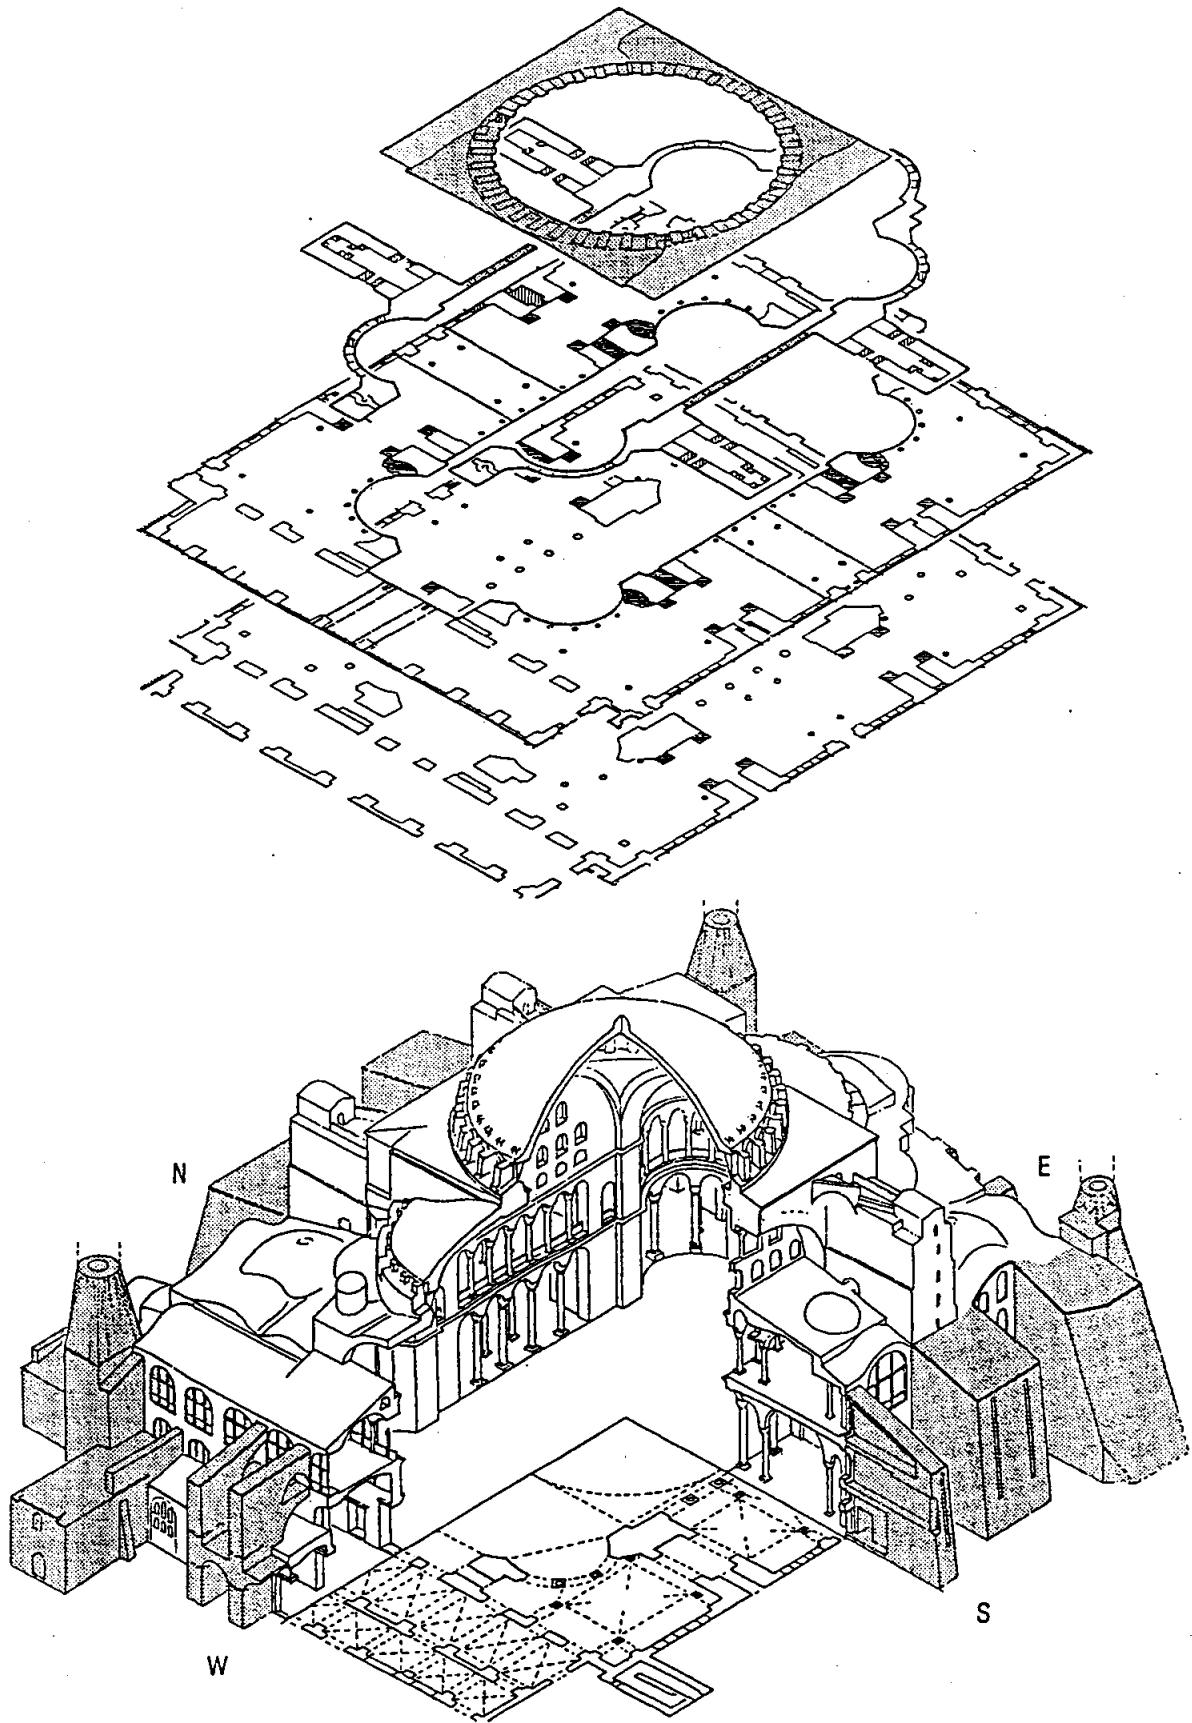
Figs 1 and 2 The structure today with partial reconstructions and main additions shown by hatching and stippling (Mainstone copyright)

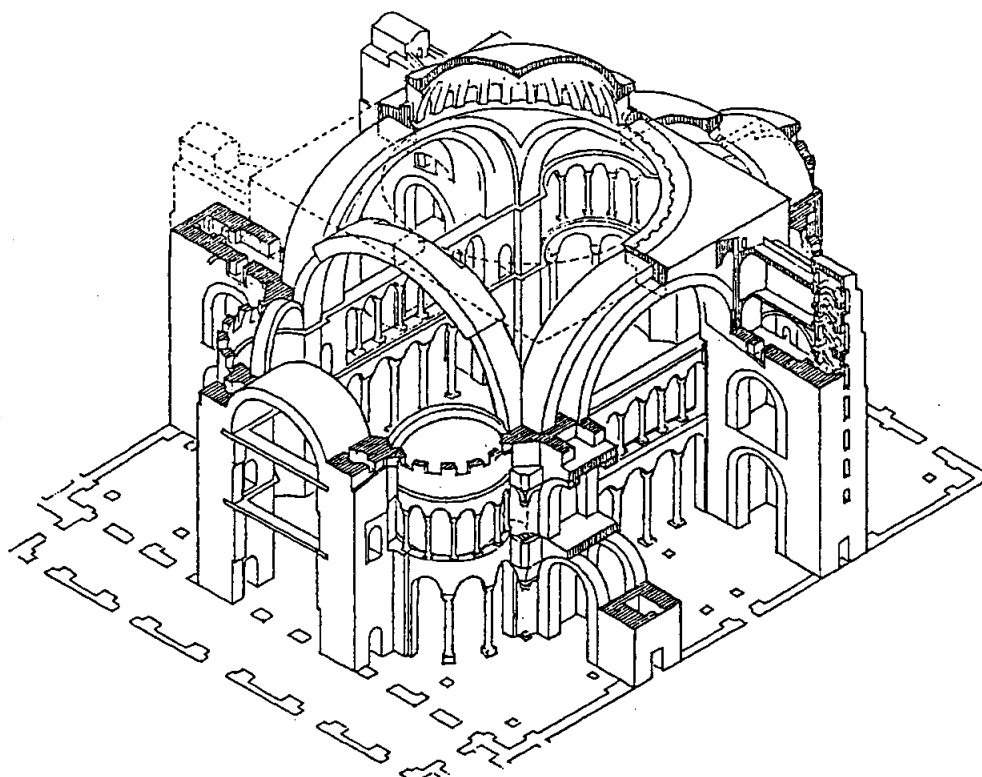
Fig.3 The original primary structure (Mainstone copyright)
