# State of Conservation 2016

## **Group of Monuments at Hampi (241 bis)**

State Party: India

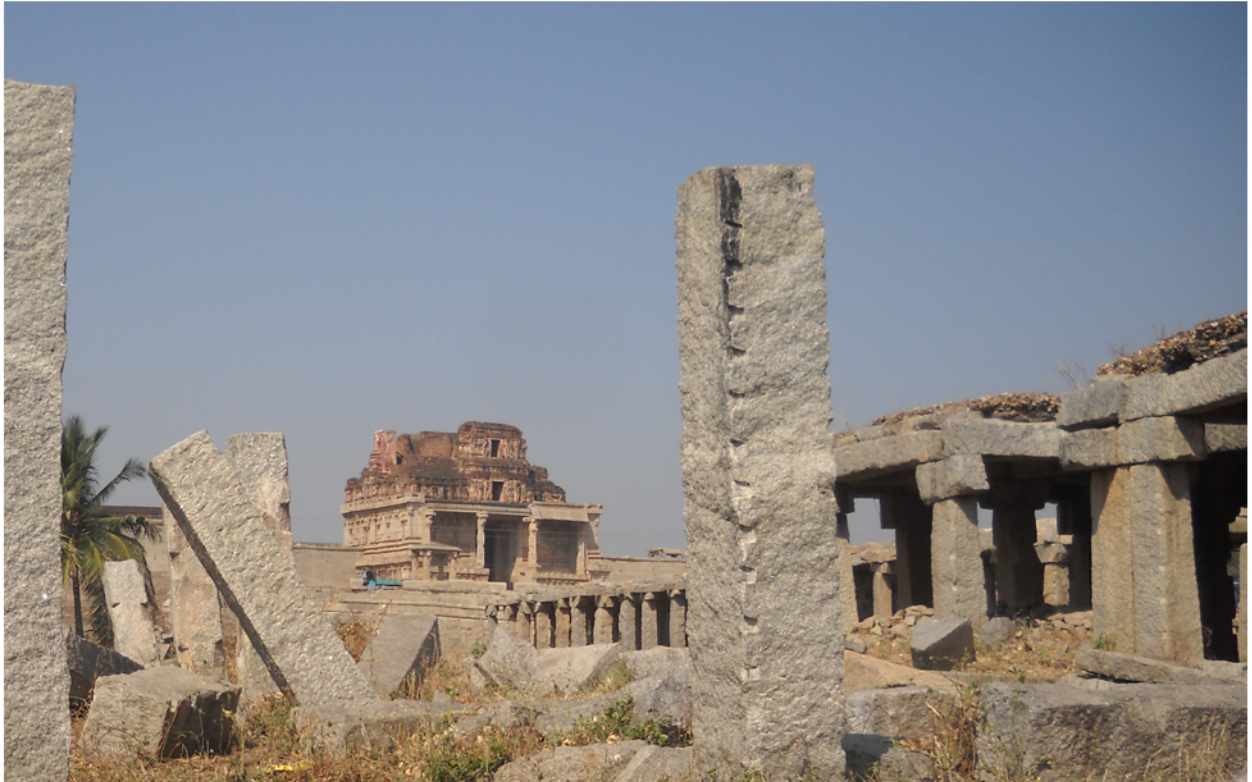
**Figure no. 01: State of conservation of stone members in Krishnapura Temple Complex (2010)**

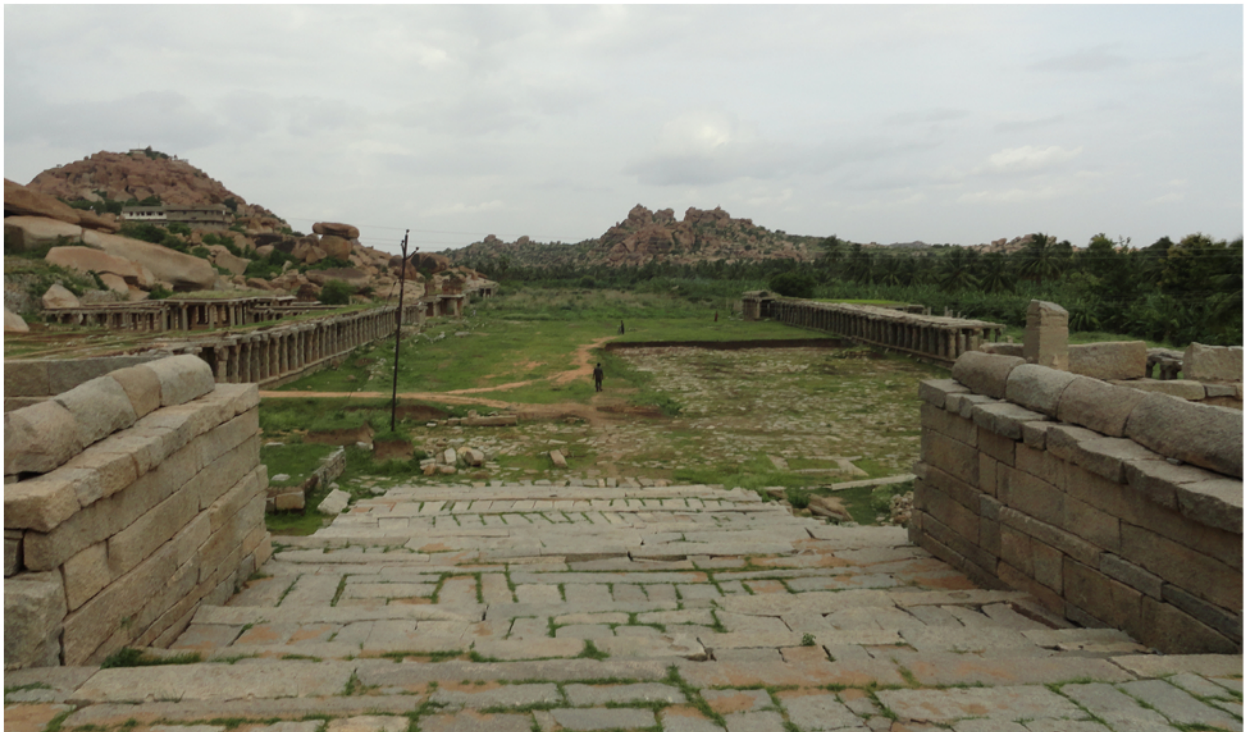
**Figure no. 02: Resetting and devegetation of Krishna Temple Complex (2012)**

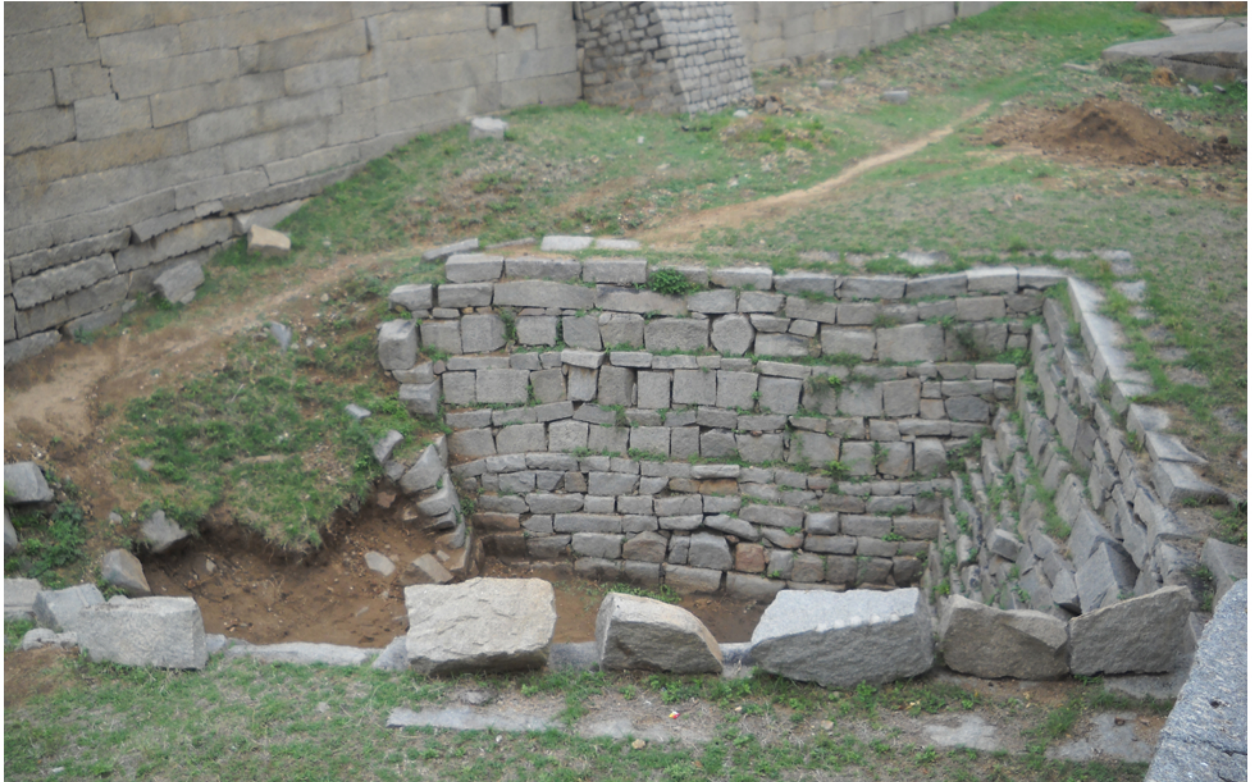
- Vegetation growth between courses of stone masonry in the embankment.
- Failure in one of the corners of the embankment causing the mud from its surrounding ground to collapse into the well
- Uneven ground with deposits of earth in heaps in the surroundings of the well.

**Figure no. 03: State of conservation of stone well in Krishna Temple Complex (2010)**

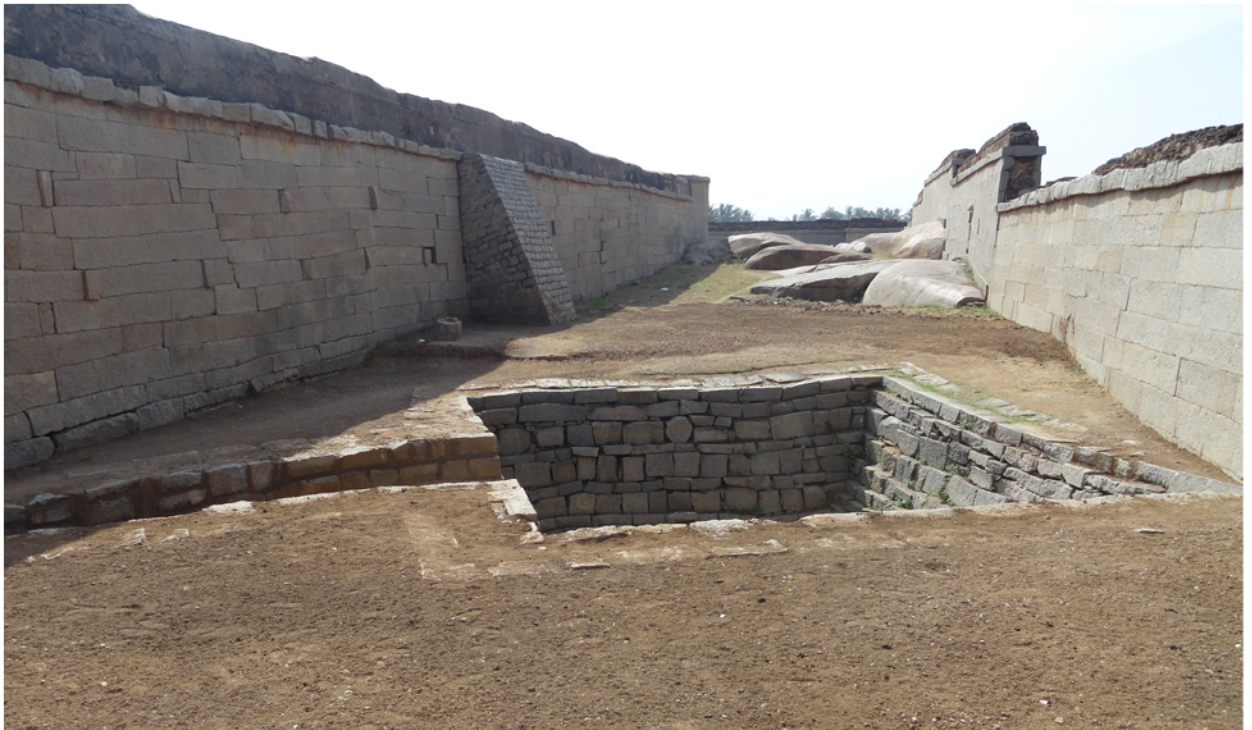
**Figure no. 04: Conserved (reset) of stone well in Krishna Temple Complex (2012)**

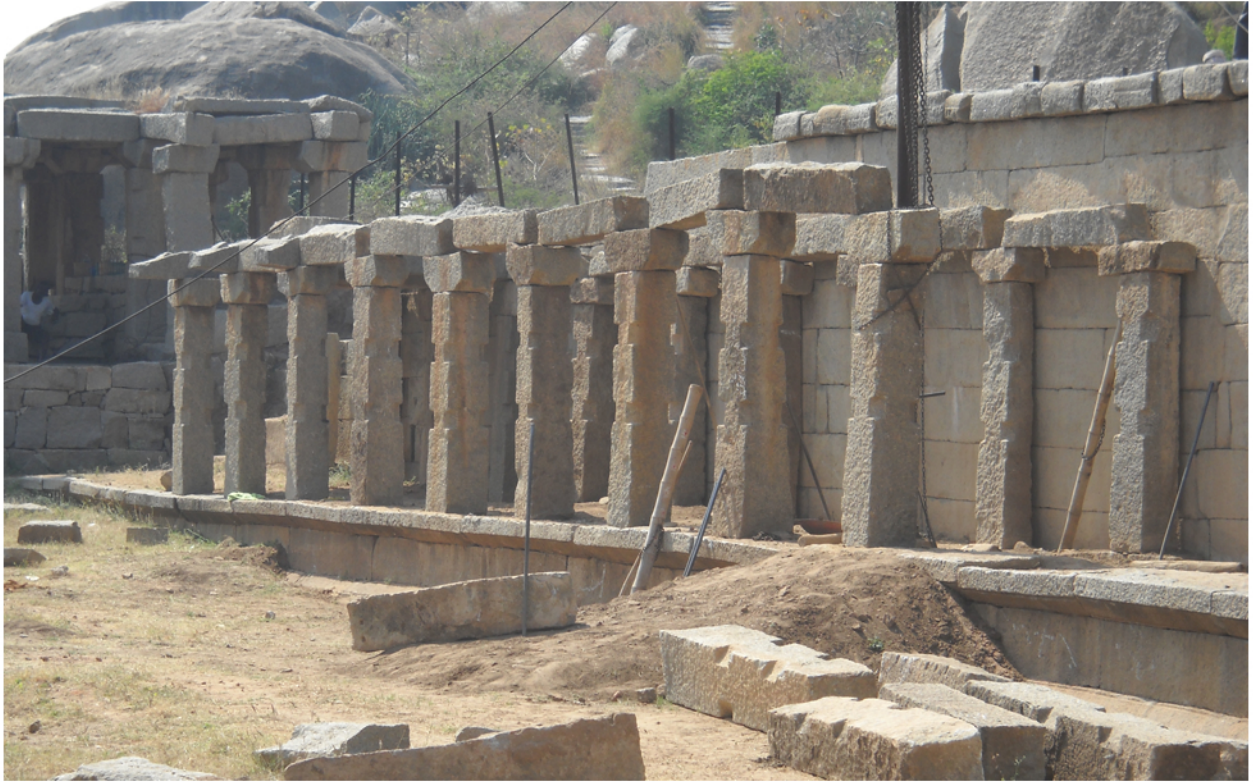
**Figure no. 05: State of Conservation of (cloistered) Mandapa of Achyutaraya Temple Complex (2011)**

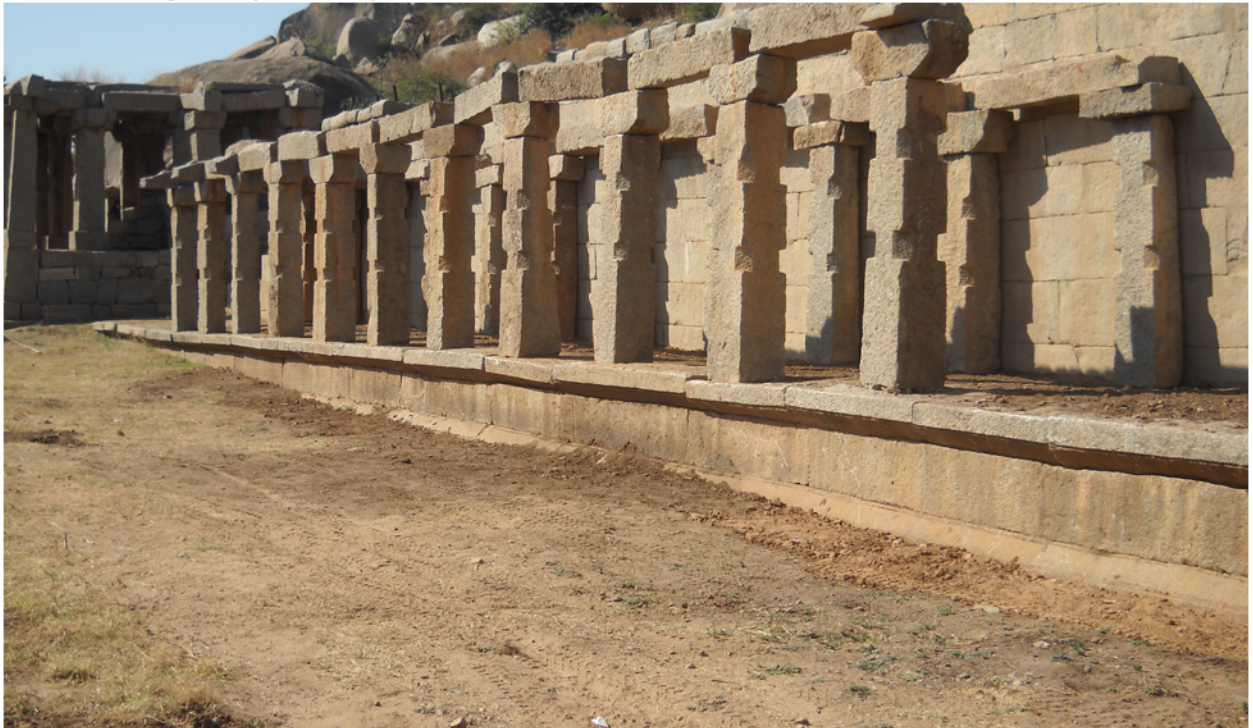
**Figure no. 06: Post conservation condition of (cloistered) Mandapa of Achyutaraya Temple Complex (2012)**

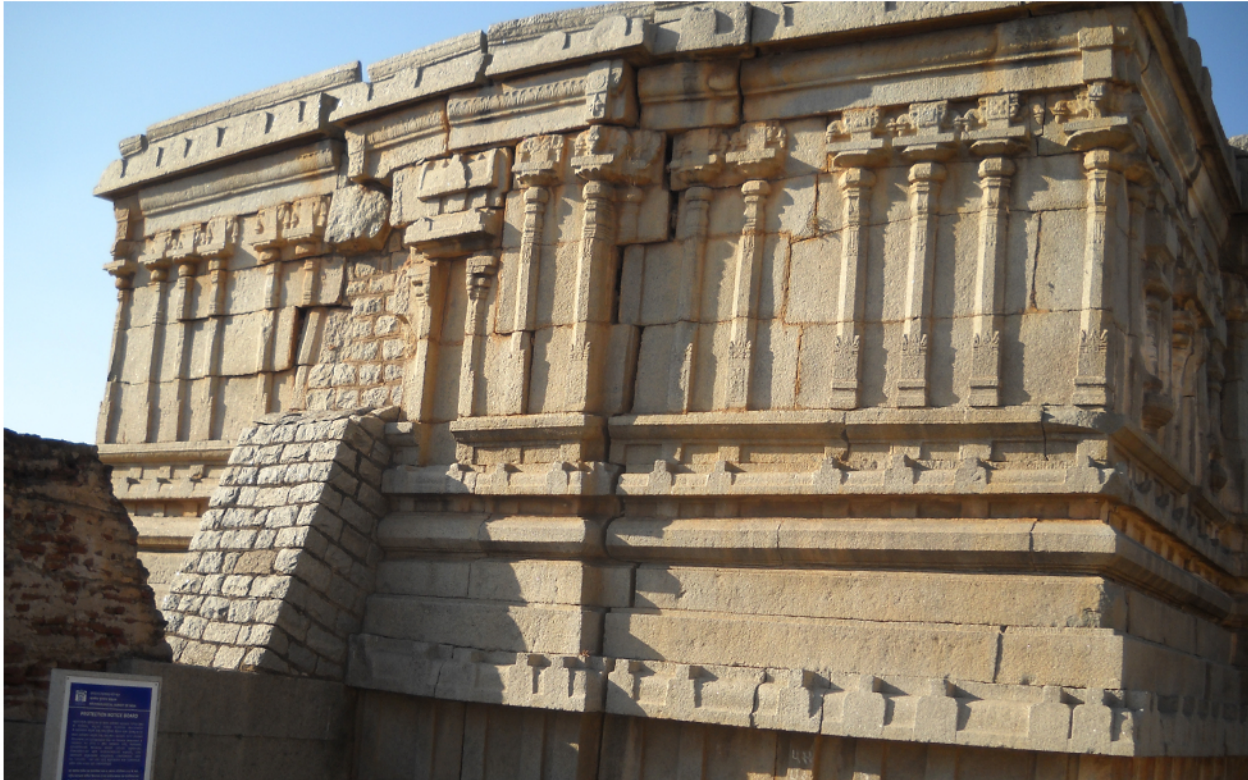
- Cracked and broken pillars supporting some of the beams and decorative members
- Several stone members including pillars, beams and even carved architectural stone blocks damaged either with minor cracks, chipped edges.

**Figure no. 07: Differential settlement and separation of members of Varaha Temple, Venkatapura (2010)**

- Documentation and numbering of all individual stone blocks of the Mahadwara
- Carefully dismantling the stone members resting on vulnerable pillars under the supervision of a conservation assistant.
- Mending broken and cracked stone columns using nonmagnetic stainless steel rods, powdered stone and adhesives.
- Re-setting the roofing using chain pulley and derrick pole system.

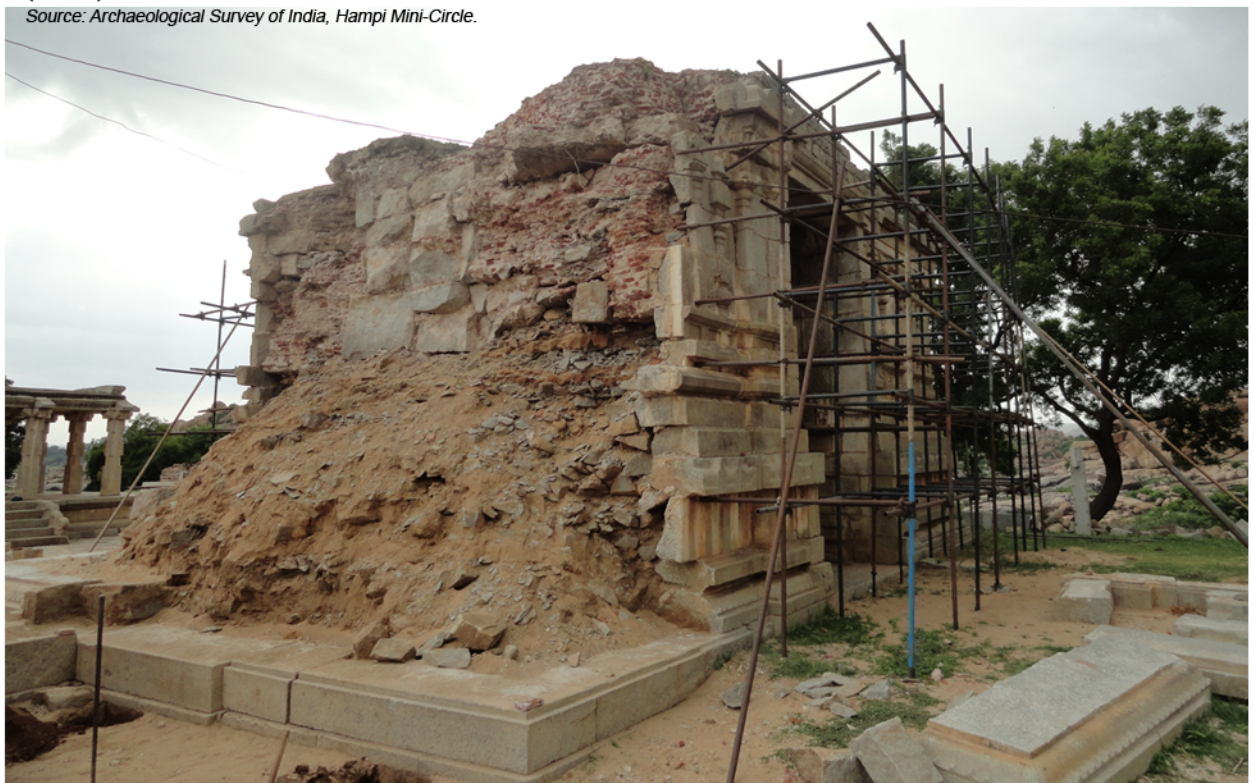
**Figure no. 10: Conservation work in progress at the Mahadwara of the Varaha Temple, Venkatapura (2012)**

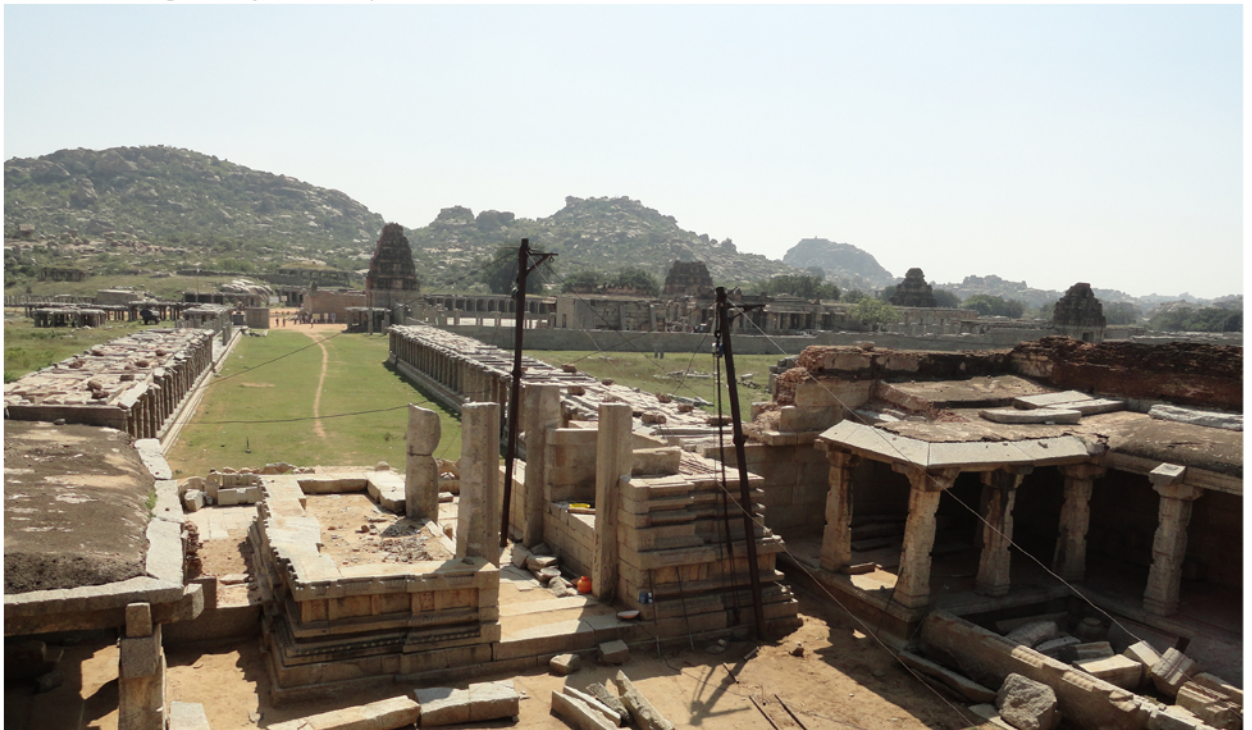
**Figure no. 12: Structural conservation (work in progress) of Old Shiva Temple (Part of Vitthala Temple Complex) (2012)**

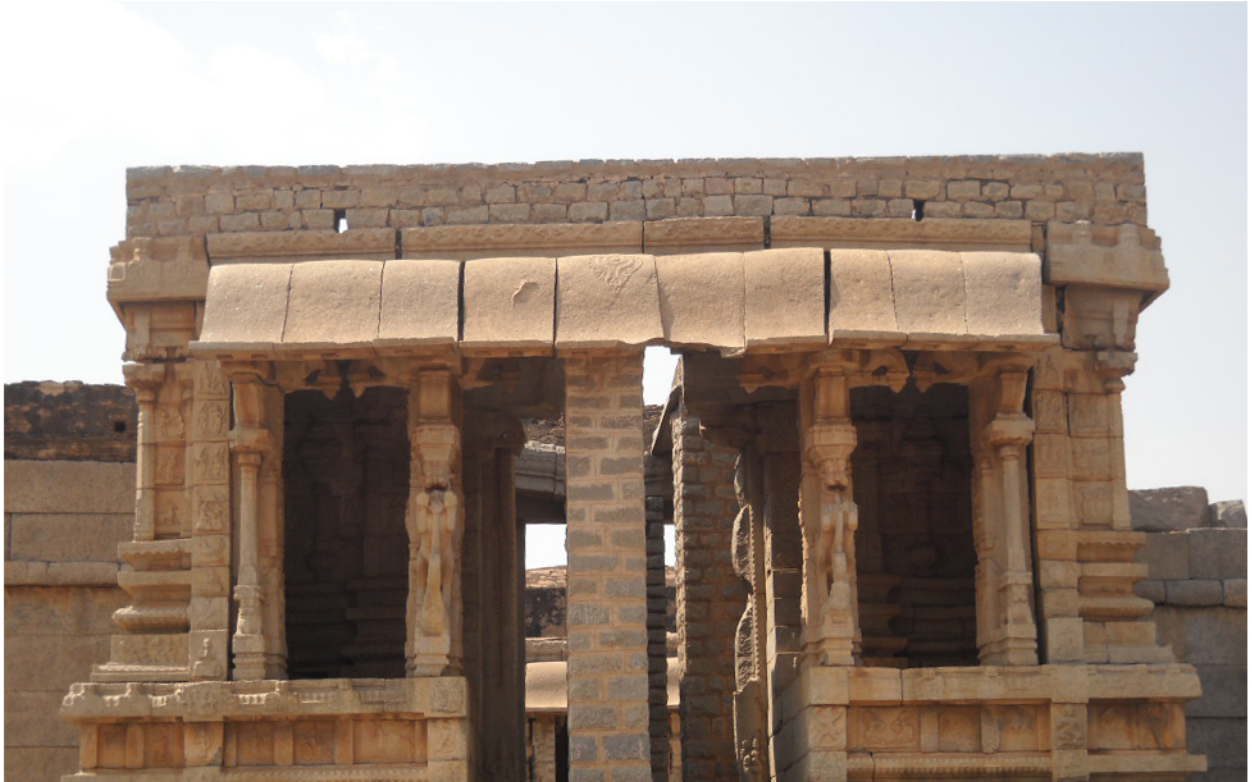
**Figure no. 13: Cracked structural members of Old Shiva Temple (2010)**

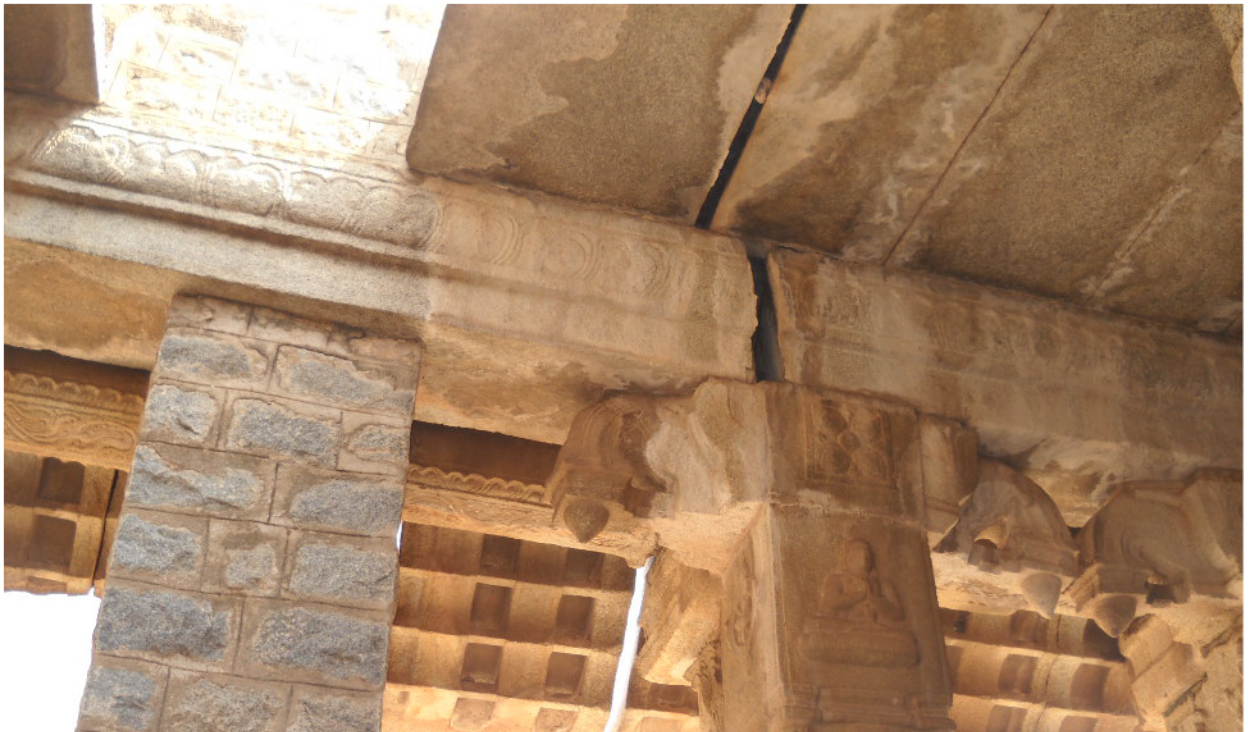
**Figure no. 14: Cracked structural members of Old Shiva Temple (2010)**

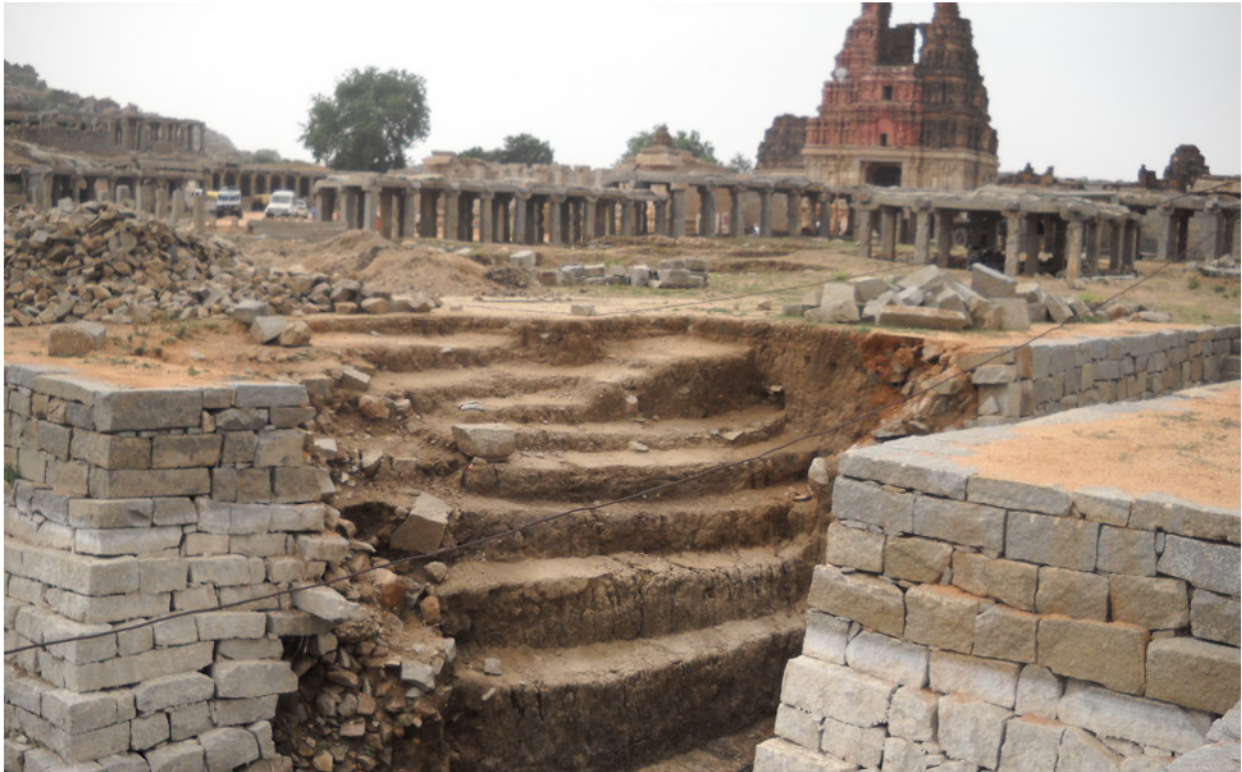
- Dislodged courses of stone blocks in the embankment and loose hearting material.

**Figure no. 15: Status of conservation of the Embankment (2010) of the Vitthala temple Well**

- Clearance of collapsed debris and loose earth
- Emptying the well of its water for further cleaning by mechanical pumping.
- Removal of silt, accumulated debris and fallen stone blocks from the bottom of the well
- Dismantling loose and plumbed out stone courses of the retaining wall.
- Removing deteriorated hearting material from the fallen and dismantled retaining walls of the well.
- Restoring the retaining walls by resetting the removed courses of stone blocks and steps of the well with new hearting material filling (soil and boulders) in layers of courses and necessary ramming for achieving consolidation.

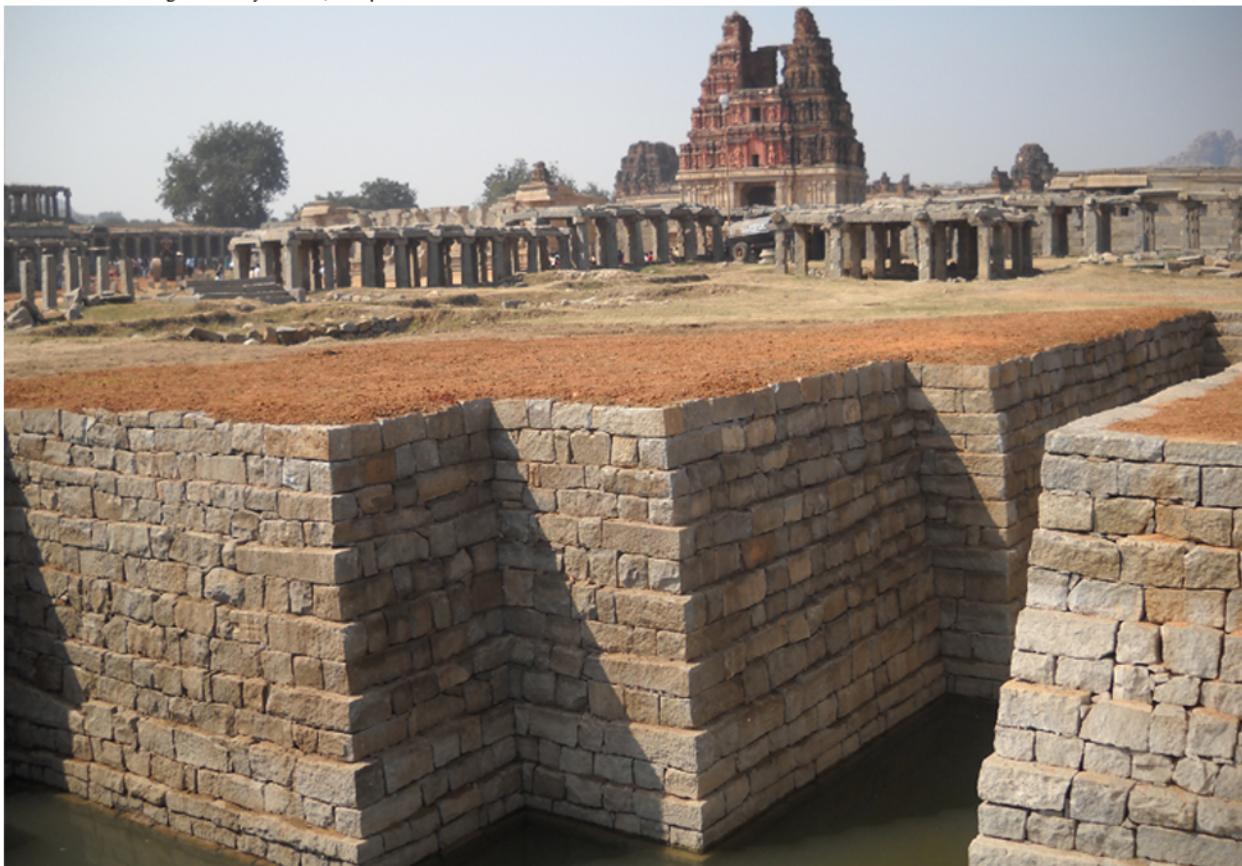
**Figure no. 16: Status of Conservation after (2010) of the Vitthala temple Well**

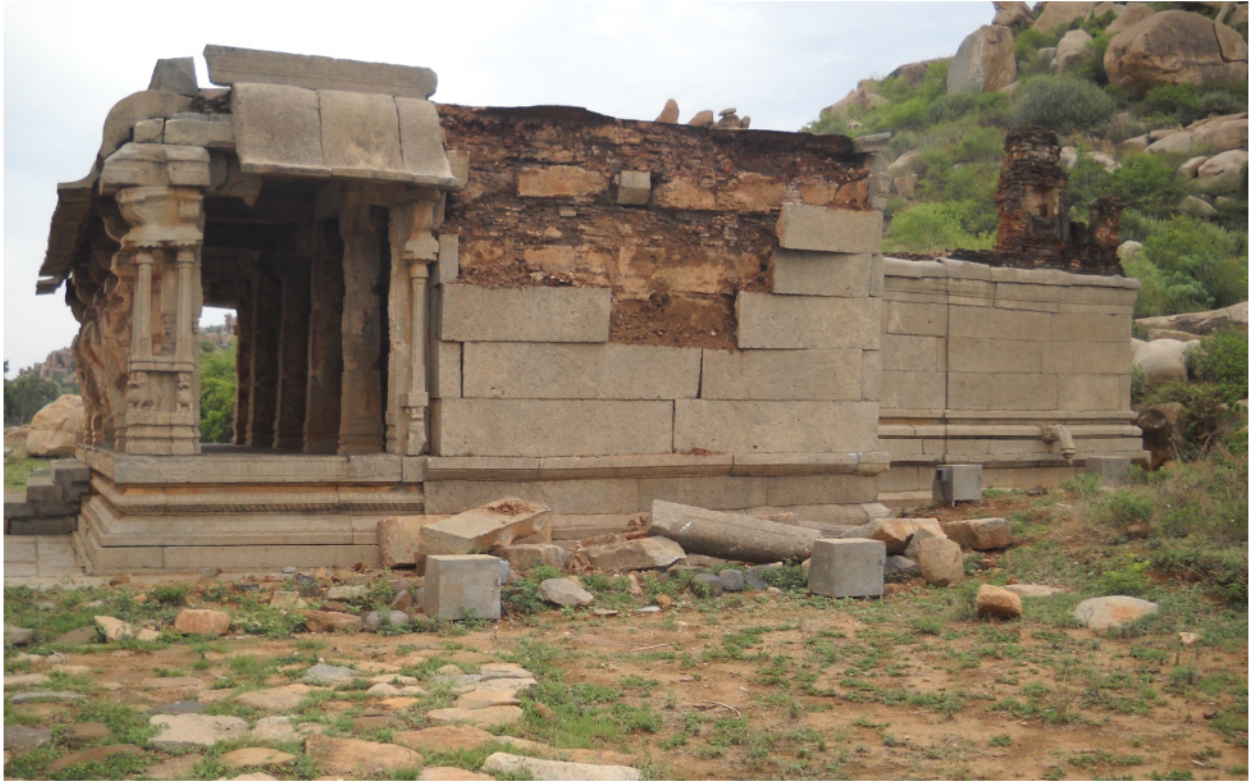
**Figure no. 17: State of Conservation of Kudure gombe Mandapa (2011)**

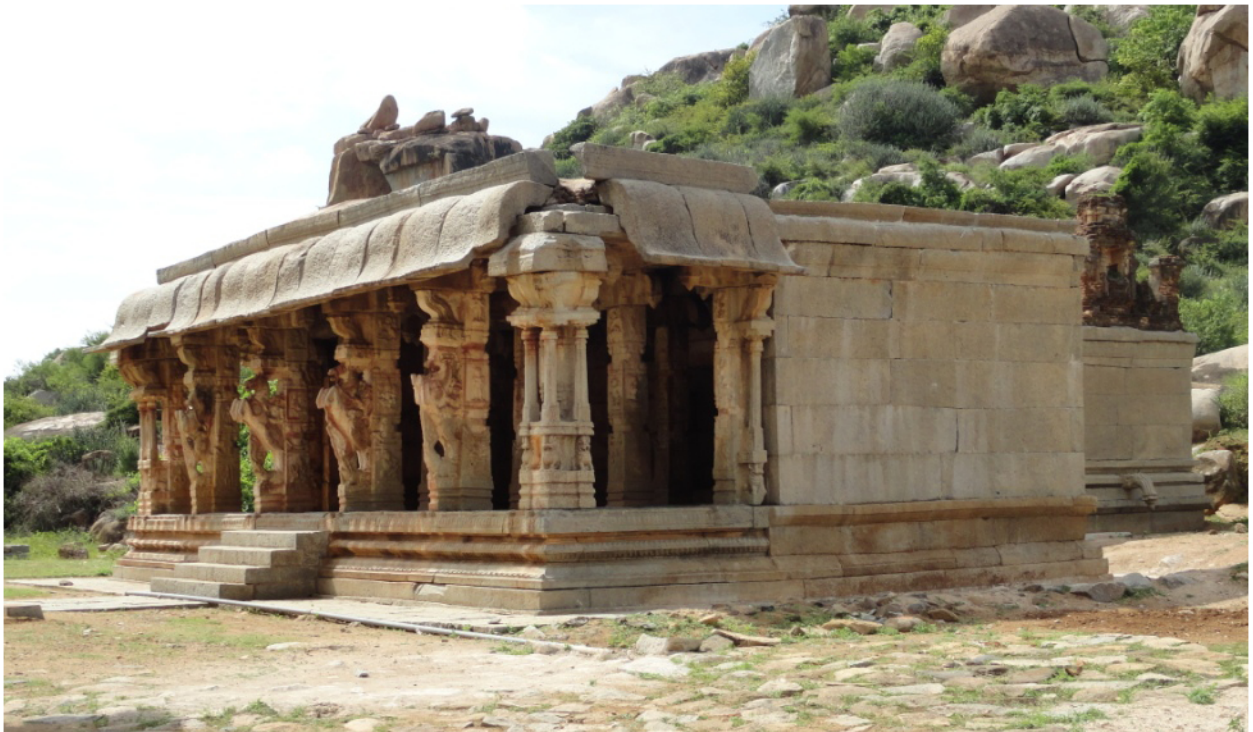
**Figure no. 18: Post conservation condition of Kudure gombe Mandapa (2012)**

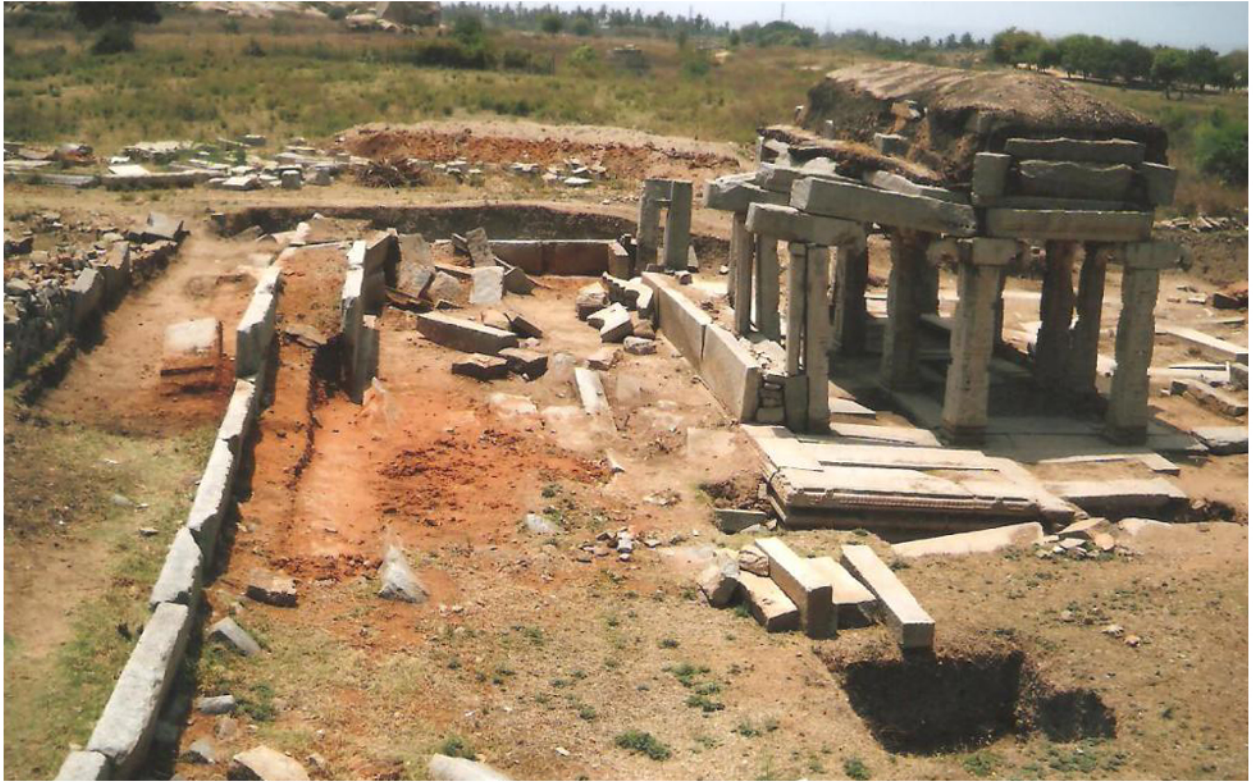
**Figure no. 19: State of Conservation of the Ranganatha Temple Complex (2010)**

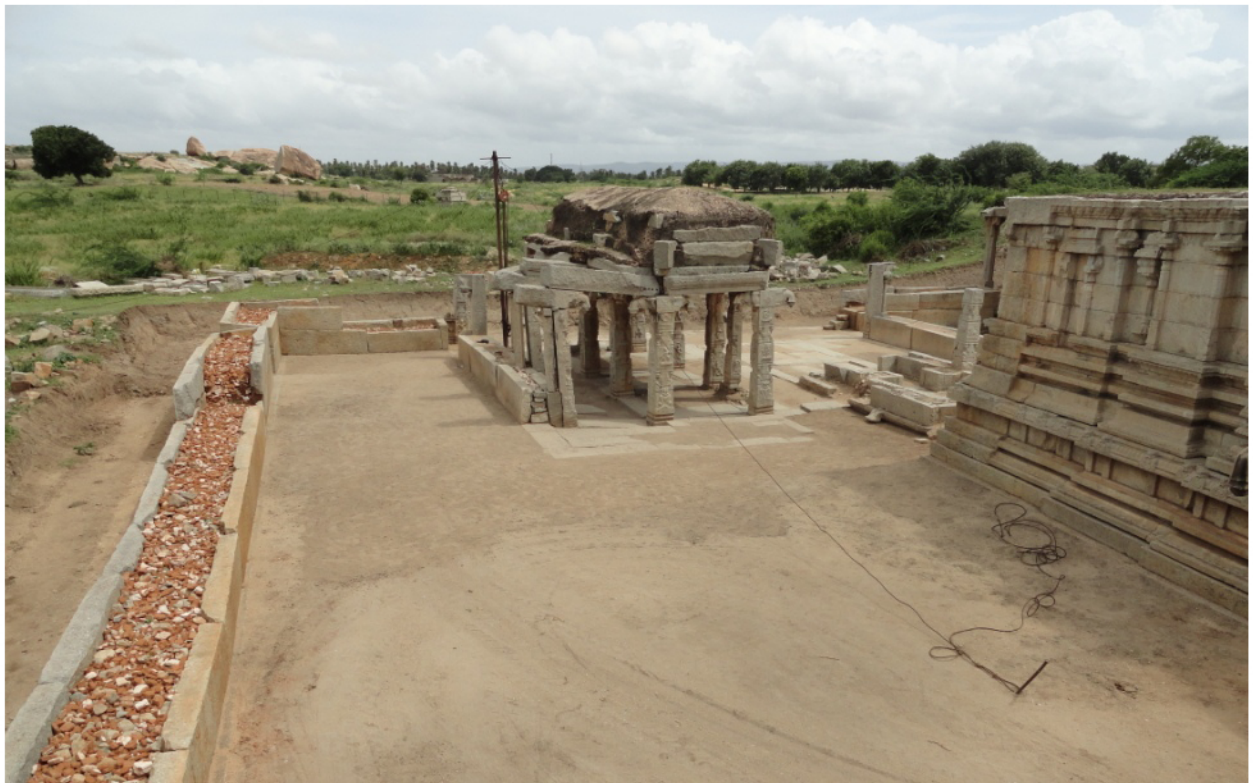
**Figure no. 20: Post Conservation condition of Ranganatha Temple Complex (2012)**

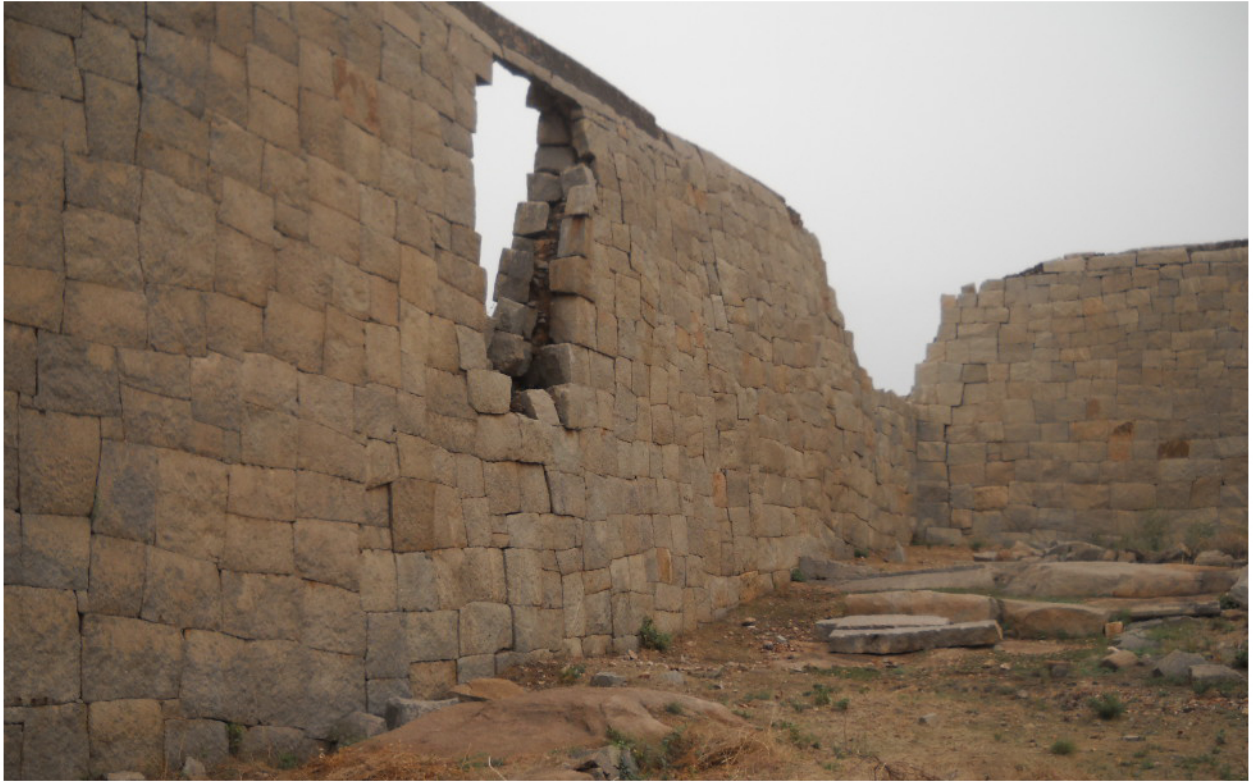
**Figure no. 21: State of Conservation of the walls enclosing Zenana (2010)**

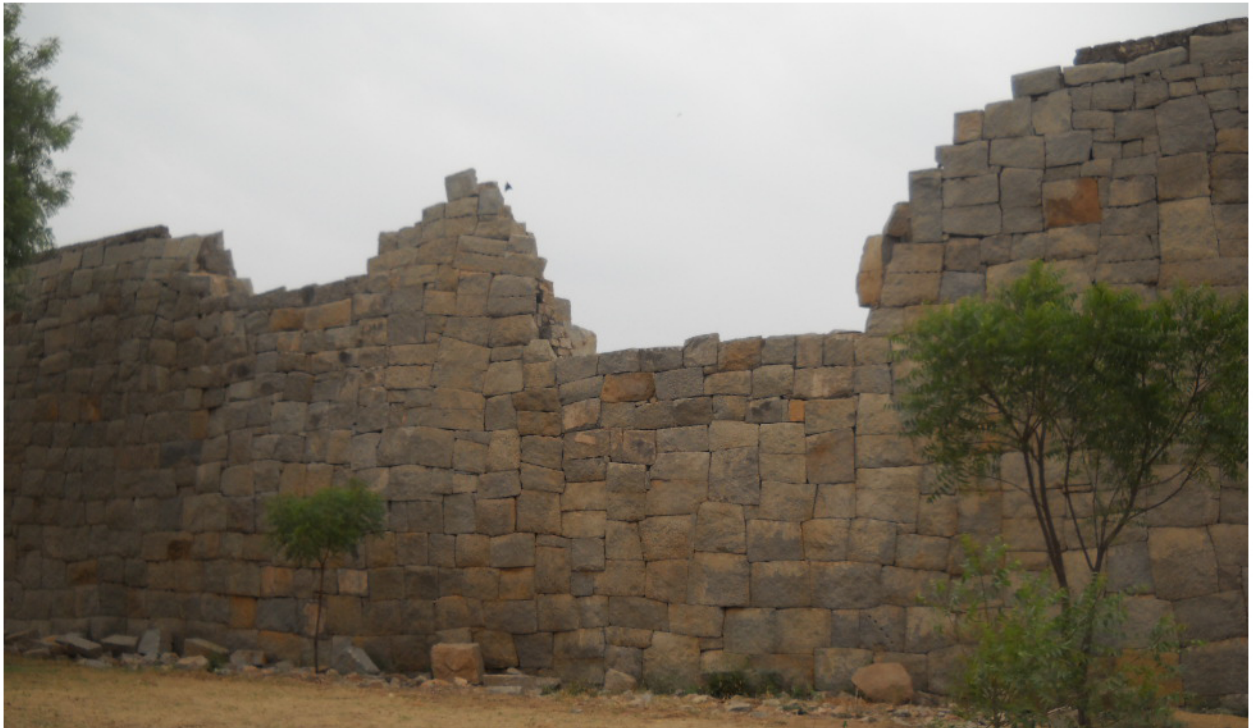
**Figure no. 22: State of Conservation of the walls enclosing Zenana (2010)**

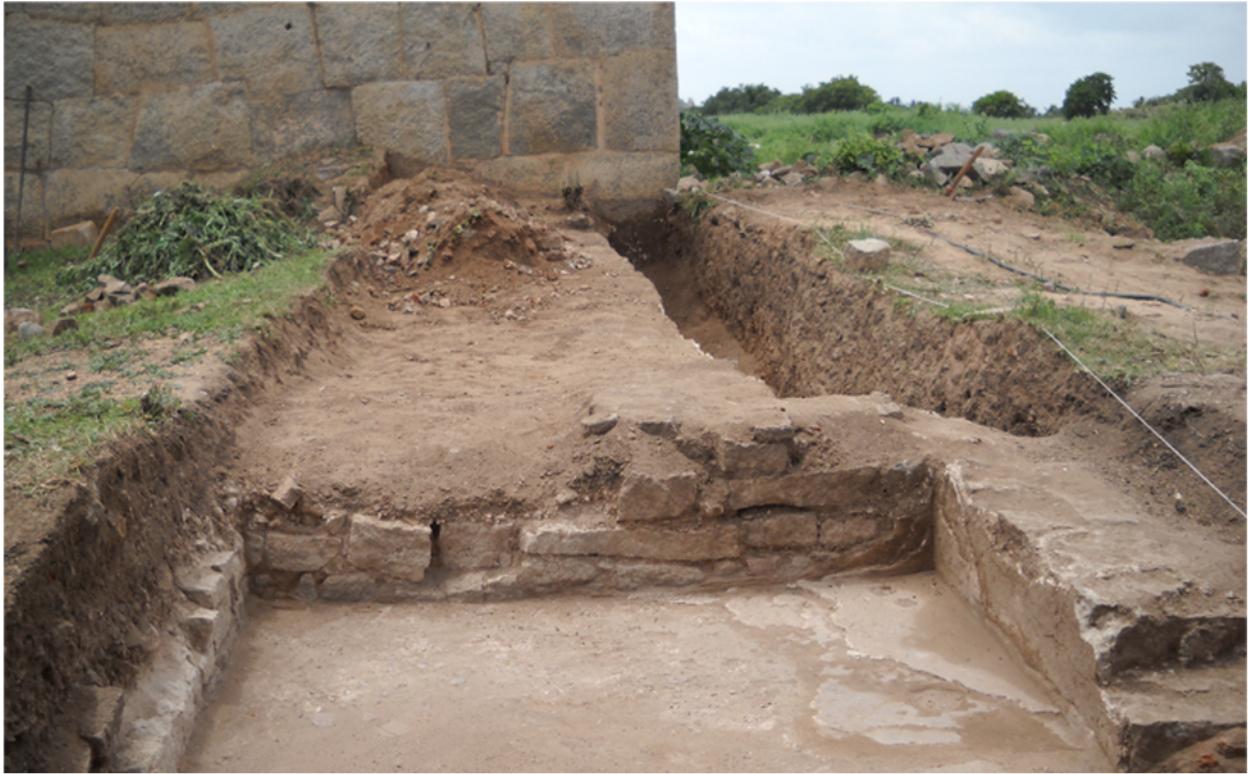
**Figure no. 23: Scientific clearance within the walls enclosing Zenana (2010)**

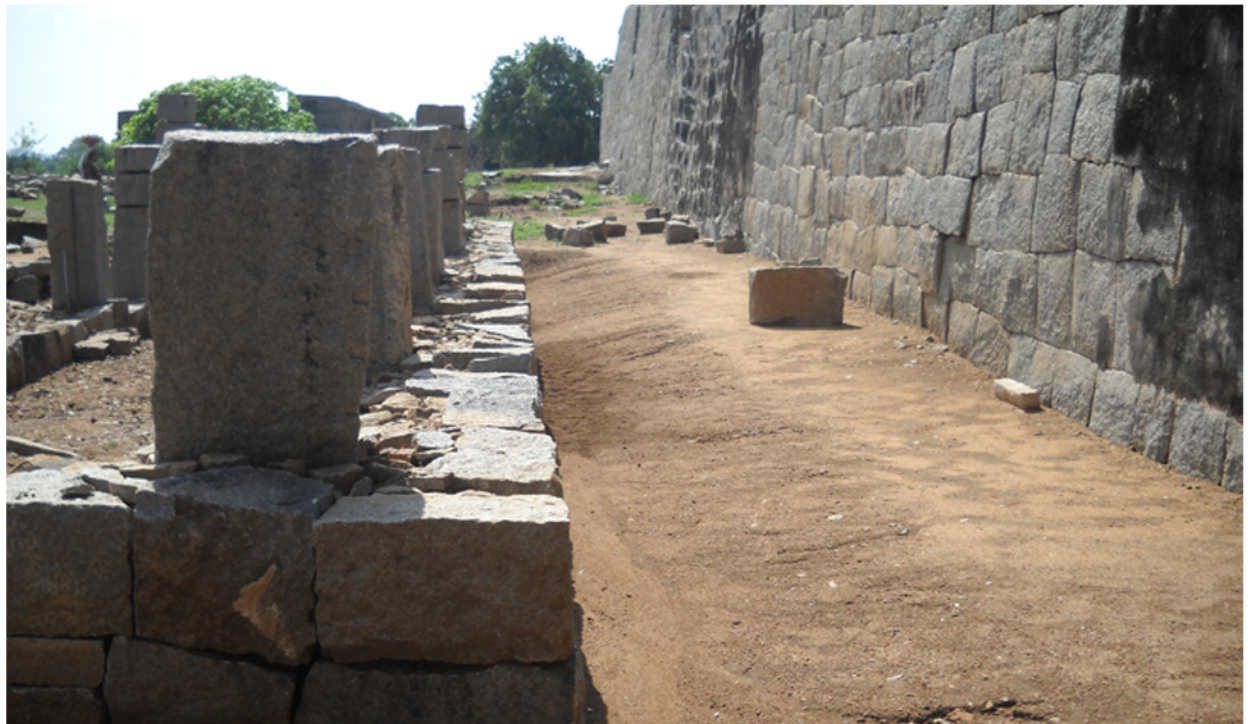
**Figure no. 24: State of Conservation of the walls enclosing Zenana (2010)**

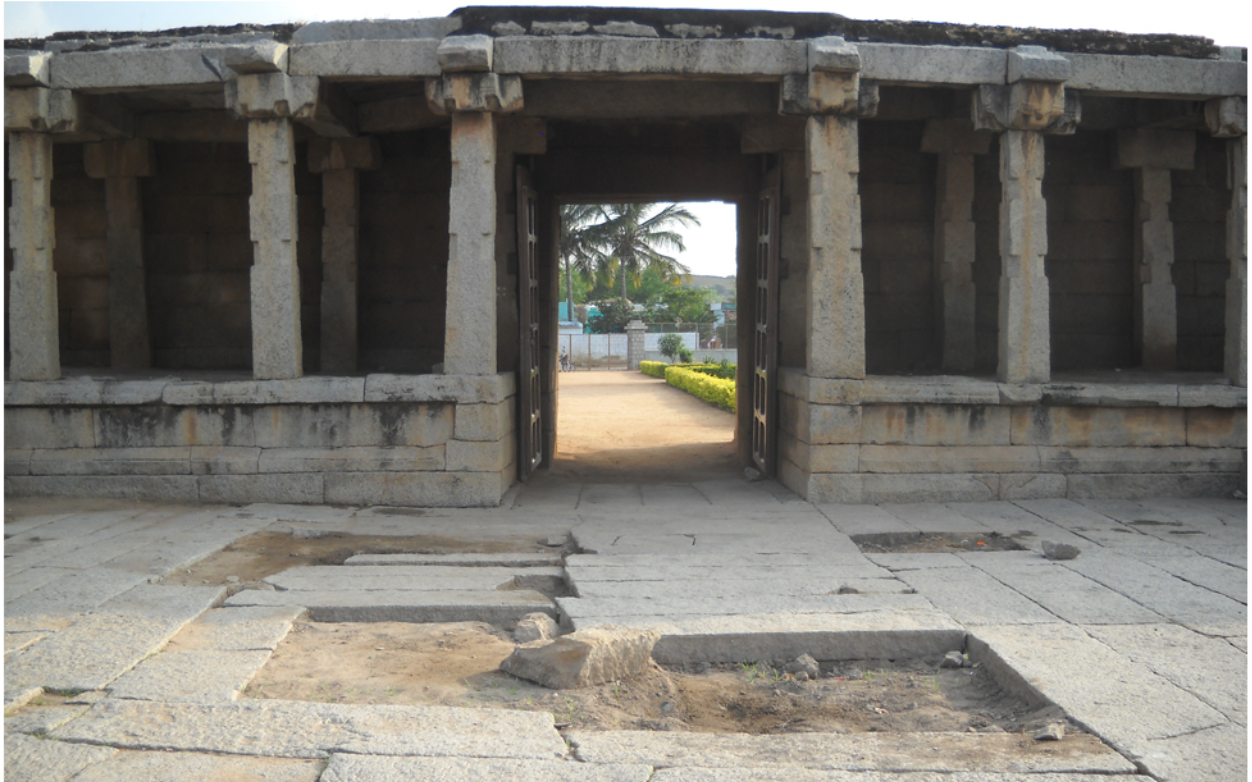
- Pavement in the temple ground uneven with several damaged and dislodged stones affecting the drainage and causing water stagnation.

**Figure no. 25: State of conservation of stone paving in Pattabhirama Temple Complex (2010-11)**  
*Source: Archaeological Survey of India, Hampi Mini-Circle.*

- Dismantling the existing stone paving to remove broken/damaged and dislodged slabs.
- Level corrections with infills and debris removal wherever necessary.
- Resetting dismantled stone paving and providing new stone paving similar to the existing paving along the edges of the temple plinth and at a few areas where missing/damaged.

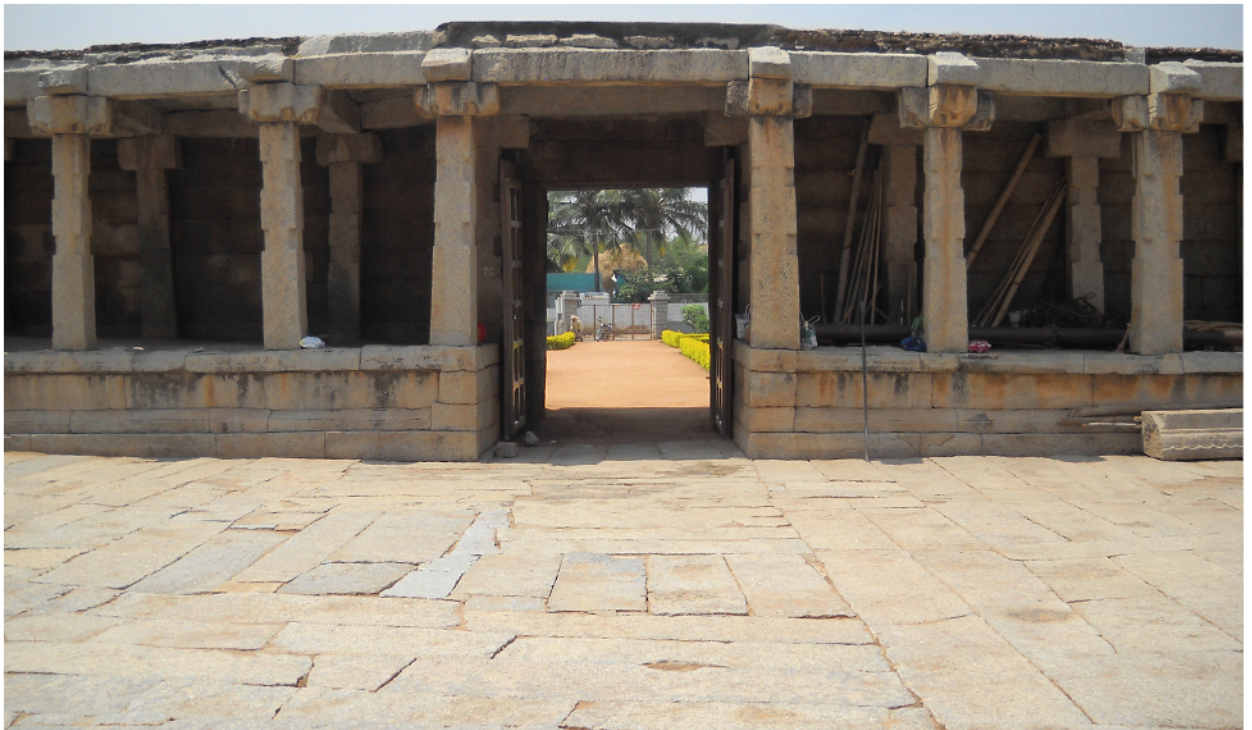
**Figure no. 26: Conserved (reset) of stone paving in Pattabhirama Temple Complex (2011-12)**  
*Source: Archaeological Survey of India, Hampi Mini-Circle.*
