# State of Conservation 2016

## **Group of Monuments at Hampi (241 bis)**

State Party: India

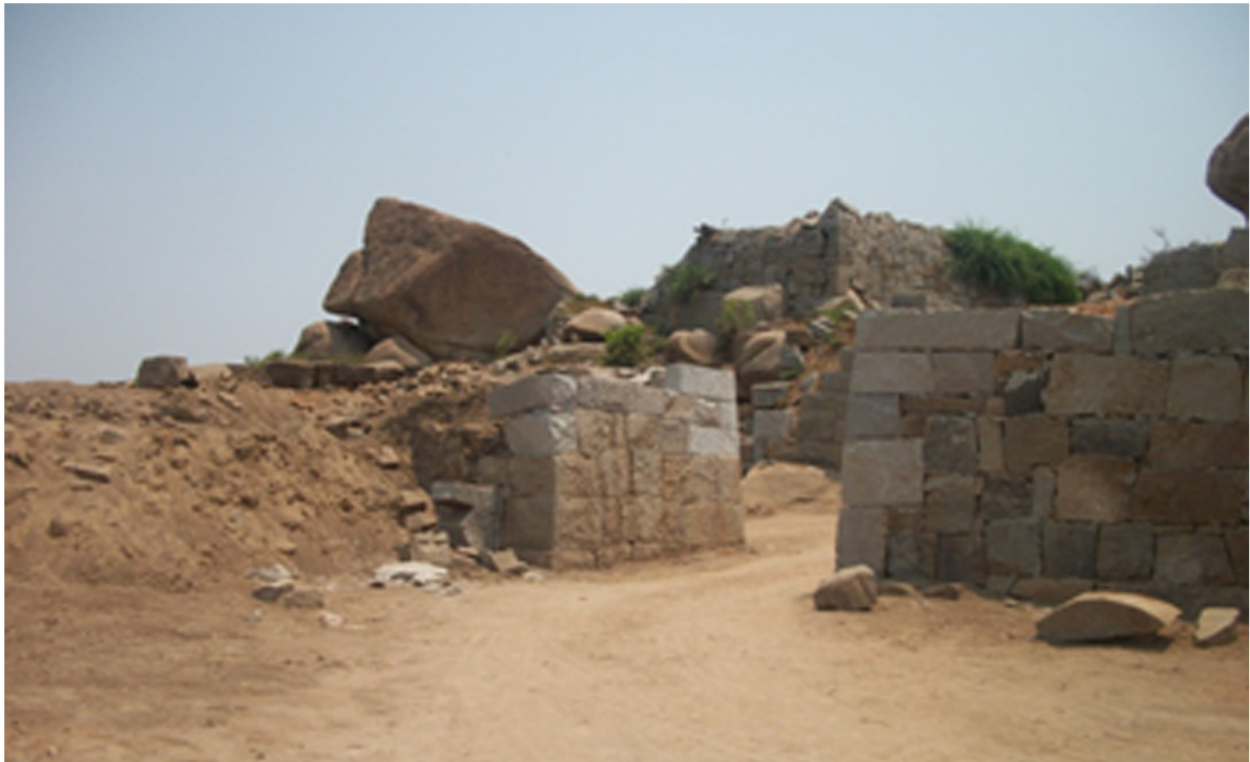
**Figure no. 28: State of Conservation of the Fort wall (2012)**

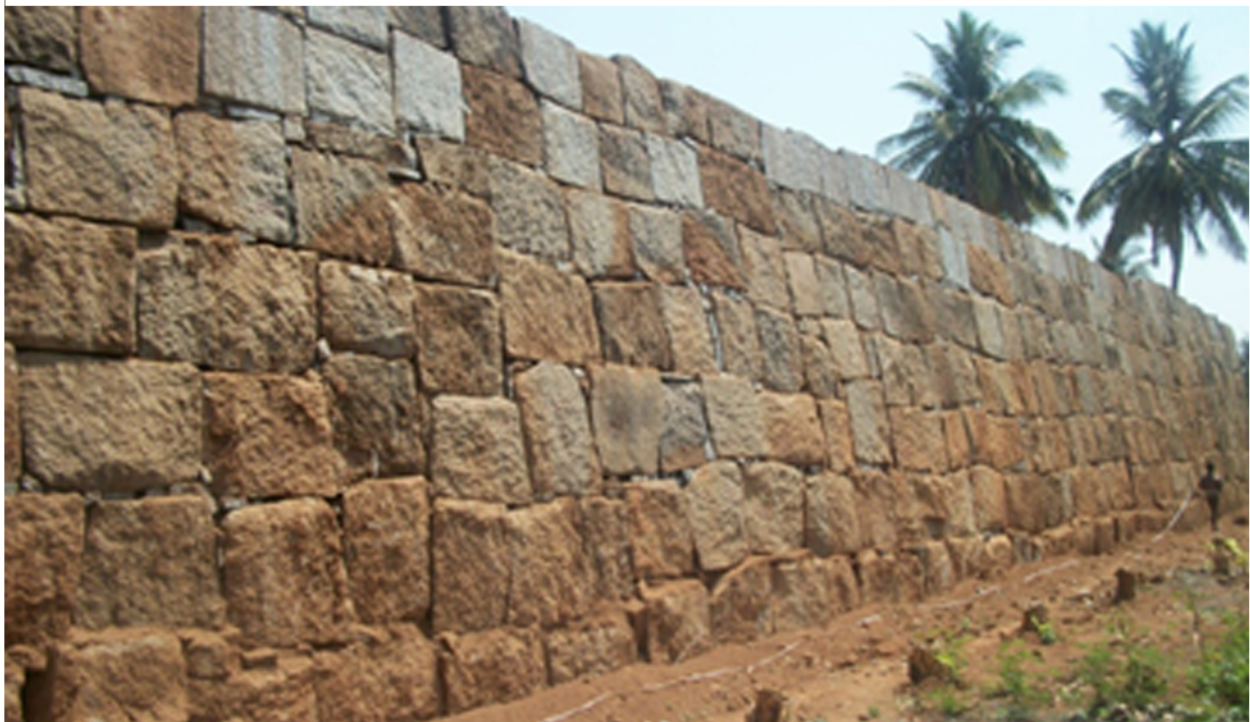
**Figure no. 29: State of Conservation of the Fort wall (2012)**

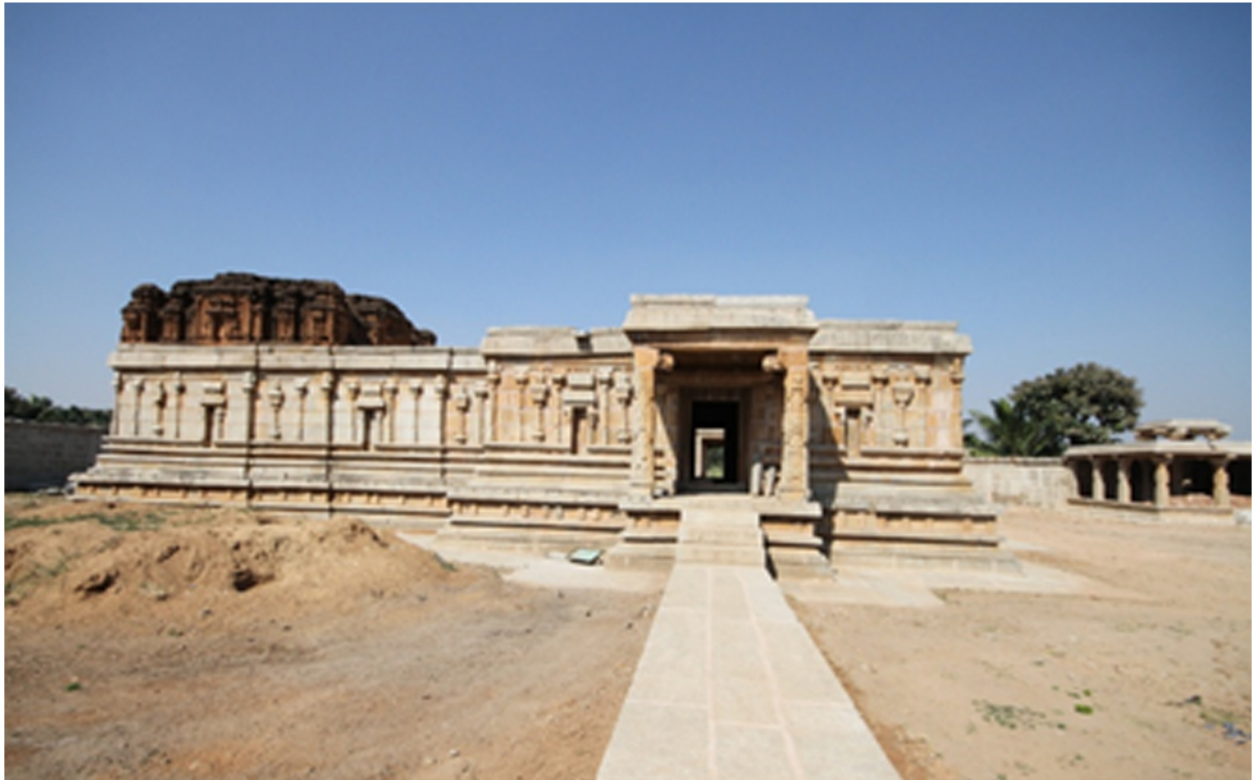
**Figure no. 30: State of Conservation of the Chikkamanagudi at Kamalapura (2012)**

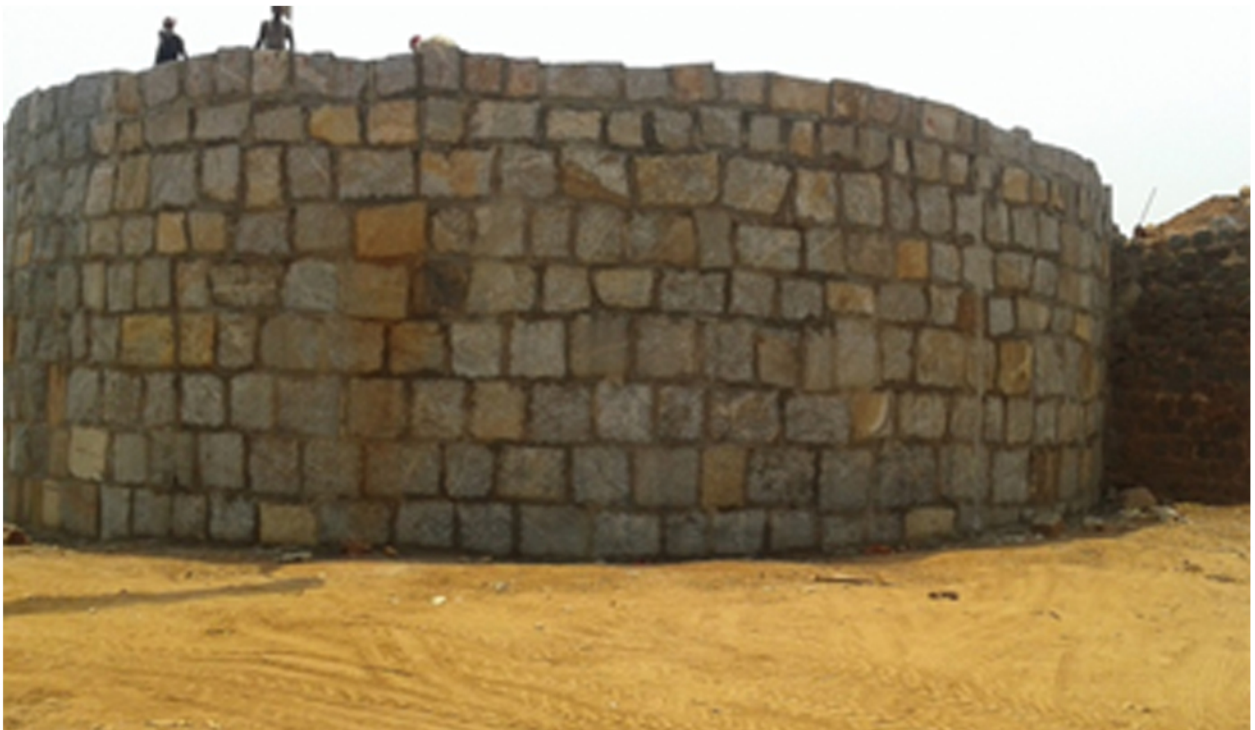
**Figure no. 31: State of Conservation of the Fort wall at Sandur (2012)**

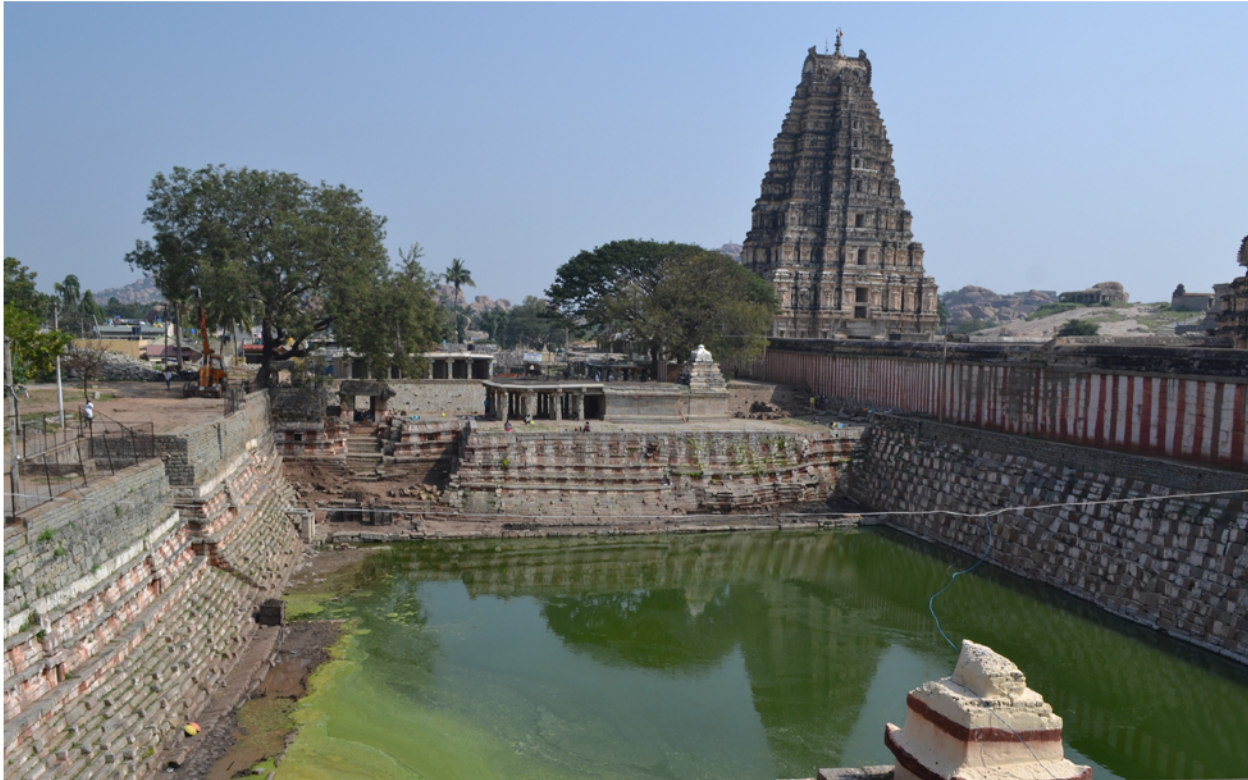
**Figure no. 32: State of Conservation of Pushkarani in Virupaksha temple complex (2014)**

- Clearance of debris and accumulated mud from the steps.
- Dismantling the displaced and damaged steps
- Restoring the steps by resetting the steps and replacing damaged stone blocks with new dressed stones

- Restoring the flanking course of stone slabs around the edges of the well by replacing missing and damaged stones

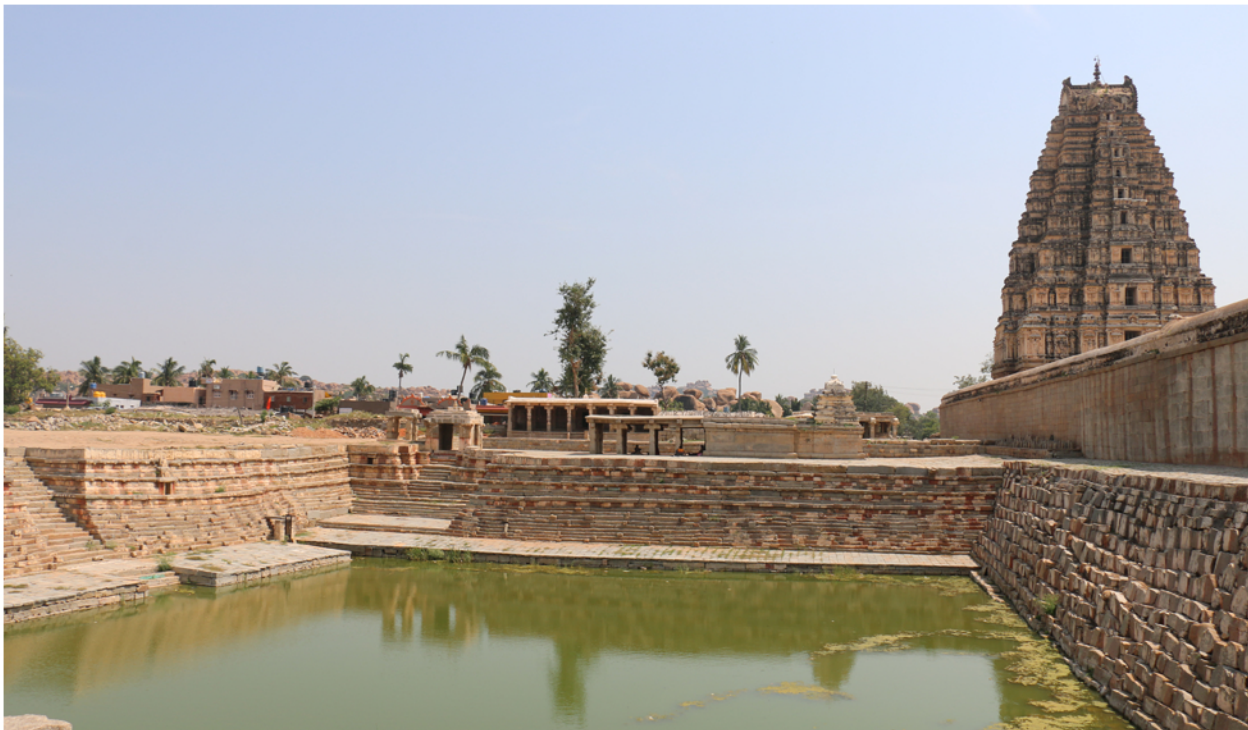
**Figure no. 33: Post conservation condition of Pushkarani in Virupaksha temple complex (2015)**
