STATE OF CONSERVATION

TOMBS OF BUGANDA KINGS AT KASUBI(UGANDA)

PROPERTY ID NO C1022

1stFEBRUARY 2017

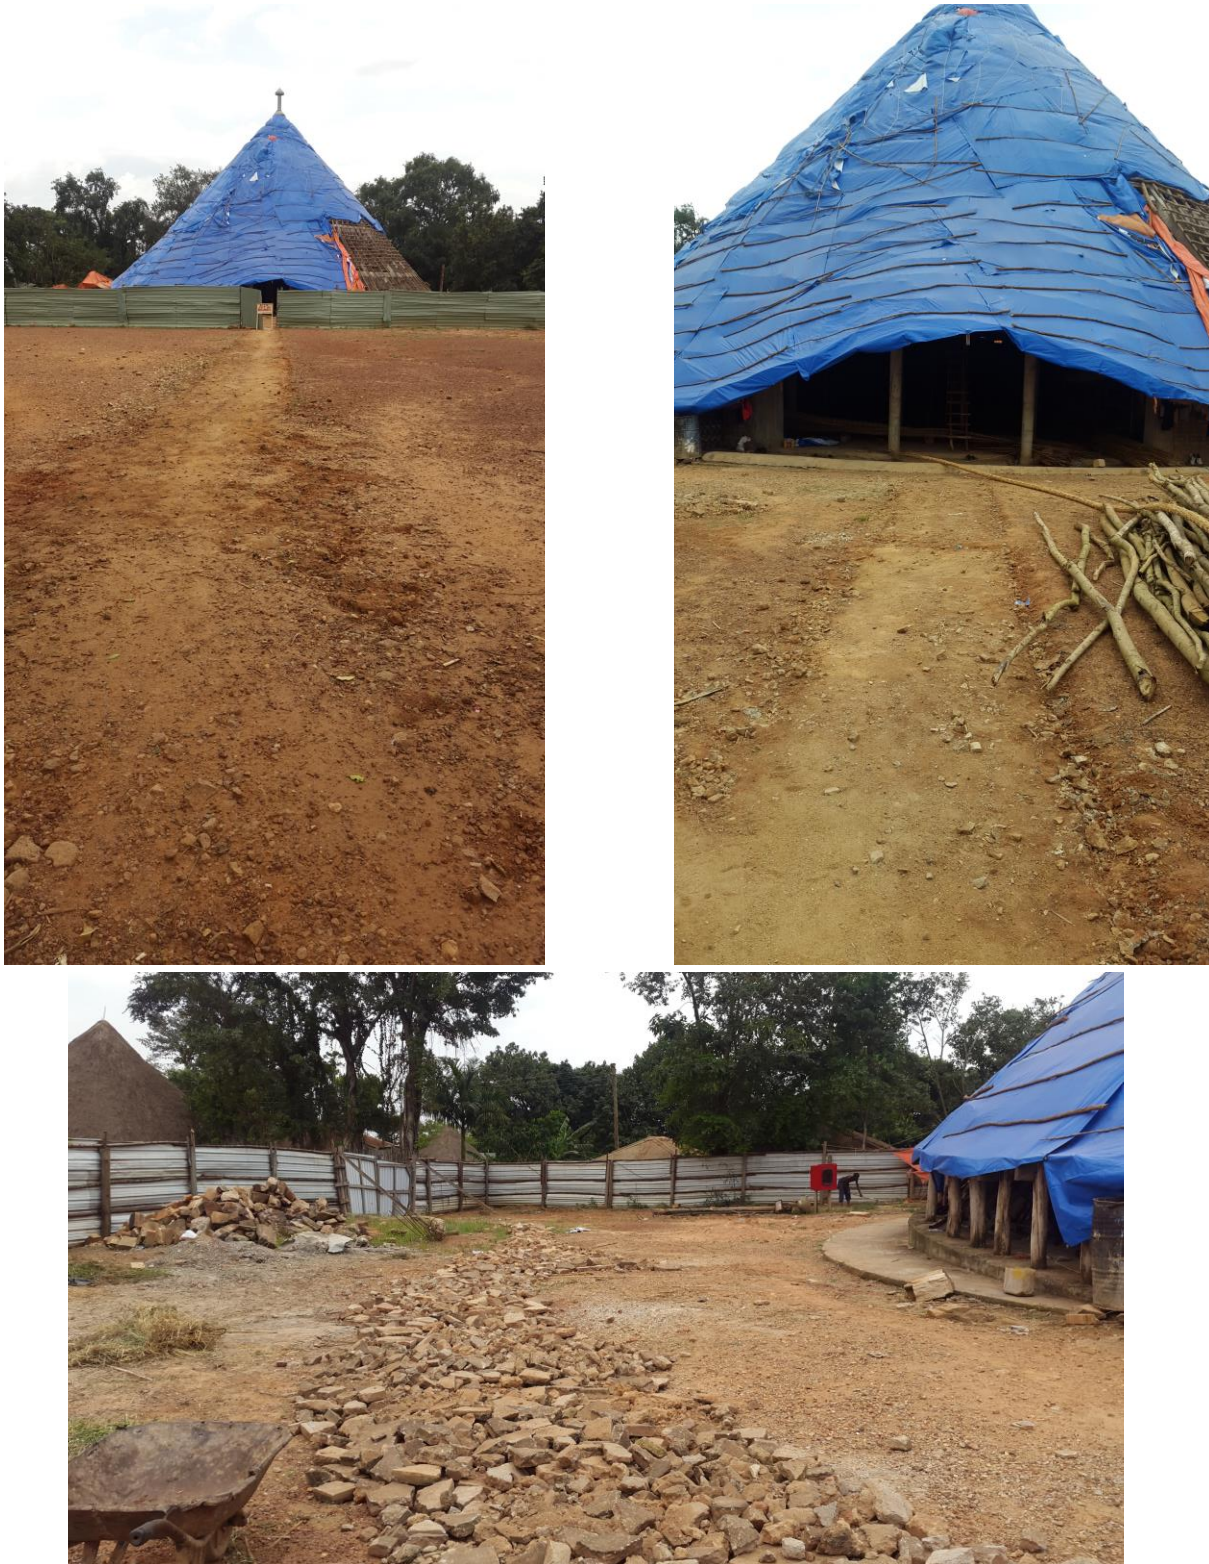
The broken and chipped concrete pavers that accentuated the approach to Muzibu Azaala Mpanga, running from Bujjabukula, were not a presentable sight for such a site. The Chairman advised that they are removed, and since the plan, during the landscaping phase is to leave the compound as bare as it was before these pavers were installed, the Project Manager agreed.

The debris was used to temporarily fill the gullies that run around Muzibu Azaala Mpanga due to erosion. These had made it unsafe to circulate and navigate the site.

Fig.1: the walkway was cleared, pavers removed and used to fill the deep erosion gullies around Muzibu for better navigation around the site.

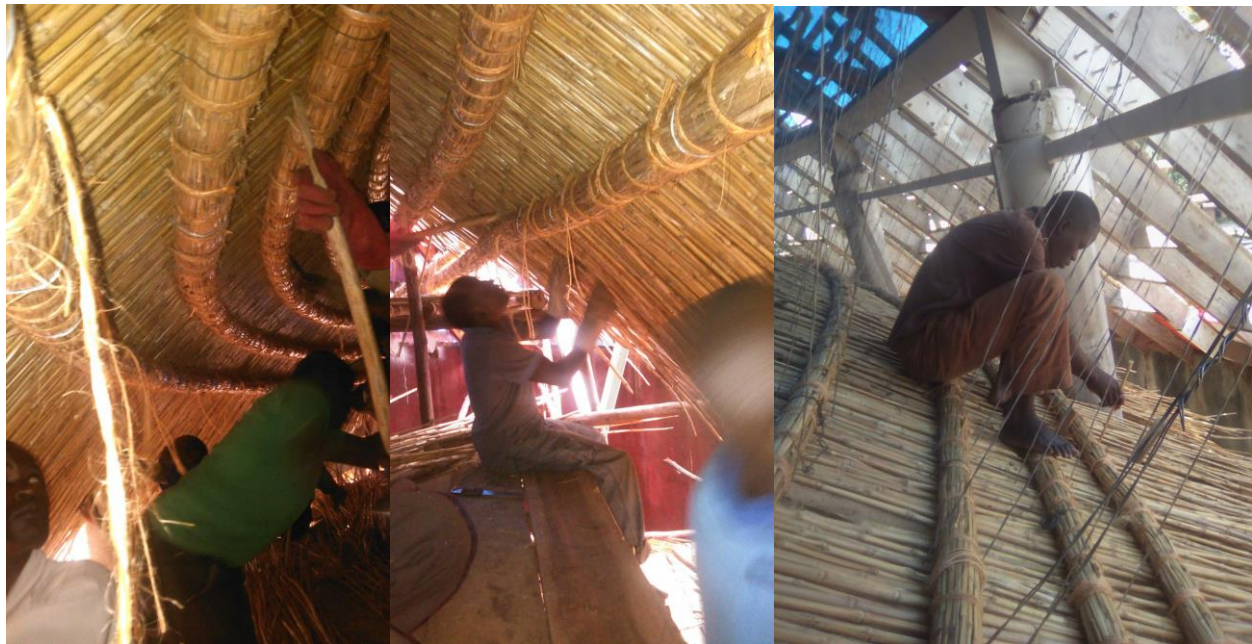
Fig. 2c: artisans working on the ceiling, the process of pushing in reeds in the reed bed to fill any gaps for compactness.

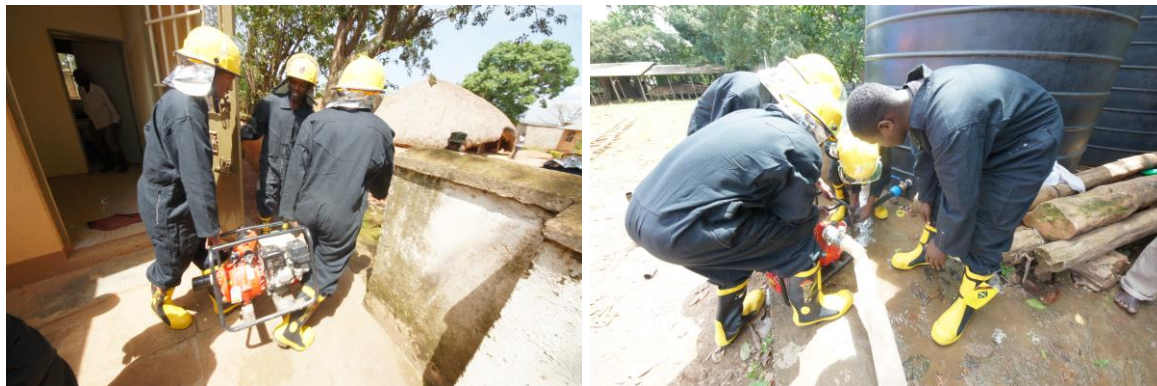
Fig. 7: Training in session: the artisans rush the pump to the site and connect to the tanks

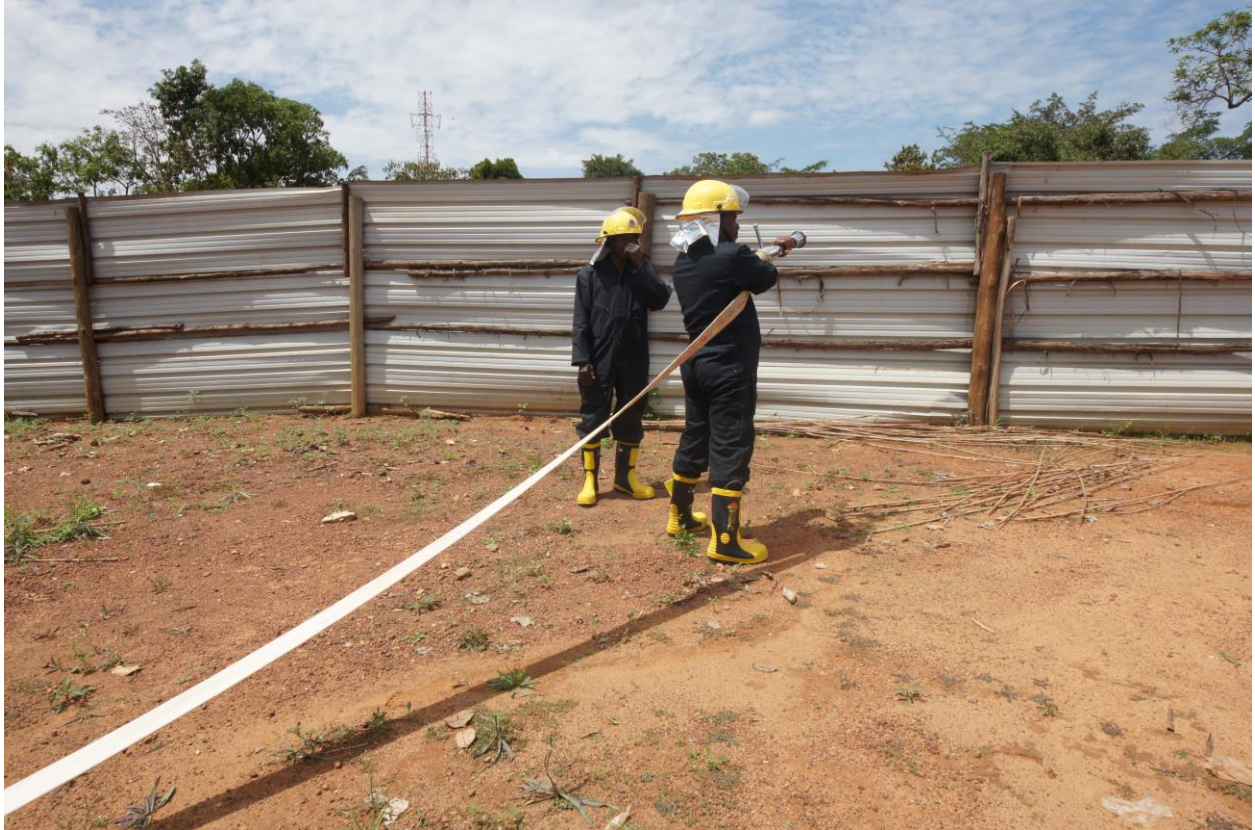
Fig.8a: Firefighting training: using the hose pipe

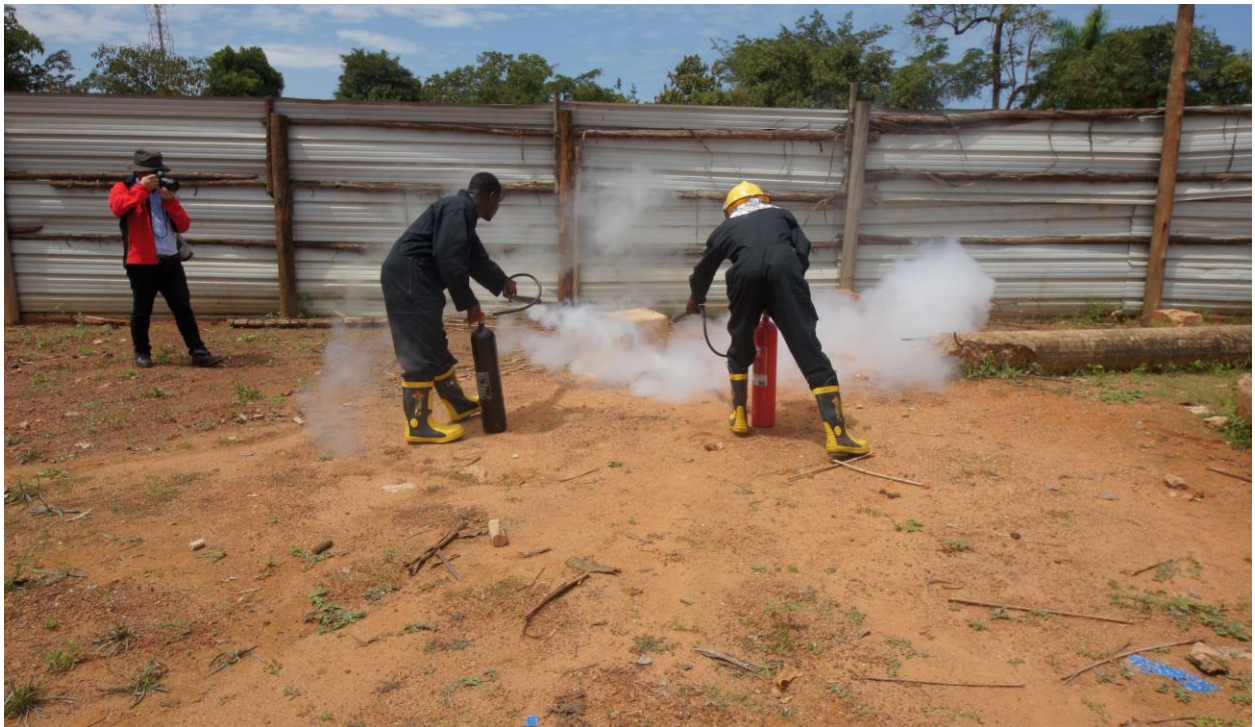
Fig.8b: Firefighting training: using the extinguishers.
(Photos above by J. Hasegawa)

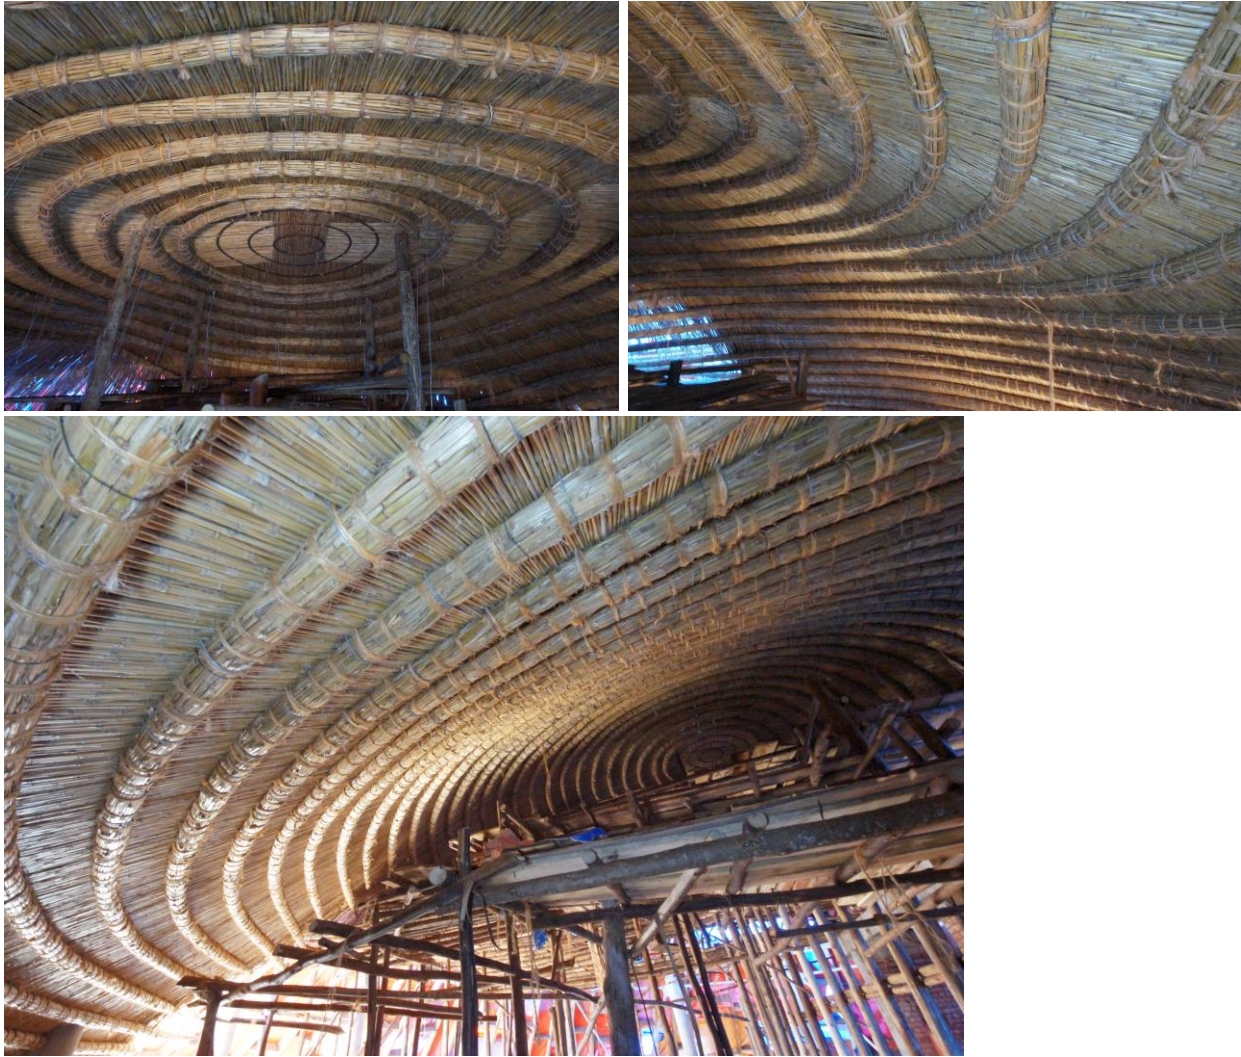
Fig. 9: ceiling progress as taken by J. Hasegawa (photos by J. Hasegawa)

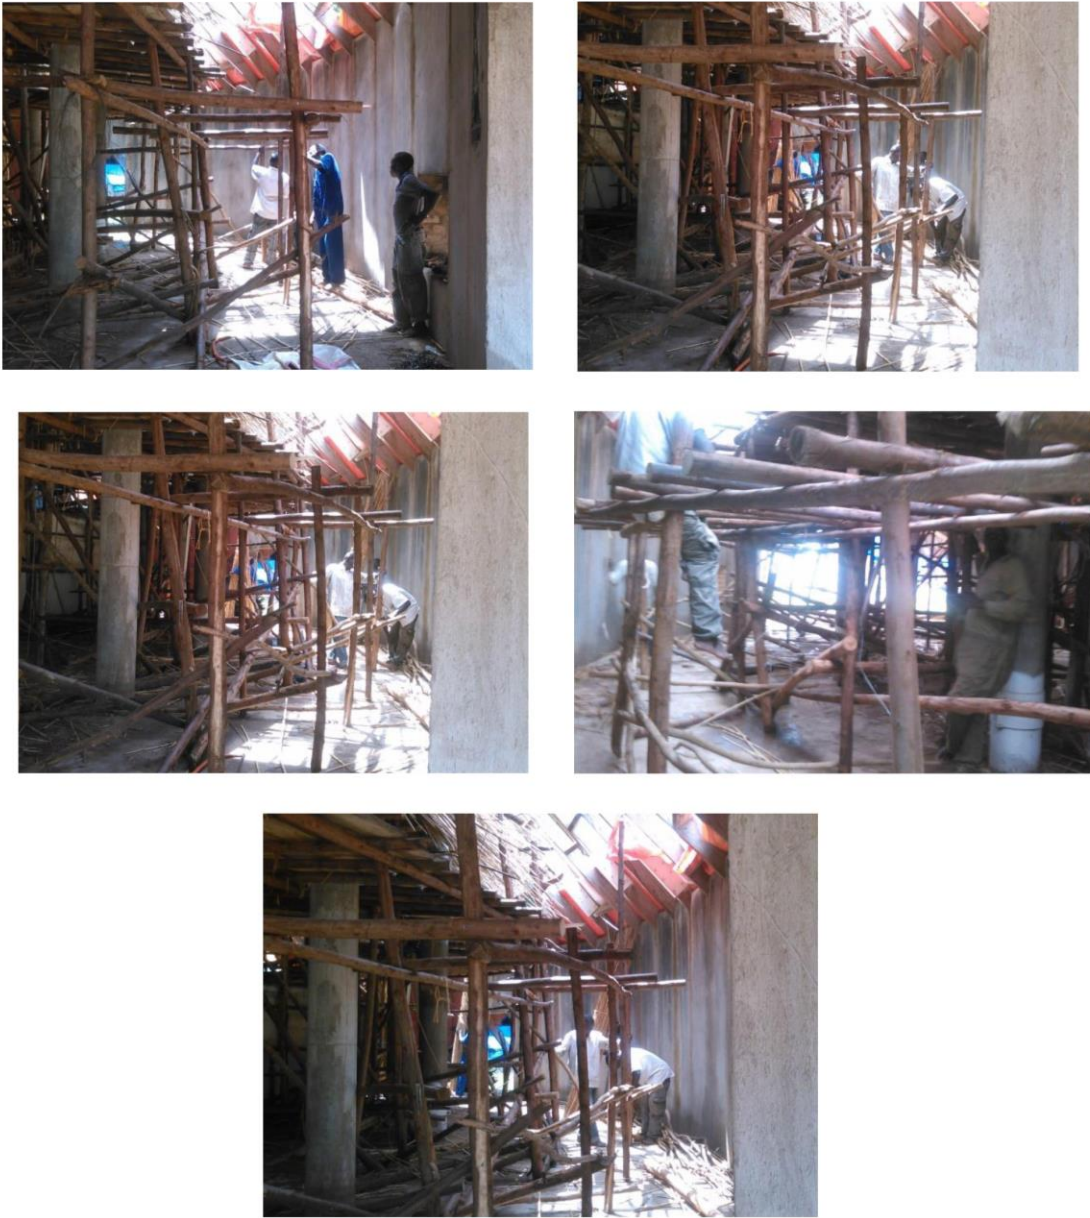
Figure 1: Workers fixing timber scaffolds

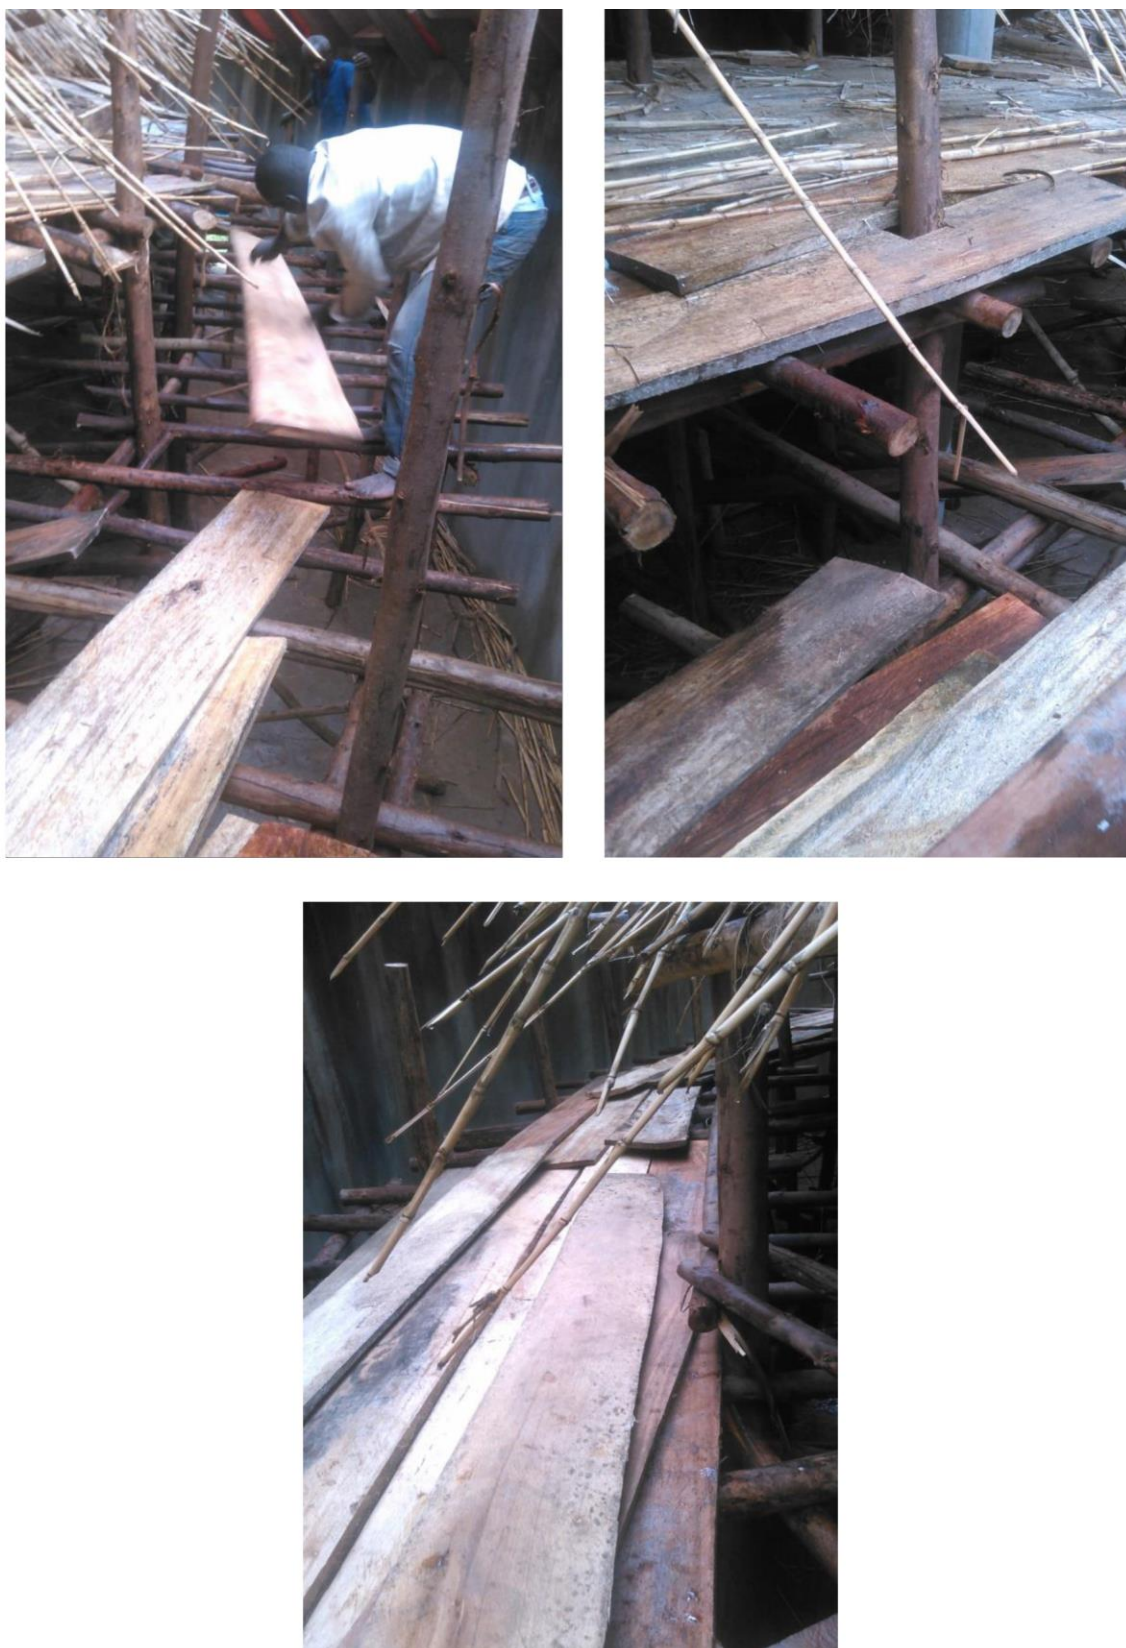
Figure 2: Placing the timber platforms to ease movement as work progresses

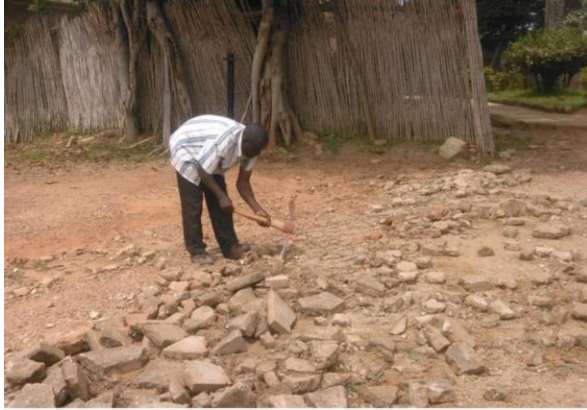
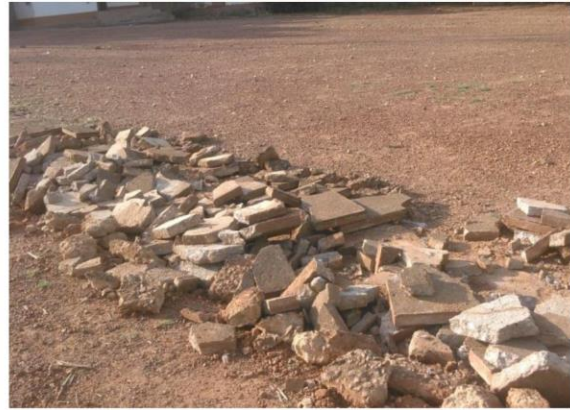
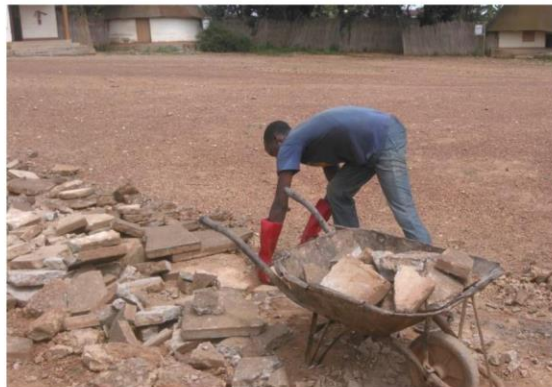
Figure 1: Working removing the broken pavers

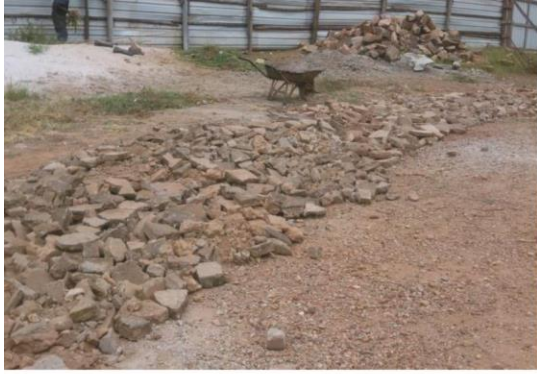
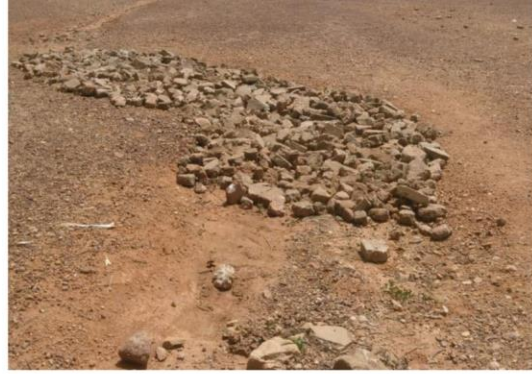
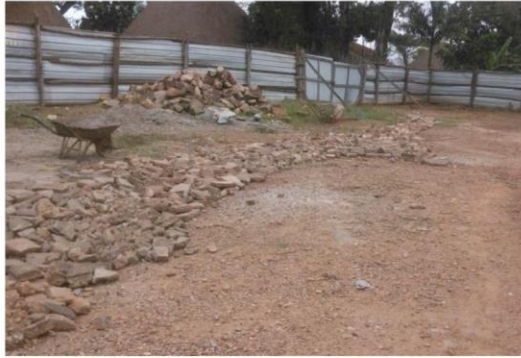
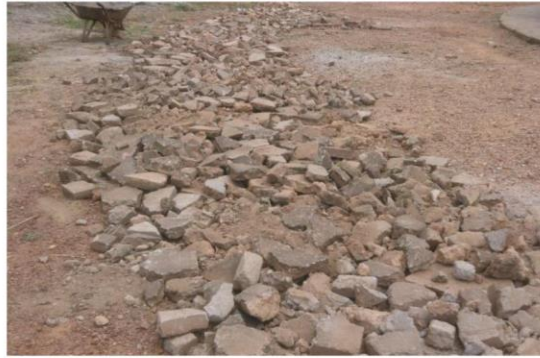
Figure 2: Broken pavers removed and placed in gulleys around site

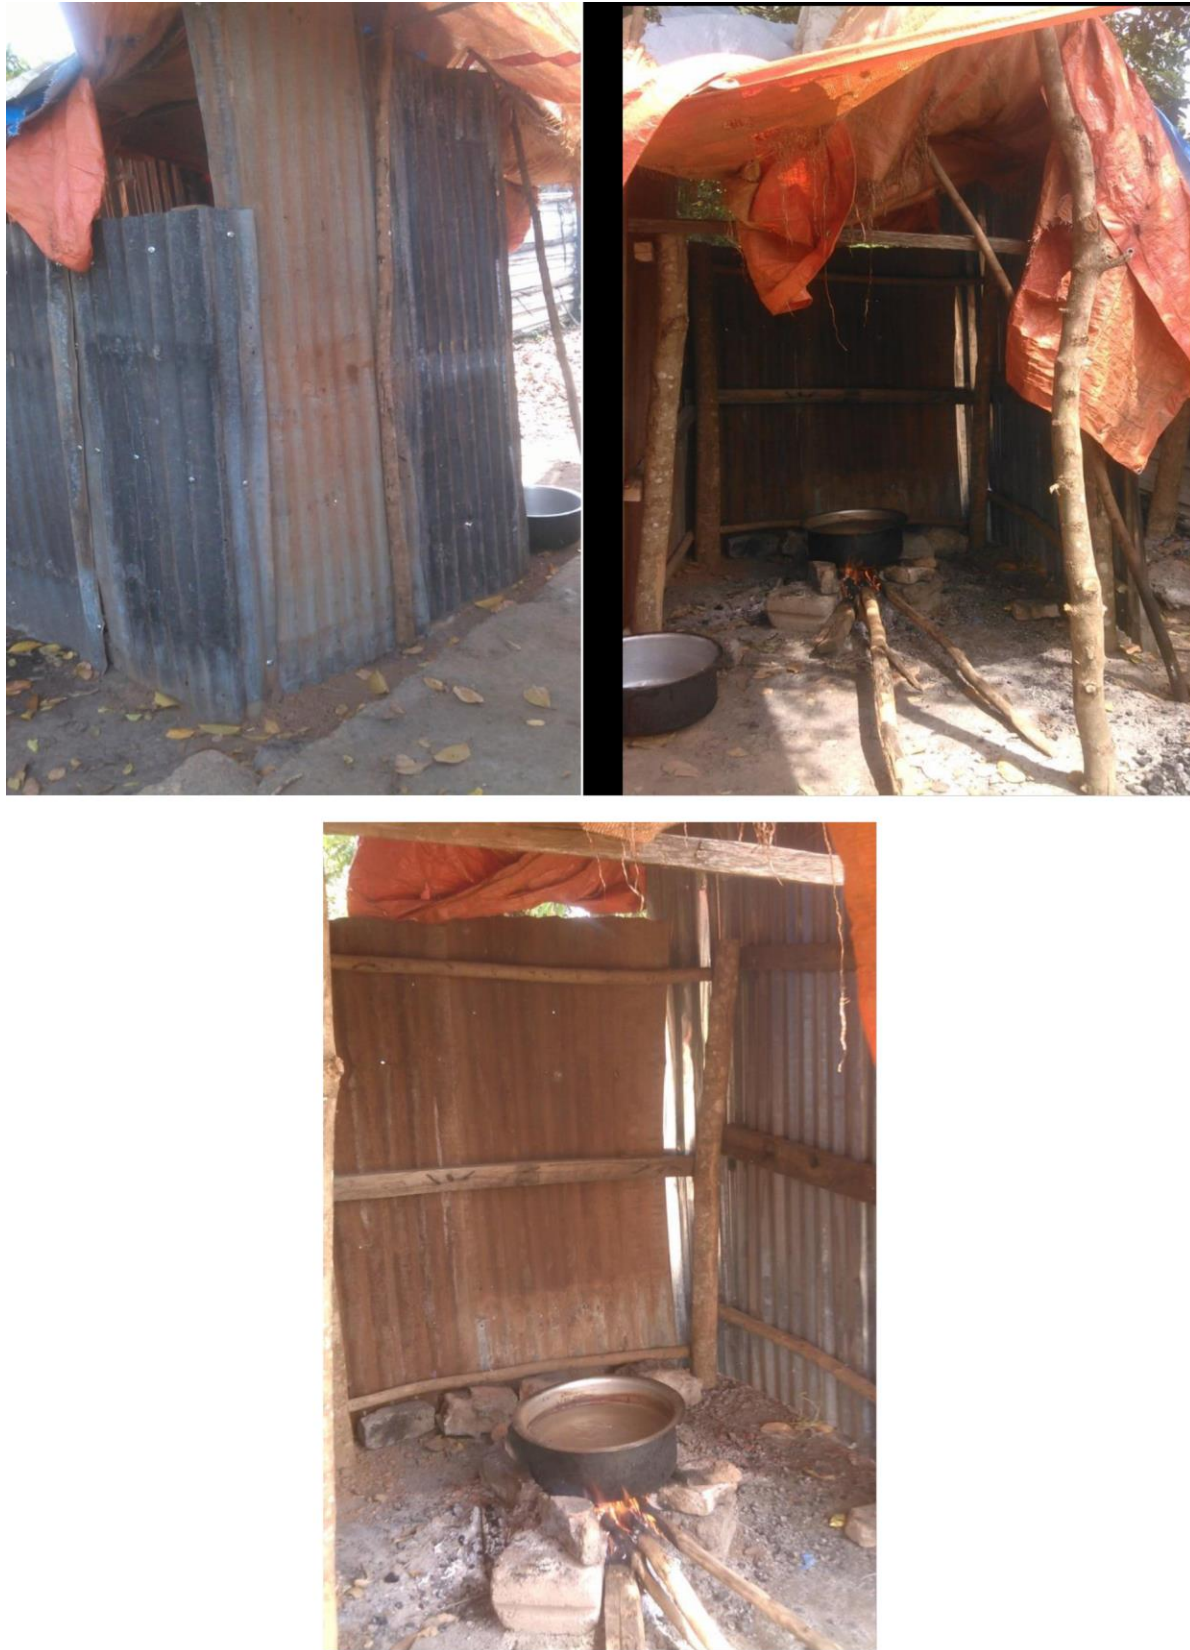
Figure 5: Hoarding fixed around the cooking area

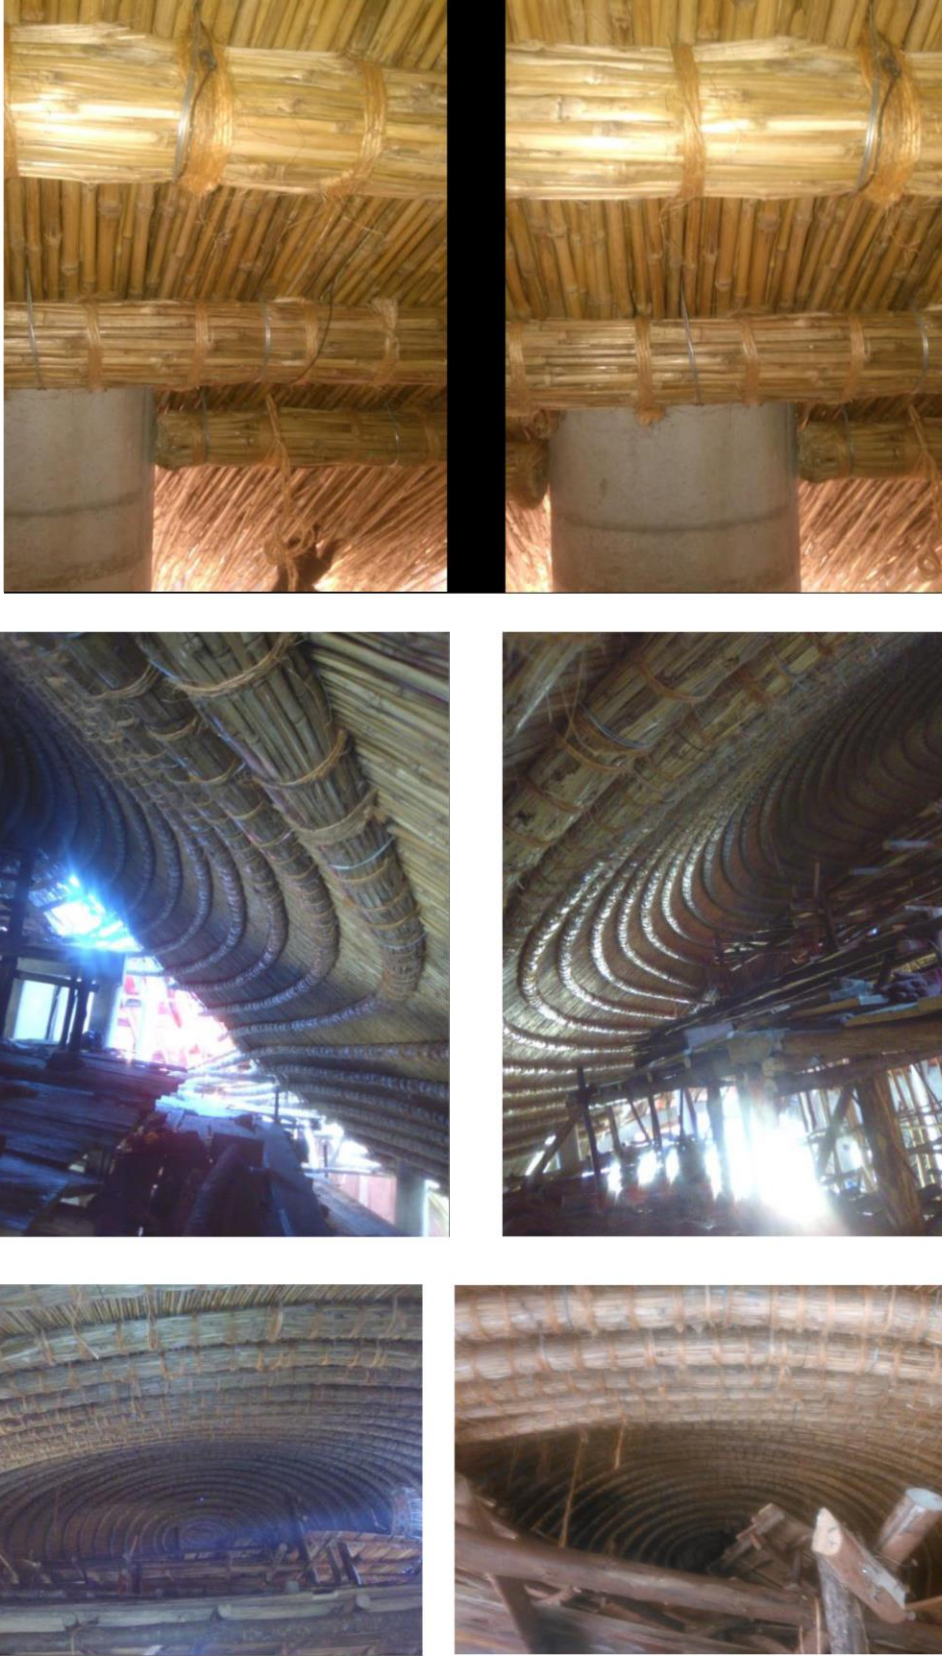
Figure 5: Ceiling works so far

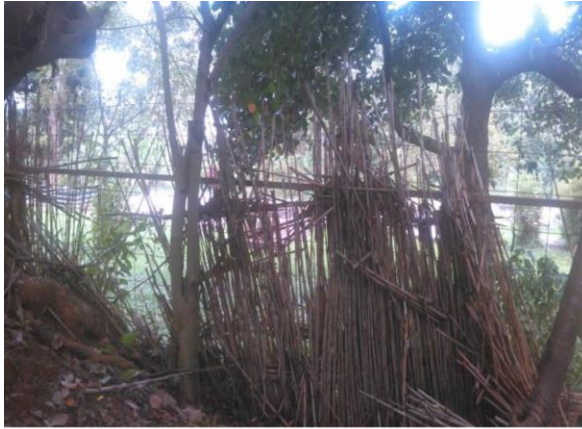
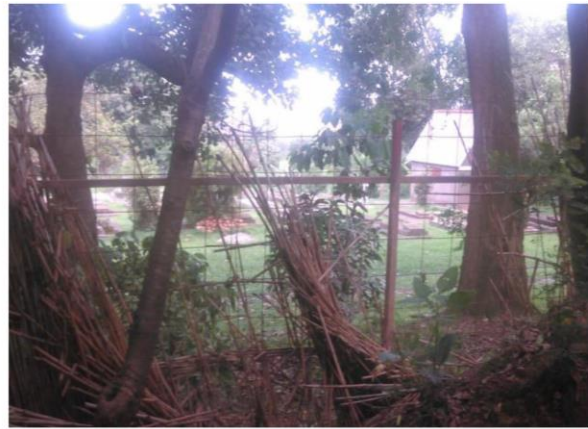
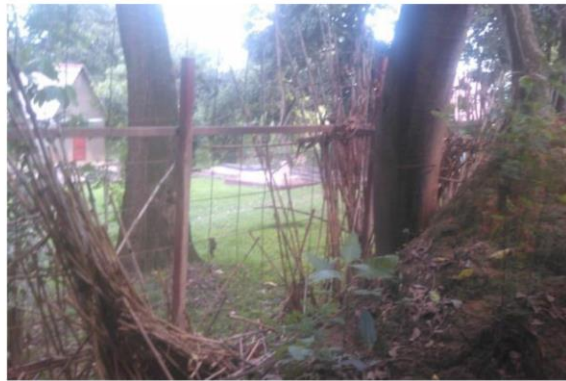
Figure 8: Hoarding behind the shed damaged

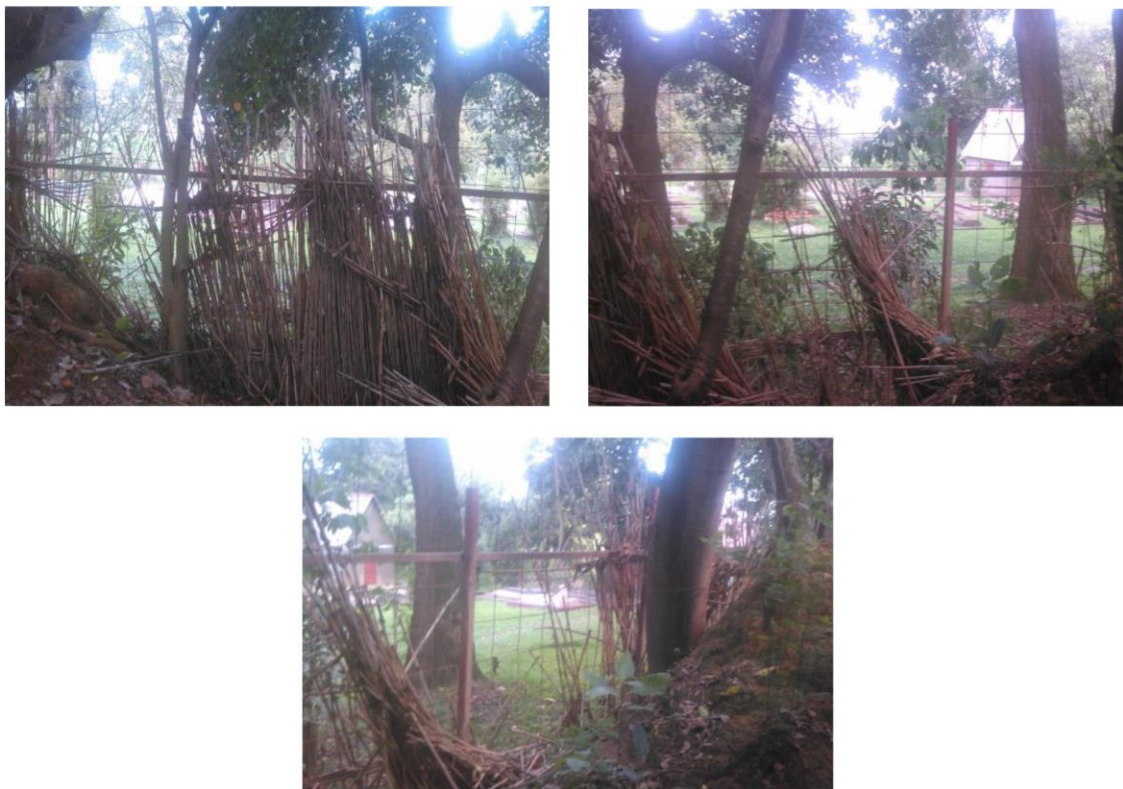
Figure 1: Hoarding behind the shed damaged

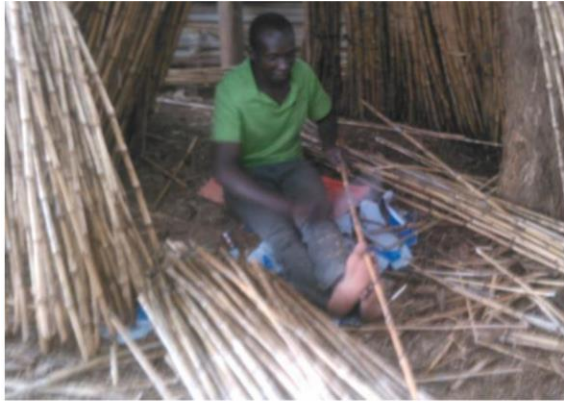
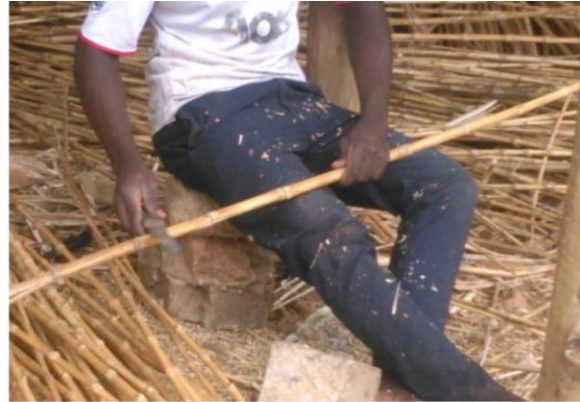
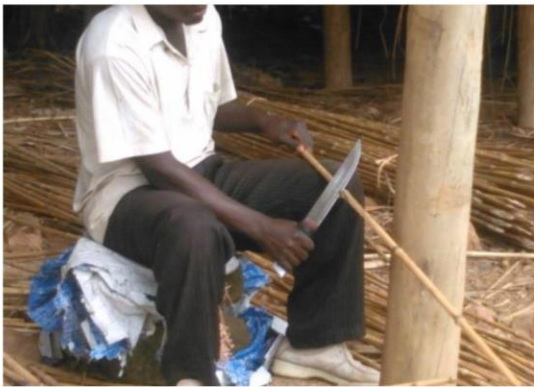
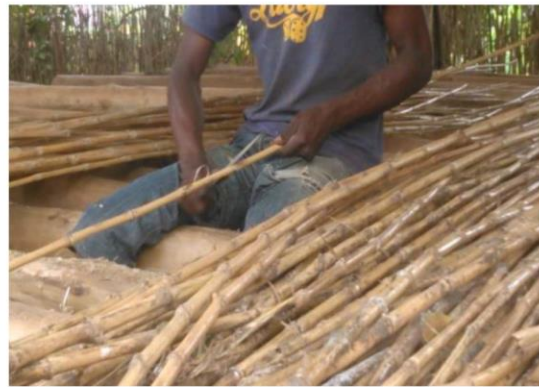
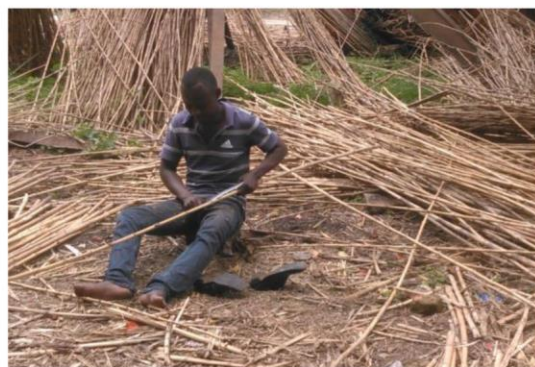
Figure 2: Removing nodes off the reeds

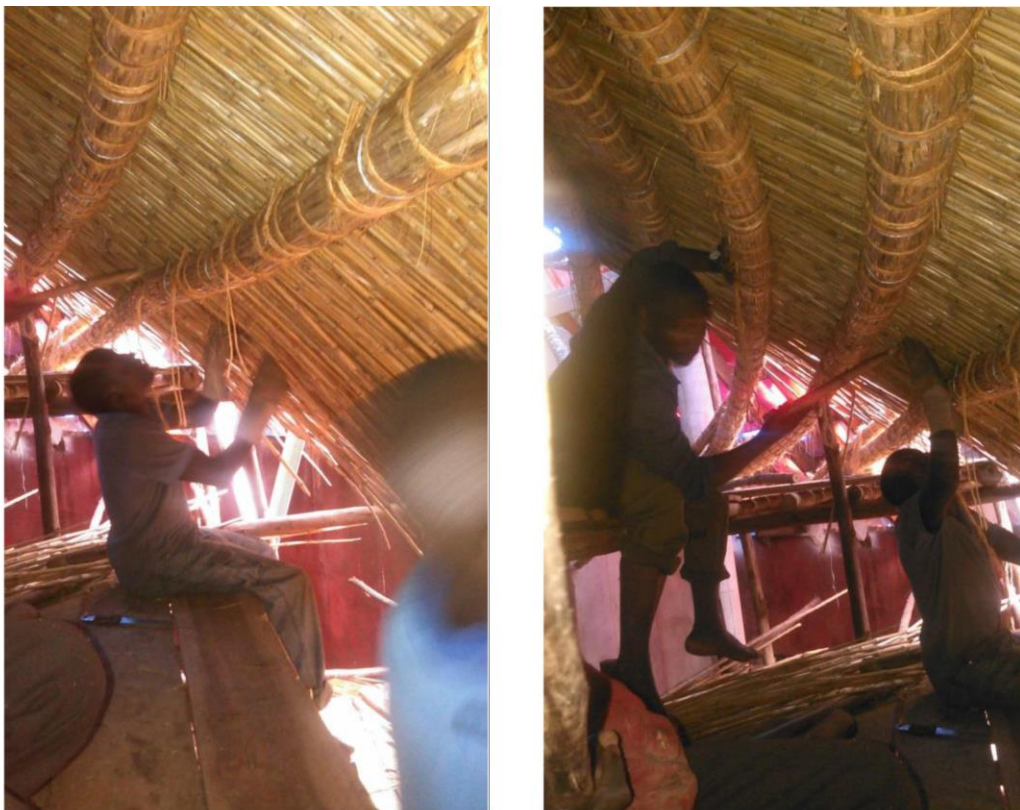
Figure 5: Fixing and aligning reeds for the ceiling

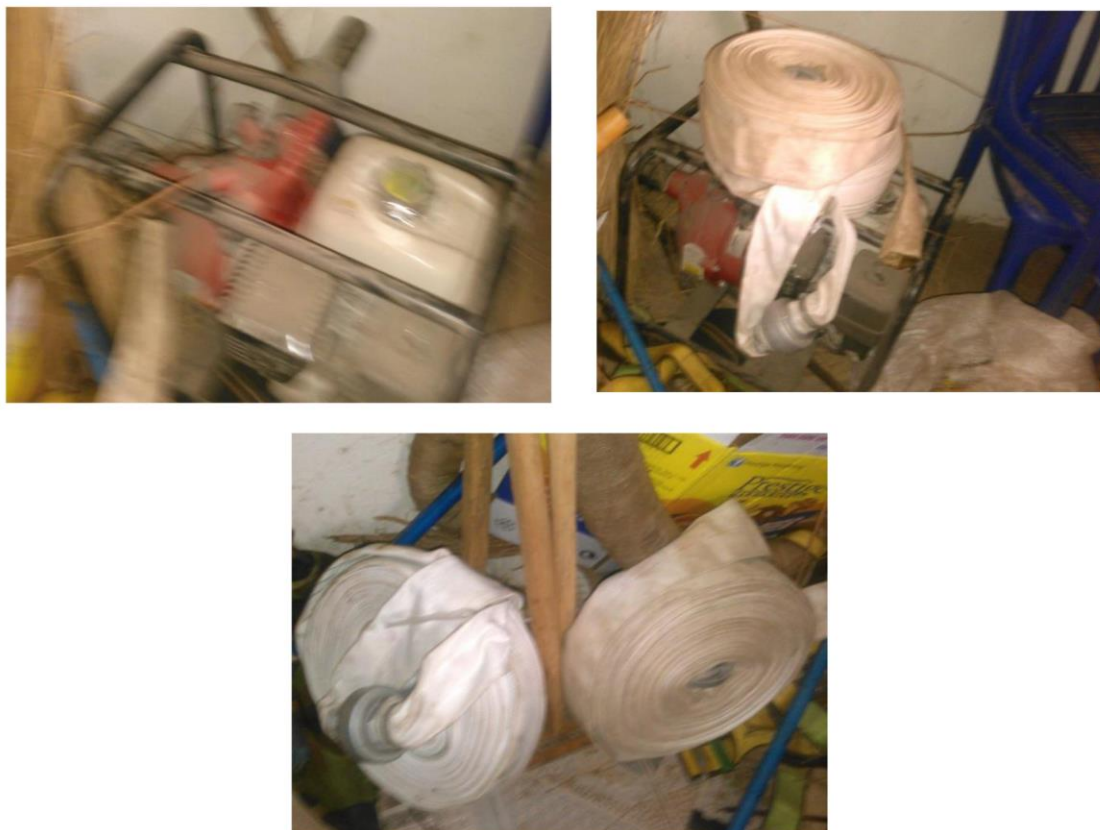
Figure 5; Some of the material left on site by Omega construction ltd

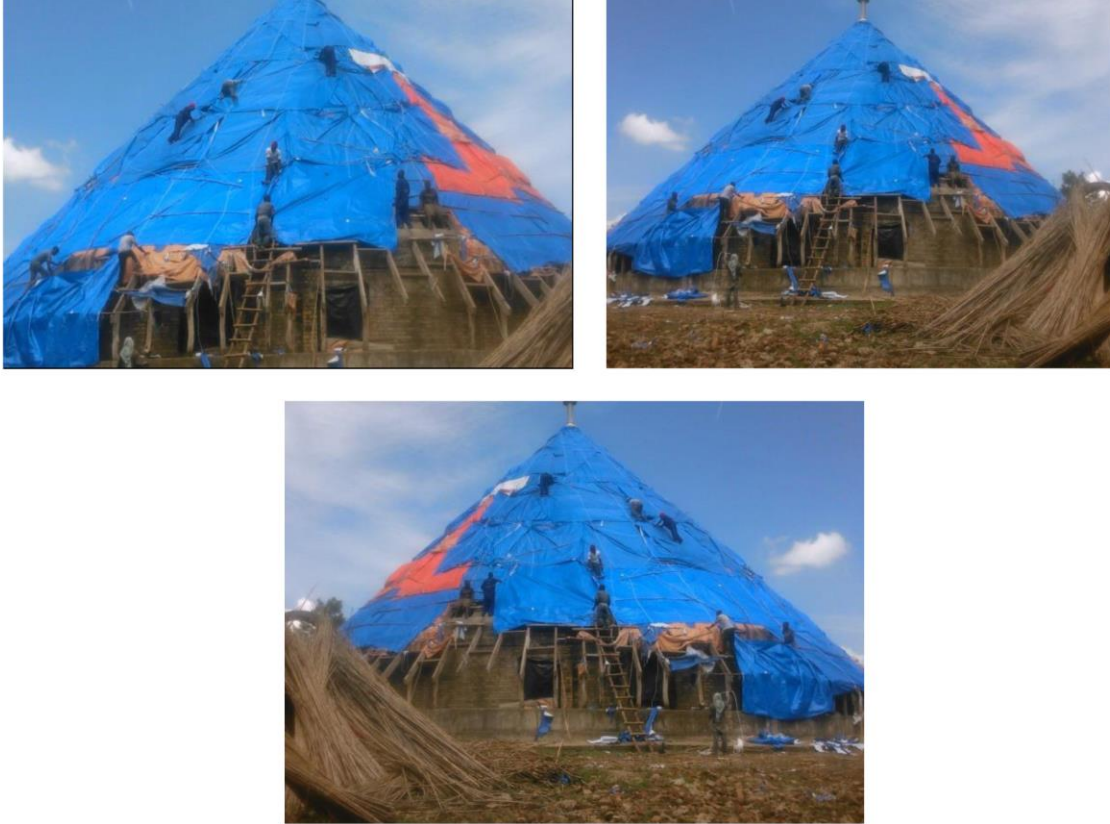
Figure 7: Workers covering the steel roof structure with tarpaulin sheet

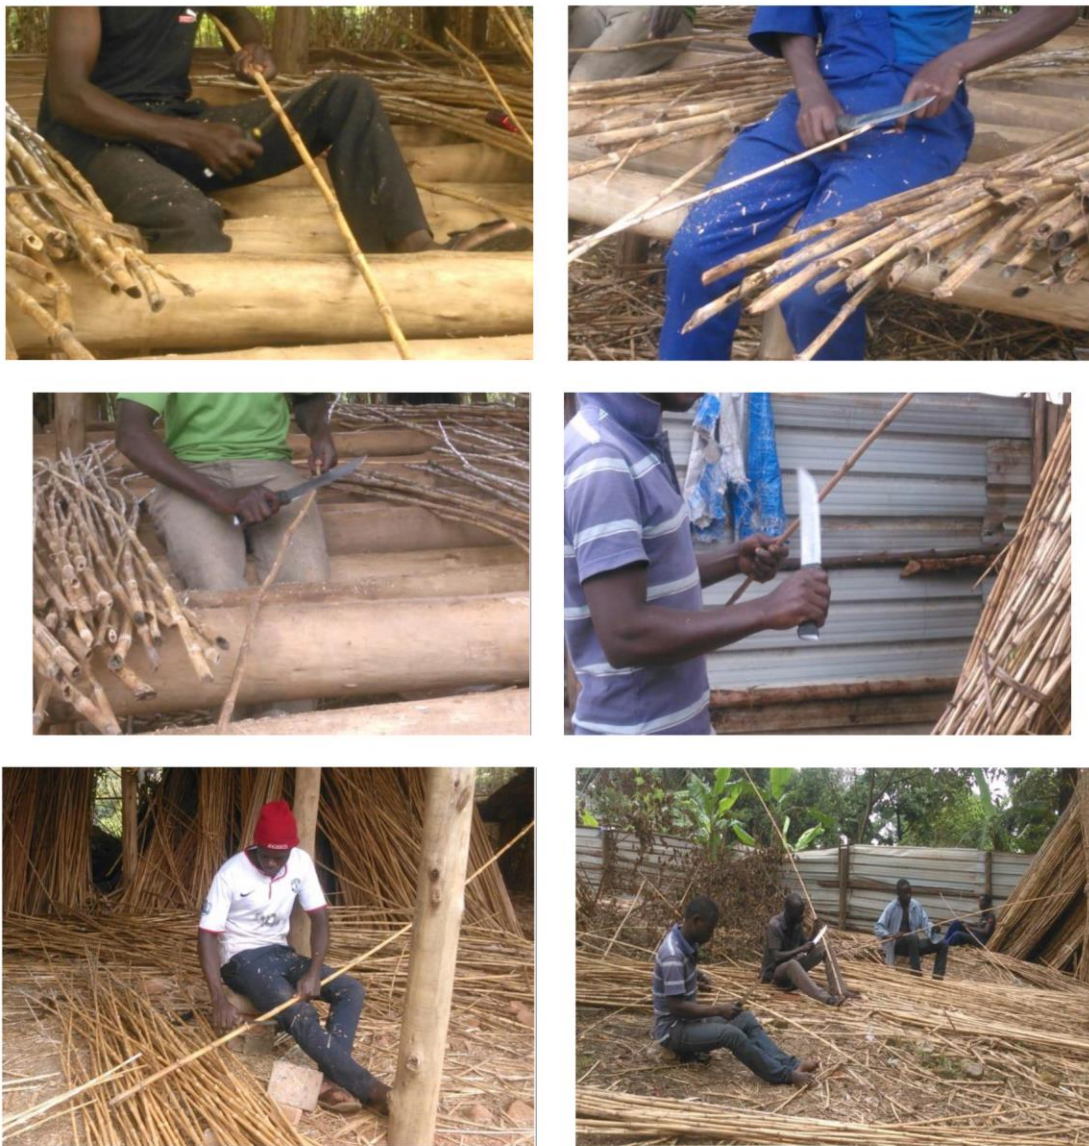
Figure 1: Workers cleaning reeds

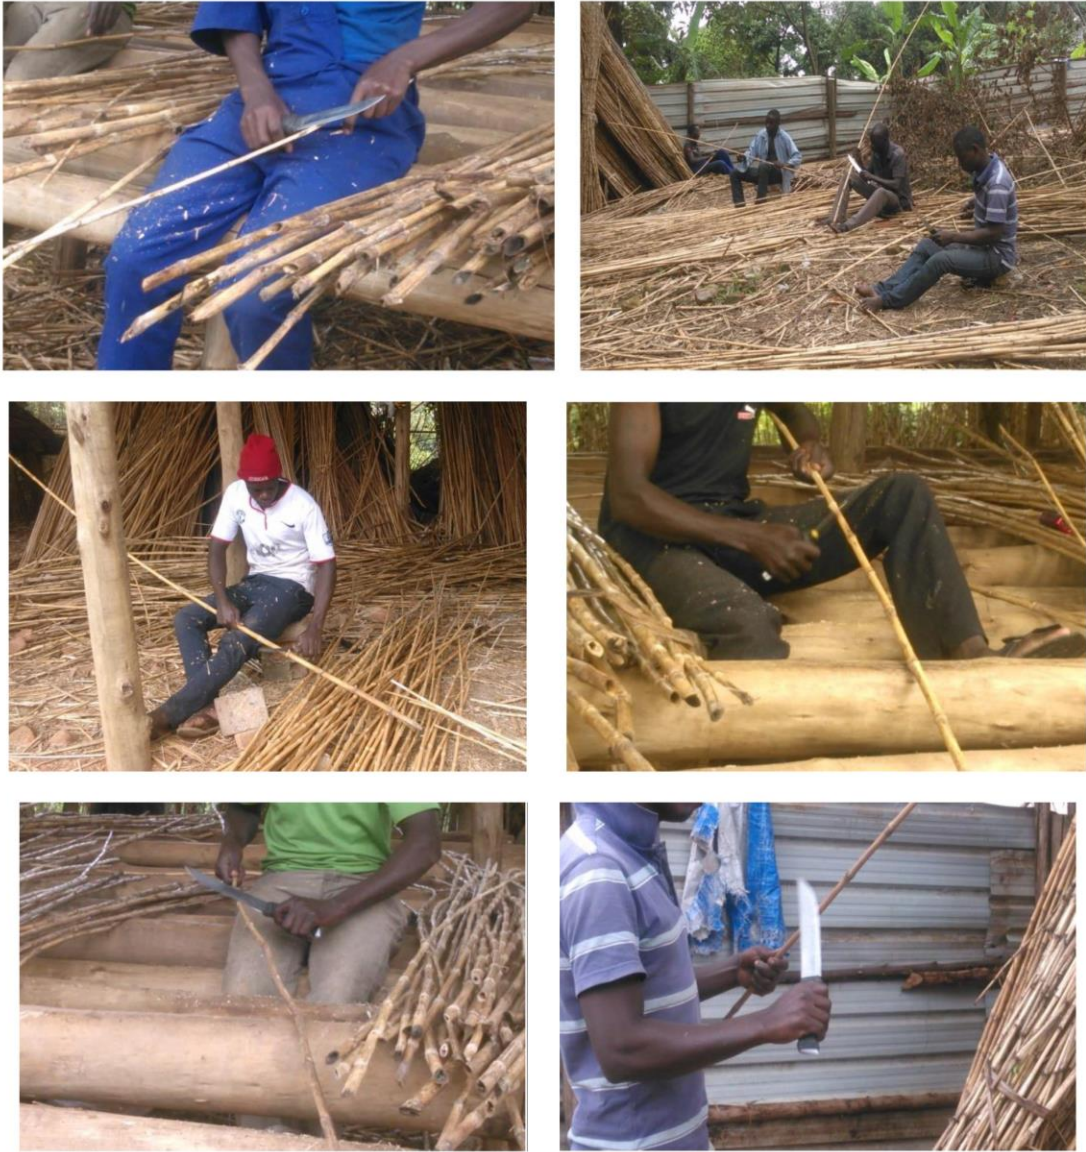
Figure 1: Workers removing nodes off the reeds
