STATE OF CONSERVATION

TOMBS OF BUGANDA KINGS AT KASUBI(UGANDA)

PROPERTY ID NO C1022

1stFEBRUARY 2017

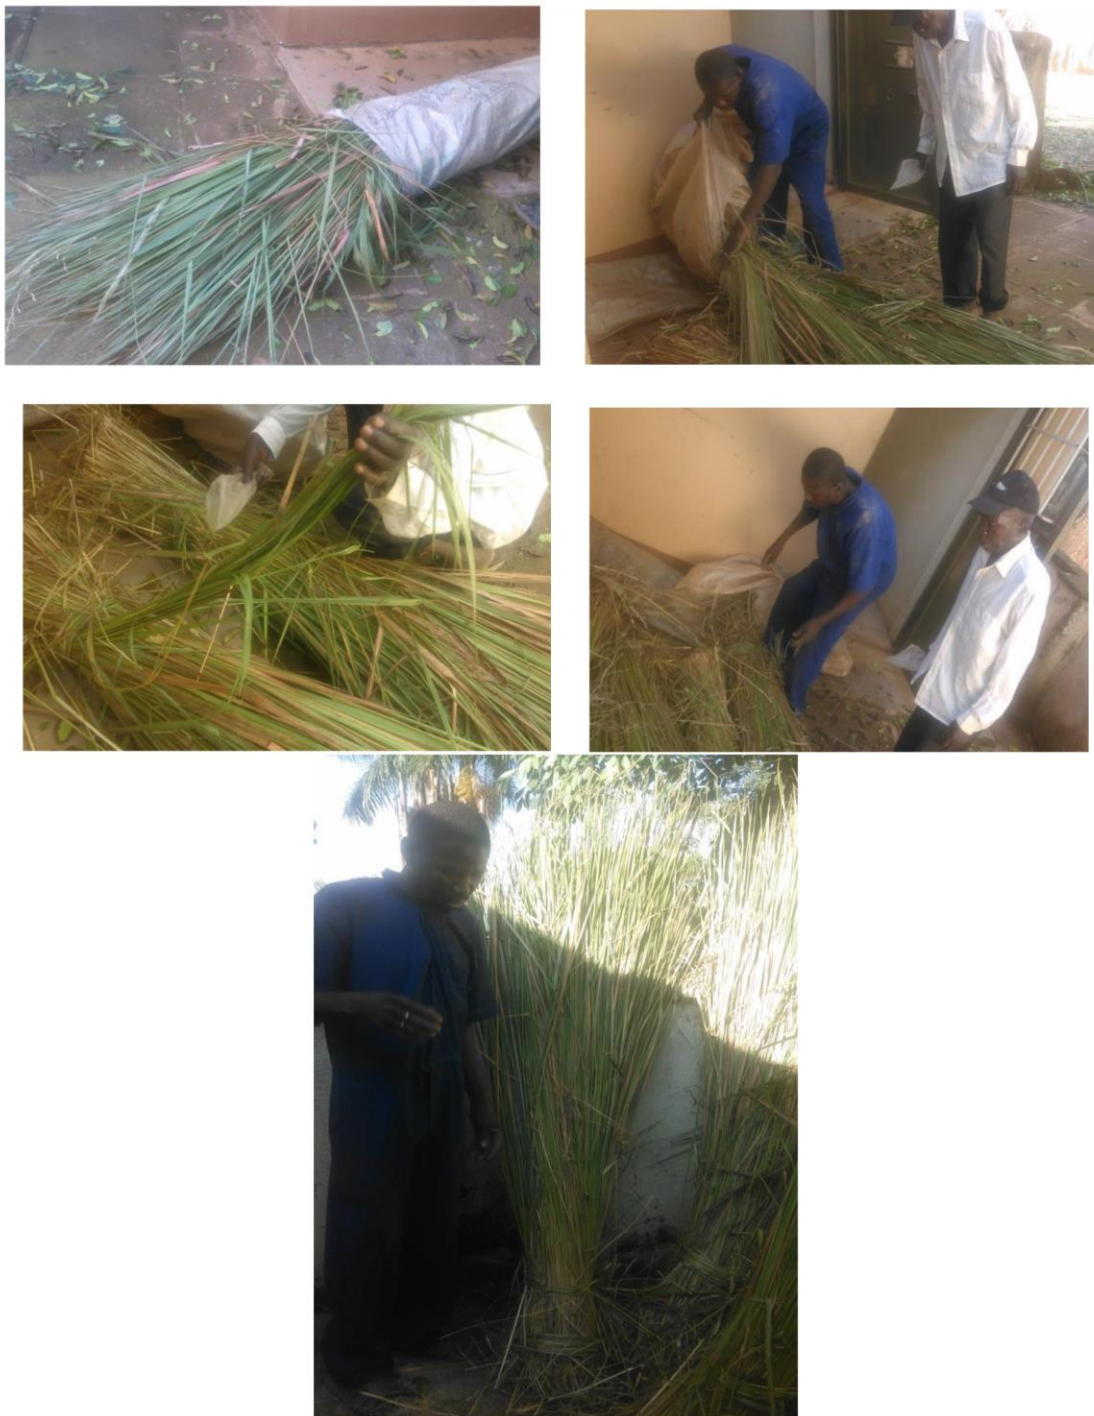
Figure 1: Wabulakayole and Lumbuye checking the samples of thatch brought to site
