SOC REPORT MALOTI DRAKENSBERG WORLD HERITAGE SITE

STATE OF CONSERVATION REPORT FOR THE MALOTI-DRAKENSBERG WORLD HERITAGE SITE

December 2016

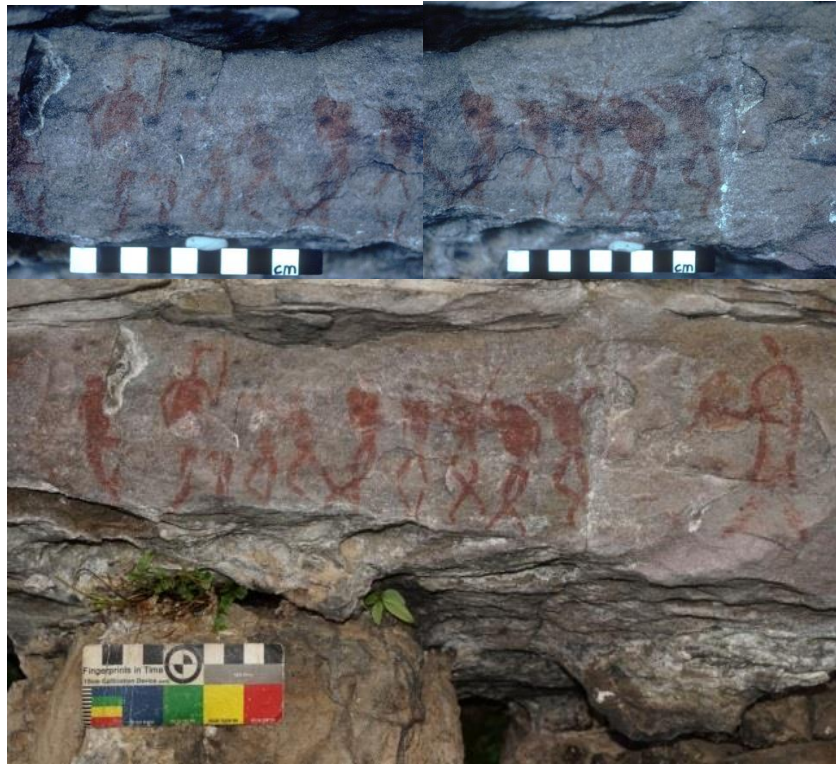
Figure 12. Above: ARAL image 1980. Below: MARA image 2015.

Much of the art in B33 is faded. The site is affected by washes, salt-seepage and animal activity. B33 is located very close to the Tsoelikane River. This proximity to the river appears to contribute to damp conditions within the site as a whole.

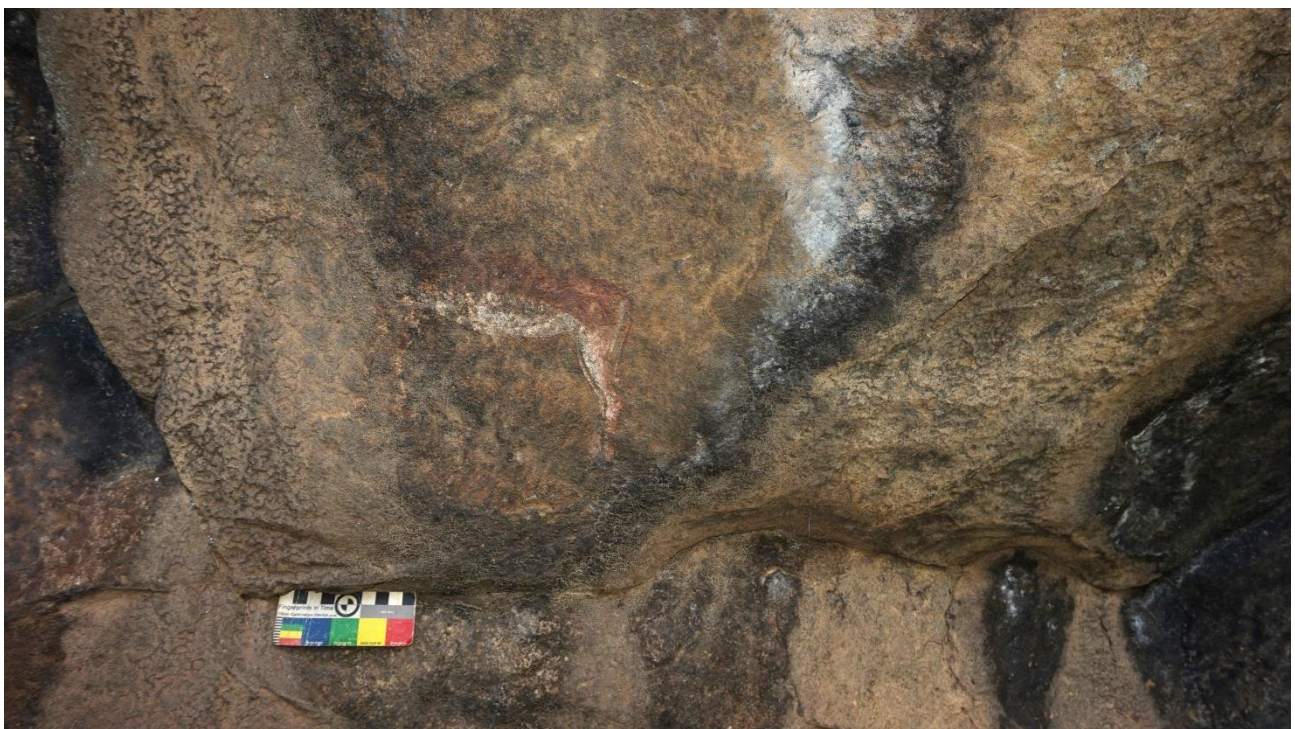
Found on the sloping ceiling of shelter B to the right of panel C. is a single polychrome eland, measuring approximately 15cm in length. Its front half, including the front legs, neck and head has been severely damaged by wash.

Figure 13. B33 shelter B, panel D. Very clear hindquarters of shaded polychrome eland. The head has been removed naturally by water running down the rockface.

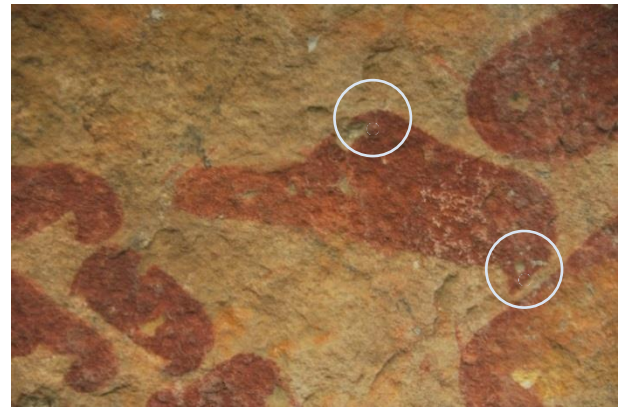
Figure 18. MARA image 2015, C17, panel C. Circles indicate areas where an increase in spalling was detected

Close-up photographs taken by ARAL were done so when wetted by spray, making it difficult to assess on a like-for-like basis. However, close scrutiny of the ARAL images shows that there has been some deterioration in the last 35 years – illustrated in the slight increase in spalling shown in the images above.

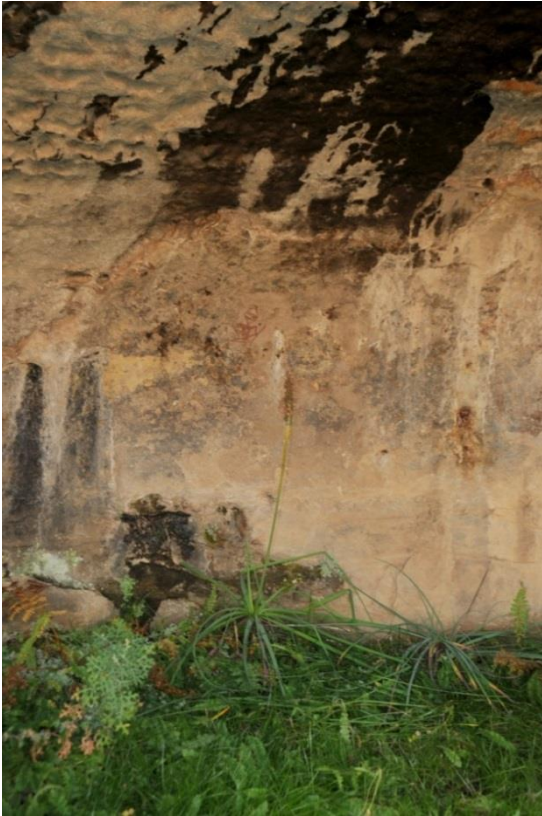
Figure 26. General shot of panel A, D04a. Showing rock art in the centre of the picture and foliage growing in very damp conditions. Note also the extensive water action and algae on the rock face.

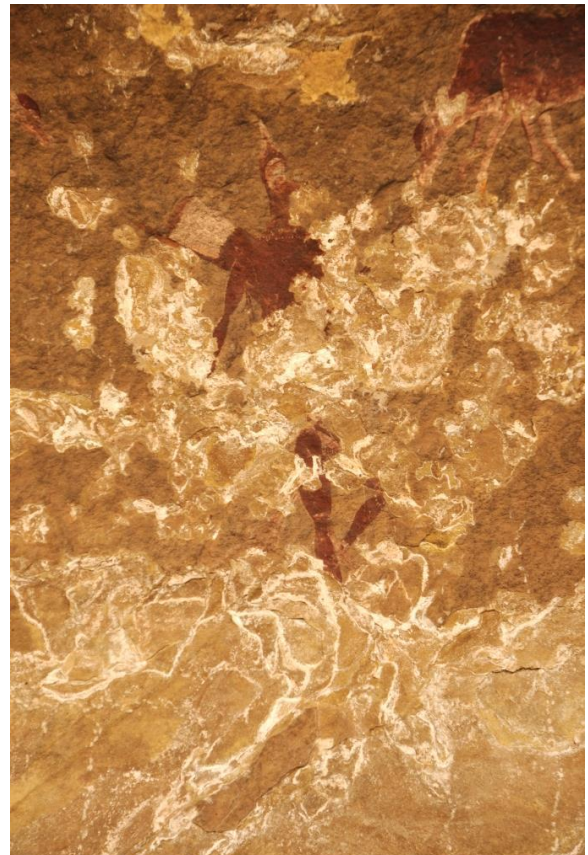
Figure 45. Close-up of E01 panel M to show natural salt build up and subsequent spalling of the rock face.

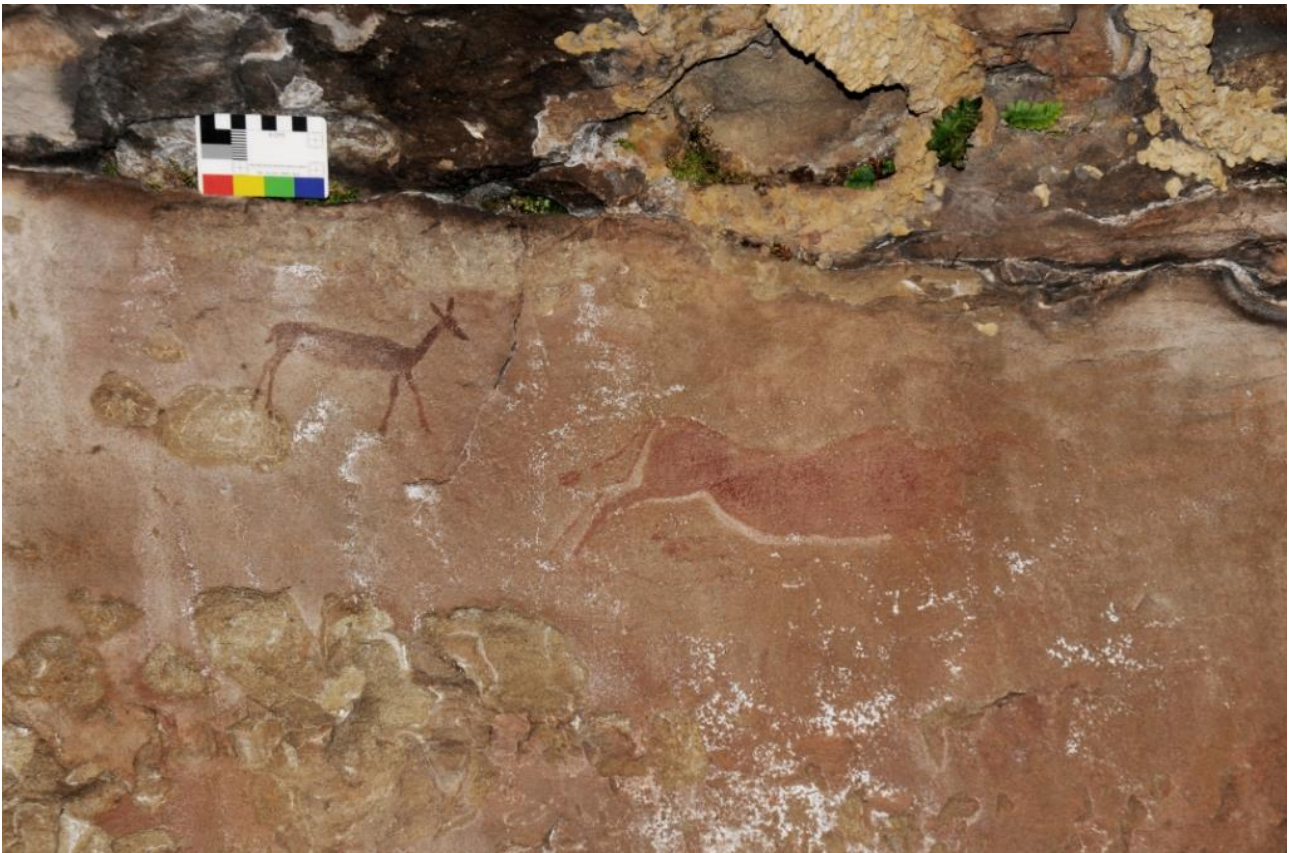
The 2 images painted at F22 are in good condition. They are very clear, though the head of the eland on the right of the panel has faded away. This is due to salt seepage and wash

Figure 58. Close-up right side panel A: bichrome eland, head faded away in relation to rhebok.

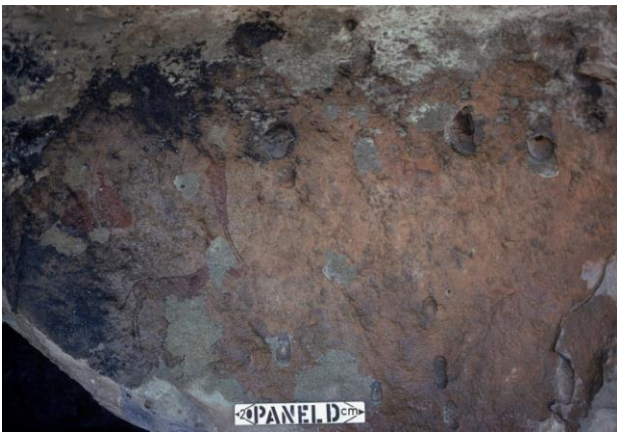
Figure 111. ARAL image 1980. Panel C (ARAL panel D) showing extensive striking of the rock face and damaged paintings.

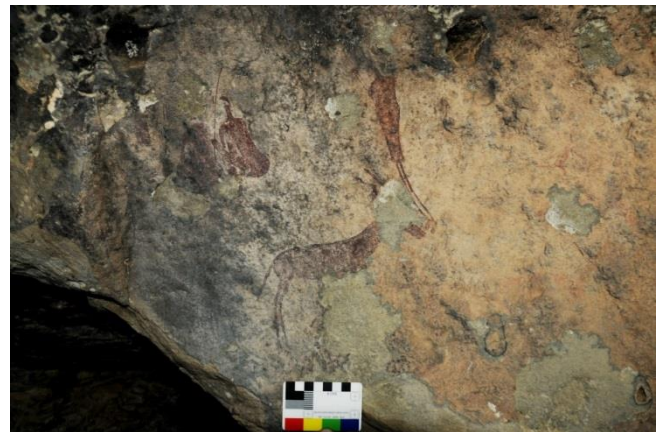
Figure 112. Figure 103. MARA image 2015. Panel C showing extensive striking of the rock face and damaged paintings

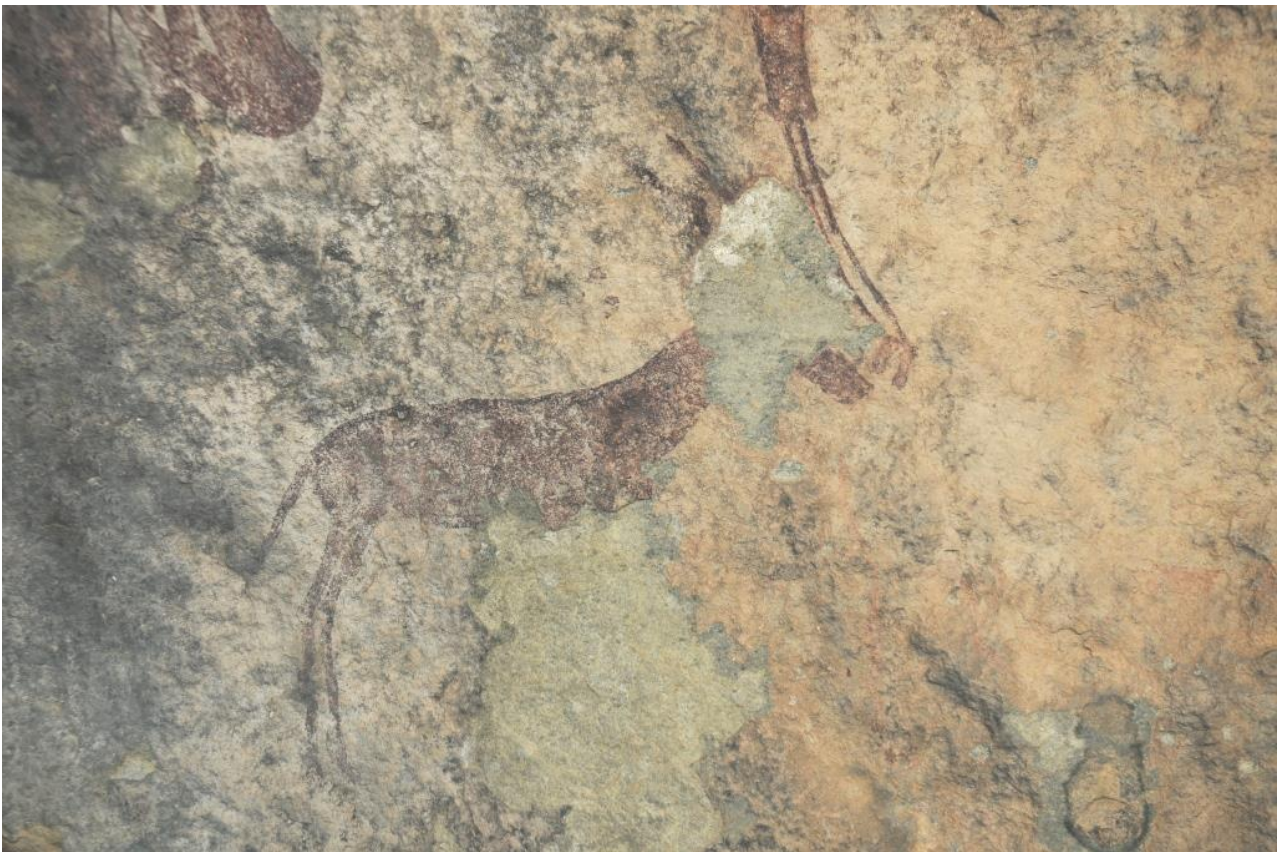
Figure 113. Bottom-centre, panel C: dark red hartebeest antelope with extensive damage caused by deliberate percussion.

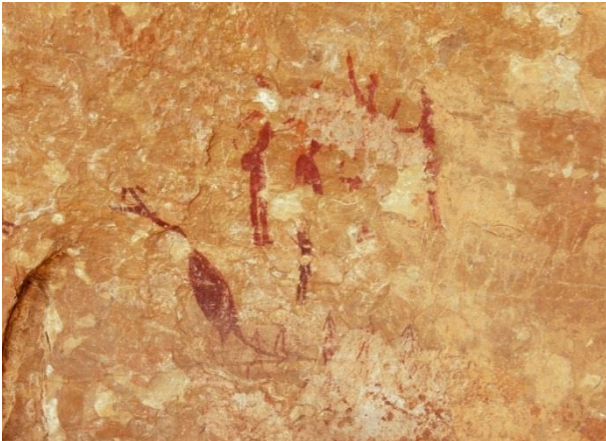
Figure 120. General shot panel G: flaked and scratched human figures with sticks and unidentifiable bird (?crane) shape, and human figures with arms raised

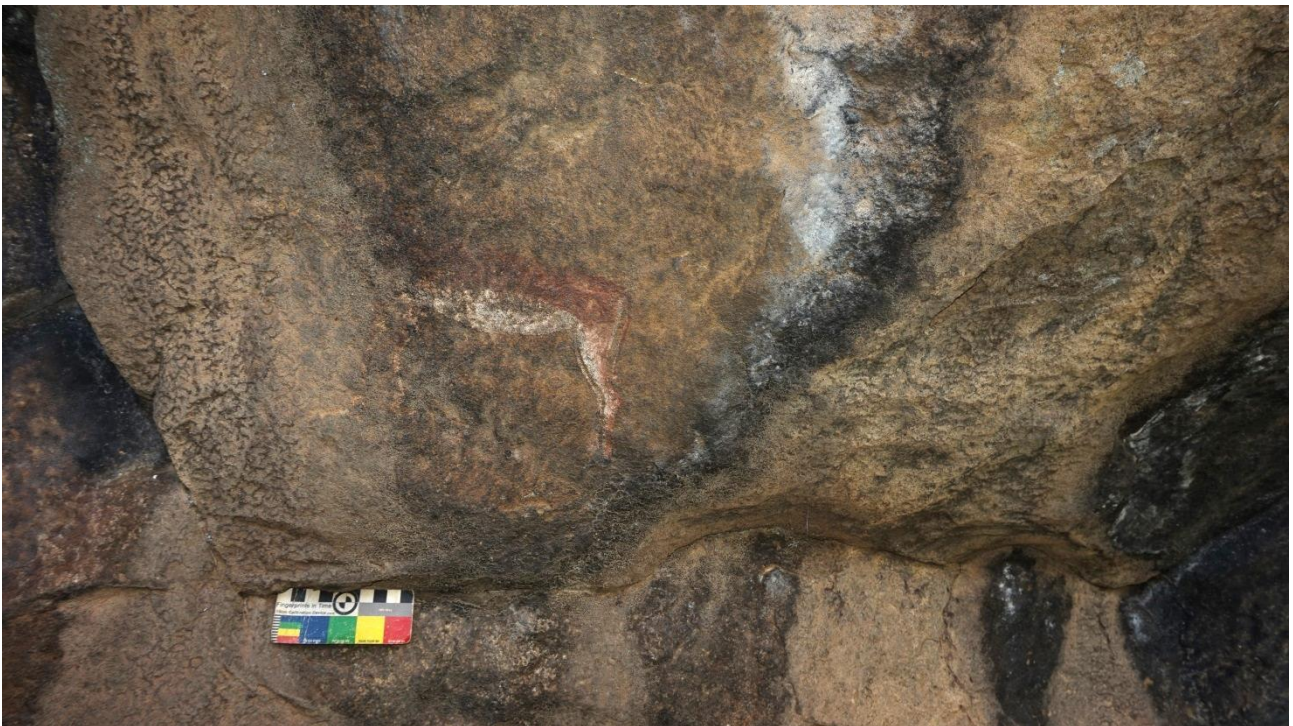
Figure 23. B33 shelter B, panel D. Very clear hindquarters of shaded polychrome eland. The head has been removed naturally by water running down the rockface.

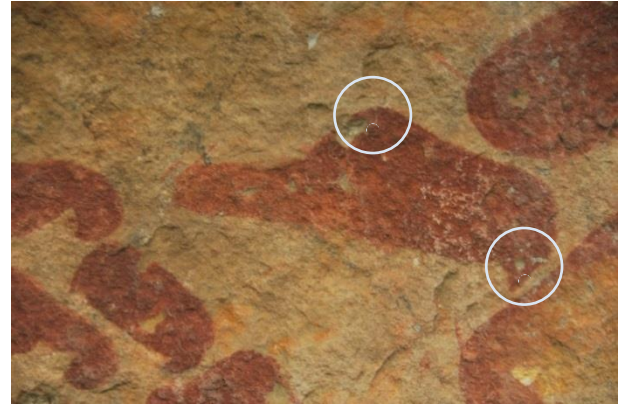
Figure 28. MARA image 2015, C17, panel C. Circles indicate areas where an increase in spalling was detected

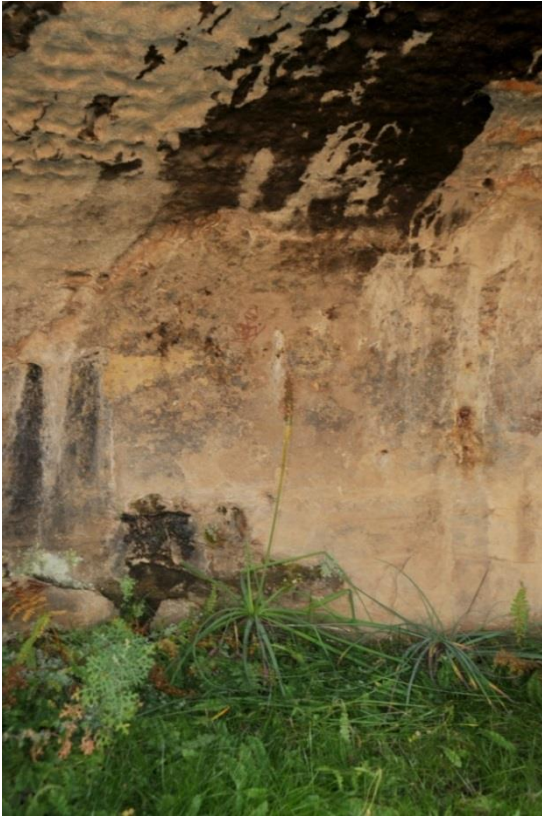
Figure 36. General shot of panel A, D04a. Showing rock art in the centre of the picture and foliage growing in very damp conditions. Note also the extensive water action and algae on the rock face.

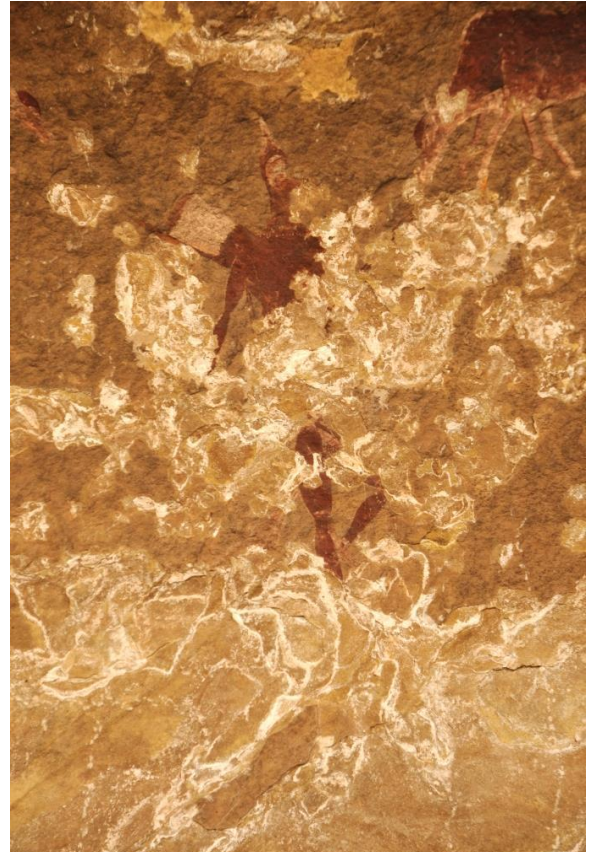
Figure 63. Close-up of E01 panel M to show natural salt build up and subsequent spalling of the rock face.

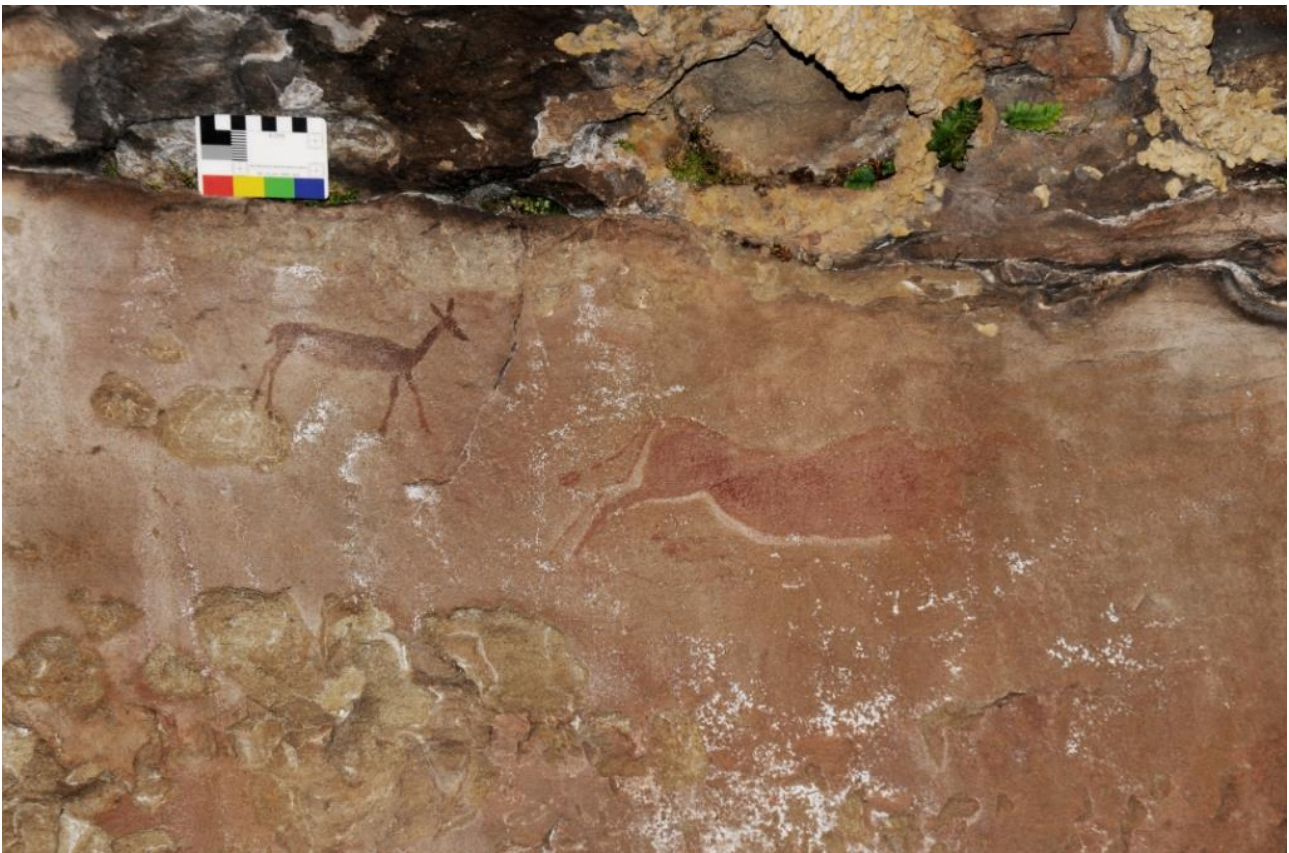
Figure 82. Close-up right side panel A: bichrome eland, head faded away in relation to redbok.

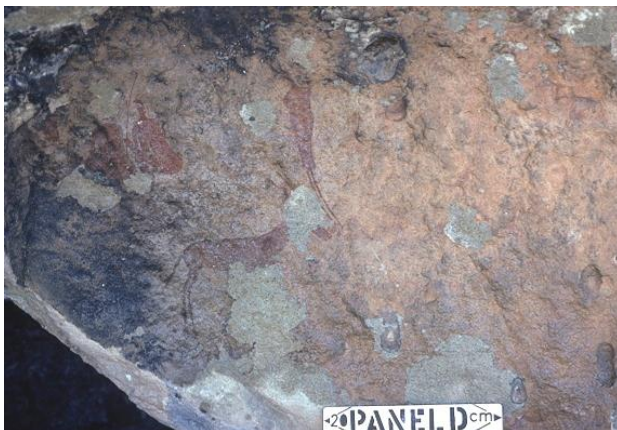
Figure 110. ARAL image 1980. Panel C (ARAL panel D) showing extensive striking of the rock face and damaged paintings.

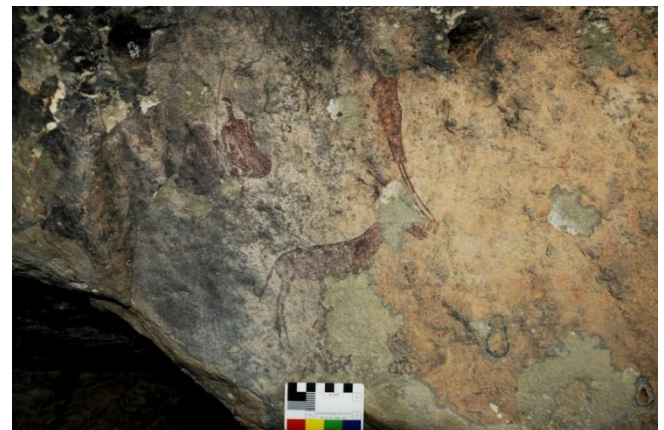
Figure 111. Figure 103. MARA image 2015. Panel C showing extensive striking of the rock face and damaged paintings.

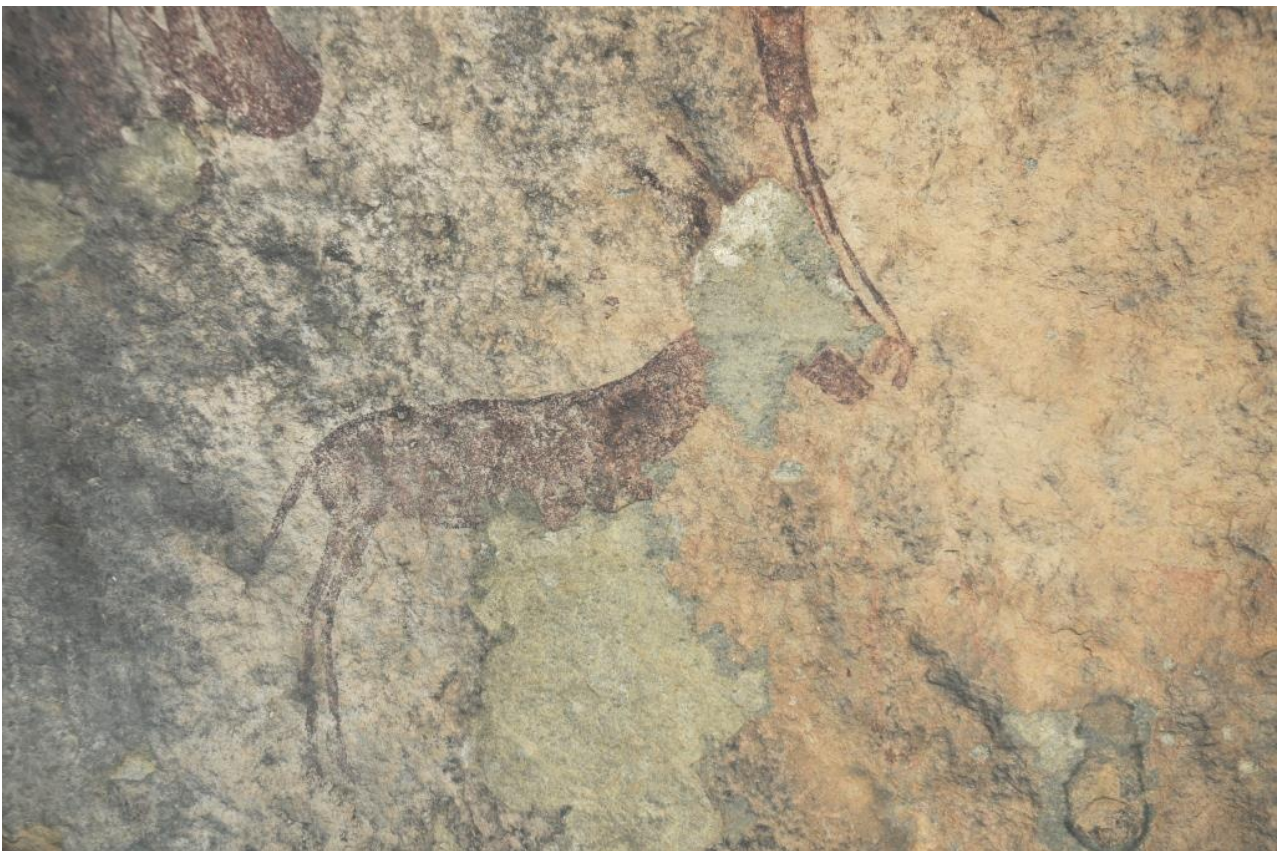
Figure 112. Bottom-centre, panel C: dark red hartebeest antelope with extensive damage caused by deliberate percussive.

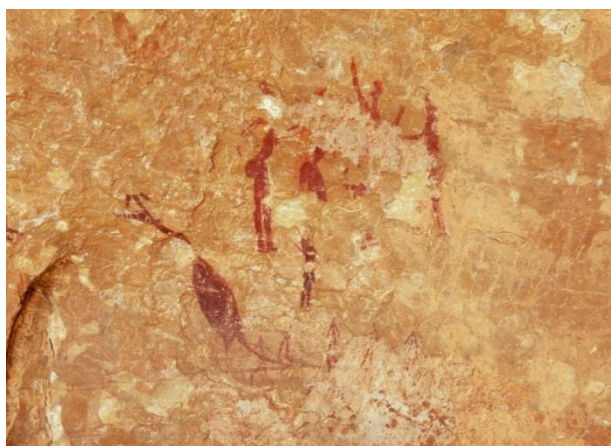
Figure 127. General shot panel G: flaked and scratched human figures with sticks and unidentifiable bird (?crane) shape, and human figures with arms raised

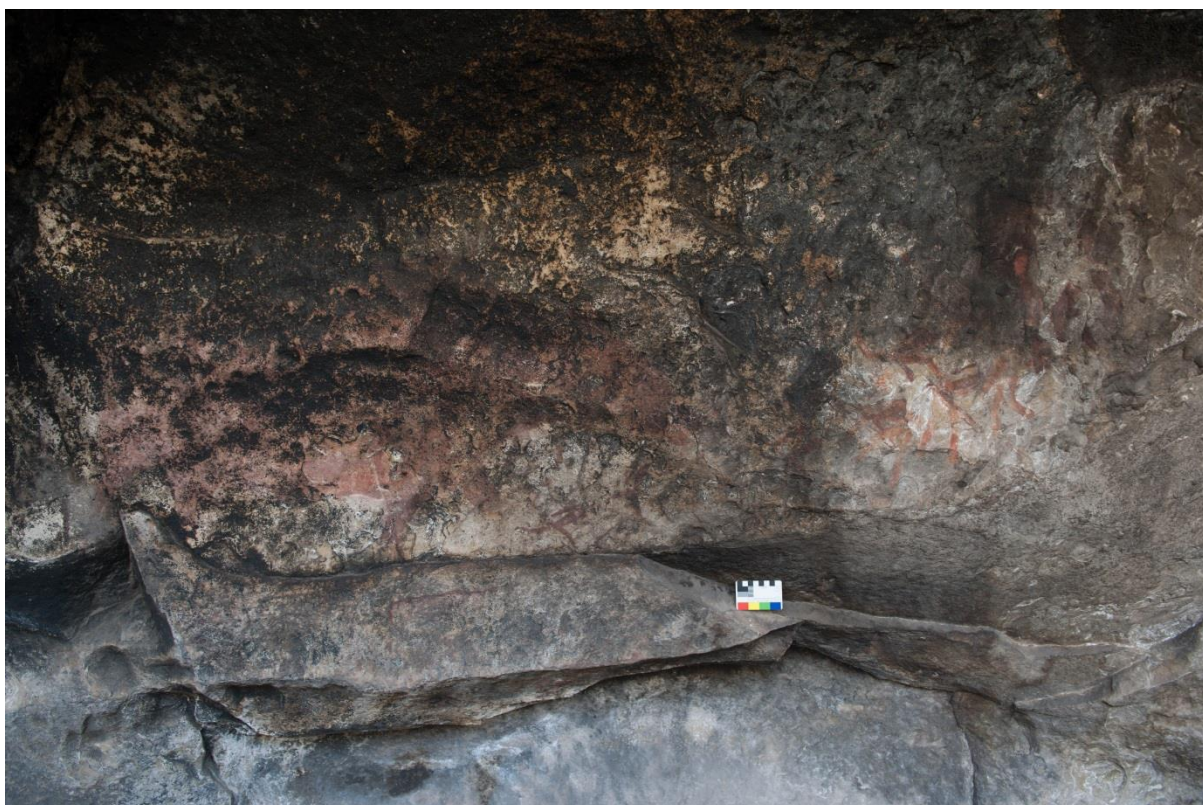
Site E01, Panel E, Rain Animal – natural light photograph before digital removal of soot and algae damage

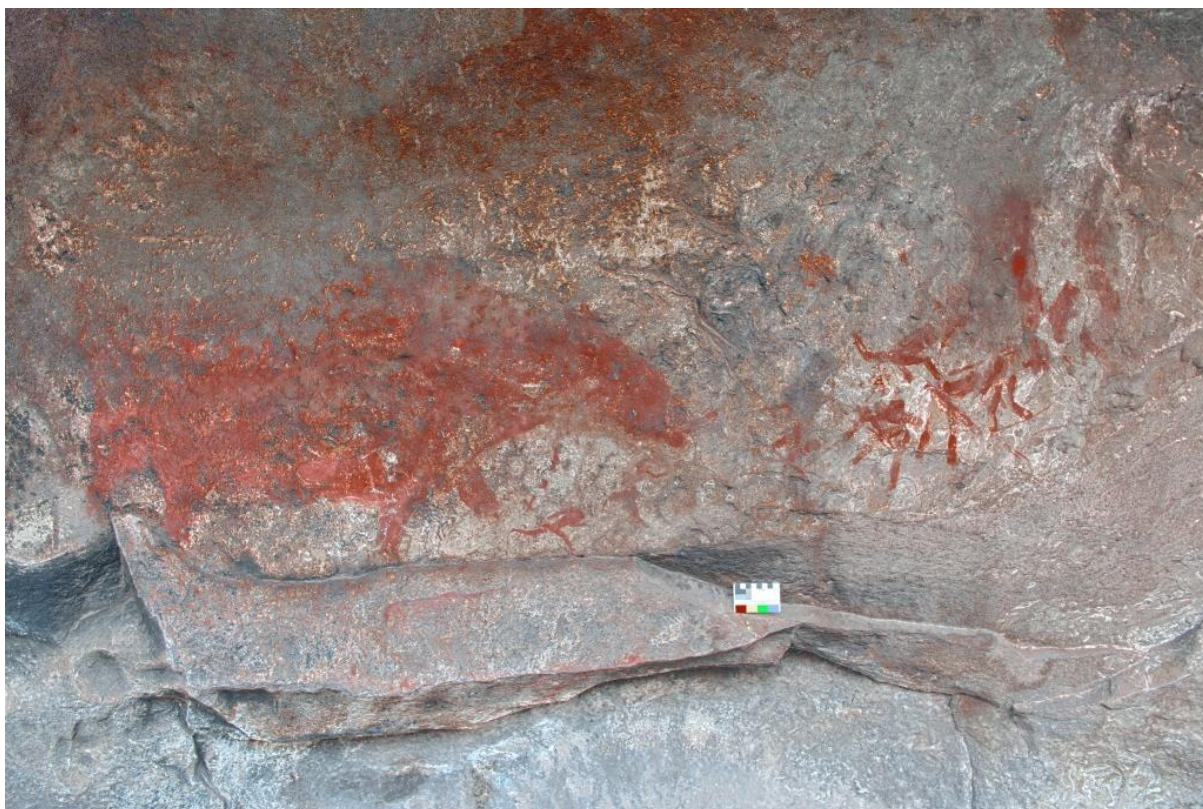
Site E01, Panel E, Rain Animal – enhancement; after digital removal of soot and algae damage
