## **Report on the State of Conservation**

### **The Minaret and Archaeological remains of Jam (Afghanistan) (May 2002, in Danger)**

**ID Number: Ref: (C 211 rev)**

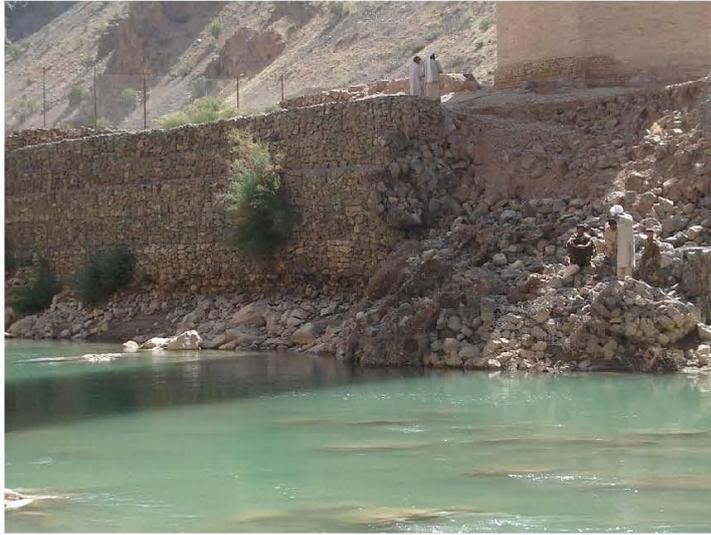
Gabion wall on the bank of Hari Rud river total length 43 meter with the height of 5.5 meter has been built on 2000 a part of the wall destroyed due to heavy floods on 2007.

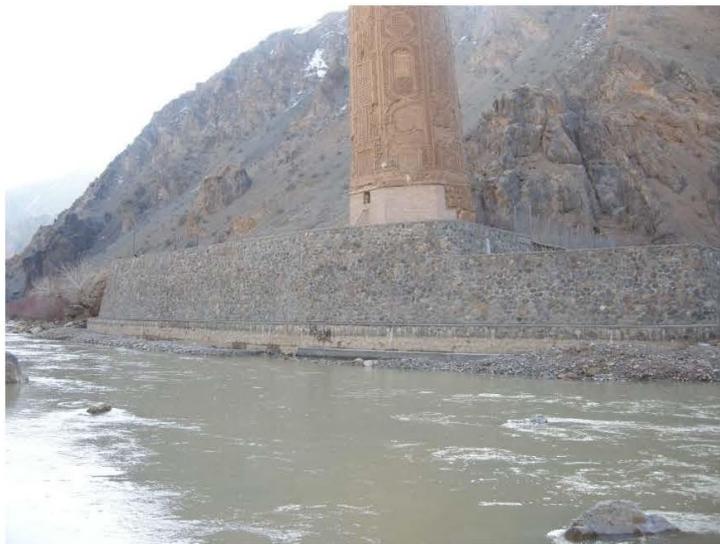
New retaining wall on the bank of Hari Rud River has been built on 2007 total length 55 meter with the height of 8 meter and wide of 2 meter. The retaining walls on Hari rud are still in good condition no cracks, no cavities, no distortions.

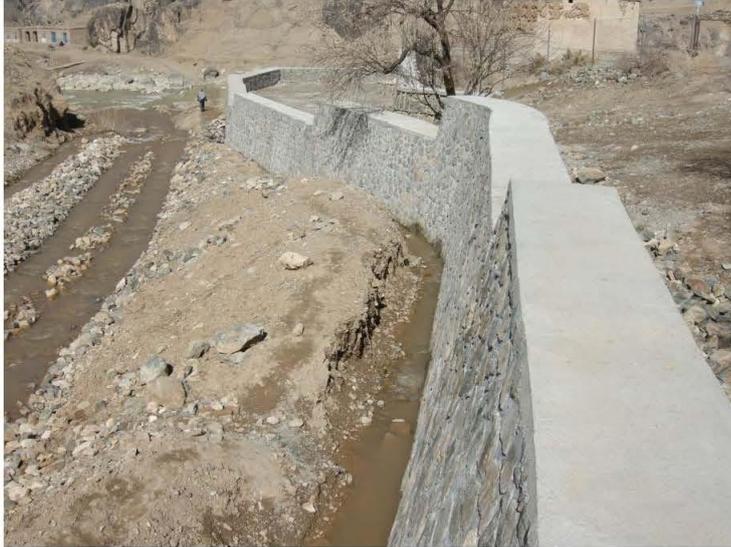
Retaining walls on the bank of Jam Rud River has been built on 2007-2009 total length 110 meter with the height of 4 meter and foundation wide of 2 meter.

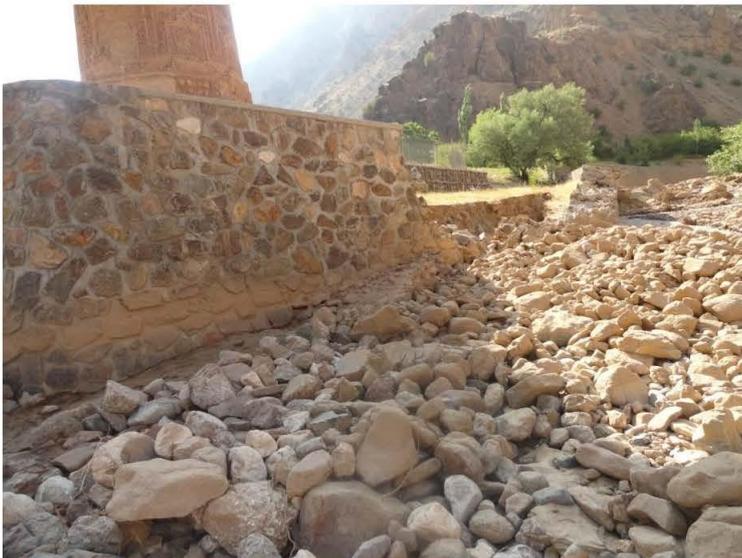
Once again floods in the Jam Rud River during spring time of 2012 damaged 30 meter of retaining wall as will a lot of stones brought by floods on the bed of river which needed for cleaning.

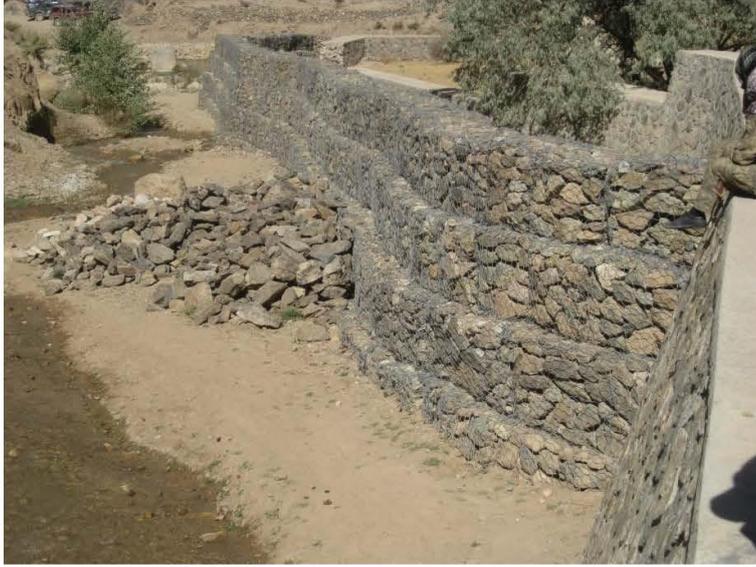
For the safeguarding of the minaret against the seasonal floods, a temporary retaining gabion wall has been constructed in the bank of Jam Rud River with the financial help of US Military Founding. Since the constructed gabion wall is considered as temporary solution, and the width of the Jam Rud River has been narrowed, this gabion wall completely removed on September 2014.

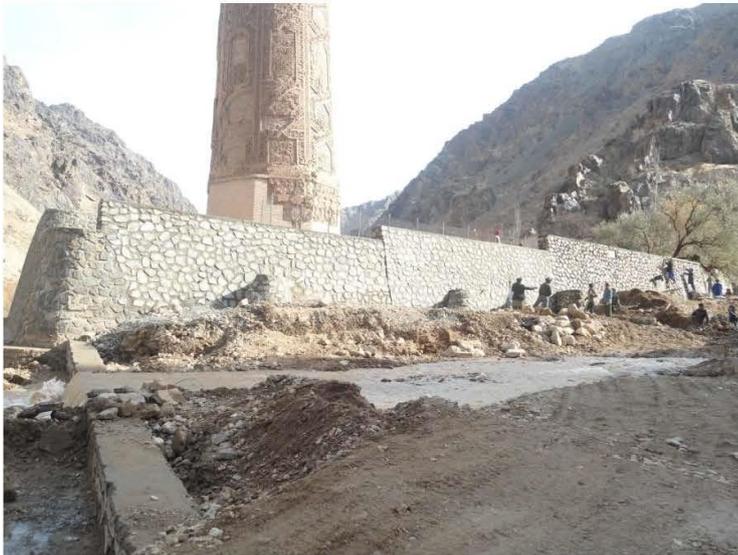
By the financial support of MoIC and UNESCO office a strong retaining wall with the length of 45 meter and height of 4.5 meter has been constructed on the bank of Jam Rud River on 2014. As will flood breakers in several points of Jam Rud River have been implemented to reduce the power of the floods.

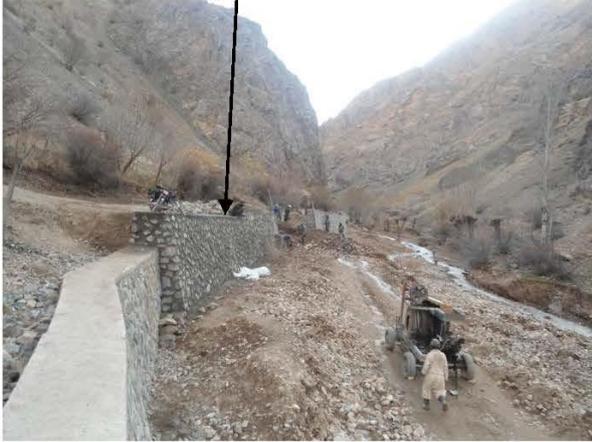
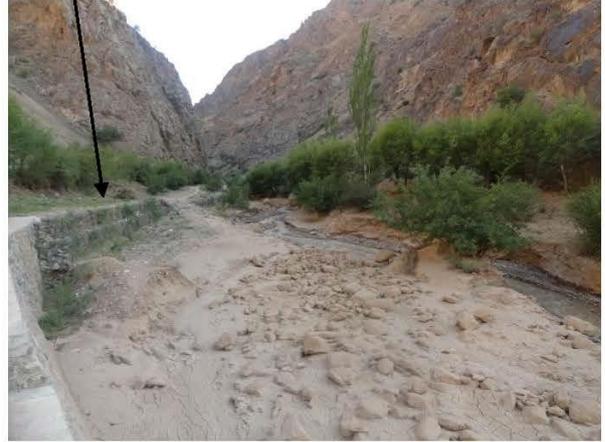
In addition in the route of Jam valley the gabion wall (Jam Rud River) which was in bad condition has been removed and new retaining wall has been constructed with length of 50 meter and high of 4.5 meter. 2014
