Umm er-Rasas

Restoration of the Stylite Tower

Mission Report

Architect:
Davide Sicilia

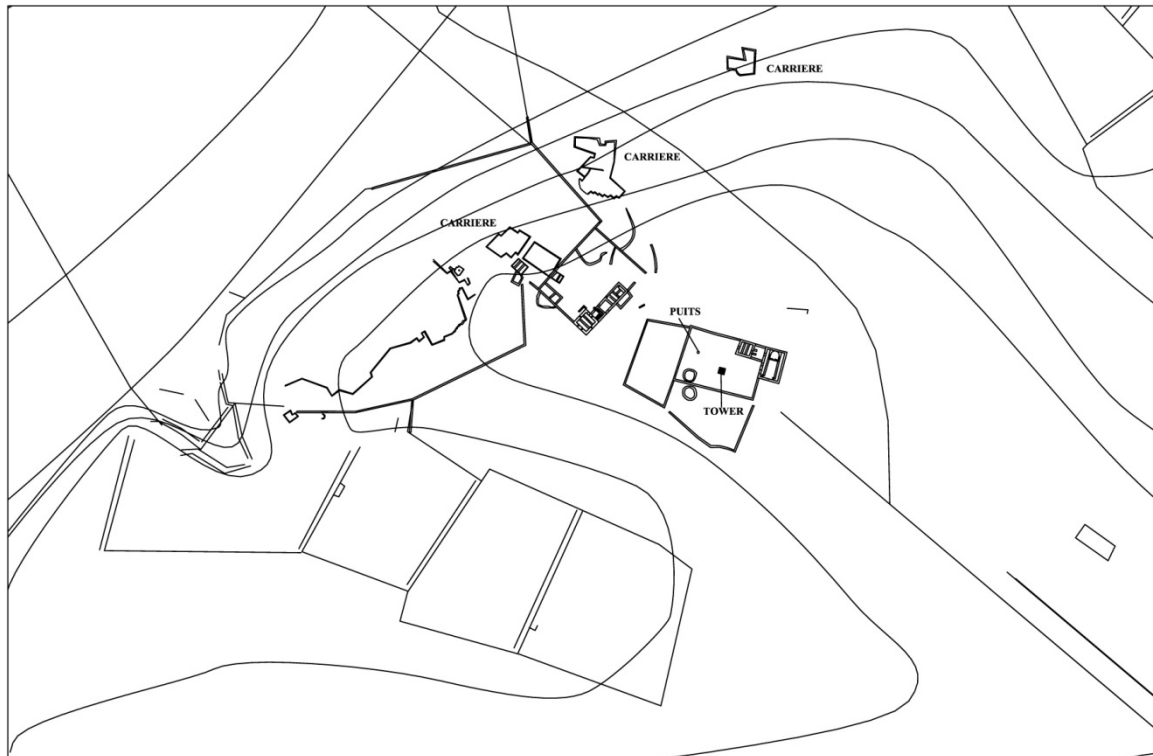
SITE MAP OF COMPLEX OF THE STYLITE TOWER

We have noted the presence of quarries and wells in the nearby of the tower

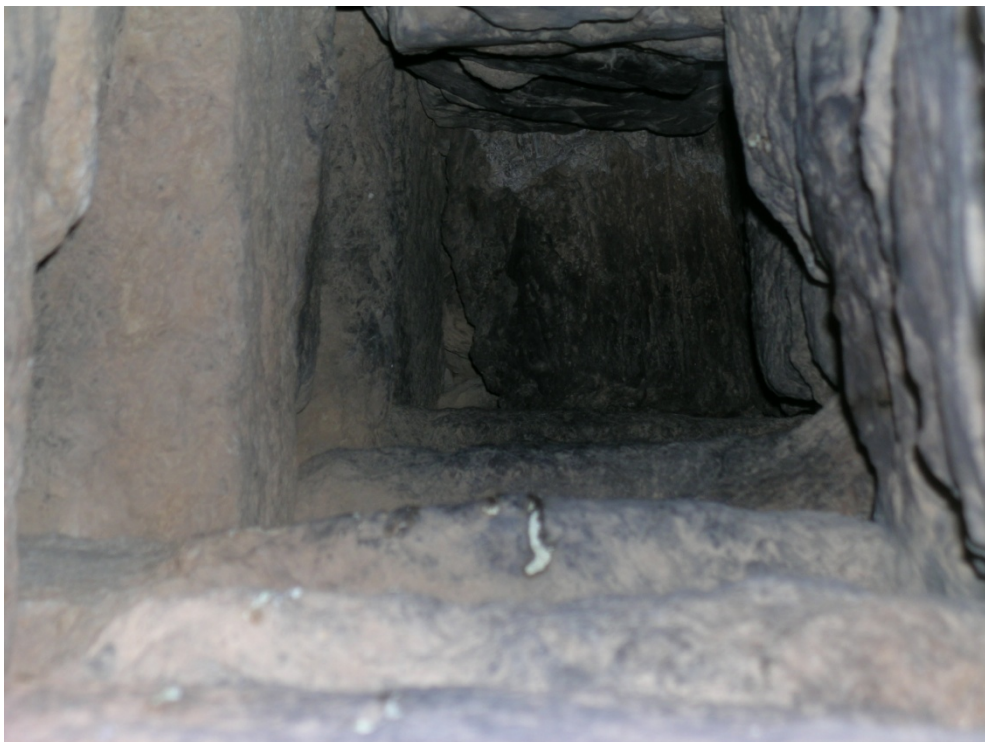
VERTICAL GALLERY OBSTRUCTION AT THE CELLA

At the base of the tower, on the north side, there is an opening through which one reaches a niche, perhaps once vaulted. In the north-west corner, inside the tower, there is a square and vertical gallery, which served as a liaison with the *cella*. One possible explanation for this gallery is that the pilgrims, after having passed through the church, could communicate with the saint by this gallery asking him for prayers and giving him offerings. This gallery with a width of 45 cm by 45 cm is blocked at the 17th row of stones, probably after the fall of stones of the dome.

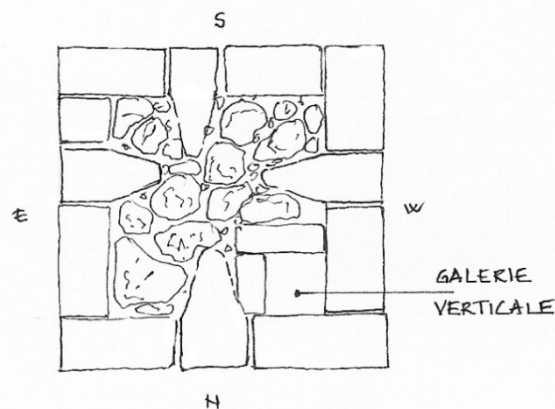
COUPE SUR LA 6^e RANGÉE

The design of the 6th row shows rocks arch stones; this is a hypothesis to be verified by further investigations. The arch stone of the 2nd row is present.

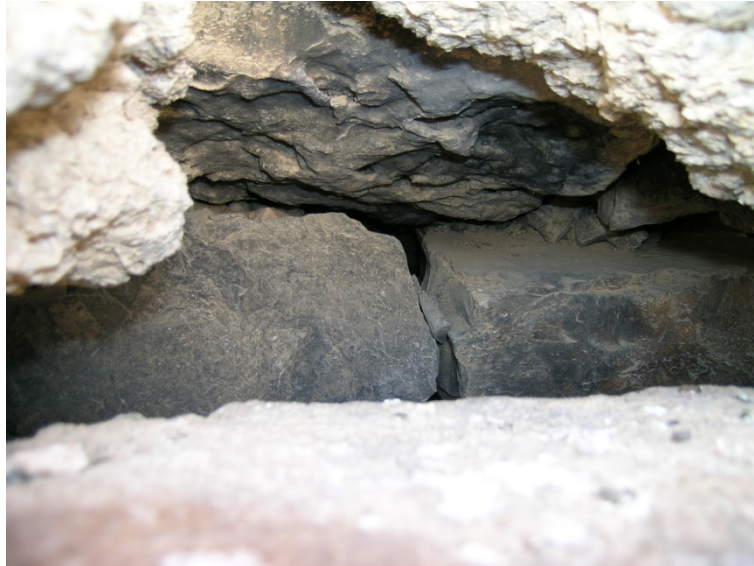
MASONRY INTERIEUR
The interiors joints are hallow

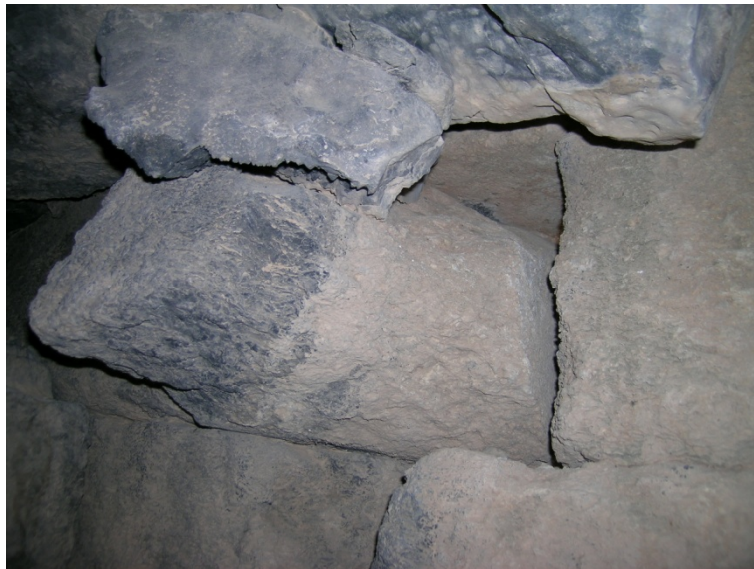
INSIDE THE BASIS OF THE TOUR
A stone face is cut so as to stabilize the filling.

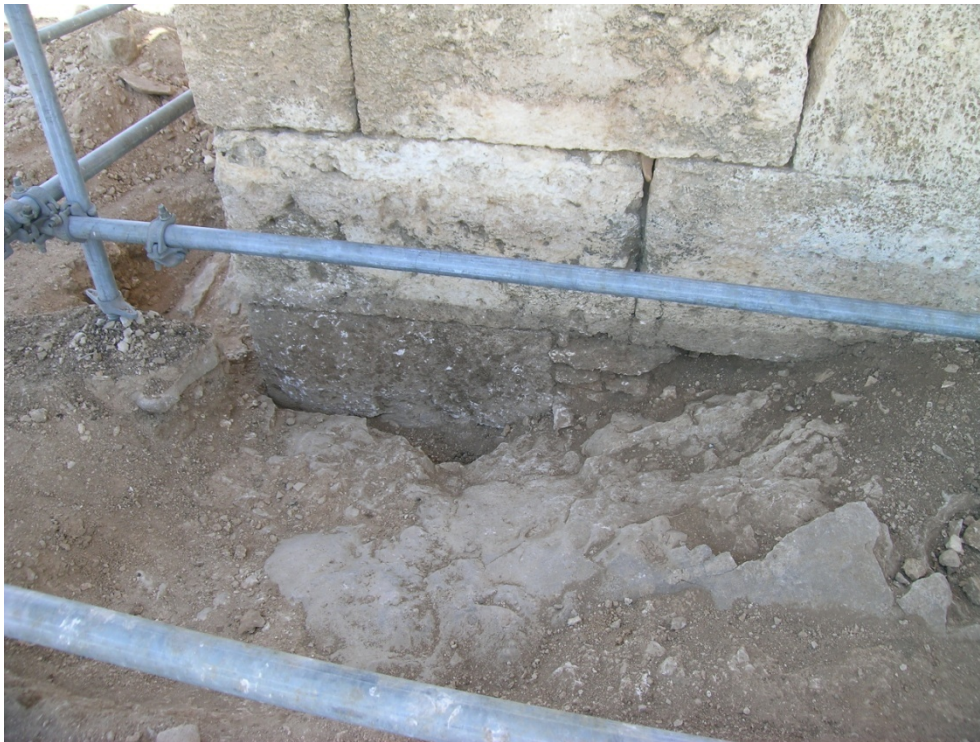
WEST FACADE

Superficial excavation: the rock is located 40 cm underneath.

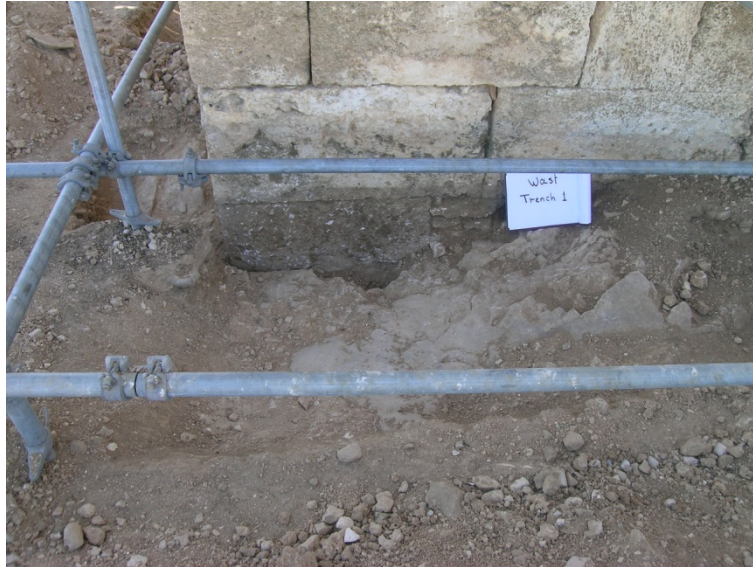
WEST FACADE

One may note the presence of the rock at the base.

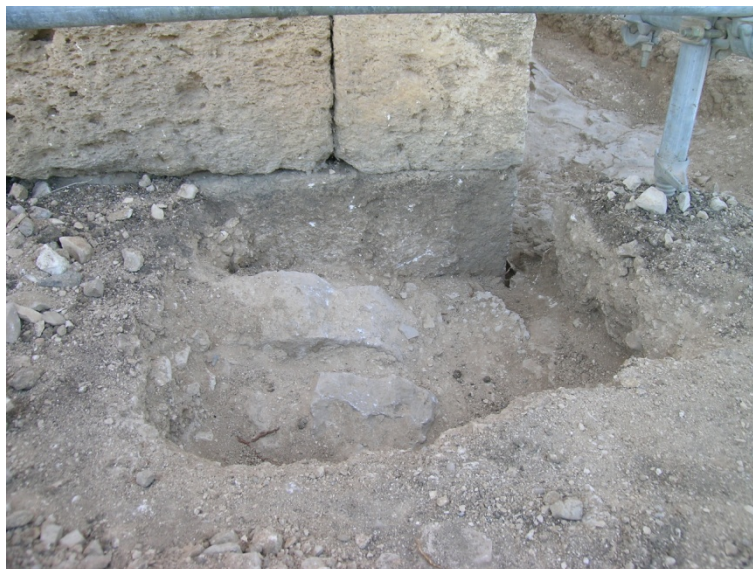
NORTH FACADE

The north-west angle represents the direction towards which the tower is poured.

If necessary, the new scaffolding will be built with a double purposed. It may also serve as temporary shoring of the tower by taking measures being appropriate to this situation (shoring against the facade of the west or north-west angle in order to oppose the dumping in this direction).

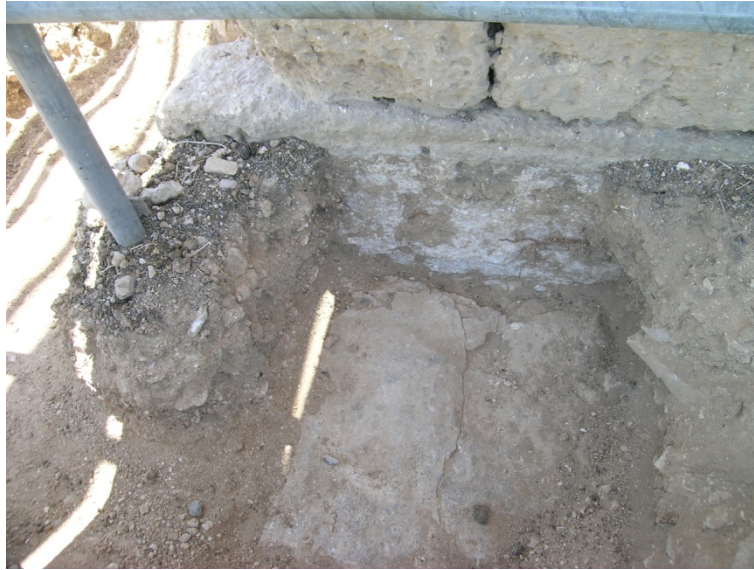
NORTH FACADE

Nord-est angle : the base stone is a long stone of 1,35 meter long.

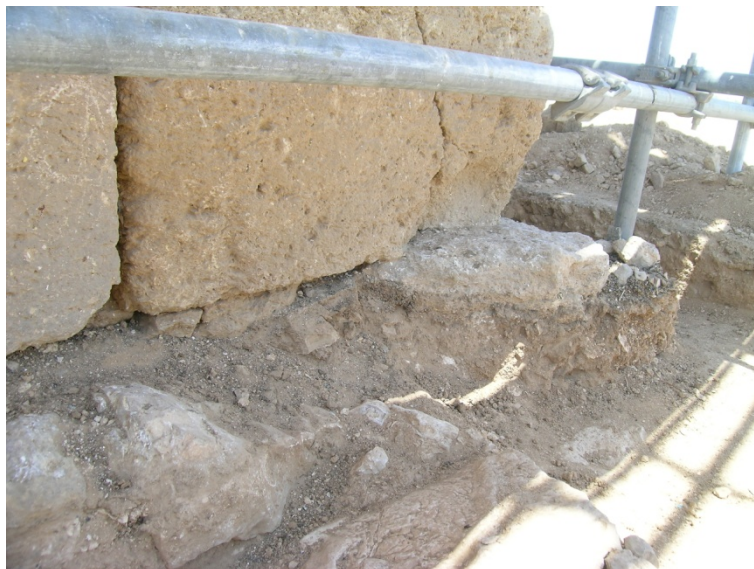
EAST FACADE

North-East angle: the rock is levelled at the lower level of the tower.

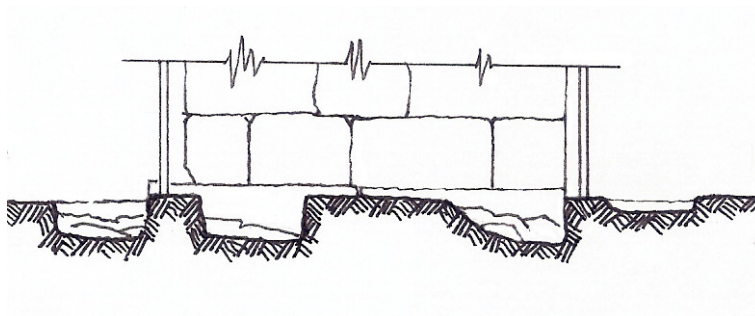
NORTH FACADE

Cross section to the ground foundations after excavations.
Two large blocks of stones are the basis at the first row of the tower

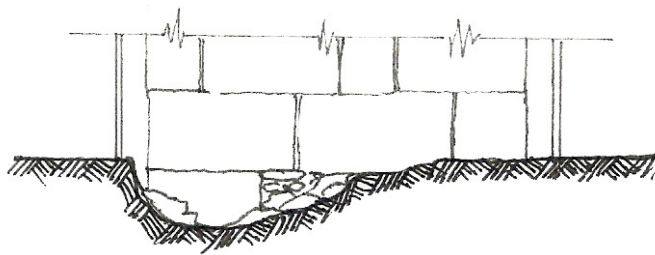
WEST FACADE

The stones on the first row are based directly on the rock

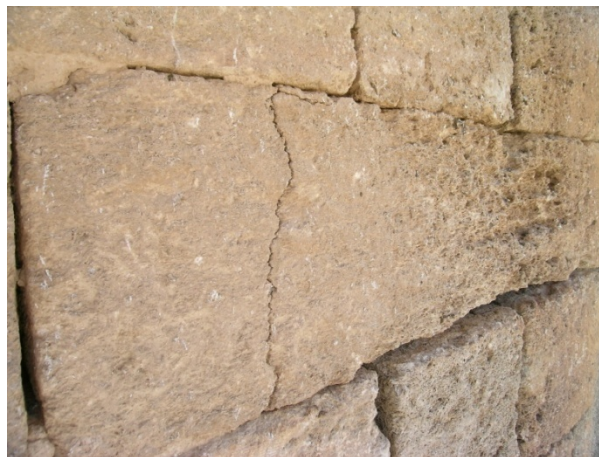
NORTH FACADE – Cracked stone.

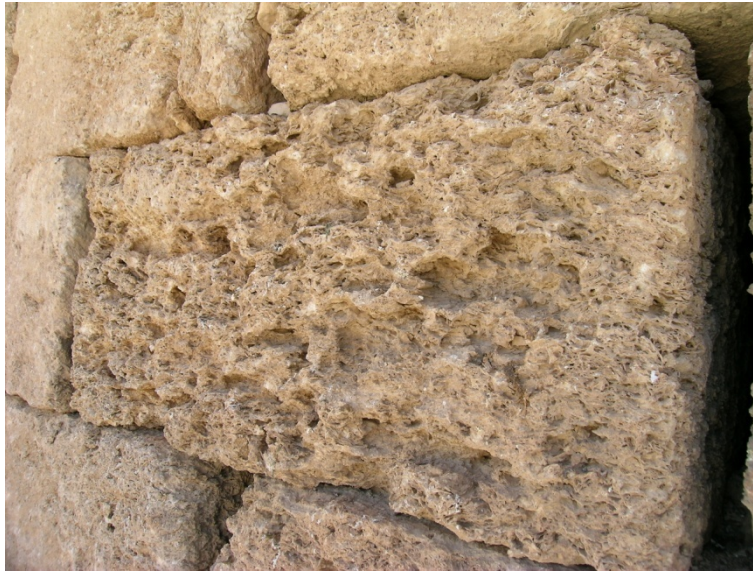
NORTH FACADE - Eroded stone.

- The erosion of stones, especially on the north side, is very important, some of the stones have lost several centimetres in thickness and the stones lying at the *cella* have changed their geometry.

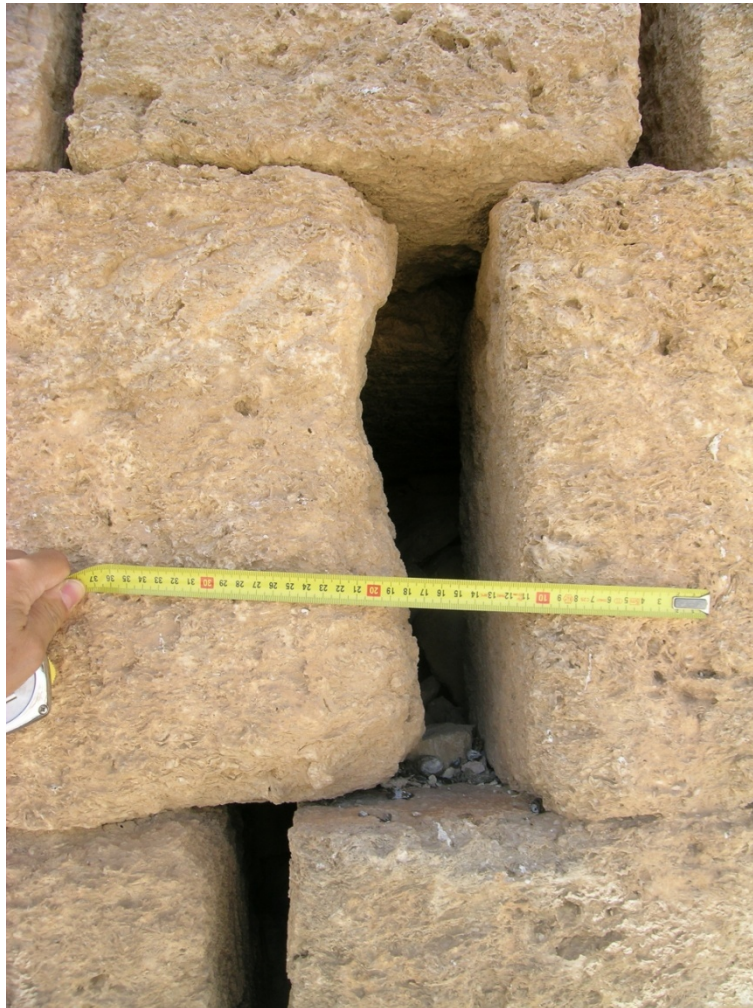
SOUTH FACADE

Spacer joints at south-east angle.

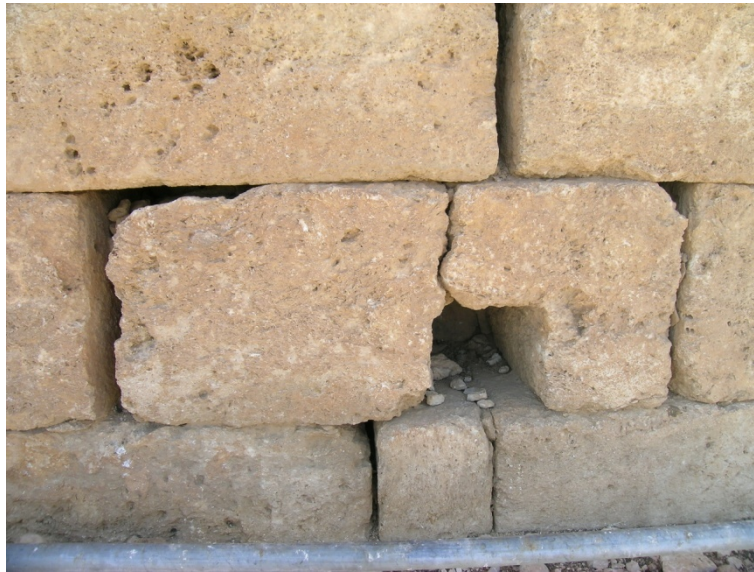
SOUTH FACADE

Broken stone at the basis of the tower

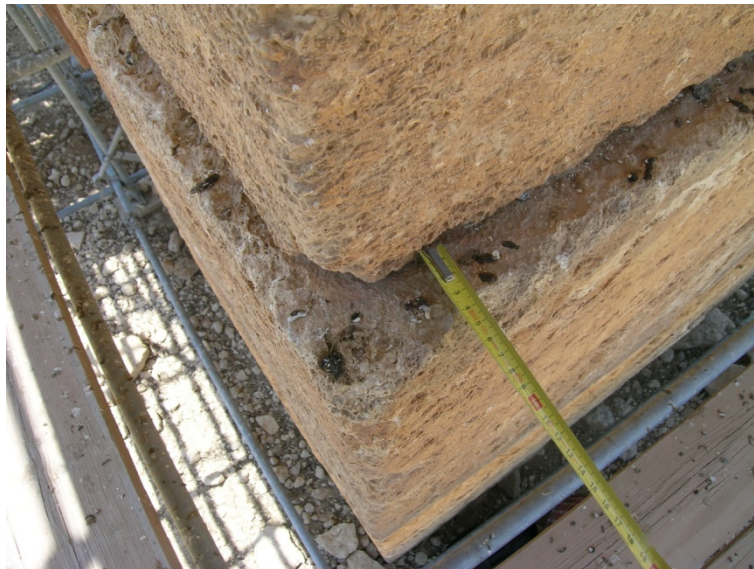
SUD-EAST ANGLE

Slippage of stones in 7 rows

- Separation of the tower over the south-east corner, from the base to the 7th row.
- Inclination of the tower in the opposite direction, north-west.
- On the northern side the majority of cracks and of the loosening stones is present on the total height of the north-west angle, at the level of the vertical gallery.

It is necessary to provide a core of soil in the vicinity of the tower to know its constitution and its properties. More important excavations will be made at the base of the tower in order to check the status of the foundations across the perimeter. The south-east angle(to a height of 7 rows) presents a detachment of stones; it is necessary to evaluate whether a settlement or collapse of the foundation took place at that location.

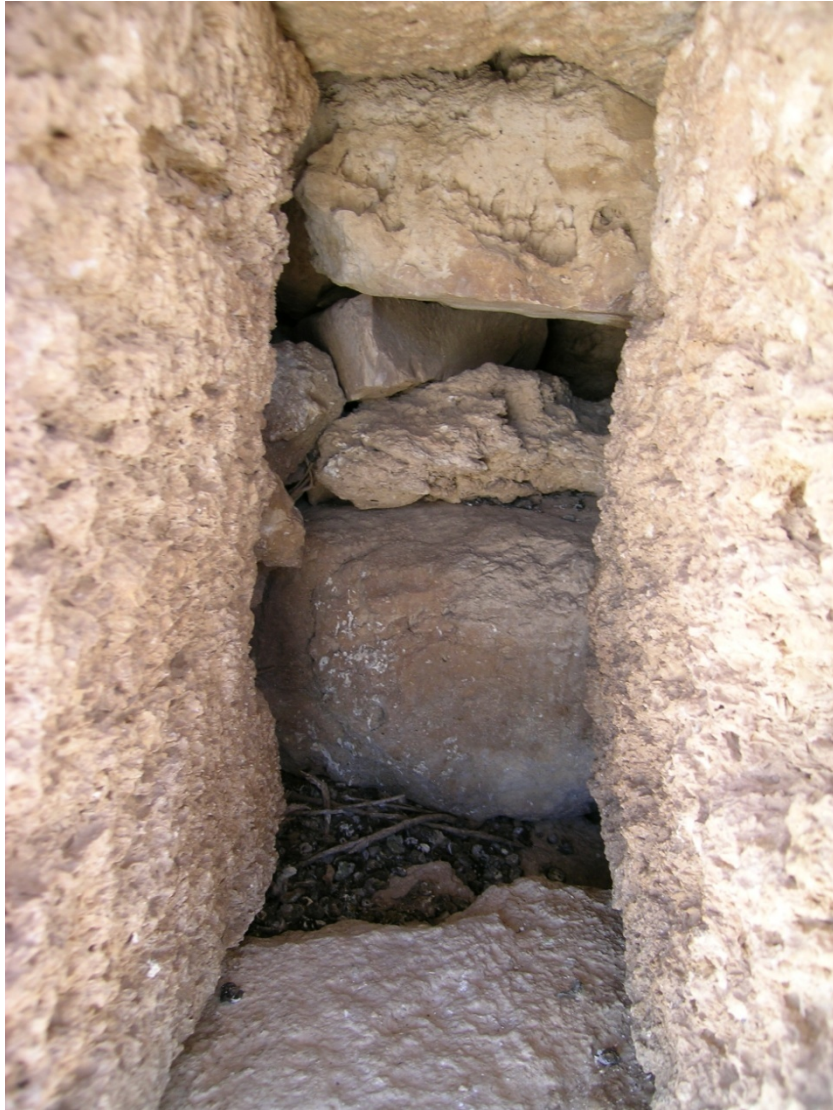
INFILLING INTERIOR

The mortar is non-existent

- The inside infilling has suffered from the shock of the collapse and the increase of the burden has caused a very important deformation. This deformation accompanied by a lack of mortar, has been shown as a shift towards the lowest point, i.e. the vertical gallery in the north-west corner.

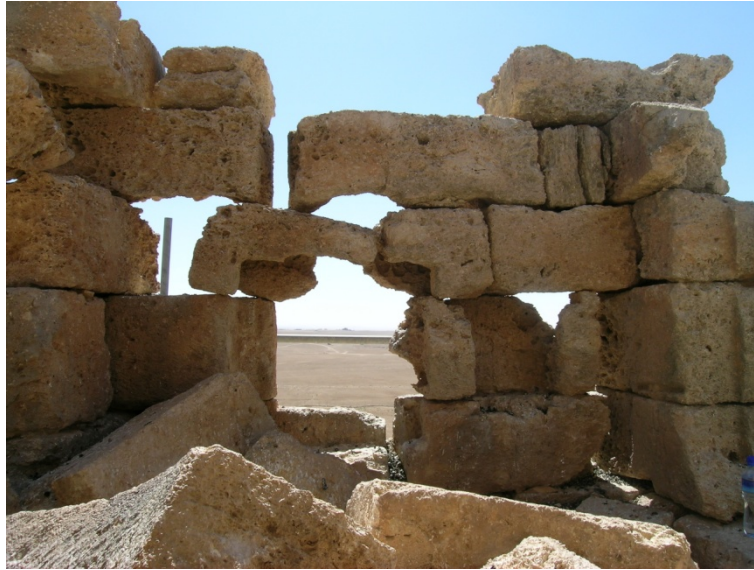
INTERIOR EAST FACADE

The majority of the stones are eroded. The lintel is broken.

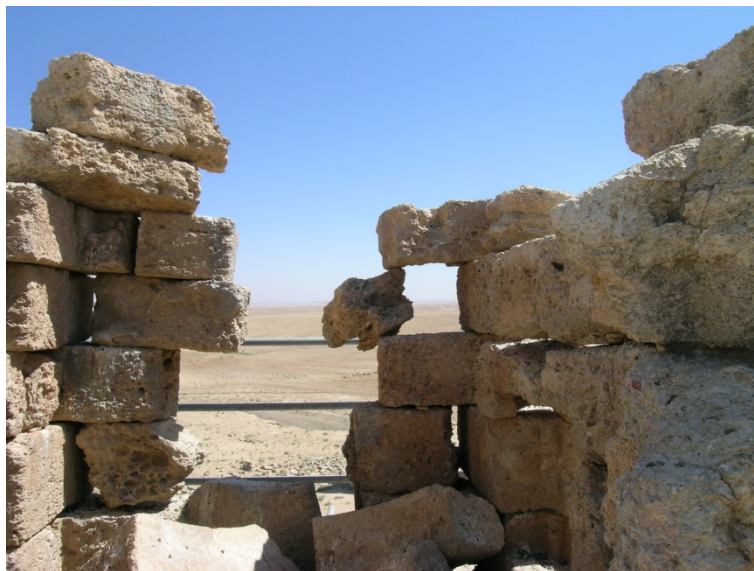
INTERIOR NORTH FACADE

A very eroded stone in a state of collapse.

As we know, the most critical part as regards the stability of masonry is the *cella*. For security reasons the stones must be lifted and numbered. The stones which formed the coverage should be removed.

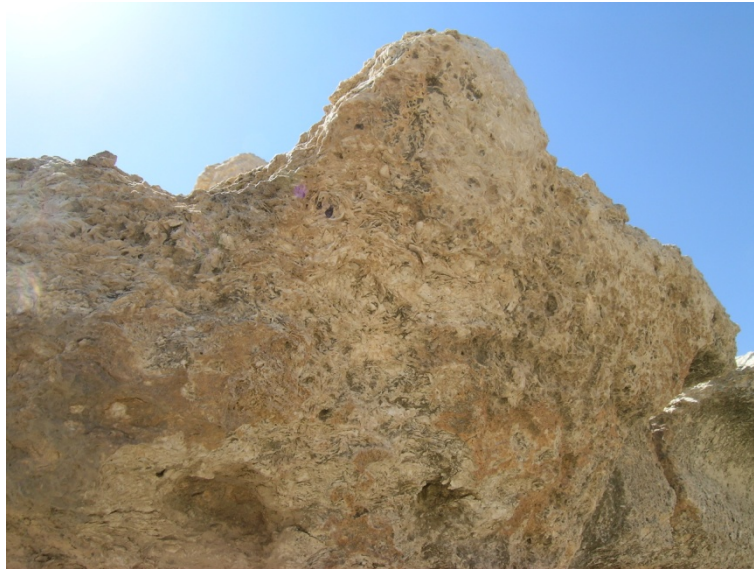
NORTH-WEST ANGLE

The decor of the capital is erased by erosion.

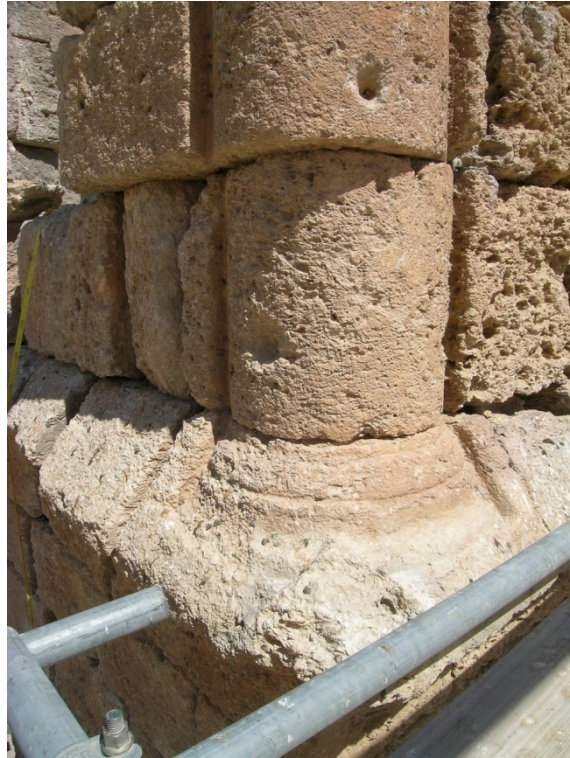
ANGLE SOUTH-WEST ANGLE

Slippage stones

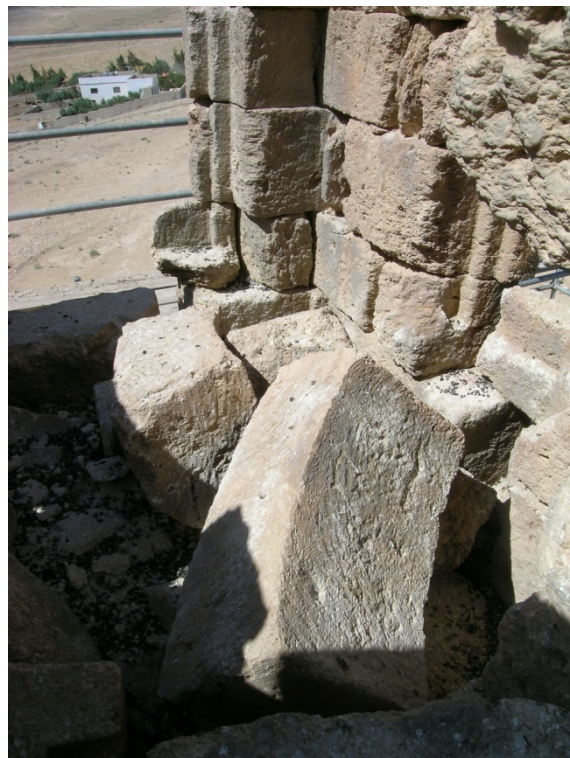
CELLA

Without doubt the most damaged part of the tower is the *cella*. We assume that the *cella* was covered with a stone dome which has collapsed on the floor of the *cella* (as we have found on the floor the arch stones). This collapse has led to an opening slot in the central parts of the facades and in the rows below the lower cornice. The stones came out of their beds and the joints are non-existent. The cornices and the upper lintels are very eroded and decorations and sculptures are in a state of advanced deterioration. Some stones have lost their original form and present an evident and future collapse.

Arch stones coverage of the dome

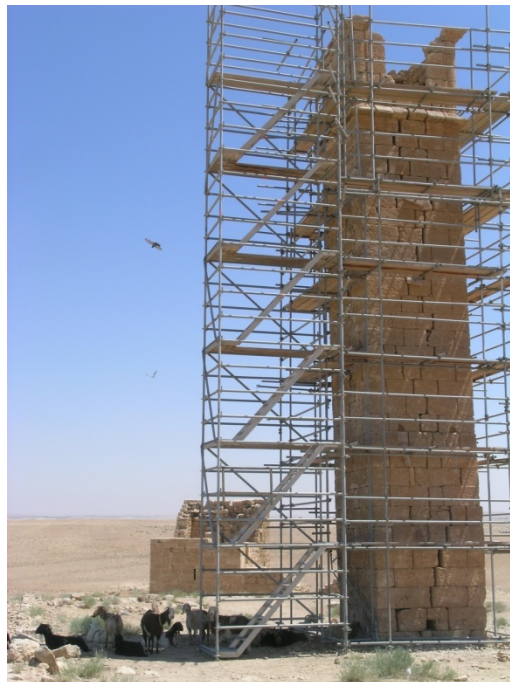
SCAFFOLDING

- Support of the scaffolding on the ground directly on the ground without crossing distribution.
- Vertical tubular structure on the scaffolding without wind braces, tubes diagonals tubes lack of the four facades across the height.
- The wooden corridors are not protected and they often lack of the wooden planks to cover the entire width of corridors. Several boards are cracked. The corridors in several place are not adjacent to exterior walls of the tower but at a distance between 50 and 70 cm (very dangerous situation), no protection is assured.
- Lack of safety net.
- At the *cella* level the scaffolding stops at 1.50 m from the lower ridge, so there is no umbrella roof of protection for the upper part of the tower.
- Only the stairs to the corridors is more stable (presence of diagonal bars, wooden planks are framed in metal structures).

No diagonal tubes to stabilize the structure.

It is necessary to dismantle the scaffolding and rebuild it according to the rules of art and by putting in place protective measures.

The existing scaffolding is obsolete. The new structure will be screened with wider corridors on which the worker can work without difficulties. It will have the wind braces to ensure greater stability and more attention shall be put on to the protection rules.

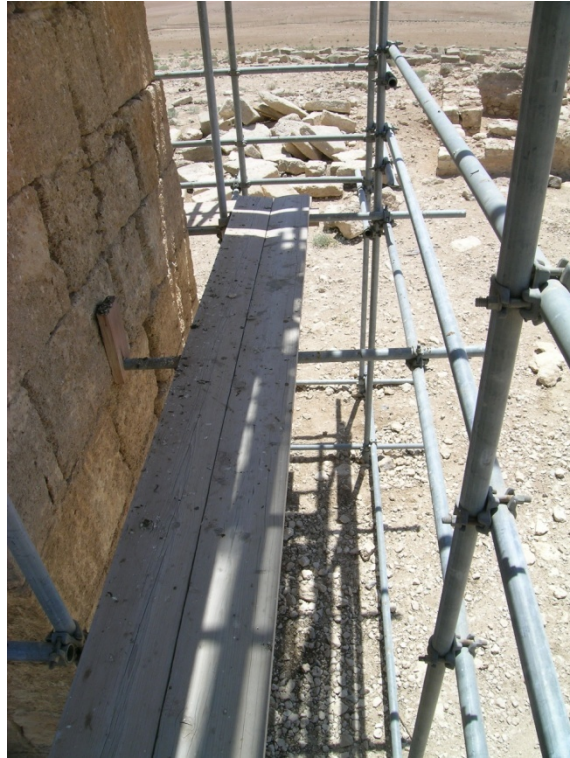
The wooden corridors do not cover the entire width

They are superimposed without any fixation.
