**State of Conservation Report**

**Birthplace of Jesus:**

**Church of the Nativity and the Pilgrimage Route, Bethlehem**

February 2016

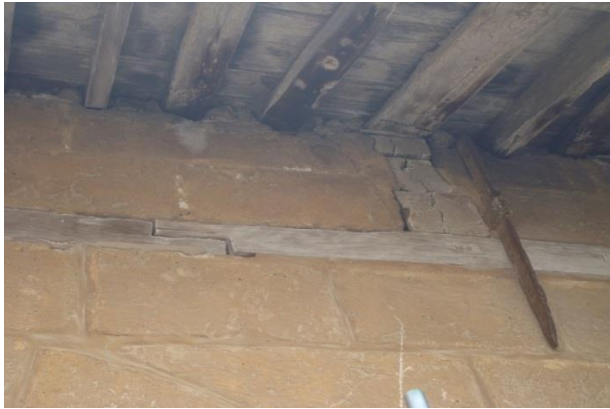
However, the stratigraphic architectural survey proves very clearly that the last layers of stones above the present wooden sleepers at the higher level (Figure 1) are not coeval with the rest of the Church but built in later periods; therefore, the present roof structure can be considered with no doubt as the result of continuous changes occurred over the centuries. Even the roof of the aisles were subject to changes, as proved by some archaeological findings, such as the holes excavated in the walls during Justinian's time (Figure 2) and used to support the purlins of the original roof, not at the same level as the present one.

Figure 1: stones above the present wooden sleepers at the higher level

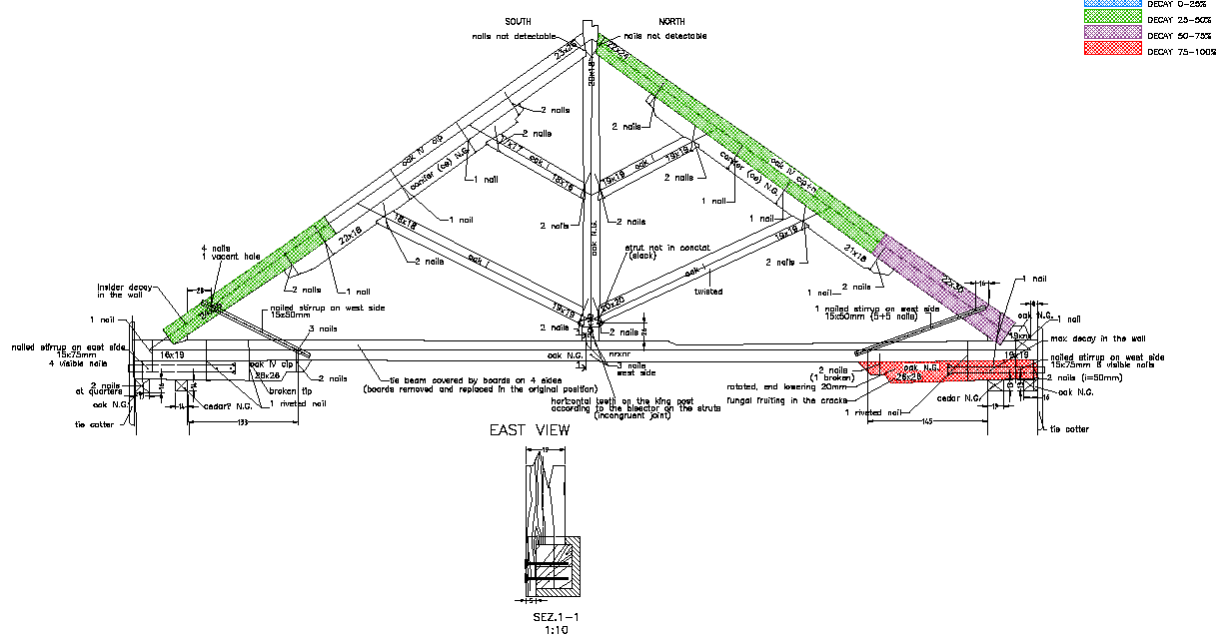
**In conclusion, as it was impossible to localize the various interventions made over the centuries, it was decided to preserve as much as possible the existing materials, in particular the wooden components of the roof.** To this purpose an accurate diagnosis of each truss was carried out by visual and instrumental inspections (see previous Report “Answer to the request for specifications addressed by ICOMOS to the State Party” dated July 2014 submitted to WHC), followed by interventions of restoration limited to the most damaged parts of the structures. **These surveys allowed defining with a high level of accuracy the state of conservation of each wooden truss by means of four percentage ranges of physical decay, denoted by four different colors (and the ranges were 0-25%, 25-50%; 50-75%; 75-100%) (Figure 3).**

Figure 3: Sample of state of conservation of each wooden truss

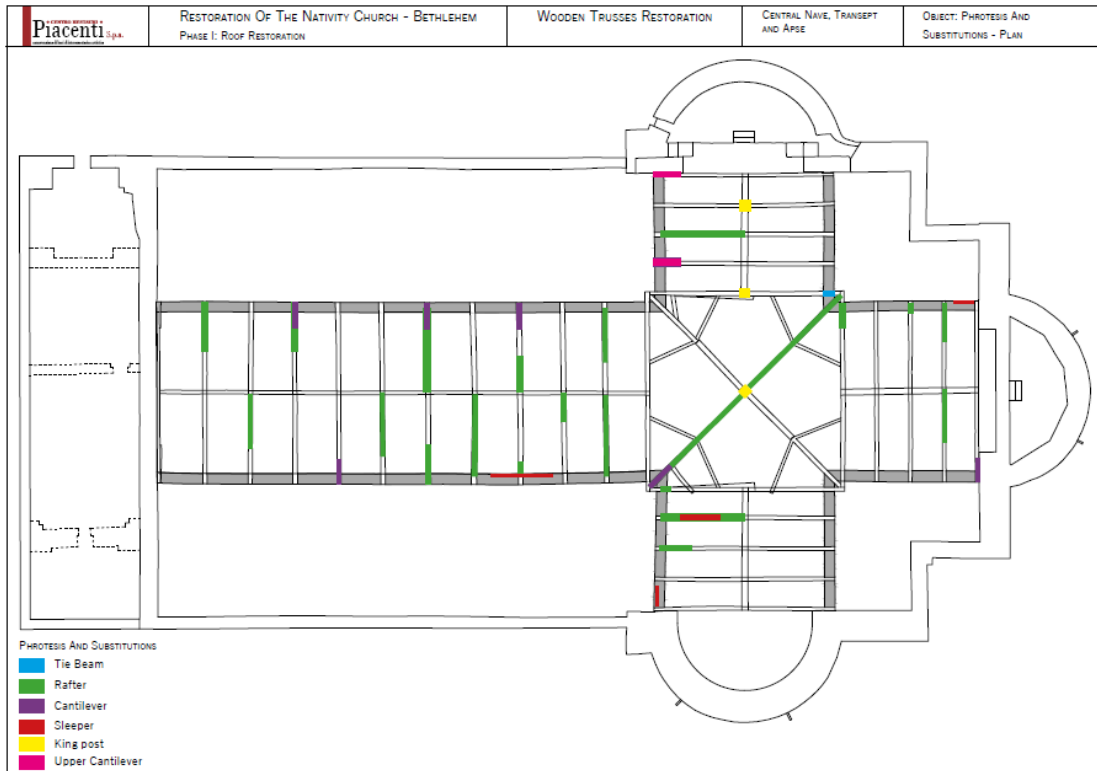
The damaged elements (either rafters or tie beams, struts, king posts, cantilevers, sleepers) are represented in a plan view for nave and transept and for aisles and corners (Figure 4 & Figure 5).

Figure 4: damaged wooden elements in the central nave, transept and apses.

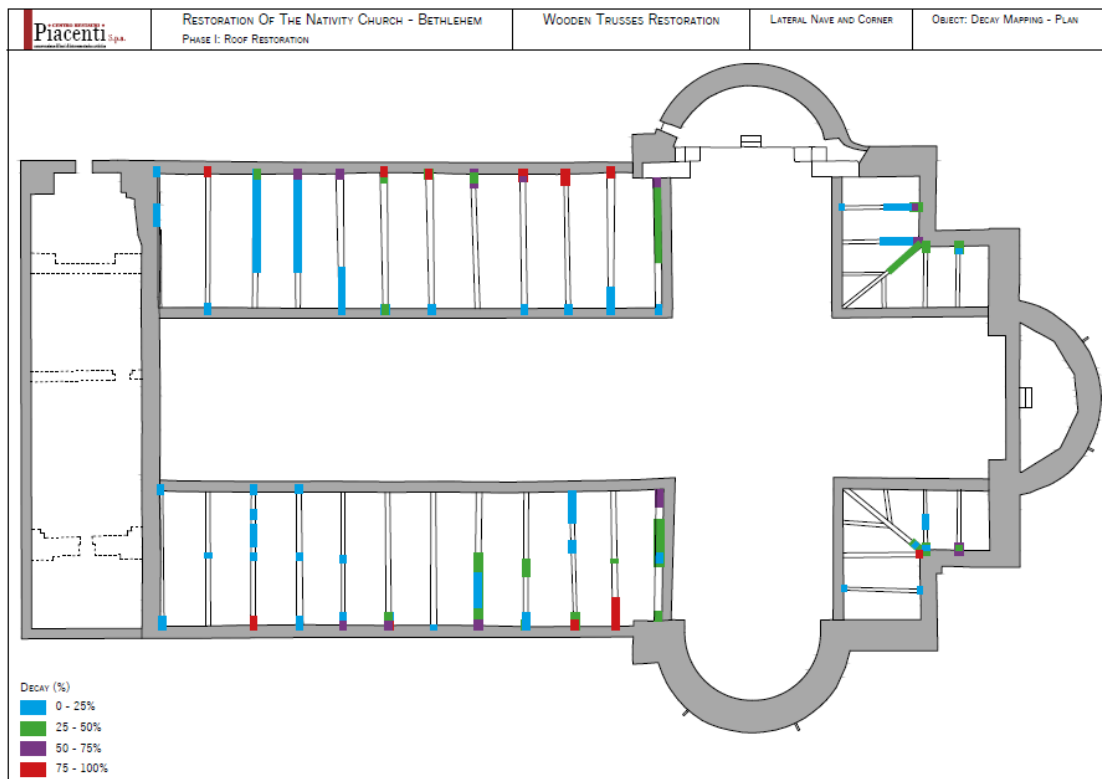
Figure 5: damaged wooden elements in the lateral nave and corners.

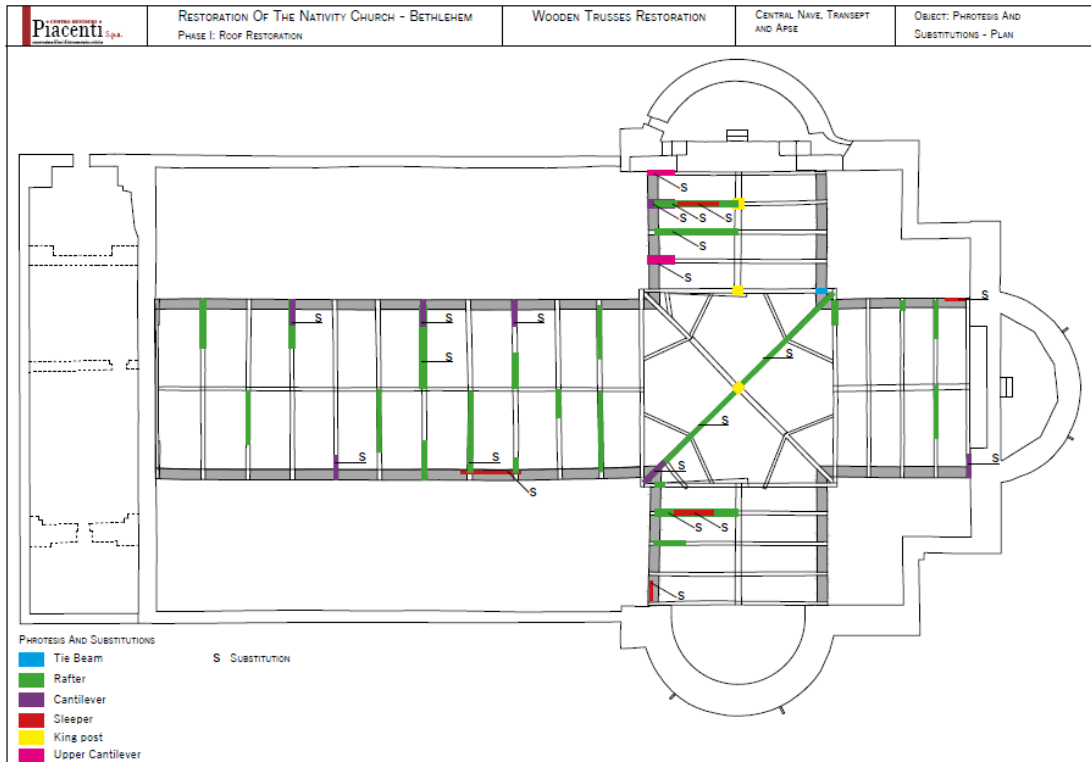
Figure 6: Interventions on wooden elements in the central nave, transept and apses.

The interventions of restoration consisted either in a replacement of entire structural elements (in a very small number) or in replacements of the only decayed parts by prosthesis. In Figure 6 & Figure 7 (S) indicates the total substitutions, all the rest are prostheses.

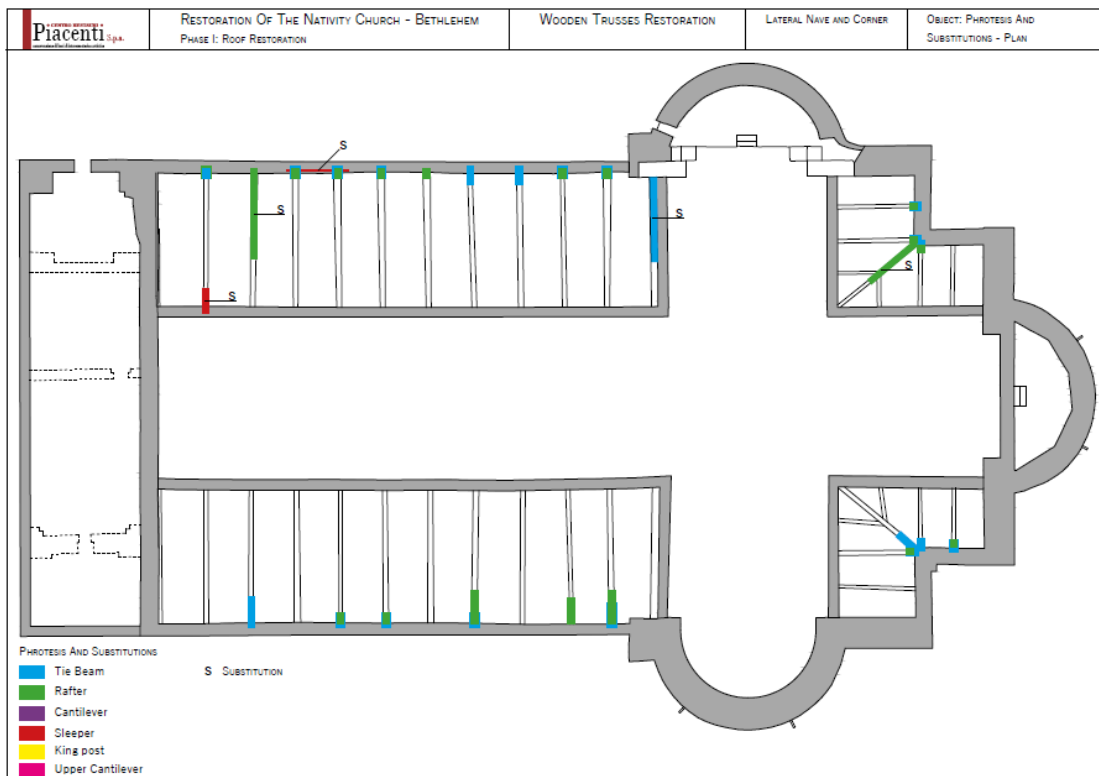
Figure 7: Interventions on wooden elements in the lateral nave and corners.

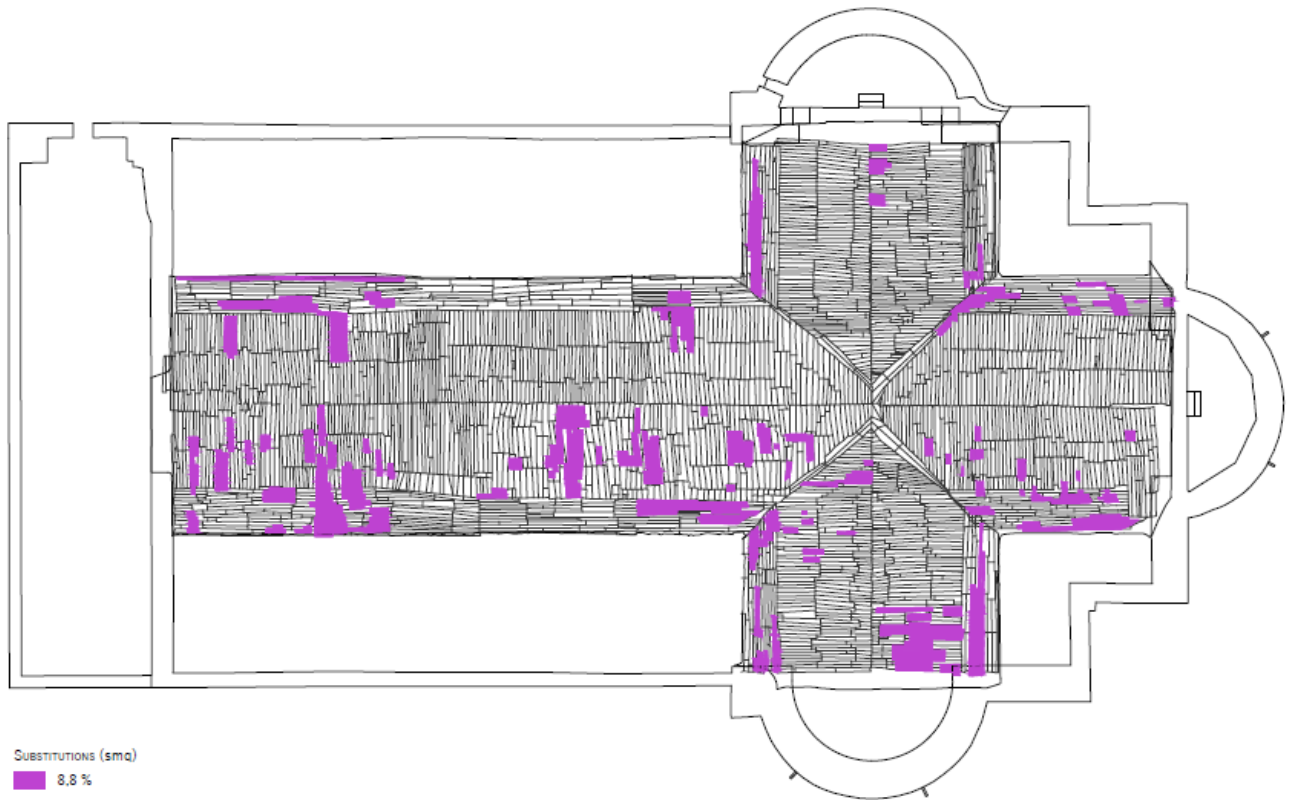
In particular, the survey carried out showed a state of conservation better than the one previously thought: less than 9% of the boards were replaced in the nave and transept (Figure 8), and only 6% in aisles and corners (Figure 9).

Figure 8: Replaced boards in central nave, apses and transept.

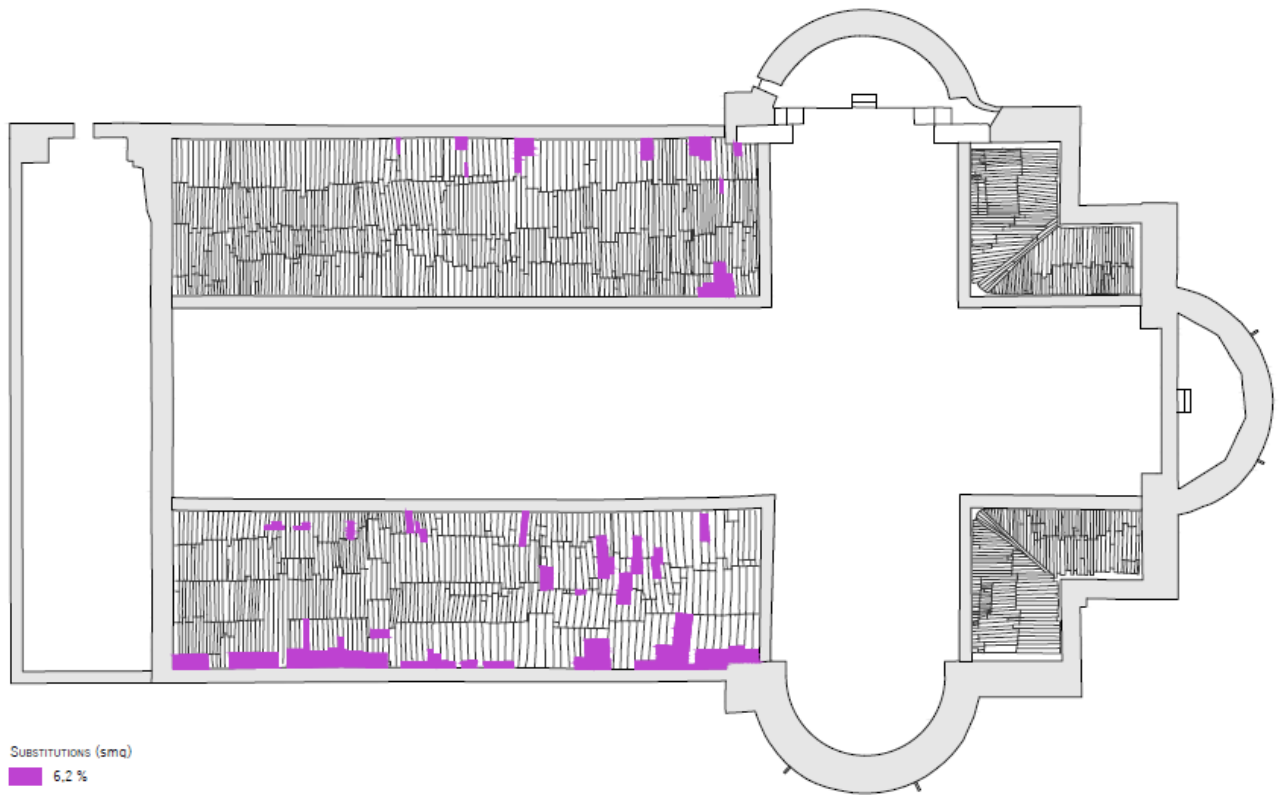
Figure 9: Replaced boards in lateral naves and corners.

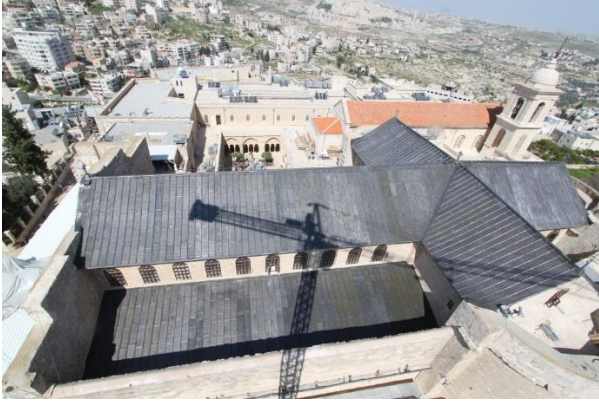
Figure 10: General View of the completed works

The restoration of the roof was completed in March 2015 (Figure 10) with the positioning of the new windows (Figure 12), a new life-line (Figure 13) and new crosses (Figure 11).

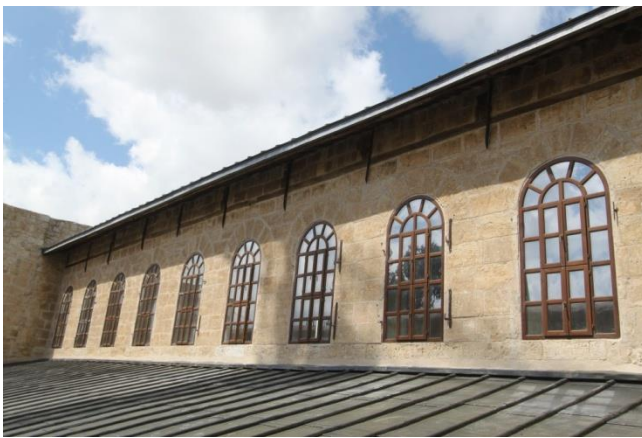
Regarding the windows, in many cases the wooden frame of the windows was not well anchored to the wall due to the mortar detachment also from the openings between the wood and the wall thus, the rain can enter the church, creating dangerous conditions for the internal mosaic. Also it was observed severe fungal decay in most of the wooden windows placed at the high level and the grey paint was often detached from the wood. The windows are not considered ancient, as this is obvious from the type of the method of hinges and handles so the decision was to replace all windows with new ones to be manufactured from a good wood. The new windows are made of cypress wood coated with a dark brown color, with double glasses of UV protection, window rubber seals and weather proof.

Figure 12: View of the completed windows

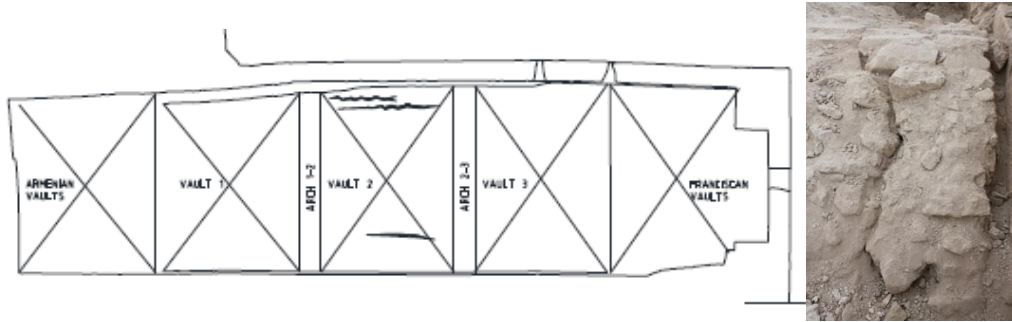
The structure of the Narthex is today strongly deformed. The façade wall exhibits a rotation towards the Manger Square more pronounced in the middle and starting approximately from the lintel of the door of Humility, about one meter above the ground. In consequence of this rotation, the façade wall has undergone a maximum horizontal displacement at the top, approximately in the middle of the free part of the wall, of about 40 cm. It is a very high value when compared with the height of the wall, about 10 meters measured at the top. If some fractures have occurred in the past, these are now closed due to local interventions of cleaning and consolidation made over the centuries, which shows that the damage evolution is now over and that it was probably over even before adding, from the sixteenth century AD, the external buttress which is still perfectly vertical. The façade of the Church, opposite to the one of the Narthex, exhibits a light out-of-plane deformation which starts from the roof of the Narthex and achieves 10 cm at the top of the tympanum. In consequence of the rotation of the façade of the Narthex the cross vaults, in particular the three most internal, have lowered in the central zones, detached from the façade walls and cracked both at the extrados and the intrados. Especially the central vault, propped since the thirties of the last century AD, exhibits detachments of 17-19 cm from the Narthex façade and 10-11 cm from the Church façade. Moreover big cracks, parallel to the façades, are visible at the extrados Figure: 18.

Figure 18: Cracks at the extrados of the central vault

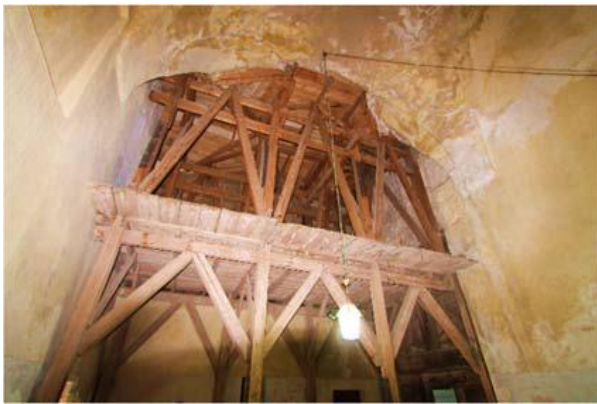
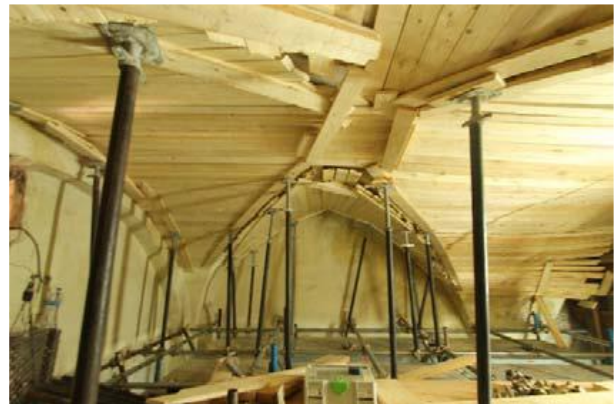
The intrados of the vaults, which had suffered also water infiltrations because of the numerous cracks and gaps and also for the absence of any maintenance at the extrados had been propped in the central part during the British Protectorate. Before the beginning of the restoration works however also the two adjacent cross vaults were propped for safety reasons (Figure 19 & Figure 20)

Figure 19: Central propping

Figure 20: Lateral propping

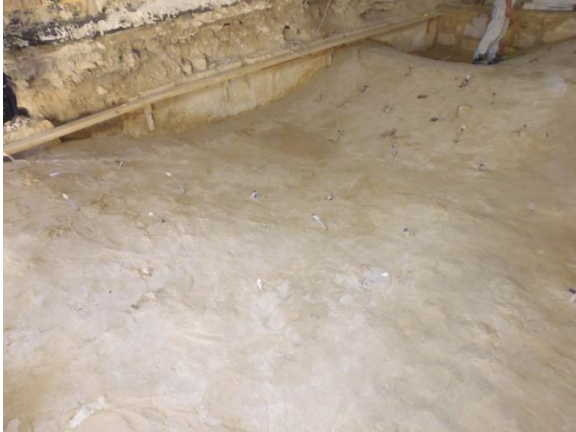
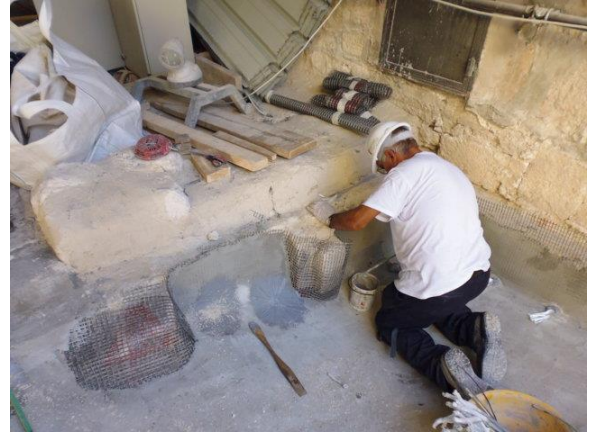
Figure 21: Consolidating mortar

Figure 22: net of glass fibers immersed in a cement matrix

Additional system was also introduced as an extra safety for unexpected and unpredictable events. It is a system of hanging of the vaults that can support these ones also if we are in presence of a total structural failure. The system consists of a series of threaded rods connected to the metal structure of the roof slab that, passing into the interior of the vaults, are connected to them at the intrados with metal plates hidden in the plaster.

The same treatment is applied to the intrados (Figure 22)

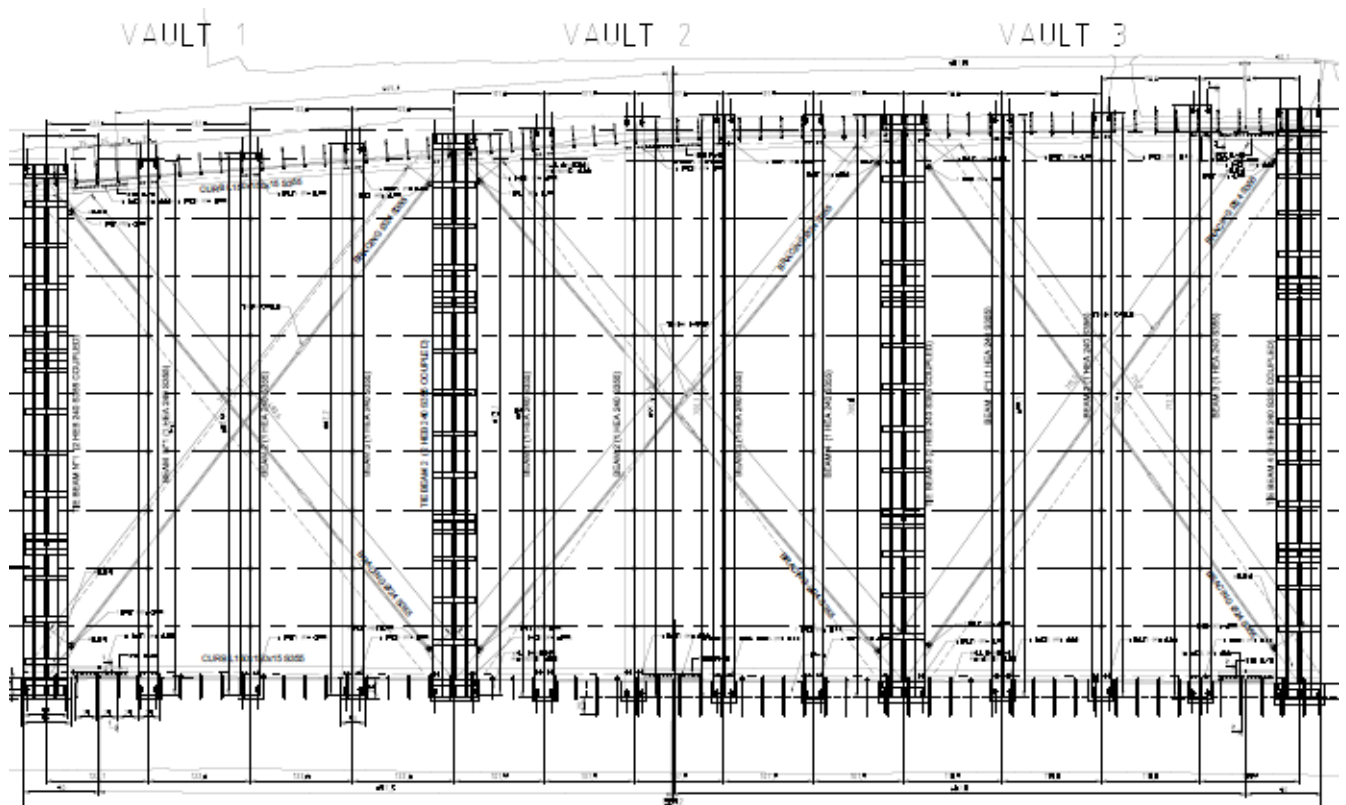
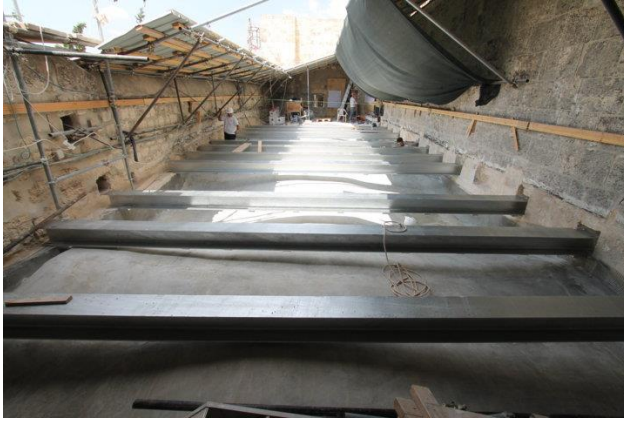
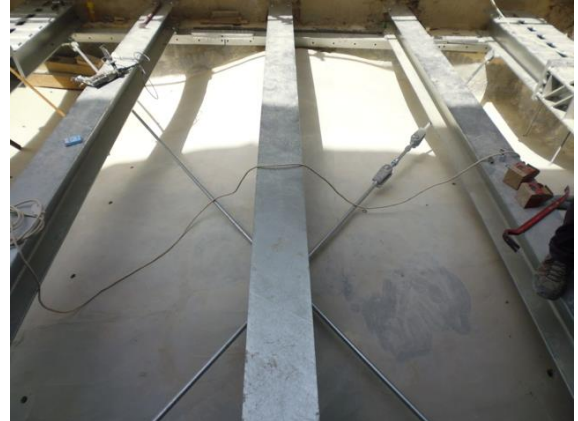
Figure 23: Plan of the added Steel structure

Figure 24: Beams connecting both façades

Figure 25: Bracing system

The new steel structure covers only the three central spans, or vaults, and consists of four main beams, above the stone arches bearing the vaults, and ten secondary beams. They all rest on the two opposite facades and are interconnected by a steel curb placed along the perimeter (Figure 23, Figure 24, Figure 25)

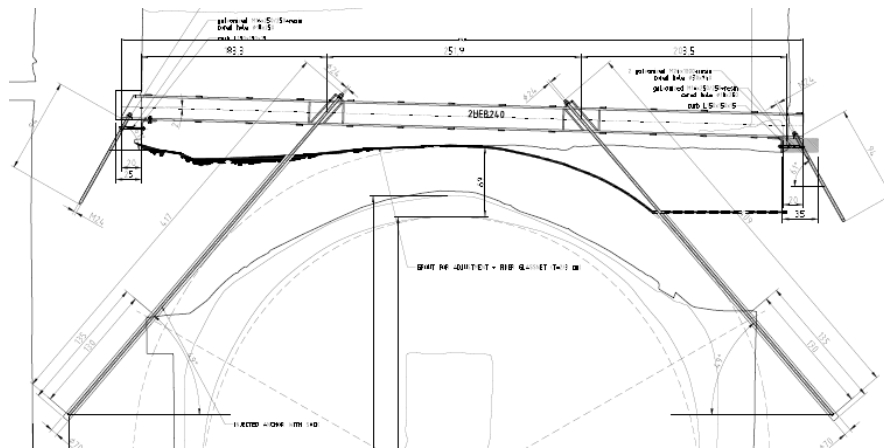
Figure 26: Cross section showing the anchoring system

Both types of beams are also strongly connected to the façade walls by means of couples of inclined bars. The longest ones, in correspondence of the main steel beams, transfer the thrust of the stone arches to the beams above and transform this thrust into stabilizing vertical loads on the masonry walls. The connection between the two façades, by minimizing the differential horizontal displacements in the E-W direction, will reduce considerably the risk of collapse of the whole structure in the case of an earthquake (Figure 26).
