INTERNATIONAL COUNCIL
ON MONUMENTS AND SITES

Report on Mission to Luang Prabang

Professor Edward N. Bromhead

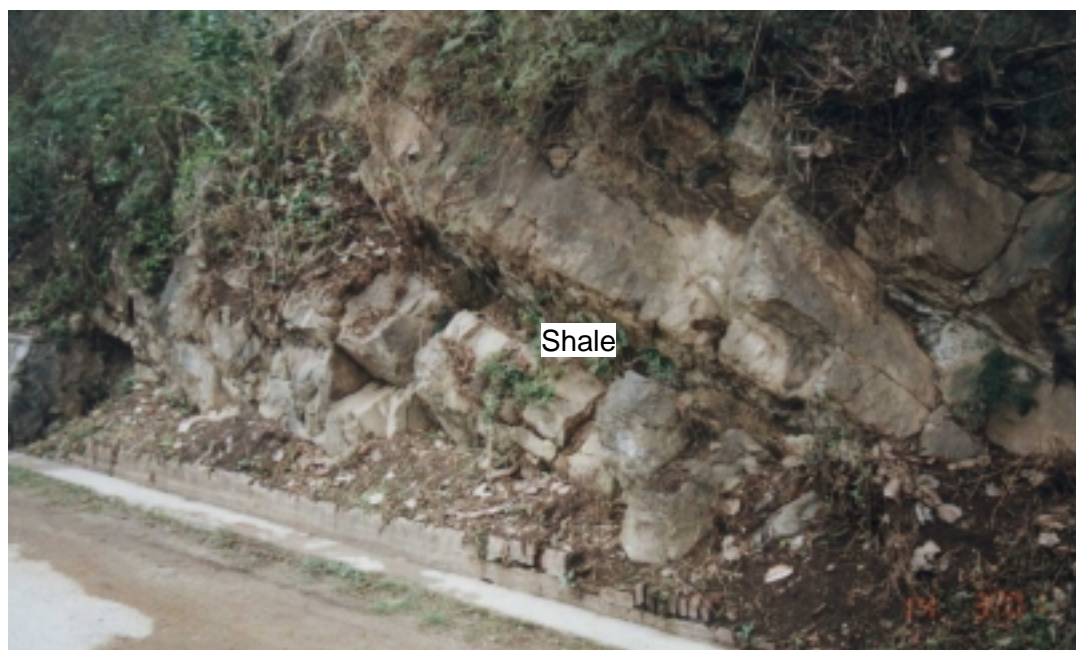
During my visit I examined the exposed rocks in the Phousi hill, adjacent to the failed section of wall. They are sedimentary rocks, with interbedded limestones, sandstones and shales. The rocks are highly fractured, and dip at about 30° to the horizontal in a northerly direction. This combination renders it unlikely that sliding of significant parts of bedrock of the Phousi hill towards the Nam Khan river will occur.

My photograph, Figure 1, shows the rocks that I examined. The dip can be clearly seen. I have highlighted one of the beds of shale.

Figure 1. Rocks adjacent to the road dipping into the Phousi hill.

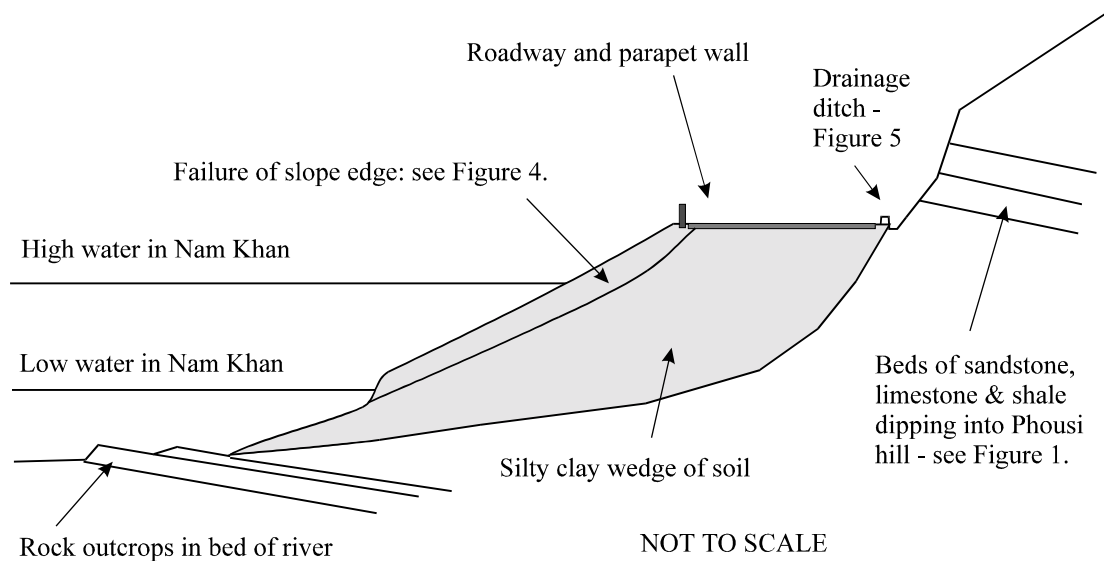
The road and slopes down to the Nam Khan river are not cut into the bedrock. Instead, they are both formed in a wedge of soil. I have sketched this in my Figure 2, which is not to scale. Bedrock outcrops in the floor of the Nam Khan river, and in places at the foot of the slope. It is better visible when the Nam Khan river level is lower than at the time of my visit, but even at this time, turbulence in the river marks the position of prominent outcrops.

Figure 2. Sketch section of affected slope showing features mentioned in the text.

The soil failure that prompted the design of river erosion control and slope stabilisation works is a small-scale slip of the slope formed in this wedge of soil. It is significant only in that it threatens a major access to the town: it does not threaten and significant parts of the historic town centre or its buildings, except perhaps on a geological time scale measured in thousands of years.

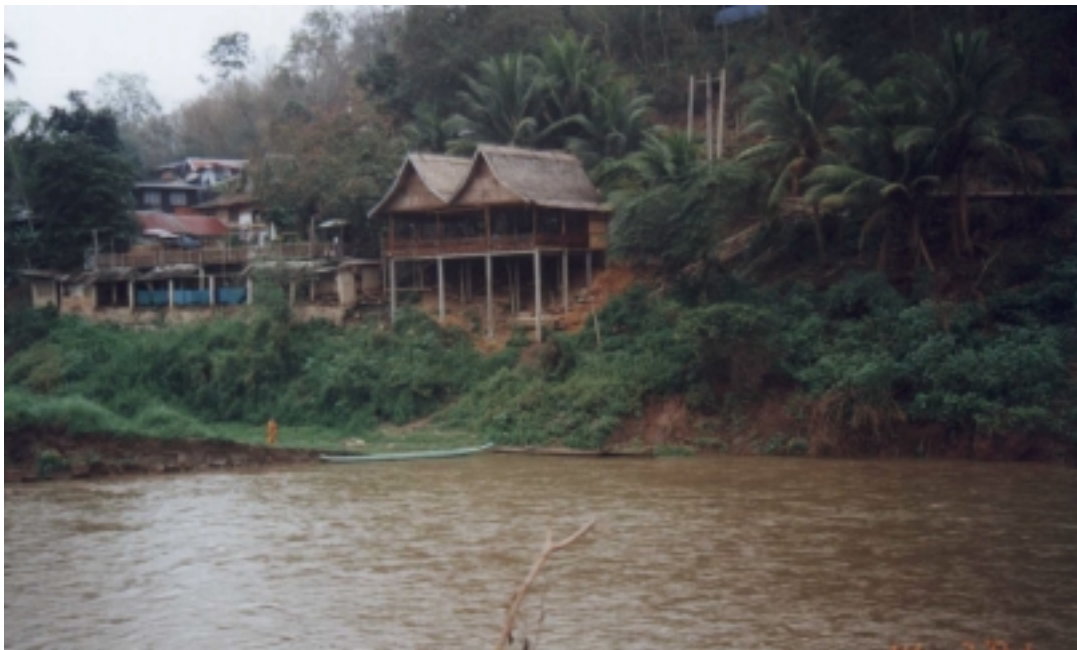
river levels, and is concentrated at the toe of the slope. This can lead to the slope as a whole being undermined, and the occurrence of slips of the type that recently affected the road. During my visit I was taken to the opposite side of the river to get a better view of the slope. Figure 3 shows the slopes a little upstream of the failure site. The photograph was taken from a vantage point on the opposite side of the river. The erosion at the toe of the slope can be seen both to the right of the house on stilts, and also in the small island formed of sediment to the left of the house. This island appears to have formed comparatively recently.

Figure 3. Upstream of the failure site. Erosion is taking place to the left of the boat and orange figure in the sediment island, and also as the river turns, to the right of the house on stilts. The high sediment load in the Nam Khan river is evident from its colour.

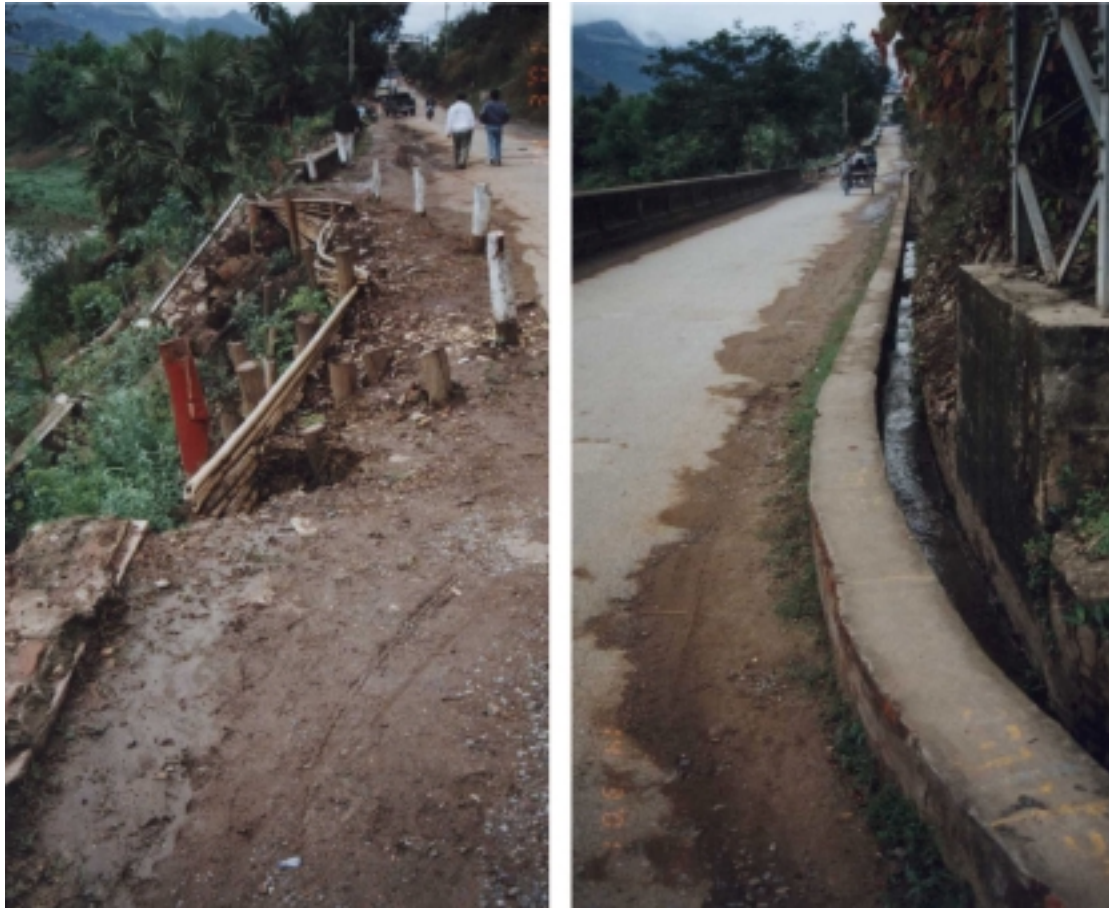
In my view, slip failures in the soil wedge are inevitable. A view of the failed section of the slope is presented as my Figure 4. Some intervention in the dynamics of the situation is necessary to ensure that the failures occur infrequently.

Quite clearly the failed area suffers several defects in construction. There are no arrangements for scour (erosion) protection in the slope below the road. This slope, as I have explained, is formed primarily in very recent alluvium, and it is subject to

changes in shape as a result of the interaction of flow patterns in the Nam Khan and Mekong rivers, as well as the effects of weather and human activity. Furthermore, the retaining wall for the road and parapet wall has no foundations of any significance. This structure is primarily cosmetic, and has little or no capacity for supporting the road.

Figure 4 (left) shows the site of the main failure, and how it affects the road. Figure 5 (right) shows the drainage ditch adjacent to the rock face (also shown in Figure 1). The wet area along the verge of the road shows where rainwater has lain, unable to escape via the ditch.

Water running off the Phousi hill is caught in a drainage ditch (Figure 5). These ditches are very widespread in Luang Prabang, and carry not only rainwater, but also waste water. I know of other cases elsewhere in the world where such drainage ditches leak, and feed water into the soils under roads (see sketch Figure 6). The ingress of water from this source can sometimes be serious for soil stability. I have no evidence that this drain at Luang Prabang is a problem, but in the reconstruction, care must be taken to ensure that the drain is not leaky.

Rainwater falling on the road cannot easily enter the ditch, and must find another route to enter the river. I do not believe that the highway drainage system is adequate for maximum rainfall events. Rainwater has clearly poured off the road in the area of the slip failure.

Faced with the problems of this site, I would recommend a gabion form of construction. It provides erosion protection to the slope at all river levels. Because it is very permeable, it lets out water from the ground. It is to be built (according to the plans) with reinforcement extending back into the slope. The resulting mass of reinforced earth is capable of supporting the slope.

In my opinion, the gabions must be founded on rock. Rock is at an irregular level at the foot of the affected slope. Sometimes it is under river level. The levels could be made up with mass concrete. This would only rarely appear out of the river, and would be indistinguishable from the natural rock when it was made dirty with river mud. Gabions could be built on this concrete before it was properly cured, (i.e. only days after placement) because the pace of construction is slow, and the concrete would be fully cured by the time it was fully loaded. Masonry could also be used.

If the gabions are not founded on rock, the scheme will be fundamentally flawed because erosion at a low level in the soil wedge would undermine the gabions. This could even take place at low river levels.

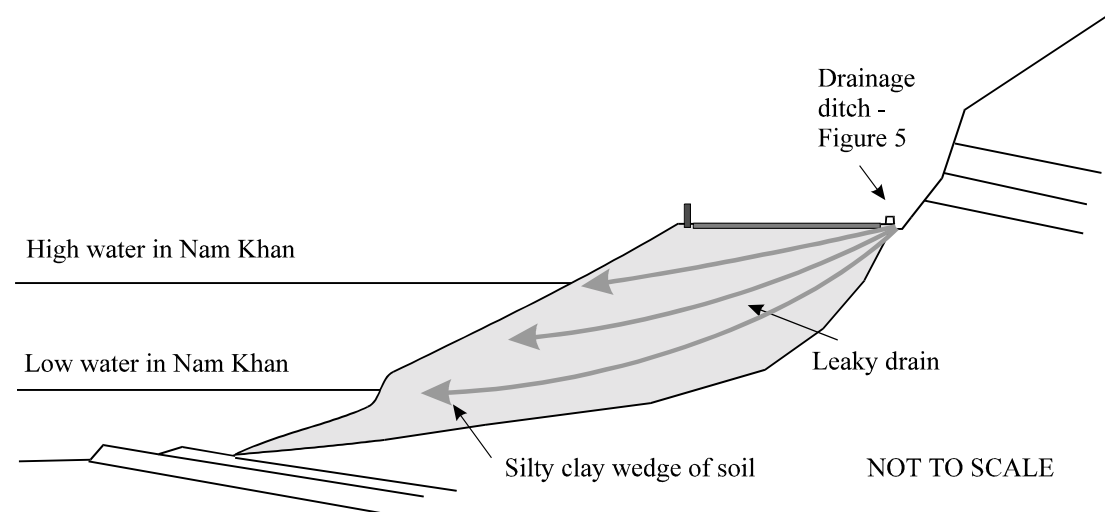
Figure 6. Water flows from leaky drains – a speculative illustration of possibilities .
