Report on Mission to Evaluate the State of Conservation of THE PAOAY CHURCH (The Philippines)

22-29 July 2000

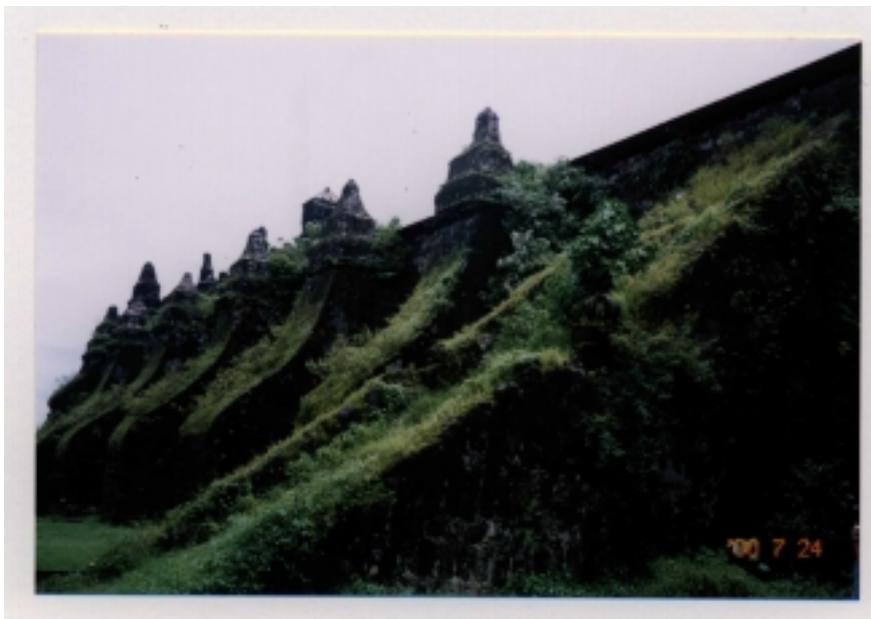
The exterior of the building suffers from vegetal growth, though the mission was told that that the vegetation had been removed in 1997. The roots of the vegetation penetrate through the stone joints and the cracks and their growth degrades the mechanical properties of stone materials.

Photo 3 Vegetal Growth on South Wall

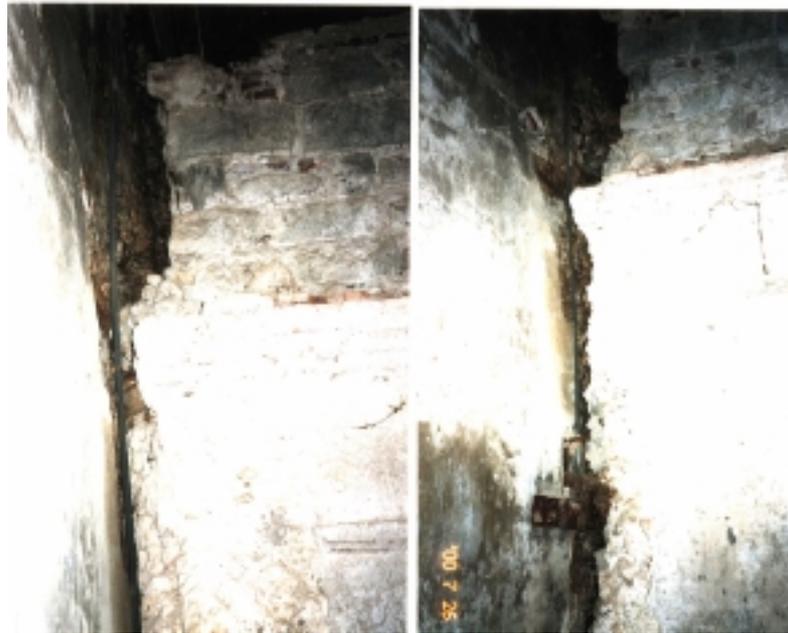
The separation (large cracks) of the main facade from the side walls constitutes a serious structural problem, as shown in Fig .4. The separation causes large cracks at the north-west and south-west corners of the building.

Photo 4 Separation of Facade from Side Wall

The priest of the Paoay Church said that the serious separation (large cracks) of the facade from the side walls resulted from the destructive earthquake of 1983. This earthquake caused severe damage to the masonry churches in the provinces of Ilocos Norte and Ilocos Sur. He also said that the cracks have not apparently widened since then.

To check the structural stability at the present state, structural monitoring should be carried out. Movement of the cracks at the main facade (separation of the facade from the side walls) should be monitored to check whether the cracks were developing or in stable situation. At the same time, the climate conditions of temperature and humidity should be also monitored, because, in general, the width of cracks varies according to climatic conditions. It is recommended that

monitoring of the main cracks should continue for at least three years in order to understand the relation between the movement of the cracks and the climatic conditions. Those data are periodically recorded by a monitoring system. The monitoring of the crack's movement should be started as soon as possible.

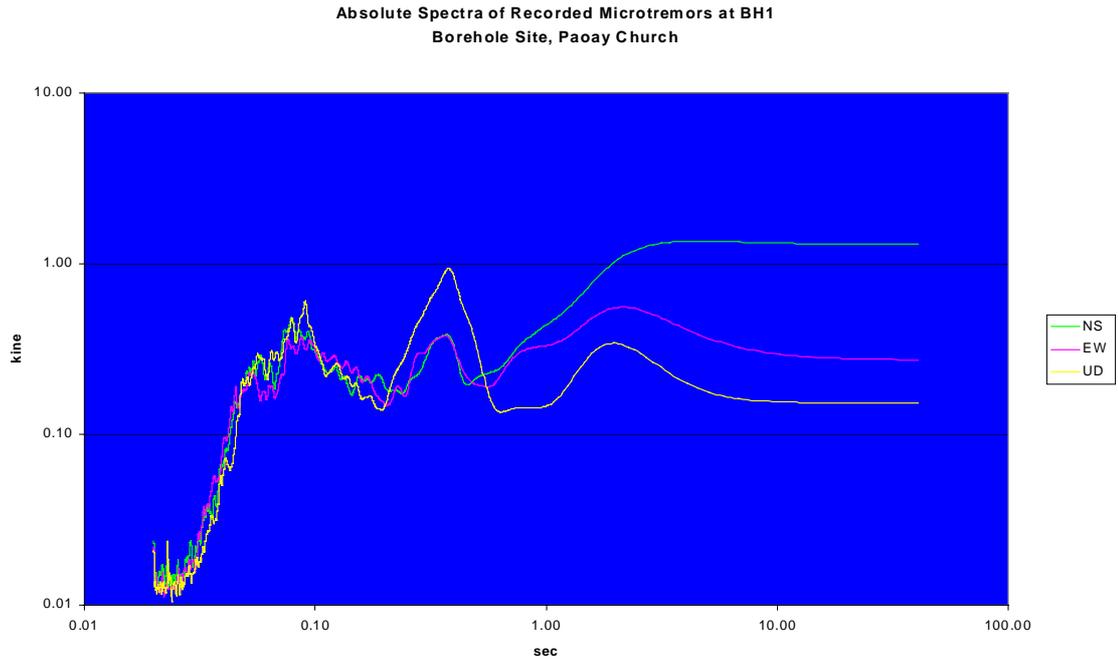
Microtremors on the ground were measured at Borehole 1 (BH1) and Borehole 2 (BH2), both of which had been dug to investigate the soil conditions. The predominant period of the microtremors at the site was observed to be about 0.4 second, as shown in Fig. 5. This suggests that, since the subsoils are moderately stiff, amplification due to soil response is not so high. If there is PS-logging (geophysical logging) data at the site, it will be possible to simulate the amplification of earthquake ground motions at the site

Fig. 5 Fourier Spectra of Microtremor at Borehole 1

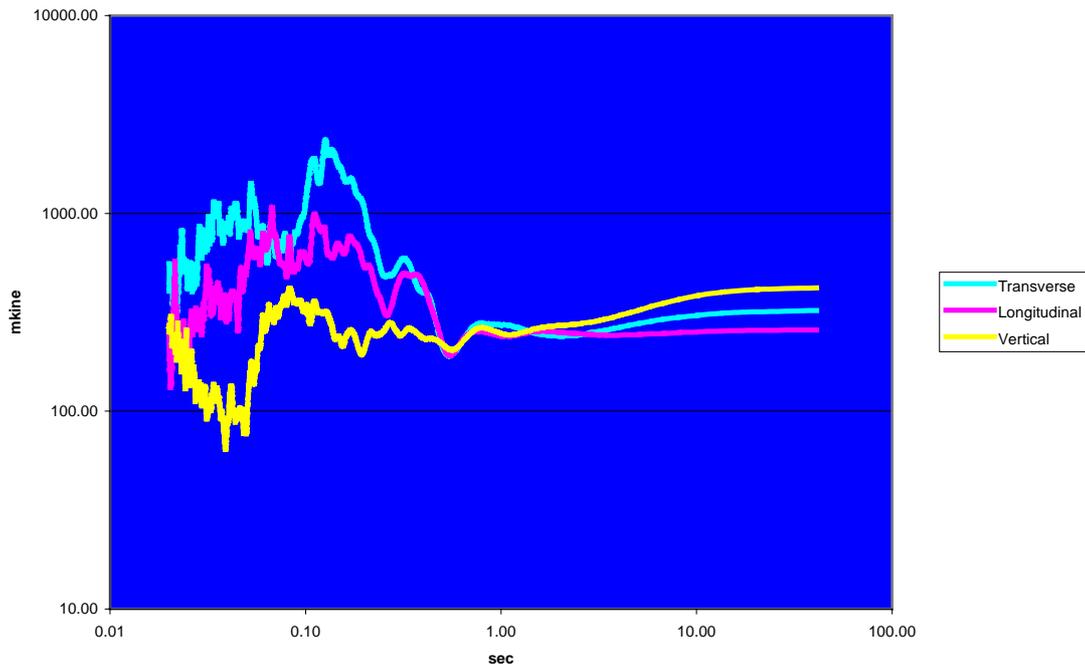
The microtremors were also recorded at the top of the side wall and at the base. The peak period of the spectral ratio of the top to the base was observed to be about 0.1 second, as shown in Fig. 6. However, the microtremors at the main facade could not be recorded, because it was not possible to reach the top of the facade to set the transducers. Further observation of the microtremor at the main facade will be needed to investigate the fundamental dynamic behaviours.

Fig. 6 Spectral Ratio of the Top of the Side Wall to the Base

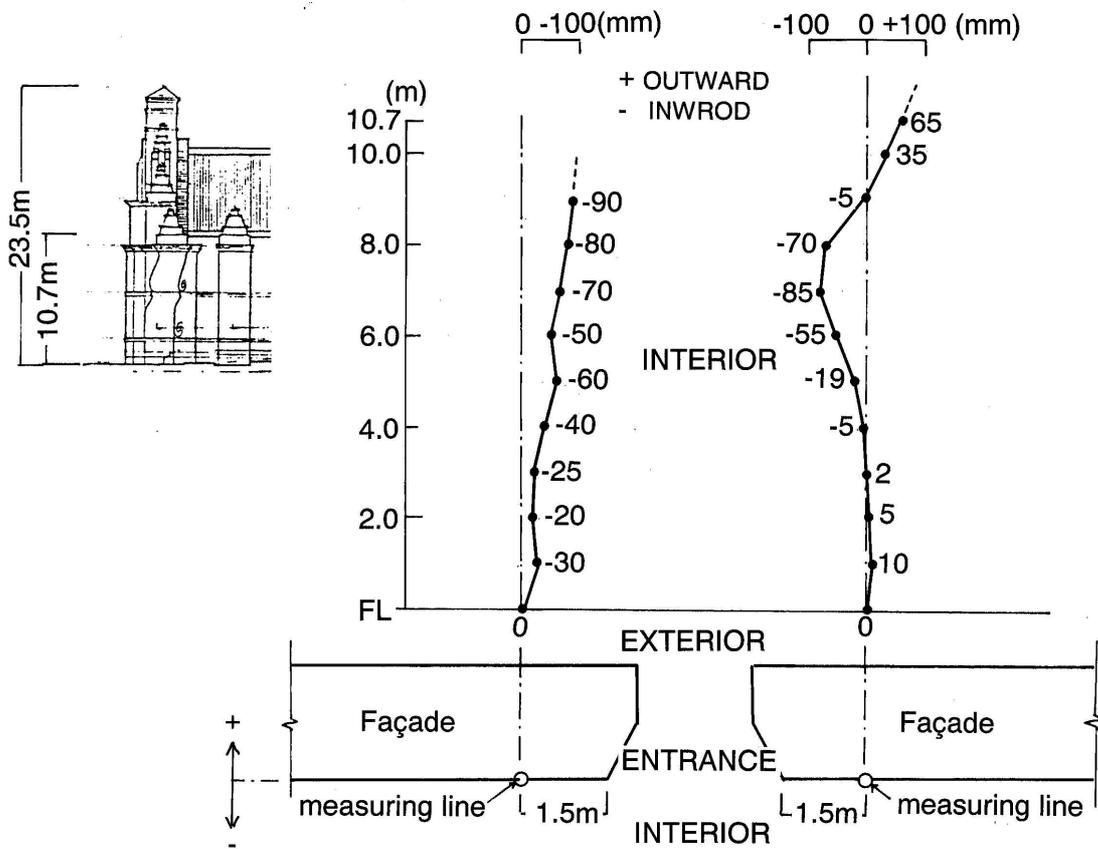
It was pointed out by the Philippine authorities that the tilting of the main facade threatens structural stability of the Paoay Church. However, there are no data about its alarming tilting. The deformation of the main facade was therefore surveyed, both along the elevation and in the horizontal plane. Figures 7 and 8 show the tilting of the facade and the deformation in the horizontal plane respectively. In Fig. 7 it will be seen that the facade tilts inwards at the lower level, whereas it tilts outwards at the upper level. At the apex (top of the facade), the inclination from the vertical was measured to be $1^{\circ}24'$ outwards. These measurements reveal that the tilting angle of the main facade is not uniform, indicating that the alarming tilting of the facade is not directly the result of irregular settlement of the foundations during the consolidation of the subsoils. On the other hand, the horizontal profile shown in Fig. 8 reveals that the facade deforms outward both at the north and the south ends where the side walls joined with the main facade

Fig. 7 Tilting of the Main Facade (FL 0.0–10.7m)

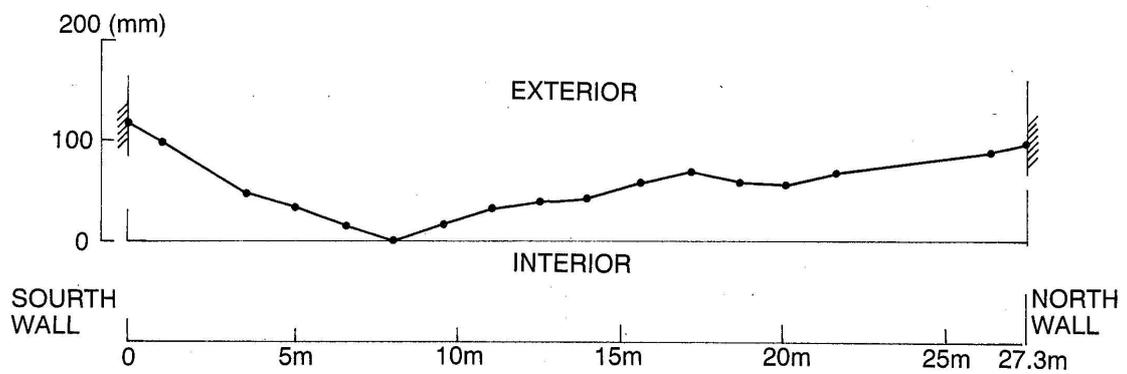
Fig. 8 Deformation of the Main Facade (Horizontal Section Profile at FL +9.0m)

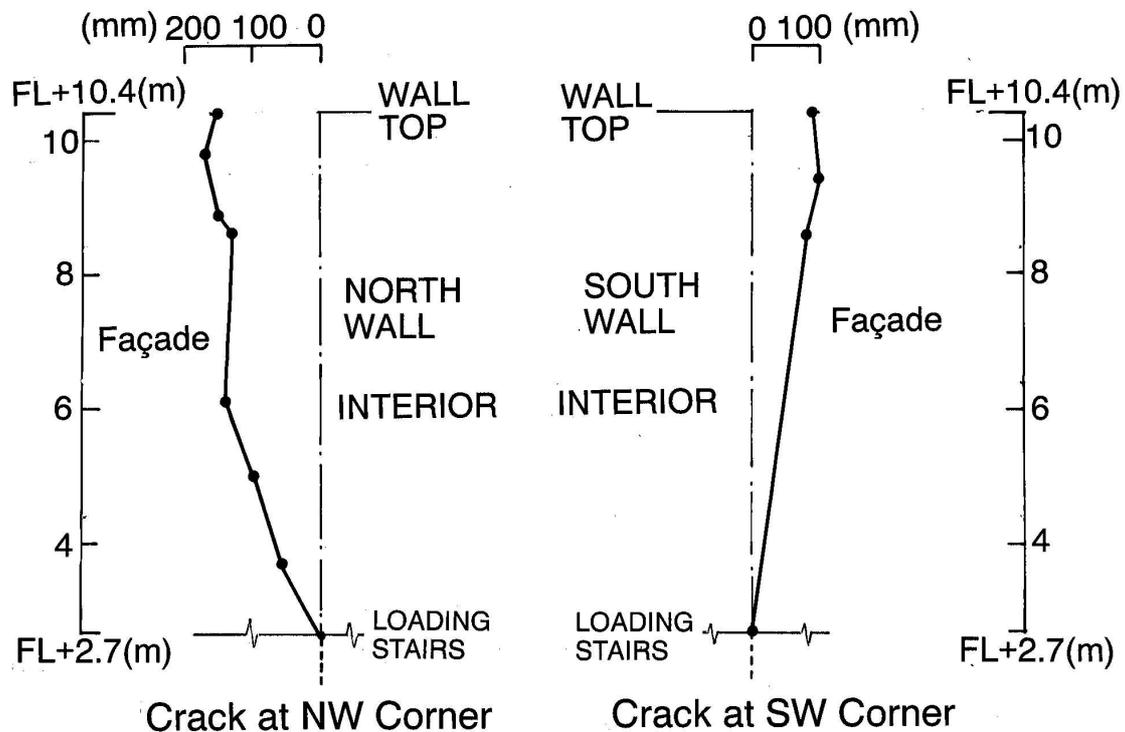
Figure 9 shows the separation (large cracks) between the main facade and the side walls (see Photo 4). The separation at both north-west and south-west corners becomes larger as it rises. As shown in Fig. 9. At the top of the side walls, the width of the separation was 15cm and 9cm at the north-west and south-west corners respectively. From a structural point of view, attention must be paid to whether the separation is increasing or not. If the separation increases gradually (the cracks widen) irrespective of the variation of the climate, the structural intervention should be done as soon as possible.

Fig. 9 Crack Width between the Main Facade and the Side Walls

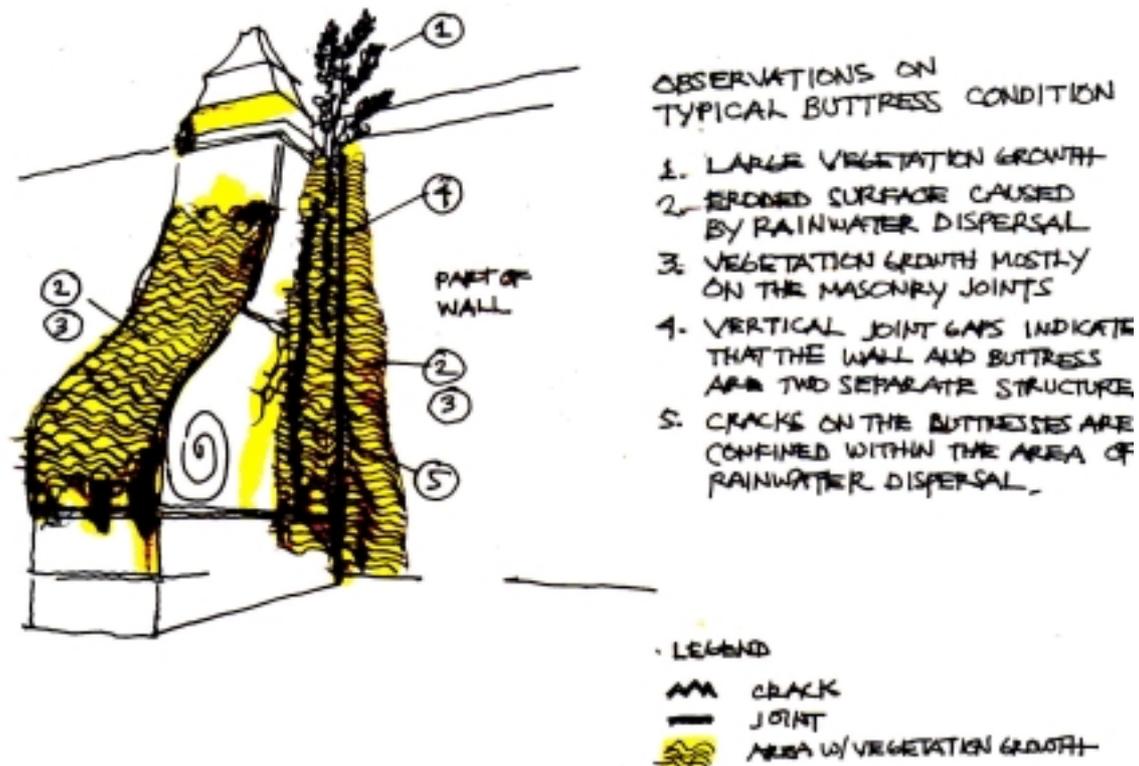
In this monitoring mission maps were drawn of visible cracks in the facade, the rear wall, and the side walls. At the same time, maps were drawn of cracks and joint gaps on all the buttresses; the condition of the buttresses, illustrated in Fig .13, was also recorded.

Fig. 13 Typical condition of buttresses
