TURKEY:
Historic Area of
Istanbul (No 356)

UNESCO MISSION TO ISTANBUL
NOVEMBER 1993

TO REPORT ON THE PRESENT STATE OF THE HAGIA SOPHIA MONUMENT
AND MAKE RECOMMENDATIONS FOR ITS PRESERVATION AND RESTORATION

MISSION REPORT

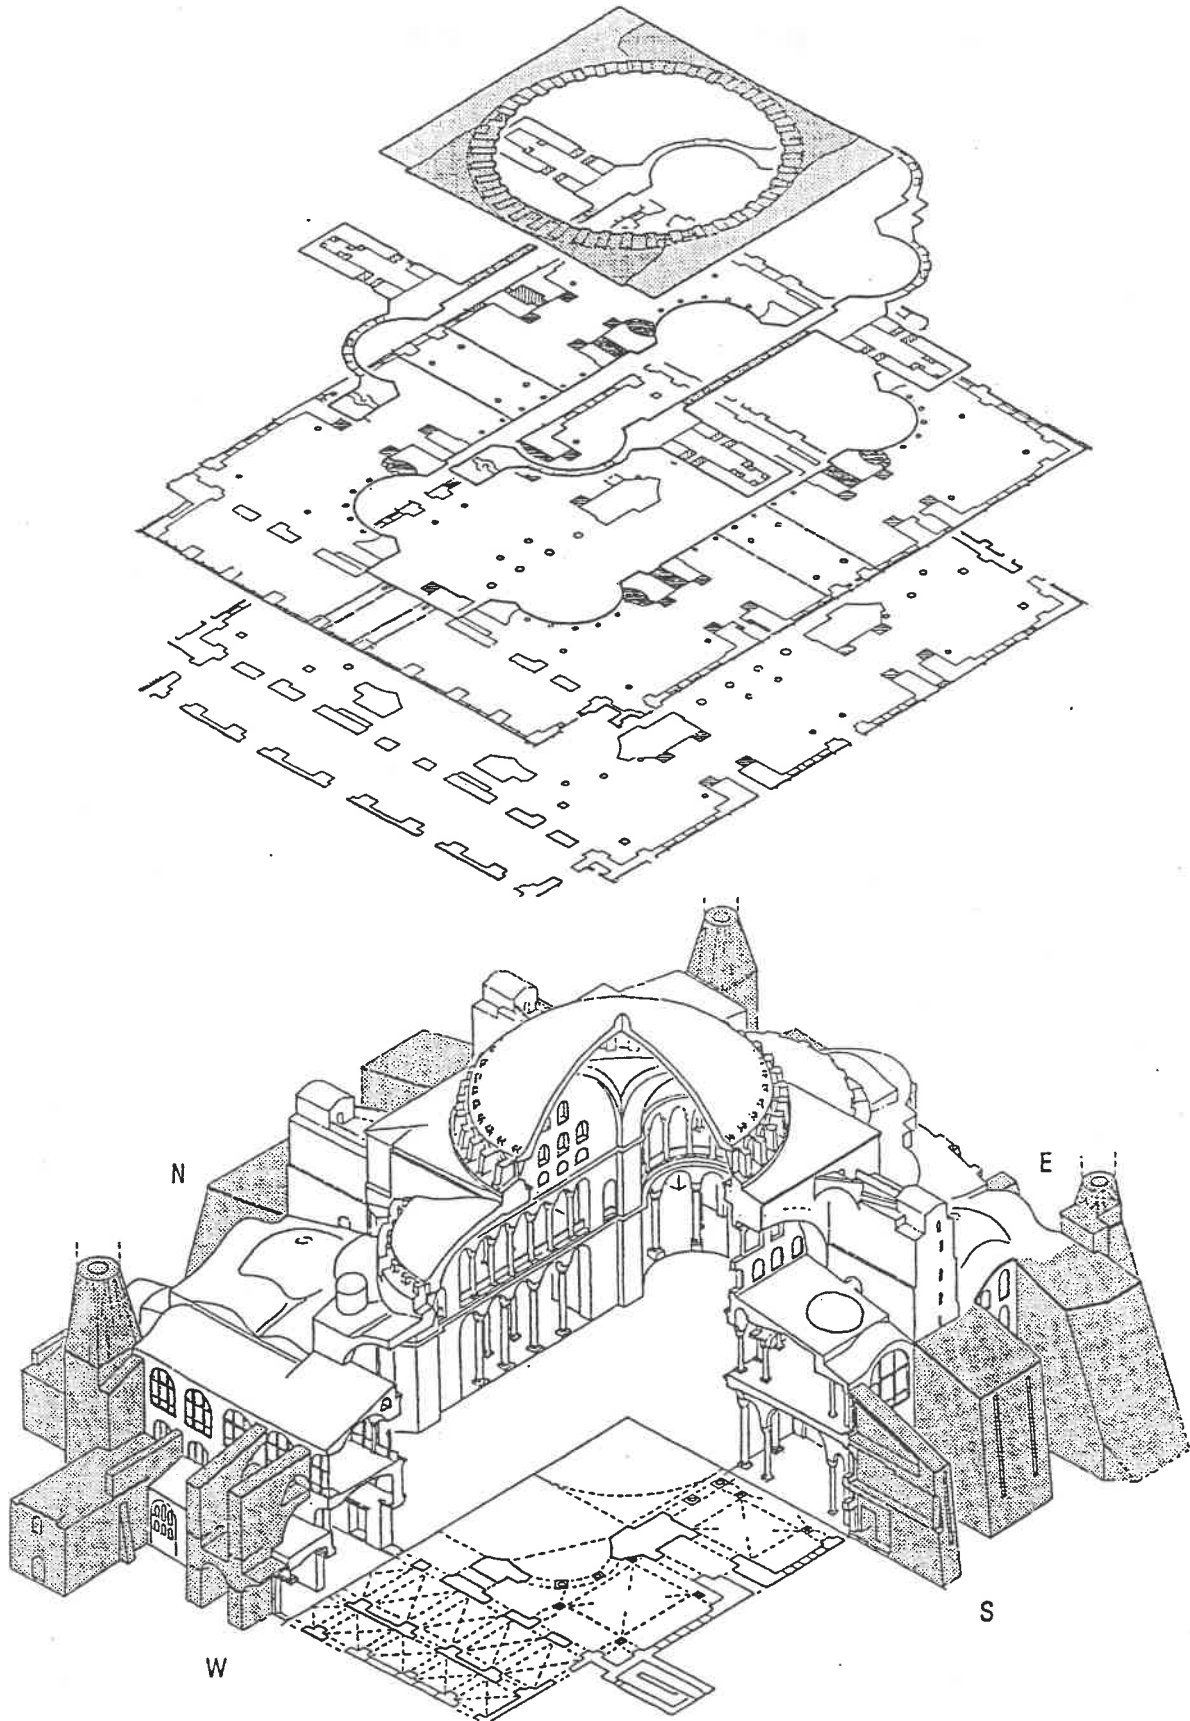
The structure was from the start a complex one and the complexity of both form and substance are now unparalleled as a result of changes during its long life (figs 1 and 2). Only four main materials were used - greenstone, marble, brick and a hydraulic mortar - with a supplementary use of timber and iron as struts and ties. But even during initial construction there were lacks of bond between adjacent elements, and there are now many more of these where later additions and infills and partial reconstructions were simply butted against the existing masonry.

Figs 1 and 2 The structure today with partial reconstructions and main additions shown by hatching and stippling (Mainstone copyright)

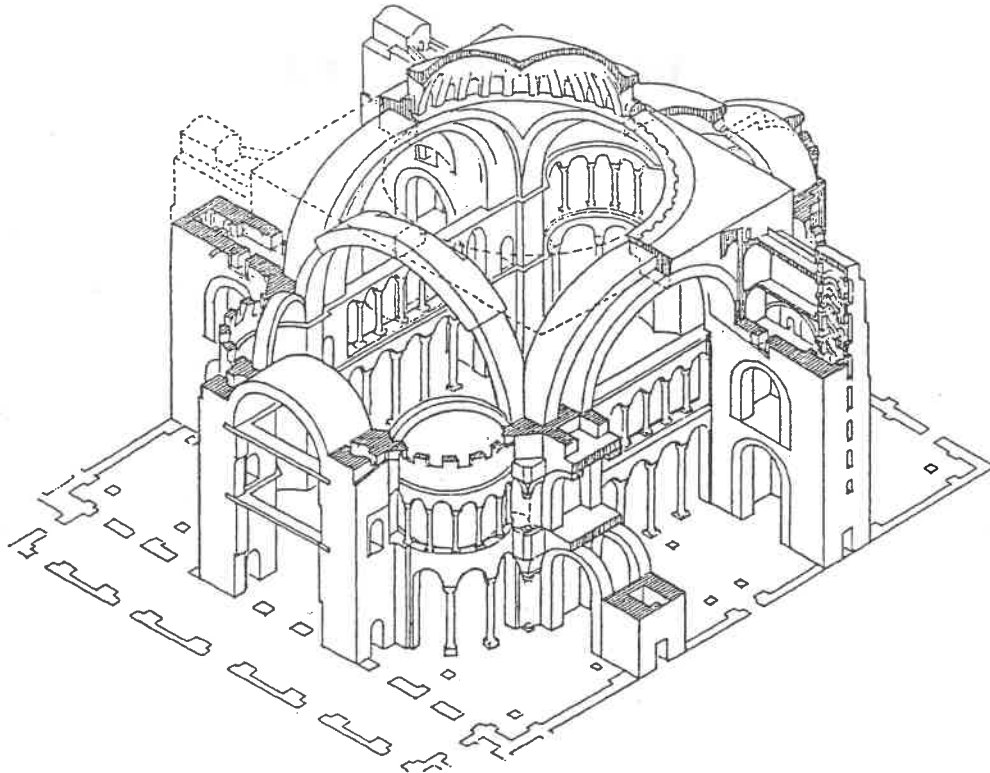
part identified in Mainstone 1988 as the original 6th century primary structure (fig.3). If such analyses had been feasible when the structure was first designed they would then have had some relevance, but not now. Grave doubts arise therefore about the validity of the conclusions drawn. Presumably because some of the assumptions were different, the analyses have also led to different predictions of possible causes for concern and different suggested strengthening measures. It has been suggested on the basis of one analysis (Erdik 1993) that E-W reinforcement of the crown regions of the main E and W arches and the adjacent semidomes is desirable and on the basis of another (Swan and Çakmak 1993) that the need is for N-S prestressing of these same arch crowns. The necessary drilling for either of these suggested measures would introduce new hazards in critical regions and there is as yet no valid evidence that either would, on completion, be beneficial.¹

Fig.3 The original primary structure (Mainstone copyright)

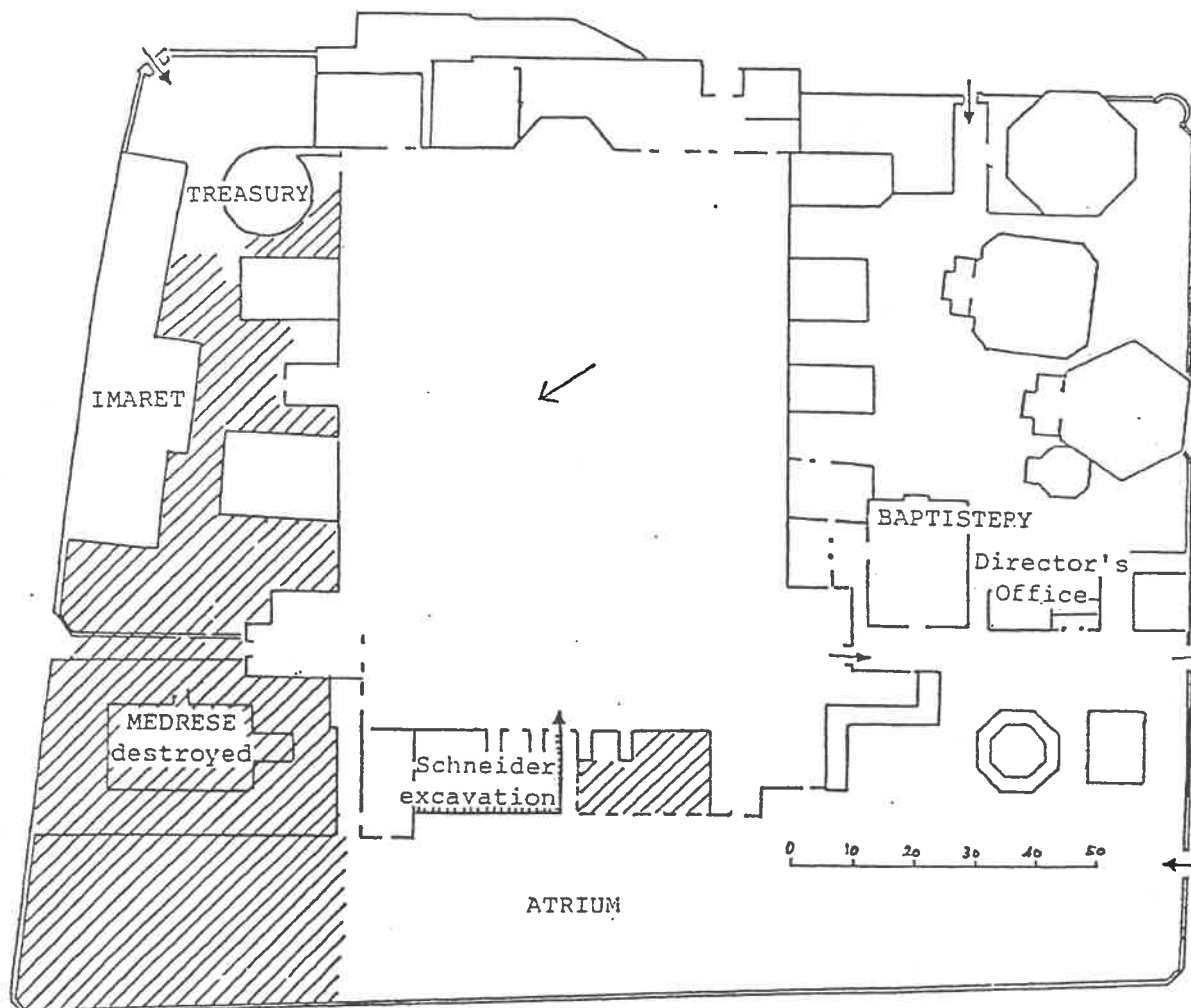
Fig.4 Sketch plan of the area within the Museum perimeter wall with approximate areas suitable for excavation shown hatched (Mango)

In a comprehensive project it would be a great pity to neglect further external archaeological investigation of these dependencies within the perimeter wall of the Museum before it becomes too late as a result of the erection of new structures, the re-arrangement of the lapidary exhibits or the ultimately desirable partial repaving and landscaping. A more serious investigation of the Treasury with exterior soundings is highly desirable. It is also desirable to conduct scientific excavation on the site of the destroyed medresse, within the northwest angle of the perimeter wall and along as much of the north side of the church as may be practicable (fig.4).
