**Mission to  
Dubrovnik and Ston**

**Earthquake  
5th September 1996**

### TECHNICAL REPORT

Mission to Dubrovnik and Ston after the earthquake of September 1996

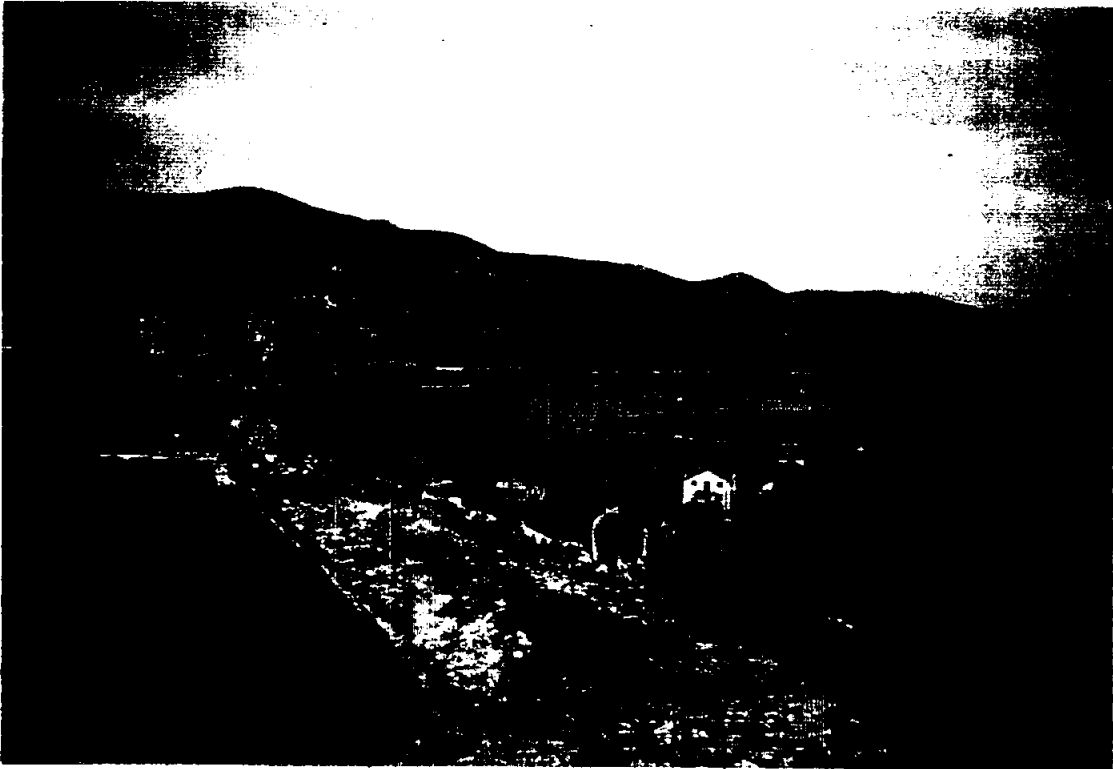
Fig. 6 The Castle of Mali Ston (The Little Ston)

In Mali Ston (the Little Stone) the buildings do not show significant damage; only the castle suffered a limited collapse and some cracks were produced (fig. 6).

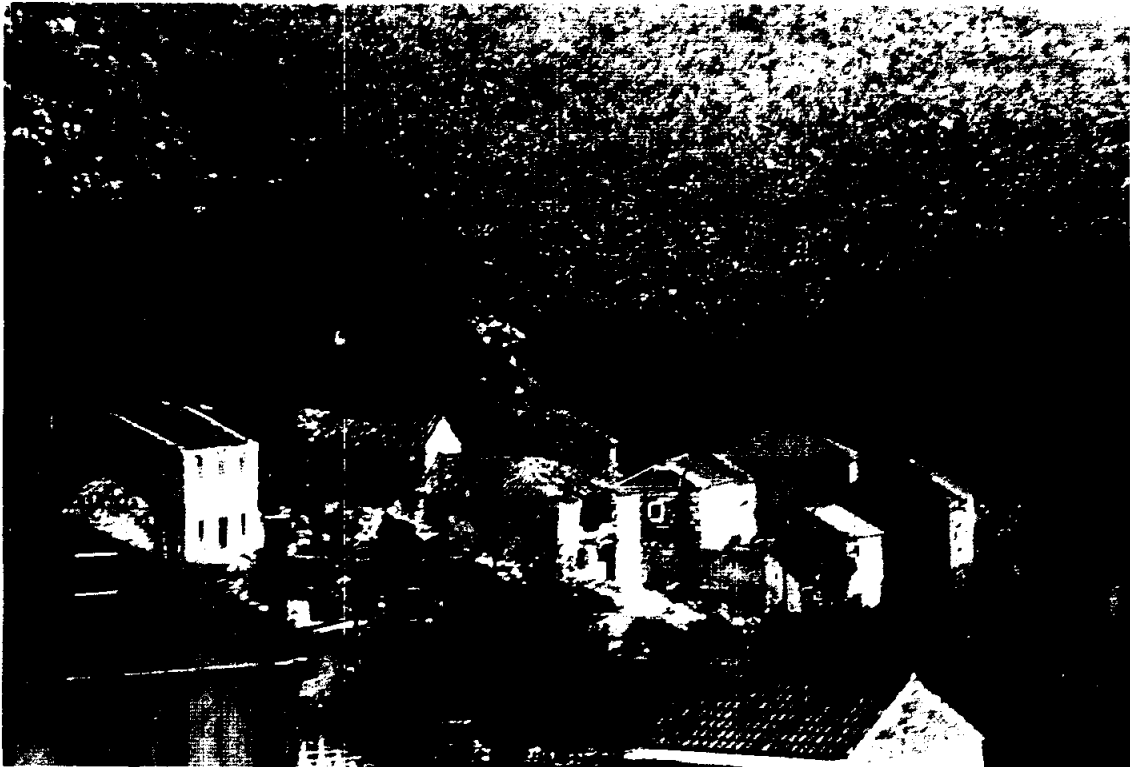
Fig. 7 The village of Trnova

The masonry buildings of the little village of Trnova (Fig. 7), very close to the epicentre of the earthquake, were all seriously damaged, and most of them collapsed.

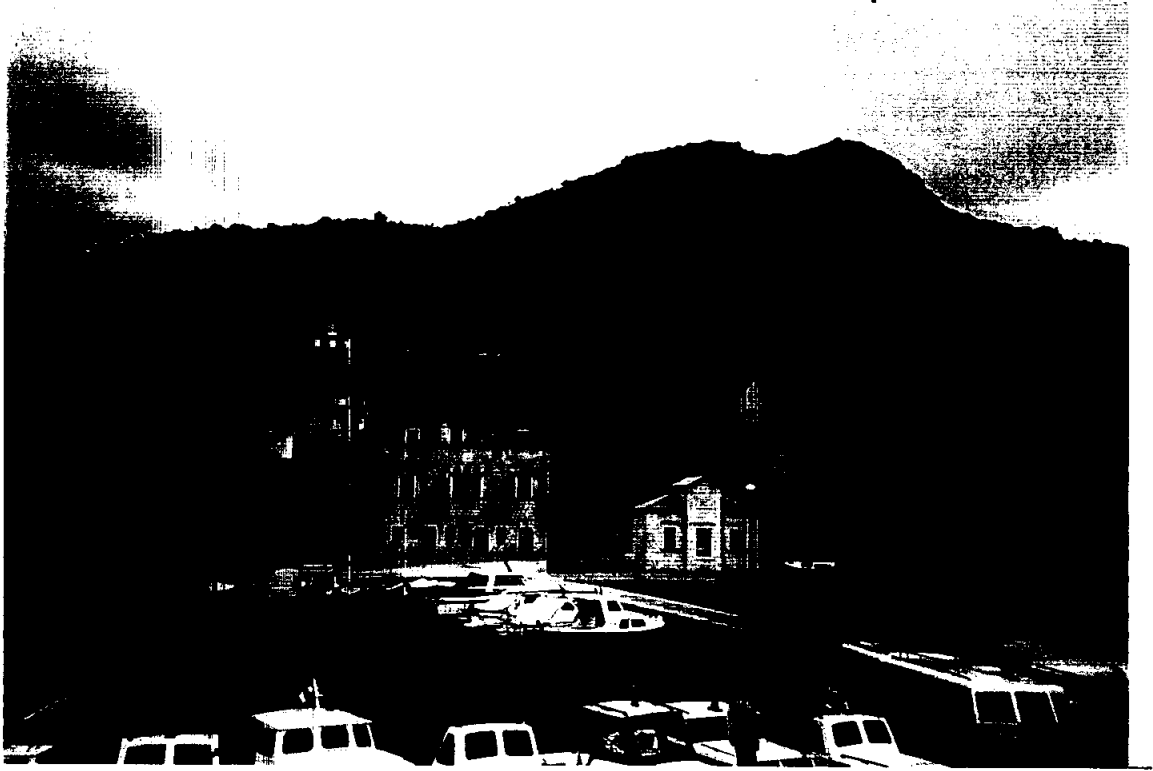
Fig. 8 The Isle of Lopud

Not relevant damage were produced in the Isle of Lopud (fig. 8); in the Benedictine Church some ancient wood cornices fell down from the wall (form 23).

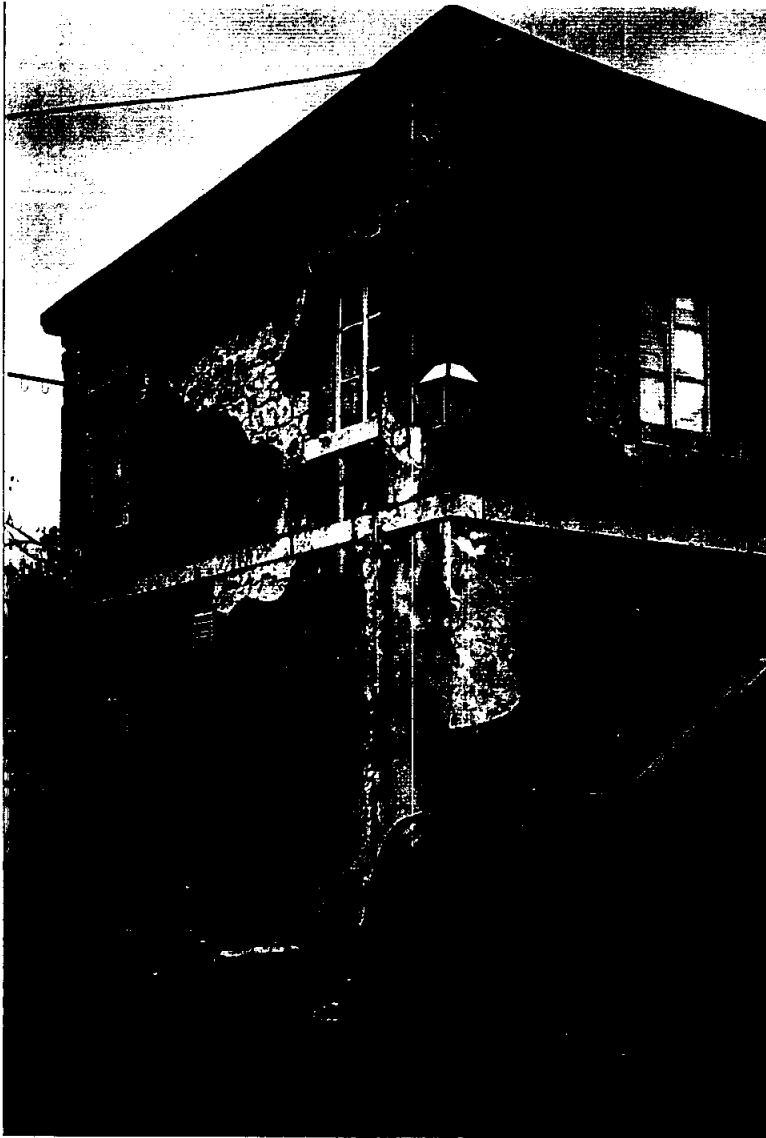
Ston  
The Main Guard Building  
South and East Façade

1. In this photo diagonal cracks at the corner in correspondence of an upper window of the South façade are visible, and diagonal cracks in the East façade, mentioned in form n° 11, are highlighted.
2. Also detachment of the window posts and of the lintels, due to an insufficient connection to the wall, are visible.

1. Horizontal chainage could have avoided the cracks at the floor level; more difficult is to prevent diagonal cracks in the masonry panel
2. Dowels or cramps to anchor the window post

- A proceeding of "unpicking and sewing" could be used to repair the diagonal cracks
- Horizontal chains should be used at the level of the floor (fig. 19e)
- Dowels or cramps could be used to anchor the window posts and the lintels to the structure

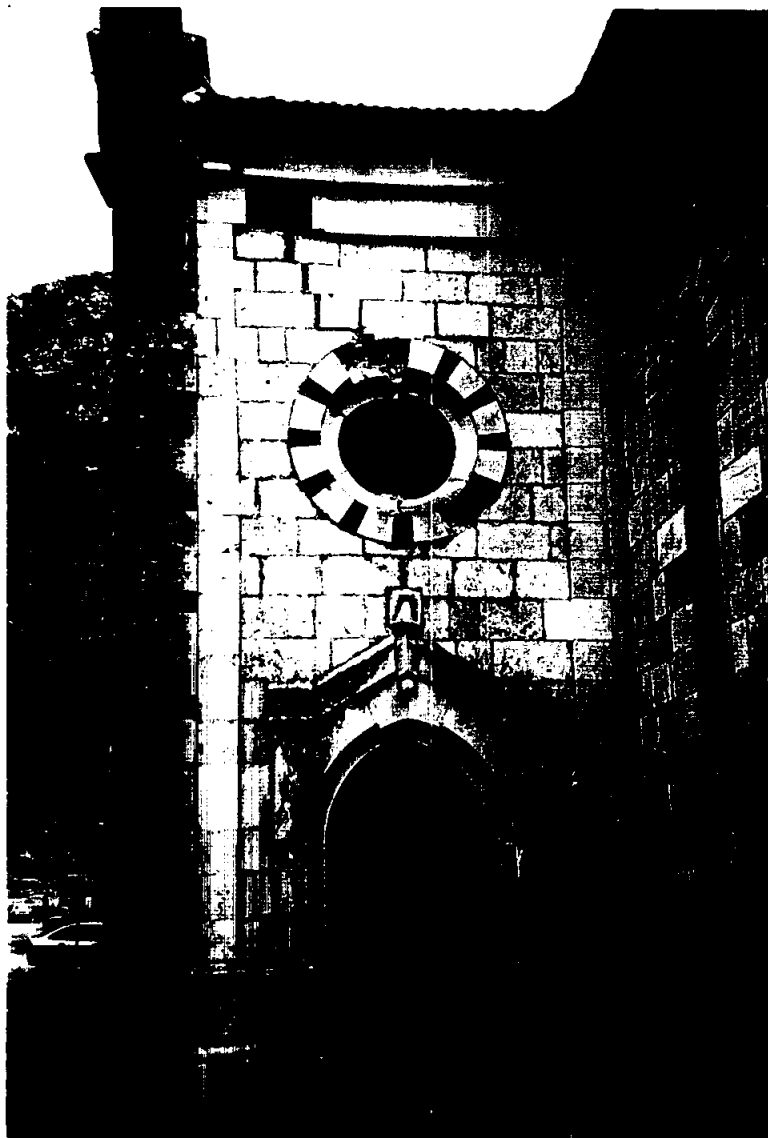
This façade was damaged substantially in the same way than the previous one

1. Diagonal cracks are clearly visible (fig. 16)
2. Detachment of stone blocks, and of blocks of the wall rosace are due to an insufficient bond between the stones and the fill
3. The displacement of the base of the spire is due to an insufficient connection to the structure
4. The displacement of the key of the arch is due to the horizontal relative movement of the two parts separated by the cracks; see detail in form 18

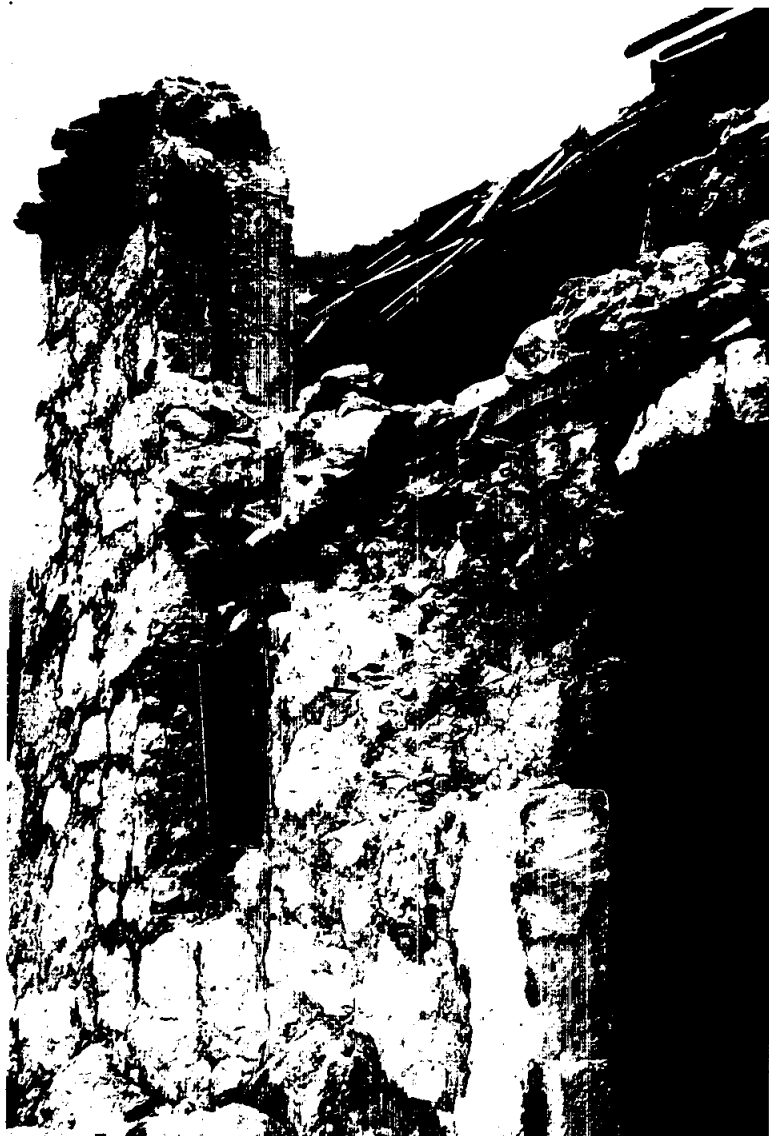
In this particular of the west façade the rather poor quality of the masonry is highlighted; in particular the chaotic structure of the filling is visible, and the consequent lack of connection between the external layer of the wall and the filling itself (collapse of the facing stones at the corner of the door, cracks on the left side of window).

See form n° 20

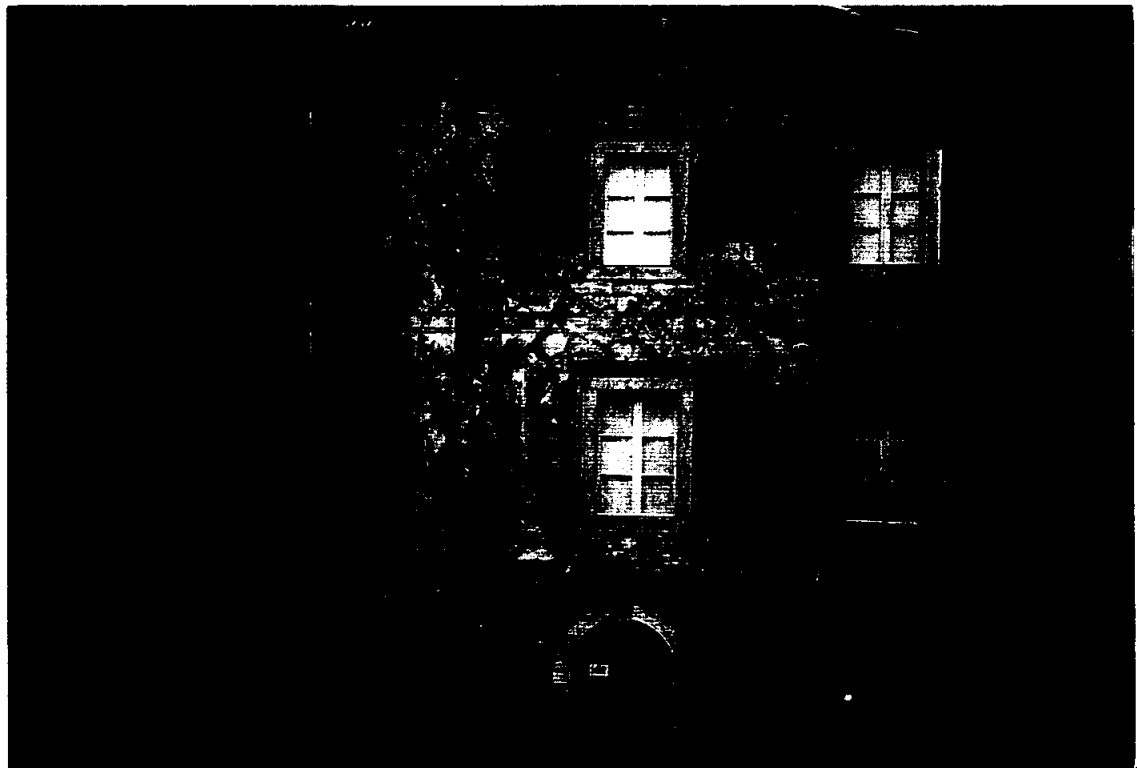
Both the buildings shown in these photos suffered just a few cracks, and their global stability was not compromised.

This confirms that when the building is realised with good materials, when a good technique of construction is respected, and when the collaboration between the walls is ensured -e. g. using horizontal chains- clearly visible in the photos, this typology of building can well perform even in case of a strong earthquake.

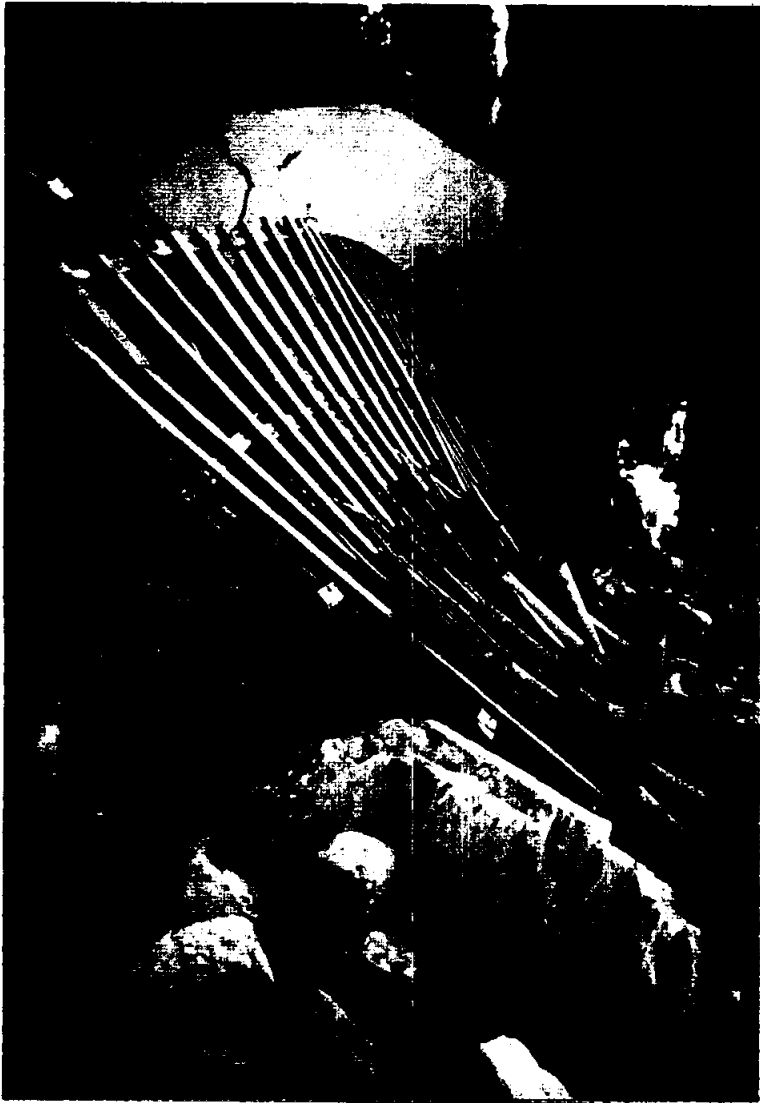
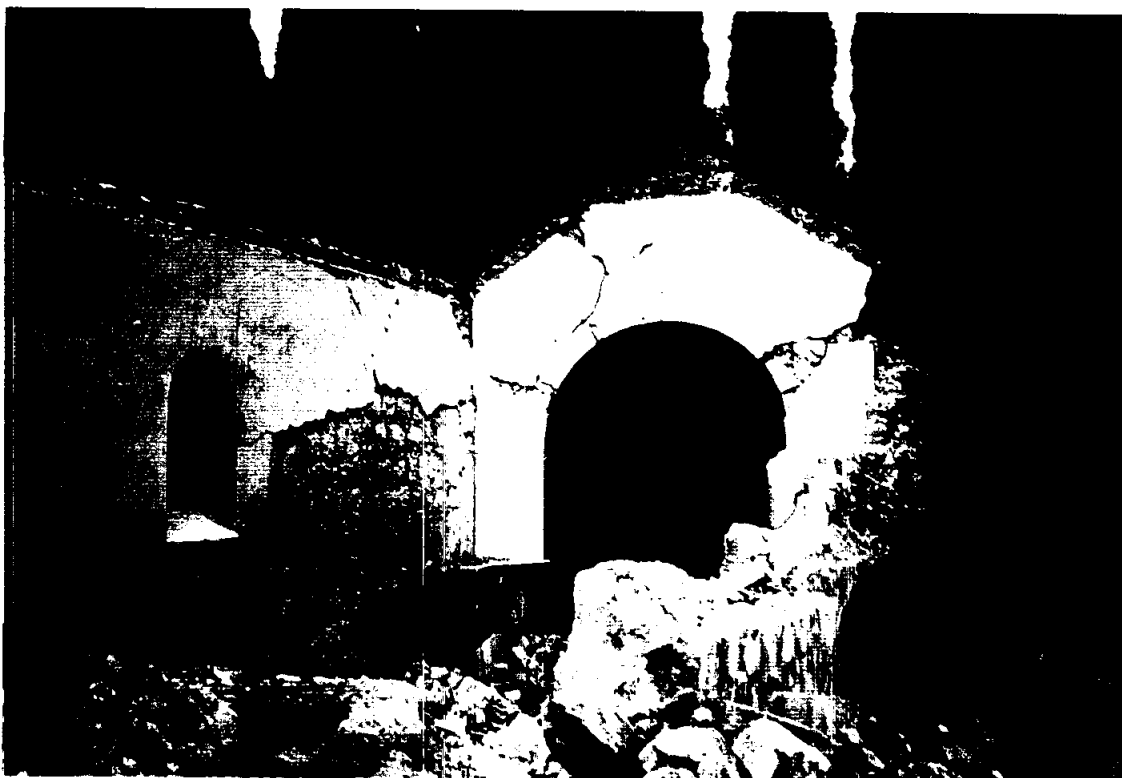
The church of Mavrinca

The horizontal slippage of the roof, is a phenomenon that often occurred, due to the lack of connection between it and the walls.

In these cases a stiffening of the roof in its own plane (fig. 19h), a good connection of the roof to an horizontal kerb (fig. 19c) and of the kerb to the wall (fig. 19a) should have prevented this kind of damage.

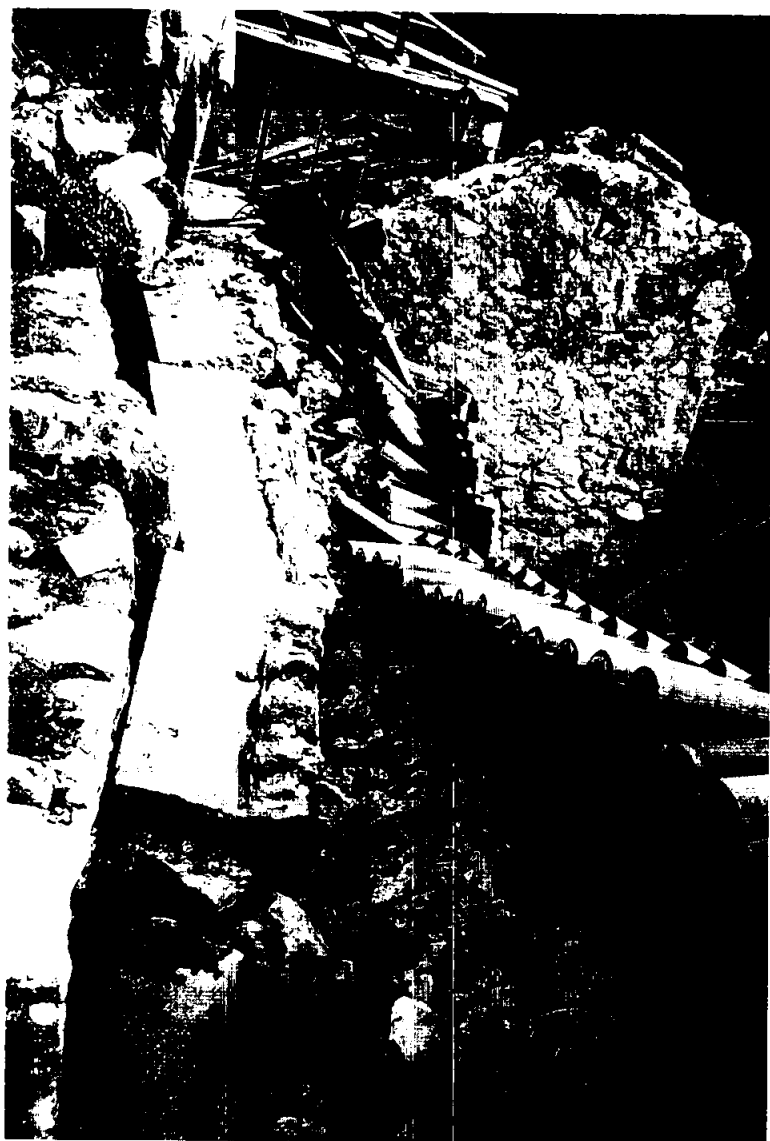
These photo show the collapse occurred in a house of Trnova recently restored with the realisation of a reinforced concrete kerb at the roof level.

Some deficiency of the interventions made this measure ineffective.

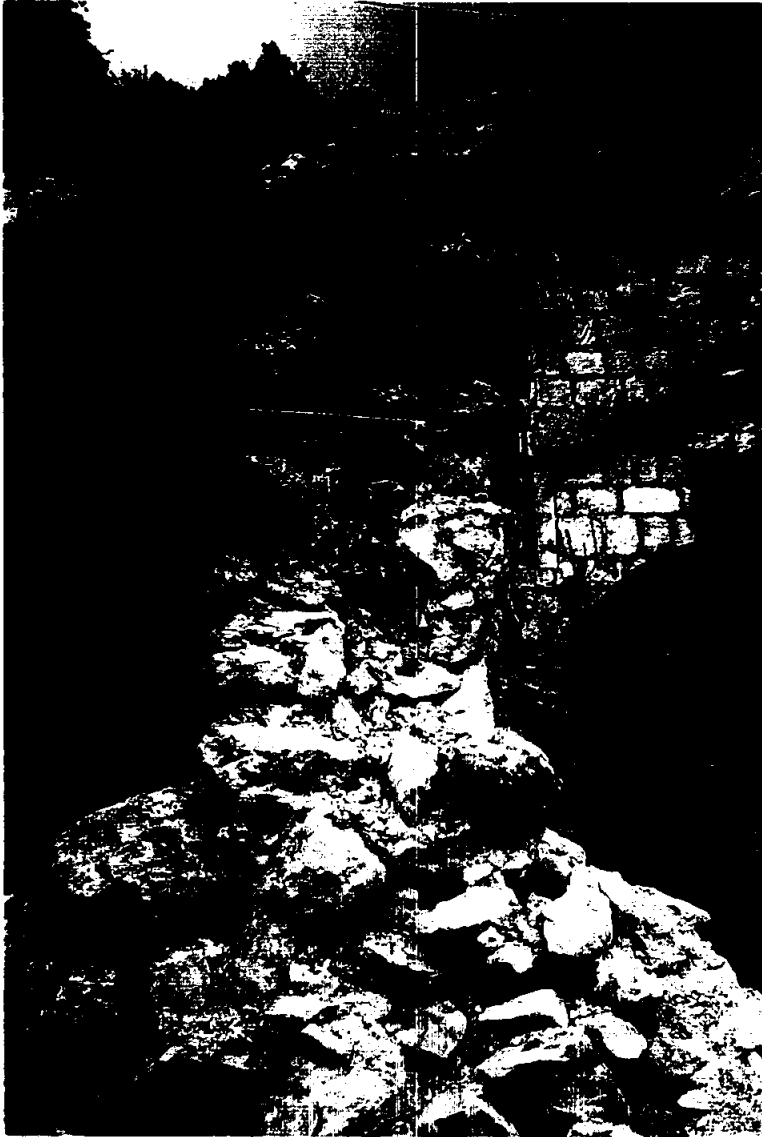
Typical sack masonry with poor quality mortar do not ensure the cohesion of the wall.
