**Mausoleum of Khoja Ahmed Yasawi (Kazakhstan)
(C 1103)**

**The report on the state of conservation of mausoleum
of Khoja Ahmed Yasawi according to the decision 38
COM 7B.16**

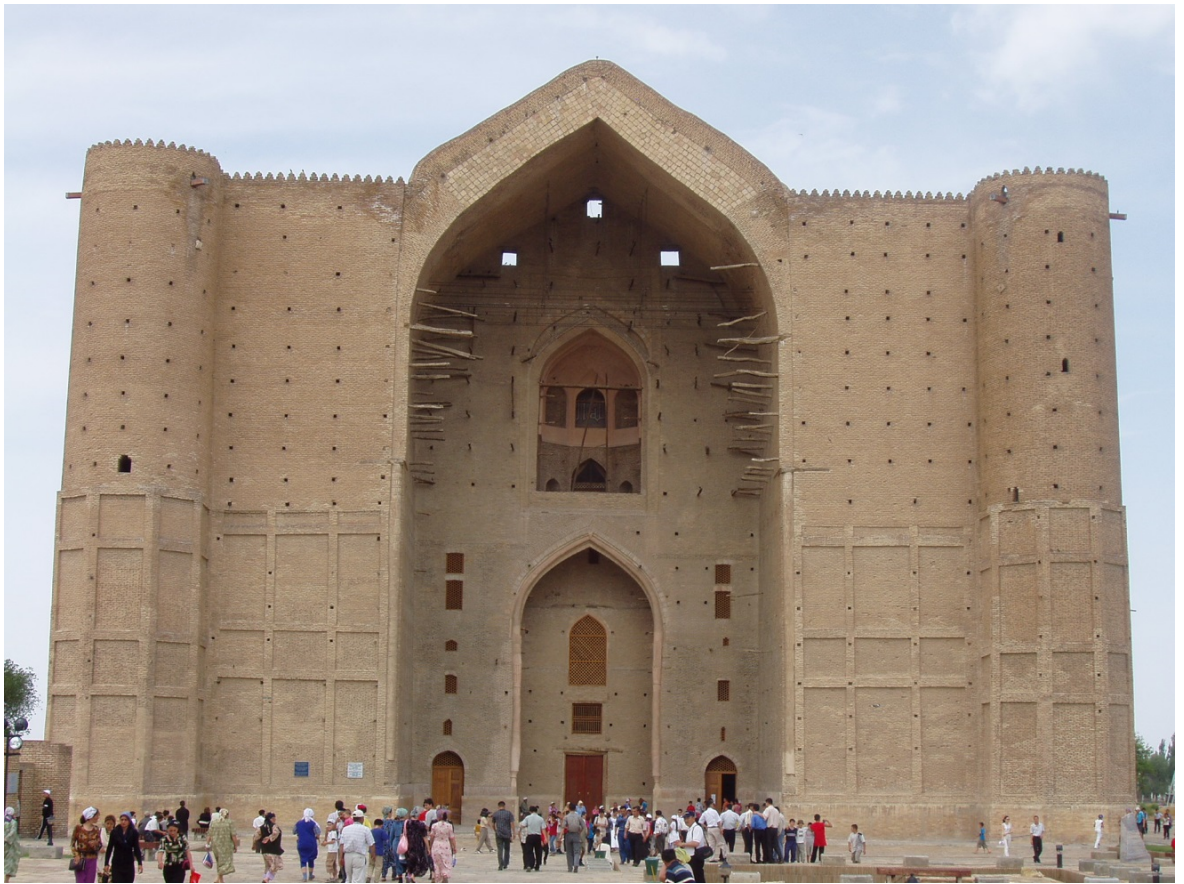
Fig.I.2. Viewpoint P1. Mausoleum of Khoja Ahmed Yasawi. View of the north-west.

It is important to mention that the pilgrims and visitors approach the mausoleum from the southern side (view-point P1). The new mosque is not visible from the view-point P1. View-points P2-P15 show the general view of the new mosque and the mausoleum. The new mosque is not visible from the northern and eastern side because of the dense construction along the Bayburt street (on the north-east) and the Almanskaya street (on the east). The new mosque is also visible to pilgrims and visitors from the view -points P14-P15 (from the hotel of “Yassy”) and from the western side of the Mausoleum of Khoja Ahmed Yasawi. Pilgrims comes to Turkestan from the village of Shaulder after having visited the Mausoleum of Arystanbab. The view-points P16 – pic.I.17 represent the view on the new mosque from this road. Dense constructions cover the lower part of both constructions, while the Mausoleum of Mausoleum of Khoja Ahmed Yasawi is clearly visible in contrast of the sky.

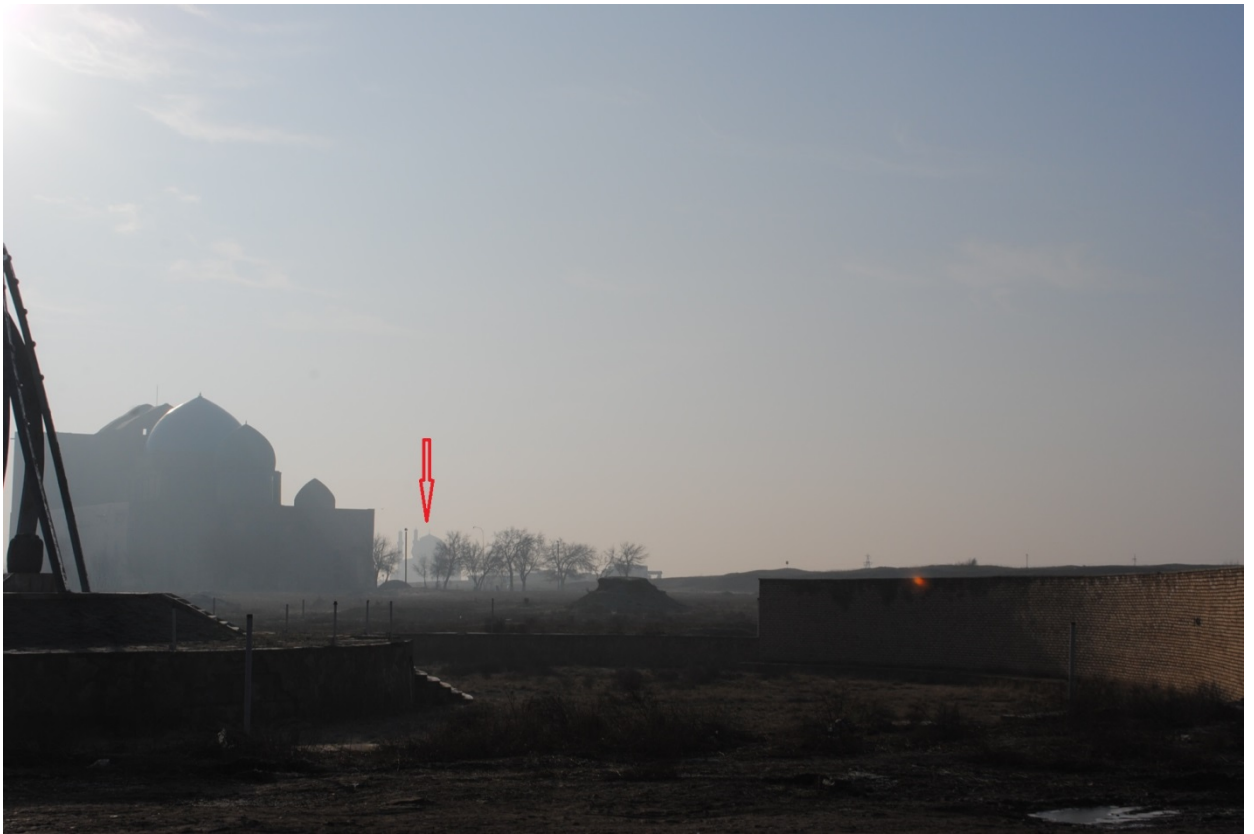
Fig.I.15. Viewpoint P14. View of the south-east.

a) From the hotel of “Yassy” (view-point P.14);
b) From the Bayburt street (pedestrian zone);
c) From the Almanskaya street – main access road to the Mausoleum of Mausoleum of Khoja Ahmed Yasawi including the parking zone for tourist transport, main and side-entrance to the mausoleum;

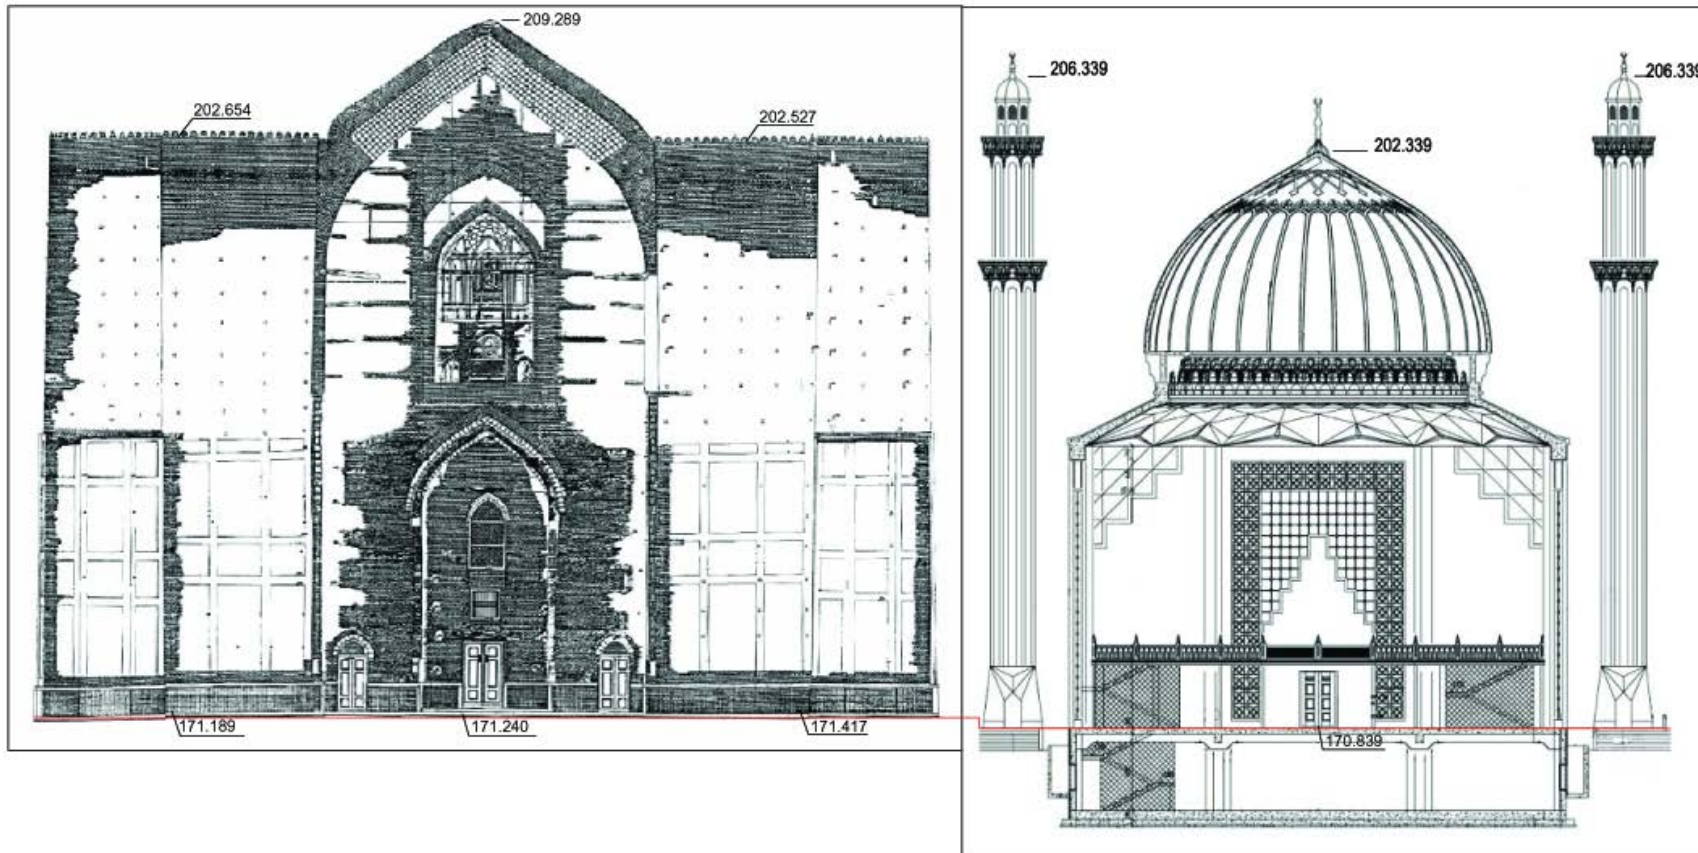
Fig.I.20. Mark the mausoleum of Khoja Ahmed Yasawi and a new mosque for 2000 places.

The pic.I.20 represents the front-faces of both constructions with the height of the minarets and the upper part of the southern portal of the Mausoleum of Mausoleum of Khoja Ahmed Yasawi and the height of the minarets and the dome of the new mosque.

3. Multiple-elevation survey of the surface of the Mausoleum of Khoja Ahmed Yasawi and the new mosque, portal arch of the mausoleum, minarets and dome of the new mosque show the domination of the Mausoleum of Khoja Ahmed Yasawi.
