**INSTITUTE FOR THE PROTECTION
OF CULTURAL MONUMENTS**

**ON THE STATE OF CONSERVATION OF
MEDIEVAL MONUMENTS IN KOSOVO [SERBIA]
INSCRIBED ON THE WORLD HERITAGE LIST IN DANGER**

MEDIEVAL MONUMENTS IN KOSOVO [SERBIA] (C 724)

Belegrade, January 2017.

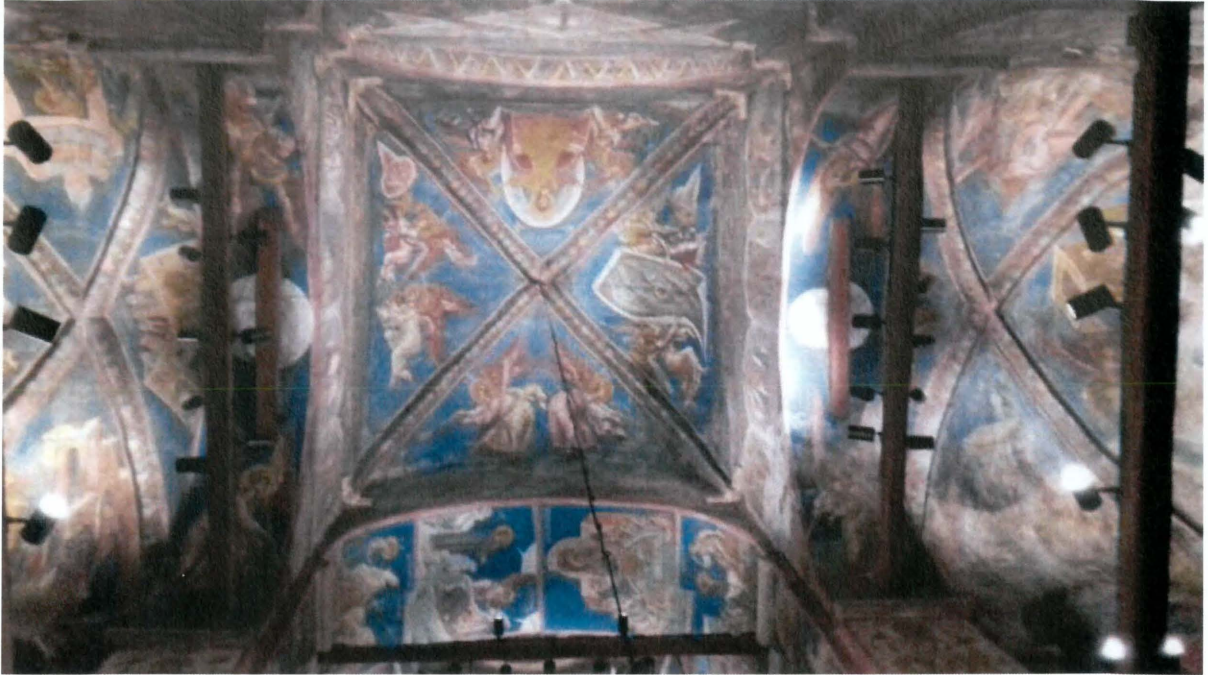
Figure 1 – Vault of the west transept of the church of the Assumption of Christ in Decani

In the Monastery Church dedicated to the Assumption of Christ in Dečani and based on **the Project design for the electrical installations** approved by the Republic Institute for the Protection of Monuments in Belgrade, works were conducted to install lighting and to restore electrical installations. The above mentioned technical Project documentation was produced by the Nenvel Project Company from Belgrade (Nenvel Project d.o.o. (Ltd.), 66 Dusana Vukasovica Street, Belgrade, Serbia), in compliance with the digital draft designs, standards for this equipment and input technical data provided by the Italian Company iGuzzini Illuminazione (iGuzzini SpA. 62019 Recanati, Italy, Via Mariano Guzzini, 37) and the Devotee Company from Belgrade (Devotee d.o.o. (Ltd.), 55 Rade Koncara Street, 11080 Belgrade, Serbia).

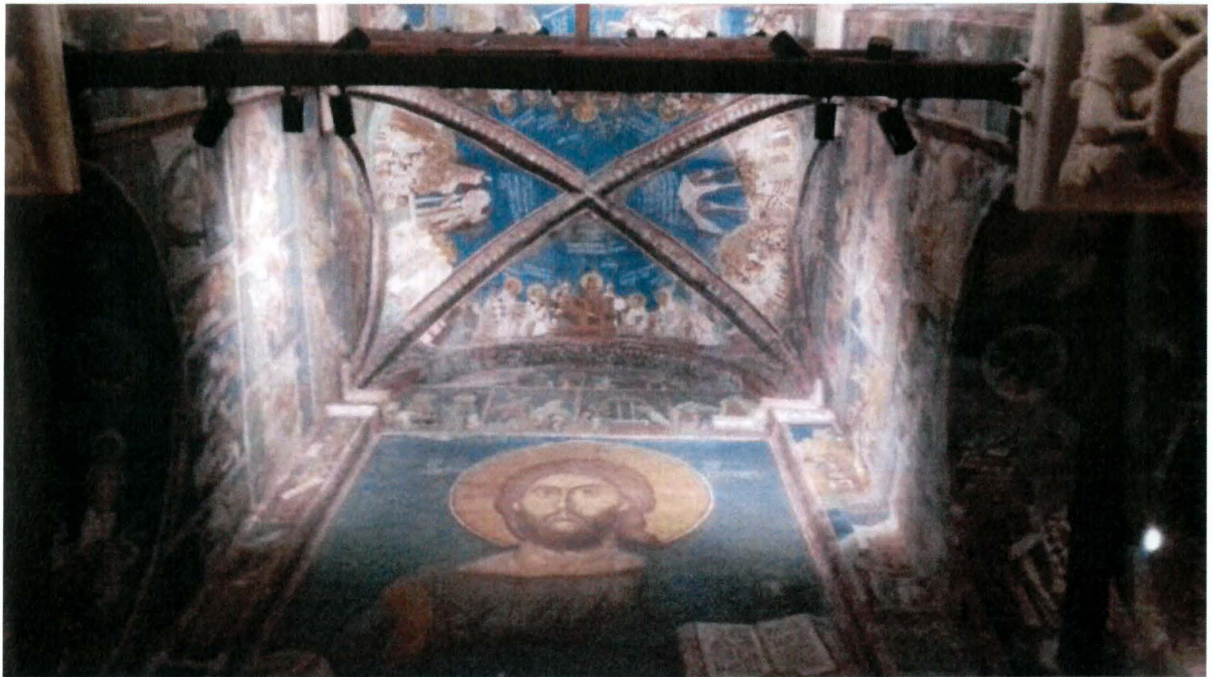
Figure 2 – East wall and vault of the narthex in the Church of the Assumption of Christ

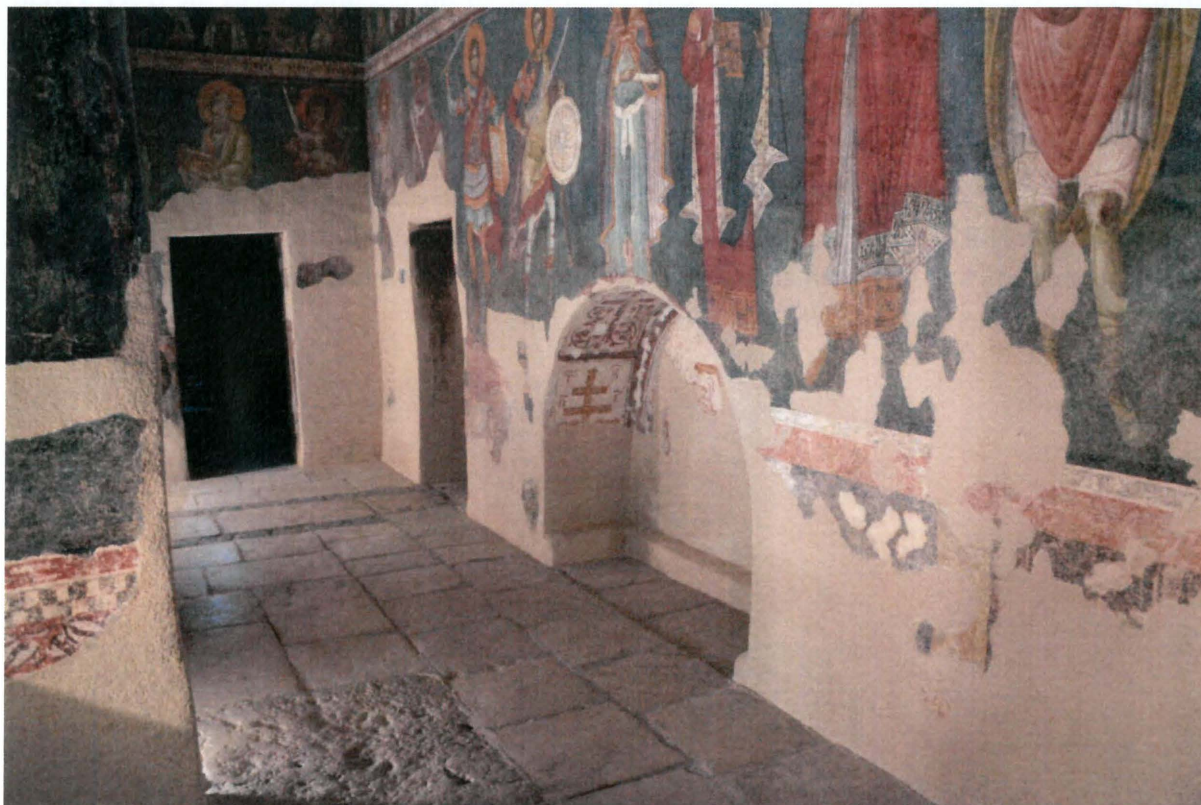
Reason for conducting these curatorial works was that parts of the most valuable 14th century fresco paintings in the Church of the Assumption of the Holy Virgin in Gračanica Monastery were under threat of degradation caused by moisture, efflorescence and intense atmospheric sediments of soot and dust. These deposits caused changes and interfered with the original artistic values of these paintings by darkening and blocking them. Methodology for the removal of the deposited layers was selected based on the physico-chemical analysis, salts' characterization and determination of the properties of the dark deposited layer.

Figure 1 - Photo documentation following completion of the conservation and restoration treatments: south wall of the south nave - lower zone

In addition to that, all the impaired parts of the fresco decoration, suffering from different levels of deterioration, were consolidated. Owing to that, these most exposed parts of the frescoes that are closest to the observers are now adequately presented. Characterized by vibrant colours and light tones, the legible iconographic content contributes to the solemnity of this space and is inspires awe with the observers. All the interventions performed, owing to use of advanced materials, adequate indoor environment of the Church should provide for the long term conservation of this valuable fresco painting, according to all indications.

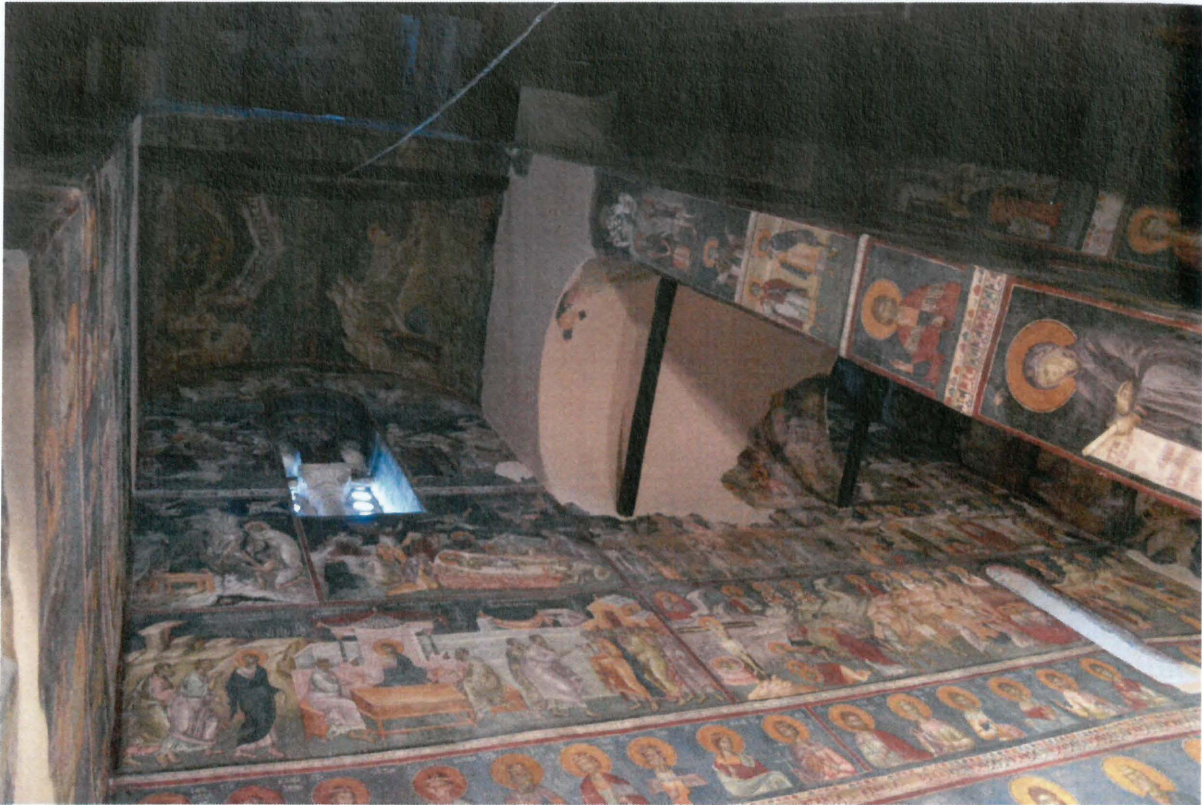
Figure 2 - Photo documentation following completion of the conservation and restoration treatments: south choir of the south nave in the Church of the Assumption of the Holy Virgin in Gračanica - upper zone
