TECHNICAL ASSISTANCE WORKSHOP
FOR THE WORLD HERITAGE SITES OF
THE CRAC DES CHEVALIERS, PALMYRA
AND THE ANCIENT CITY OF DAMASCUS
Beirut 13, 14, 15 December 2016

ANCIENT CITY OF DAMASCUS
Building of the Ottoman Bank

December 28, 2016

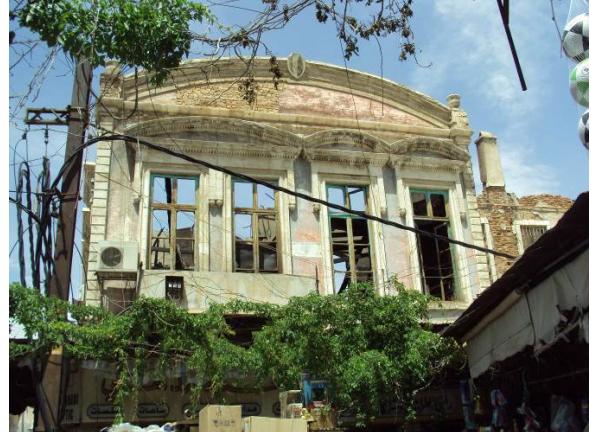
The roof and the interior of the first floor, mostly made up of a wooden structure sheltering large stocks of combustible goods when the fire broke out, have been completely destroyed. The peripheral masonry facades and the windows remained as gaping holes opened on the sky.

and after the fire

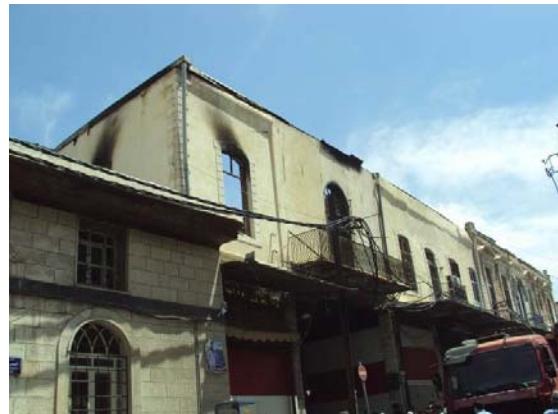
and after the fire

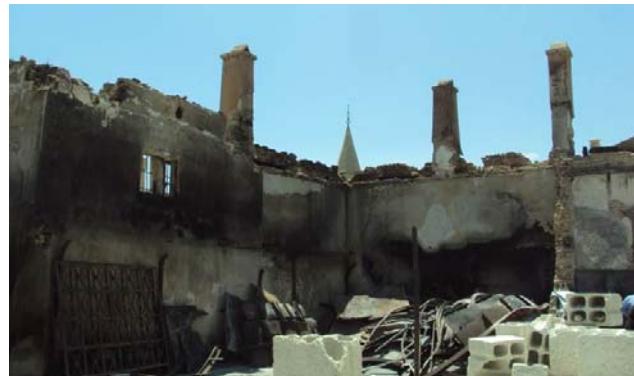
Deprived of its roof, the whole building is today totally open weathering. Obviously, the roof can not be rebuilt back without the prior implementation of important preliminary works concerning the shell and core works and the restauration of the internal supporting structures.

Interior view of the 1st floor after the fire

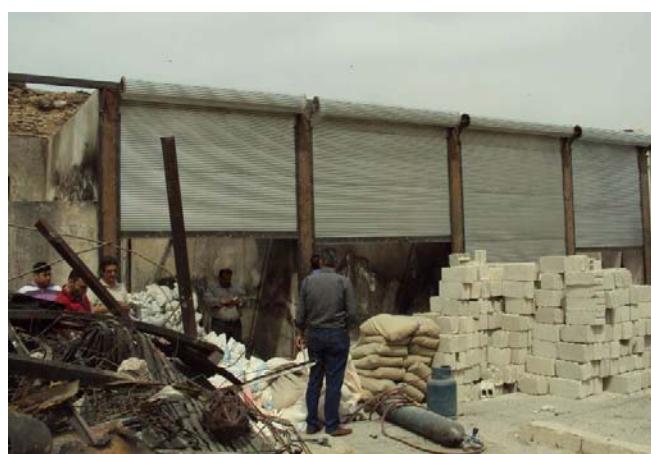
- Inside the building, the project kept the previous modern wall partitions, built at the first floor, within the initial volumes of the Bank, and which have, over the years, more or less been progressively replaced by cement blocks, giving them a structural role along with the old facades they didn't initially have.

Storage at the 1st floor, being repaired after the fire

The additional masonry partitioning the first floor were built as non-load-bearing walls. In the project, their use is "diverted" in order to give them a structural role in replacement of the old inner framework of pillars destroyed by fire. Thus, the weight is transferred on the superstructures of the upper flooring of the ground floor, possibly already weakened by the fire and whose residual strength has not been verified.

- Abandon the construction principle currently proposed (i.e. to use the recent partitioning walls at the 1st floor to support a framework of metal profiles, itself supporting in an undifferentiated way the various roofing frameworks) and favour an independent structure of pillars implanted at the same locations as those of origin and, in particular, at the corners of the different pavilions,

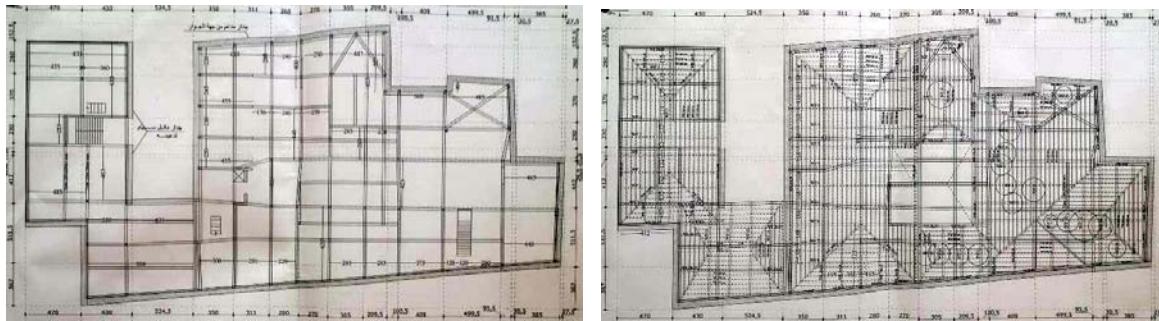
Project for the rebuilding of the superstructures

From a general point of view, the project proposed is incomplete as it lacks adequate structural transversal and longitudinal sections in order to clearly understand the design process.

The project presented for the potential recovery of the building appears insufficient from the point of view of the structural choices taken and of the structural consolidation proposed. Moreover, a careful analysis of the structural damage fire on structures caused by the fire is mission as well as the resulting decisions to be taken in relation to structures.

- If necessary, reduce the facades of the excesses of load that they would no longer be able to support, and implement, at their back, a secondary structure able to support the load,

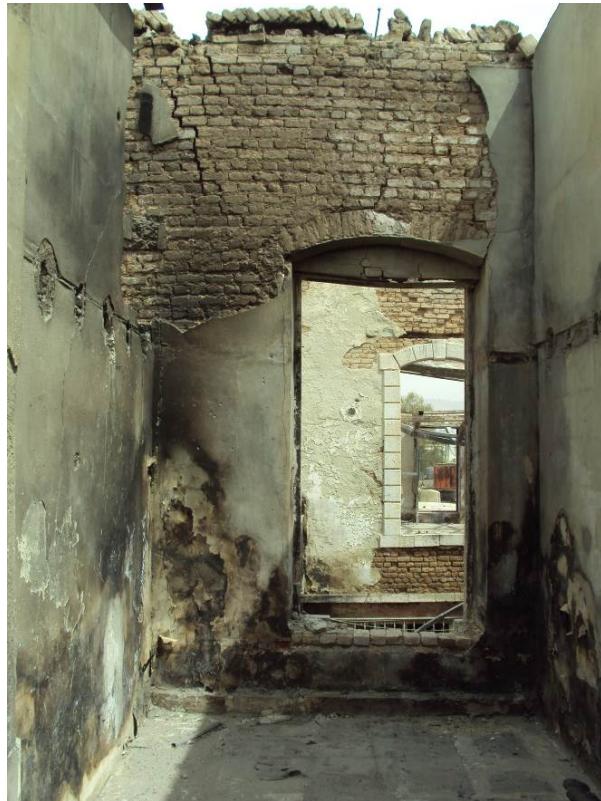
The building shows structural problems due to the damages of fire on the bearing mortar-brick walls of the building. The fire destroyed the wooden roof structure, which collapsed.

The status of the structural damage caused by the fire needs to be carefully considered, in particular load bearing outer walls and the iron beams that support the floor between the ground floor and the first floor.

Damage caused by the fire on the inside and top of the facade walls.

Before designing the structure of the future project, and decide if it should be based on the pre-existing one and/or a new one, the assessment of the state of the load-bearing walls affected by fire should be conducted, the following technical recommendations should be implemented:

1. Evaluate in detail, by means of visual inspection, the state of damage induced by the fire to the masonry walls, which can be identified through: a) disappearance of the plaster, b) change in the color of the bricks, c) partial disappearance of the mortar joints, d) fractures in the bricks, e) material's losses;

2. Withdraw at least three bricks from the severely damaged boundary wall (see Annex 21) that are still intact, and proceed with a compression breaking test in a proper lab; the evidence will refer to the maximum number of brick-cubes of 5 cm side derivable/obtainable from the three brick through a special cut made with suitable equipment;

3. Verify that the brick's faces are coplanar between them in order not to affect the validity of the compression tests;
4. Withdraw from a masonry wall that has not been damaged by the fire in the same building, the same number of bricks , and proceed with the same compression test;

5. Compare the values of compressive strength obtained;
6. If the compressive strength values related to the brick affected by fire are significantly different (lower or higher with less deformation) than those that are not affected by the fire, proceed with the following actions: a) intervene with "cuci e scuci" methodology in the areas that are the most affected by the fire with new bricks similar in terms of geometry, weight and characteristics to the

existing ones; b) replace and/or reinforce the mortar joints with a new mortar compatible with the previous one, c) the less damaged walls can be cleaned using sand spray, d) remove all existing plasters and replace them with a new plaster that includes fire retardant powders;

- 7. If the values of the bricks affected by fire are similar to those not affected by the fire, it will be sufficient to restore mortar joints, and clean masonry with sand before removing the plaster and replacing it with a new one that includes fire retardant powders;*
- 8. In order to assess the indirect action of the fire on the state of the iron beams that support the first floor seen in the drawings presented during the meeting: a) assess any changes in the color of the iron; b) evaluate the potential transversal displacement (deflections); c) assess the potential cracks in the junction of the beams to masonry walls (due to the potential longitudinal thermal dilatation of the beams);*

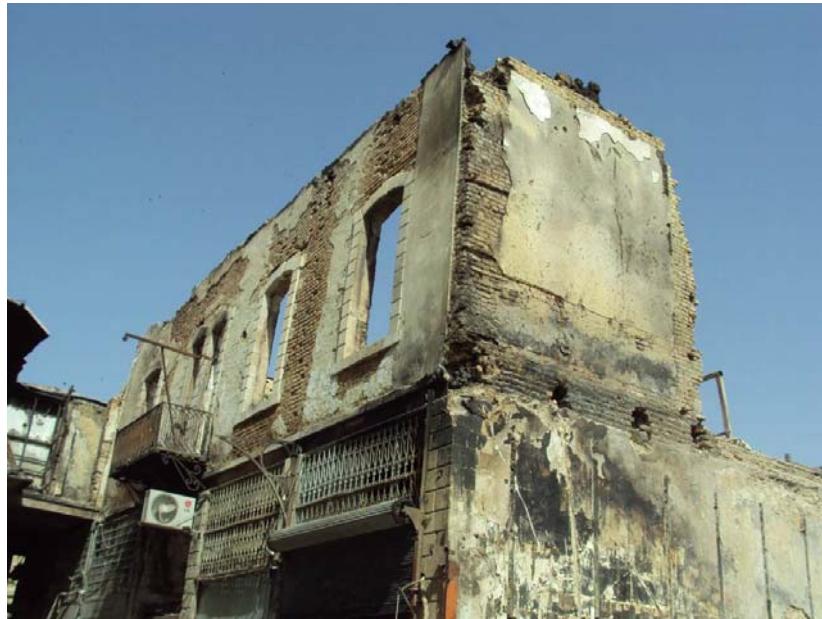
7. **Implement the urgent security and stabilization measures:** The fire has severely weakened the building, which is currently directly exposed to weathering, due to the destruction of the roofs. The remains of the building are exposed to a rapid deterioration, and its instability is a serious threat for its direct environment (falling parts or partial collapses).

Therefore, it is recommended to install urgently a protective umbrella over the building in order to ensure the complete protection from weathering of the remains, especially the upper parts of the façades and the upper flooring of the ground floor.

Such covering can be realized with the materials available in the market and without loading the damaged structures. If the walls will support the covering, they should be shored up first with a spatial "St. Andrew's cross" wooden shoring system in order to passively support of all walls. The shoring of the floors damaged by fire will be also realized with a passive double FRP band belting all the affected perimeter masonry walls.

- 1: Umbrella protecting the building from weathering
- 2: Supporting structure of the umbrella potentially acting for the triangulation of the façades
- 3: Double belting of facade walls
- 4: Inside shoring of the upper flooring of the ground floor
- 5: Shoring and triangulation of the various openings in the façades
- 6: implementation of a security fence on the street to ensure the public safety (risk of material falling)
