PHILIPPINES

Baroque Churches of the Philippines

II.1 Introduction

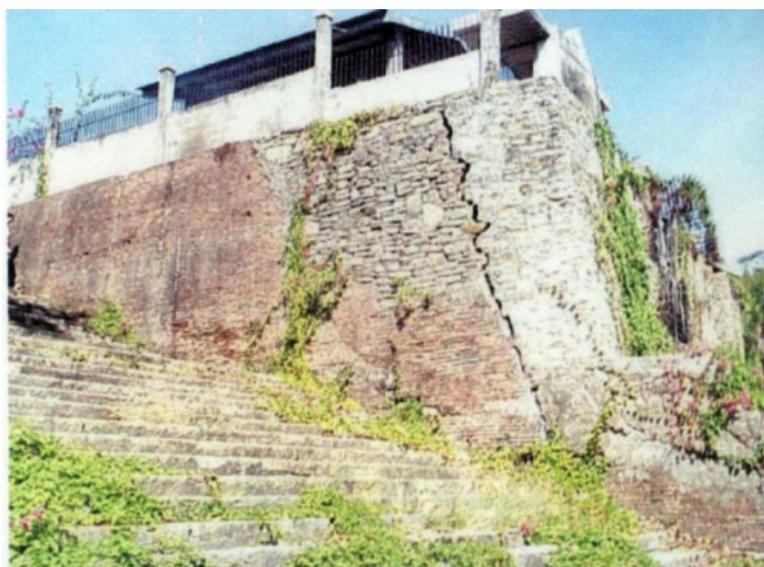
- The boundaries and buffer zones are considered adequate, except in the case of Sta Maria.
- A revision of the site boundaries around Sta Maria is being actively considered to gain access to retaining walls that are in need of remedial action.

Cracks in the retaining wall of Sta Maria Church, Ilocos Sur

- Emergency/management plans are in preparation. San Agustin (Intramuros) is to have seismic monitoring.
- Sta Maria is to have an improved drainage system.
- San Agustin (Paoay) will benefit from a traffic re-routing programme.
