*Culture, Tourism & Antiquities Department
Government of Sindh (Pakistan)*

**STATE OF CONSERVATION REPORT
HISTORICAL MONUMENTS AT MAKLI, THATTA (PAKISTAN) (C 143)
DECISION: 41 COM 7B.97**

November 28, 2018

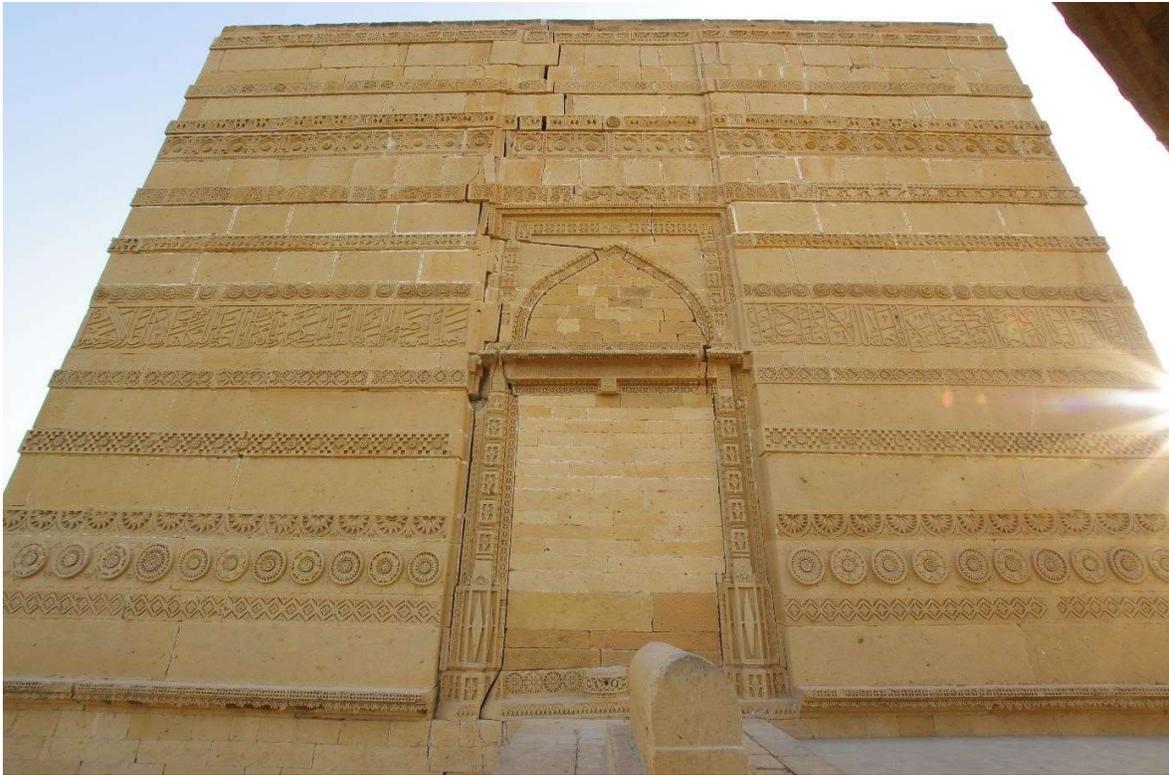
Image 11: North façade of Jam Nizam al Din, showing the sealed northern doorway and the series of cracks above.

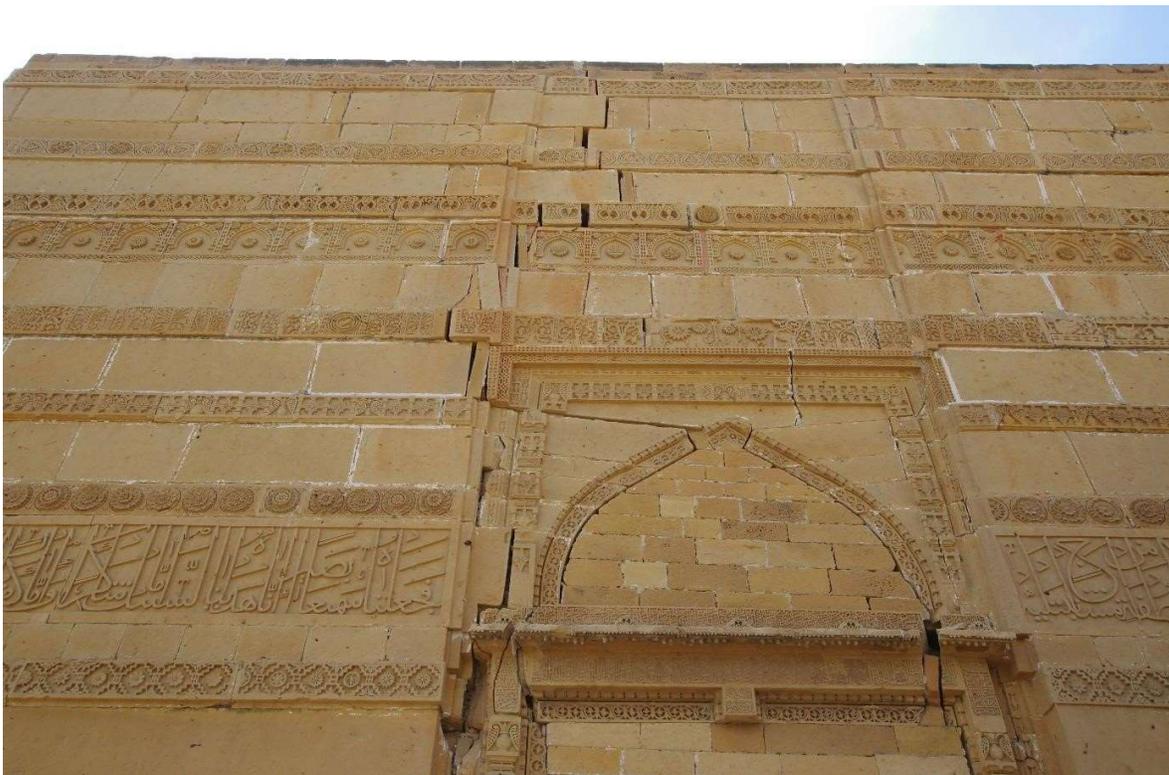
Image 12: Upper part of north façade with opening gaps between the stone elements (some former infill patches caved outwards and are missing, the maximum opening since 1994 measures approx. 18mm.)

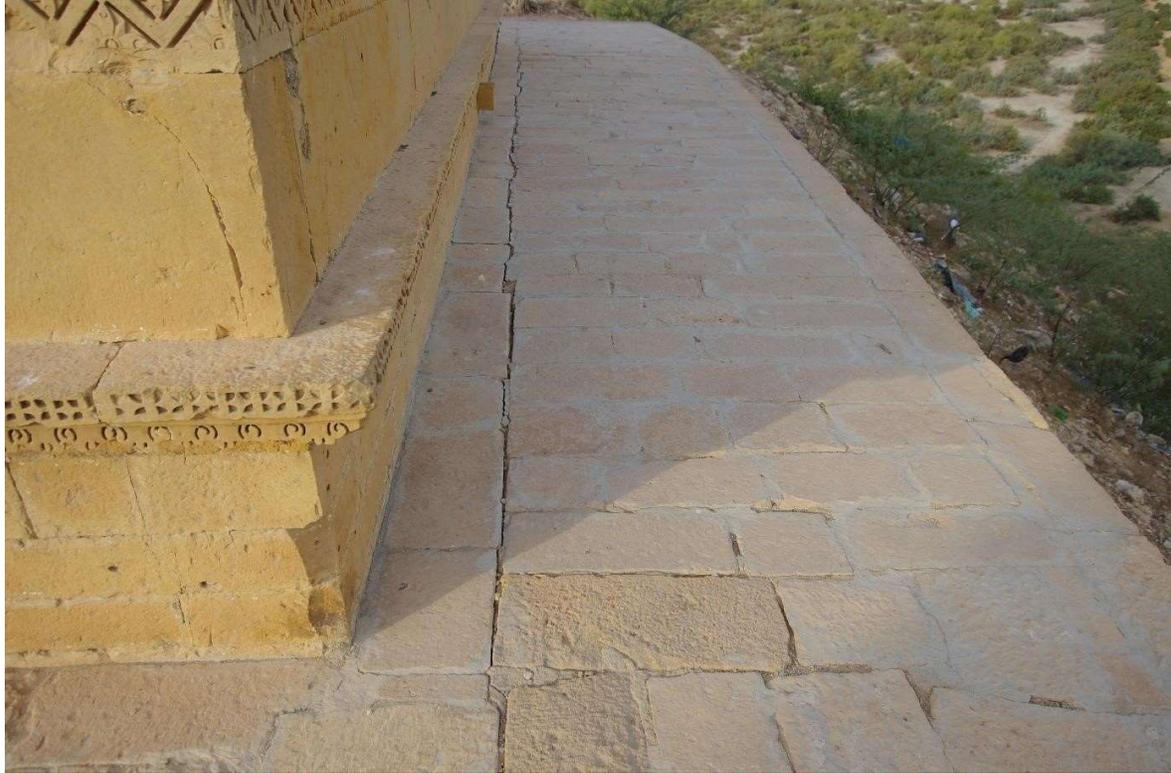
Image 13: Encasement of the added retaining wall (1994), showing a horizontal gap with increasing width from south to north. Note that the waterspout that drains the central space dewaters directly into the crack between the foundation wall and the newly built retaining wall, which is encased in the plinth (built in 1994). The water is trapped in the gap in between and is funnelled directly to the moisture-sensitive clayish layer below the foundation walls.

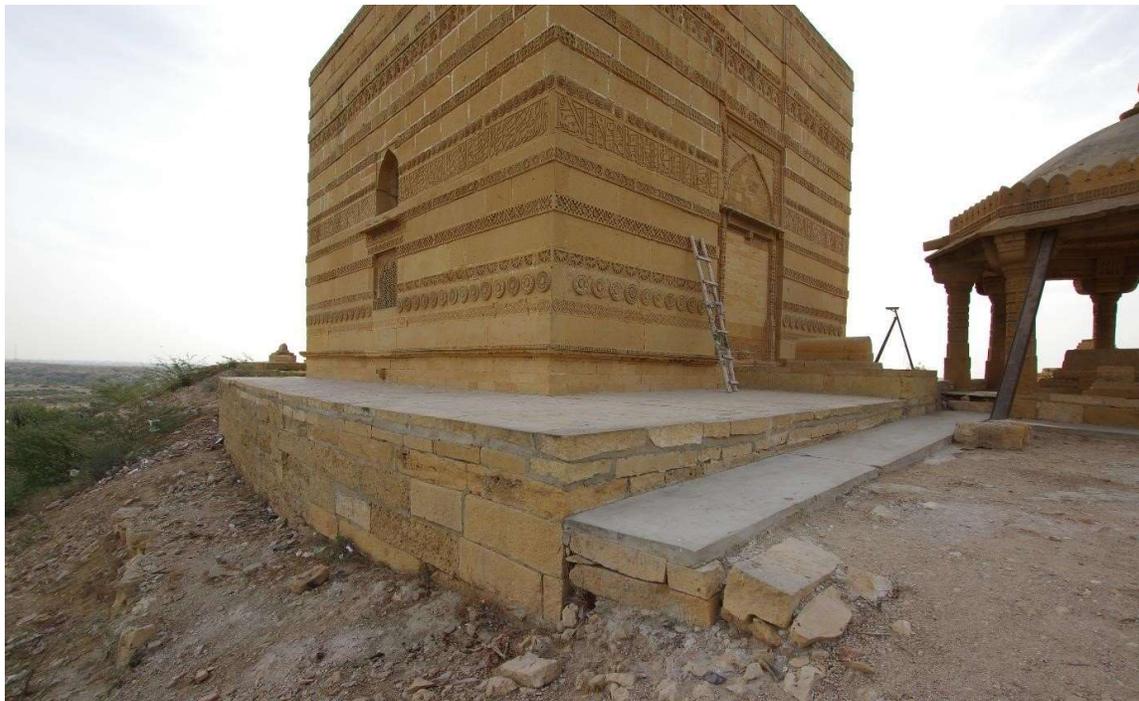
Image 14: North-east corner of Jam Nizam al Din with the encased retaining wall (built in 1994) and – below, right side, the newly added apron made of cement mortar for rainwater protection.

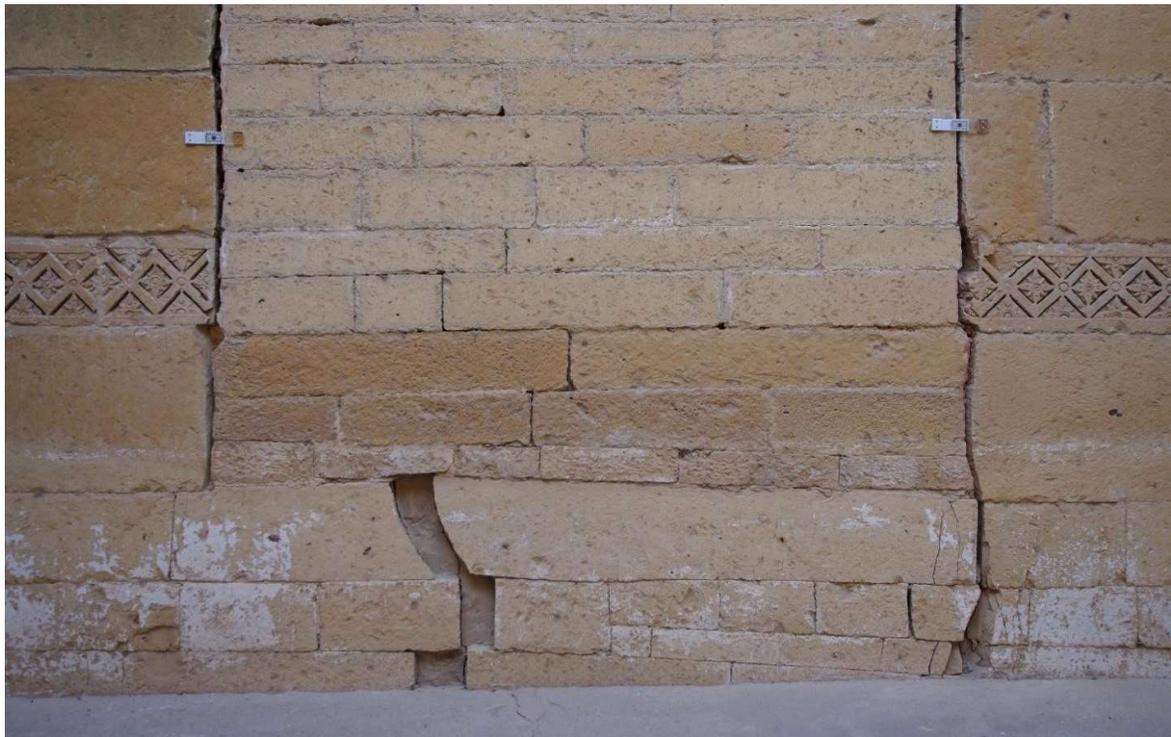
Image 18: Sealed northern doorway with installed crack-meters. The lower (previously sealed!) crack through the lowest three courses shows very clearly that the foundations of the monument are not only subject to vertical settlement but also to horizontal sliding.

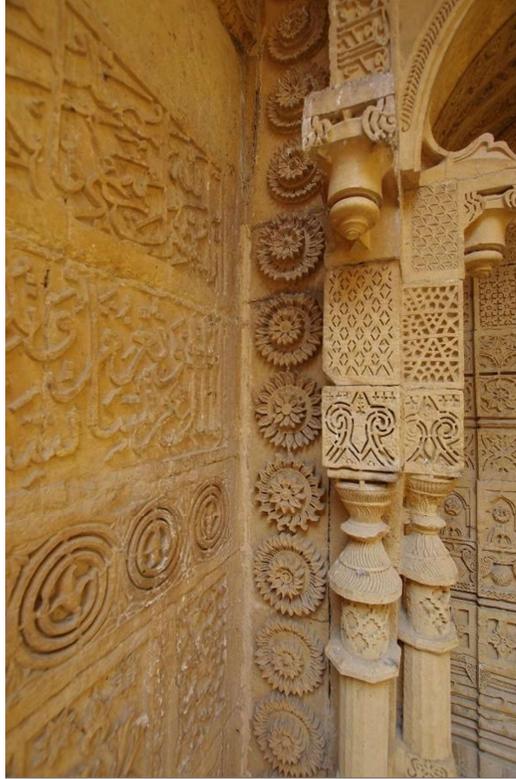
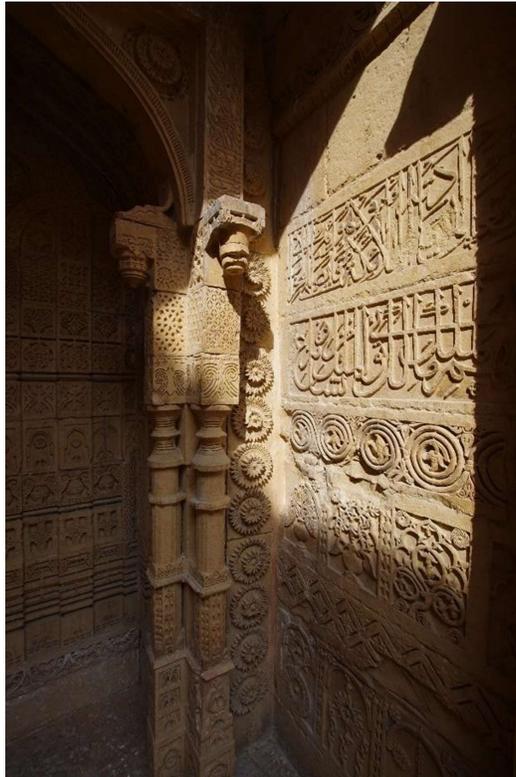
Image 20 a/b: Repointed former cracks inside of the mihrab (carried out in 1994)

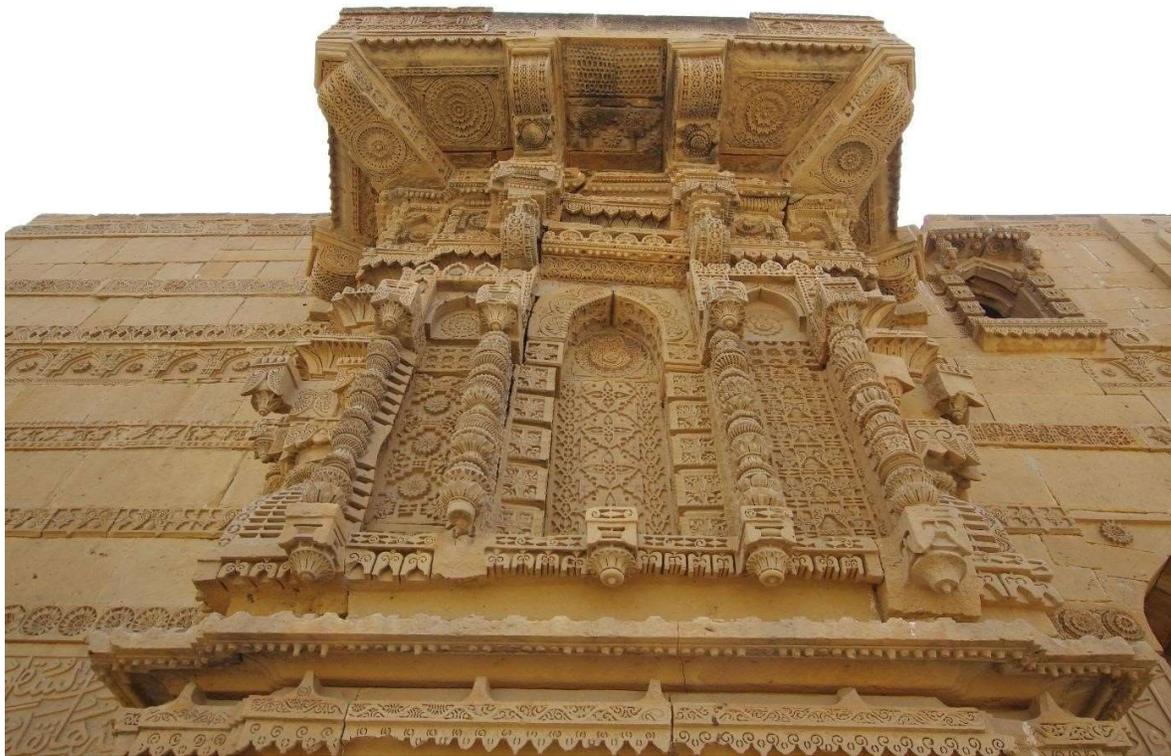
Image 24: Central risalit, looking upwards, with severe cracks below the protruding balcony structure and elements bulging outwards left of the symmetry axis.

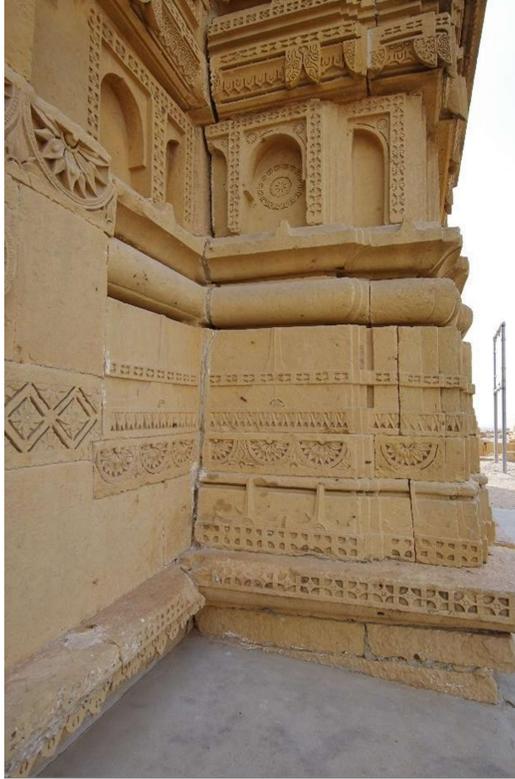
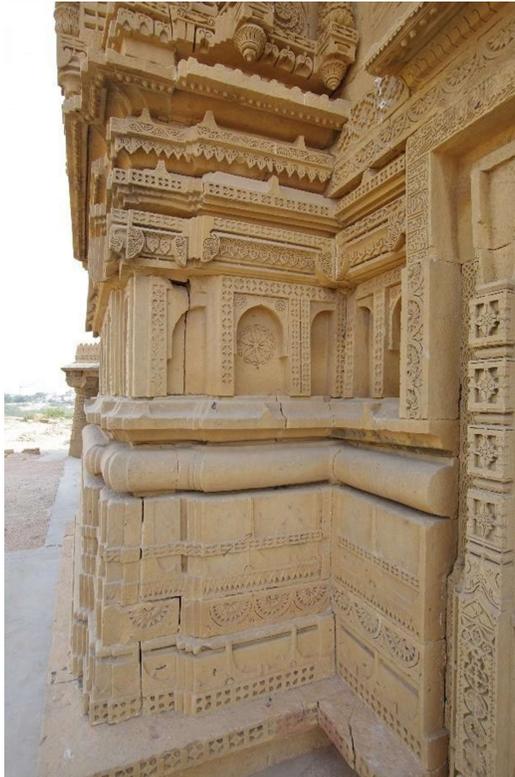
Images 25 a/b: Lower part of central risalit from north / south – with a continuous vertical gap on the north side.

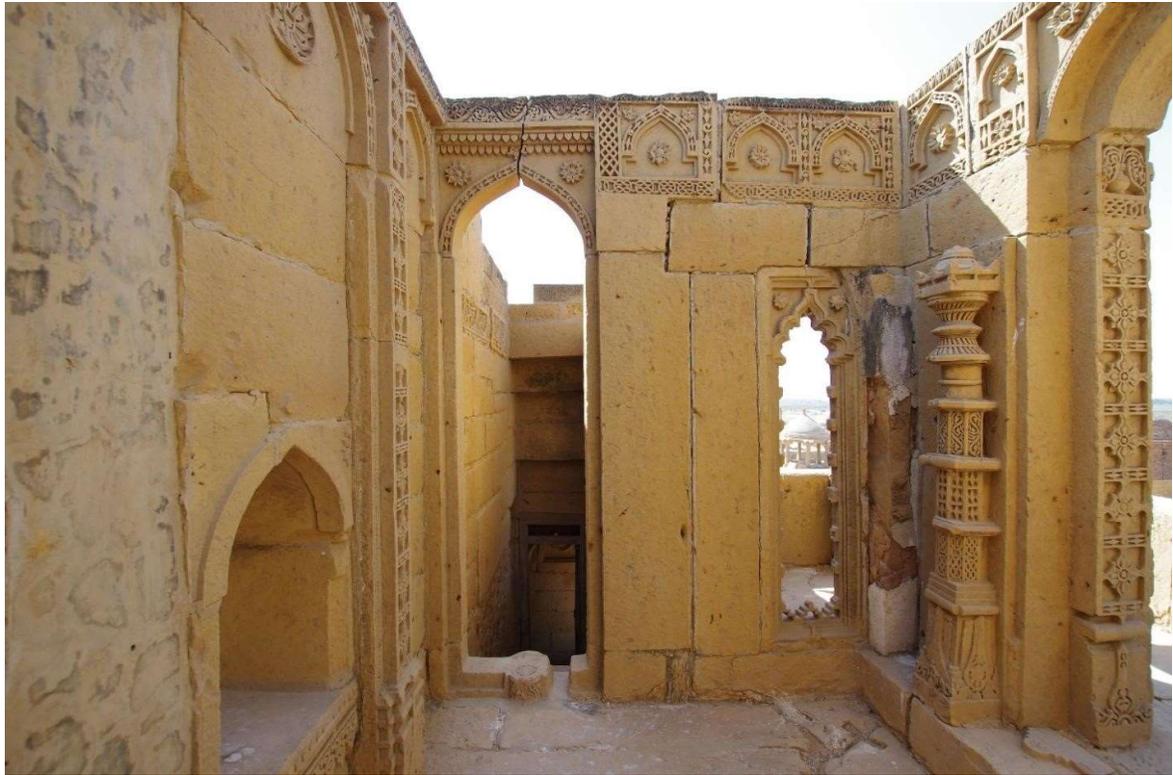
Image 30: Vestibule of the Darshan Jharoka, looking south, with the broken lintel above the doorway.

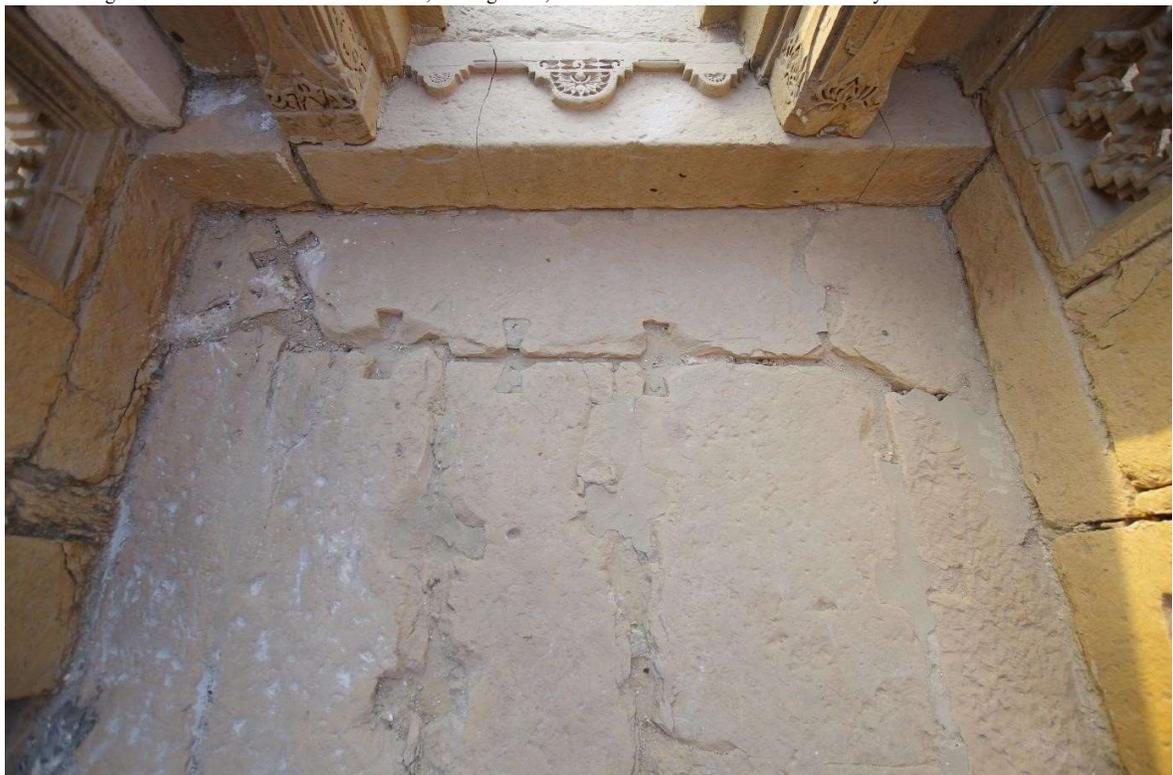
Image 31: Vestibule of the Darshan Jharoka, stone planks with missing iron clamps.

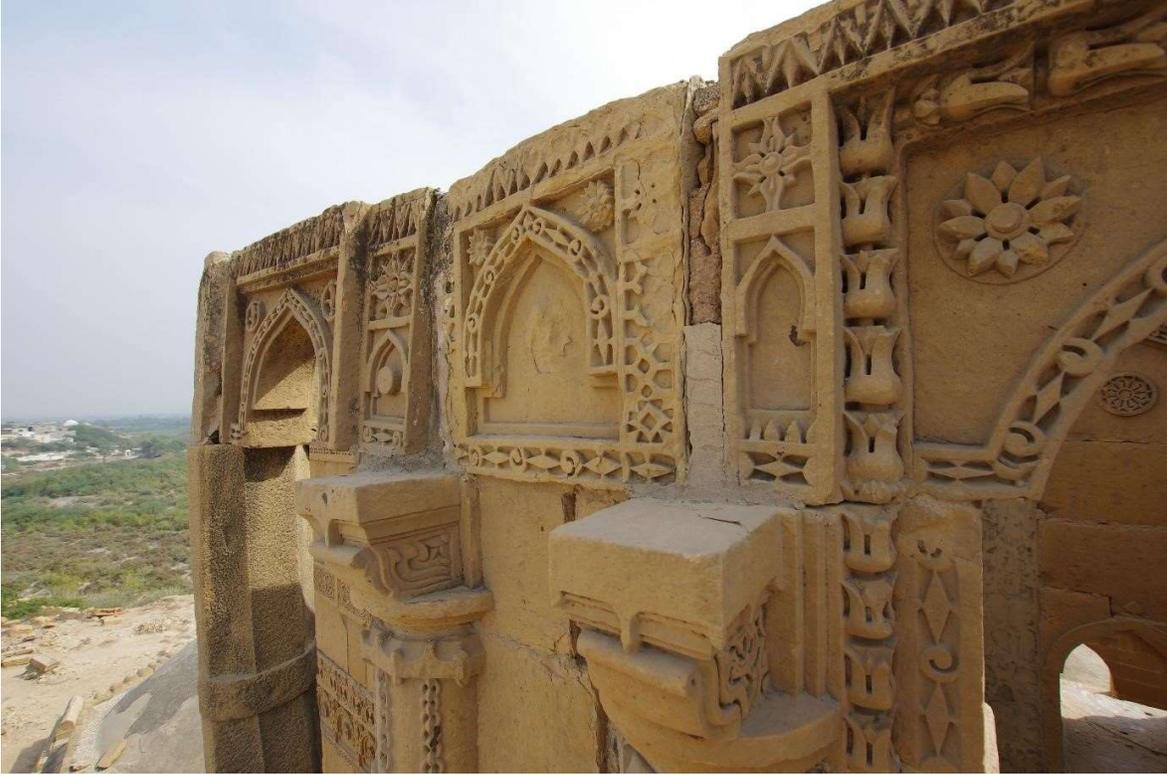
Image 32: Upper entablature of balcony structure, looking north. The disruption and perturbation of the structural elements is clearly visible, with wide (partly repointed) gaps, dislodgements and misalignments and lost original elements (e.g. post on the left hand side).

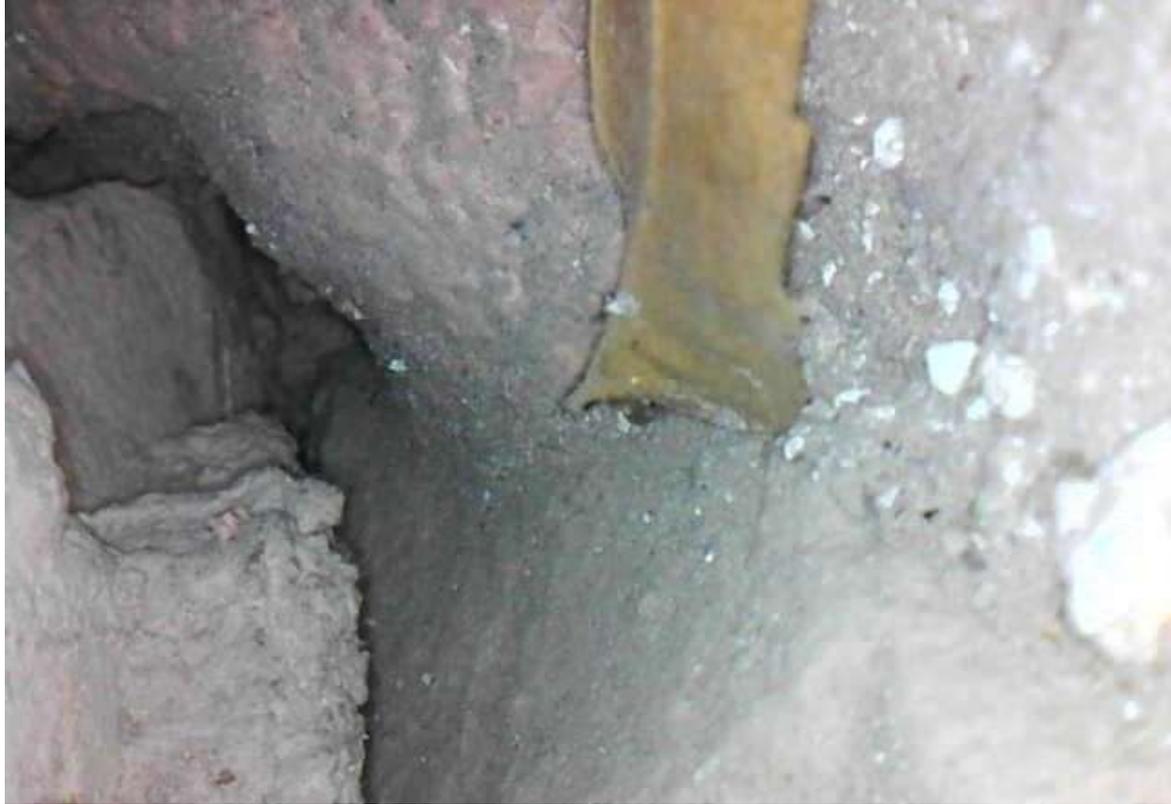
Image 38: Endoscopic view of crack between the detached central pilaster and the main structure. It shows a patched crack within the mihrab niche (taken from the opposite site).

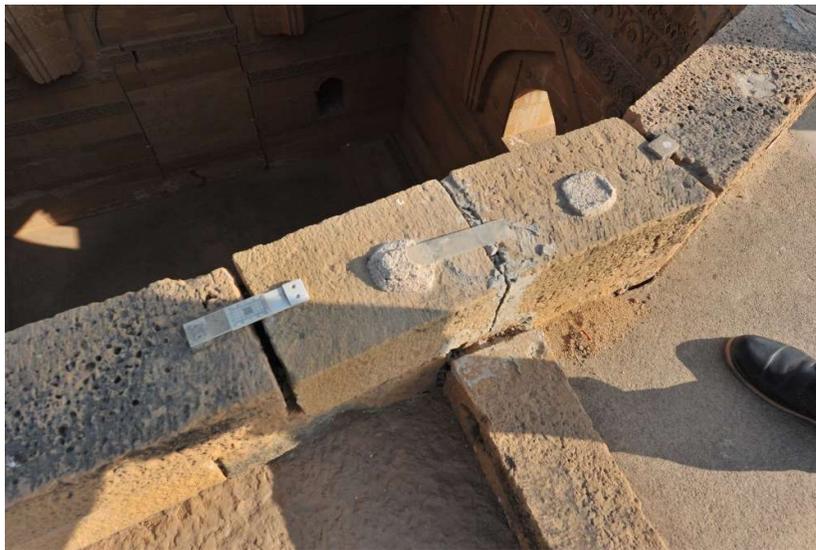
Figure 11 – Crack monitors installed at Jam Nizzamuddin, unfortunately, the existing glass crack monitors of uncertain date (but before 1980) were broken or removed

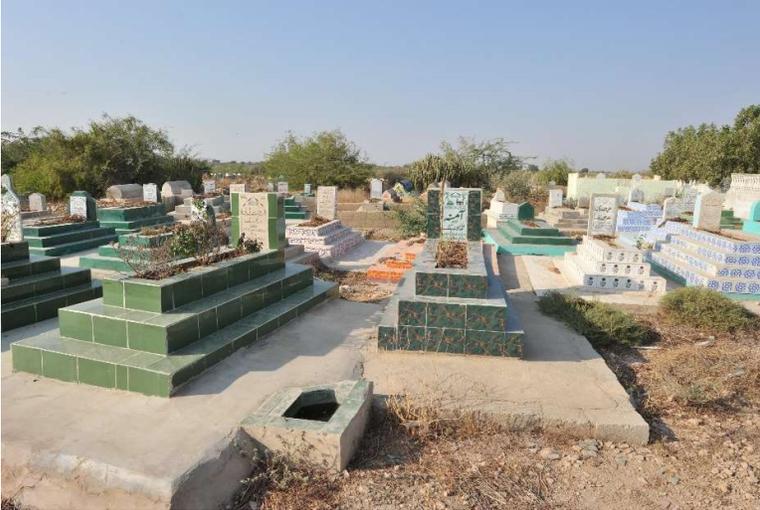
Figure 13 – Three areas at the western boundary of the site have seen recent burials, while these are within the site boundaries there is no evidence of archaeological remains. These areas have yet to be approved by the Department of Health.

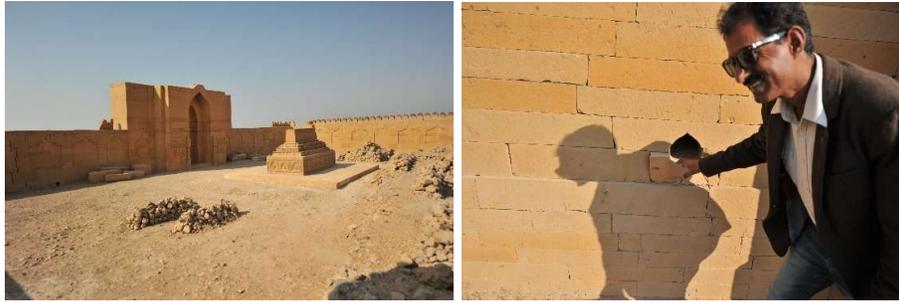
Figure 42 – Mubarak Khan – cleaned with positive drainage, platform consolidation, and clean scupper inspection

The floor of this open tomb was cleaned with rubbish and vegetation removed. This cleaning lowered the level and made the tomb more accessible. The scuppers were cleaned, and now there is positive drainage. New doors with locks were installed and the tomb closed unless by appointment. The main platform was conserved with loose stones secured and the installation of new compatible stones with lime mortar. New signage was installed. It must also be noted that the areas around this grouping of tombs have been cleaned and lines of lime washed rocks placed to prevent vehicles from coming close to the tombs.

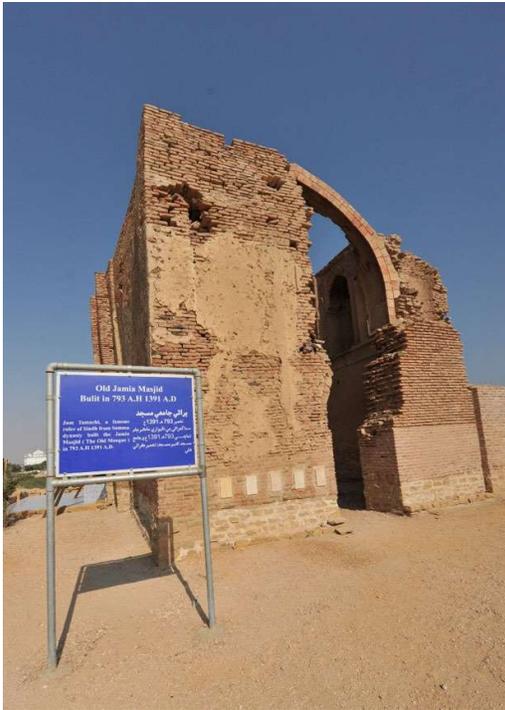
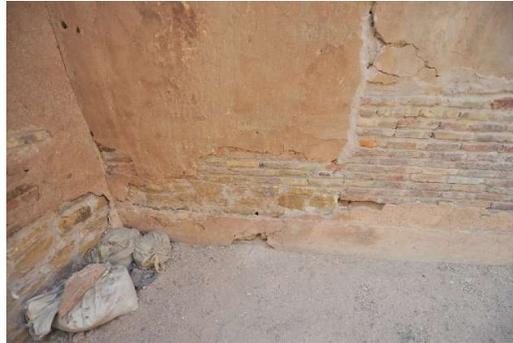
Figure 44 – Old Jamia Mosque with new sign board and plaster edging

There was underpinning with compatible brick and lime mortar of eroded base of the walls both inside and outside. The extant plaster was edged to prevent water infiltration behind. However this was too pronounced and of an off-white color. A discussion was held to spend the time to mix with brick dust and test samples for color matching and texture. The monument was cleaned inside and out, and there was the removal of portland cement at the north façade. The buttress at the southeast corner stair was restored as it is structurally necessary. This small restoration followed the historic photographs which were found on site. It was also discussed that the repointing of the brick could also be neater. New notice boards were also added, and wasps cleaned out of the structure. This structure must undergo extensive structural evaluation, but the above measures were within the current capacity of the on-site staff.

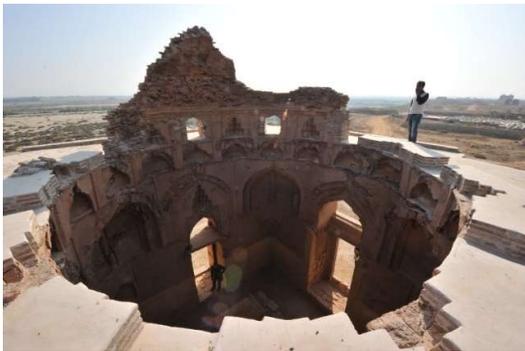
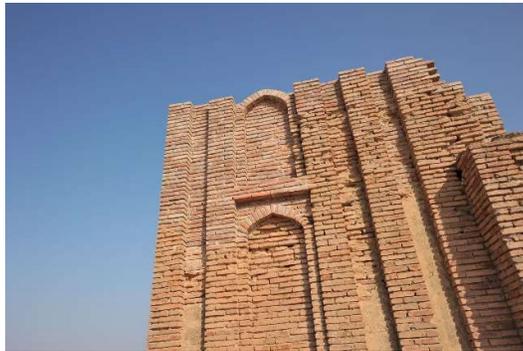
Figure 45 – Emergency stabilization of the upper wall surfaces of Sultan Qaus and the restored corner near the stair. The masonry work is acceptable and followed a historic photograph found in the office on-site

Structural stabilization of the remaining portions of the dome and wall capping to prevent the infiltration of water. The lime mortar used was whitish in color, and there were discussions to reduce the visual impact. This coloration was a minor issue as it is only seen from the top of the structure. Also new security doors were installed, and the roof access stairway stabilized and in one portion rebuilt as it acted as a buttress. There is historic plaster in the structure, and the topic of injection behind this plaster to re-attach the plaster to brick was discussed. This tomb, along with the others in this group, were cleaned of wasps which were a hazard to visitors. There must still be work to improve drainage within the tomb as the dome has been lost.

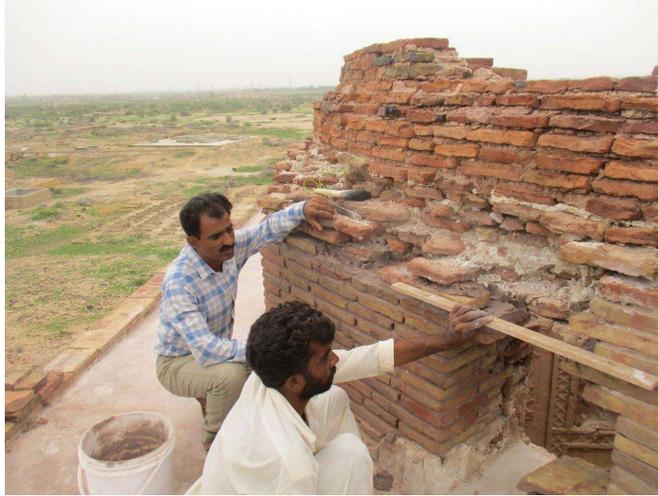
Figure 46 – Work at the dome remains at Sultan Qaus (Serfraz Nawaz) The masonry is now stable, and water infiltration has been prevented into the walls, but the historic plaster remains to be consolidated.

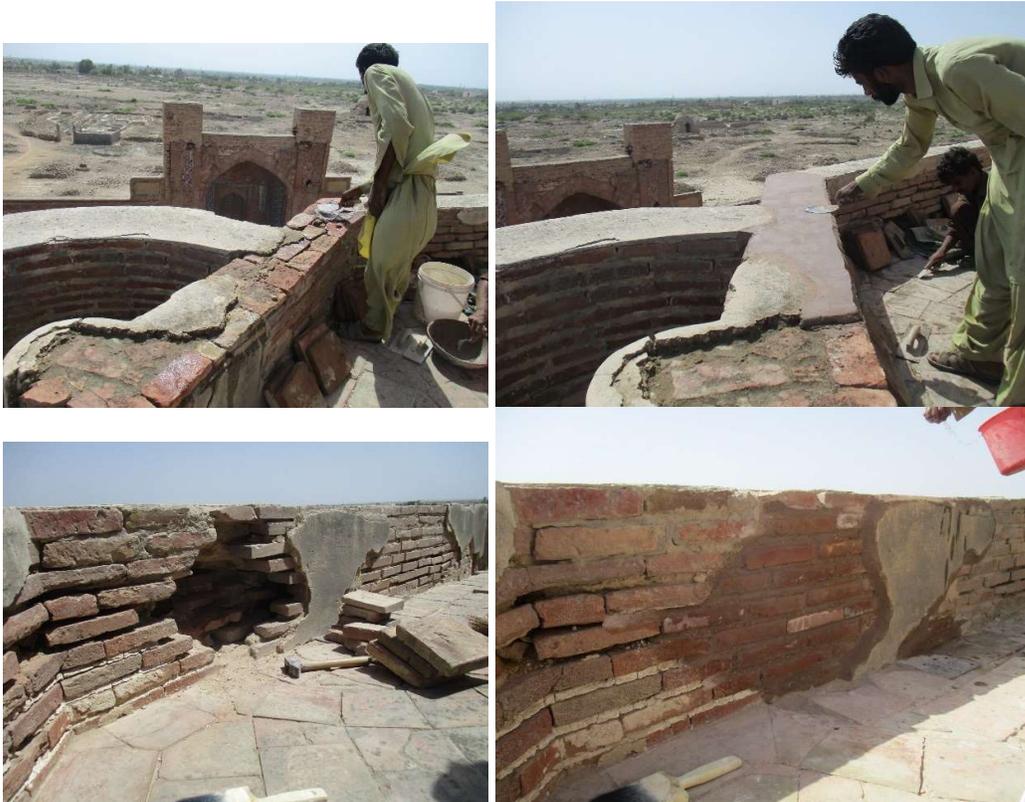
Figure 55 – Before and after images of the repair to the parapet (Serfraz Nawaz)

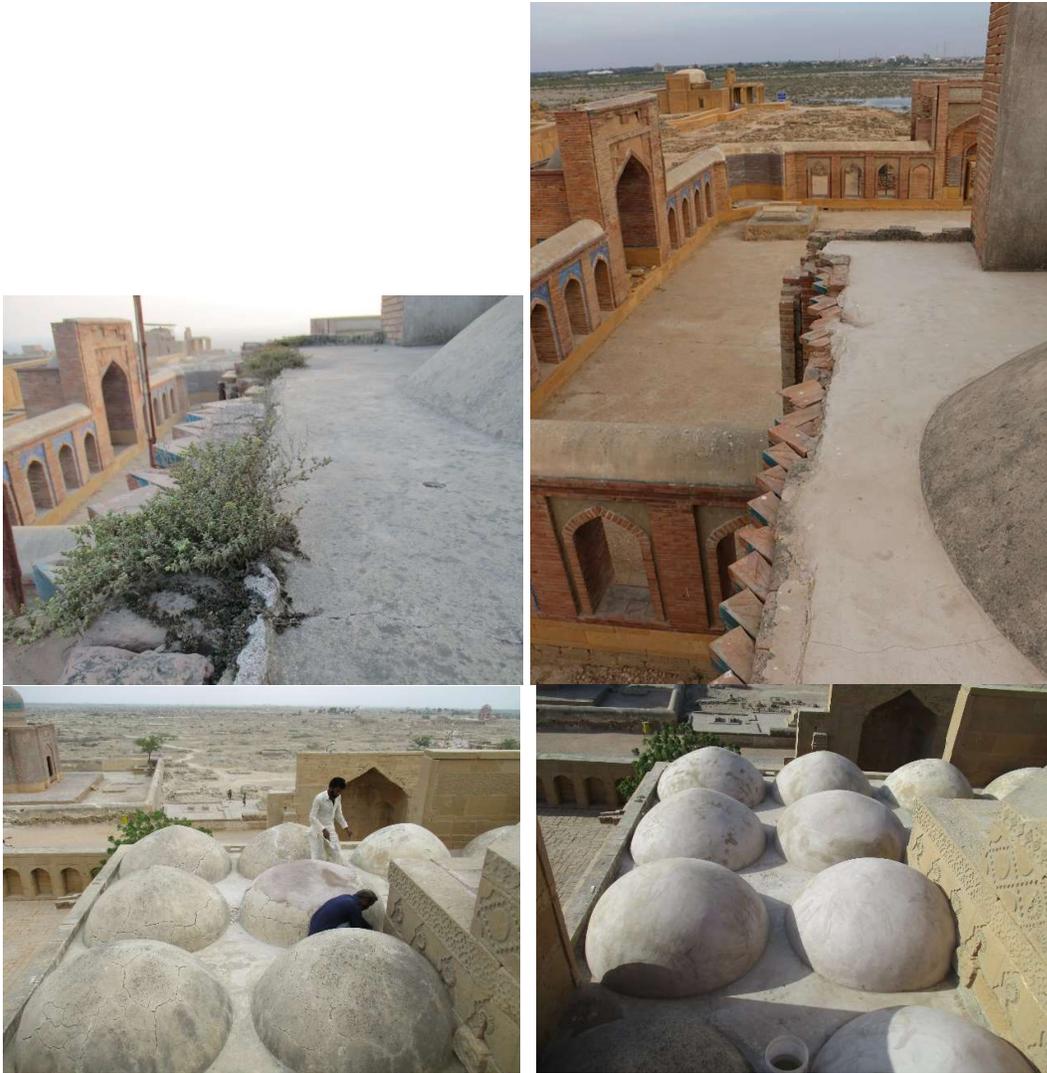
Figure 58 – Before and after images of the work done to remove vegetation and waterproof the roof of Isa Khan before the monsoon (Serfraz Nawaz)
