**Document d'information : Rapport de la mission conjointe UNESCO-ICOMOS-Le  
Gouvernement de Sa Majesté du Népal sur l'état de conservation de la Vallée de  
Kathmandu, site du patrimoine mondial, et plan d'action à échéances fixes des mesures  
correctives (résumé analytique en français)**

# **UNESCO-ICOMOS-His Majesty's Government of Nepal Joint Mission**

10 March - 14 April 1998

## **Report on the State of Conservation and Time Bound Action Plan of Corrective Measures for Enhanced Management of the Kathmandu Valley World Heritage Site**

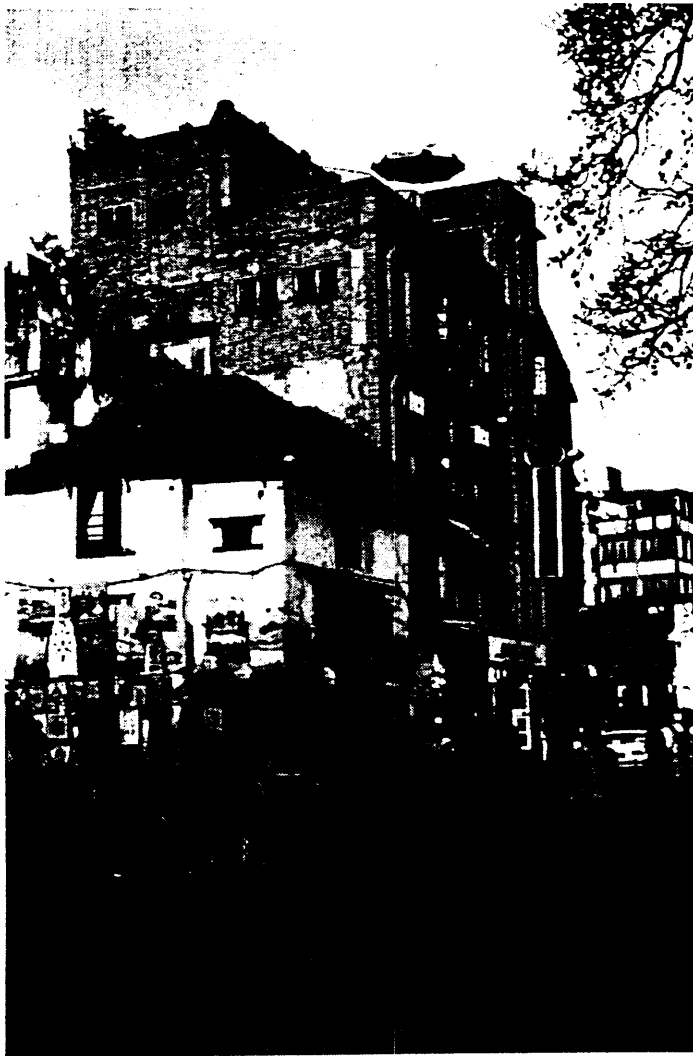
**III. Hanuman Dhoka 2.** Two illegal buildings facing the Taleju Bhawani Temple tower over the traditional *sattal* in the foreground at Hanuman Dhoka Darbar Square MZ. ICOMOS has recommended corrective measures for these two buildings to restore the setting and traditional urban fabric of this MZ. (See Ch. 3: Corrective measures Nos 29-30). (© DM)

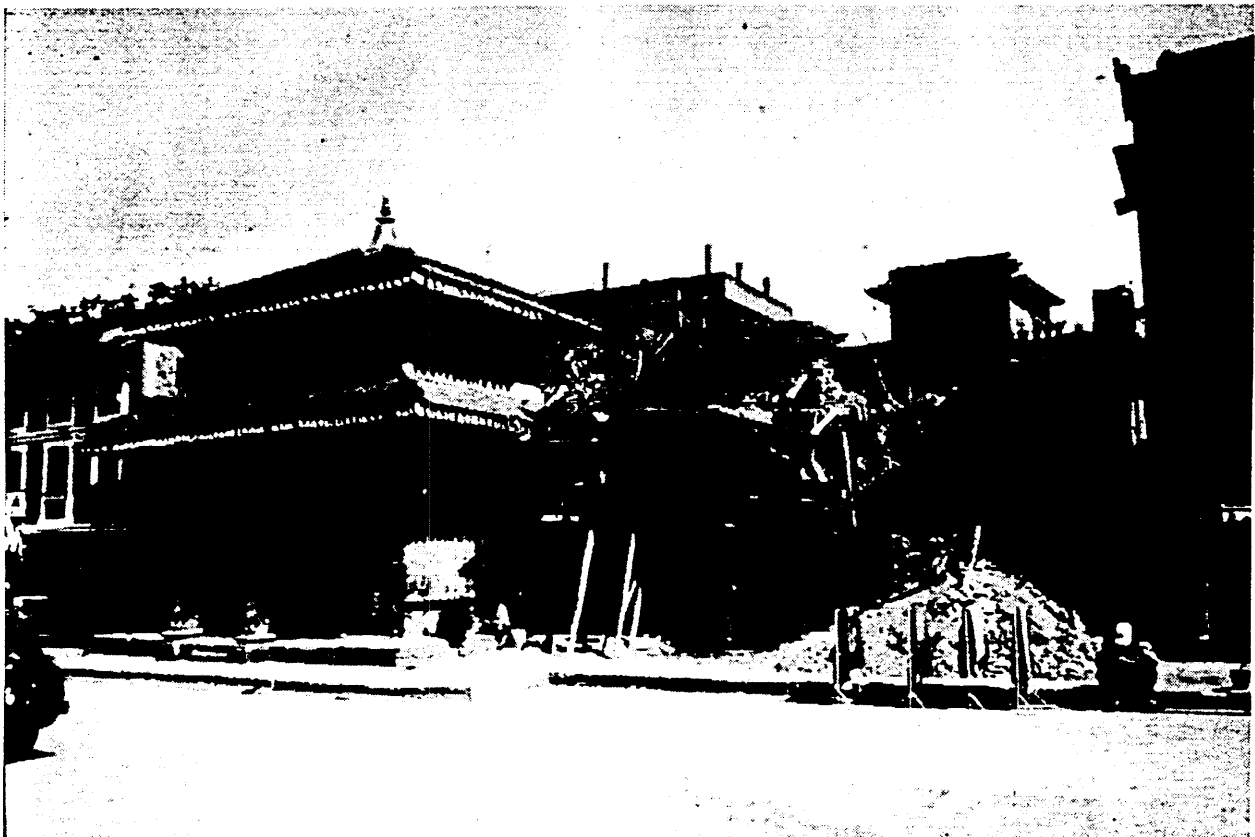
**III. Patan 3.** This partially collapsed Ayaguthi Sattal (1760) within Patan Darbar Square MZ, adjoins the Ganesh Temple. Ayatughi Sattal will be restored after it becomes a national property (See Ch. 4 ICOMOS state of conservation No. 18, 23). (© DM)

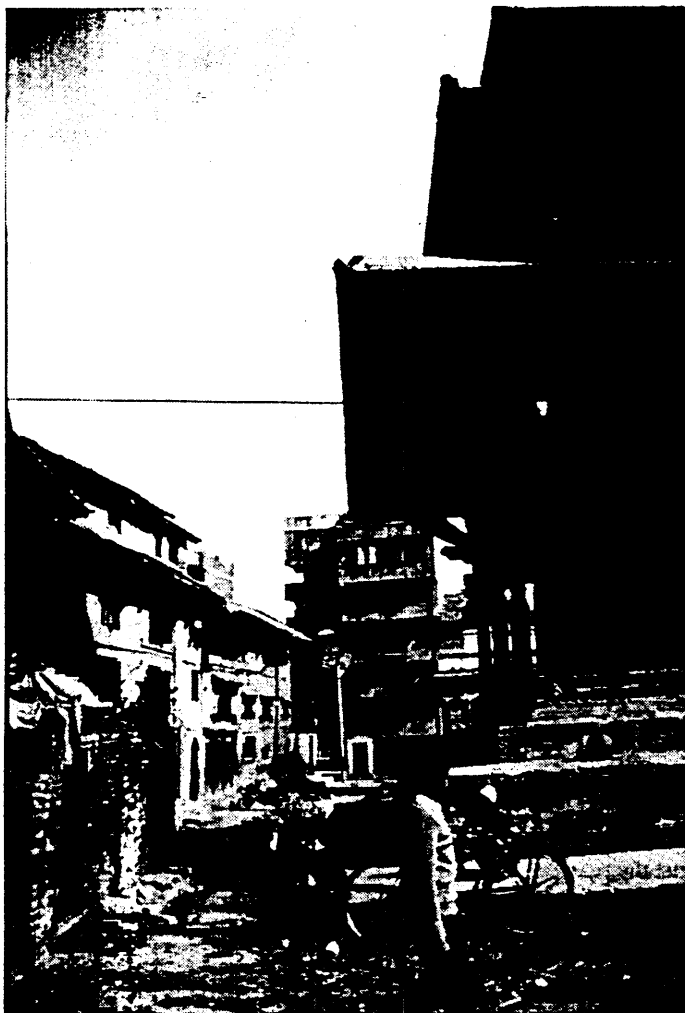
**III. Patan 7.** These Rana-period houses in Mahapal, Patan Darbar Square MZ, show movement resulting from the 1934 earthquake. However, the structures are currently stable. ICOMOS recommends that these houses should be repaired and retained. (© GP)

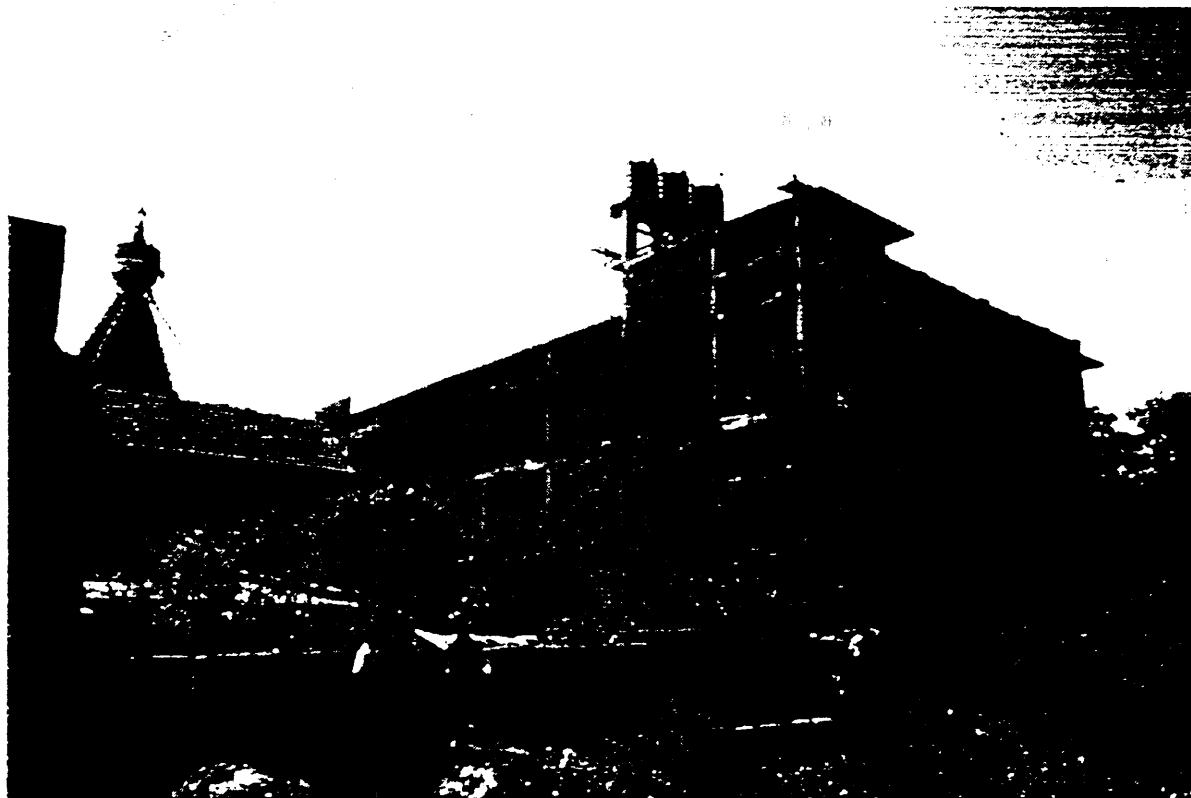
**III. Bauddha 3.** The illegally constructed rear extension of the house of Mr Beti Laxmi Shakya at Bauddhanath MZ. This is a typical example of massive illegal new buildings, which destroy the skyline and view of the stupa (See Ch. 7. Corrective measures recommended by ICOMOS, No. 29) (c DM)
