UNESCO-ICOMOS-His Majesty's Government of Nepal Joint Mission

10 March - 14 April 1998

Report on the State of Conservation and Time Bound Action Plan of Corrective Measures for Enhanced Management of the Kathmandu Valley World Heritage Site

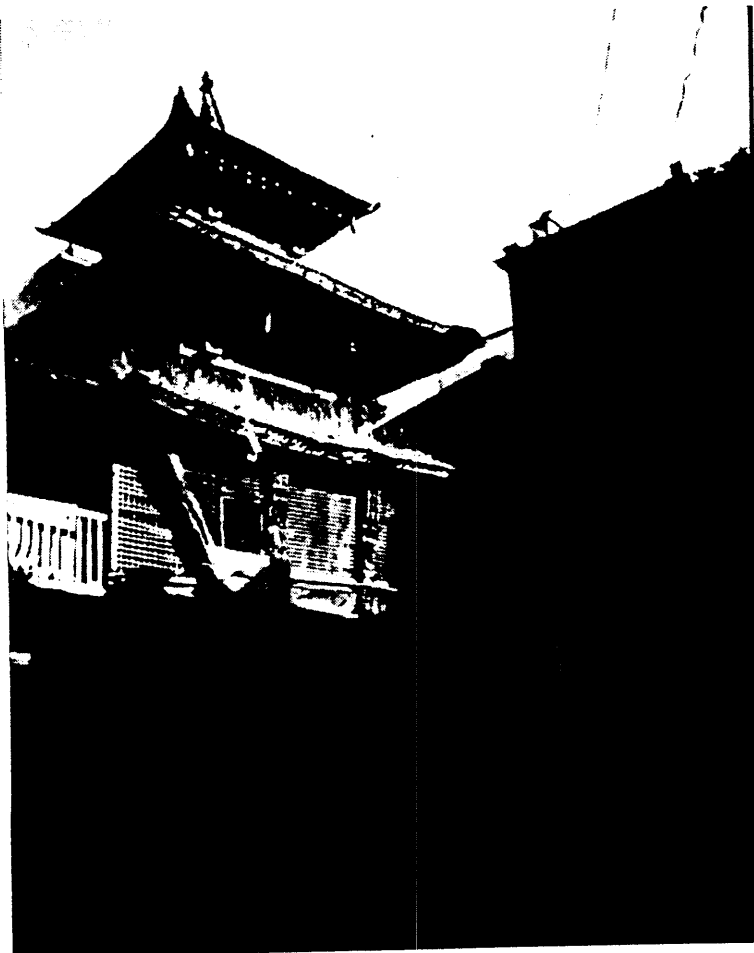
III. Kathmandu Valley 2. Joshi Agamchhe at Hanauman Dhoka Darbar Square MZ. This monument is in a poor condition and its authenticity is threatened by proposals to rebuild the flanking wings (© DM)

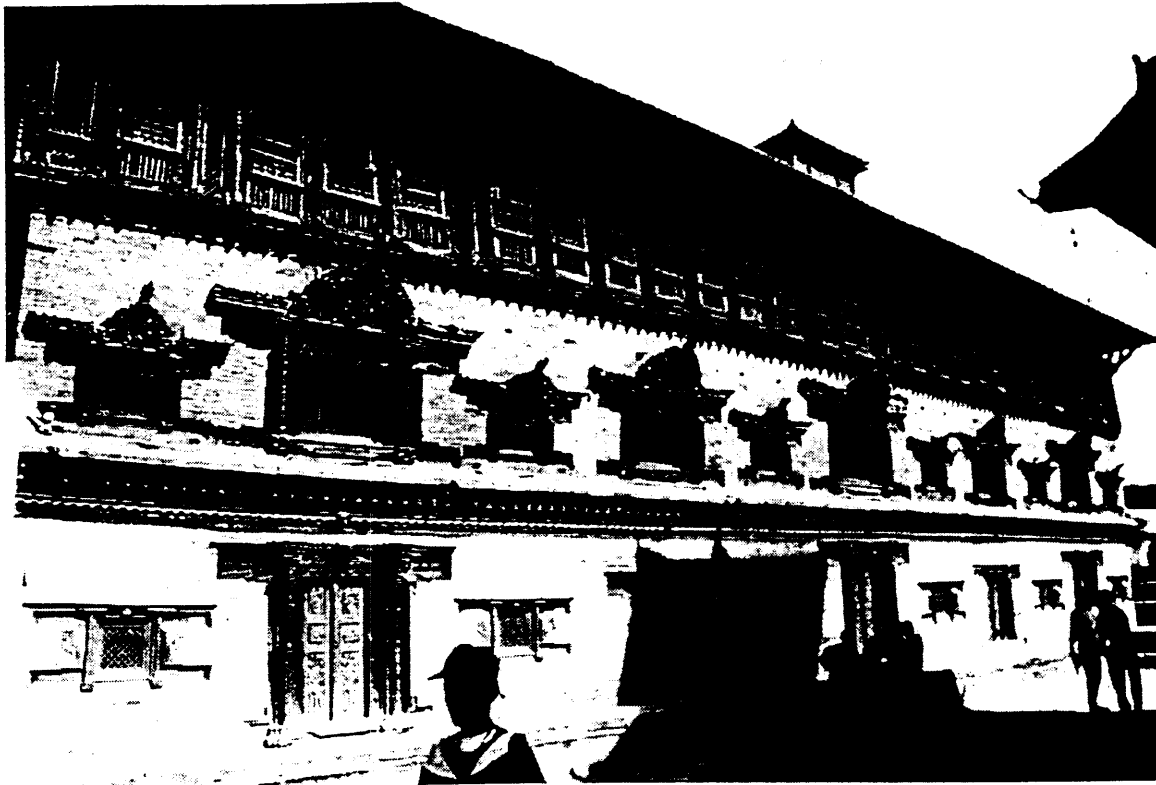
III. Kathmandu Valley 3. 55-Window Palace, Bhaktapur Darbar Square MZ, dated 1697. The World Heritage Fund is providing technical co-operation for conducting a thorough structural survey. (© DM)

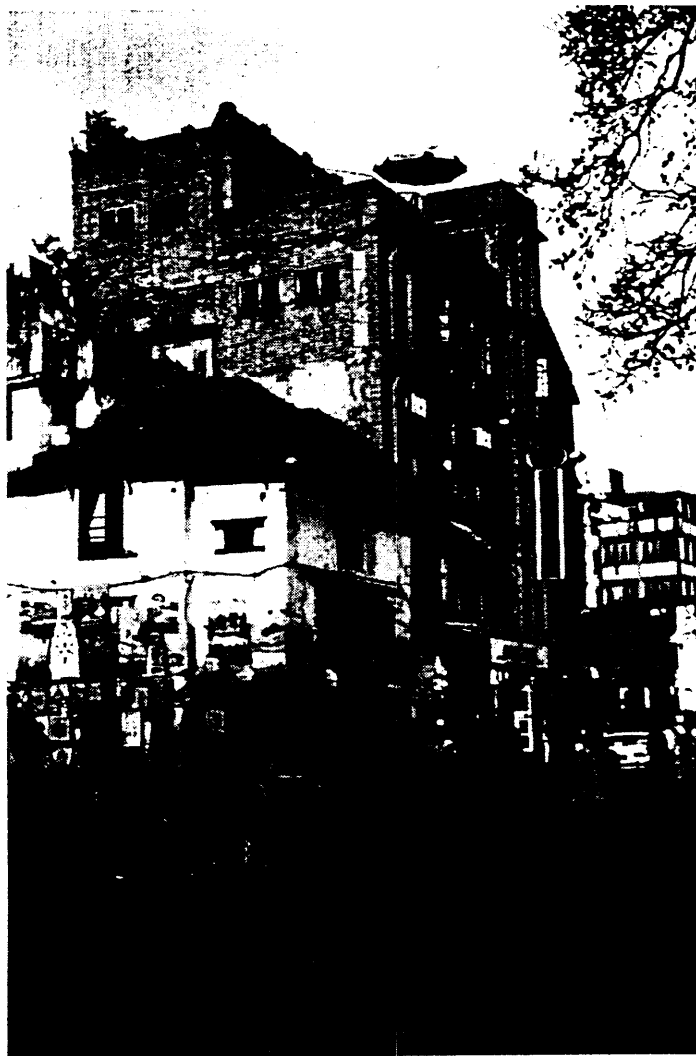
III. Hanuman Dhoka 2. Two illegal buildings facing the Taleju Bhawani Temple tower over the traditional *sattal* in the foreground at Hanuman Dhoka Darbar Square MZ. ICOMOS has recommended corrective measures for these two buildings to restore the setting and traditional urban fabric of this MZ. (See Ch. 3: Corrective measures Nos 29-30). (© DM)

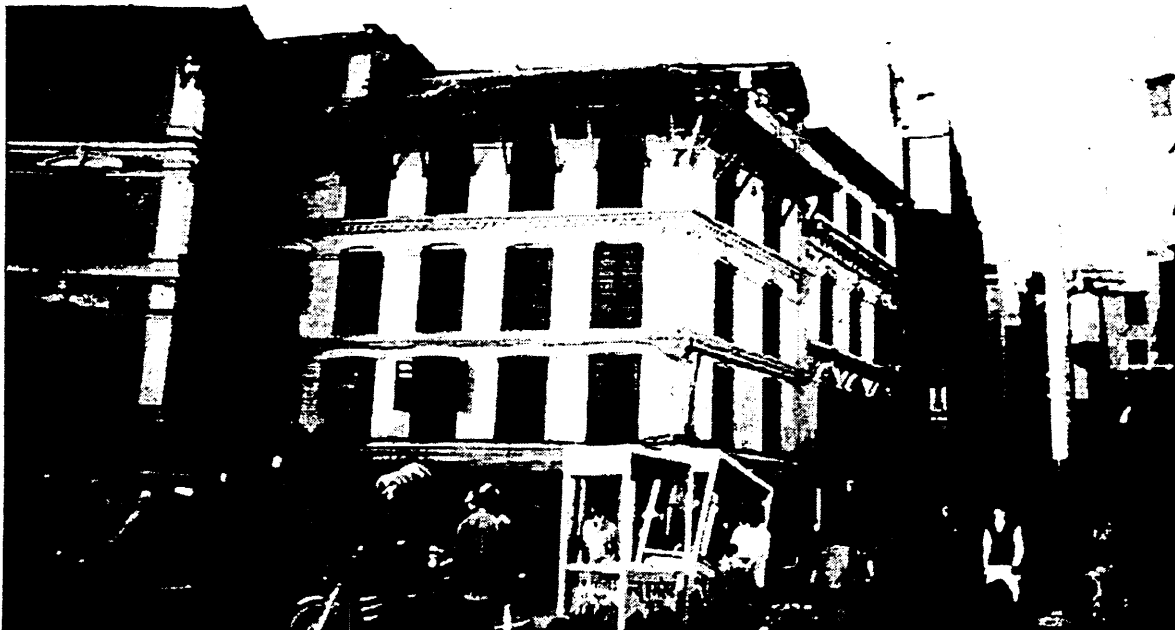
III. Hanuman Dhoka 6. Illegal modern buildings, partly demolished by DoA, rise behind the surviving Rana-period houses facing the Taleju Bhawani Temple at the Hanuman Dhoka Darbar Square MZ. ICOMOS recommends corrective measures for these buildings (See Ch. 3, Corrective measures Nos 37-38) (© GP)

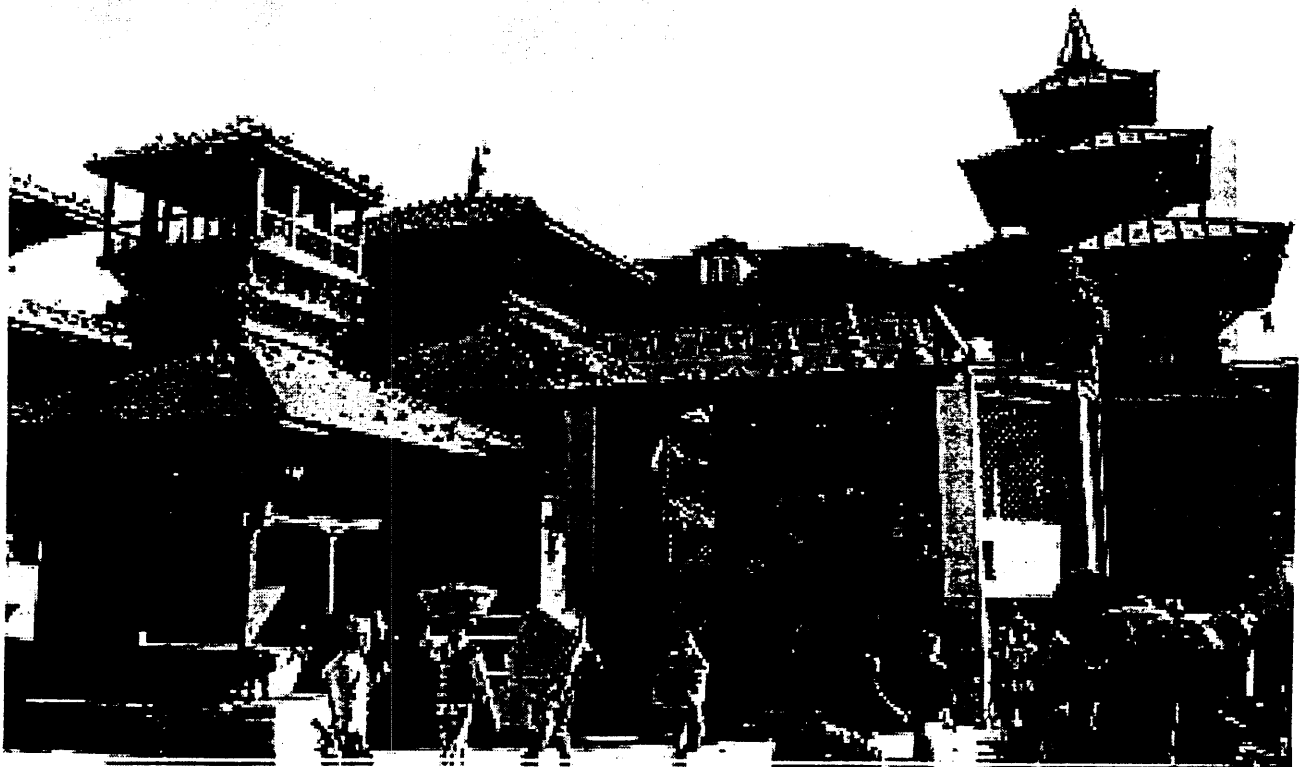
III. Hanuman Dhoka 9. Kal Bhairab Shrine (dated 1660) in Darbar Square, Hanuman Dhoka Darbar Square MZ (see Ch.3, ICOMOS state of conservation report, Ref. no. 30 [K-177]). This shrine, composed of a huge sculpture of a six-armed Bhairab, is surrounded unsympathetically in renewed grey marble, built around 1980. The Joint Mission was informed that this renewal was done without the consent of the statutory authorities. Behind the Kal Bhairab Shrine are the buildings of Hanuman Dhoka Palace complex. It is unfortunate that the use of new building material (marble) has disrupted the architectural fabric of the Darbar Square. (© JT)

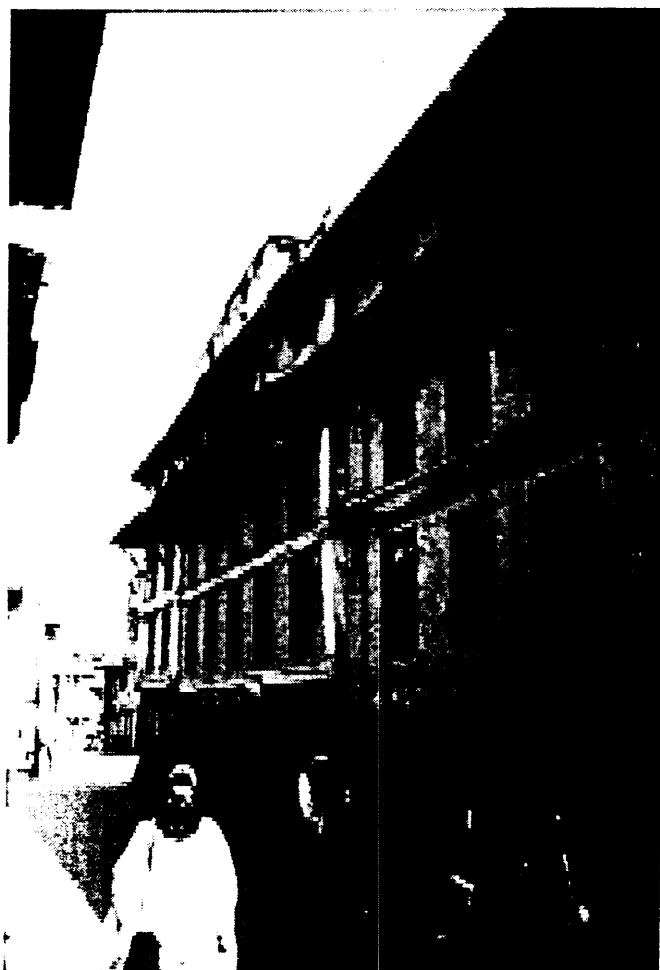
III. Patan 7. These Rana-period houses in Mahapal, Patan Darbar Square MZ, show movement resulting from the 1934 earthquake. However, the structures are currently stable. ICOMOS recommends that these houses should be repaired and retained. (© GP)

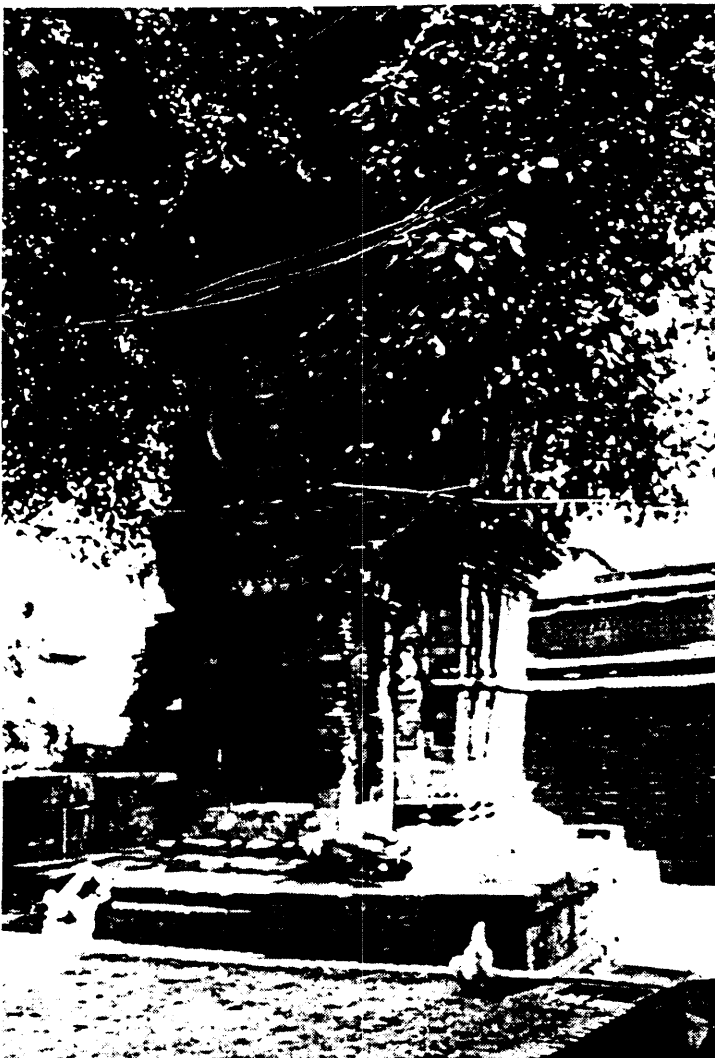
III. Bhaktapur 3. The Balakhu Ganesh Temple at Bhaktapur Durbar Square MZ needs roof repairs. It stands in front of the derelict Pasu Kha Jhha Dyochhe, circa 15th century (See Ch. 5, ICOMOS state of conservation report, Darbar Square; No. 8). (© GP)

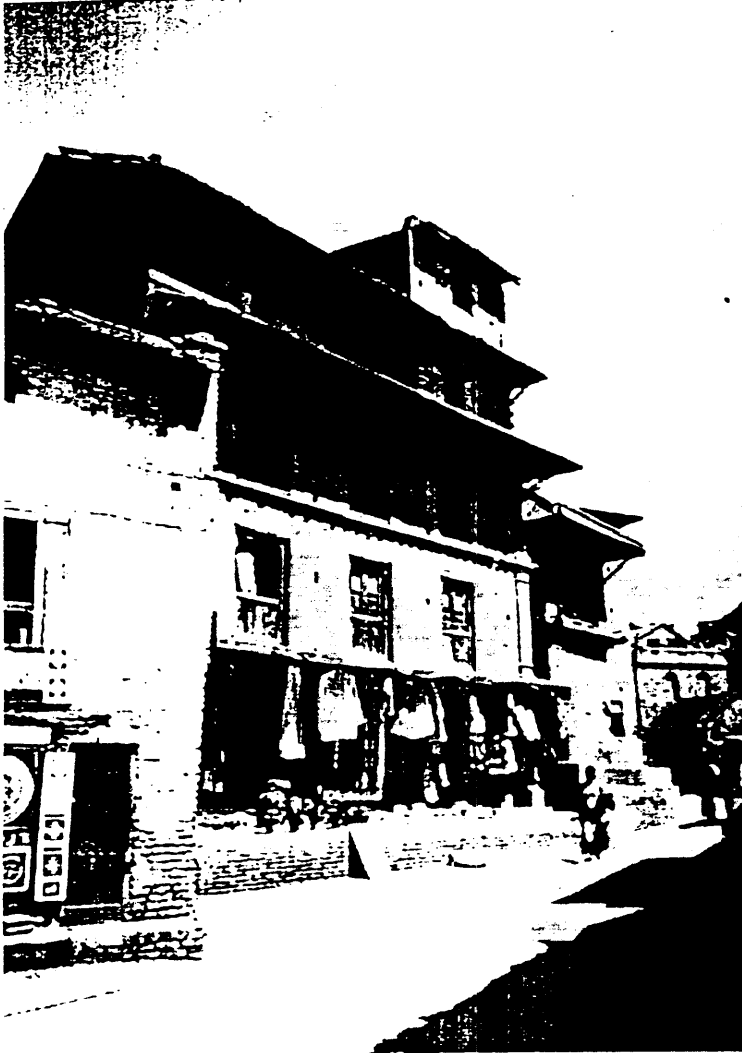
III. Bhaktapur 5. ICOMOS has advised that demolition of the house of Ram Prasad Prajapati, which faces the Kasi Biswanath Temple, would set an extremely bad precedent for the MZ and that the recently granted permission to redevelop the site should be revoked (See Ch. 5, ICOMOS state of conservation report, Tamaudhi Square) (© GP)

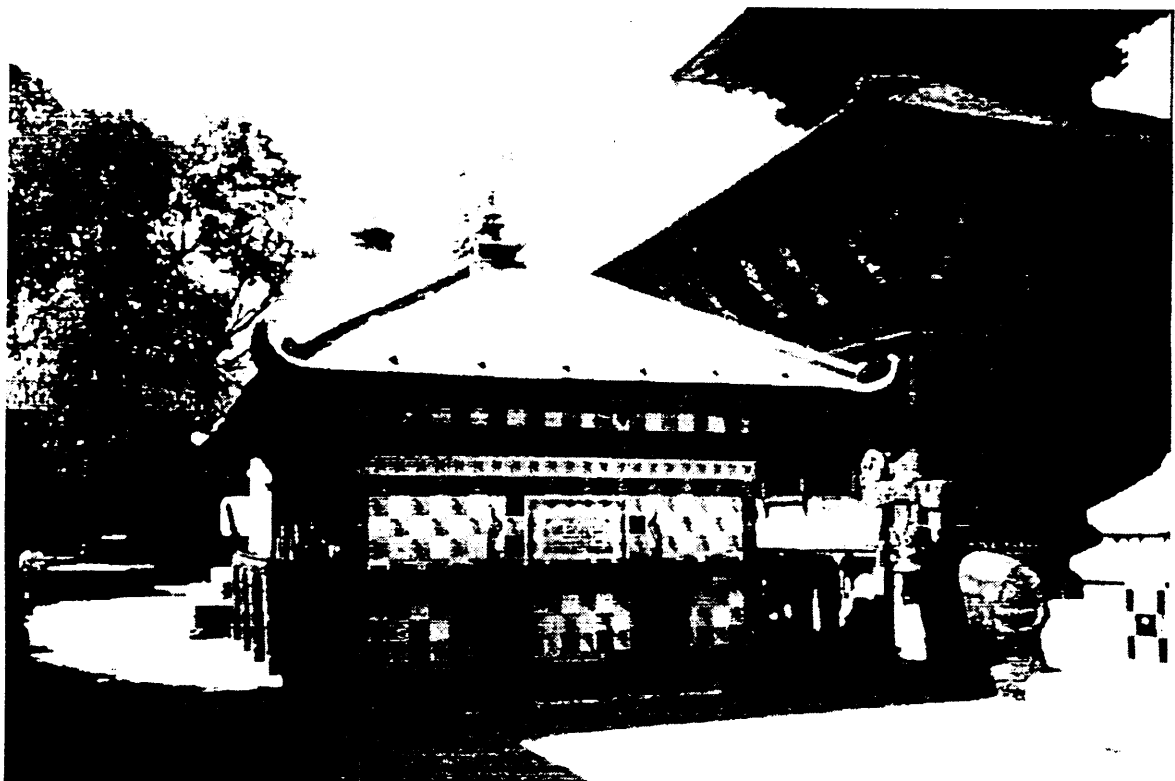
III. Changu 5. The highly worshipped Chinna Masta Temple within the temple complex of Changu Narayan MZ dates to the 17th century. The glazed ceramic tiles were added to the temple between 1930-1931 (See Ch. 9 ICOMOS state of conservation report, No. 9). (© GP)
