# KATHMANDU VALLEY WORLD HERITAGE PROPERTY NEPAL

Ref. 121bis

## STATE OF CONSERVATION REPORT 2022

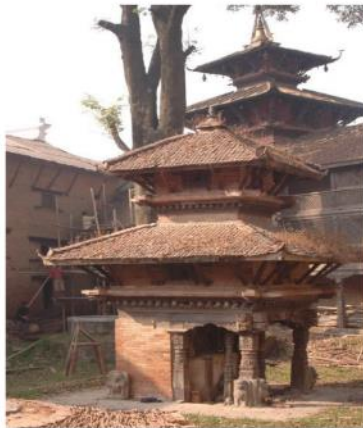
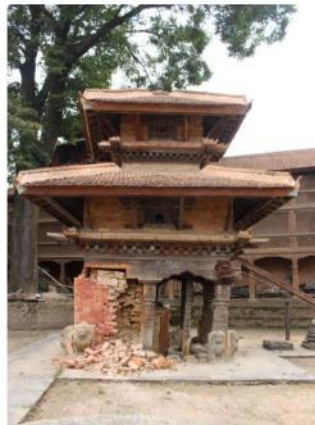
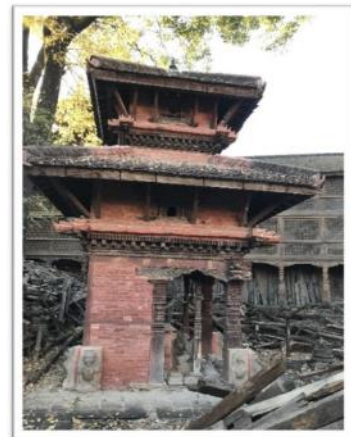
| s. no. | Name of the monument (Location) | Status of Monument after earthquake | Damage assessment of Monument: | Architectural Documentation of monument | Type of conservation Method applied for conservation | Management of material to be reused | Implementation Modality | Changes made in material and technology during conservation process | Specific traditional technology and material found during execution |
|---|---|---|---|---|--|---|---|---|---|
| 1 | Nateshwor Temple (Masan chowk) | Partially damaged | | | Traditional technology | Inside the courtyard | Tendering process | No | No |

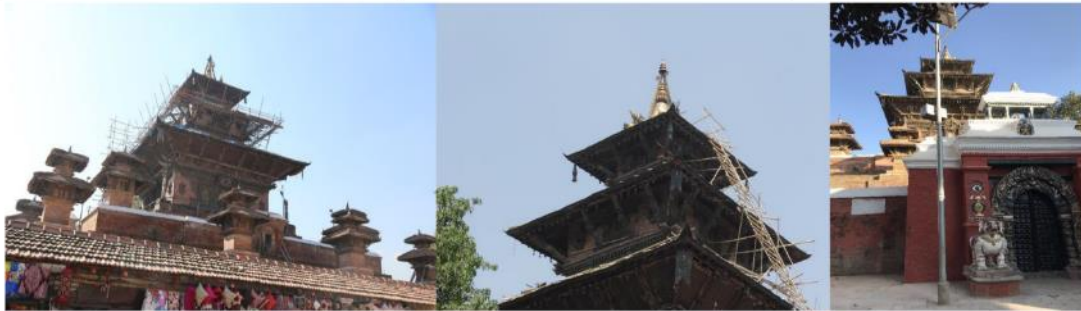
| s. no. | Name of the monument (Location) | Status of Monument after earthquake | Damage assessment of Monument: | Architectural Documentation of monument | Type of conservation Method applied for conservation | Management of material to be reused | Implementat ion Modality | Changes made in material and technology during conservation process | Specific traditional technology and material found during execution |
|---|---|---|---|---|--|---|---|---|---|
| 3 | Taleju Temple | Partially damaged | | | Traditional technology | Inside the courtyard | Tendering process | No | No |

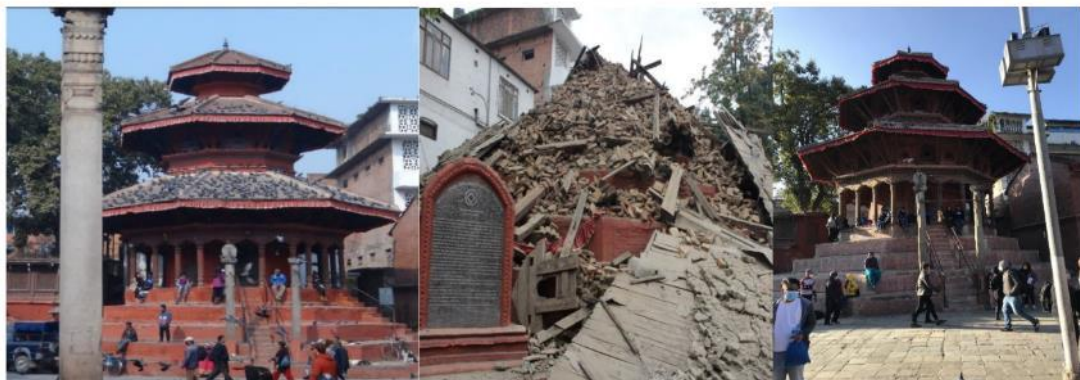
13. Chyasin Dega (Reconstruction by Department of Archaeology)

| s. no. | Name of the monument (Location) | Status of Monument after earthquake | Damage assessment of Monument: | Architectural Documentation of monument | Type of conservation Method applied for conservation | Management of material to be reused | Implementat ion Modality | Changes made in material and technology during conservation process | Specific traditional technology and material found during execution |
|---|---|---|---|---|--|---|---|---|---|
| 4 | Chyasin Dega | Partially damaged | | | Traditional technology | Inside the courtyard | Tendering process | No | No |

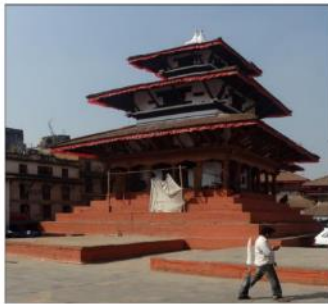
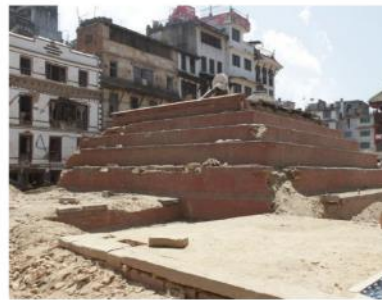
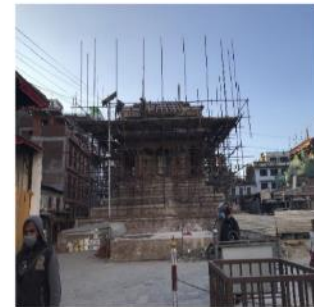
| s. no. | Name of the monument (Location) | Status of Monument after earthquake | Damage assessment of Monument: | Architectural Documentation of monument | Type of conservation Method applied for conservation | Management of material to be reused | Implementation Modality | Changes made in material and technology during conservation process | Specific traditional technology and material found during execution |
|---|---|---|---|---|--|---|---|---|---|
| 5 | Trailokya Mohan Temple | Partially damaged | | | Traditional technology | Inside the courtyard | Tendering process | No | No |

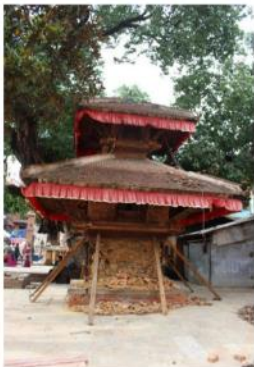
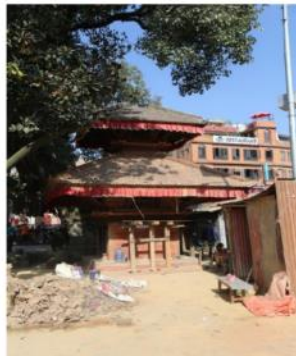
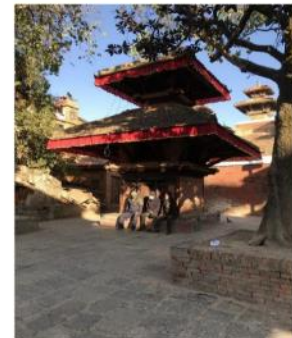
| s. no. | Name of the monument (Location) | Status of Monument after earthquake | Damage assessment of Monument: | Architectural Documentation of monument | Type of conservation Method applied for conservation | Management of material to be reused | Implementation Modality | Changes made in material and technology during conservation process | Specific traditional technology and material found during execution |
|---|---|---|---|---|--|---|---|---|---|
| 7 | Mahadev Temple | Partially damaged | | | Traditional technology | Inside the courtyard | Tendering process | No | No |

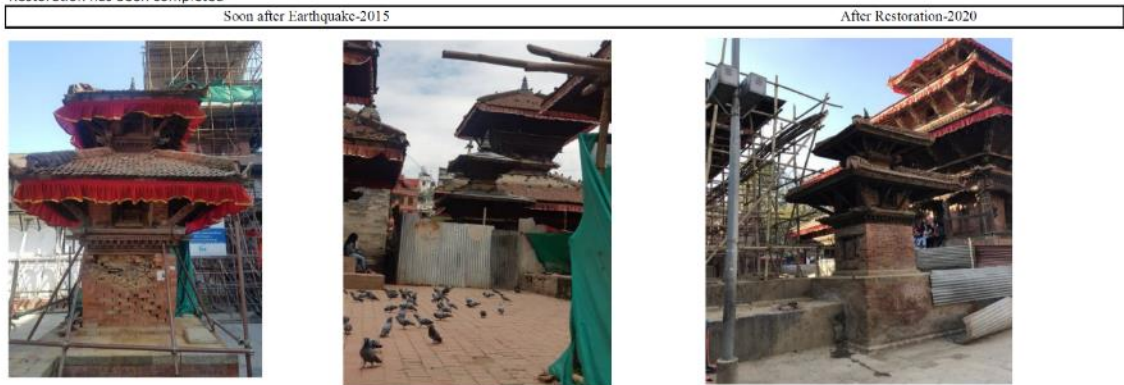
| s. no. | Name of the monument (Location) | Status of Monument after earthquake | Damage assessment of Monument: | Architectural Documentation of monument | Type of conservation Method applied for conservation | Management of material to be reused | Implementat ion Modality | Changes made in material and technology during conservation process | Specific traditional technology and material found during execution |
|---|---|---|---|---|--|---|---|---|---|
| 23 | Small Temple around Jagannath Temple | Partially damaged | | | Traditional technology | Inside the courtyard | Tendering process | No | No |

Restoration has been completed

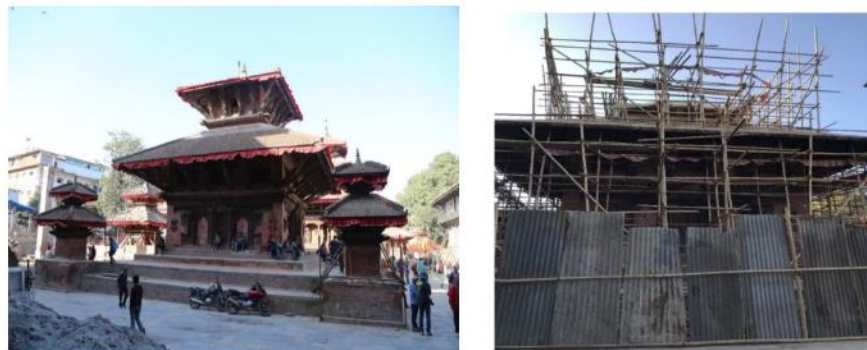
| s. no. | Name of the monument (Location) | Status of Monument after earthquake | Damage assessment of Monument: | Architectural Documentation of monument | Type of conservation Method applied for conservation | Management of material to be reused | Implementat ion Modality | Changes made in material and technology during conservation process | Specific traditional technology and material found during execution |
|---|---|---|---|---|--|---|---|---|---|
| 9 | Jagannath Temple: | Partially damaged | | | Traditional technology | Inside the courtyard | Tendering process | No | No |

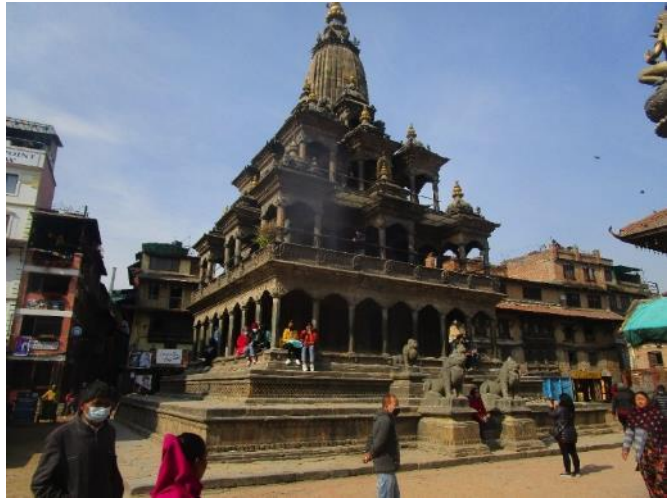
2. Project Description: The project completed by Kathmandu Valley Preservation Trust (KVPT) with approval and close coordination with Department of Archaeology through its site office in Patan. The completely stone built temple was only partially damaged by the earthquake. Stone blocks in several places were dislocated and the problem of rain water seepage appeared.

The conservation project implementation process applied by KVPT is different than the methods applied by other organizations. The daily wage based system under the management of KVPT is common all project conducted by this NGO.

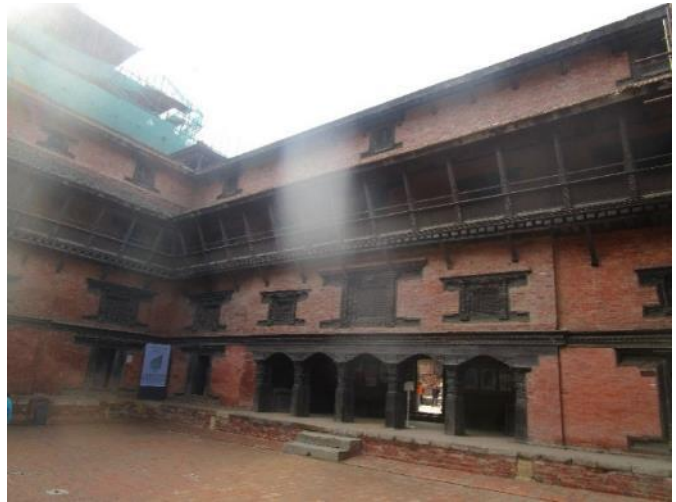
2. Project Description: The project was completed by Patan Durbar Museum Development Committee with approval and close coordination with Department of Archaeology. However the all four wings of Keshav Narayan Chowk were partially affected by the earthquake, conservation of western wing has been completed now. The restoration work has been completed following completely the traditional method and materials.

3. Status of Monument after earthquake
- Partially damage ✓
  - Totally damage
4. Damage assessment of Monument: Detail damage assessment was done before the conservation.
5. Photographs of monument after damage: Detail photographic documentation has been prepared.
6. Architectural Documentation of monument: Detail architectural and structural document has been prepared.
7. Implementation Modality
- users' group
  - Daily wage basis
  - Tendering process: ✓
  - Foreign agencies
8. Changes made in material and technology during conservation process: There is not any change in architecture.
9. Photographs of ongoing construction during conservation: Detail photographic documentation has been prepared during and after the conservation.

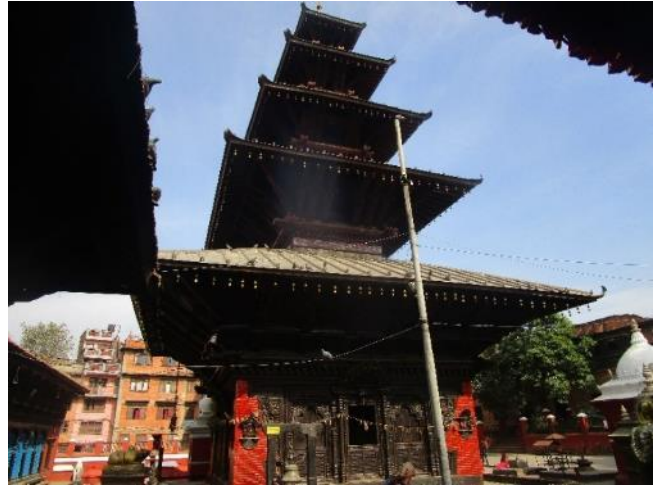
2. Project Description: The project was completed by Department of Archaeology. The Kumbheswor temple, a five story temple devoted to Lord Shiva, in the Lalitpur Durbar Protected Monument Zone is another temple which also was badly damaged especially upper two-three stories. Since the first and second story was found strong enough and not found big damage by the earthquake, only the upper three stories were dismantled for conservation. Almost all artistic wooden elements acquire from the original temple are reused with necessary conservation.

- a. Partially collapsed ✓
- b. Totally damage

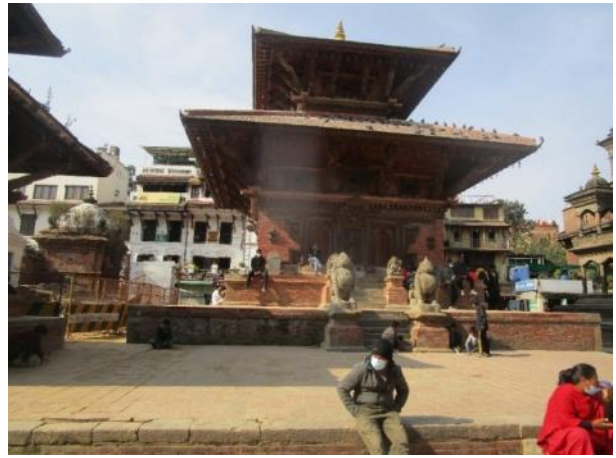
2. Project Description: The restoration of Char-Narayan Temple has been already completed. The Char-Narayan Temple, devoted to lord Vishnu, enshrined a cylindrical four faced beautiful stone image of Vishnu, representing the art and architecture of 17<sup>th</sup> century was completely collapsed above the plinth level by devastating 2015 earthquake. As reported in previous report, from the very beginning after the earthquake, Kathmandu Valley Preservation Trust (KVPT) has been actively

involved in the total activity of restoring the temple in its original state. All the damaged wooden carved elements which were salvaged and well documented with detail inventory are properly reused with necessary conservation. Since the foundation of the temple was found unaffected and strong enough in examination, the temple is restored over the previous plinth without disturbing original foundation and plinth. As its own modality, KVPT had completed the entire conservation project through daily wage system in close coordination with Department of Archaeology.

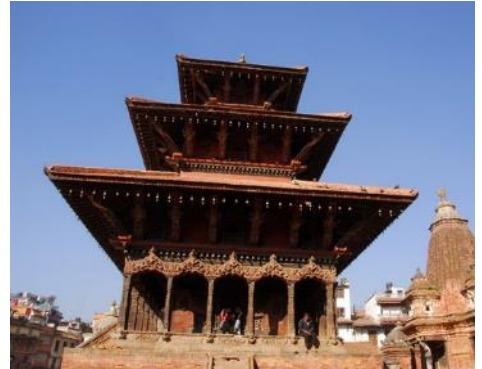
2) Project Description: The restoration work of Hari-Shankar Temple has been already completed. The Hari-Shankar Temple devoted to lord Vishnu and Shiva, in Patan Durbar Square, near to collapsed Char-Narayan temple and just beside the Narasimha temple also was completely collapsed above the plinth level by the earthquake. As reported in previous report, all the damaged wooden carved elements of the three roofed temple with extraordinary wooden art and architecture was well salvaged with detail documentation. Almost all identified columns, windows, door, Carnes, tympanum, door wings, struts etc. were inventoried and are reused in present restoration of the temple. As the foundation of the temple was found intact and strong enough in the rescue archaeological investigation, the temple is restored keeping the original foundation intact. All the wooden emblems are installed with maintenance of original adding some new wood for missing portions. Fine yellow clay is used as mortar in the wall as its original state. Sufficiently wooden pillar and tie-up beam is given. All the new wood used for the temple is Sala Wood. In Hari Shankar temple some new intervention is also carried out particularly in the outer plinth. Strong Ma-apa (brick) foundation is erected replacing the loose soil and brickbats filling. The restoration work was conducted by KVPT in its own daily wage base system in the close inspection of Department of Archaeology.

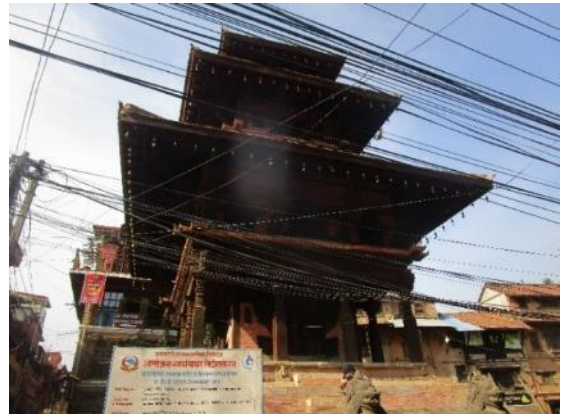
2. Project Description: Radhakrishna temple situated in Swatha Tole in northern side outside of Patan Durbar complex was completely collapsed by the earthquake. All the wooden and stone elements of the temple were immediately salvaged and secured inside palace complex. The temple restoration work has been completed by Department of Archaeology.

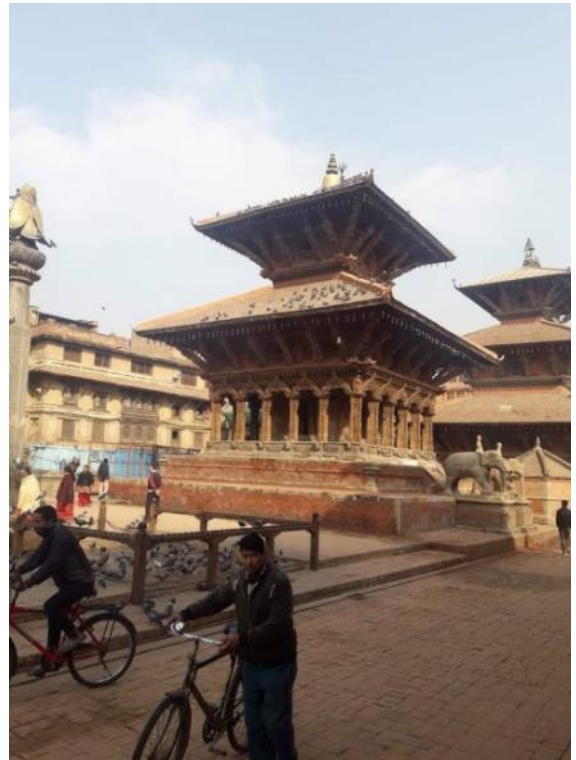
2. Project Description: As reported in previous report the Bishwanath Temple, near to Krishna temple, was partially but severally affected by the earthquake. Now the conservation of Bishwanath has been completed by KVPT.
3. Status of Monument after earthquake
  - a. Partially damage✓
  - b. Totally damage
4. Damage assessment of Monument: Several discussion and meeting were organized in Steering Committee.
5. Photographs of monument after damage:
6. Architectural Documentation of monument:
7. Implementation Modality
  - c. users' group
  - d. Tendering process:
  - e. Foreign agencies✓
8. 13 Changes made in material and technology during conservation process: Hydraulic lime and stone dust used as a changed.
9. Specific traditional technology and material found during execution: Yes,  
Photographs of ongoing construction during conservation:

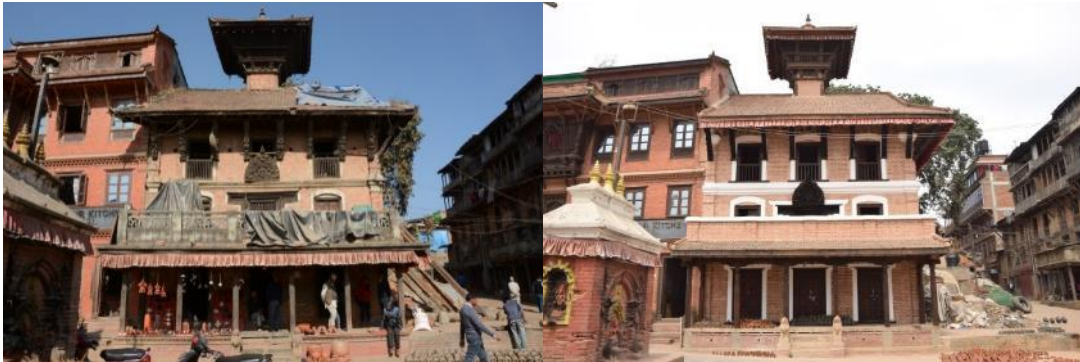
#### **1. Jetha Ganesh Dyochhen, Bhaktapur**

2. Project Description: The project completed on Fiscal Year 2077-78 was executed by Monument Conservation and Palace Management office Bhaktapur under Department of Archaeology. It was completed through tendering process under the close supervision of Engineer and Archaeological Officer for Department of Archaeology. Materials were reused as much as possible in the conservation work.

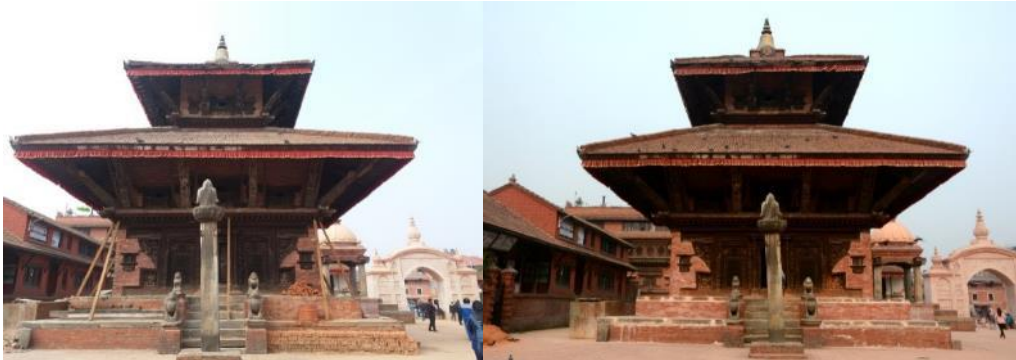
### **1. GopiNath Temple, Bhaktapur**

2. Project Description: The project was completed already in the Fiscal Year 2076-77. The entire conservation project was executed by Monument Conservation and Palace Management office Bhaktapur under Department of Archaeology. It was completed through tendering process under the close supervision of Engineer and Archaeological Officer for Department of Archaeology. The temple located on the premises of Bhaktapur Palace was conserved carefully and skilfully without dismantling the structure but repairing and replacing the damaged brick wall and wooden elements.

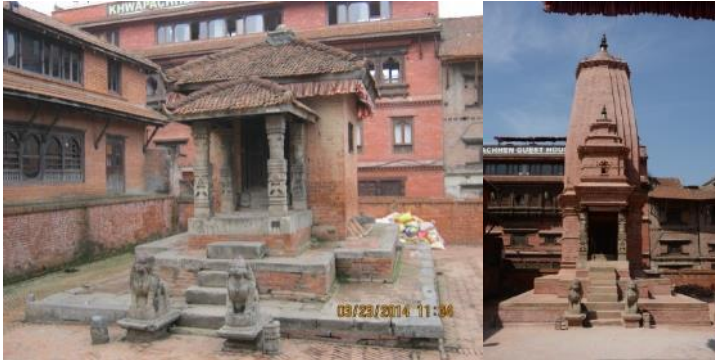
### **1. BadriNath Temple, Bhaktapur**

2. Project Description: The restoration of BadriNath temple was started before the 2015 earthquake. It was damaged by previous earthquake of 1934. Presently it has been restored in its original shape and size of 1034. It is a Shikhara built of Brick, stone and wood.

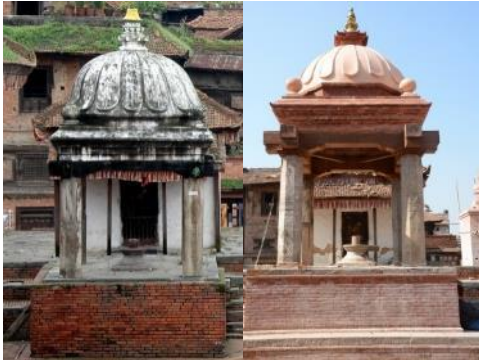
### **1. Rameshwor Temple, Bhaktapur**

2. Project Description: The project was completed already in the Fiscal Year 2076-77. It was completed through tendering process under the close supervision of Engineer and Archaeological Officer for Department of Archaeology. The small temple erected on the four stone pillars was tilted even before the earthquake; and it was more affected by the earthquake in 2015. Reusing the same stone elements the temple was restored from the very foundation.

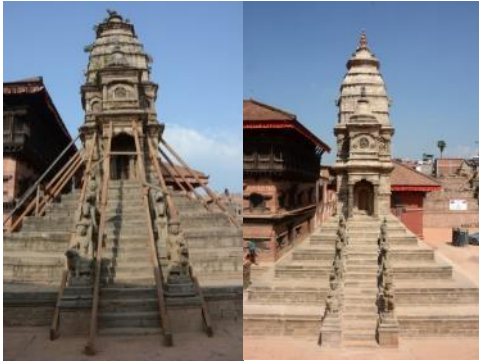
### **1. Siddhi Lakshmi Temple, Bhaktapur**

2. Project Description: Though not collapsed the Siddhi Lakshmi temple was badly damaged by the 2015 earthquake. With the financial and technical support of UNESCO office in Kathmandu there was done detail assessment and dismantled the structure with detail documentation. Preserving its original foundation and plinth level the temple was restored over the high raised plinth level. All the stones were reused which were numbered before removing from the structure. Wood is new application in the present conservation work.

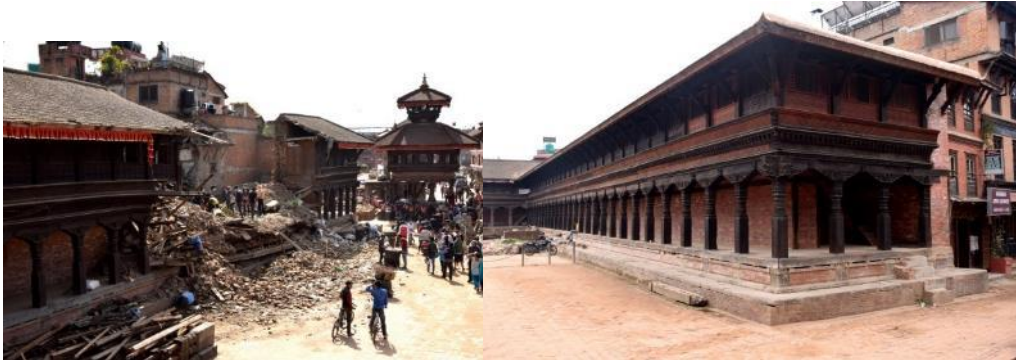
### **1. Tawa Satal, Bhaktapur**

2. Project Description: The restoration project of TawaSattal was started in Fiscal Year 2073-74 and was completed in 2076-77. The long Sattal, the traditional rest house with artistic wooden column, bracket, beam and windows was partially collapsed by the earthquake. With the reuse of its original material as much as possible, the structure has been already completed.

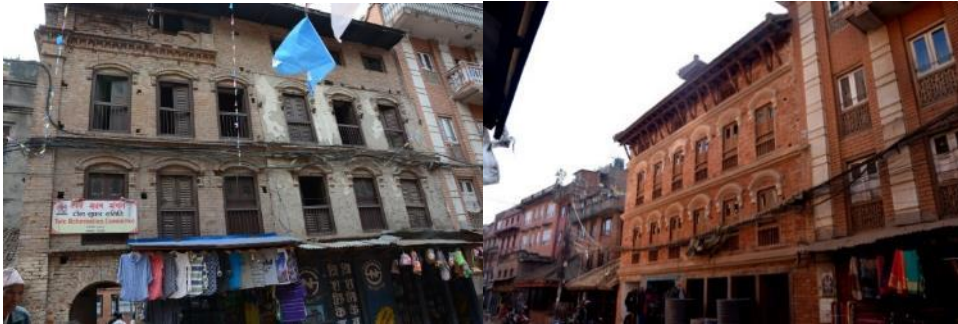
### **1. NasamanaBhajanGhar, Bhaktapur**

2. Project Description :NasamanaBhajanGhar has been restored from the very foundation. It was not collapsed but severely damaged by the earthquake. The conservation of this heritage structure was completed in Fiscal Year 2078-79.

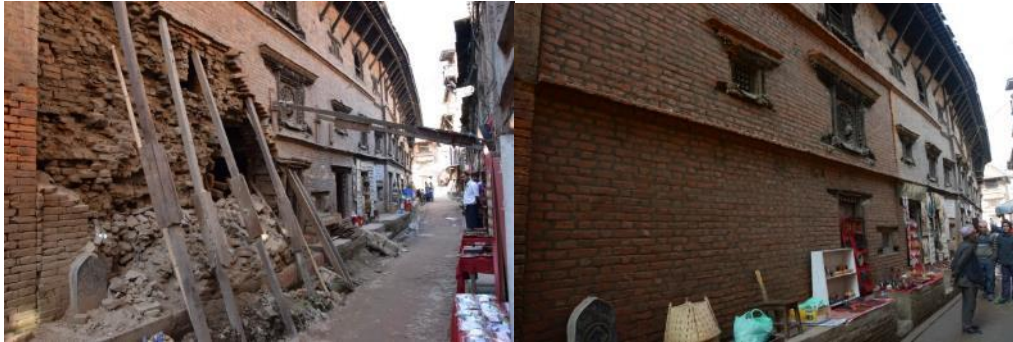
### **1. Pujari Math, Bhaktapur**

2. ProjectDescription :The South-eastern outer façade of the Pujari Math was damaged by the earthquake. To protect the huge old structure abundant shoring was given immediately after the earthquake. This damaged portion was conserved just after the earthquake applying mud mortar in its originality. This conservation project was funded by German Government. Department of Archaeology had executed the project.

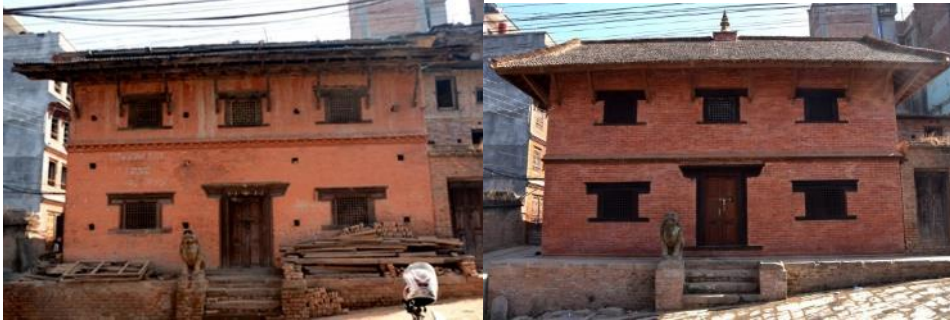
2. Project Description: Balakhu Ganesh Dyochhein restoration work has been already completed. The roof was collapsed and several cracks were observed in the brick wall. The Dyochhein has been restored in its original style.

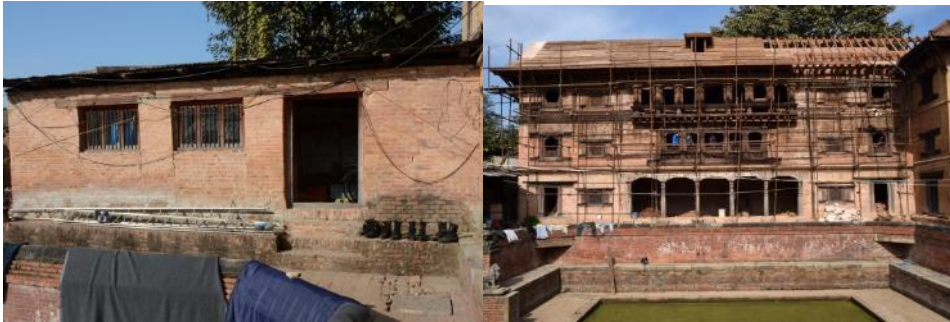
2. Project Description: Balakhu Ganesh Dyochhen restoration work has been already completed. The roof was collapsed and several cracks were observed in the brick wall. The Dyochhen has been restored in its original style. Bilachhen is a part of Bhaktapur Palace. It was destroyed already in history and was not rebuilt. Presently it is being restored in its original architecture on the basis of available photographs. The project is ongoing in its final phase.
