STATE OF CONSERVATION

TOMBS OF BUGANDA KINGS AT KASUBI(UGANDA)

**THE
BUJJABUKULA ROYAL GRANDIOSE
ENTRANCE BUILDING**
To the Tombs of Buganda Kings at Kasubi – UNESCO World Heritage
Property in Uganda

PHOTOGRAPHIC PROGRESS REPORT

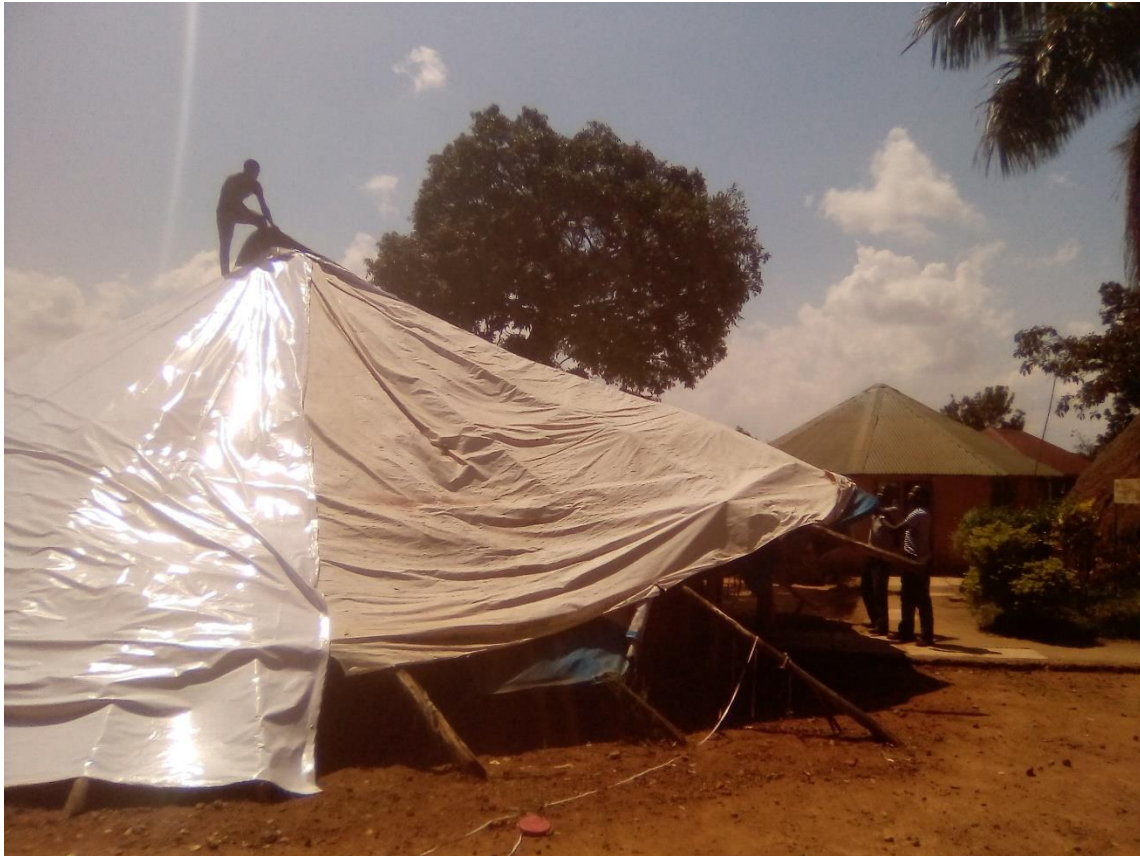
Fixing of the new-tarpulin.

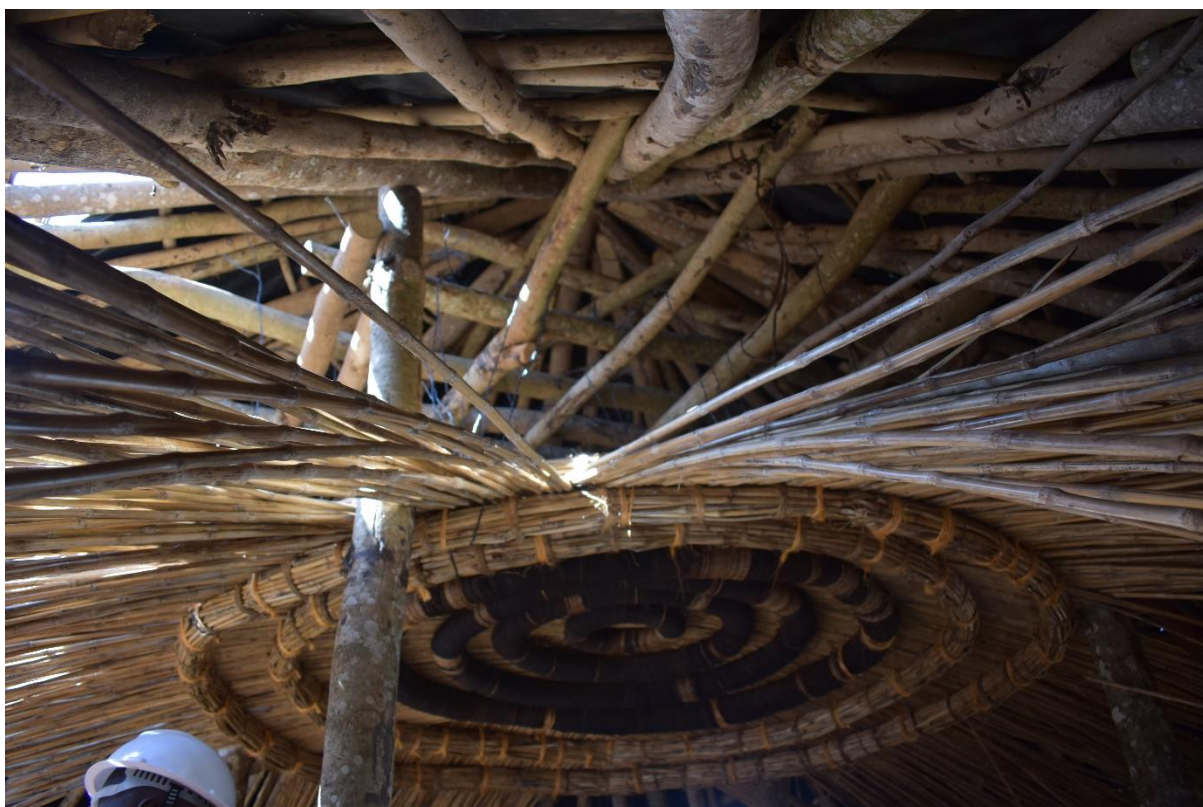
Repairing the worn-out parts of the sacred rings.

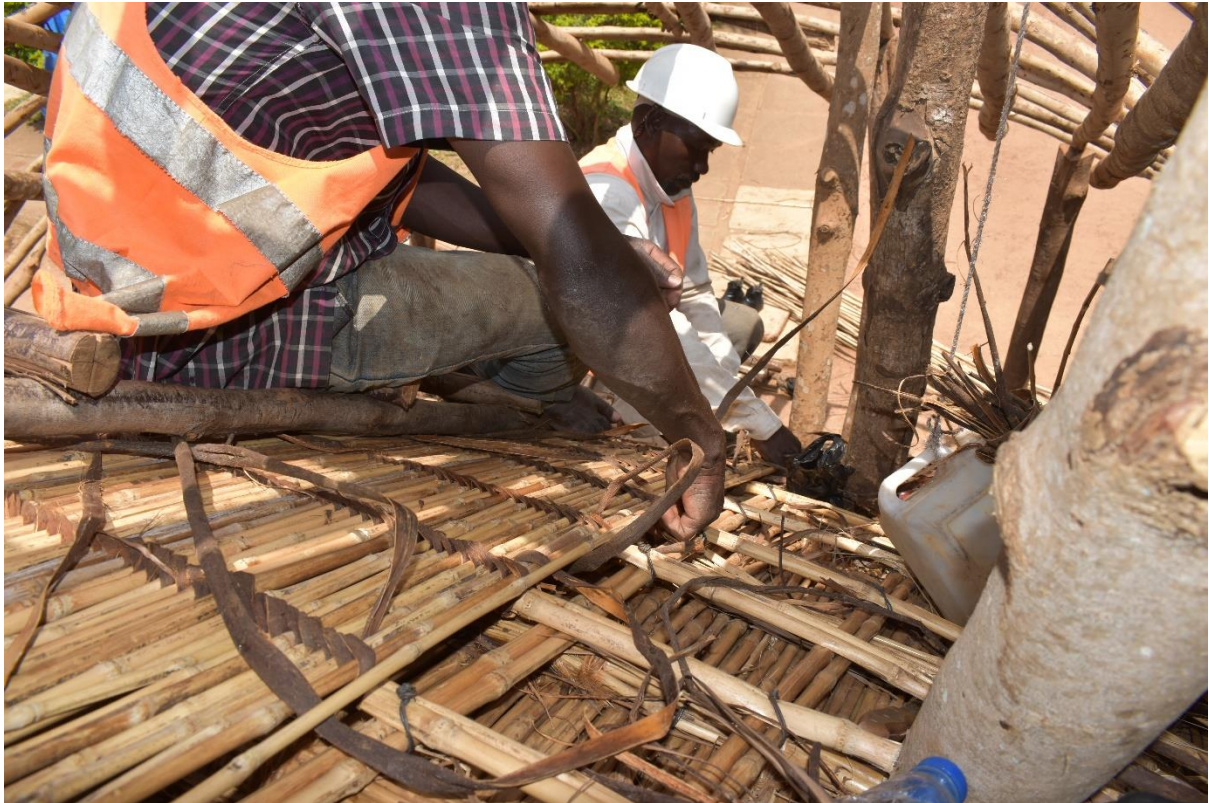
Repairing the existing damaged reeds cladding at the rear entrance of the building.

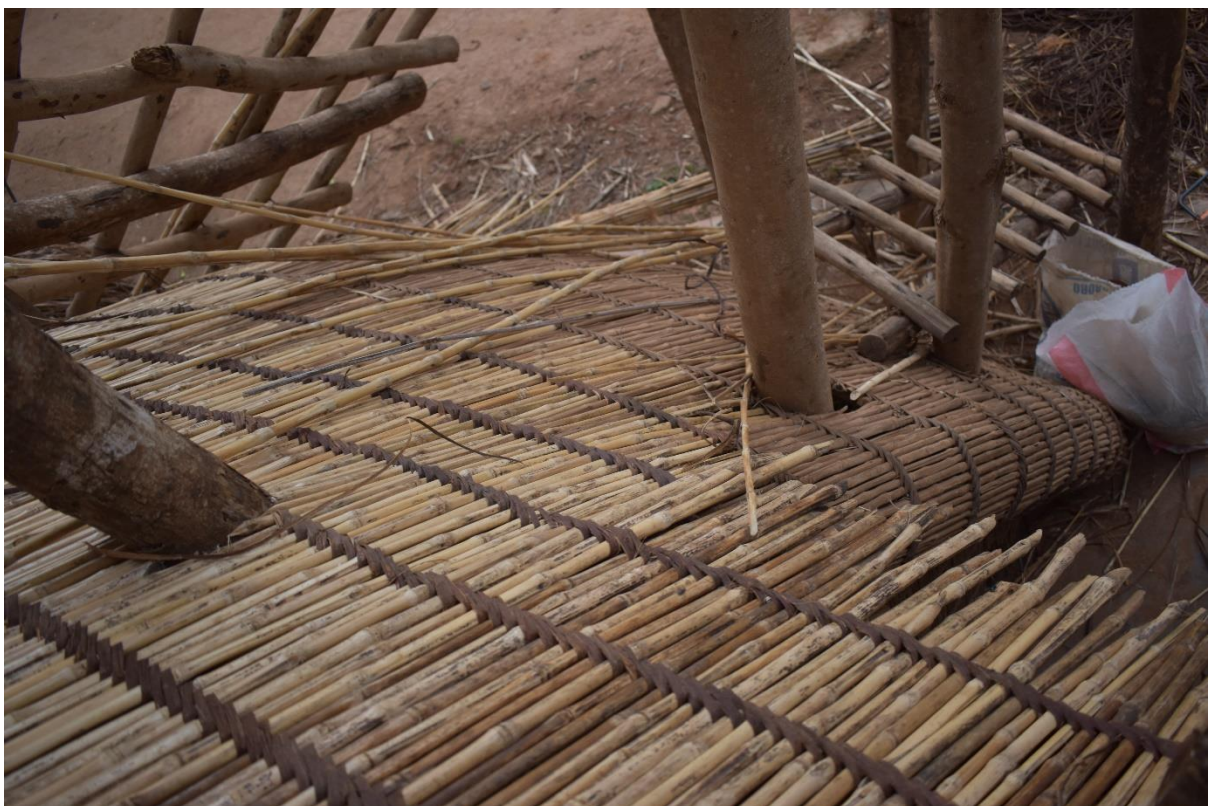
Aerial view of showing the repairing of the existing damaged reeds cladding at the rear entrance of the building.

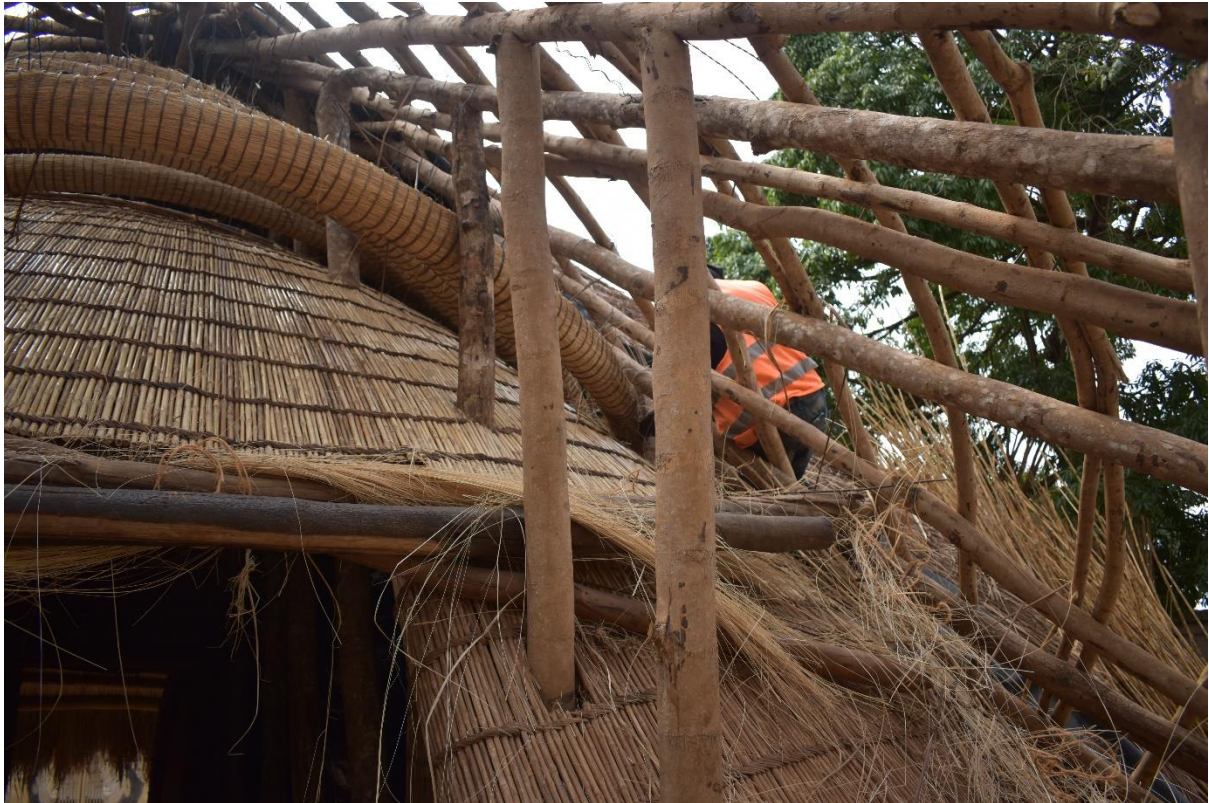
Firmly fixed approved repaired reeds-cladding, in the foreground, with the existing reeds-cladding. in the immediate background, at the rear entrance of the building.

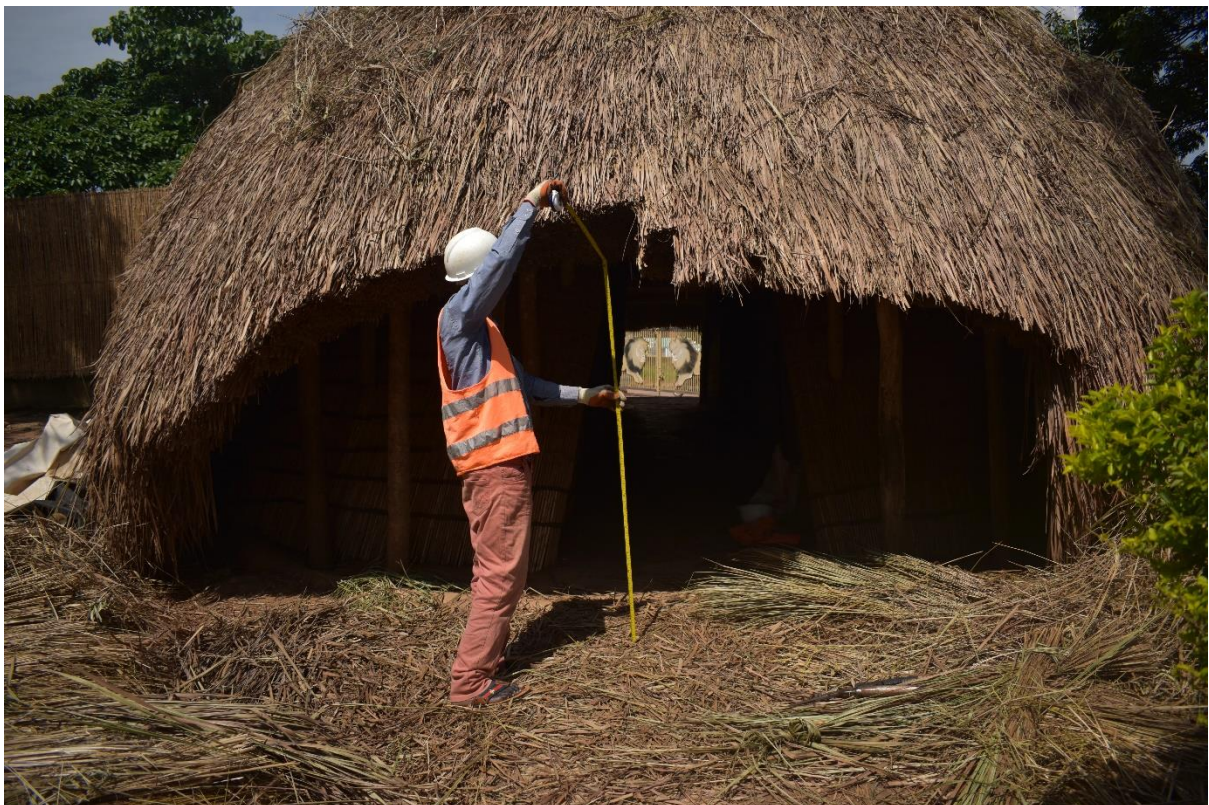
Verification of the trimmed area at the entrance using the provided image of the building taken before any substantial roof repair to this building.

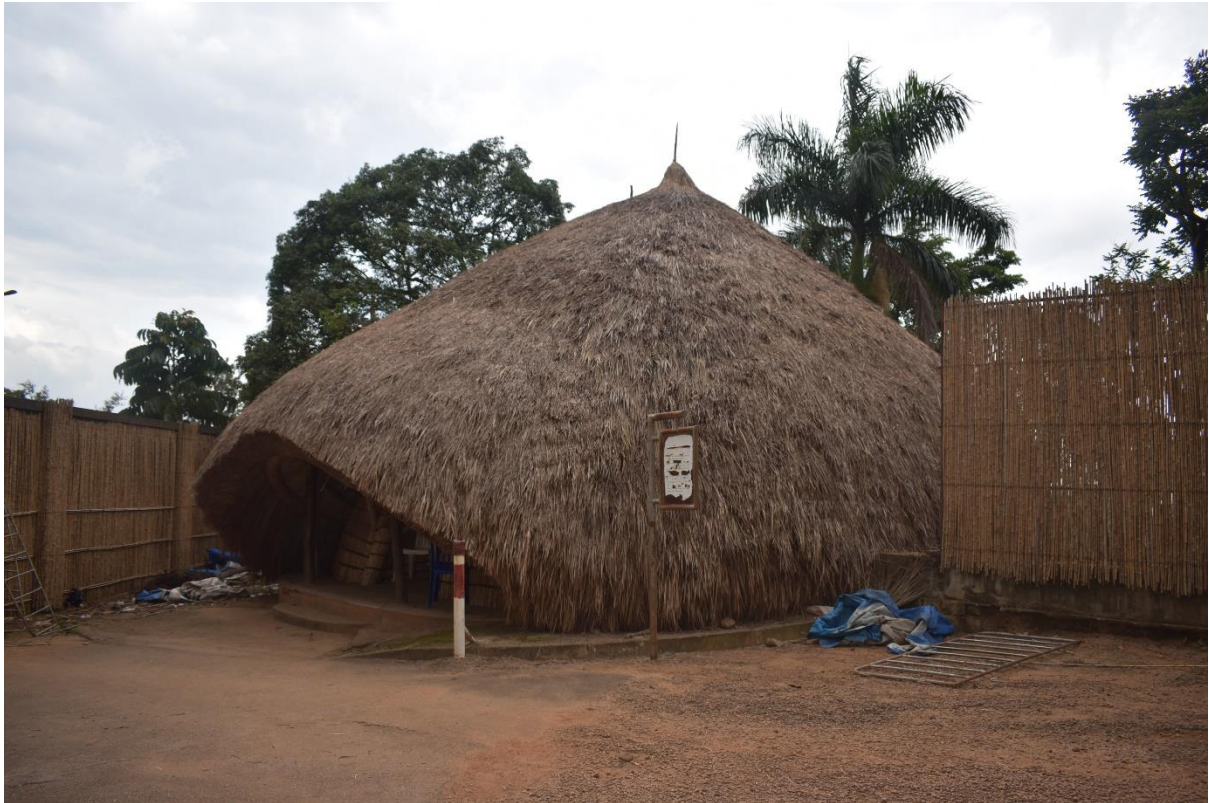
The image showing the appearance of the front side of the firmly thatched Bujjabukula building with the approved repaired reeds-make cladding and the restored Nzingu vertical natural poles.
