**STATE OF CONSERVATION REPORT
HISTORICAL MONUMENTS AT MAKLI, THATTA (PAKISTAN) (C 143)
DECISION: 45 COM 7B.170**

Updated as of December, 2023

Field Mission Report 2022 Monsoon

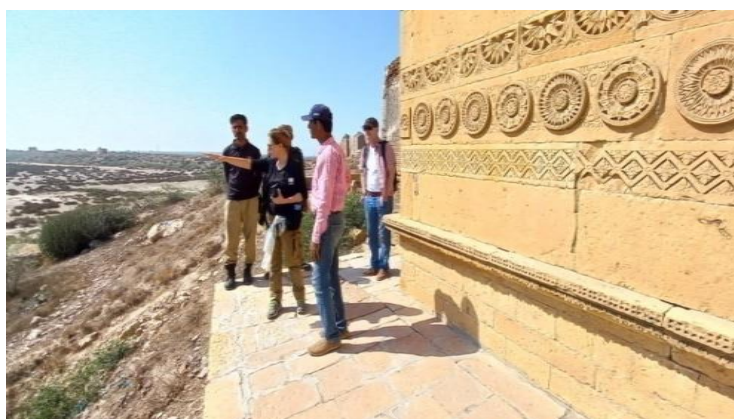
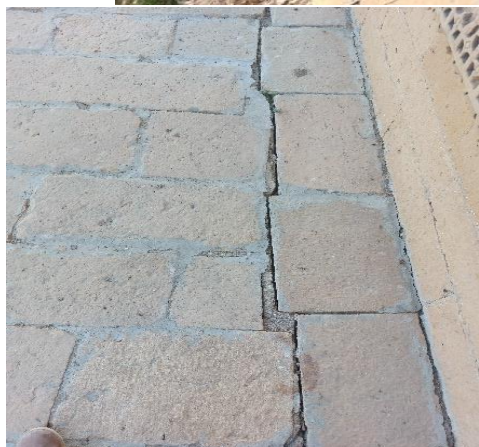
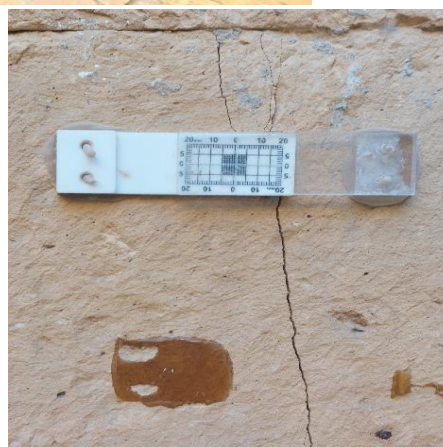
This monumental tomb is at particular risk because it is located at the head of the slope and has been moving due to differential settlement for approximately 100 years. The experts assessed the tomb immediately after the monsoon and determined that it has not suffered significantly during the rains. However, over time it has suffered from cracks and wall distortion caused by rough weathering and erosion of the slope on which it stands. Monsoon torrential rains affected the exterior portion of tomb including the foundation of the structure. During this monsoon, the rainwater penetrated into the foundation and eroded the platform, although this is difficult to measure.

Even though it appears that the monsoon of 2022 did not seriously affect Jam Nizamuddin, a long-term project must be made for the stabilization of the monument immediately, given its significance and contribution to the Outstanding Universal Values of Makli. However, some stabilization work is required on this Monument.

UNESCO assessing the impact of the monsoon on the Tomb of Jam Nizamuddin-II

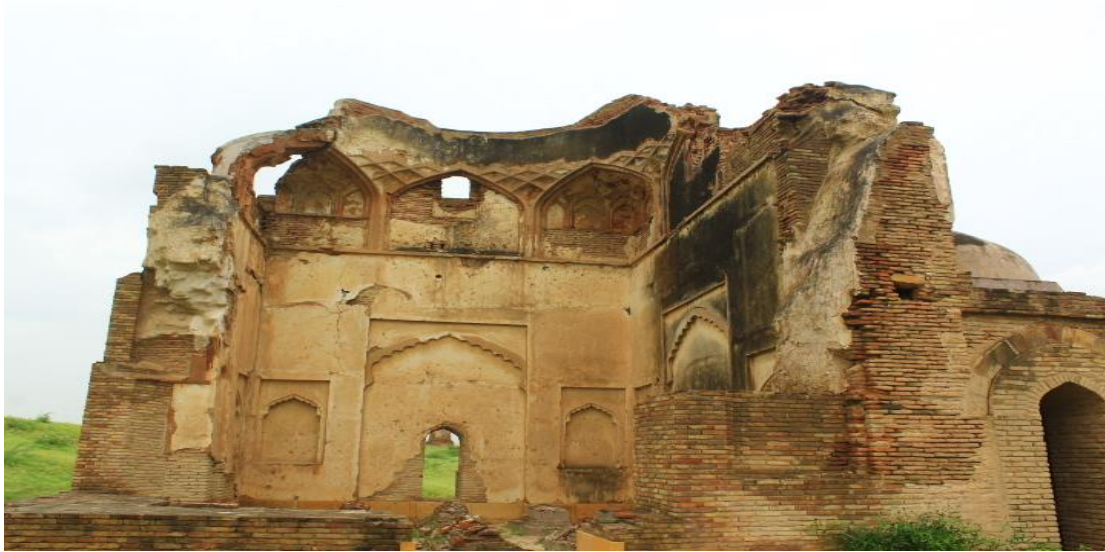
LALI TOMB

The tomb is located at the head of the slope, there has been some erosion that has resulted in structural cracks throughout the remaining monument walls and squinches indicating a continuing differential settlement. The cracks appeared due to the loss of surface plaster as the continuous rains washed the material and entered the masonry. This is understandable as the interior of the main space is exposed to the extremes of weather; it is in an inevitable state of disintegration and total collapse. It is recommended to continue monitoring, inspection of the wall capping, repointing, and eventual re-plaster.

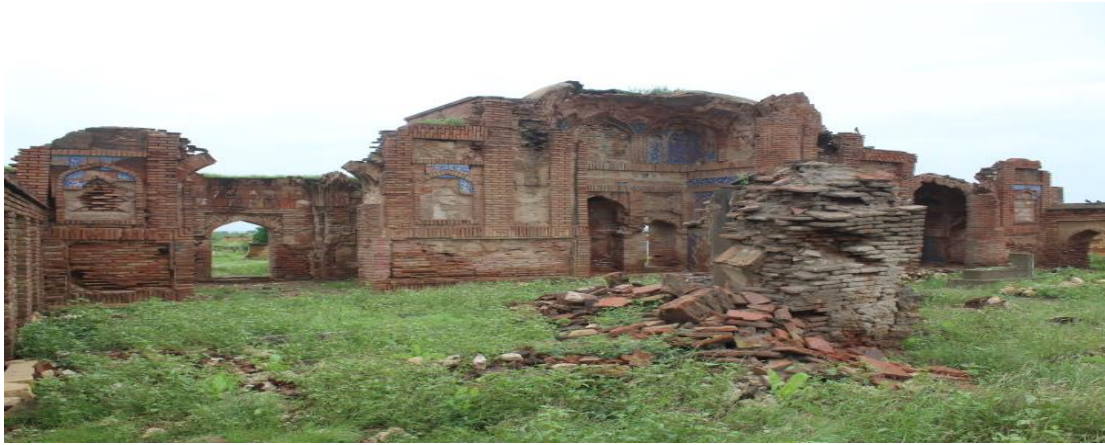
AMEER KHANI GRAVEYARD

This graveyard was not treated before the 2022 monsoon. This complex structure was badly damaged in the monsoon with a portion of the arch from southern side that collapsed and another annexure structure from east northern of the site has been partially damaged. Both structures needed emergency stabilization and restoration work. The emergency works must take place immediately.

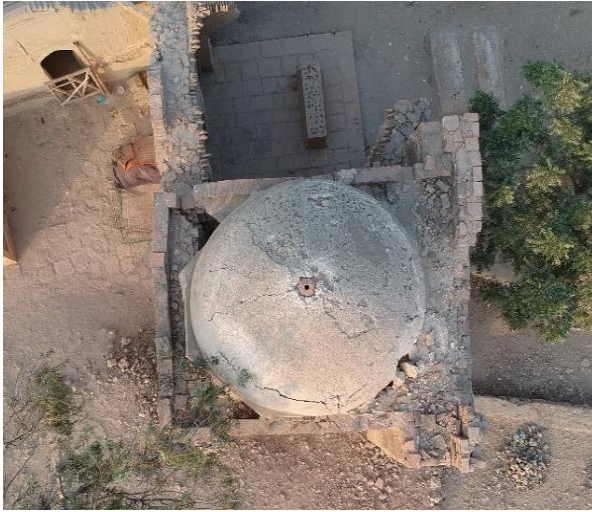
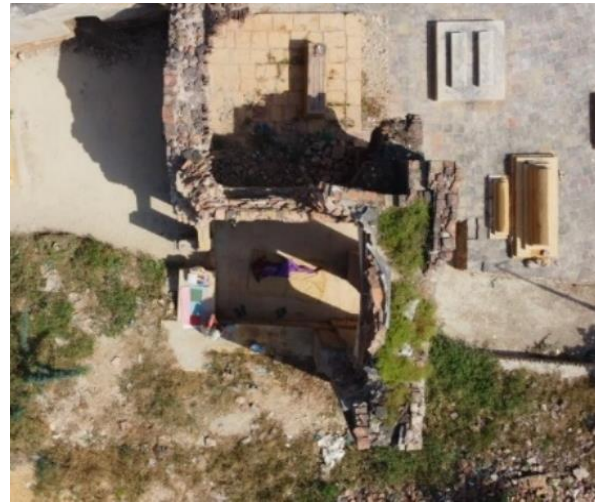
Aerial view of an unknown tomb in 2019 on left side and in 2022 after rains on right side

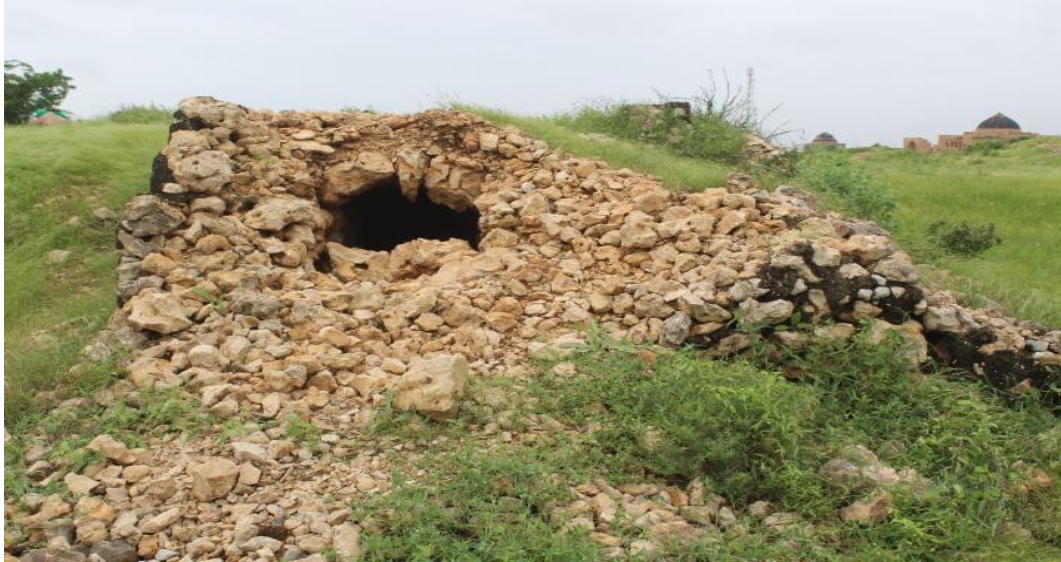
AN UNKNOWN GRAVE DAMAGED

Dozens of rubble stone minor graves have been seriously affected and some of them destroyed during last torrential monsoon rains of 2022. The weathering from erosion and wind exposed the core of the loosely bonded earthen masonry and with the passage of time mortar between stones was eroded and bonding was broken.

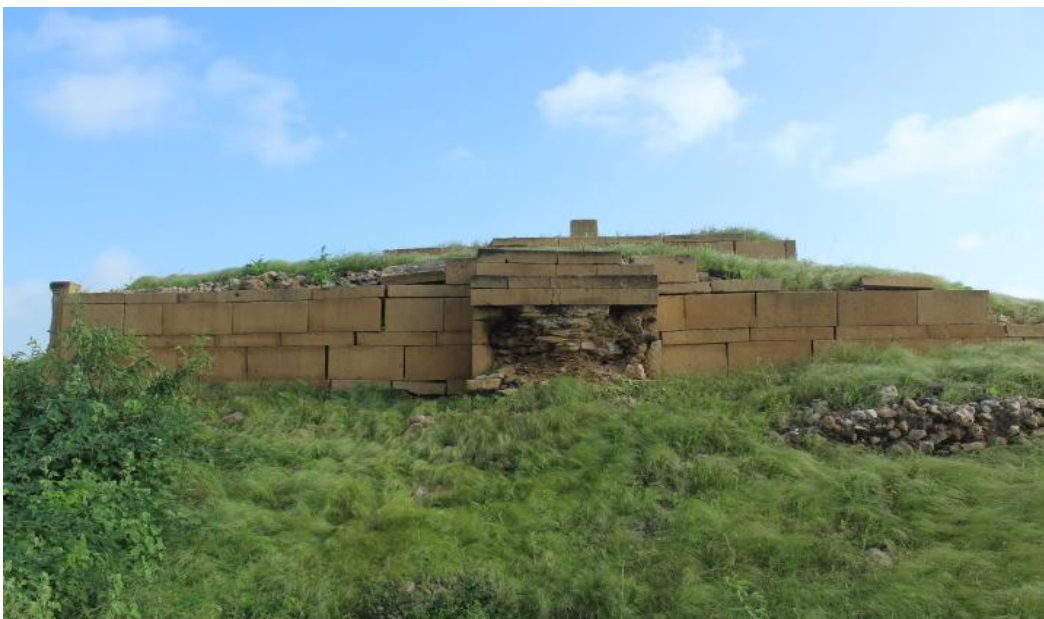
AN UNKNOWN PLATFORM DAMAGED

Several (eight) known and unknown stone slab platform tombs were damaged in rains. Water entered the core of the rubble masonry walls eroding the mortar and this led to a detachment of the facing ashlar stone. This is concerning as it indicates structural deficiencies within the masonry wall, but it is easy to remedy if action is taken before the next monsoon. The masonry must be cleaned, the facing stone saved and replaced. Lime mortar grouting should be tested in the weak rubble core taking care not to have any visible from the outside.

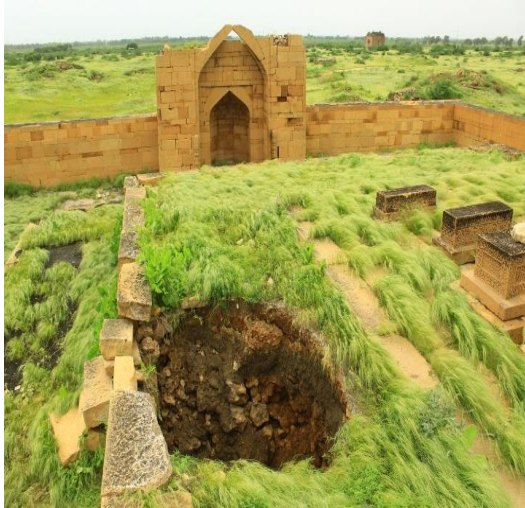
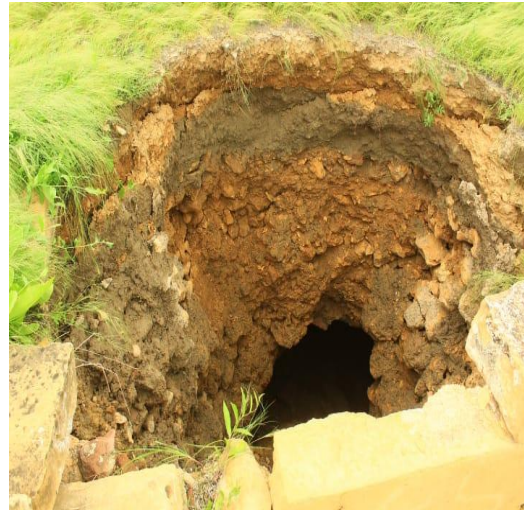
FAMILY ENCLAVE OF MIRZA ISSA KHAN TARKHAN-I

The early 16th century family enclosure of Issa Khan Tarkhan I suffered a collapse of the tomb platform. Loss of mortar in the masonry vault led to the detachment of bricks and failure of the vault leading to a collapse. This contributed to the extreme degradation of the monument. This also led to loss of the surrounding masonry wall and massive loss of the finish stone. During the heavy monsoon of 2022 southern side of raised platform was seriously damaged which needed more attention and emergency stabilization to avoid additional damage.

Rainwater penetrated inside the foundation and weakened the brick subsurface structure

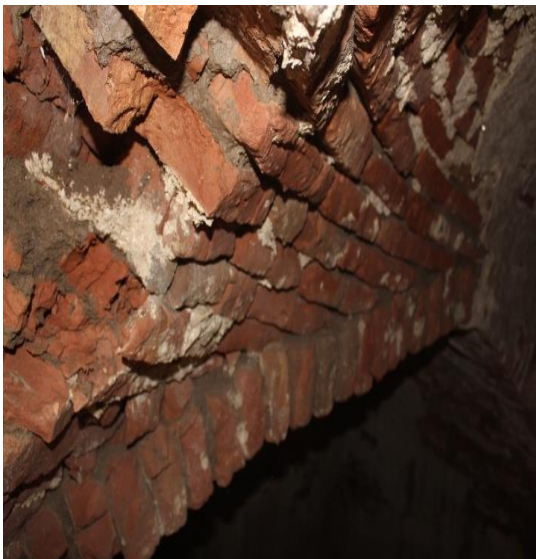
The experts while assessing the rain damages at this enclave highlighted that if immediate measures are not taken, the platform will suffer more damages because the foundation of structure has been badly damaged due to penetration of rainwater. The platform requires conservation work in order to help conserve the structure. Emergency works were undertaken and the brick vaults secured, but more work is needed. This is a similar case with all other platform tombs.

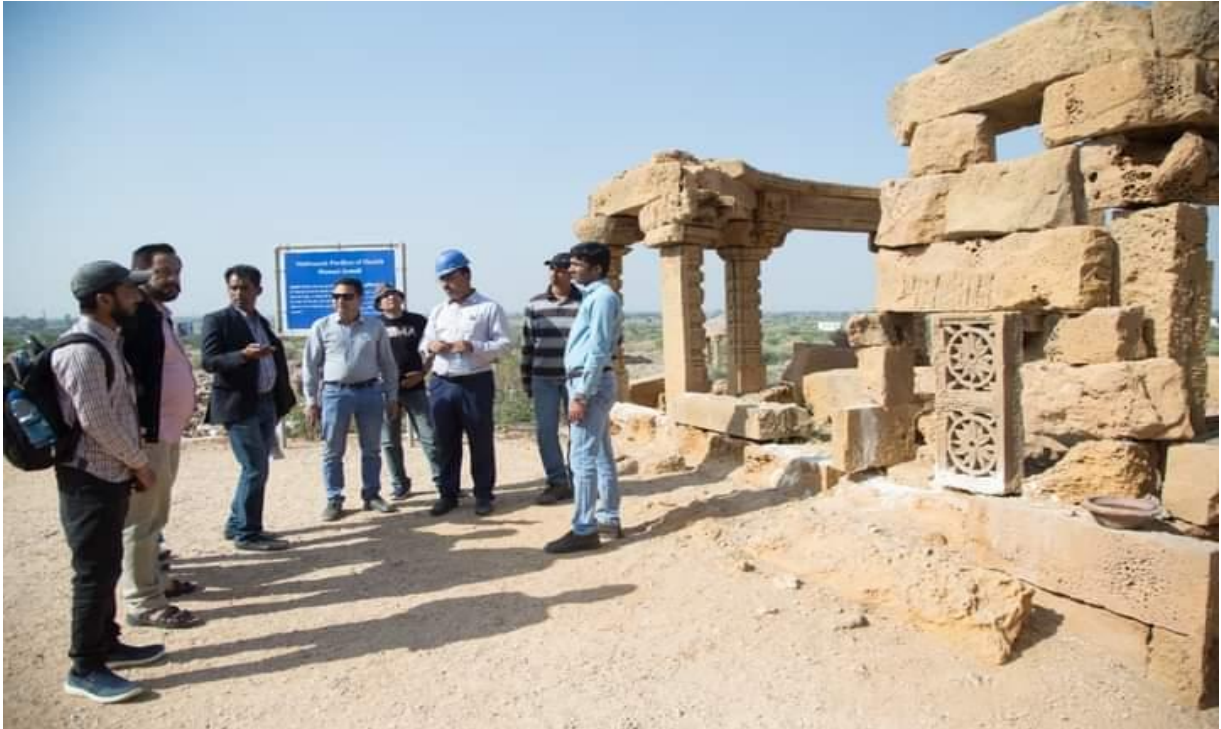
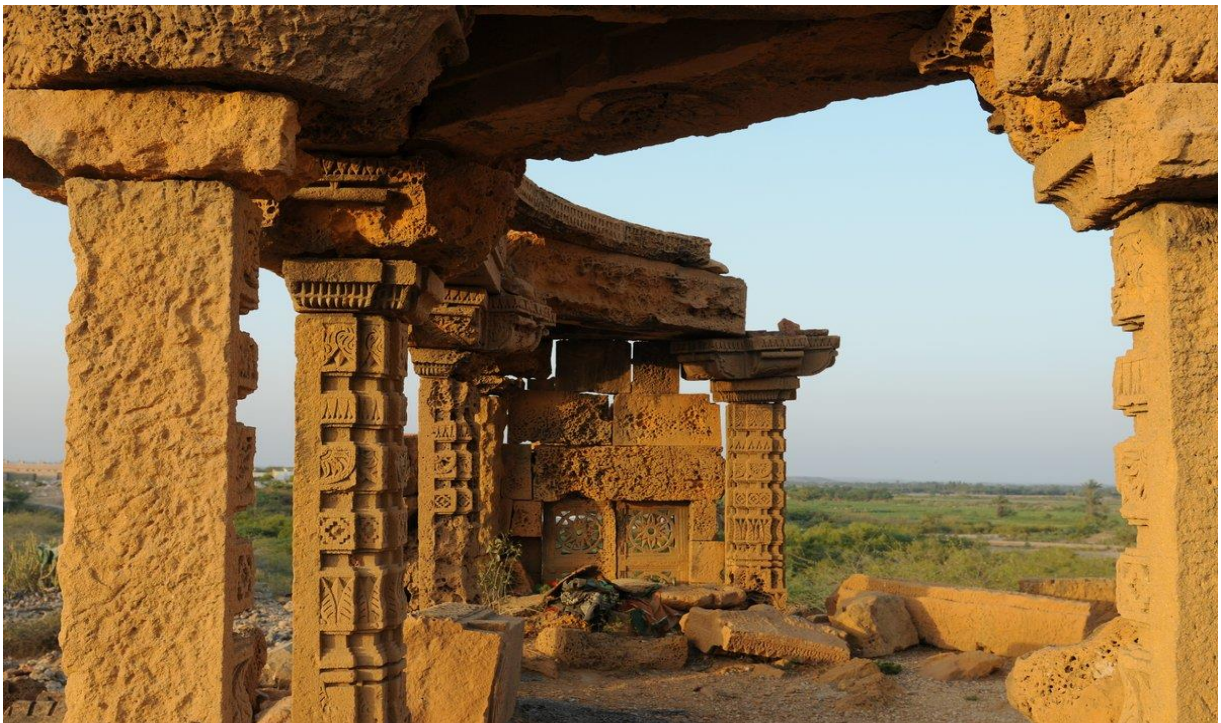
The Khanqah of Hamad Jamali lies in the north of Jam Nizam's Tomb. Presently, only a portion of the Mehrab is left. Due to rains, the sides of structure have collapsed with only limited surviving portions.

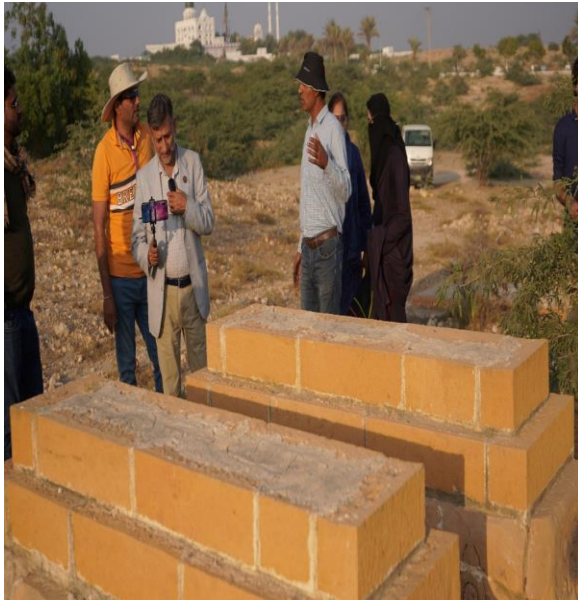
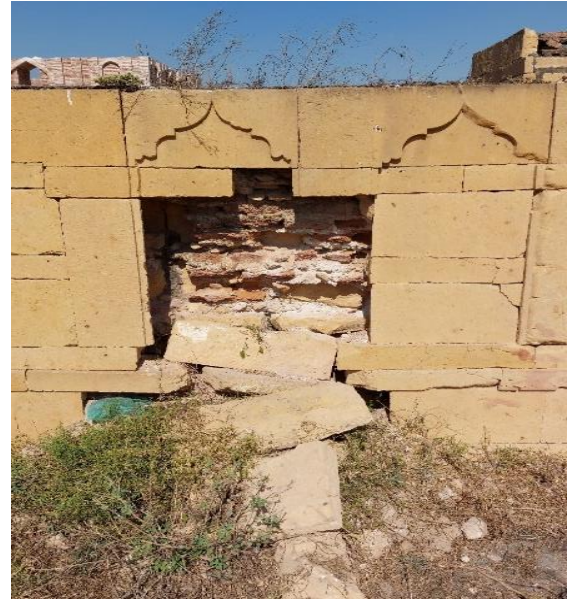
MUGHAL CLUSTER & SAMMA CLUSTER

The monumental tombs at both of these clusters suffered minor damages while the minor graves in these clusters were badly affected during heavy rains. The rain water entered the core of the wall and detached the facing stone causing a partial collapse and deterioration of the graves. This was particularly evident in the tombs with an decorative enclosure wall constructed of rubble masonry with stone facing. It was impossible to know the status of the interior of the walls prior to the monsoon. These must be repaired as soon as possible to avoid further loss in the upcoming monsoon season.

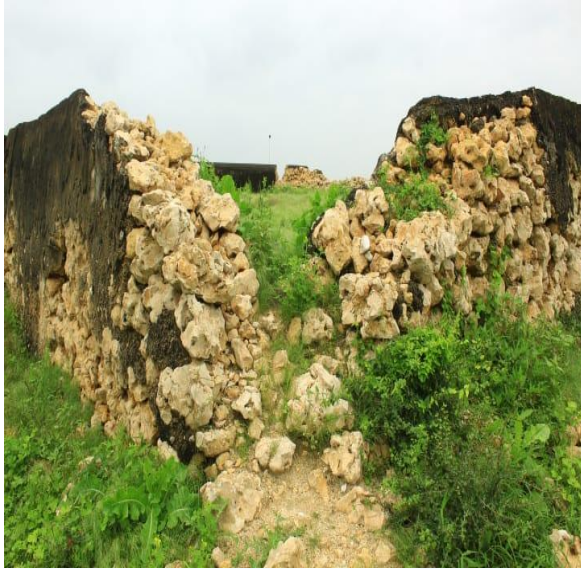
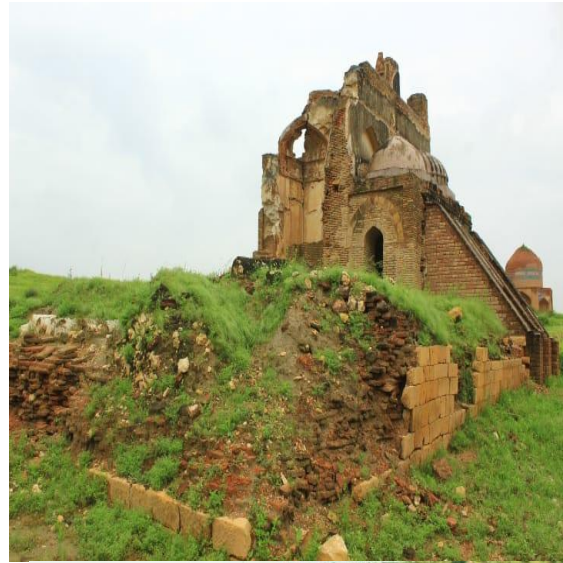
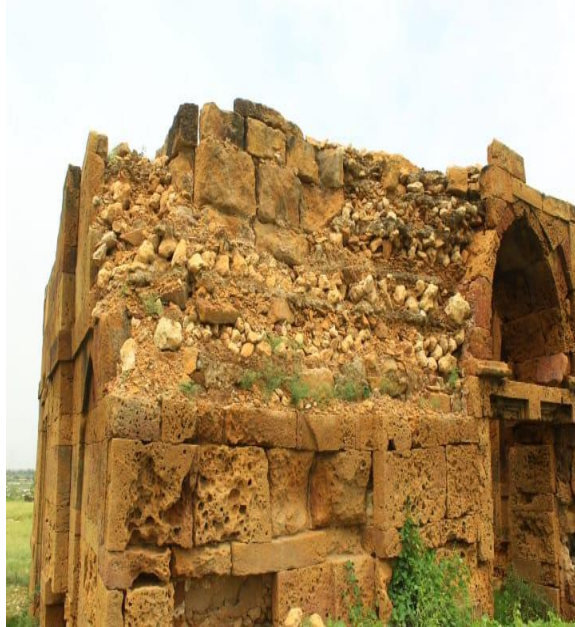
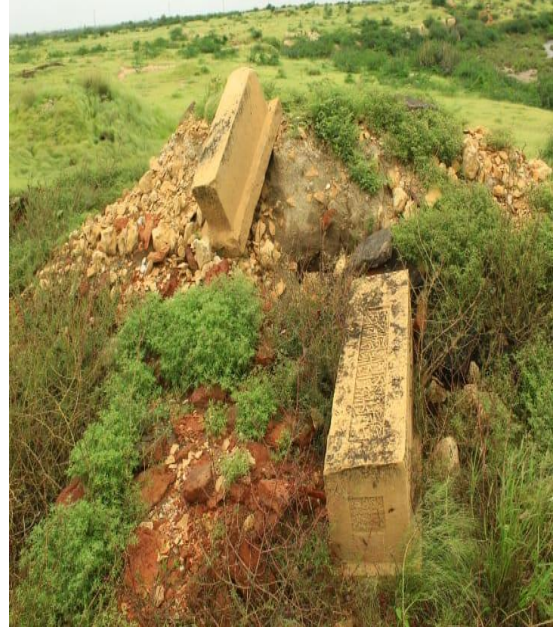
IMAGE SHOWING WILD GROWTH OF GRASS AFTER RAINS

Not only heavy rains and flooding affected the tombs, graves, platforms, and canopies of Makli Necropolis but also the subsequent wild growth of unwanted grass. This was because of two distinct impacts.

The experts suggested eradicating the unwanted grass in such a way that the tombs are not affected during removal of grass. The roots of grass badly affect the base and foundation of monuments, which is dangerous for monuments if not removed while the plants are young and roots have not penetrated deeply into the masonry.

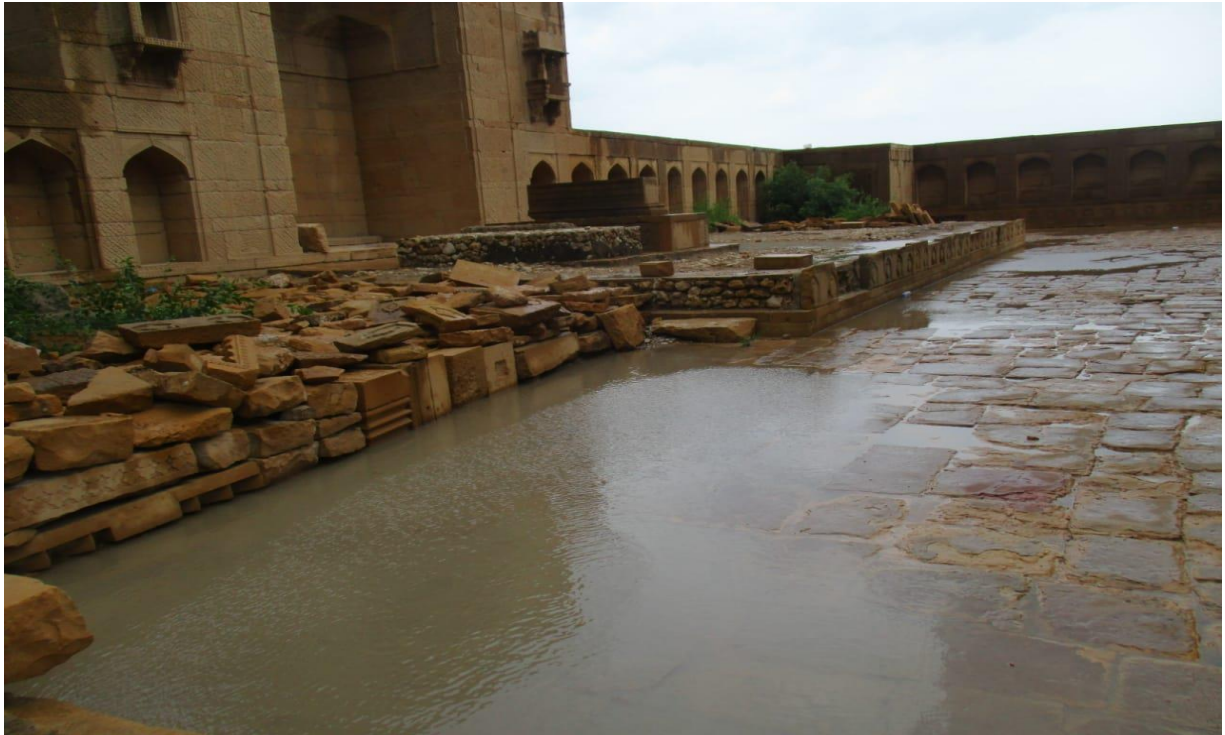
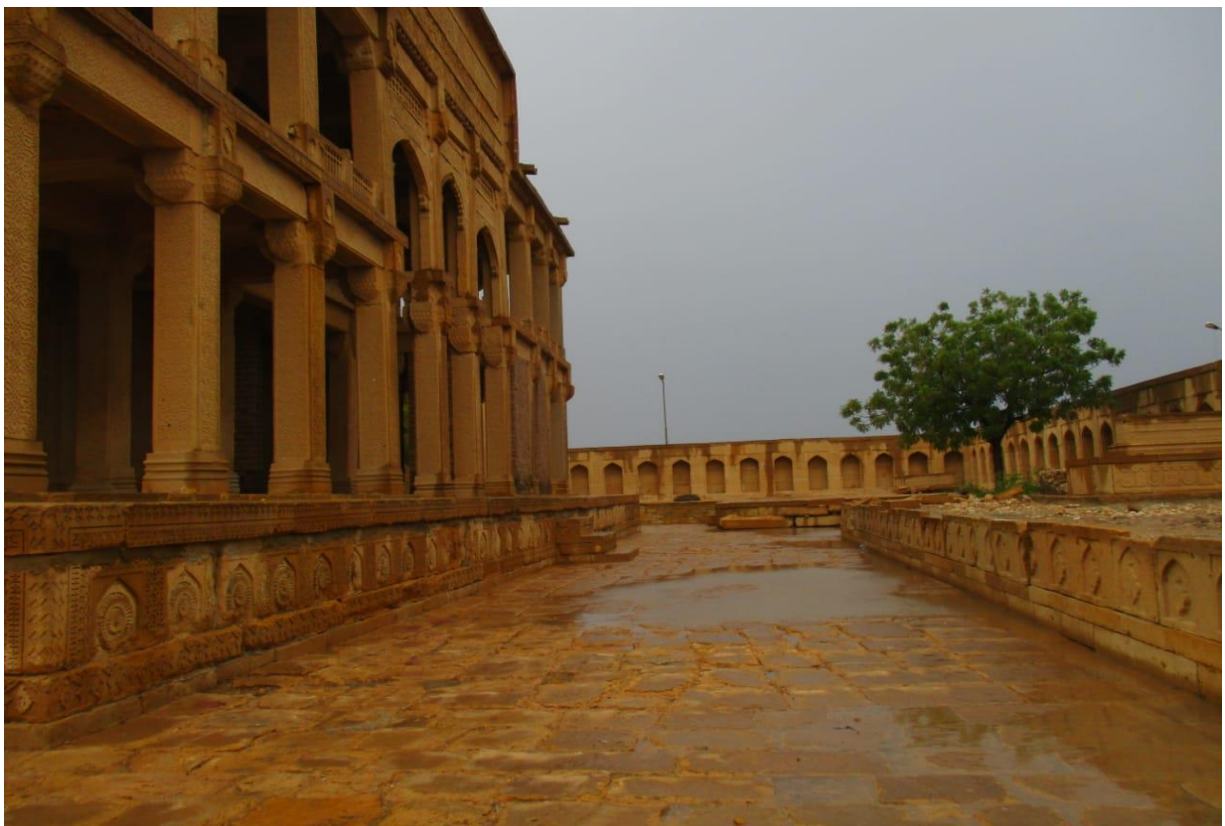
PICTURES OF NEW PAVING IN THE AREA OF MAUSOLEUM OF ISA KHAN TARKHAN-II

If the new pavement had not been provided the rainwater would have penetrated into the foundation of mausoleum and resulted in more damage to this significant structure.

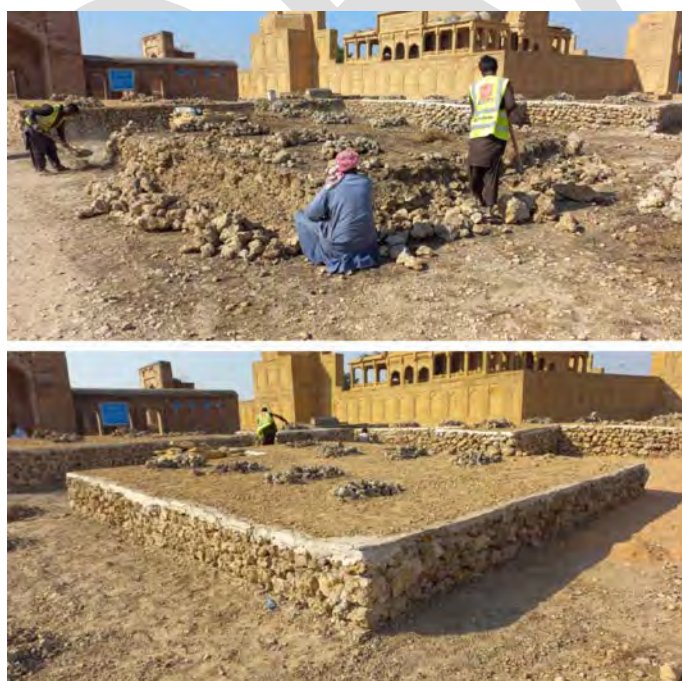
Figure 3 Restoration of a rubble masonry platform tomb near the monumental tomb of Isa Khan II that was damaged in the monsoon. Above, before, below after (Serfraz Nawaz)

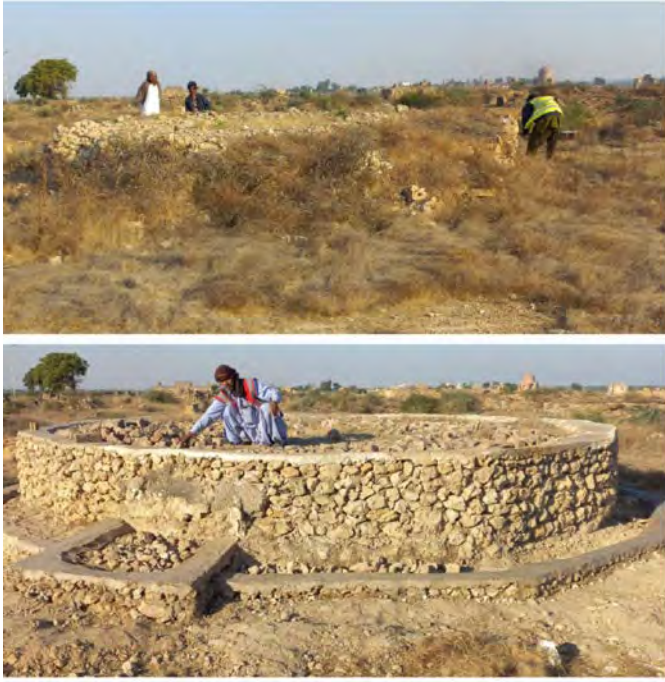
Figure 4 Restoration of an octagonal rubble masonry platform tomb just off the main road that was damaged in the monsoon. Above, before, below after (Serfraz Nawaz)

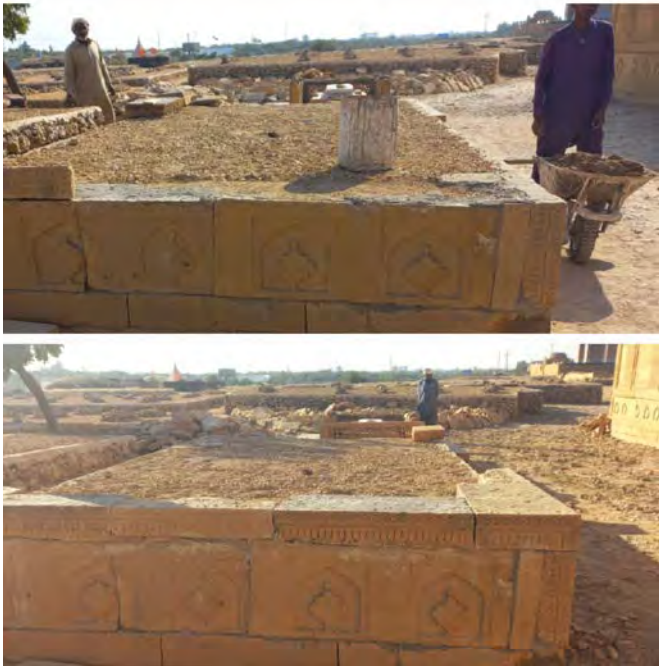
Figure 5 Restoration of a cut stone platform tomb near the monumental tomb of Isa Khan II that was damaged in the monsoon. Above, before, below after (Serfraz Nawaz)

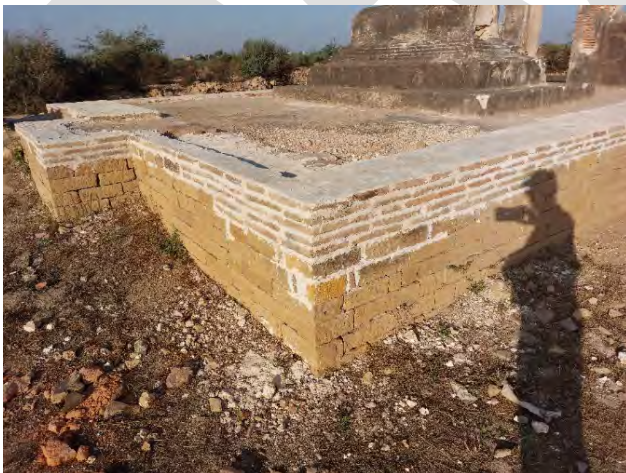
Figure 10 The work is generally well executed, with the correct materials, lime mortar created on site and the original bricks, or replacement bricks of the same dimensions and composition. However, the mortar could be colored to better blend in with the age-value patina of the lower masonry courses. This is a small detail, as time will add to the patina.

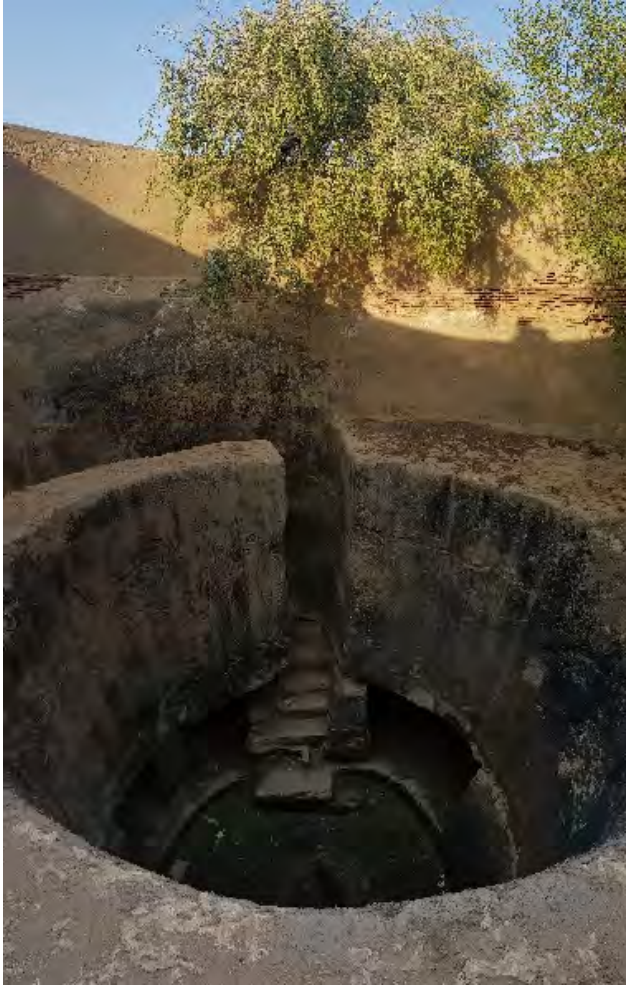
Figure 11 The impressive step well at the south of the site has been cleaned and can be used as a natural drainage. However, the historic channels leading into the well must be carefully investigated (Eppich)

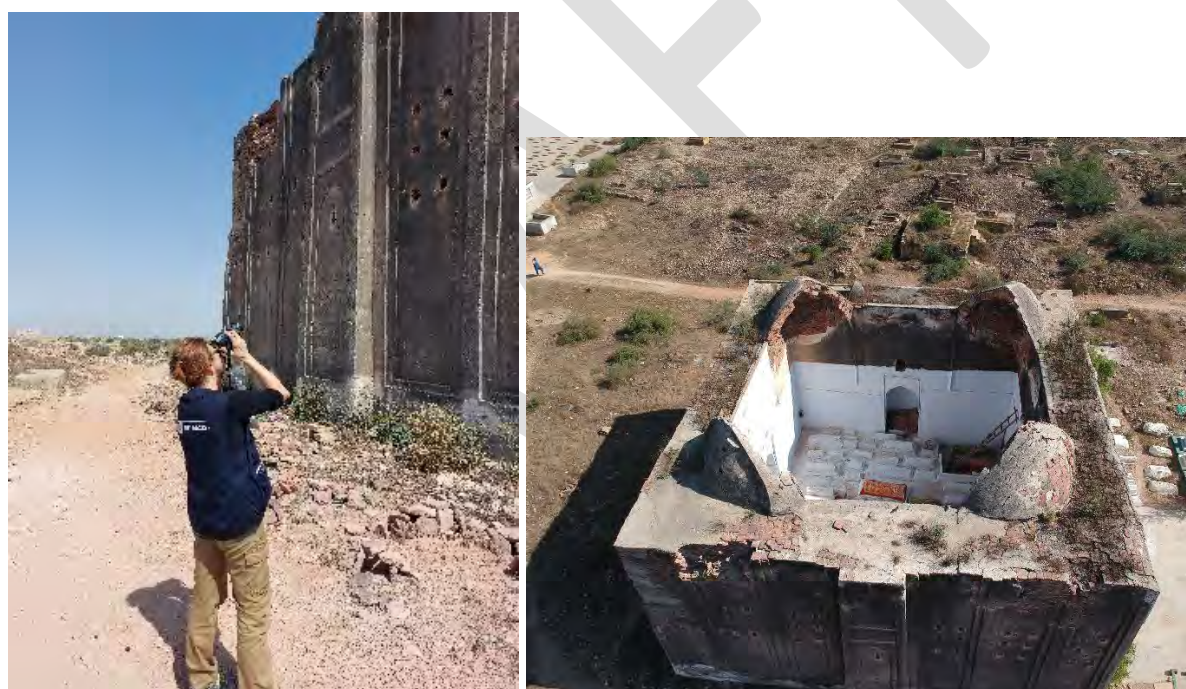
The inspection began at the monumental tomb of Shiek Jeo, which is an active shrine. This tomb was severely impacted by the monsoon, but it is easy to dismiss the impacts given its large size and durability. The effects of the monsoon were exacerbated by numerous modern interventions, including the concrete slap to the south, impermeable materials in the interior (tile and concrete), and the application of portland cement mortar at its base. The impacts of the heavy rains and flooding also increased due to the archaeological ruin of the enclosure wall and the popularity of the shrine that has compacted the soil around the tomb. Finally, its sheer mass prevents easy access to the upper levels of masonry, and the masonry capping are in poor condition. Shiek Jeo has never been worked on before by the Directorate.

Figure 12 Inspection of Shiek Jeo. This significant tomb was damaged in the monsoon and is of a sensitive nature as it has a permanent caretaker and is an active shrine that is heavily used several times per year. Left, UNESCO expert Christina Menegazzi inspects the loss at the top of the wall. This is evident from the drone photo in the right image. There is also damage at the base from inappropriate portland cement patches in the plaster and the retention of water at the base of the wall due to the remains of the boundary wall.

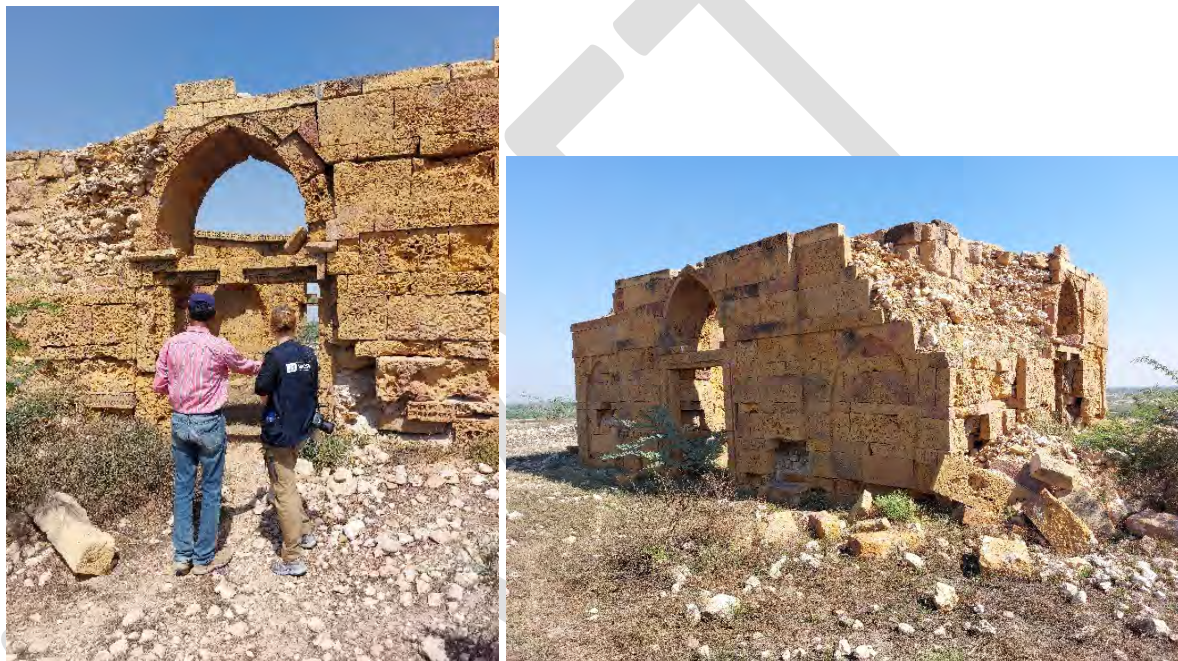
To the northeast of Shiek Jeo, there is an unknown tomb that suffered significant damage from the monsoon. Unlike Shiek Jeo, it is not as massive and is at serious risk of collapse. Water had penetrated the masonry interior, the large facing ashlar had detached, and three of the four arches were in danger of imminent collapse. This is a unique tomb because it is a hybrid of the existing typologies; it is not an enclosure tomb as its boundary walls are significantly higher, yet it is also not a monumental tomb and was not originally designed to hold a dome. While not massive or monumental as other tombs, it contributes to the overall site and must be addressed. During this project, more research must be conducted. All of the ashlar and rubble masonry are still on site, so this is mainly a process of anastylosis and consolidation. Finally, a new trail should be constructed that would bring visitors to this tomb and raise awareness of its unique typology. This tomb has never been worked on before by the Directorate but was identified in 2017 as vulnerable.

Figure 13 small unknown tomb northeast of Shiek Jeo. This is a high priority given its poor condition and uniqueness (Eppich).

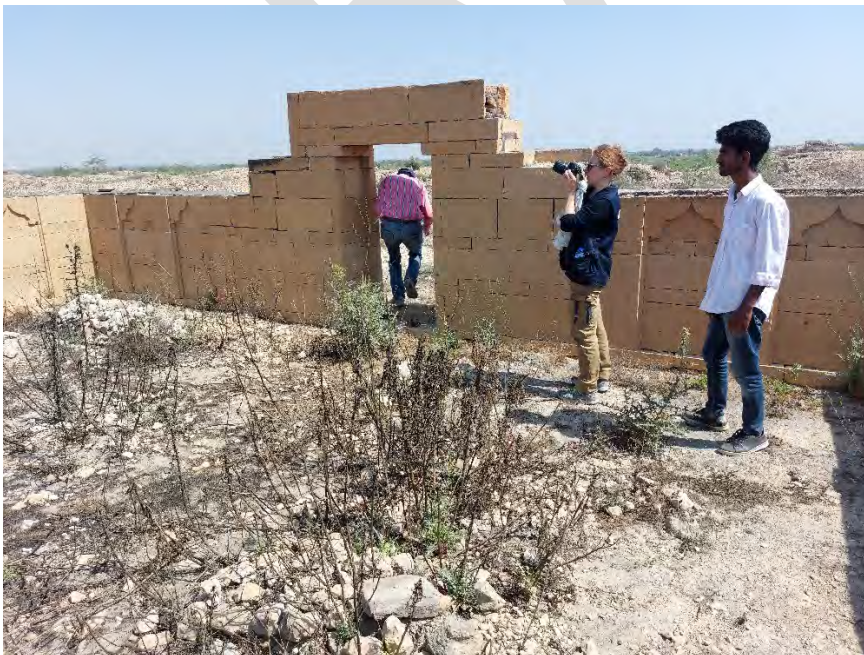
Figure 16 Unknown enclosure tomb inspection. While the damages are not major, without addressing these smaller losses, the enclosure wall will eventually collapse. In addition, the tombs must be investigated for underground vaults (Eppich).

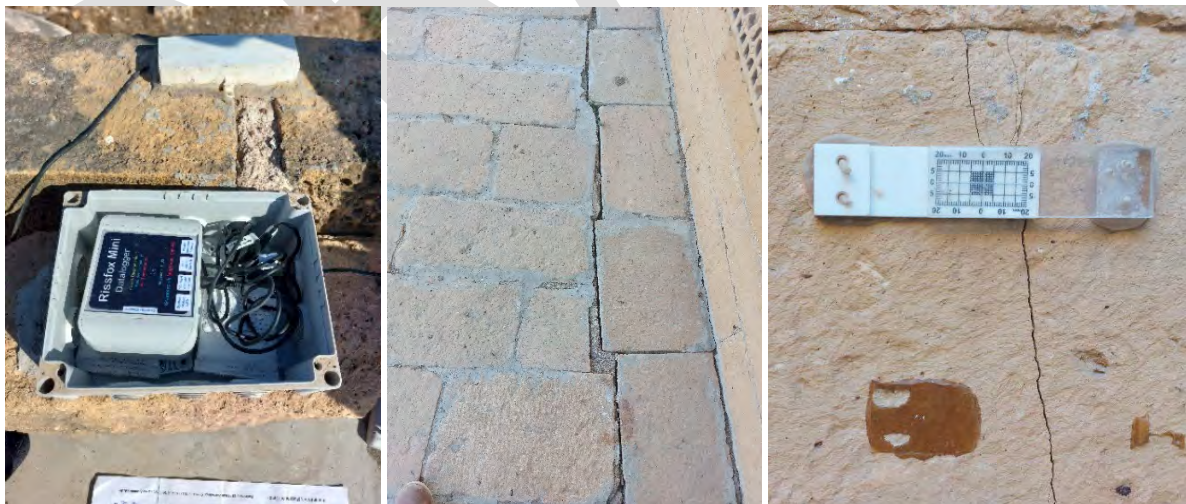
Figure 20 Left, the crack monitor, center the crack at the exterior base at the head of the slope, and a sketch of how water will enter this crack and erode the underlying soil. Figure 21 Right, polycarbonate crack monitors installed by Engineer Beckh were observed and showed a 1mm movement, but this was after the 2018 monsoon. Unfortunately, many crack monitors were lost (see below and right) and must be reinstalled for continued monitoring (Eppich).

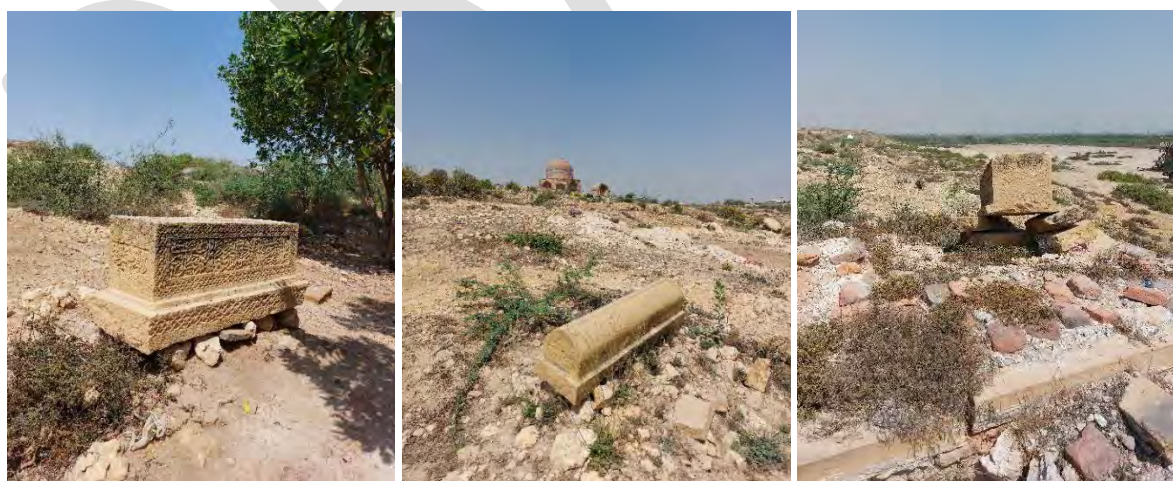
Figure 25 Other small unknown tombs that have been displaced by the monsoon. Most are constructed without mortar on rubble masonry platforms. Fortunately, the masonry platforms can be restored, and the markers reassembled anastylosis. Right, there are other damages, such as the erosion of the platforms that expose the graves below (Eppich).

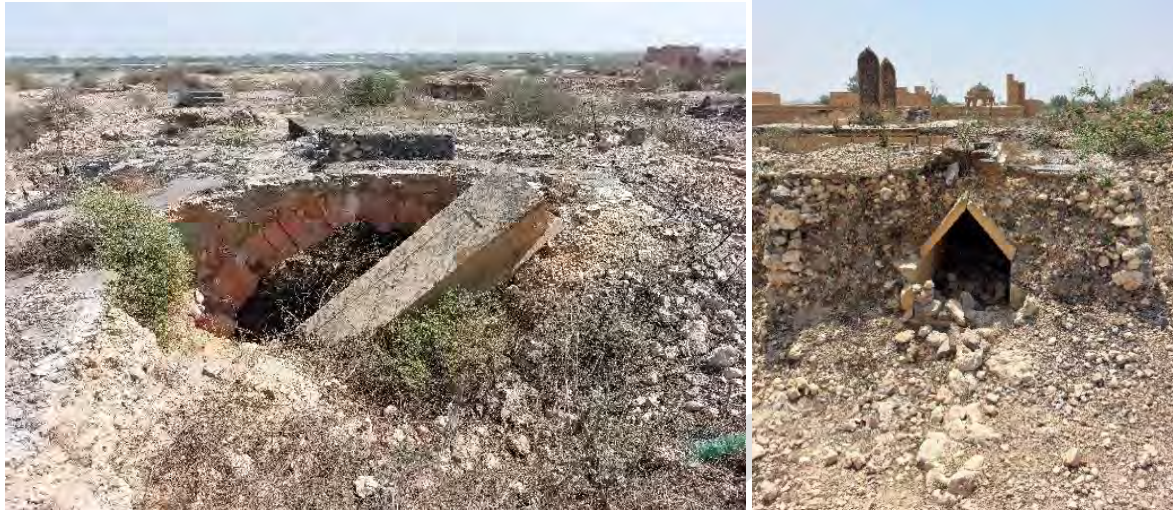
Figure 26 Other damages include the erosion of the platforms that expose the vaults of the tombs below.

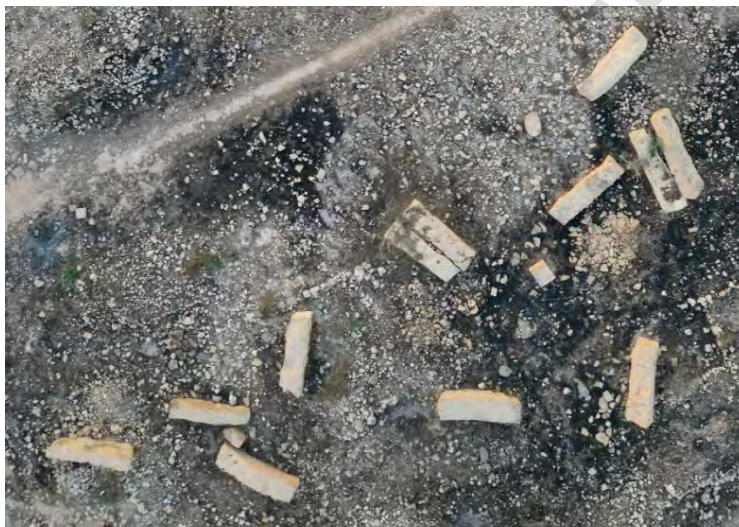
Figure 27 An aerial image of displaced elements near the Mongul Cluster after the fire burned the vegetation that was nourished by the monsoon. Now it is especially important to address these smaller elements as there is less vegetation, and easier to work on (Daud Jatoi).

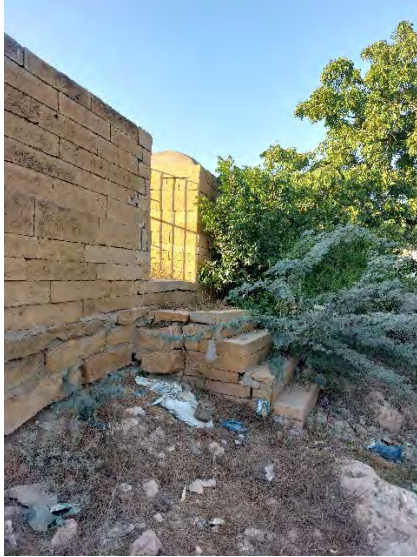
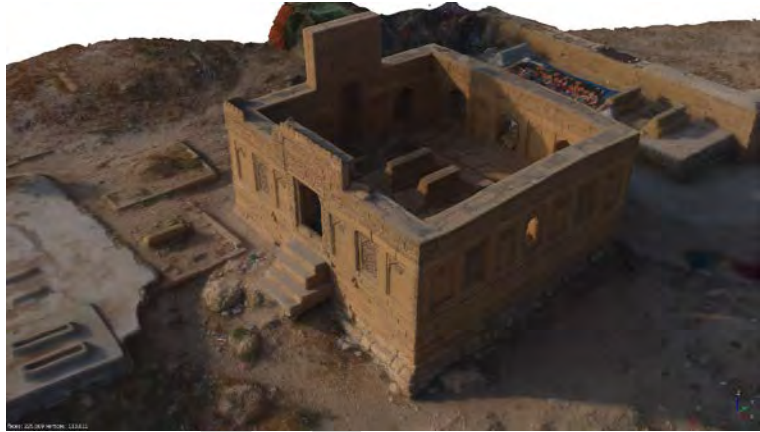
Figure 28 Continued erosion of the access steps and eastern boundary wall of the enclosure tomb of Badi Uz Zamman Tarkhan, left. Right, a 3D model was created of the enclosure tomb of Amir Habshad Bai to document the erosion.

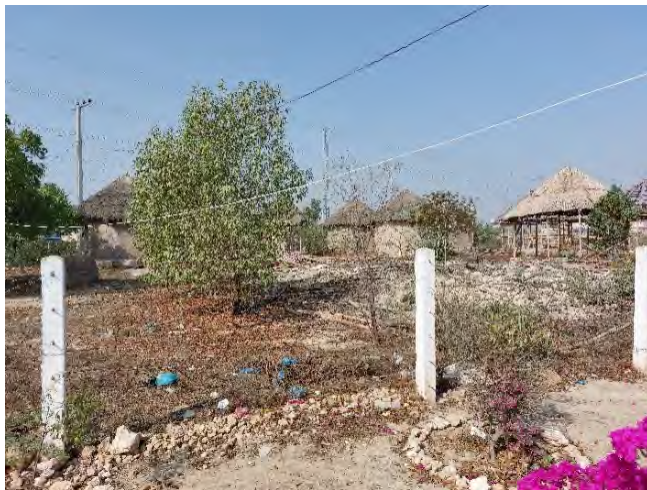
Figure 32 The workshop, offices, and demonstration space of the Pakistan Heritage Foundation, constructed of bamboo and earth, collapsed during the monsoon and created an unsightly entry for V.I.P.s. The debris should be cleaned, the remaining structures removed, and the site made presentable.

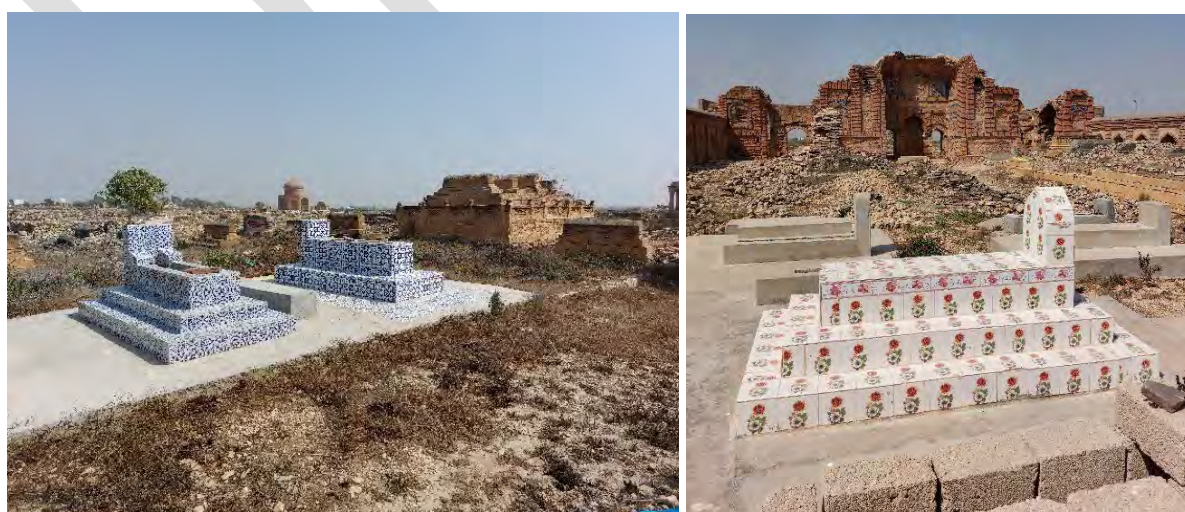
Figure 41 New burials are abundant near the eastern edge of the site and use modern materials, many near historic monumental tombs. Some dates on the graves are from the past 2-5 years.
