**Mission report** on the preparation of the reconstruction of

# Muzibu-Azaala-Mpanga Tombs of Buganda Kings at Kasubi

A World Heritage property of Uganda

#### A World Heritage property of Uganda (C 1022)

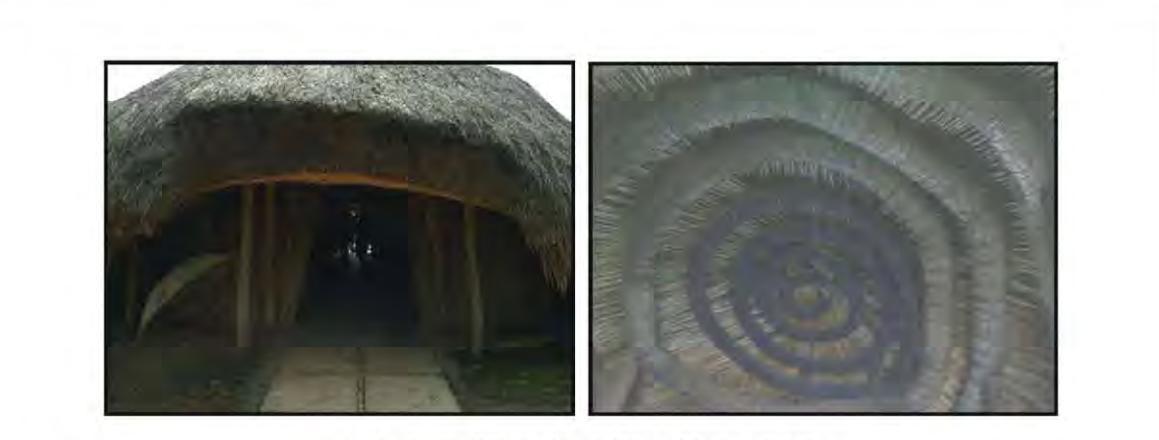
The door to this guardhouse, which is also the barrier between the exterior and the interior of this site, is in extremely poor state. It is broken into half and can barely be referred to as a door.

Fig 2: images showing the condition of the Bujjabukula

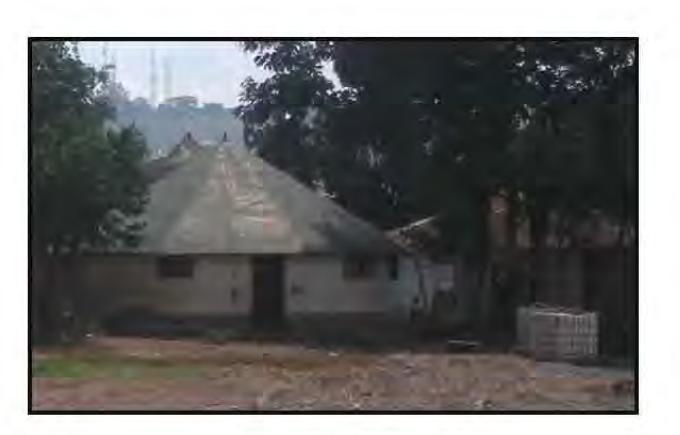
Similar to the other modern buildings earlier mentioned, Gazimbe is rectangular, built with modern materials, rather than traditional. The roof is at a lower angle/gentler slope than the previous buildings, proving to have more leakage problems. Electricity points point out on the exterior wall, next to the entrance, raising a matter of concern for the safety of the residents.

Fig. 7b 'Gazimbe'

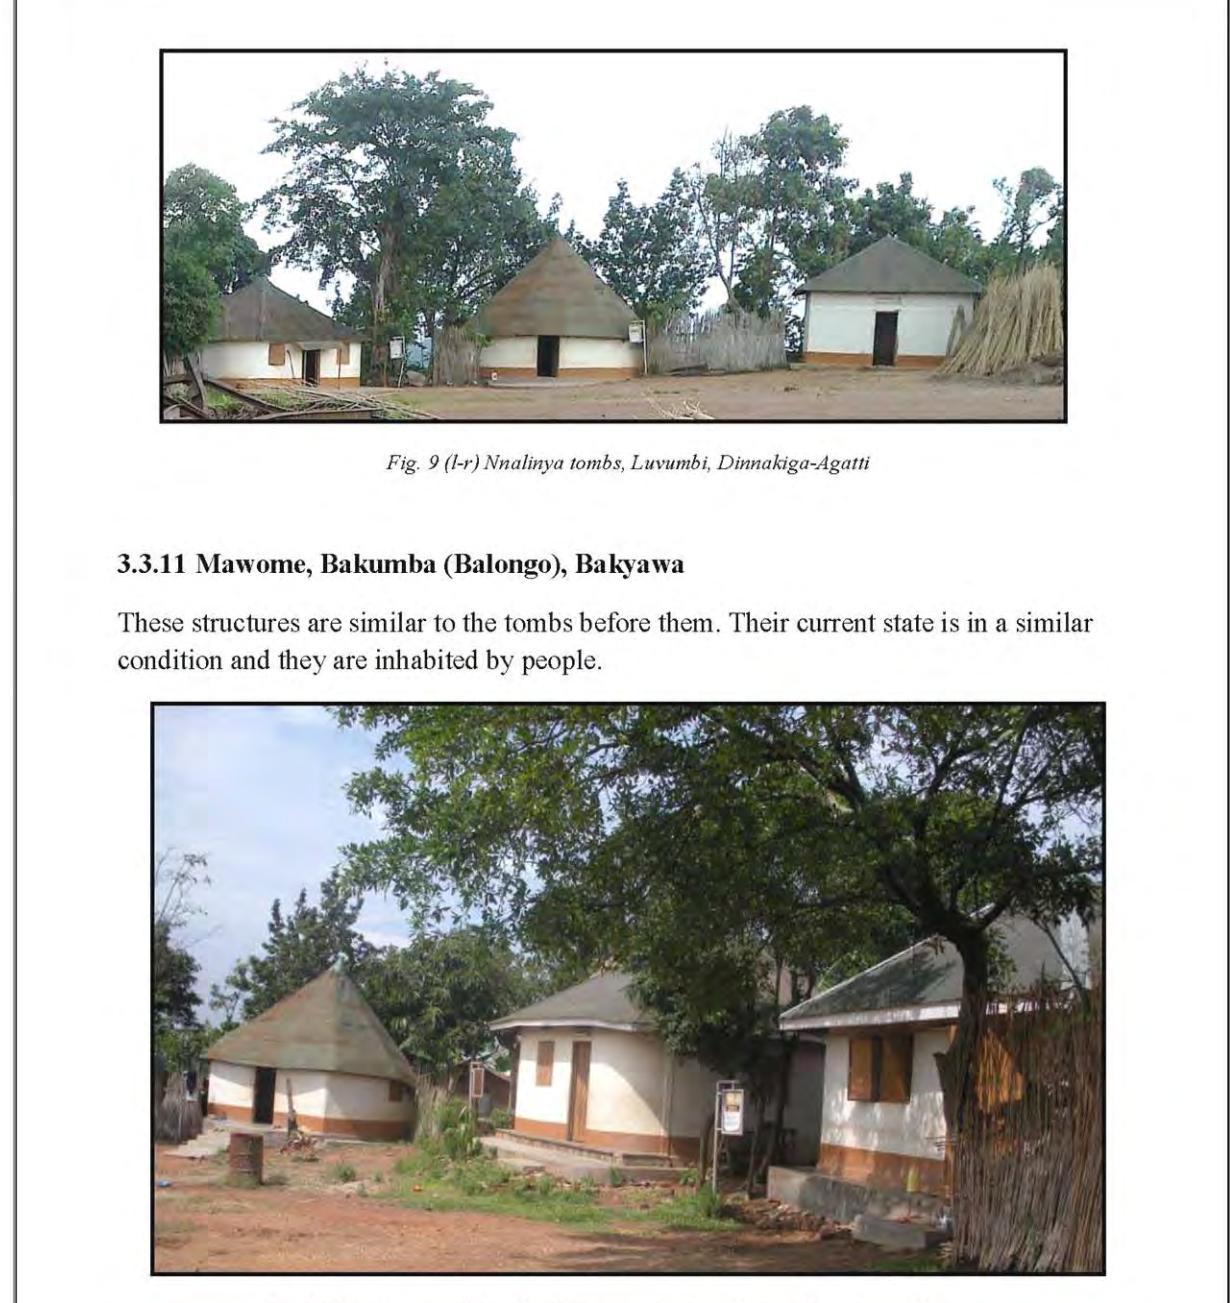
The maintenance condition is good enough as seen from the exterior and the slight interior part that is accessible to the public. There are few areas of cracks and worn out paint spots exposed.

Fig 10 (l-r) Mawome, Bakumba, Bakyawa: structures built with modern techniques, with no reflection of the Buganda traditional architecture

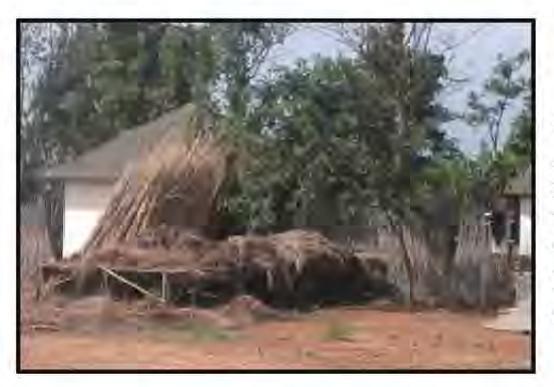
This is a currently an open wooden platform, acting as storage. The materials here are reed and thatch. Because of the exposure to the elements, the materials kept or placed here are getting destroyed with time before being used.

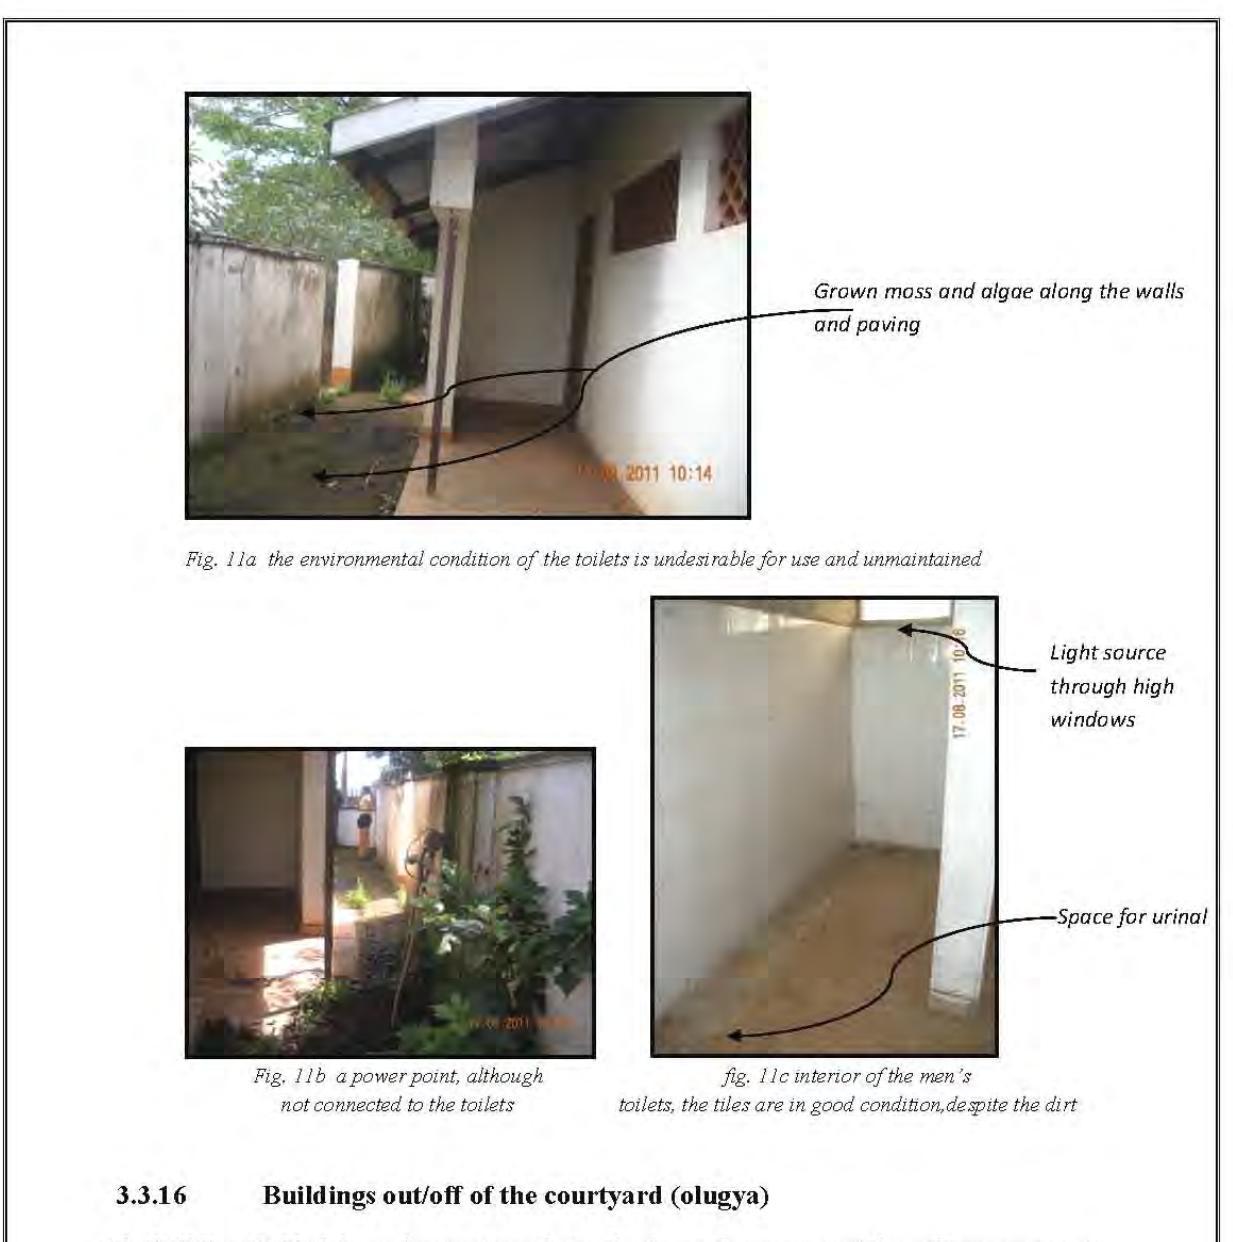
The maintenance condition of the building environmentally is rather poor. The area is surrounded with lots of weeds, rotting and fresh, along with rotting leaves and uncontrolled rubbish within its enclosure. There are no signs of cleaning at any one point having been done.

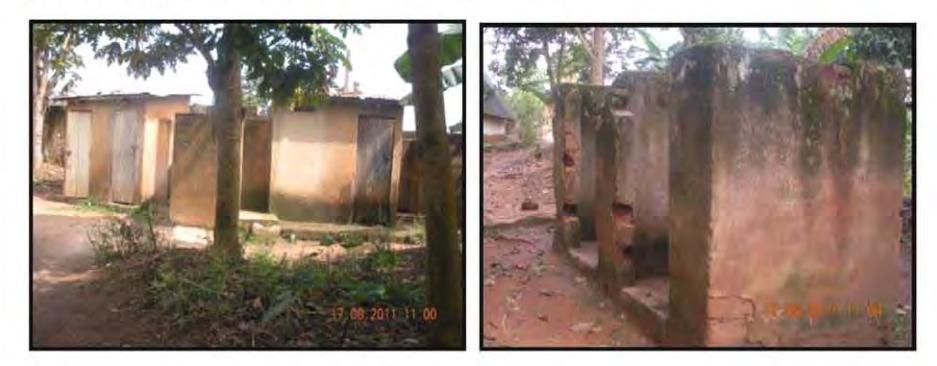
Fig. 12a pit latrines (L) and bath areas(R) for workers behind the katalama structure; the state of the buildings does not supports safe livelihood, and therefore the need for demolition or restructuring.

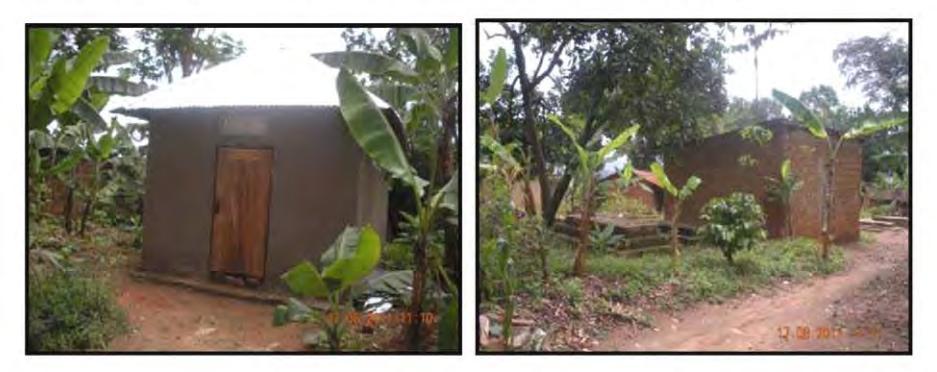
Fig 12b mausoleums, one built with mortar and brick like many others and the other with mud, adobe and wattle, similar to many others as well. Between these two mausoleums lie other graves, which one finds in many areas among these residences from time to time

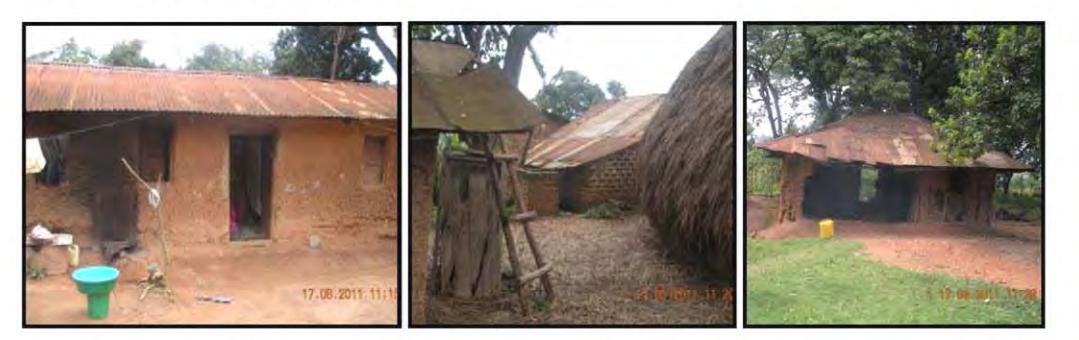
Fig. 13afig. 13bfig. 13cResidences and kitchen behind the buildings that make the main courtyard, which exhibit the poor living state of the residents

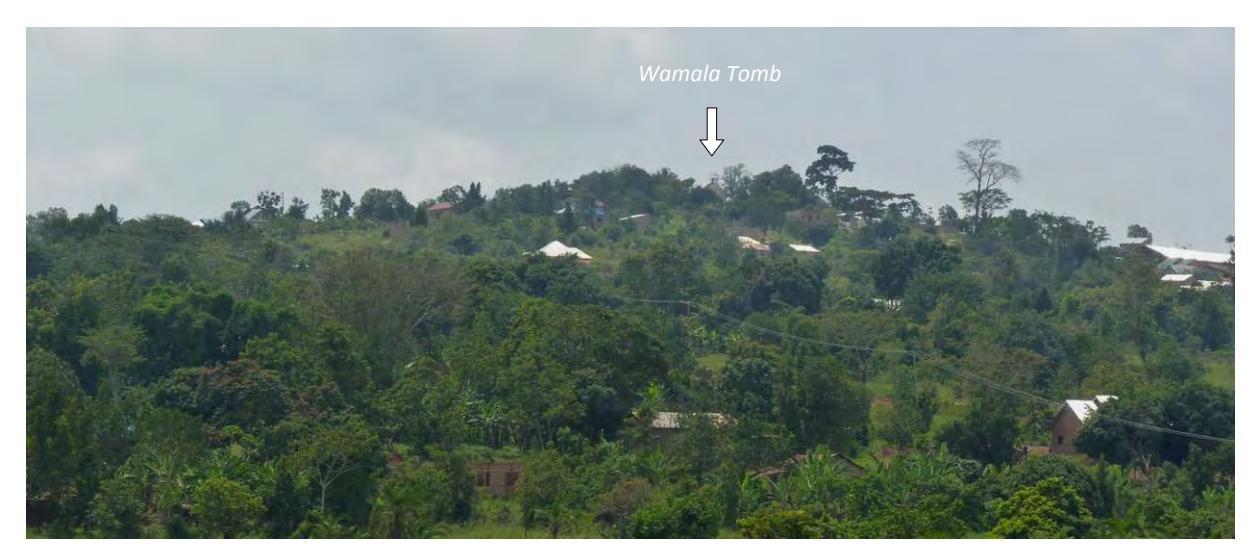
Wamala Hill. The hill goes through a rapid development process which is detrimental to its serenity and authenticity.

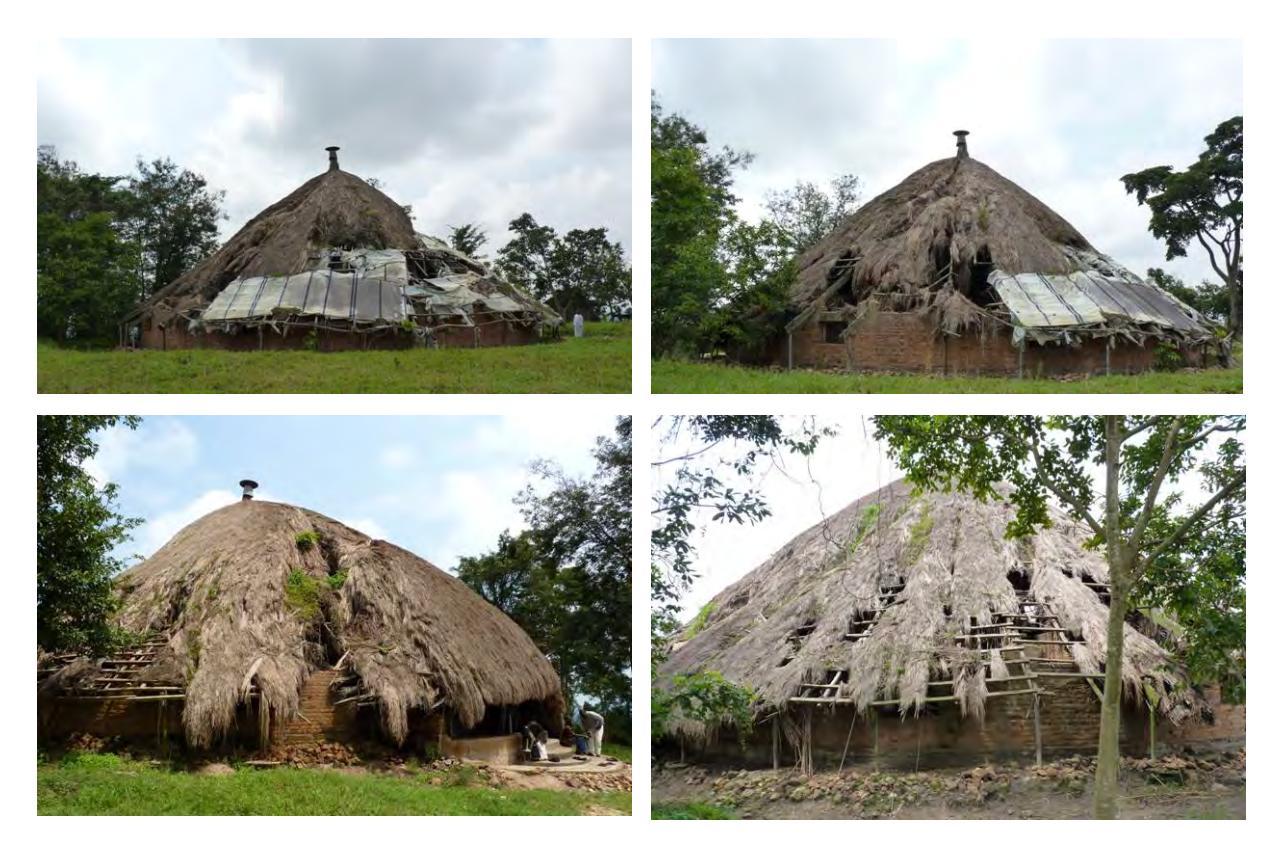
Back of the Tomb building. Water enters the building from all sides.

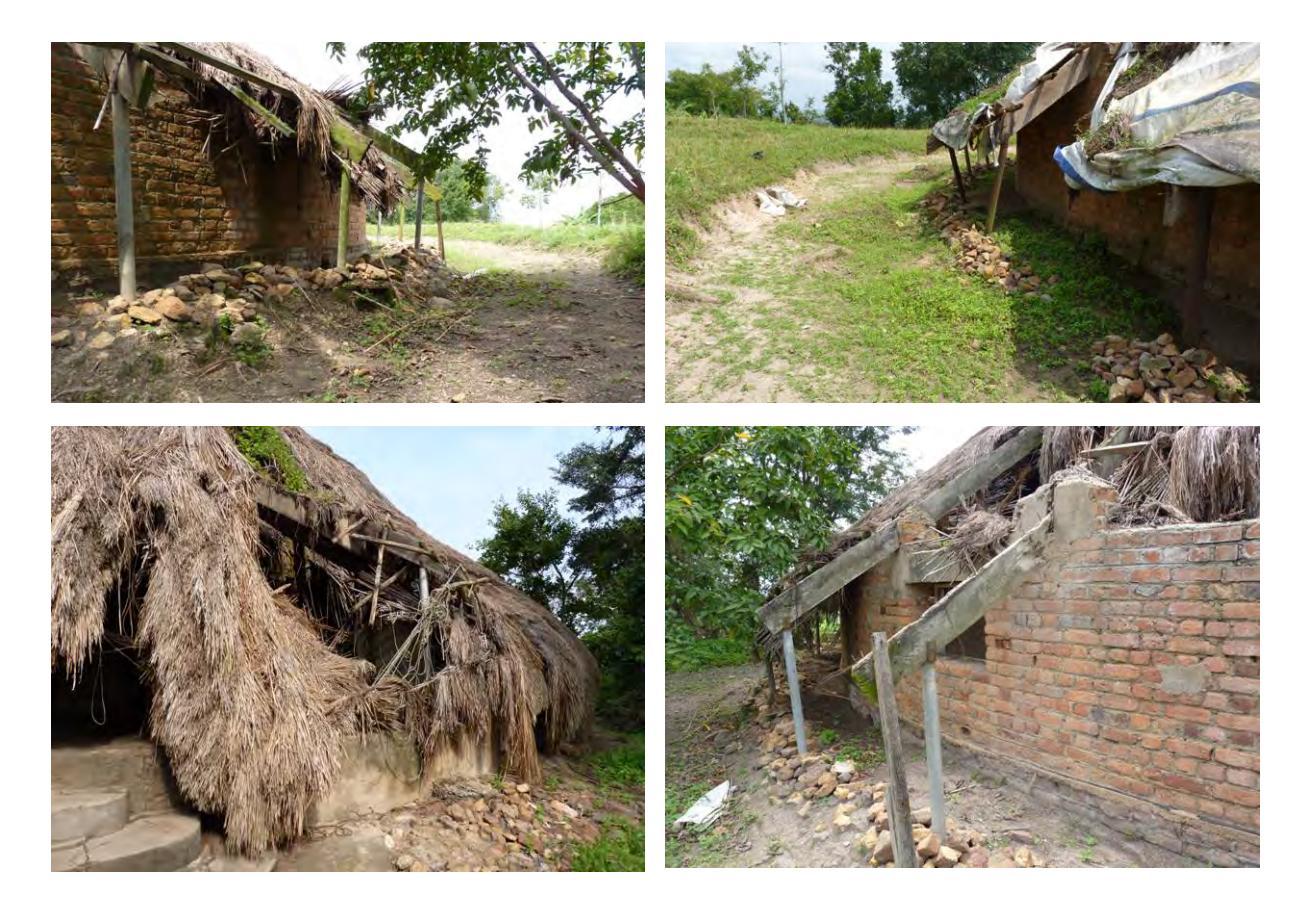
The tarpaulin is torn and moisture gets under the slab because of drainage problems.

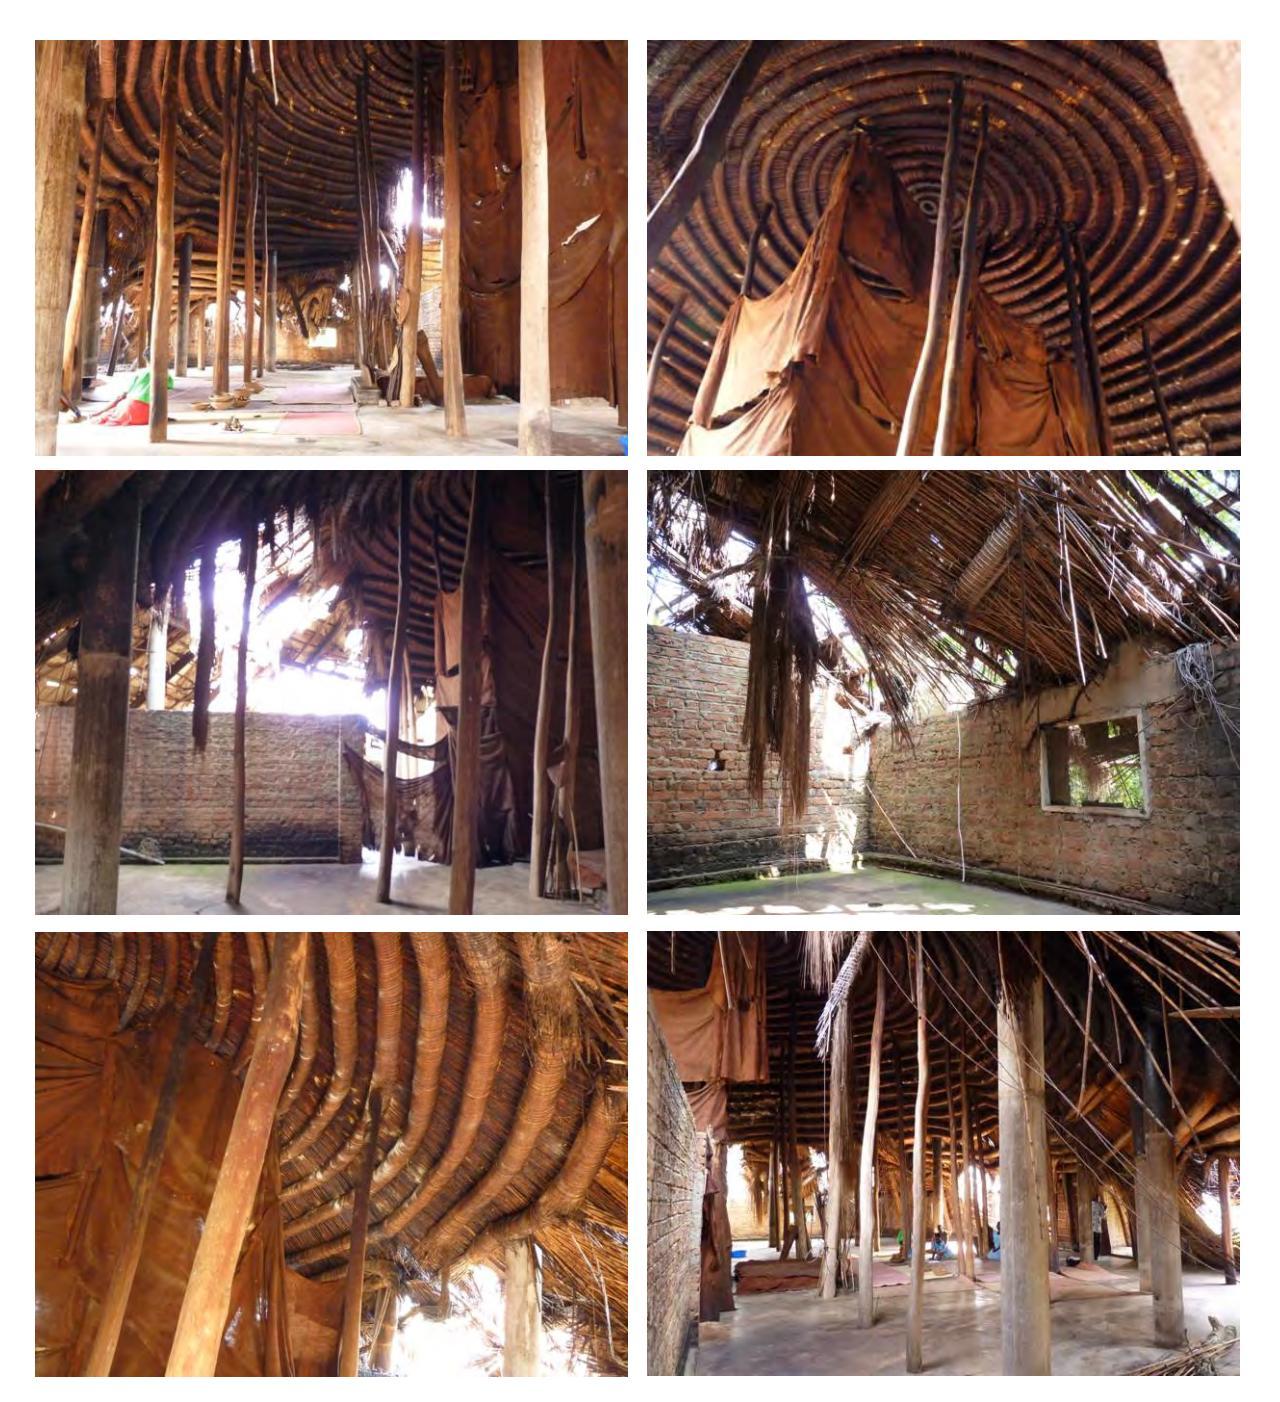
Inside the Tomb building. Only the top of the roof is not open, but traces of moisture indicate high humidity. The extent of damage does not allow for the retrieval of items from the roof. Only the wooden poles are still resisting and should be conserved. The roof is too affected by moisture, termites, and bats droppings to be kept.

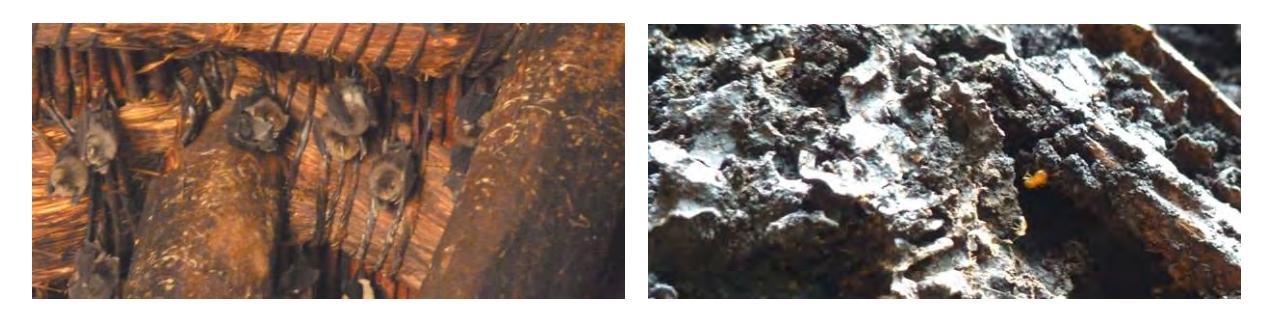
Bats have invested the top of the ceiling and the termites are present in all the leftover straw

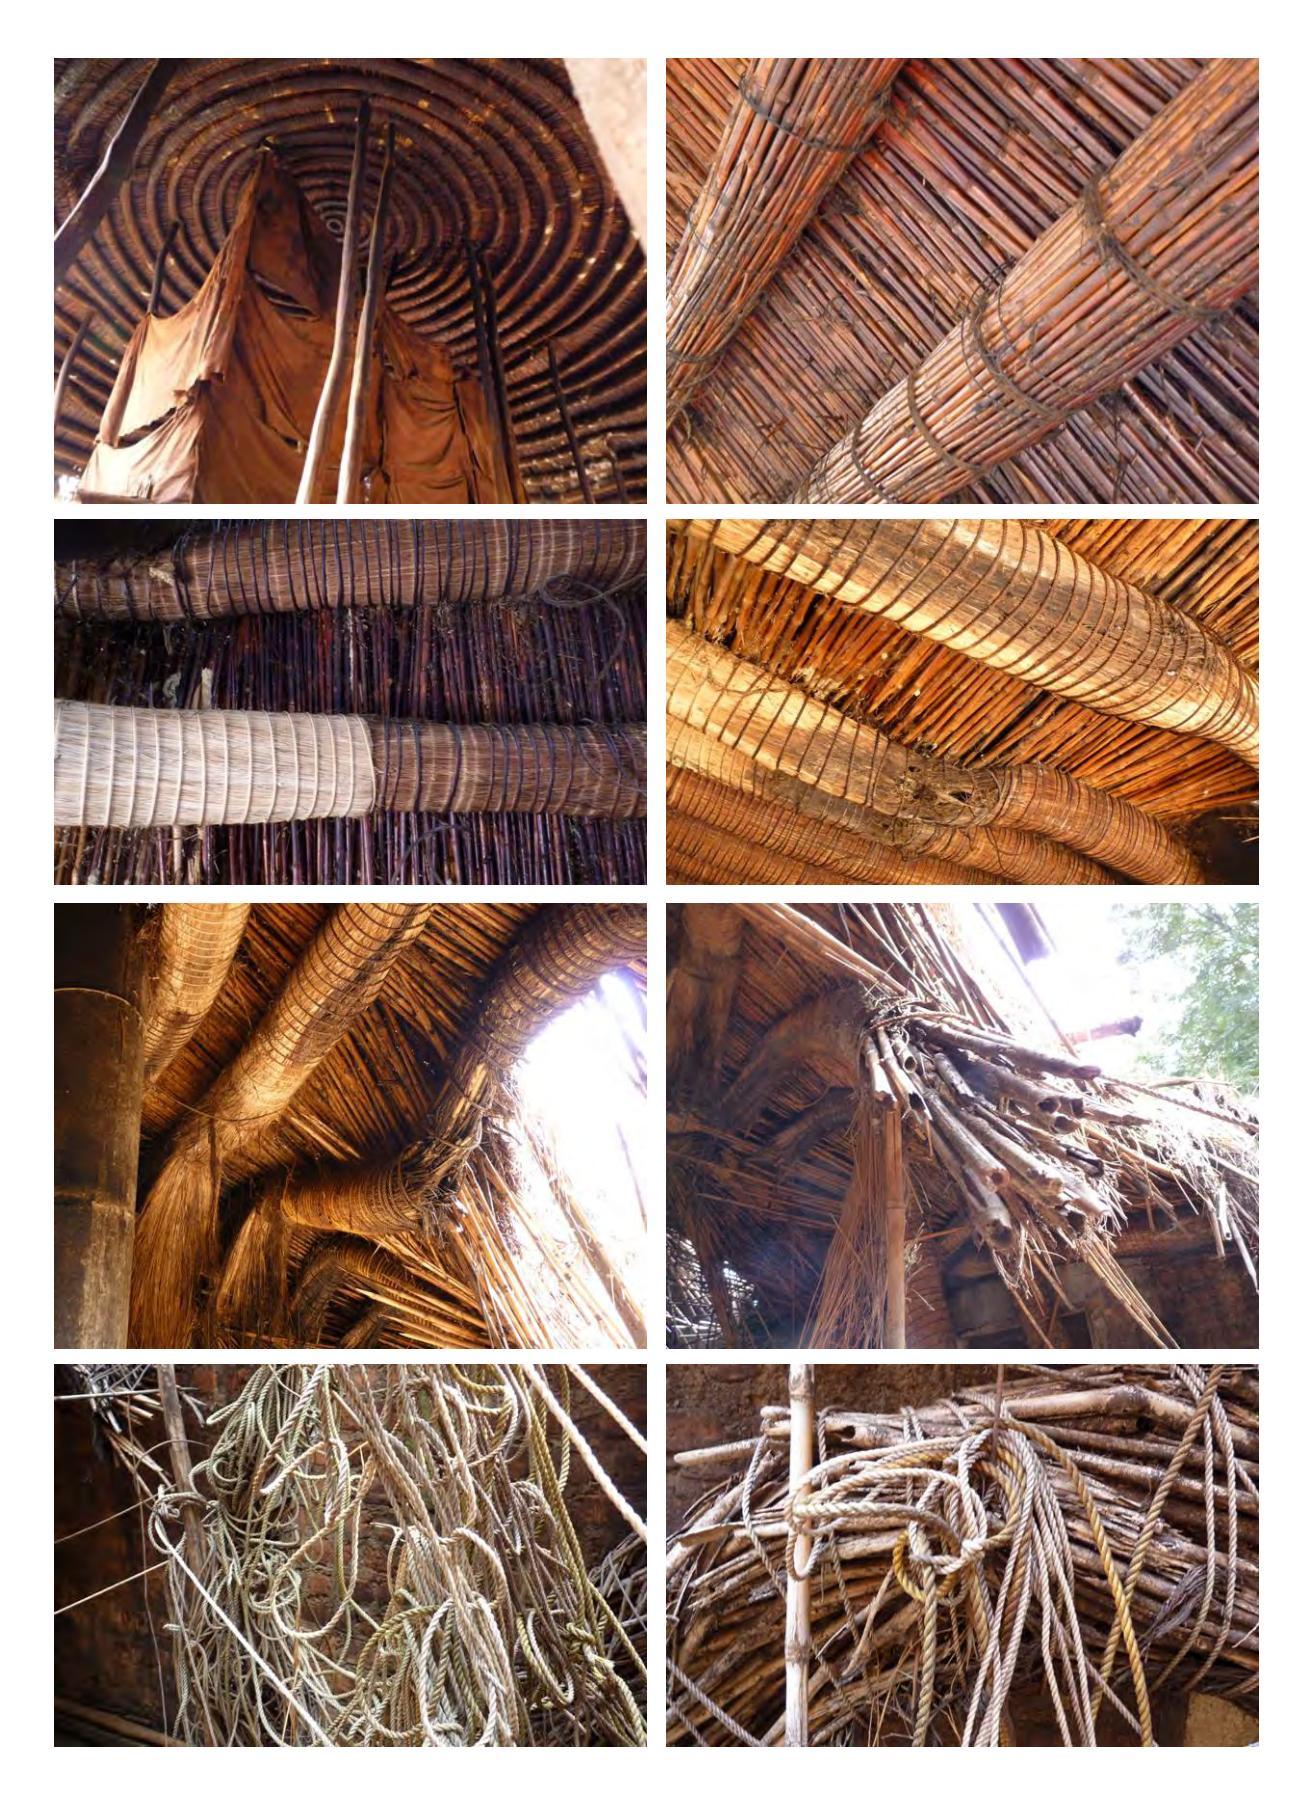
The rings are also damaged, although some sections seem intact and authentic. Many rings indicate that they have been repaired several times. Most rings are tied up with synthetic strings.
