Protecting BAALBEK's Integrity

A PROPOSAL FOR AN INTEGRATED RISK PREPAREDNESS STRATEGY

CAPACITY BUILDING OF HUMAN RESOURCES FOR
DIGITAL DOCUMENTATION OF WORLD HERITAGE SITES
AFFECTED BY THE 2006 WAR IN LEBANON

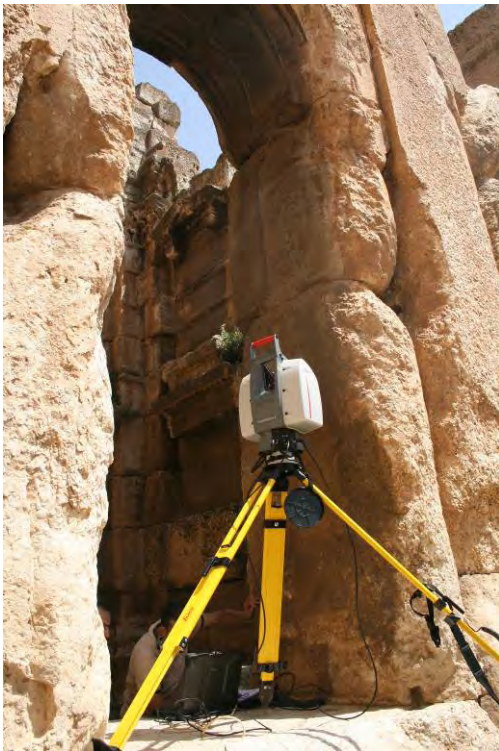
Figure 6.1: Laser scanner set up in Baalbek historical site

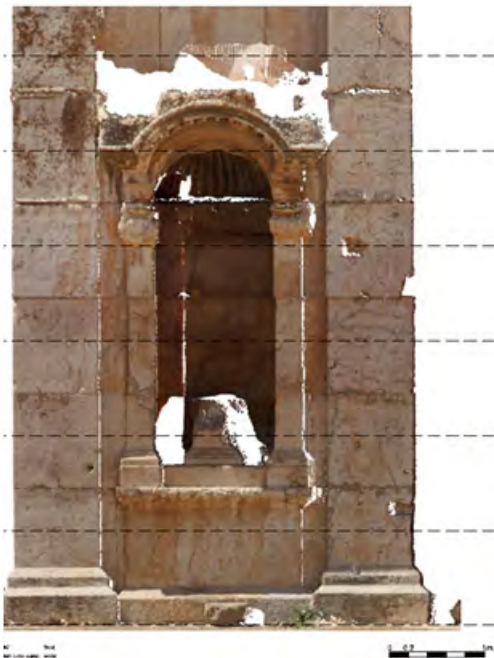
Figure 6.4 : Completed orthophotograph

Therefore, a procedure was developed to overcome this problem, in spite of the loss of resolution. For each scanworld (coloured by a different panorama) a set of layers was created. The scanworld containing the maximum visible area of the structure for that particular orthophoto was taken as a starting point. Then the missing parts of that scanworld were

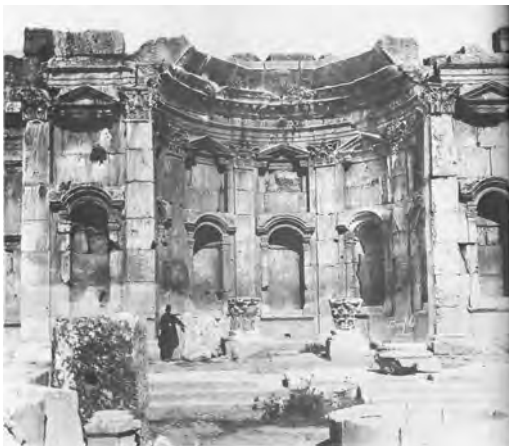
Figure 7.1: North-western semicircular chamber before the reconstruction, view from the Great Court. Photograph from 1900. (In: Nina Jideian, *Baalbek Heliopolis 'Cité du Soleil'*, Librairie Oriental, Beirut, 1986, p:66)

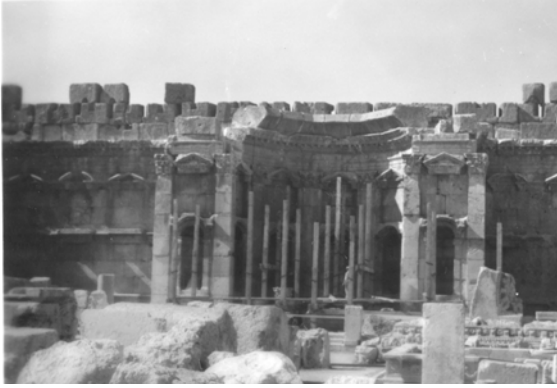
Figure 7.3: The starting of the restoration works, view from the Great Court. Photograph around 1960. (DGA iconographical inventory)

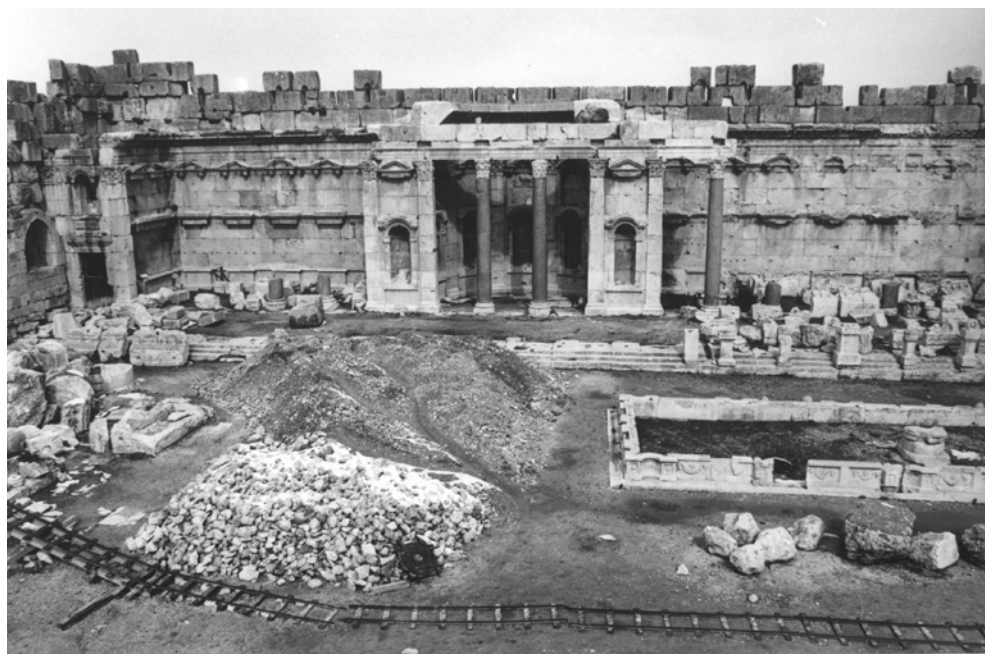
Figure 7.6: The North-western semicircular chamber after the restoration works, view from the Great Court. Photograph around 1960. (DGA iconographical inventory)

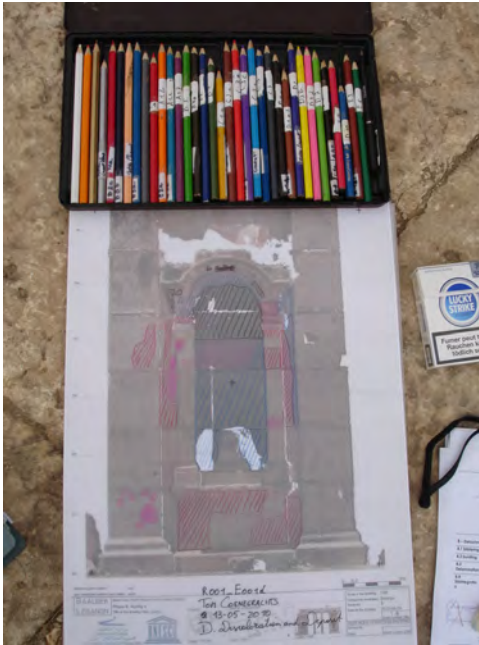
Figure 8.1: Graphical survey of the surface degradations on transparent sheets with coloured pencils.

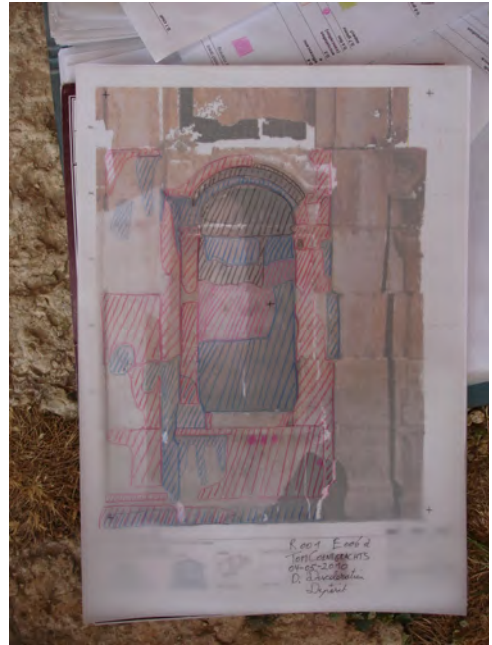
Figure 8.2: Example page of the produced Damage Atlas

In order to prepare the illustrated Damage Atlas, a complete mapping of the surface degradations was carried out. The mapping is a full description, recording and presentation of the various weathering forms and patterns. It is firstly composed of the classification and identification of the different patterns and secondly of their documentation. The complete documentation is developed on three levels: phenomenological registration (written description of damages), graphical registration (graphical representations of all modifications in geometry, colour, deposits and detachments), and photographic

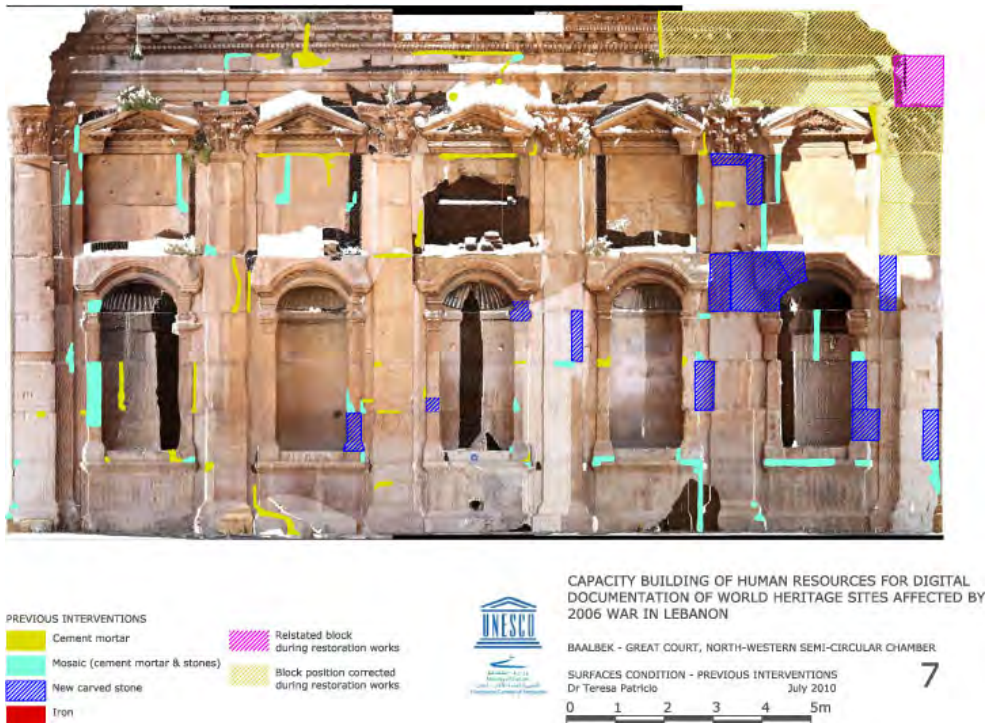
Figure 8.7:
Mapping of the previous interventions and materials on the interior wall of the semicircular chamber.

For a proper understanding of the degradations’ evolution, the notion of time is fundamental, because it greatly facilitates the evaluation of the risks. For this reason, the risk assessment takes into account the historical data and the reported changes through time. During the Surface Condition Mapping all the transformations and historical phases of the structure were added to the maps (restorations, new additions, and new materials). The north-western semicircular chamber suffered several modifications through time, such as reconstruction (colonnade, entablature and roof), surface restorations and the completion of missing parts (with new stone blocks, concrete and iron). To complete the information about the

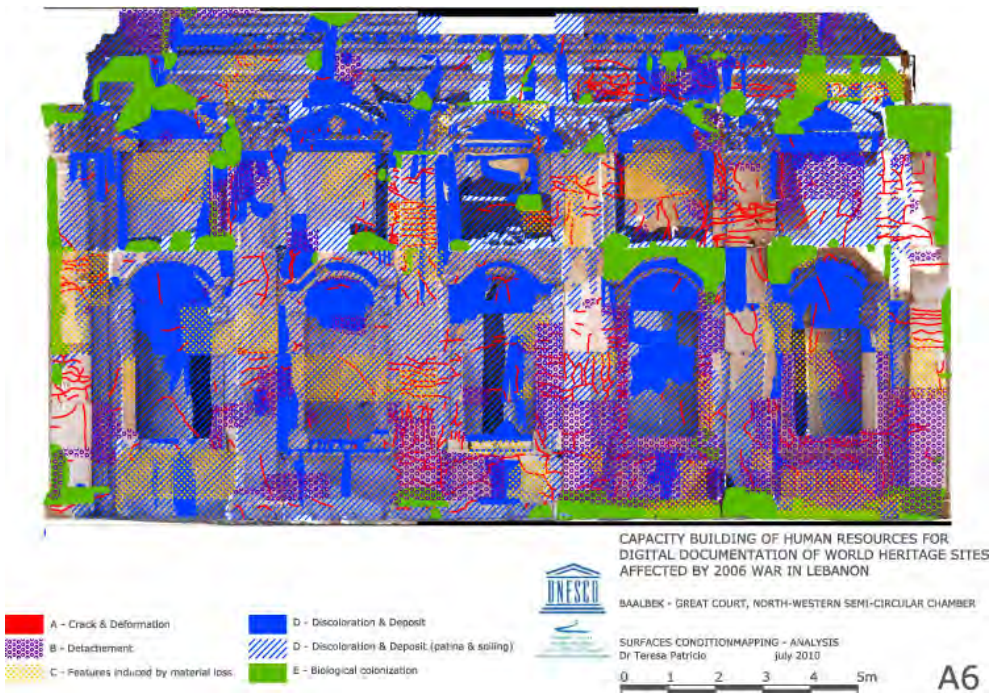
Figure 8.8: Mapping of the previous interventions on the main façade of the semicircular chamber: green - reinstated blocks by Anastylis technique; brown – block positions corrected during restoration works; dark blue – new stone blocks introduced during restoration works; grey & light blue – cement mortar

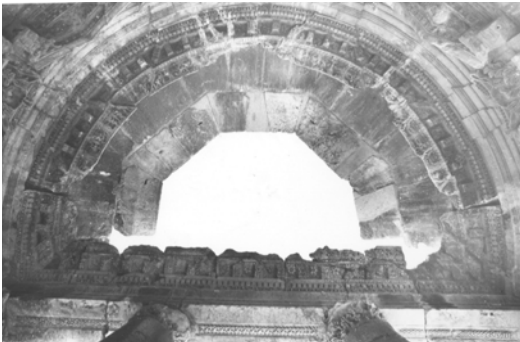
Figure 8.14 & 8.15: The ceiling of the semicircular chamber. The left image is from the 60s (DGA iconographical inventory), the right image is an orthophotograph from the 3D laser scanner. The erosion on parts exposed to rainwater leakage is visible.

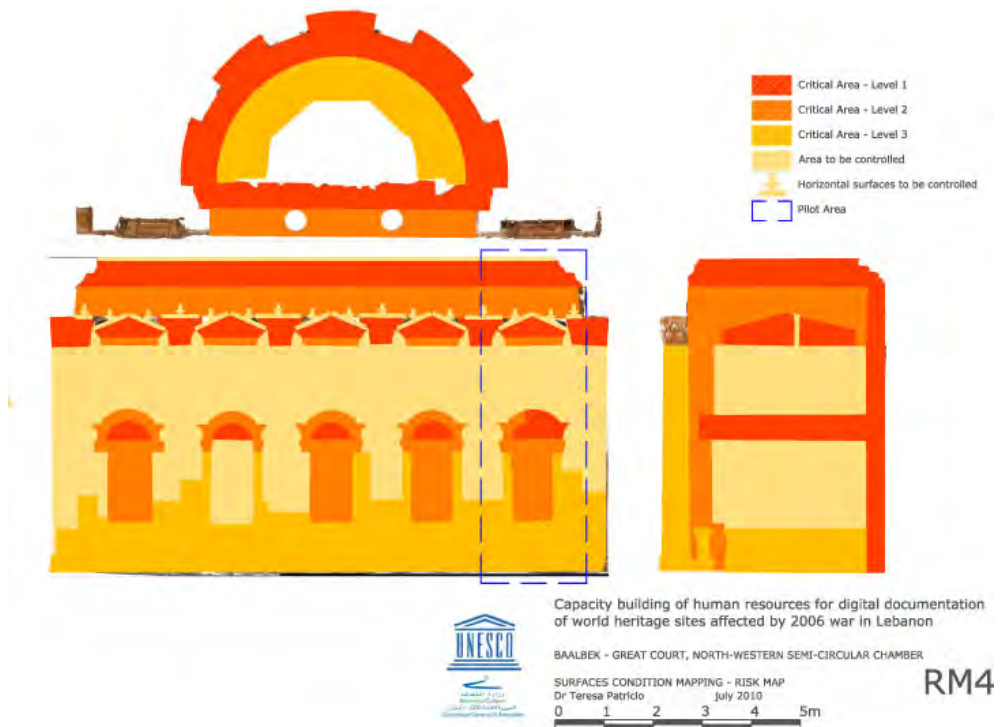
- Critical areas - risk of irreversible damage and loss of integrity.
 - o Level 1: surfaces with severe level of degradation – High level of integrity loss.
 - o Level 2: surfaces with advanced state of degradation – Moderate level of integrity loss.
 - o Level 3: surfaces with advanced state of degradation – Low level of integrity loss.
- Areas to be controlled – reversible damages and low level of integrity loss. These areas are characterized by soft and reversible damages, if prompt conservation action is taken and should be controlled regularly (monitoring the damages through time).
- Pilot area – area characterized by all types of damages, where the hazards are more recurrent. The monitoring of this area is fundamental for the comprehension of the damages' evolution, the impacts of hazards, and the impacts on values.

Figure 8.16 - Great Court semicircular chamber - Mapping of the risk estimation for the interior wall, ceiling and exterior north wall.

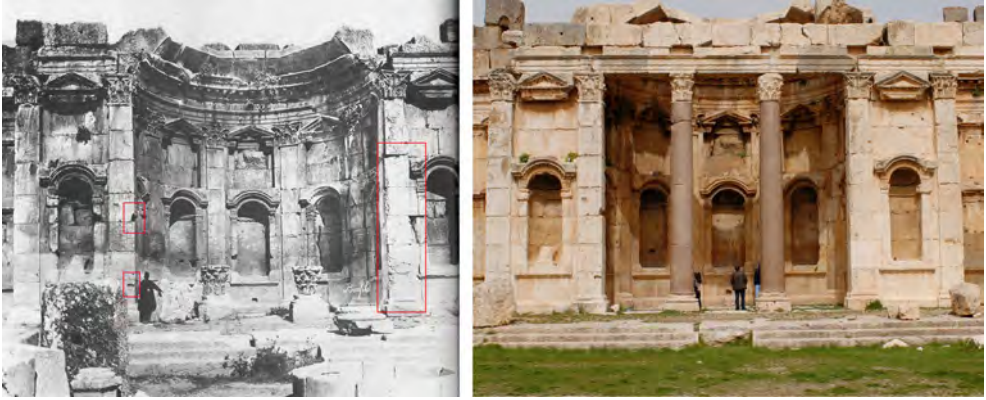
- Historical information (Fig. 9.1): Many structures of the site still hold traces of past earthquakes (the last important one occurred in 1759) and previous interventions. Analysing them can help us understand the behaviour of the structures and also evaluate the effects to be expected in case of a new occurrence.

Figure 9.1: Left: semicircular chamber of the Great Court in 1900. Right: same semicircular chamber in March 2010. The parts in red rectangles on the left side show areas which did not change, and on the right side where stones were replaced.

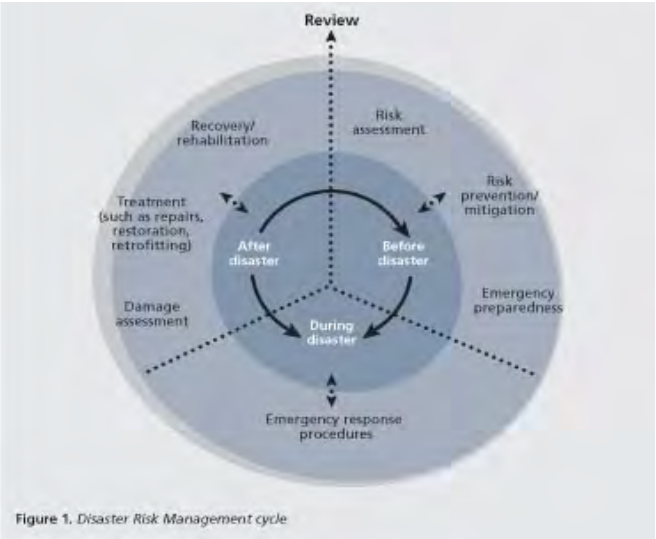
Figure 11.1: Disaster Risk Management cycle.
