REPORT

ON THE STATE CONSERVATION OF
MEDIEVAL MONUMENTS IN KOSOVO
INSCRIBED ON THE WORLD HERITAGE LIST IN DANGER

MEDIEVAL MONUMENTS IN KOSOVO (C 724)

Belgrade, January 2015

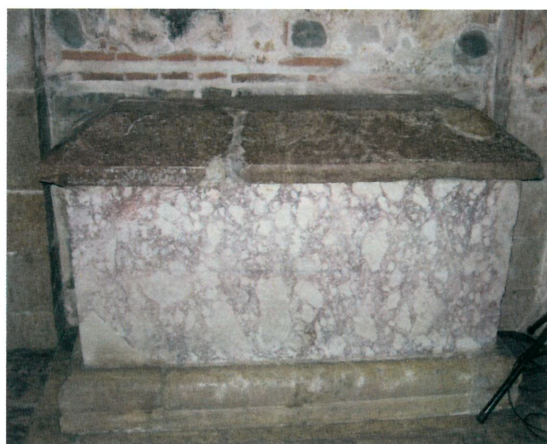
In the period from October to December 2014, the works were done on the sarcophagus in the narthex of the monastery church ascribed to Đorđe Ostouša Pećpal. After the removal of the lid, an ossuary together with fragments of marble, oculi, and fresco plaster with and without painted layer have been found, as well as various small objects, laid down together with the deceased. Several fragments that belong to the lid have been found at the bottom of the sarcophagus.

Sarcophagus before the works

The stone that the sarcophagus is made of was cleaned, while its back side, that was missing, was made of stone equal to the original. The missing parts were reconstructed in the restoration plaster which by its structure, colour and texture was equal to the original.

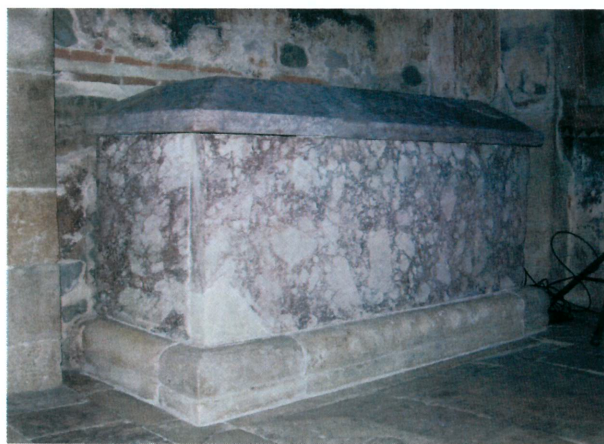
Sarcophagus after the works were completed

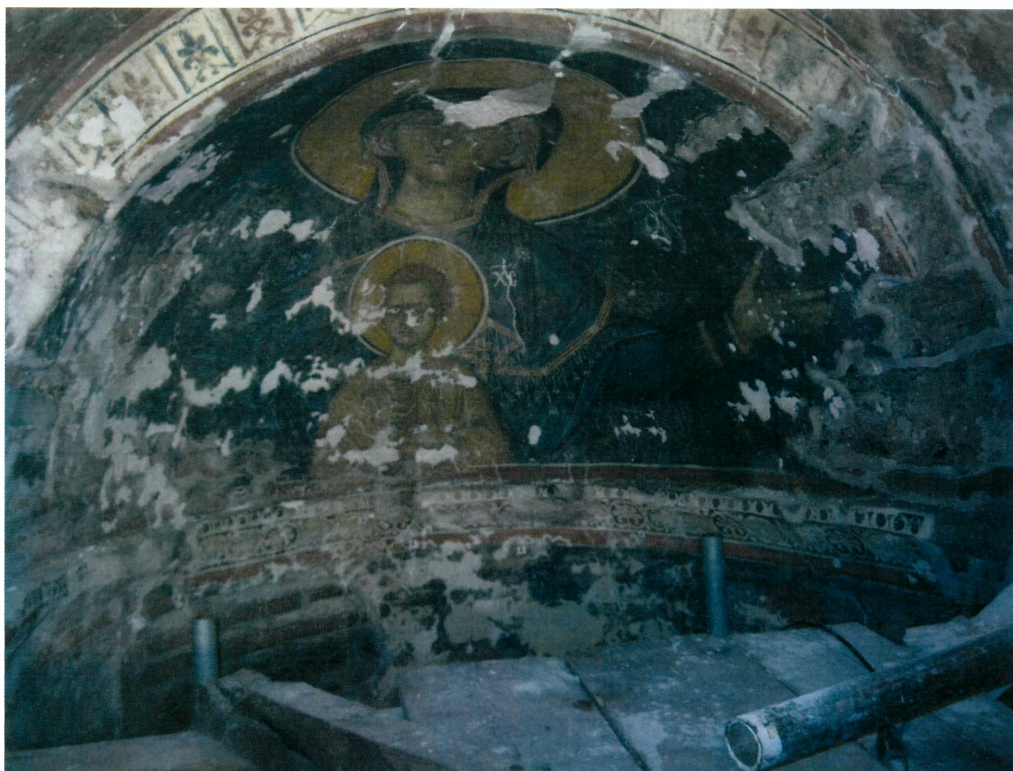
The painting and conservation works were done in the St. Nicholas parekklesion during September and October 2014. The detached areas of fresco plaster were the biggest problem in the cross vault owing to a danger of possible collapse. In addition to this form of damage, in places there were larger cracks that could expand owing to unstable parts along their edges. In the apse, the most endangered were the frescos in the middle section above the window. There were numerous damages in those places with only boundary reinforcement – lining. The cracks had not been treated in the earlier conservatory actions and therefore large areas with parts of plaster containing fresco painting moved at a touch of a hand. The damaged areas were consolidated by injecting and filling up of larger craters and cracks. The strengthening of the painted substance was also partially done by fastening it.

The parekklesion paintings during the works

- Taking pictures of all iconographic wholes, their prominent parts and details that depict conservation issues – the present state;
- Descriptions on the basis of the visual inspection;
- Contact with all parts of the frescos' surface (palpation, wiping tests);
- Recording of damages, their description and schematic drawing;

- Conducting of the surface deposits cleaning tests on each iconographic whole according to the encountered problems;
- Computer data processing;
- Undertaking conservation measures, necessary procedures with appropriate materials for the purpose of repairing the damages – on the principle of minimal interventions and minimal addition of new materials;
- Processing of photos and texts – preparation of the final report on the conducted protective painting and conservation works.

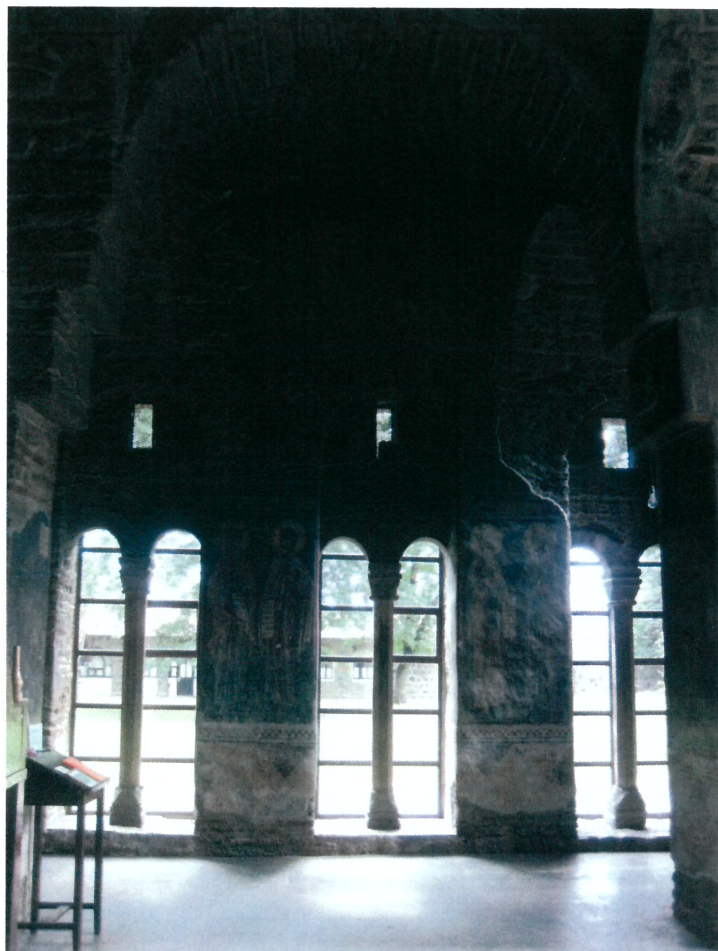
Parts of the exceptionally valuable fresco decoration from 14th and 16th centuries are endangered by the action of humidity, efflorescences and intensive deposits of soot. After completing physical and chemical surveys, characterization of salts and establishing the features of the dark deposit, the method for their removal was determined, because of possible damaging effect on the frescos' pigments. The conservation works encompassed cleaning and strengthening parts of wall paintings on all preserved wholes in the exonarthex.

Exonarthex prior to the works

The conservation works included interventions on all weakened parts of the fresco decoration, of different degree of destruction. The task of these works was a direct contact and consolidation of these areas. The fixing of the painted layers was conducted on all of the parts of the fresco decoration where it was necessary. In the vault above the entrance, the inappropriate plaster lining was replaced with a new, appropriate lining. In places, partial strengthening by injecting was done, and all the parts of the wall paintings were cleaned from the large deposits of soot and dust.

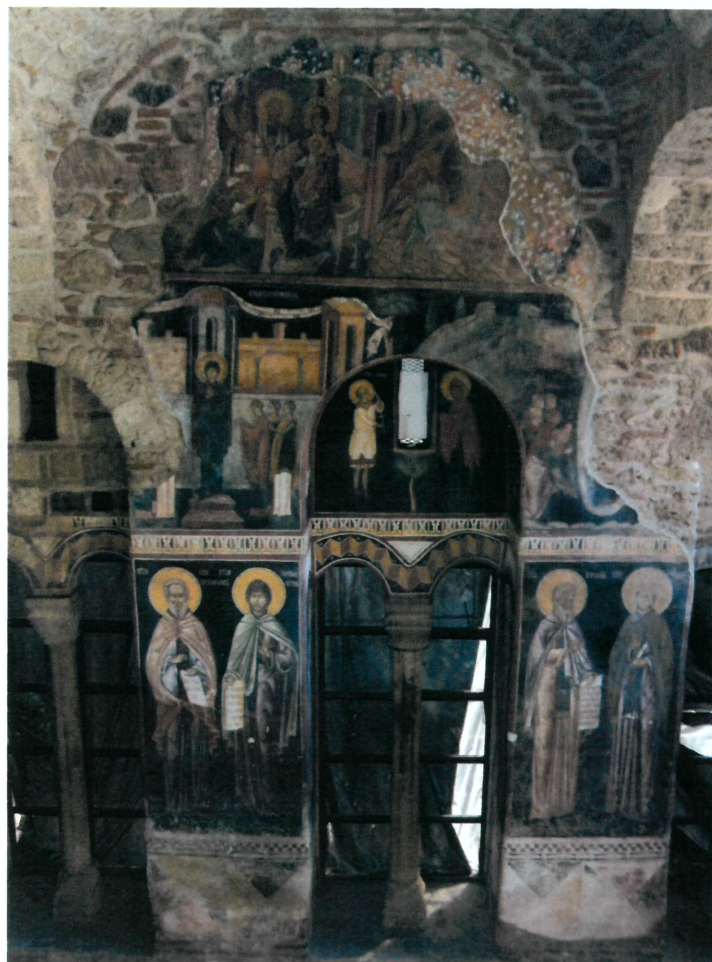
The exonarthex which is first entered when going into the church is now presented in an appropriate manner. The conducted works and the use of contemporary materials, in the suitable interior ambient of the church, should ensure long-lasting existence of the wall paintings. Around 120 m² of frescoes and 260 m² of free surfaces (presented walls without plaster) were treated.

Exonarthex after the works
