**Mission report**  
on the preparation of the reconstruction of

# **Muzibu-Azaala-Mpanga**

## **Tombs of Buganda Kings at Kasubi**

A World Heritage property of Uganda

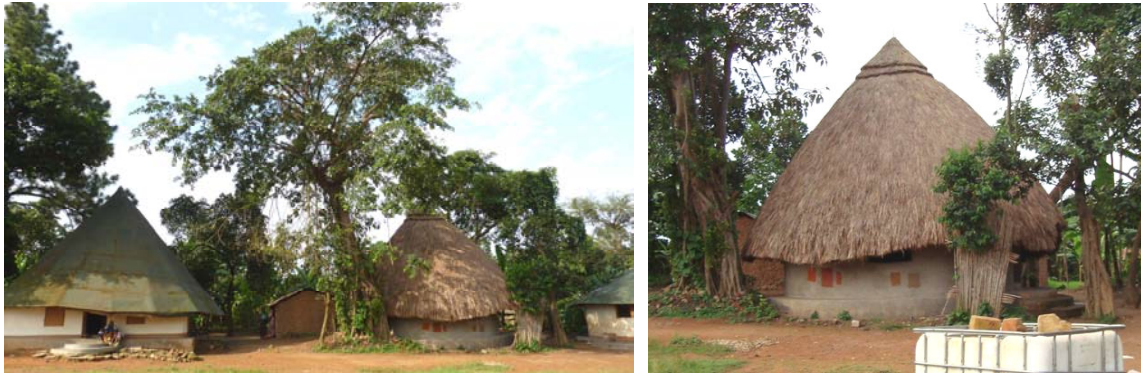
*One of the twin houses with its new thatched roof.*

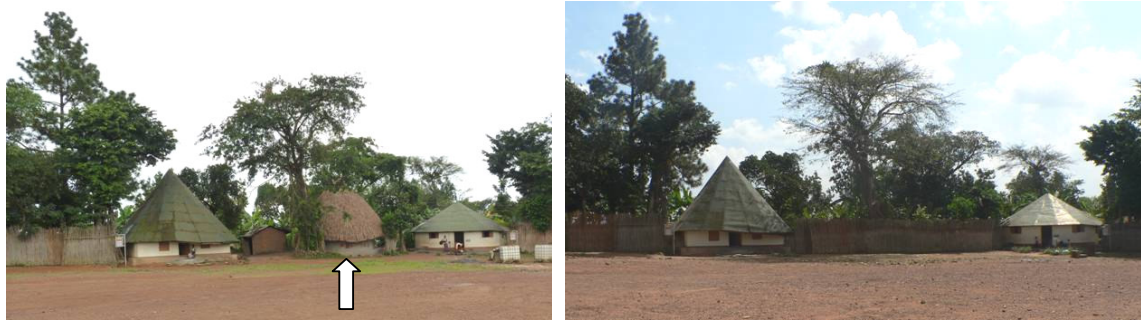
*November 2010*

*July 2009*

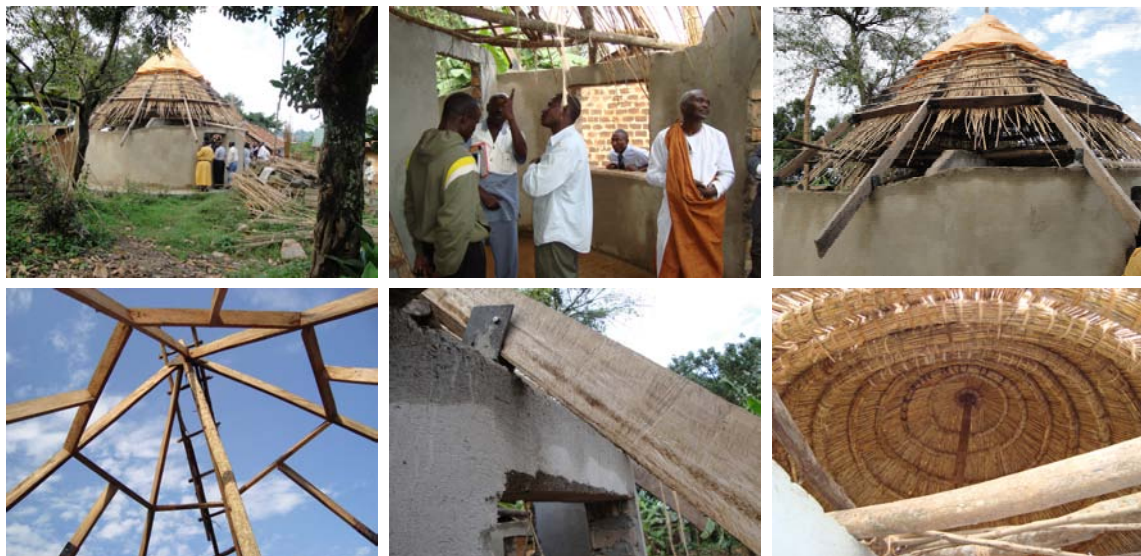
*The dress house and the other twin house under construction*

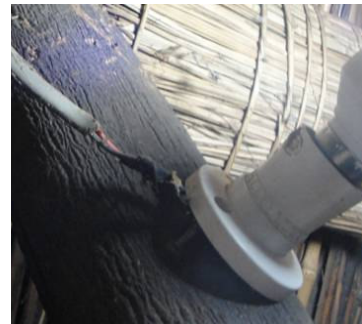
The Reconstruction Strategy of the national Technical Committee pays close attention to the management of fire outbreaks and has laid out fire management and security system. Details of these will be presented with the final reconstruction strategy for broad-based consultations. The use of incandescent electric bulbs and faulty wiring remains a fire threat to the thatched buildings on the site, especially the *Bujjabukula* and *Ndoga-Obukaba*. The situation needs to be addressed as soon as possible. As this is foreseen in the 2011 action plan, it is **imperative** that it will be duly considered.

*Electric wiring in the Bujjabukula.*

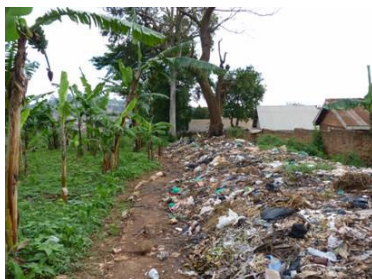
Encroachment and pollution due to garbage dumping remains a constant threat. The garbage heaps are constantly increasing on the eastern and southern boundaries of the site. The site is protected under the provisions of the Historical Monument Act that protects the Kasubi Tombs from residential encroachment or any other activity inconsistent with its character. It also has additional protection under the Land Act (1998). However this legal protection is useless if there is no regular monitoring of the site boundaries.

*Southern boundary*

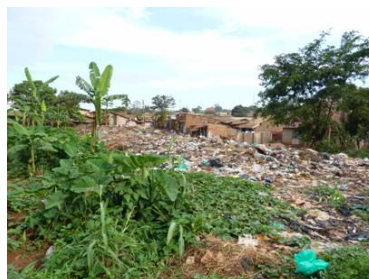
*Eastern boundary*

The presence of rubbish heaps on the site pollutes the site in terms of view and smell. The health hazard is also ever present.

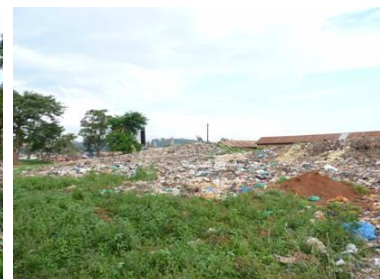
The security of the site is important and needs to be addressed. The lack of clear security markers makes the site porous and prone to looting of artefacts.

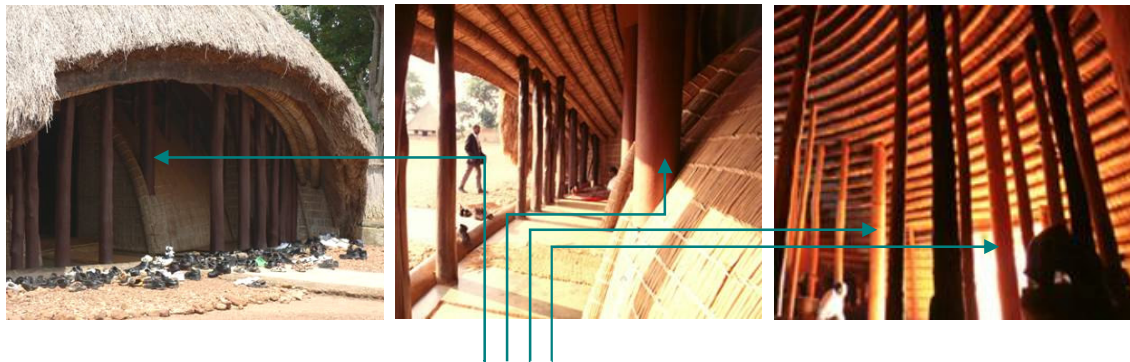
The only exceptions to this decision are the four concrete columns at the entrance – it is being investigated if these can be replaced by wooden columns while still adequate for required structural support of the roof. The other concrete columns which are invisible to visitors will remain.

*Investigate the possibility that the 4 concrete columns at the entrance can be replaced with timber ones*

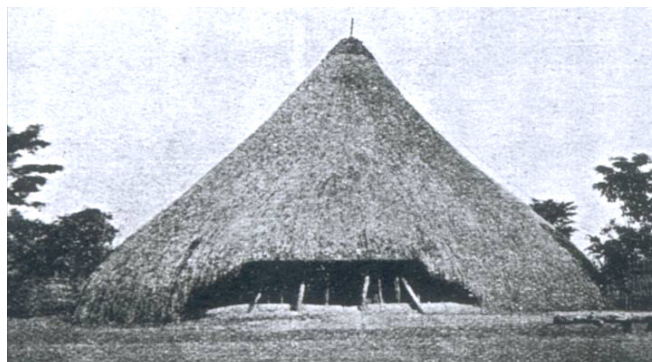
### Muzibu-Azaala-Mpanga

Extracted from Reverend J. Roscoe's book:  
*"The Baganda. An account of their natives  
 customs and beliefs"*  
 Published in 1911

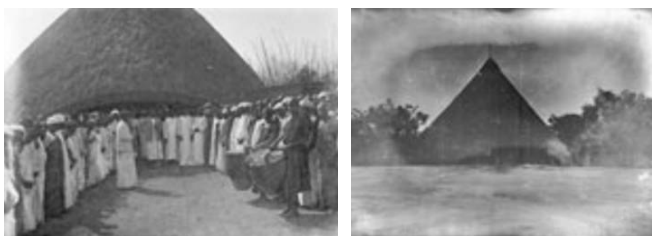
### Muzibu-Azaala-Mpanga

Photos by Ernest Gedge, 1891  
 Royal Geographic Society, London

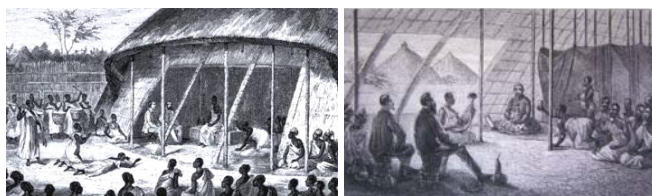
### Muteesa's Palace

1864  
 Engravings extracted from J.H.Speke's book :  
*"Journal of the Discovery of the Source of Nile"*

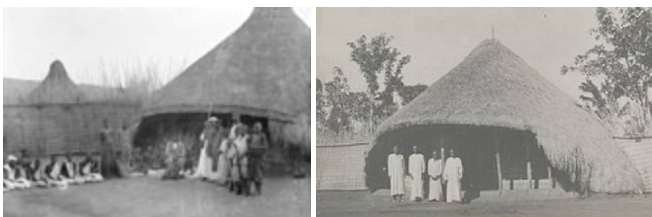
### Unknown building and Bujjabukula

Photo on the left by Ernest Gedge, 1891  
 Royal Geographic Society, London

Photo on the right by Richard Storch, 1900-1909  
 Musée du Quai Branly, Paris

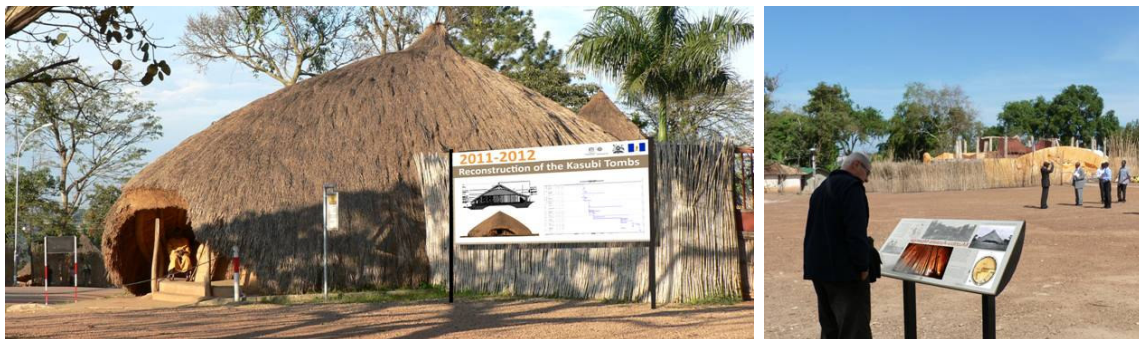
Example of signs which could be placed at the site

In view of this, the mission recommends that it is important that while preparatory works are ongoing, and even during the reconstruction, a temporary exhibition on the site, showing the various facets of its life span, up to its destruction, be set up. The suggested venue for this is the interpretation centre that is presently under utilised. In as much as the building is incongruous on the site, it can be given some use as a stopgap measure to keep the site alive. A temporary exhibition would also afford the public a chance to get information on the reconstruction work and better educate them on the need to tread the path of caution as a strategy for the reconstruction. It might be interesting for the exhibition to grow as a function of the progress of the reconstruction work.

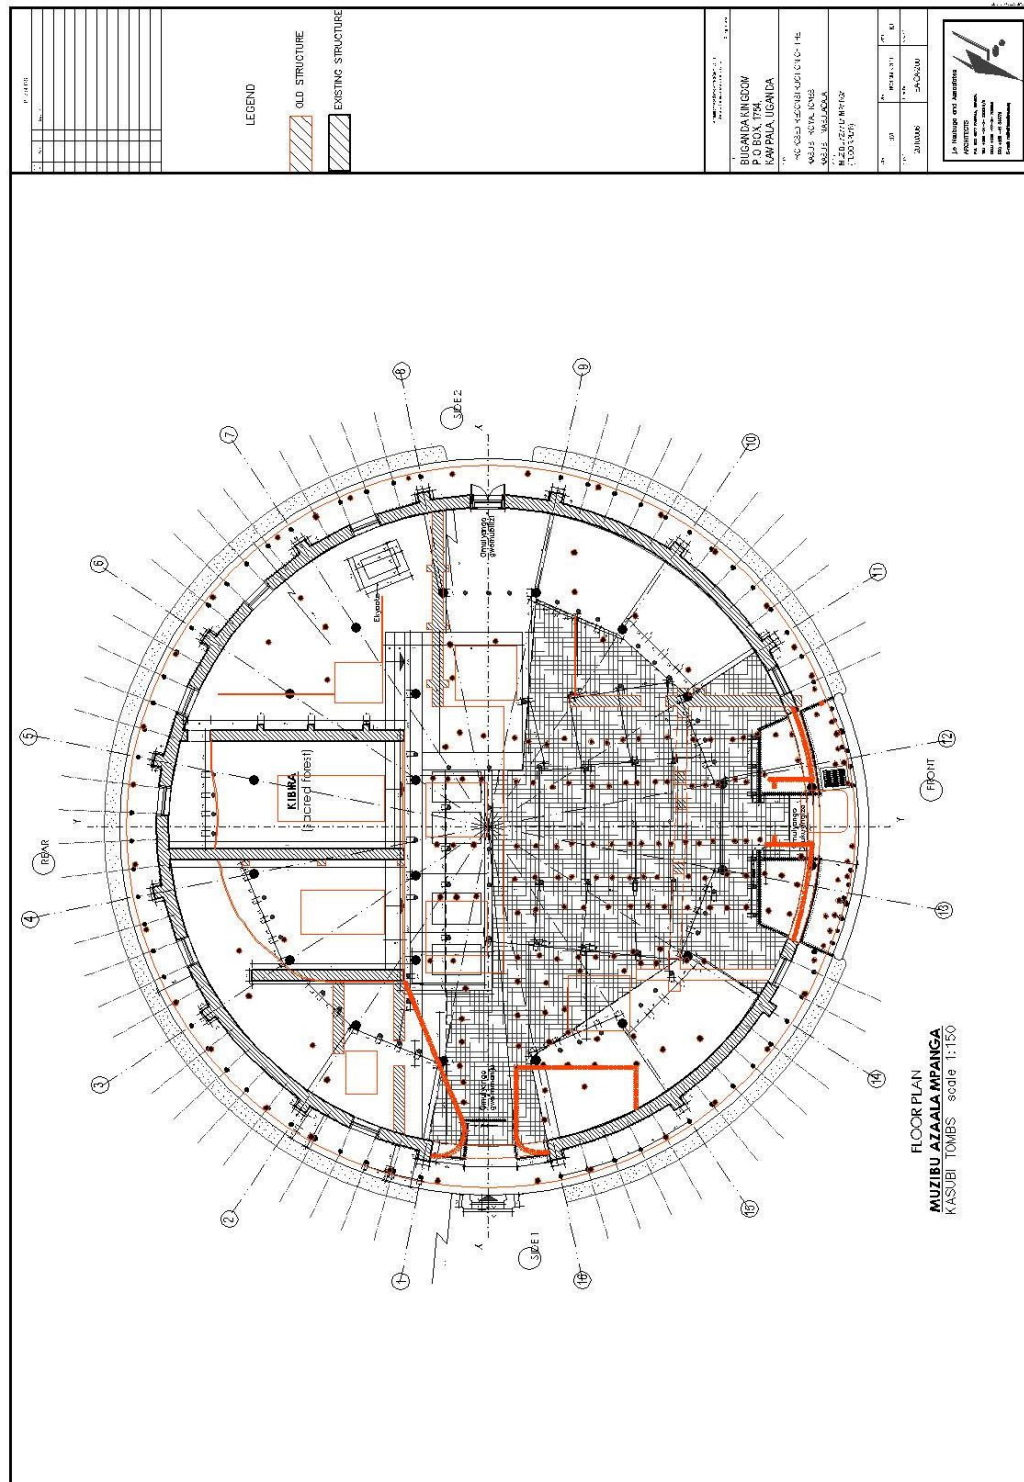
b) Muteesa's palace and 1938-model Kasubi tombs overlayed

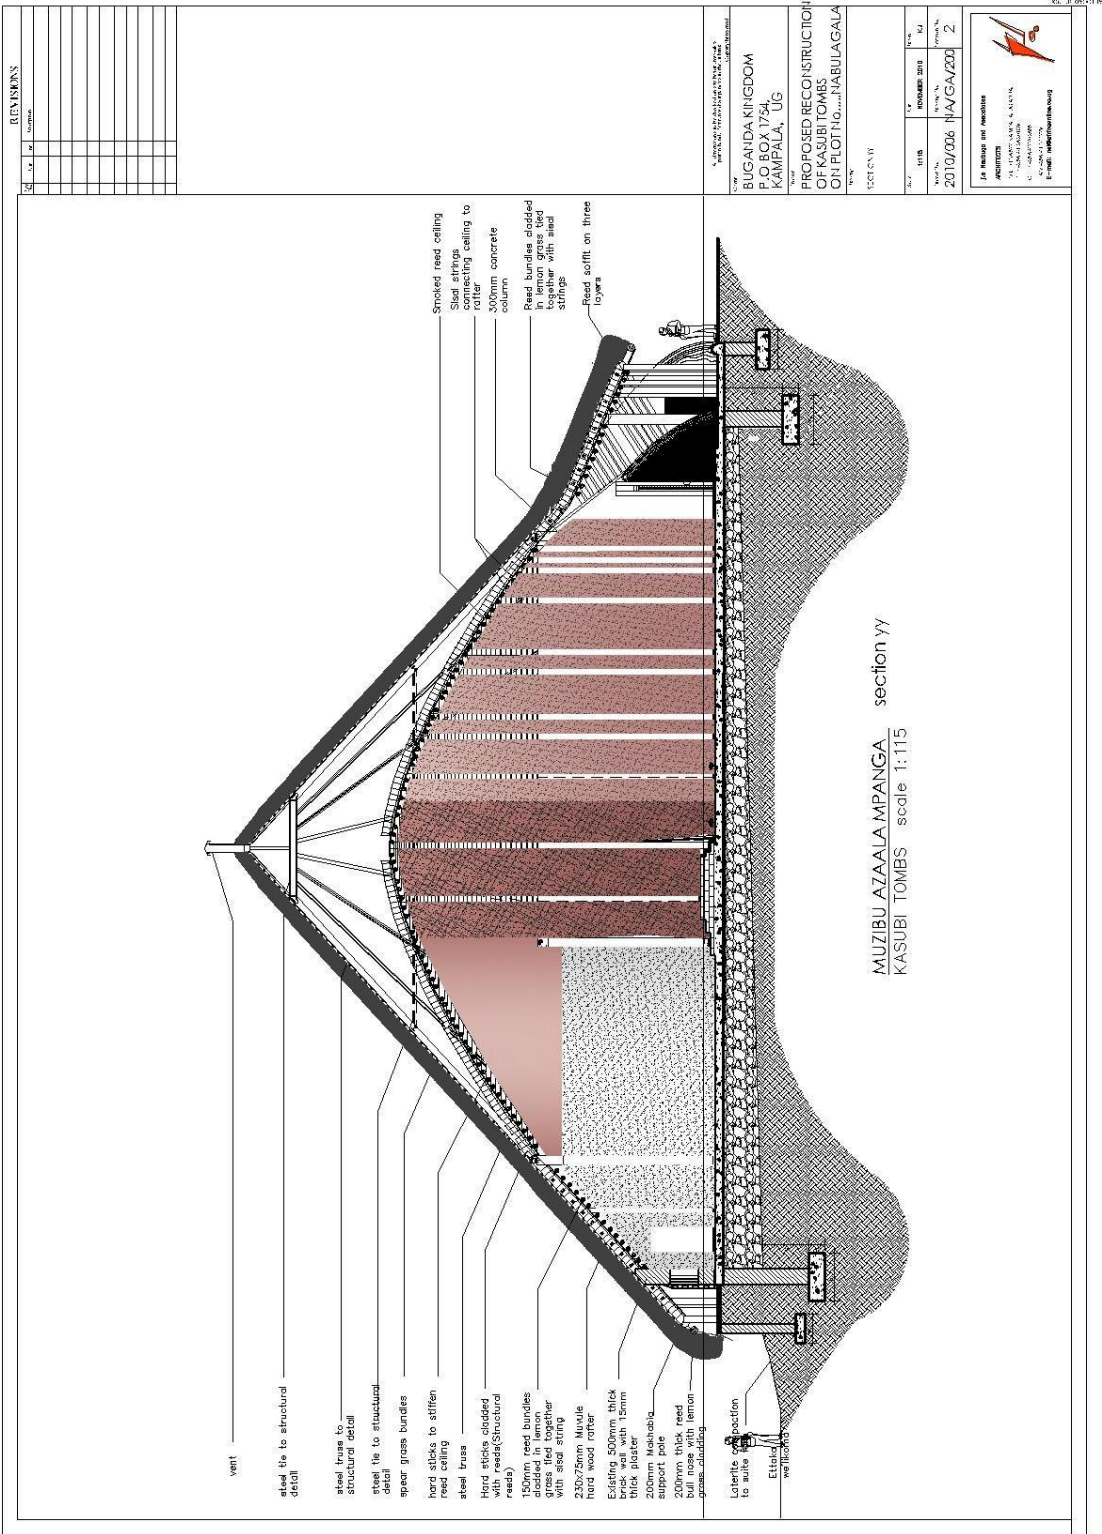
d) Reconstruction: Section through building.
