NATIONAL HISTORY PARK CITADEL-RAMIERS-SANS SOUCI – HAITI

Mission 14-29 May 2013

Summary Technical Report

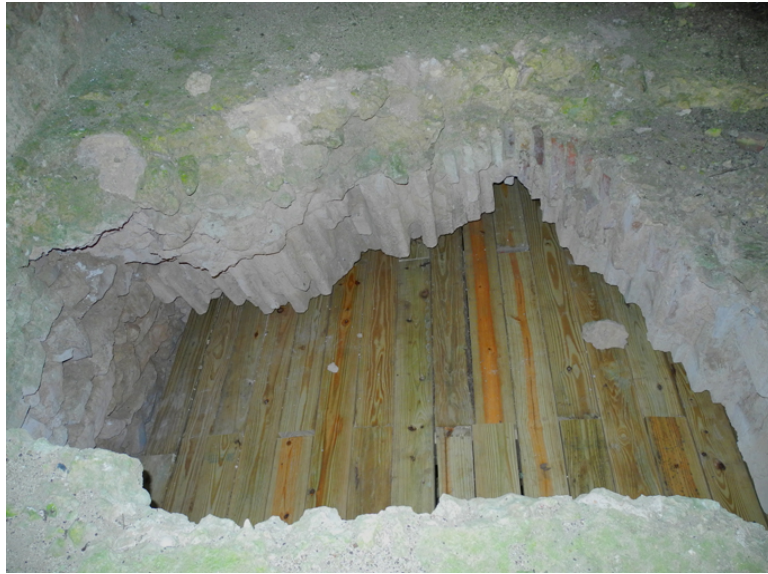
Figure 1. Scaffolding supporting one of the Coidavid vaults

Building wooden scaffoldings that isolate the single levels, reaching the ceiling (figure 1), helped in supporting the vaults. The structures are strongly built in order to guarantee the highest resistance to the mechanical solicitations induced by the detached vaults (figure 2). However, due to bureaucratic causes, the work was temporary stopped, but restarted on 25th May, using all wooden frames that were recovered in the court of the battery (figure 3). The prolonged stop of the job risks to cause serious problems to the monument stability, because the weight of the vaults is distributed in inhomogeneous way, so that the unsupported areas may move independently. Indeed, the new wooden floors strongly connect the walls of the adjacent rooms (figure 4) increasing the general stability of the building, whilst the unsupported parts may suffer the mechanical solicitations induced by the wind, and the weight of the battery itself, mainly where large fissures affect the walls (figure 5) in the highly solicited areas.

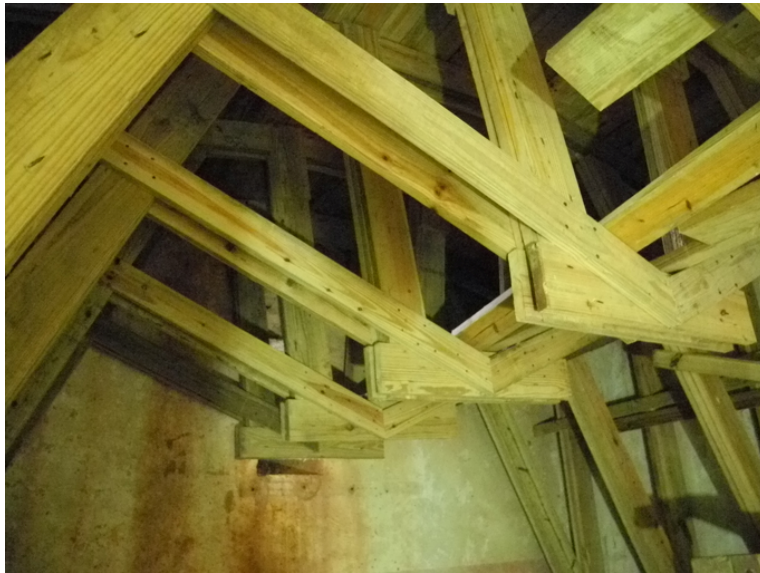
Figure 2. The trusses supporting the vault are strong enough to support the weight of the detached part of ceiling.

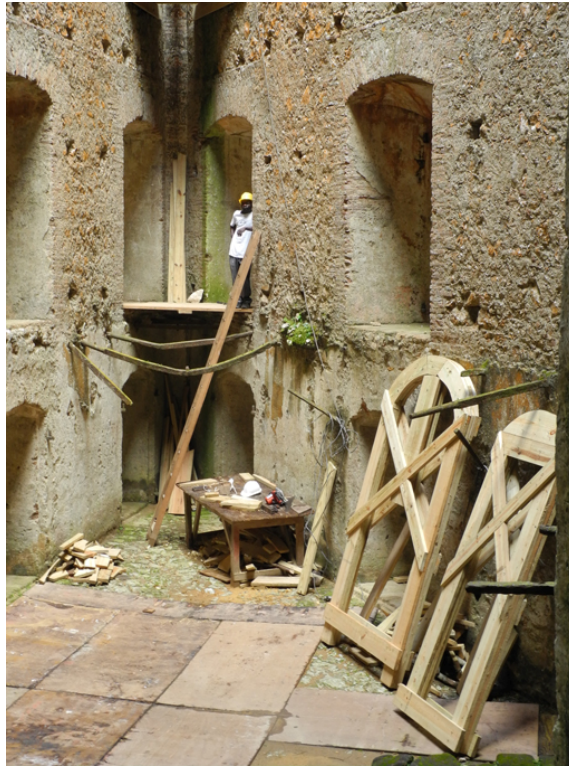
Figure 3. Wooden frames are still weather exposed and risk to damage seriously.

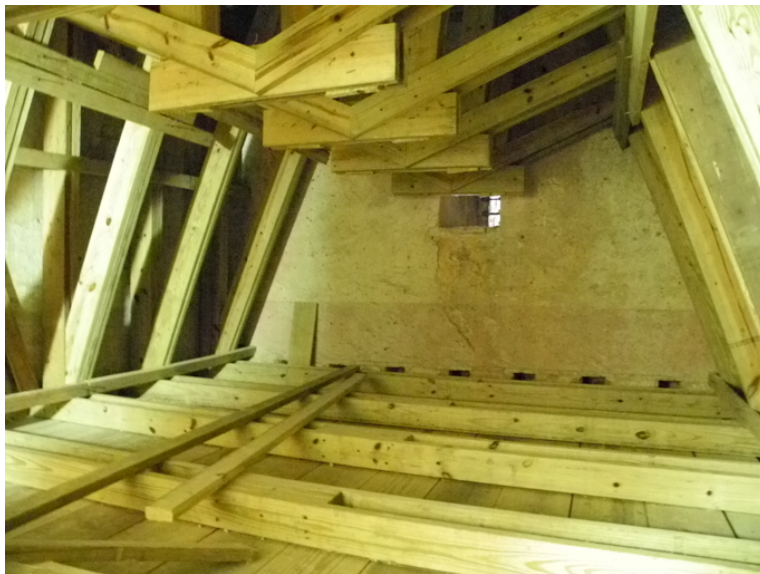
Figure 4. The new wooden planks connect the walls of the adjacent rooms increasing the stability of the building.

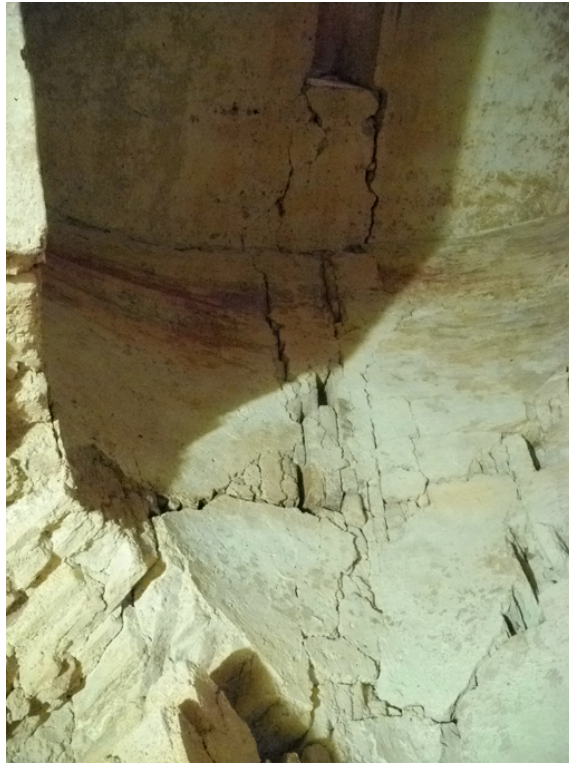
Figure 5. Fissures affecting the walls of the Coidavid Battery in the unsupported chambers

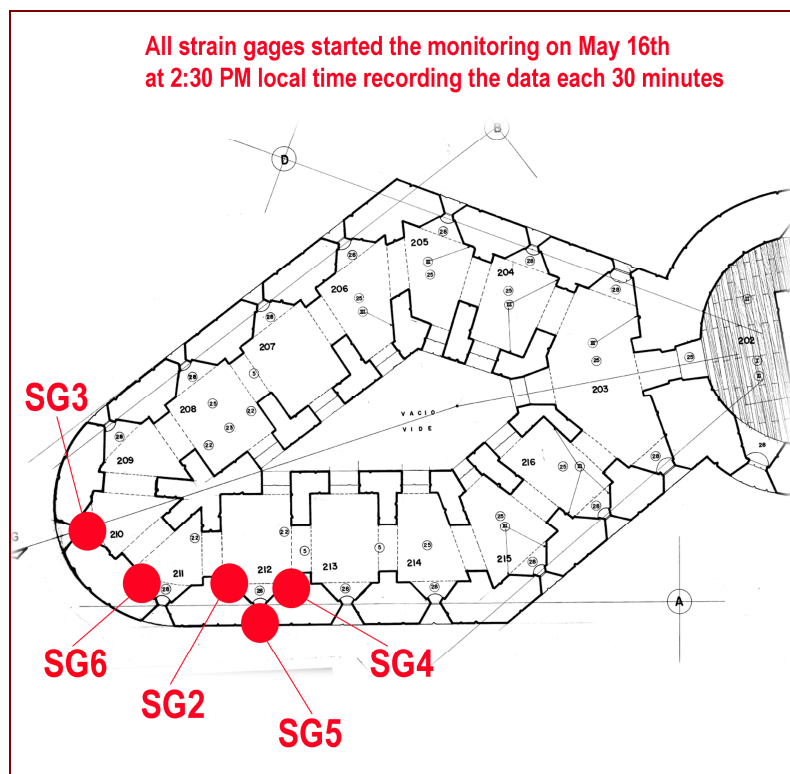
Aiming to assess the efficacy of the safety measures carried out, as well as their effects on the building stability, the new fissure's monitoring has been performed using the same locations and tools of the monitoring taken in 2012 (figure 6).

Figure 6. Location of the probes to carry out the monitoring of the fissures

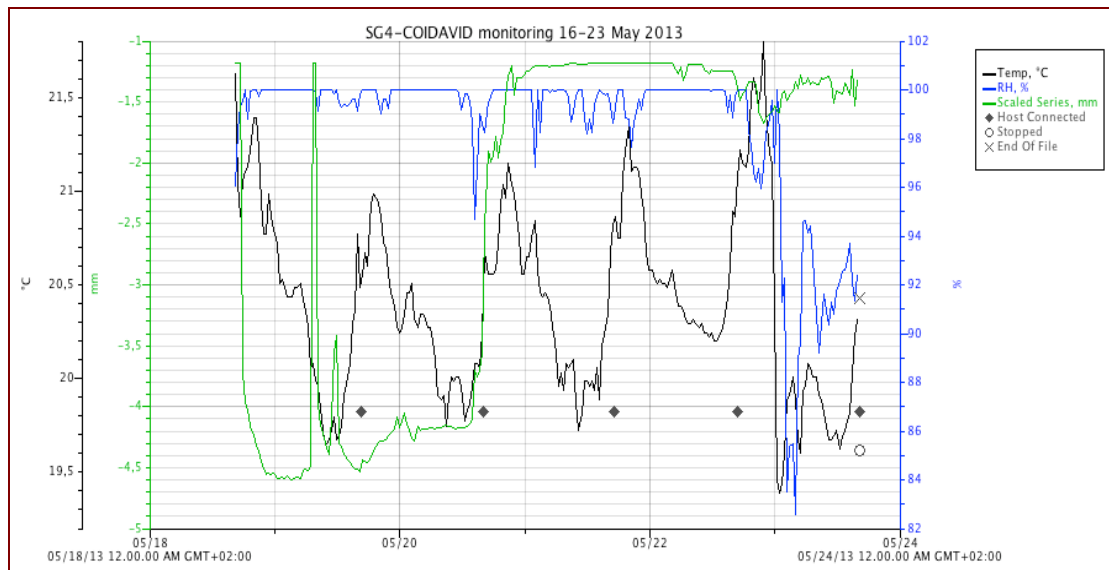
Figure 7 shows the typical graph of the trend of the three measured parameters in the whole monitoring period, and refers to the location SG4, which resulted the most active in the variability of the deformation. However, comparing all detected values, and evaluating the absolute deformation of each location allows individuating that all fissures move, according to the peculiar orientation of the fissure with respect to the geometry of the building. Figure 8 clearly shows that in case of compression, location SG4 suffers the highest negative deformation, while the other locations only slightly move. On the contrary, the strongest enlargement has been recorded in location SG2 (figure 9) that is opposite to SG4.

Figure 7. Graph of the monitoring in SG4 location showing the variability in the deformations of the fissure (green line)

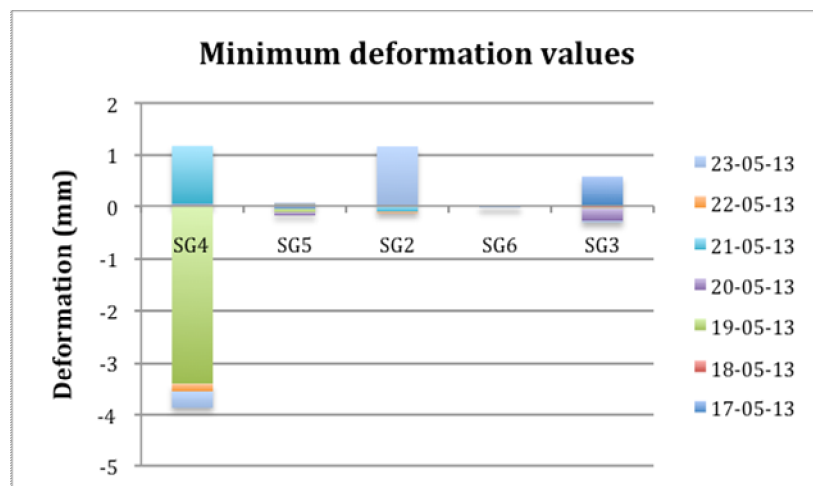
Figure 8. Cumulative negative deformation of the monitored fissures due to compression

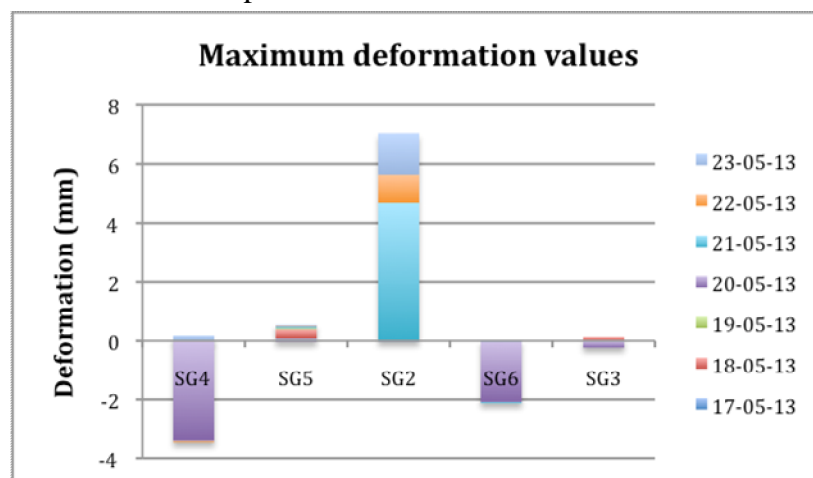
Figure 9. Cumulative positive deformation of the monitored fissures due to expansion

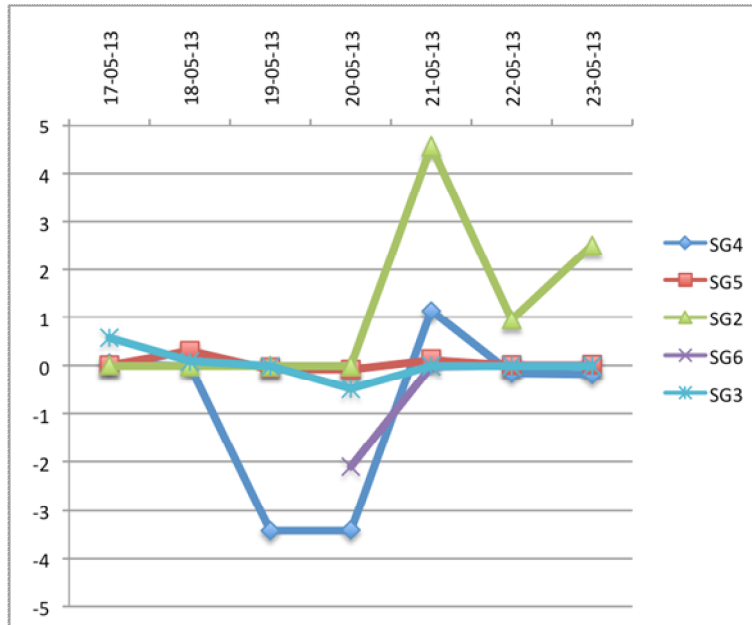
Comparing all data and calculating the absolute deformation for each location confirms that each solicitation in SG4 location induces deformation of the others fissures (figure 10); in particular, after the maximum compression value of SG4 is reached, the structure tends to react enlarging all fissures, so that the maximum enlargement is recorded in the SG2 location, which starts to move strongly. On the

Figure 10. Absolute deformation trend in the monitoring time

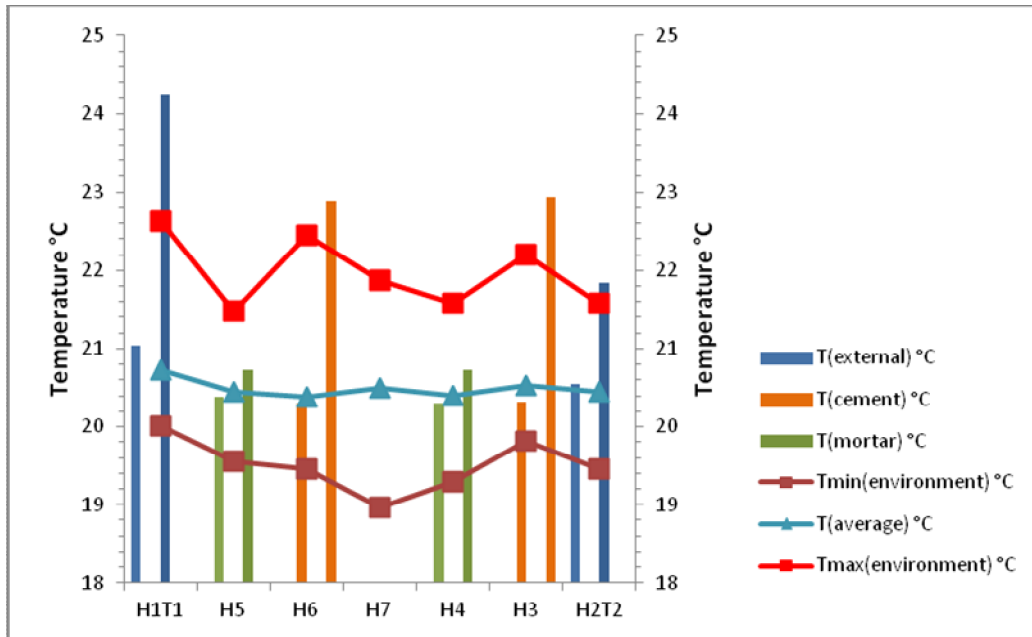
Table 1 summarizes the maximum, minimum and average values recorded in the short monitoring time from 16 to 23 May 2013, while figure 12 shows how the values vary with respect to the average temperature value of each location. Figures 13a÷g show the charts recorded during the microclimate monitoring.

The external reference probes in the locations H1T1 and H2T2 have great differences between the maximum and minimum values, but the difference decreases in the inner court of the battery, which is sun exposed and protected by the wind. The environment values refer to the temperature recorded by the probes located close to the wall surface and allow evaluating that all probes little differ according to the peculiar location. This confirms that the geometry of the chamber and the protections applied to the windows and to the arches contribute to stabilize the indoor

Figure 12. Comparison among the Temperature data collected in the Coidavid Battery in the period 16-23 May 2013

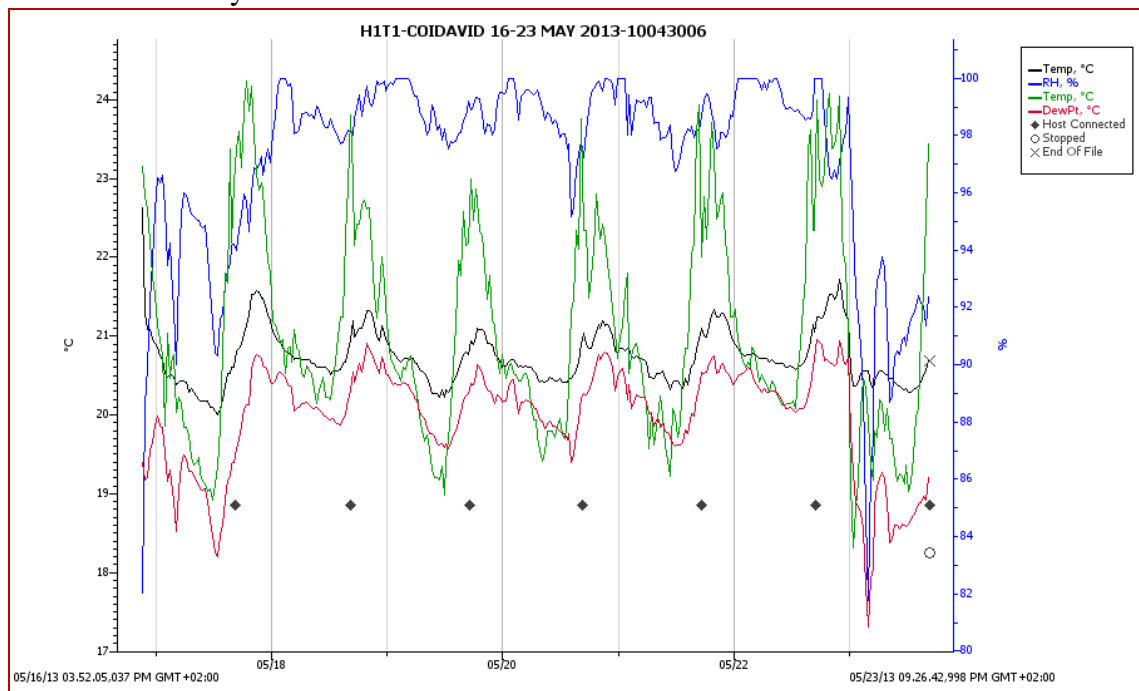
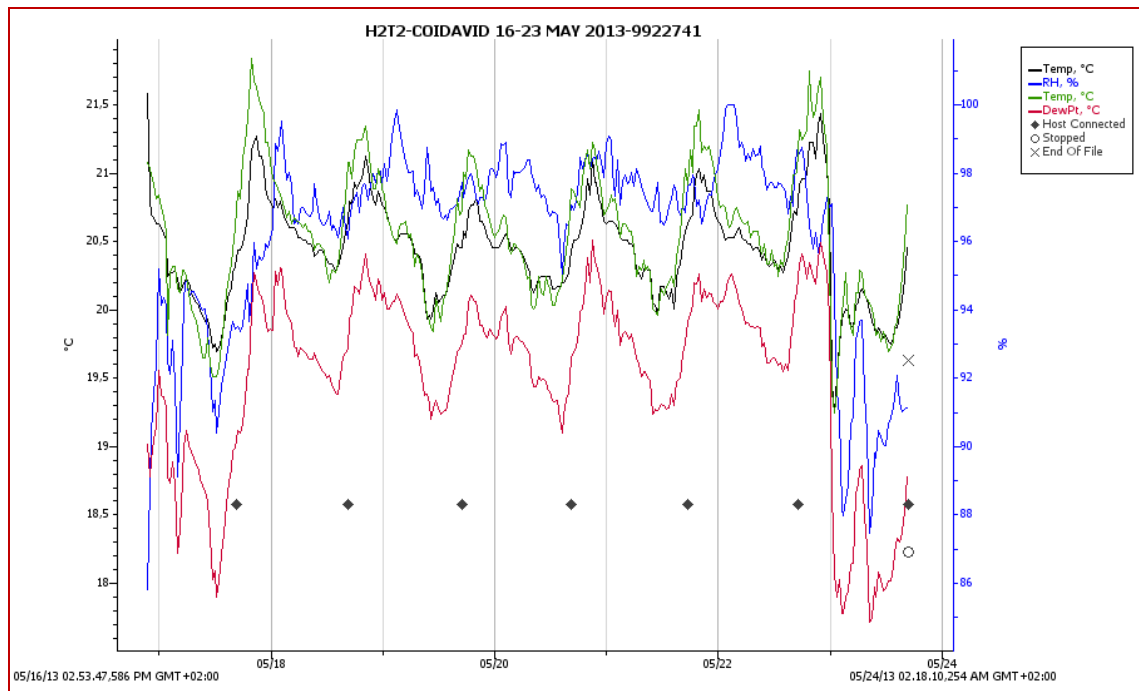
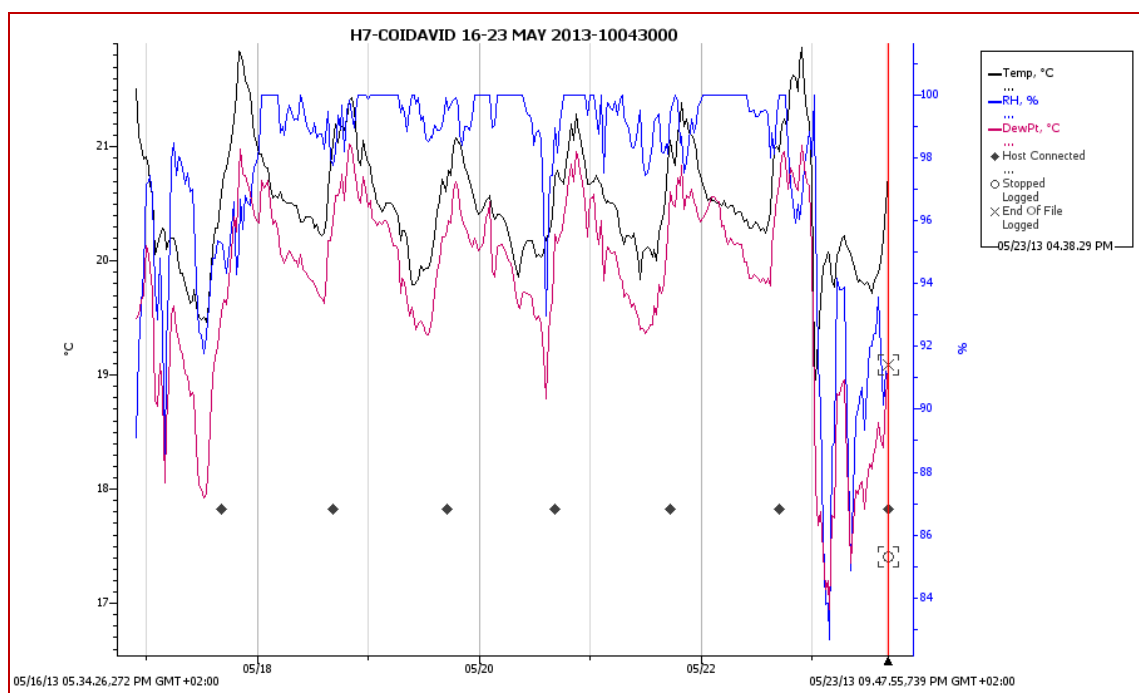
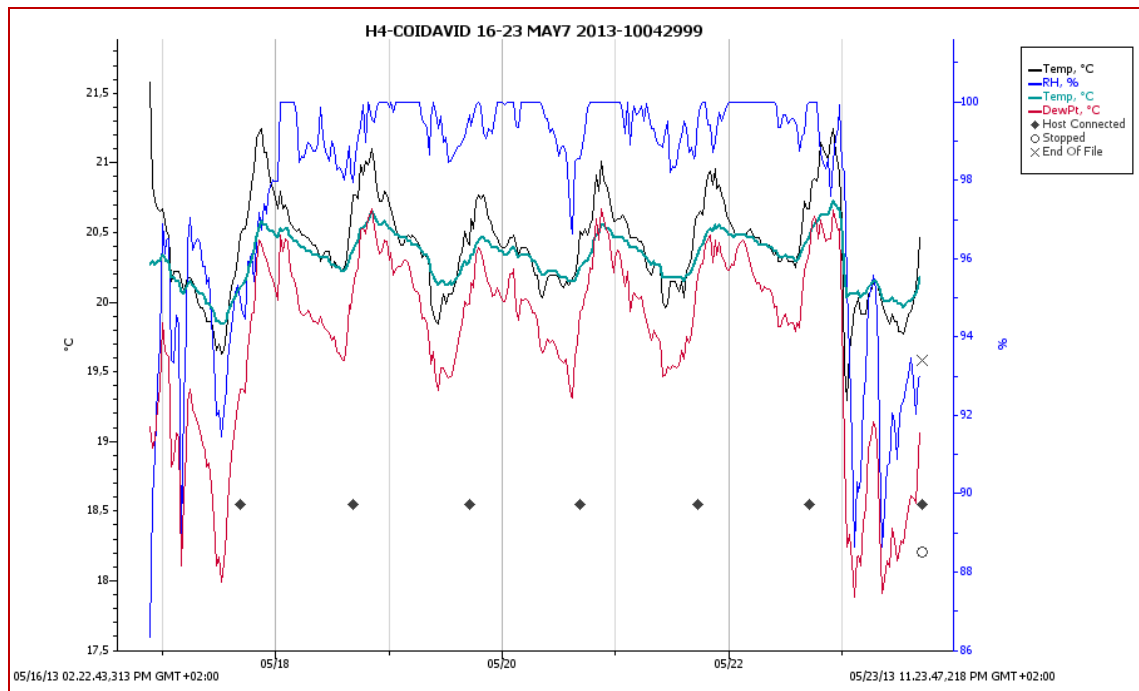
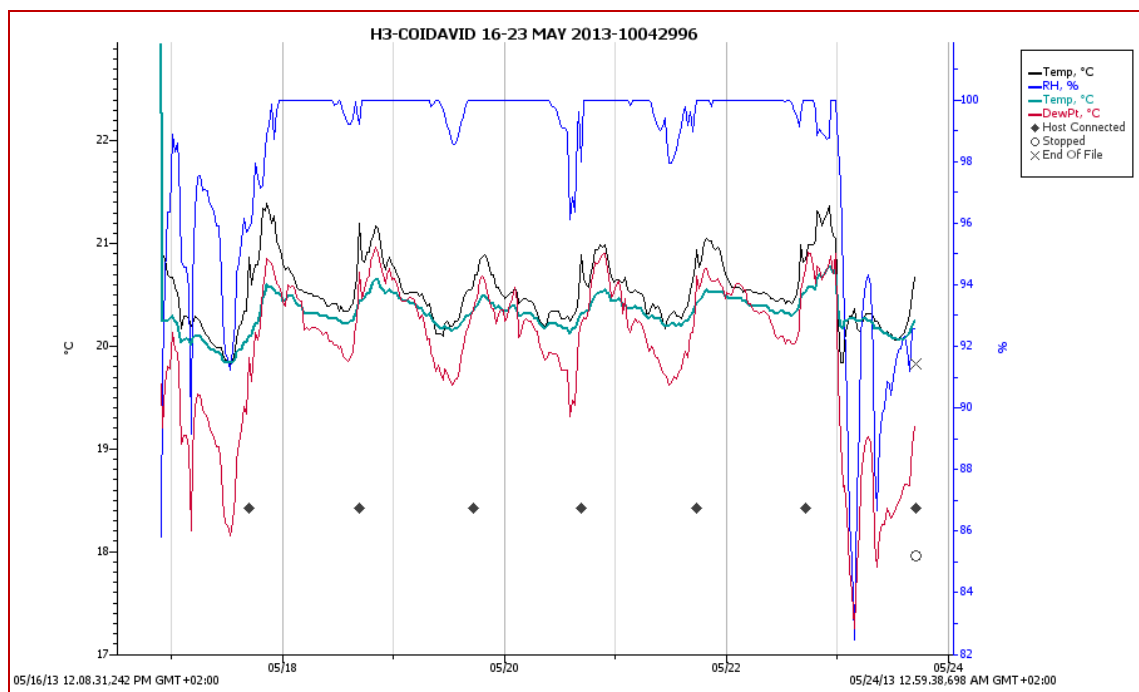
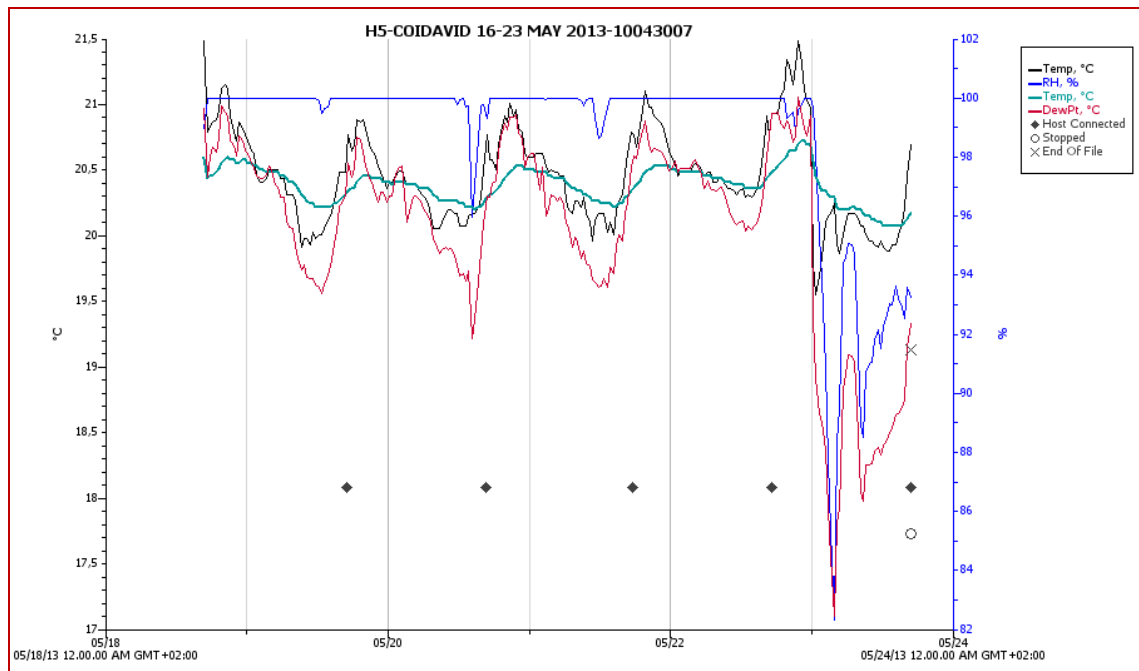
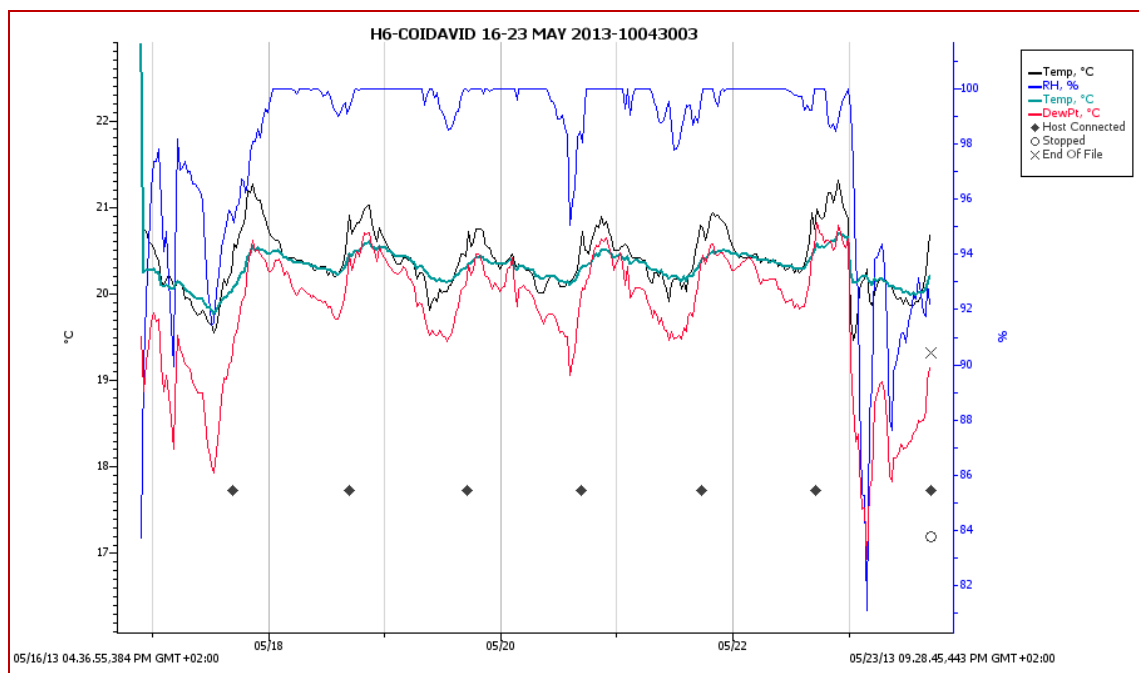
Figure 13a÷g. Charts of the microclimate within chamber 3L of the Coidavid Battery from 16 to 23 may 2013 in the several locations

microclimate. However, opening the doors reduces the relative humidity values in the chamber, but not eliminates the phenomenon of the water condensation on the wall, as the Dew Point trends and values confirm. Indeed, the locations from H3 to H6 shows that the water condensation temperature is often greater than the mortar or concrete temperature, while in the same location the RH % values often reaches the saturation point. Thus, liquid water forms on the walls, but also comes from the top of the arches as the thermal images show. Furthermore, looking at the images recorded outside and inside the closed cannon embrasure (set 3L) confirms that completely closing the room increases the frequency of the water condensation on the walls and consequently the risk of damage of the plasters (figure 14)

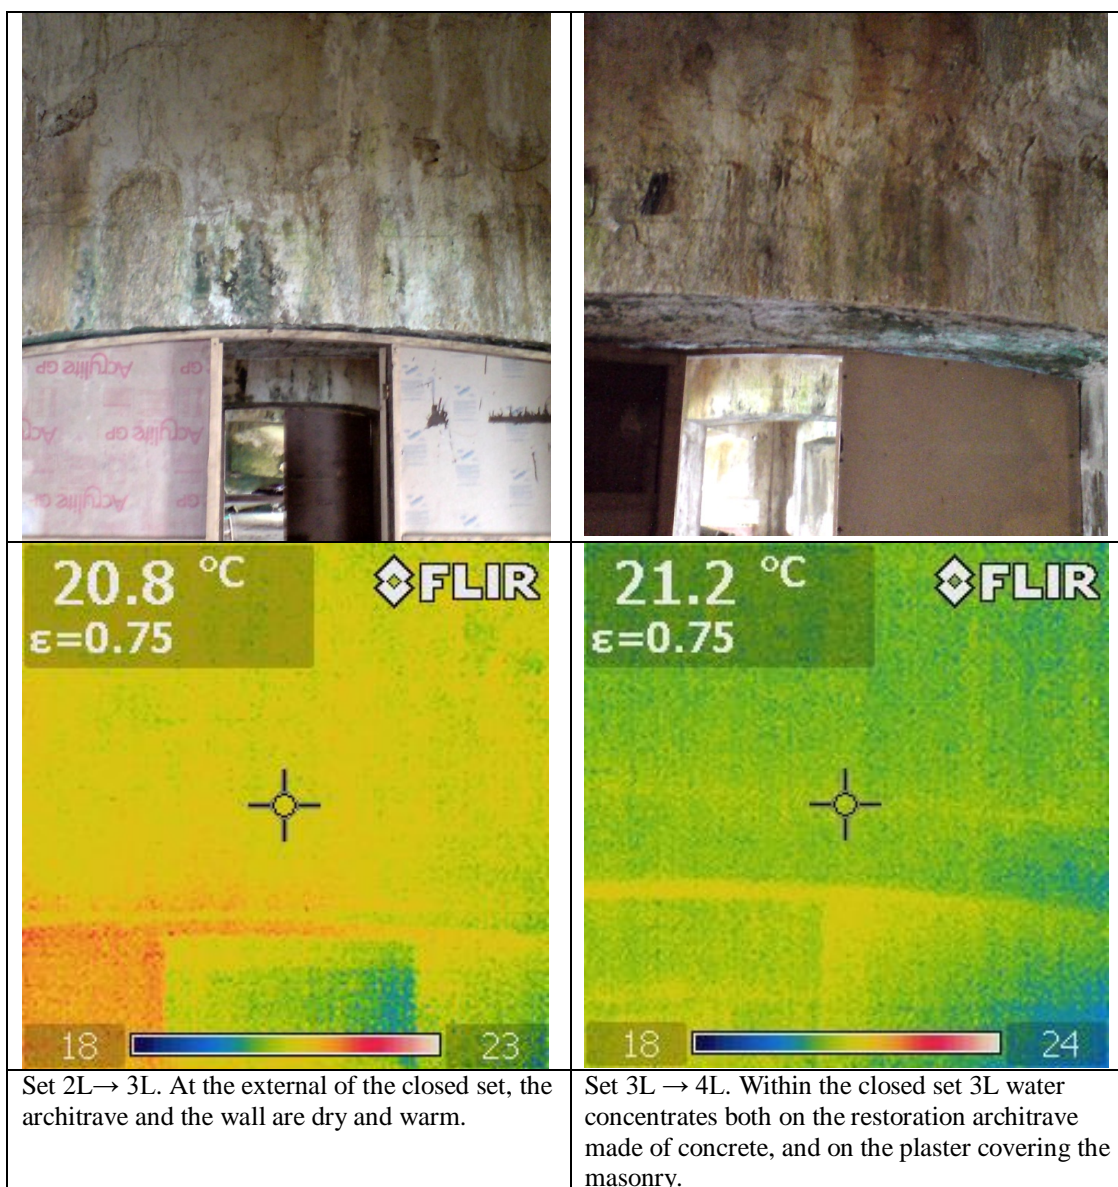
Figure 14. Comparison of the FLIR images outside and inside set 3L

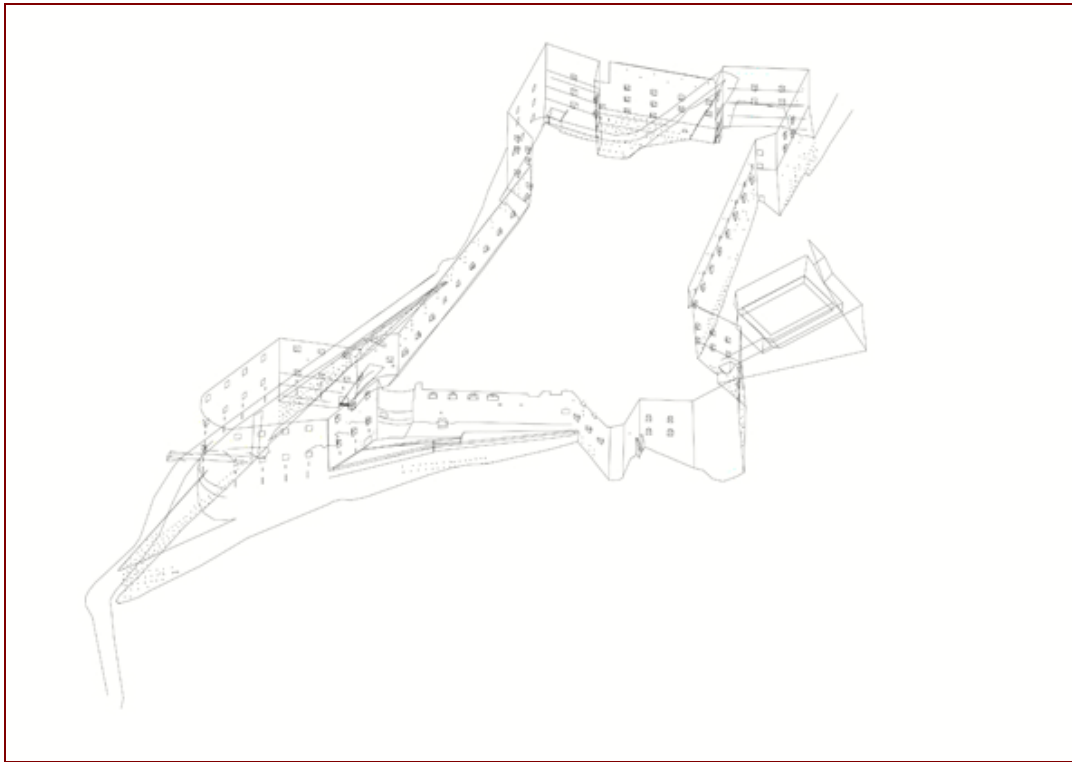
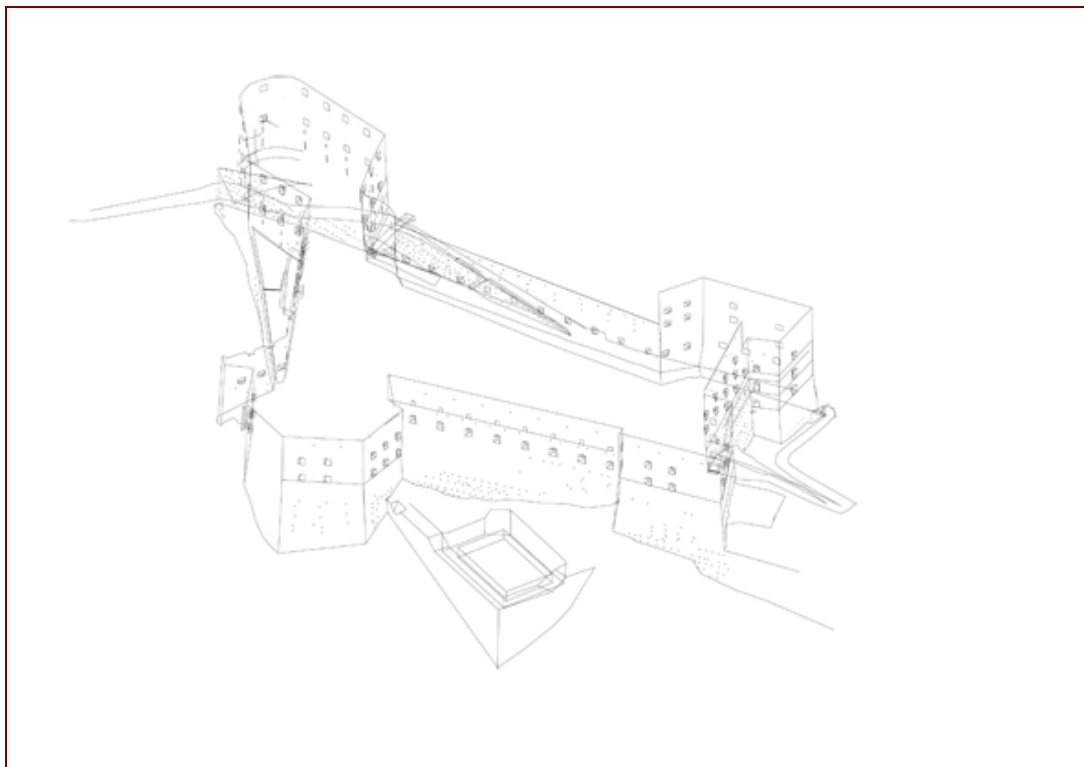
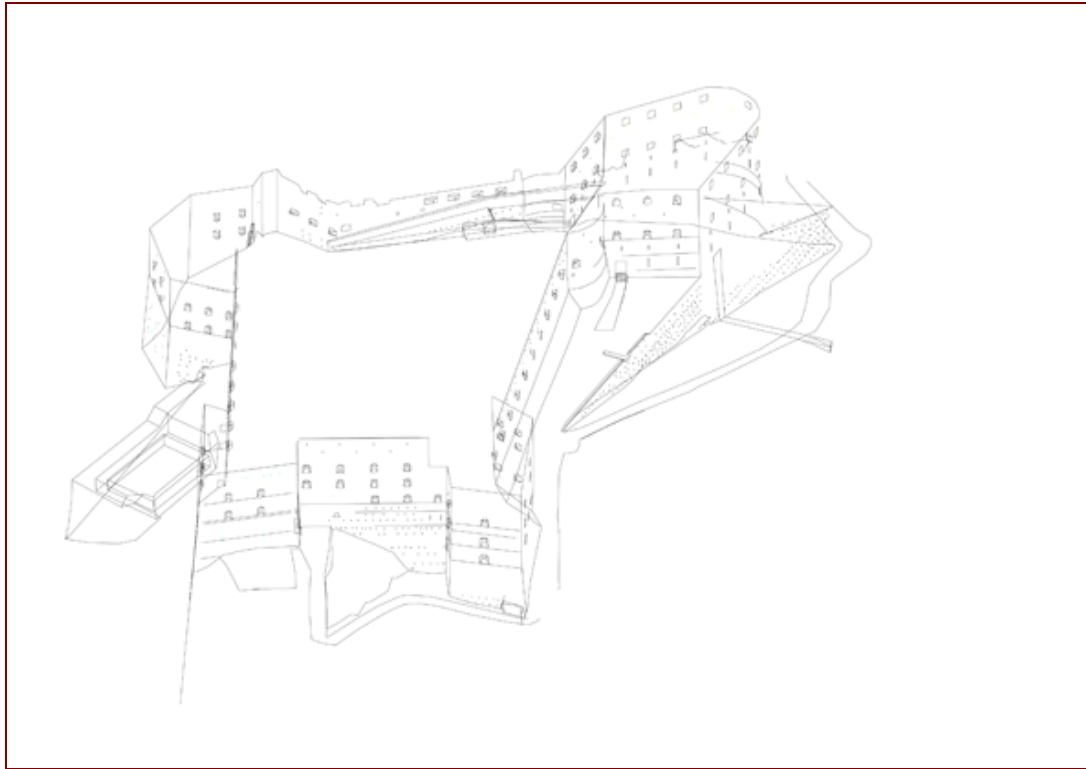
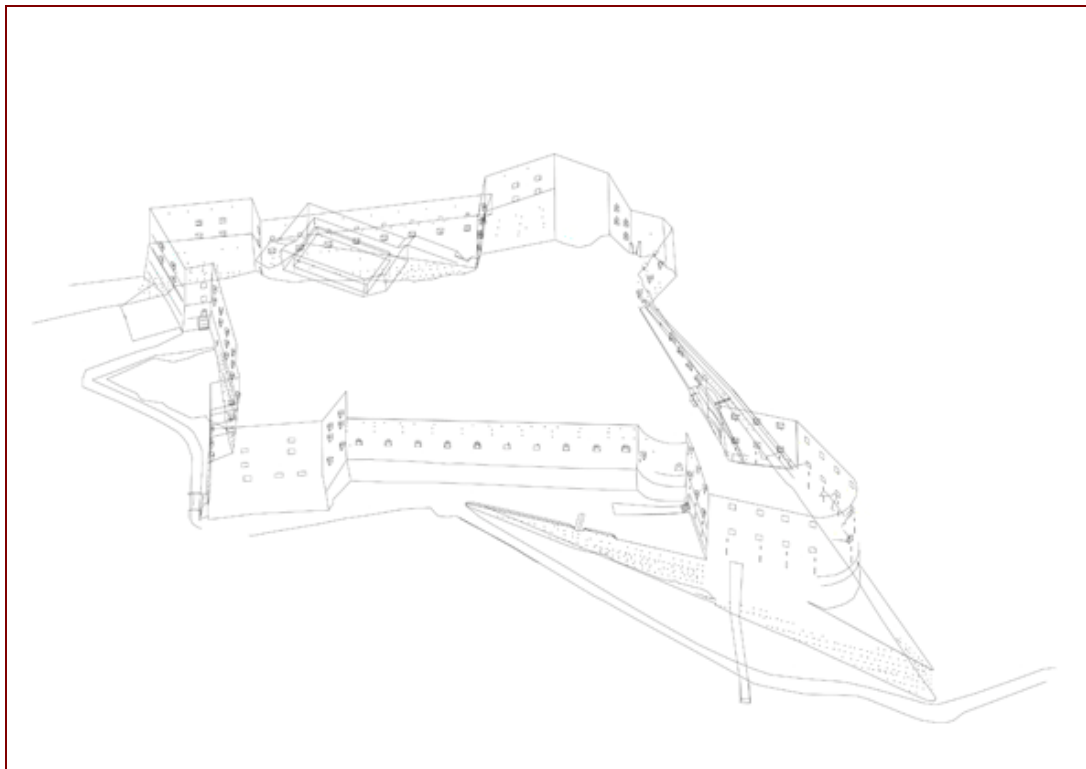
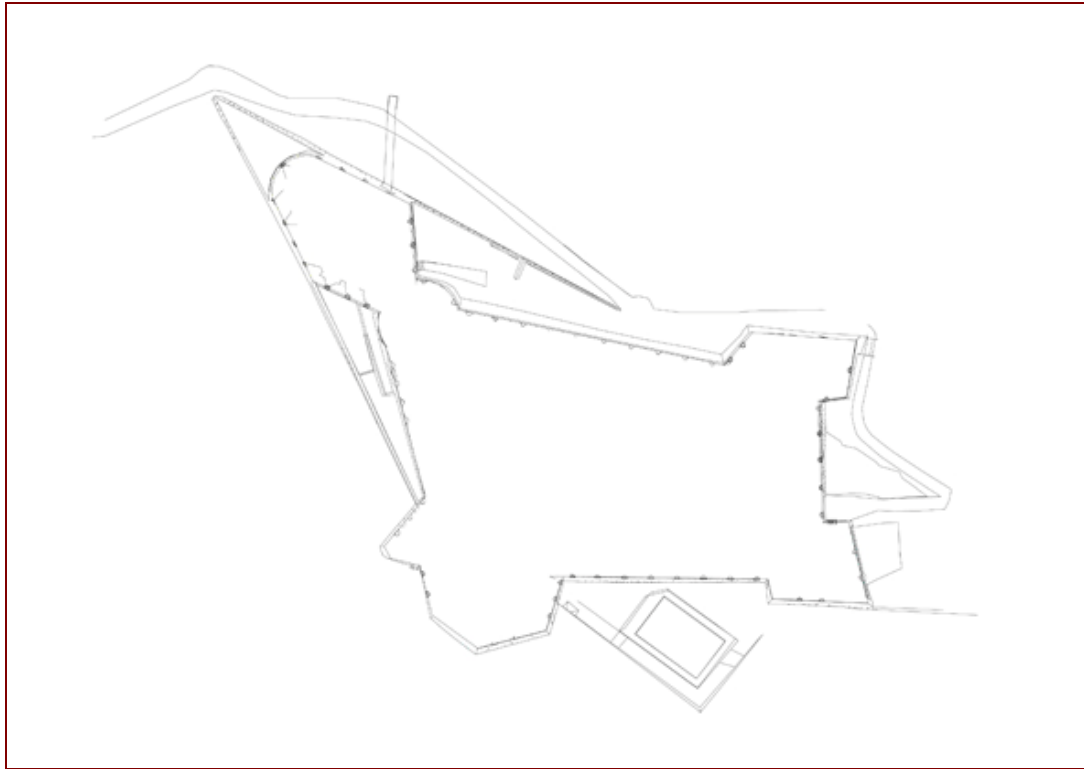
Figure 15. 3D isometric view (sky-line) of the Citadel from Northeast side

Figure 16. 3D isometric view (sky-line) of the Citadel from Northwest side

Figure 17. 3D isometric view (sky-line) of the Citadel from Southwest side

Figure 18. 3D isometric view (sky-line) of the Citadel from Southeast side

Figure 19. Plan of the Citadel from 3D sky-line.

As for the project and the contract, one of the activity to be carry out aimed to obtain the digital and graphic representation of the external surfaces of the whole monument, in order to assess the reliability and usefulness of the drawings given by ISPAN as base of the next projecting activity. The survey has been performed by a total station and allowed obtaining a 3D representation of the monument in its complexity (figures 15, 16, 17, 18, 19). The comparison with the take-over obtained in the years 1980-82 has shown that these drawings do not match perfectly with the present 3D sky-line representation, probably due to the increased precision of the new instruments. Consequently, in order to prepare the best suitable graphic material to support the restoration project of the Coidavid Battery, the plan of the third level of the pavilion was taken (figure 20), also locating the collapses of the vaults and the height of the pavement in several locations.

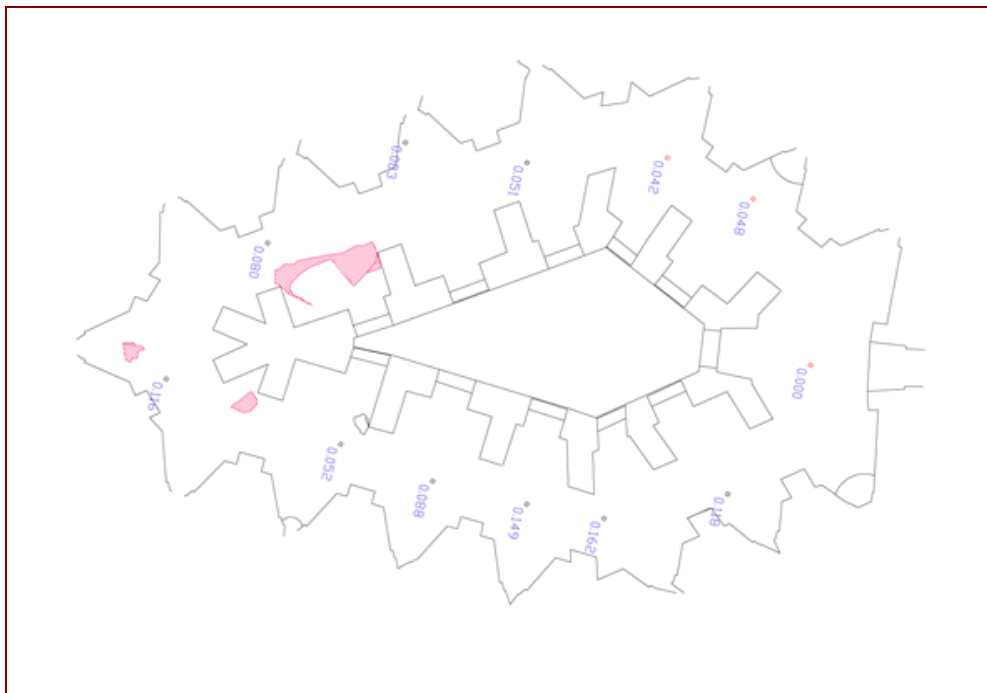
Figure 20. Plan of the third level of the Coidavid Battery

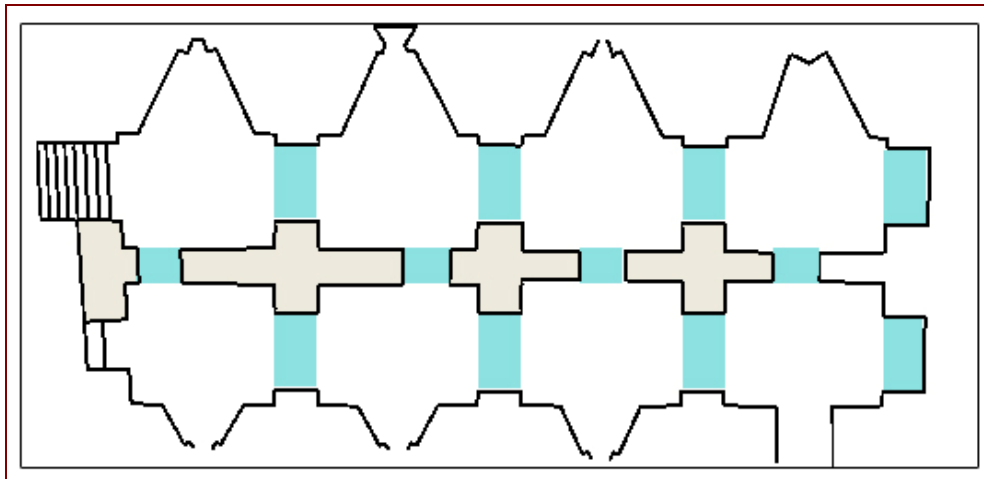
Furthermore, the 3D sky-line recording of the inner court connecting the Princess, Queen and Prince Royal Batteries was taken in order to obtain the front representation of each battery suitable to record the distribution of the degradation patterns and to plan the restoration activities. In particular, the front of the Queen Battery has been connected with the plan recorded at the last floor level (figure 21), where the strain-gage monitoring system was placed to monitor the deformation of the fissures affecting the vault of the second chamber in the west side of the battery.

Figure 21. Plan of the upper level of the Queen Battery

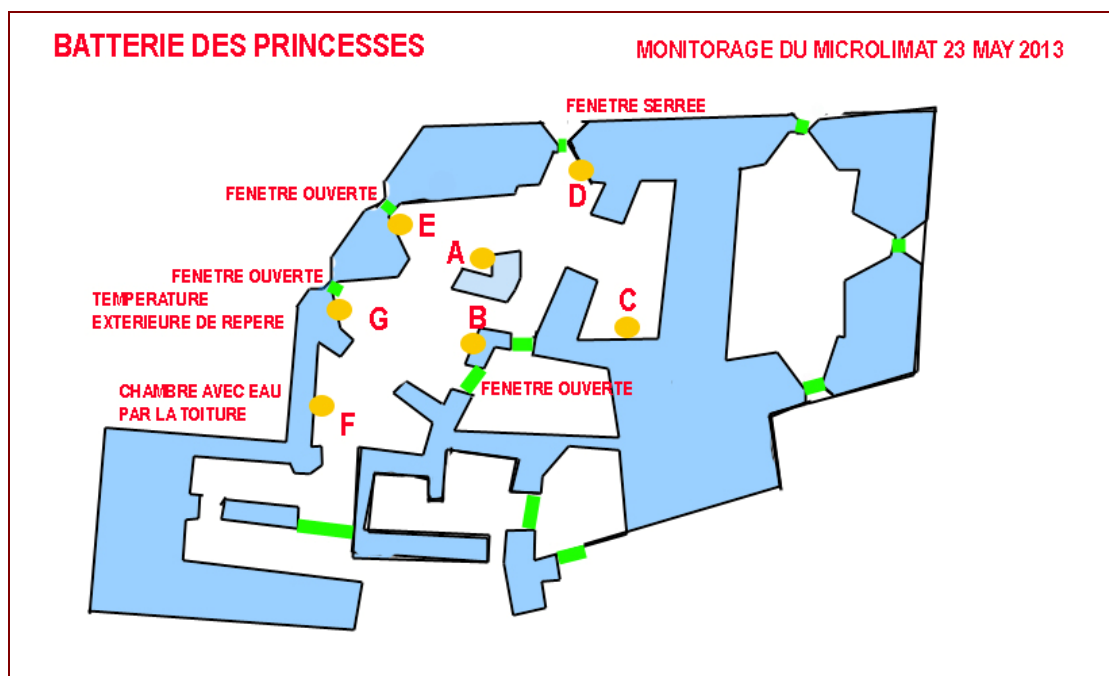
On May 23rd the microclimate system was placed in the upper level of the Princess Battery in order to collect data regarding the measures to be applied to properly use the level for the exhibition. The probes were distributed within the level according to the plan proposed in figure 22: location A is the reference probe recording both average temperature and relative humidity, while location G contains the external reference temperature in the north exposed front. The remnant locations will record

Figure 22. Location of the microclimate probes within the Princess Battery

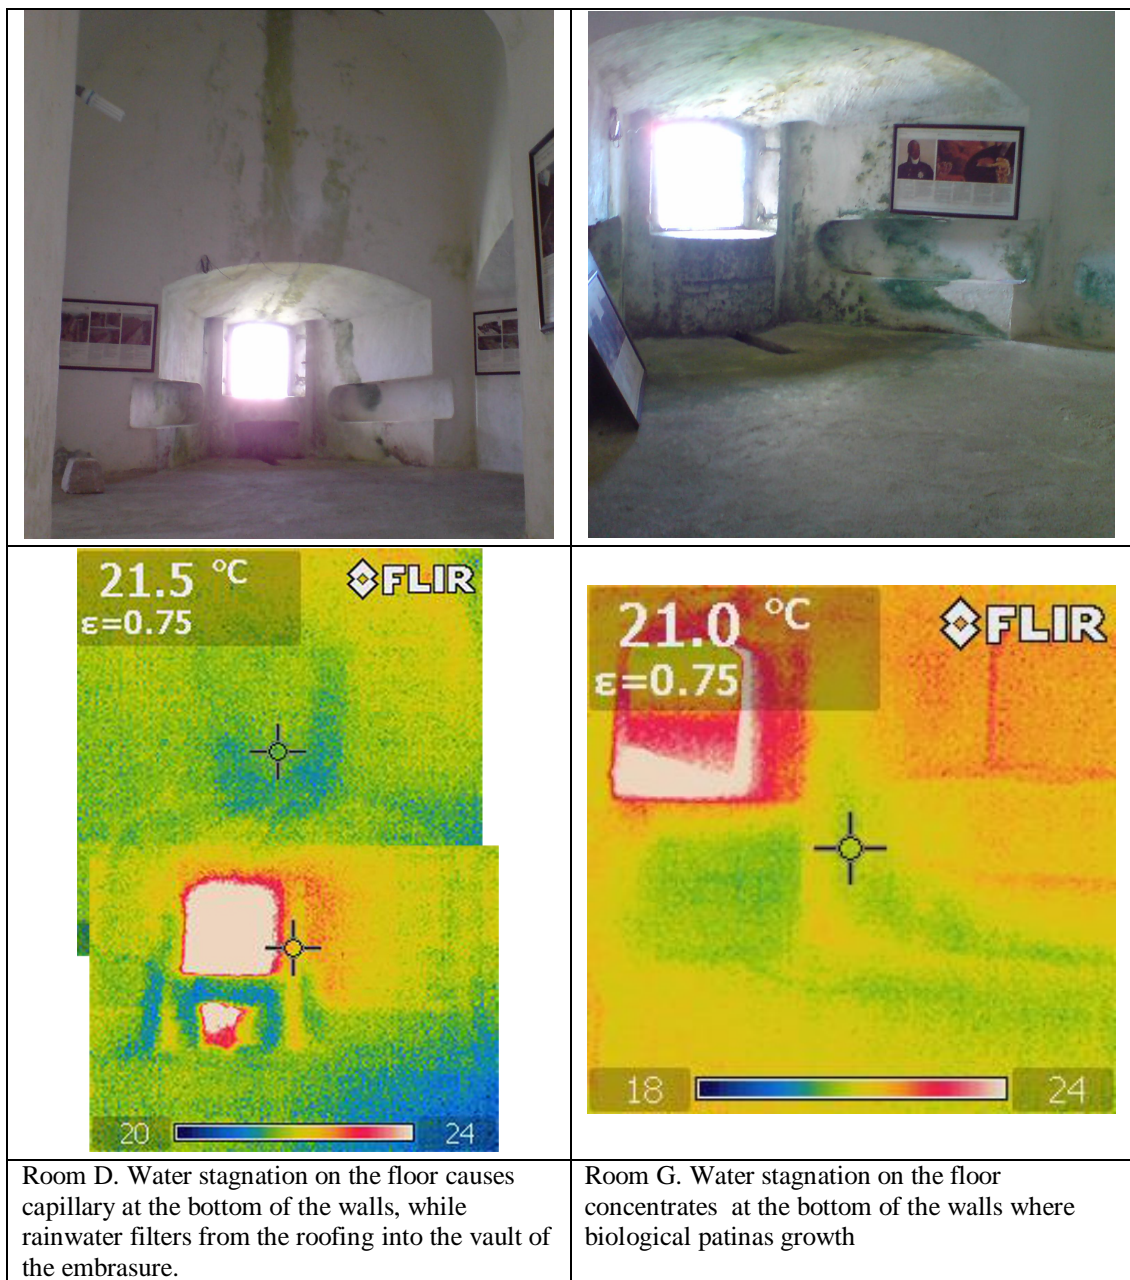
Contemporary, the recording of FLIR images has been made aiming to individuate the anomalies in the water distribution inside the masonry. The comparison among the pictures recorded in the several rooms of the battery allows verifying that water affects the masonry both because of the infiltration from the roofing, and the capillary at the bottom of the walls, owing to the stagnation of liquid water at the floor level, when rainwater filters inside the battery (figure 23).

Figure 23. Within the Princess Battery water affects the masonry both because of the capillary from the floor, and the intrusion from the roofing

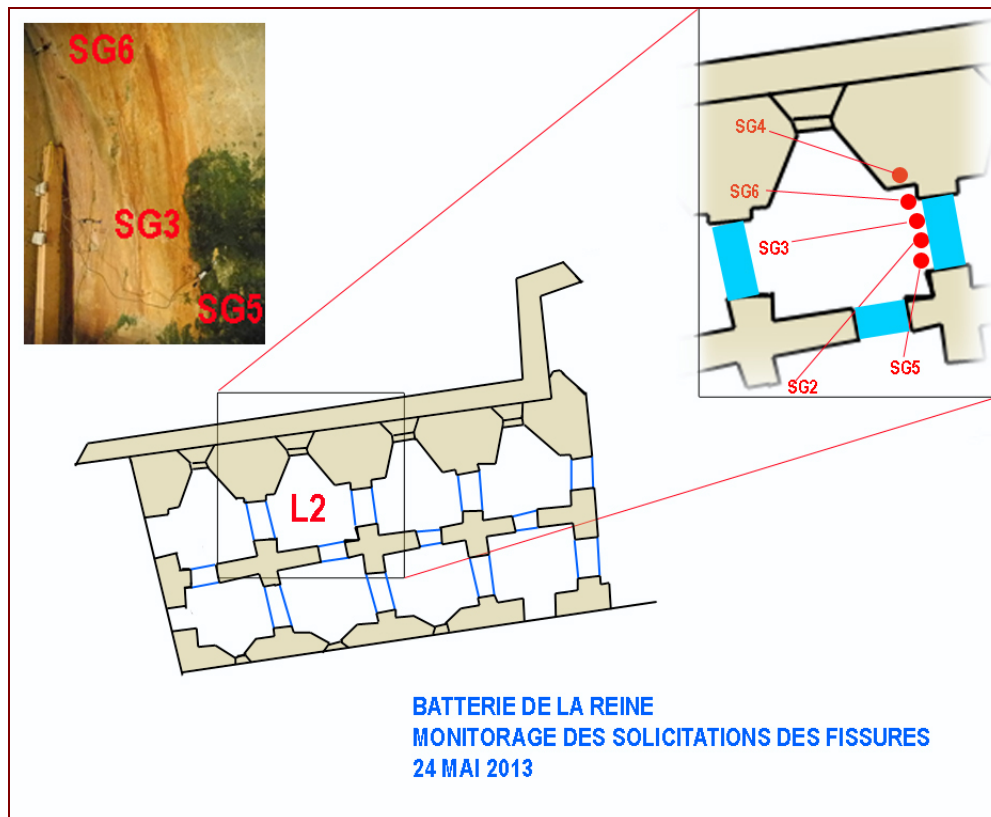
On May 24th the dynamic deformation monitoring system made of five probes was placed within the second chamber of the upper level of the Queen battery (figure 24) in order to monitor continuously the movements of the fissures affecting both the walls and the vault. The data collected on May 25th show that all fissures suffer minimal deformations that are generally opposed: SG4, SG6 and SG3 recorded negative absolute deformation (the fissures tend to close by compression), while SG2 and SG5 tend to enlarge. However, the general trend of deformations will be properly evaluated after a long monitoring time.

Figure 24. Location of the deformation monitoring system in the Queen Battery
