NATIONAL HISTORY PARK CITADEL-RAMIERS-SANS SOUCI – HAITI

Mission 14-29 May 2013

Summary Technical Report

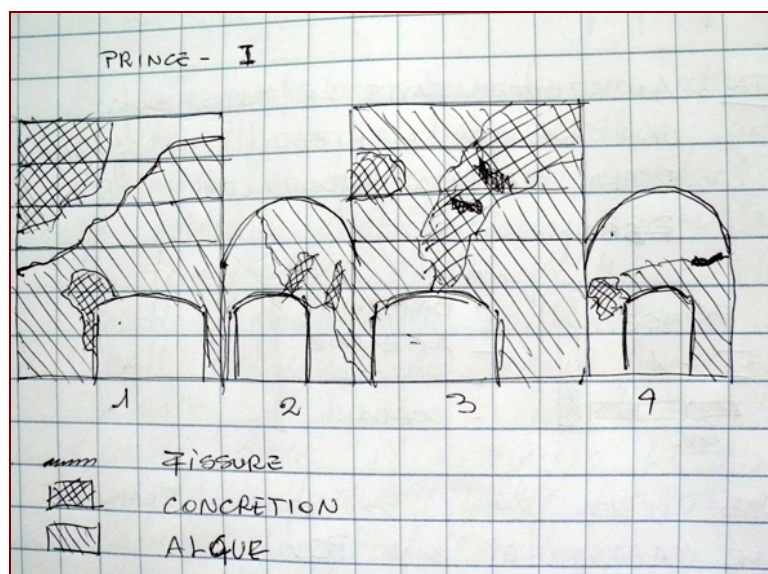
The levels of the battery were investigated both visually and by IR camera in order to record the distribution of the typical damages and the presence of water inside the masonry. During the visual survey sketches and photos were taken, aiming to simplify the graphic representation of the damages (figure 25) to be properly recorded in general degradation tables, according to the labeling of the rooms proposed in figure 26.

Figure 25. Example of sketch representing the distribution of typical damages on the walls

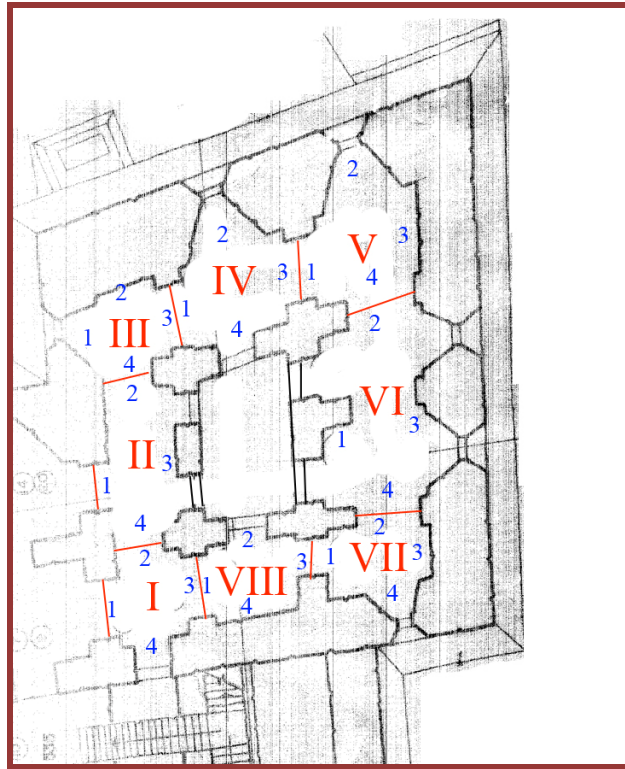
Figure 26. Conventional labeling of the rooms and the walls within the Royal Prince Battery

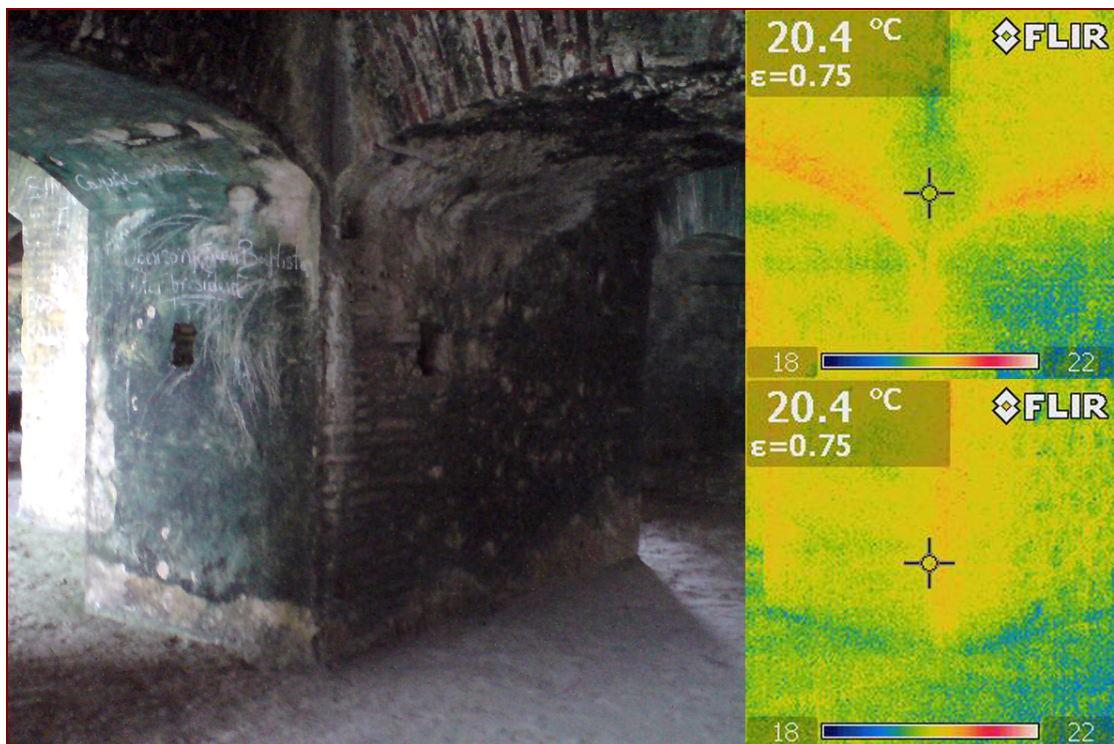
Contemporary, the instrumental investigation of the most damaged areas has been carried out in order to collect images representing the distribution of water inside the masonry. Using the IR camera, which gives both color and IR pictures of the investigated area, made this peculiar survey. Figure 27 shows an example of the collected information. A total number of about 140 pictures were recorded analyzing the battery chambers.

Observing figure 27 allows individuating in the high relative humidity value the main cause of biological degradation: indeed, all walls are covered by green algae patina that develop thanks to the water absorbed by air and salts extracted from the masonry. However, the IR images show that water mainly concentrates in the upper vault levels and at the bottom of the wall, as well as in the less sun exposed surface (the right side of the arch). Thus, the presence of water is due both to infiltration from the ceiling, and to the accumulation at the pavement, which was plastered by cement mortar during the last restoration works. However, the texture of the masonry also affects the

Figure 27. Example of IR investigation of damaged masonry within the Royal Prince Battery.

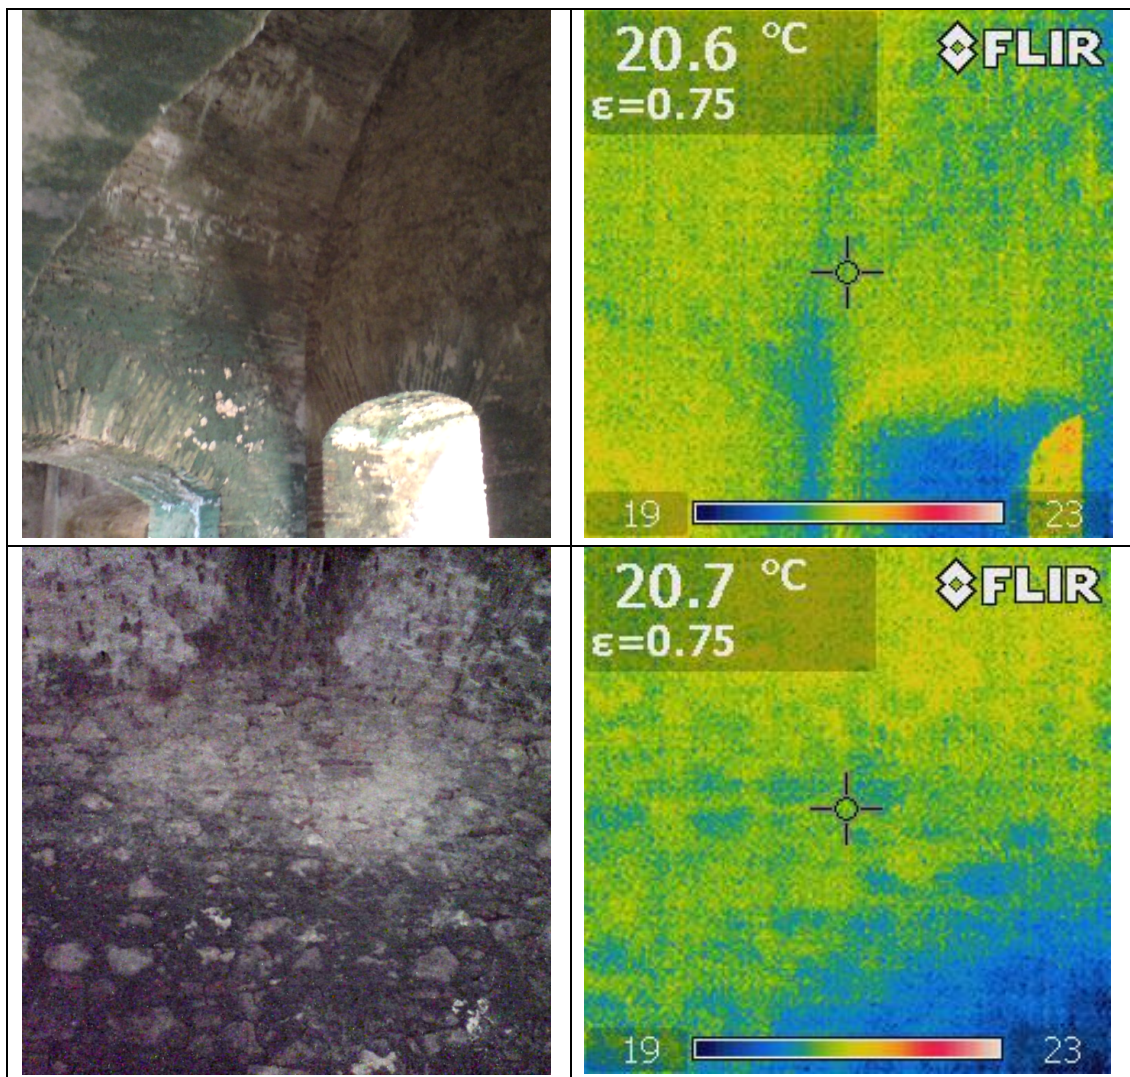
distribution of water inside the masonry when rainwater penetrates inside the vaults (figure 28) casually distributing into the walls.

Figure 28. Royal Prince Battery, Room II,2-3. The vault and the wall exposed to the court are water saturated, as well as the arch of the window. Analyzing the wall 3 evidently appears that water preferably concentrates in correspondence of the stones, defining the texture of the masonry.

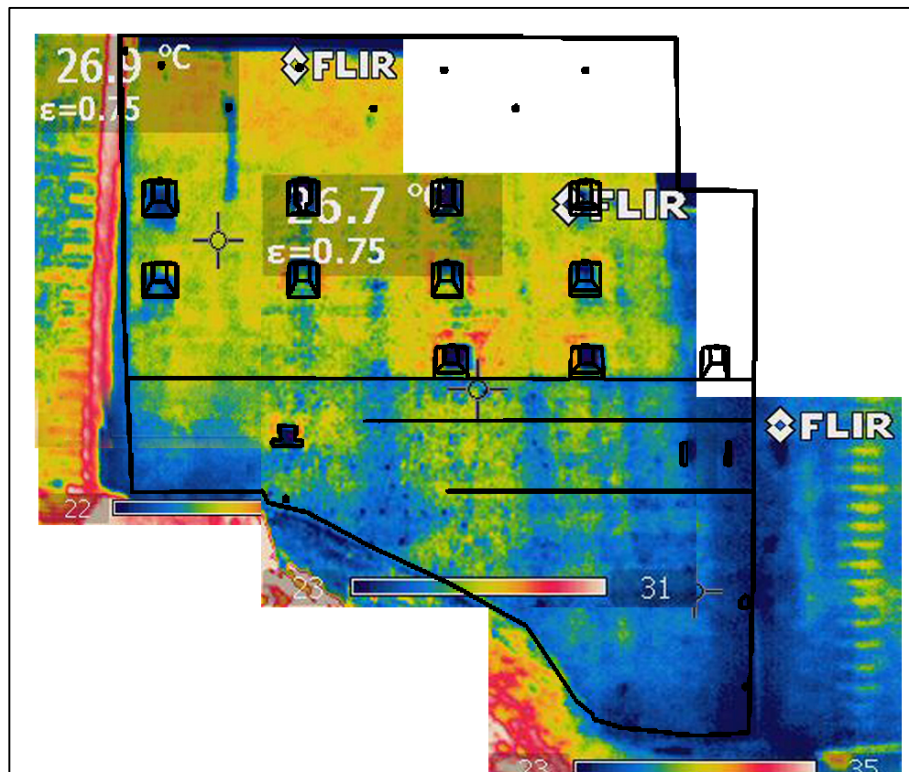
The investigation of the external surfaces of the batteries (namely Princess, Queen and Royal Prince Batteries) has been possible because of the favorable weather conditions that ensure the penetration of rainwater in the night and its evaporation during the day. Figure 29 shows an example of integrated representation of the water distribution into the masonry of the Queen Battery obtained merging the skyline front from topographic survey and the IR pictures recorded in the same day and hours.

Observing the figure clearly appears that water enters the wall from top, owing to both the fissures in the vault of the upper level, and to the drainage system that do not works properly. The blue areas, indeed, represent the coldest areas where water preferably accumulates; this is true for the upper half of the building, while the lowest part is mainly affected by water capillary owing to the presence of soil on the left side and of an external well in the right side. Furthermore, the level immediately under the gun embrasures must be better investigated because of the anomalous distribution of water, declared by the blue and green areas that start from this ideal line

Figure 29. Integrated representation of water distribution into the external masonry of the Queen Battery

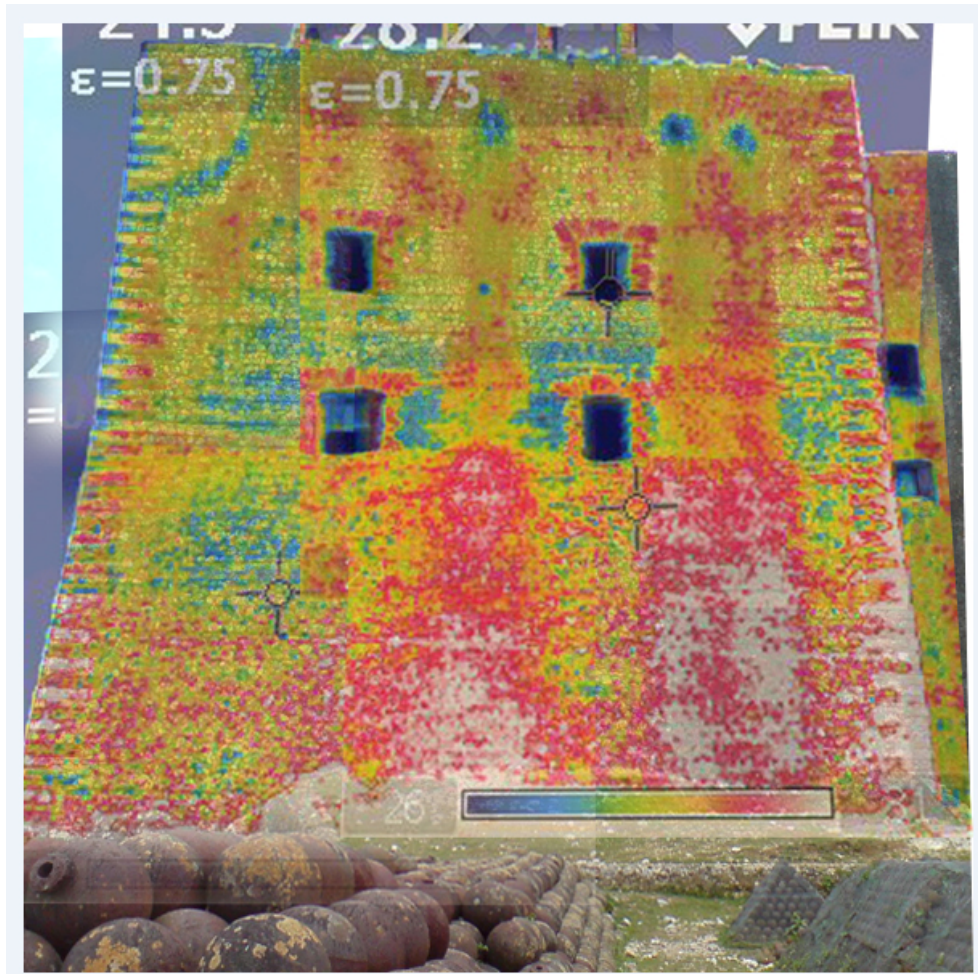
Figure 30 shows the water distribution inside the external facade of the Royal Prince Battery obtained merging the several pictures recorded in the same weather conditions: the distribution of the blue areas (corresponding to the coldest and wet ones) clearly shows that water preferably comes from the roofing and that distributes into the masonry according to its texture and conservation history. Indeed, all gargoyles are water saturated, while the upper left corner is partly isolated from the fortress by a fissure or restoration mortar, which needs to be better investigated.

Furthermore, the concentration of water above the first level of the embrasures confirms that water deeply penetrates the vaults affecting the stability of the building.

Figure 30. External facade of the Royal Prince Battery showing the distribution of water (blue and green areas) inside the masonry
