STATE OF CONSERVATION REPORT
JANUARY 2016
BAHLA FORT WORLD HERITAGE
SITE
SULTANATE OF OMAN (C433)

Bahla Fort World Heritage Site

Sultanate of Oman (C433)

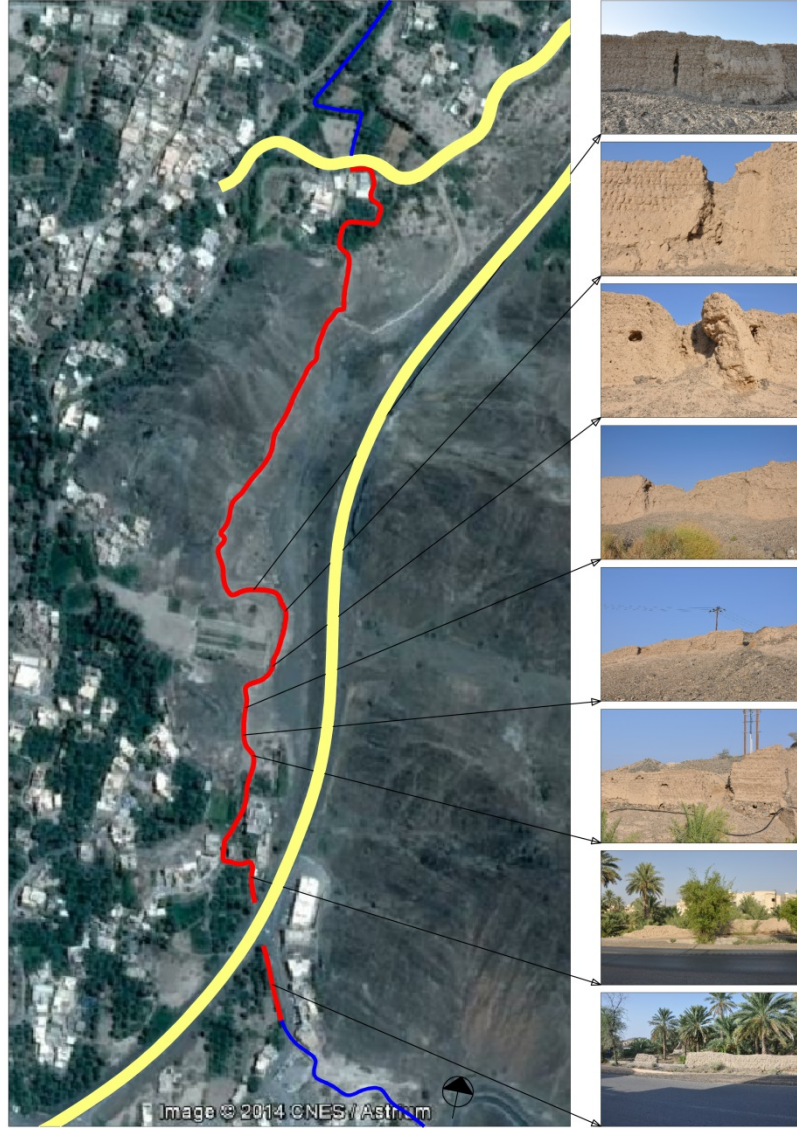
رقم الوثيقة: 04	المقياس: 0 10 20 30 40 50 100m	الحالة الراهنة لمكونات السور	مشروع ترميم وصيانة سور بهلاء القديم	سلطنة عمان وزارة التراث والثقافة
التاريخ: 28/09/2014

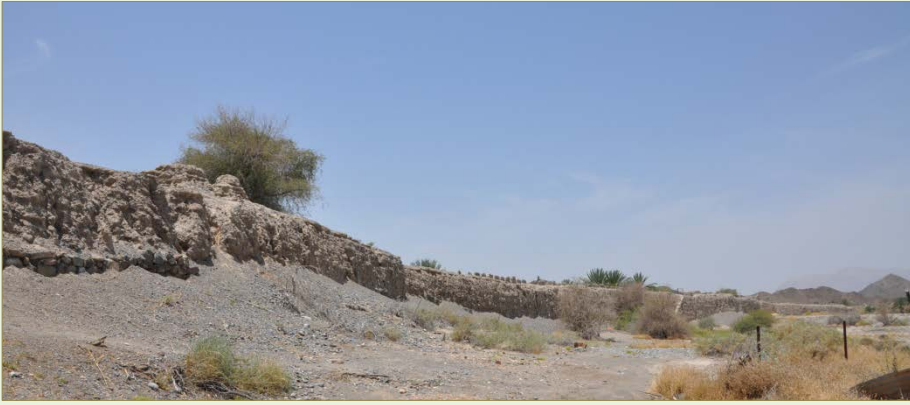
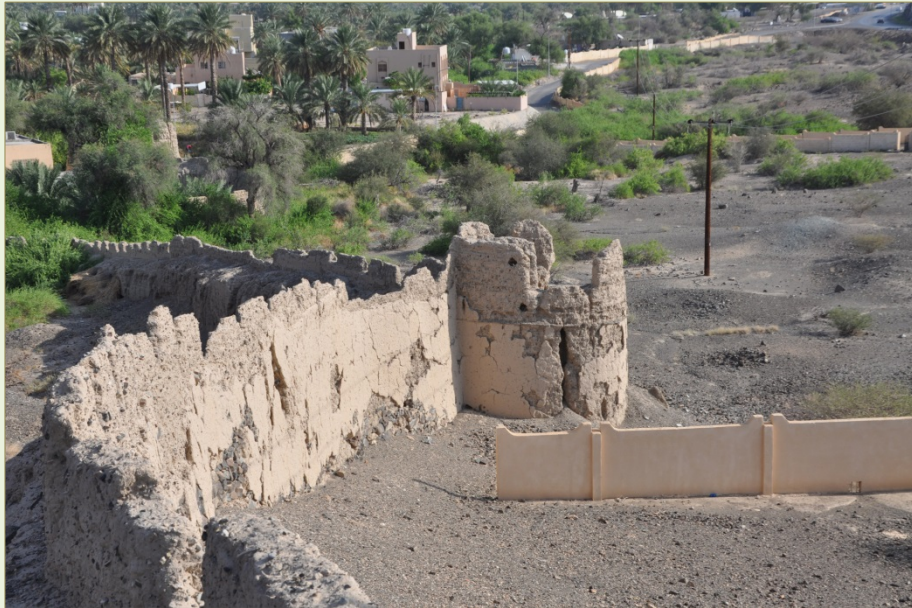
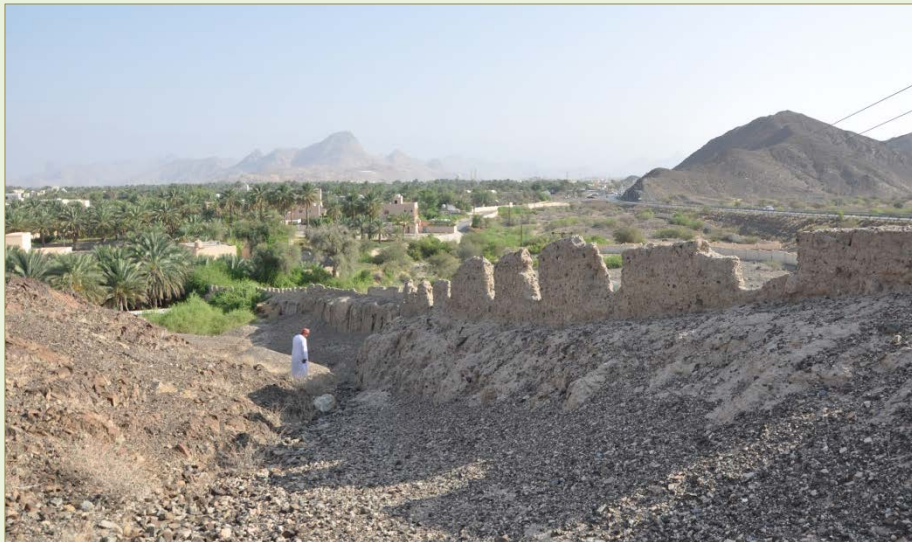
- Major and important deterioration in certain parts.
- Cracking in the adobe walls.
- Destruction in some of the top parts.
- Completely demolished parts.
- Corrosion of mud plastering.
- Demolition of some of the Masonry bricks.
- Destruction and loss of some of the adobe bricks.

Photos for parts of the wall

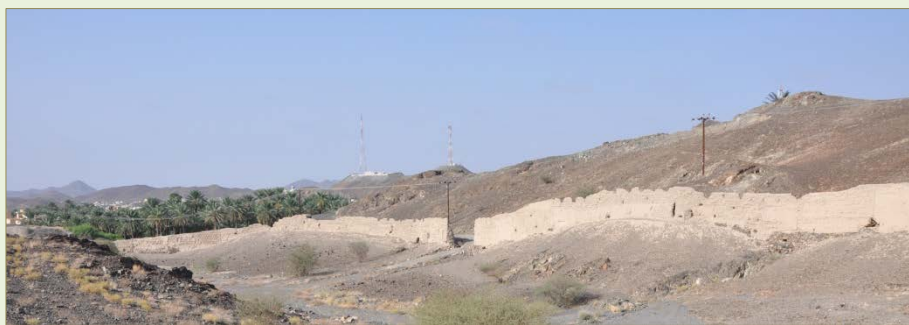
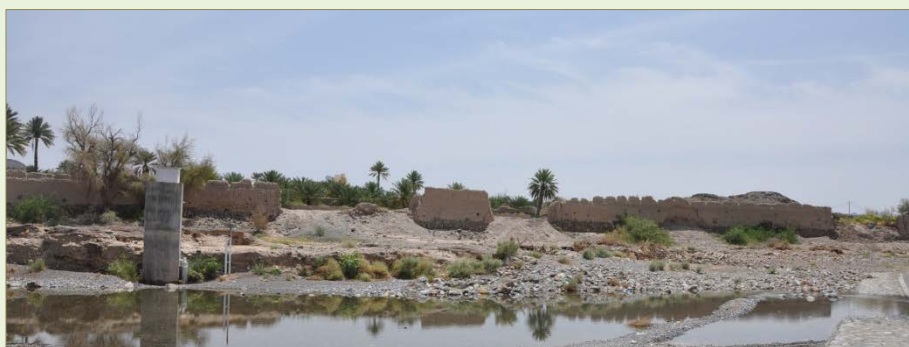
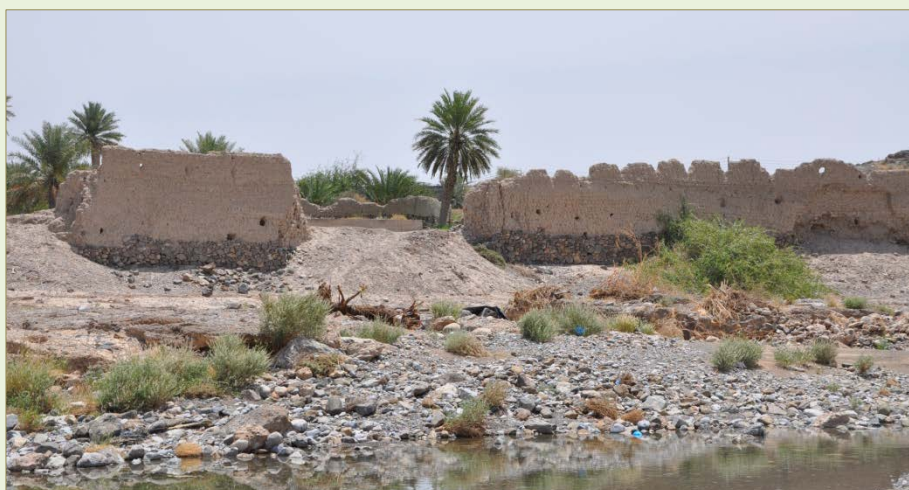
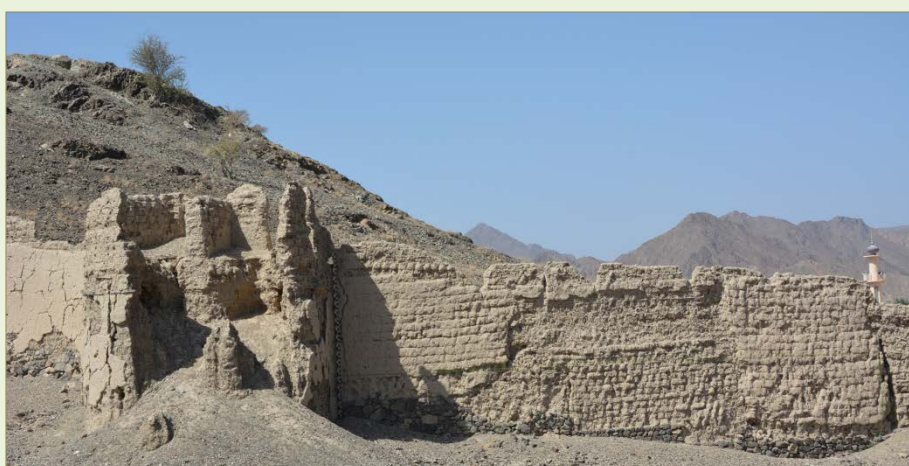
Sections of different parts of the Wall

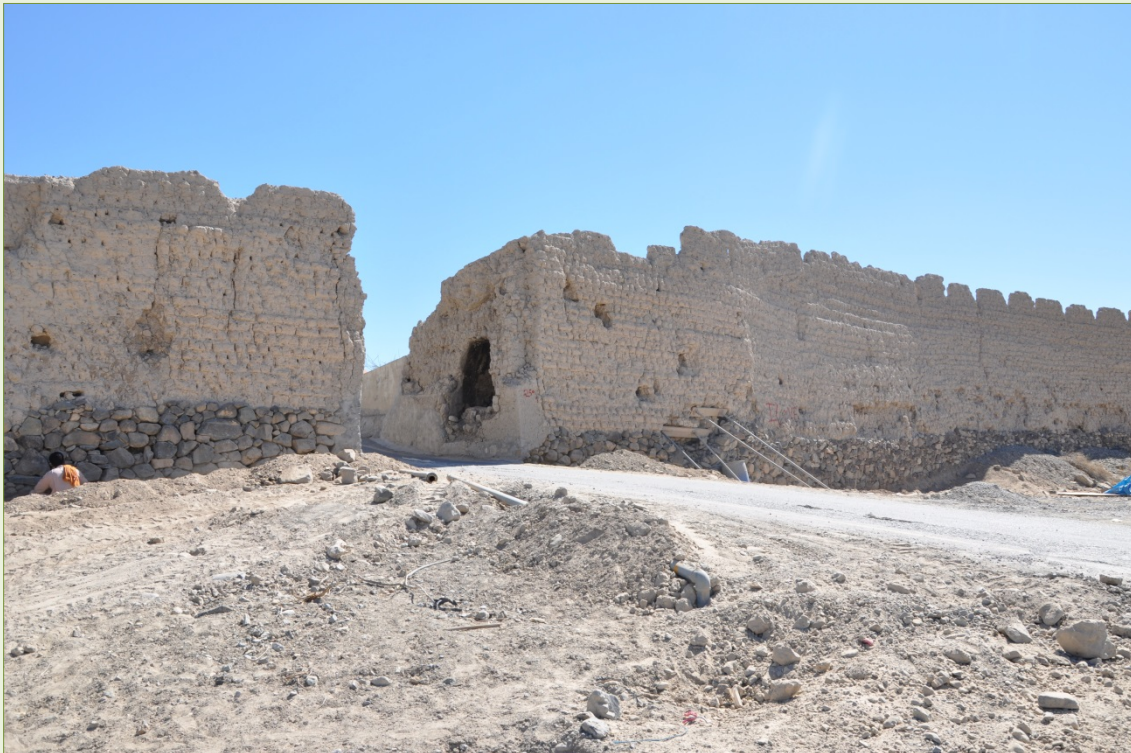
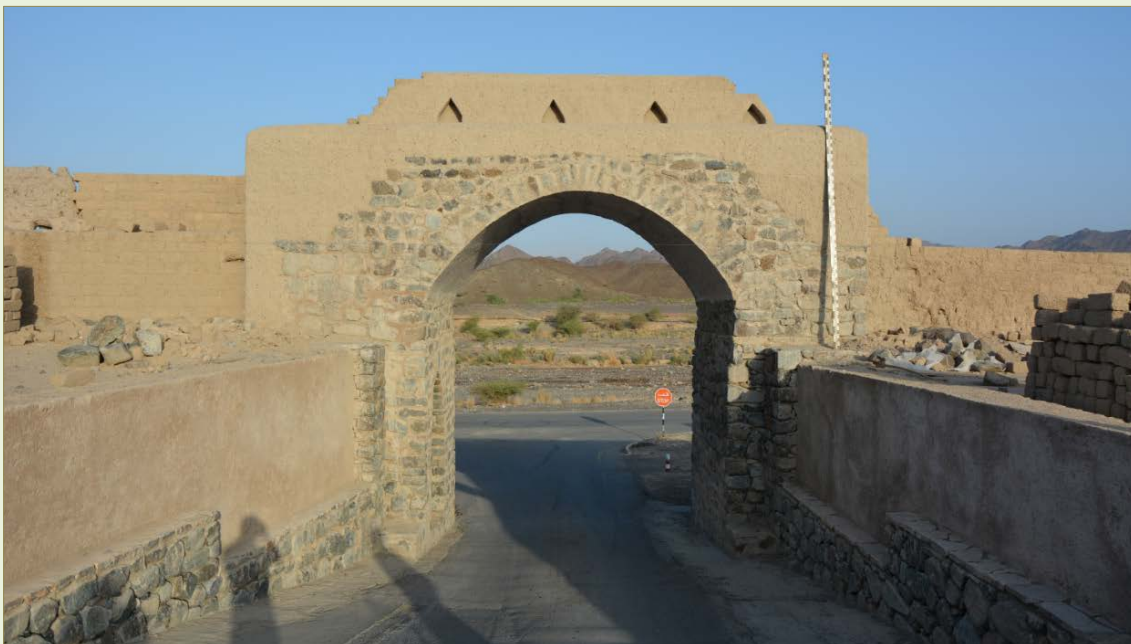
The gate appeared cracked from both the right and left sides with total destruction of the roof. Restoration works aimed at restoring it to its original state. After completion of the restoration works the gate returned to its original state and function and people is now able to access the World Heritage Site preserve passing through it.

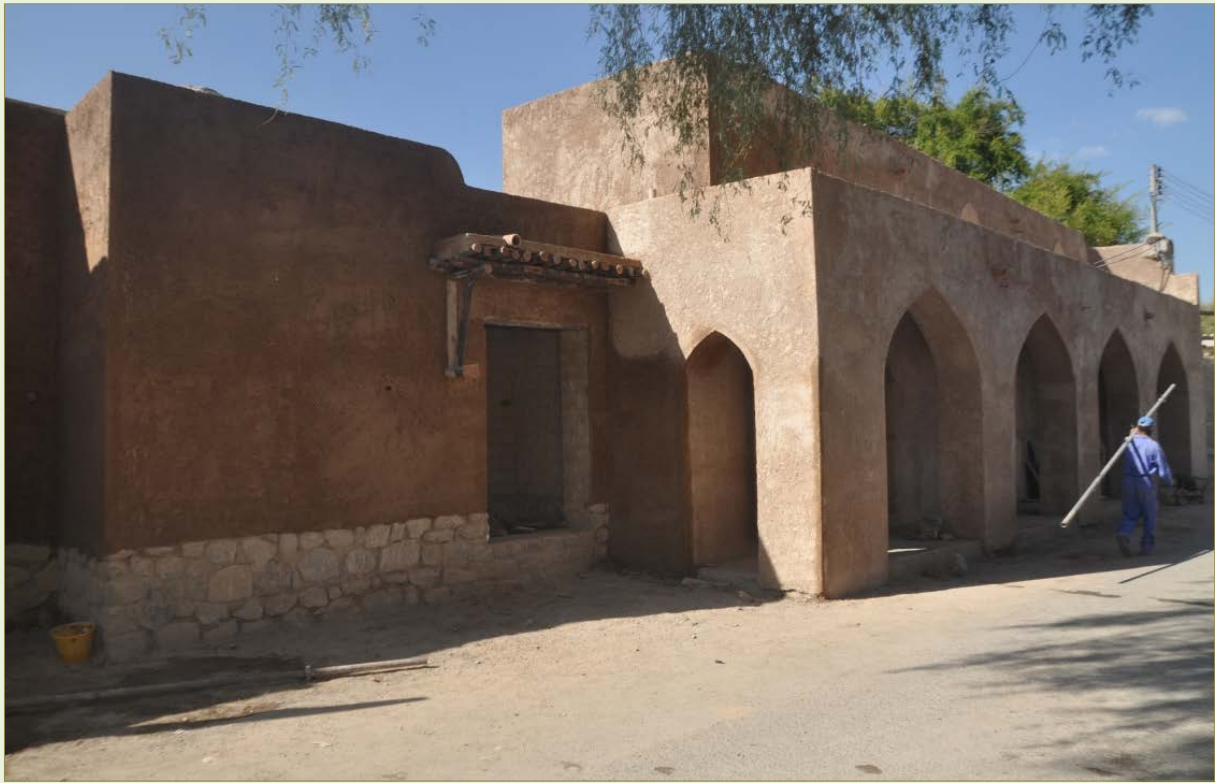
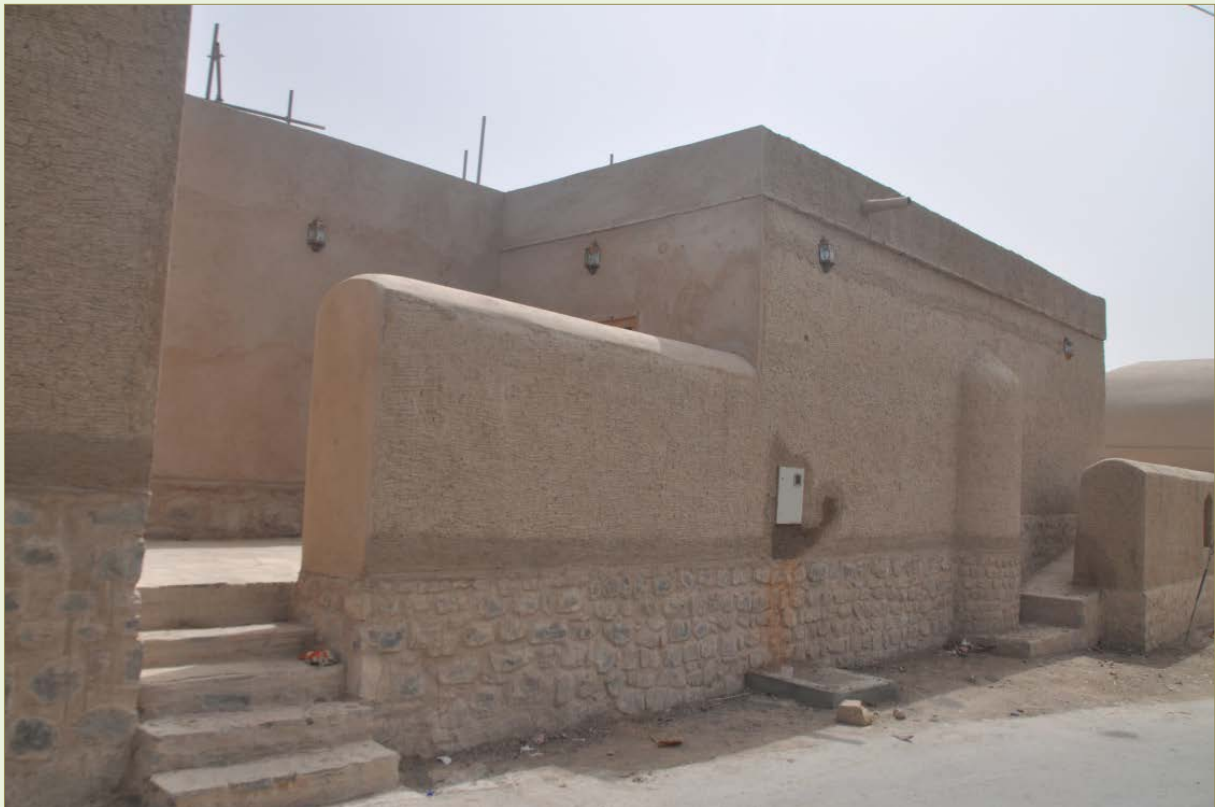
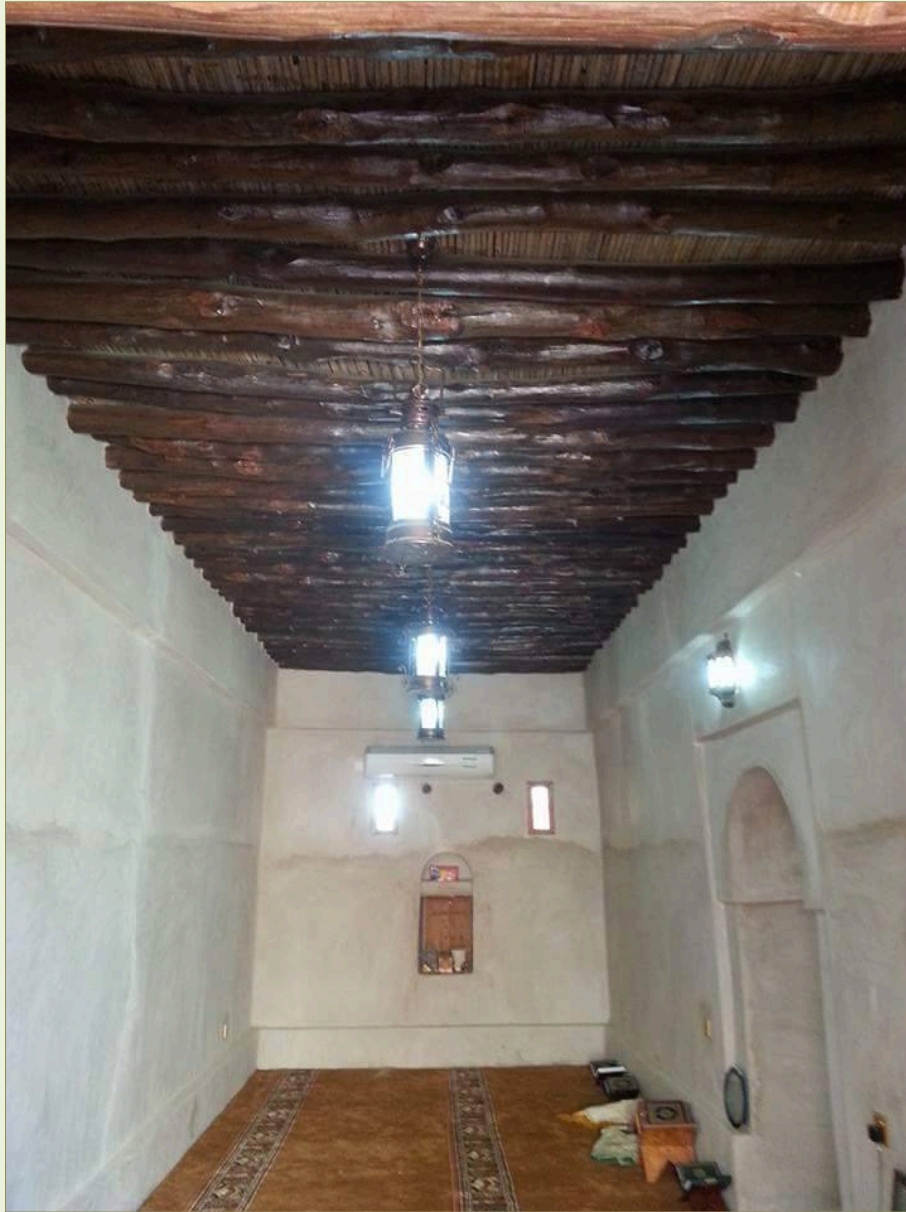
The mosque and the mausoleum were largely deteriorated and their conservation state endangered the safety of both the visitors and worshipers.

- Reconstruction of the mausoleum's demolished walls, using traditional materials and traditional techniques, in addition of applying special treatments to the severely damaged walls risking collapse.

- Treatment of the deteriorated parts of the Alkhair mosque walls, with specific focus on the parts directly connected to the rampart, which were about to be fully destroyed.

- Reconstruction of the mausoleum dome with traditional materials, restoring its authentic form following analysis of the remains of the old dome.
- Applying internal and external plaster to both monuments with traditional local materials (Sarooj).

- Prefabricating of the mosque's doors and windows with traditional Teak wood.
- Roofing of the mosque using traditional materials and techniques (Kandal wood and Daoun).

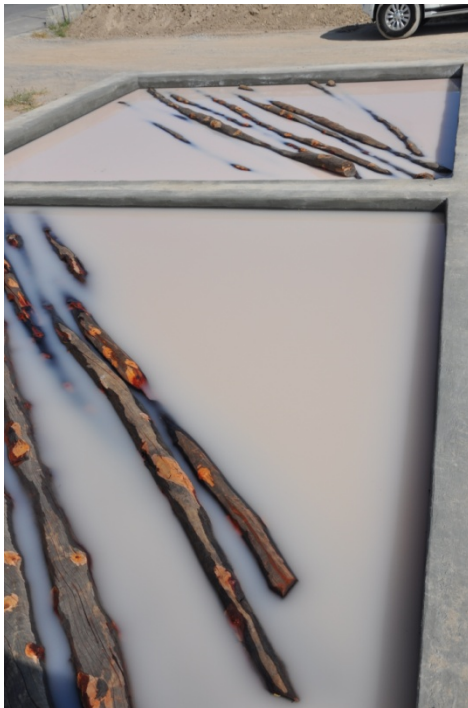
Soaking Kandal wood for treatment

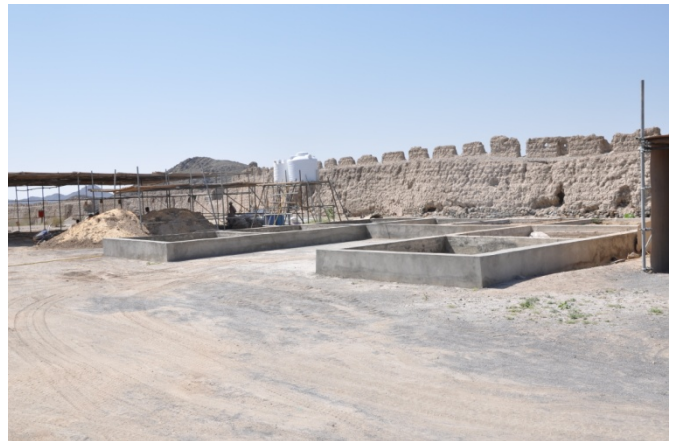
Workshop space and soaking tubs

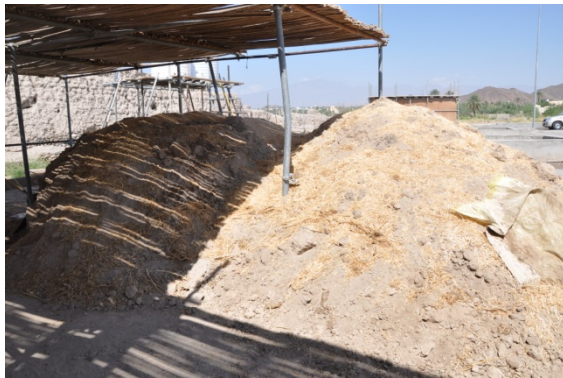
Piling the hay to mix with soil

- 3- Following fermentation, the soil is transported close to the drying site, where it is mixed in adequate quantities with hay and water to reach an appropriate viscosity. To accomplish this, each trolley of soil is mixed bucket by bucket until it is fully and evenly incorporated.

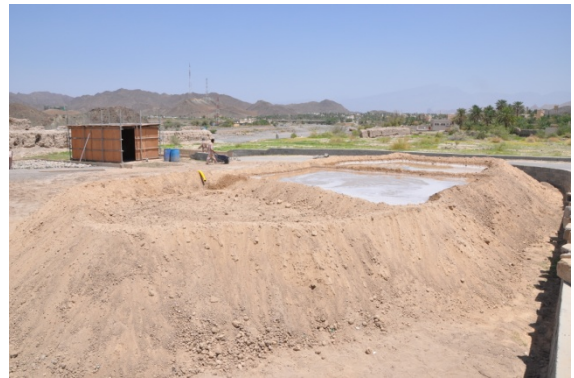
Soil and water are mixed and allowed to ferment

- 2- Soil fermentation, a long process that takes a month or more to complete, involves watering the soil and then leaving it to ferment until the soil develops characteristics that facilitate its mixing at a later stage.

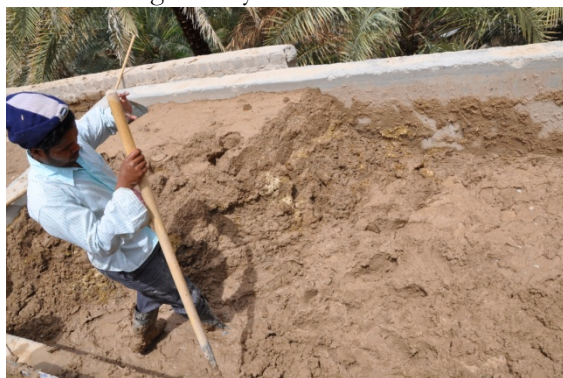
Mixing hay and soil

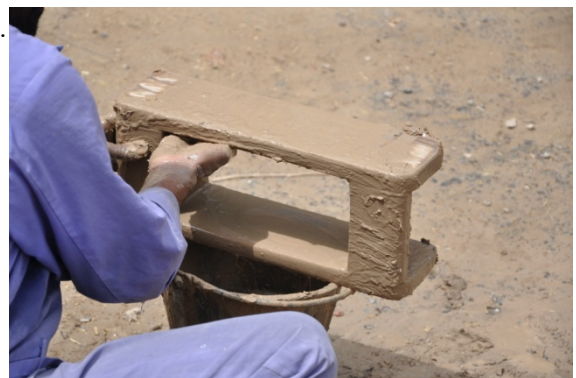
Preparing moulds

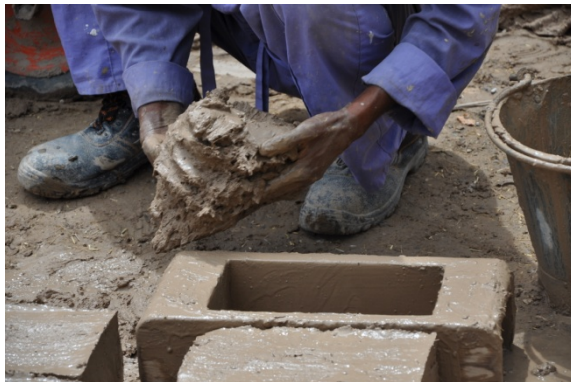
Filling the moulds

- 4- After the mix has been prepared, the moulding begins, in sizes specific to demand, for example 15X15X35 cm and 15X15X40 cm. The mix is placed in moulds and compacted manually to remove all air and thus preempt the development of cracks.

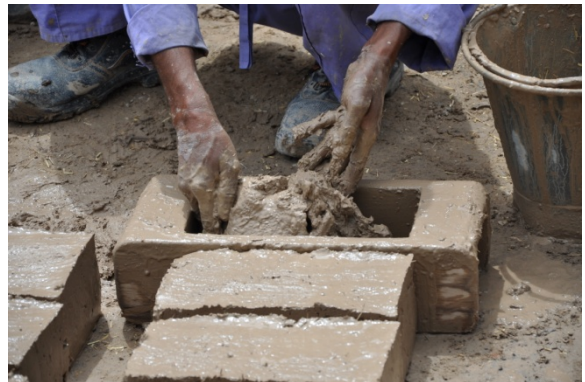
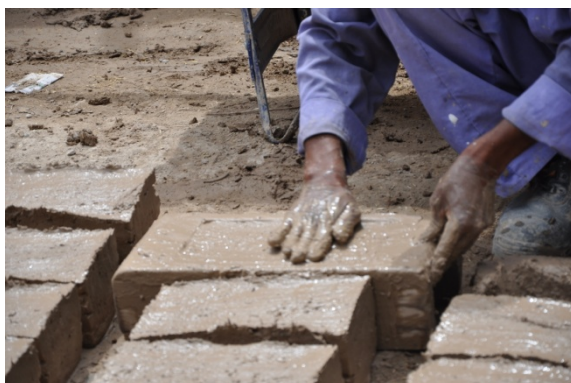
Compacting the mixture

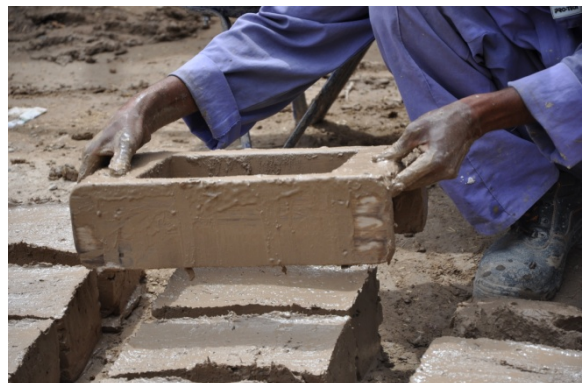
Removing the mould

- 5- The bricks are subsequently removed from the moulds to be air dried, and turned over regularly to ensure the drying of all sides equally. The drying period varies depending on the season and other factors. It takes approximately a week in summer and more than two weeks in winter.

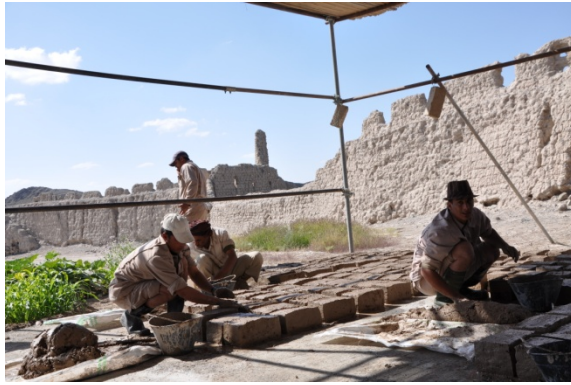
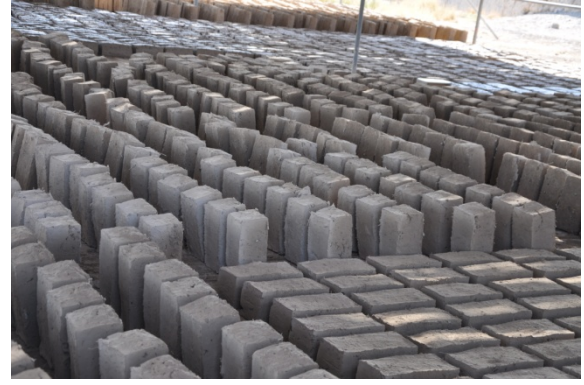
Air drying the adobe bricks

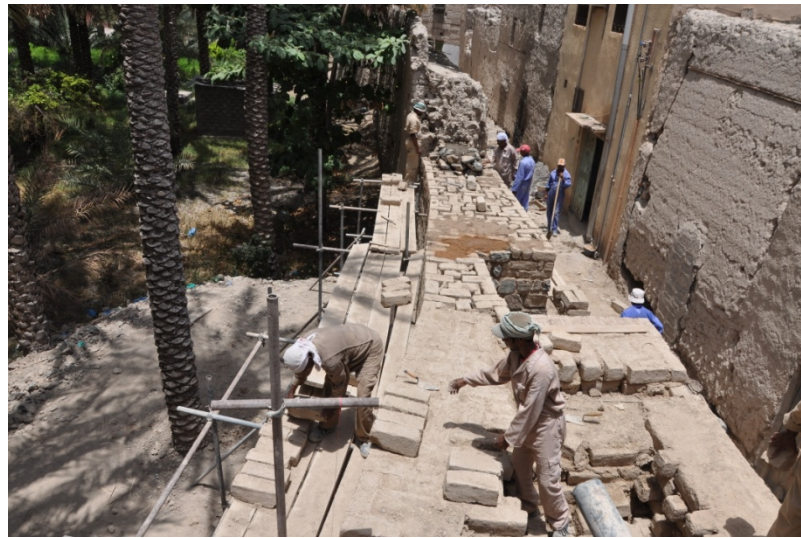
Using the adobe bricks in the reconstruction of parts of the rampart

Outcome: the adobe bricks prepared by the workshop and constructed in the first phase of Bahla Souk project area have shown no deterioration or degradation since their installation, despite exposure to extremes of nature. The same results can be observed in the intact original structures which have not suffered from demolition. In contrast, some of the original brickwork in roofless structures has experienced some cracking and deterioration as a consequence of exposure to heavy rains.
