KATHMANDU VALLEY

WORLD HERITAGE SITE, NEPAL

Report and Recommendations of The Joint UNESCO/ICOMOS REVIEW MISSION

14 - 30 November 1993

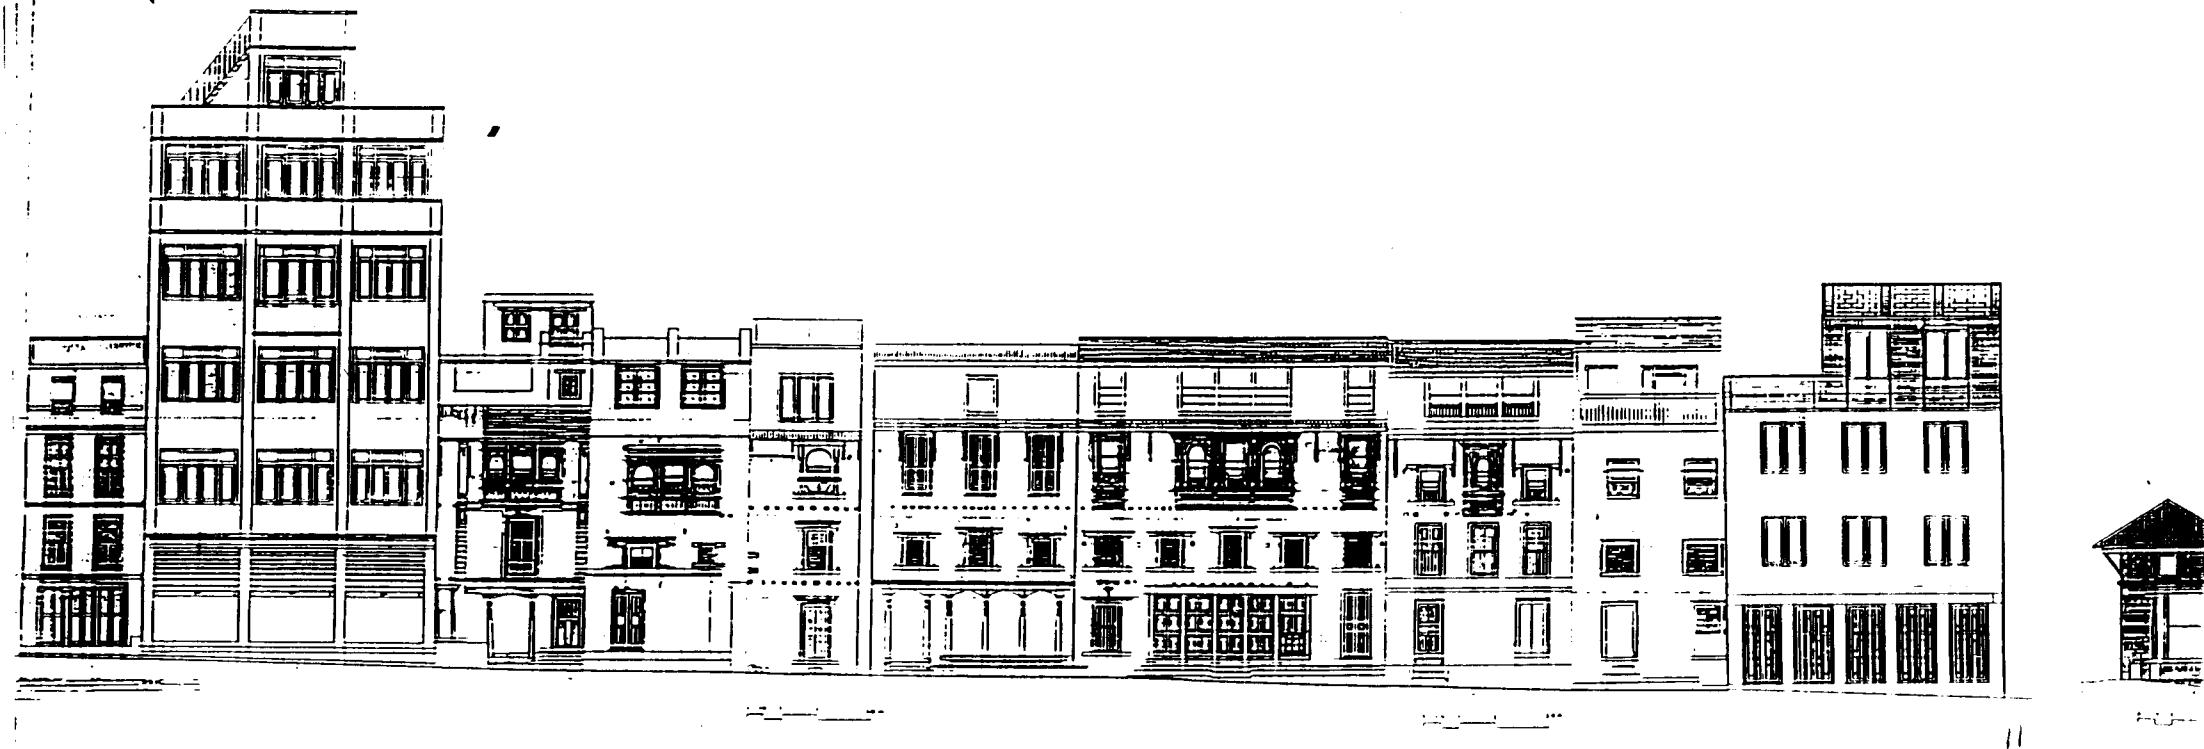
Fig. 32

**Kathmandu Valley World Heritage Site
Monument Zone 2: Patan Darbār Square**

- 17.1.6 That, in order to ensure control of new development within the World Heritage Site, concerned authorities (Department of Archaeology and Municipalities) should begin preparing complete documentation of all house and street elevations (see Fig. 32) within the Monument Zones in their jurisdictions.

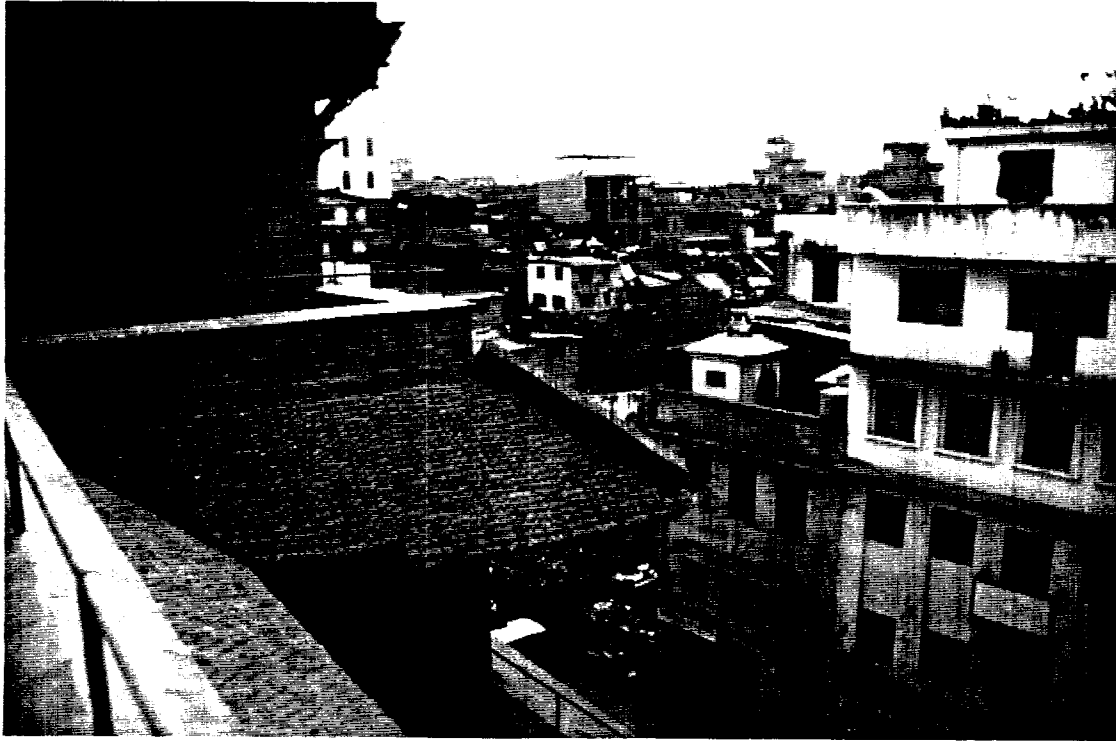
Pl. 1

Rebuilt structure directly facing Hanuman Dhoka Palace; the small building with the Aagan Dega shrine on its roof is a recent rebuilding of a demolished traditional building (Monument D/K 208 in the Protective Inventory)

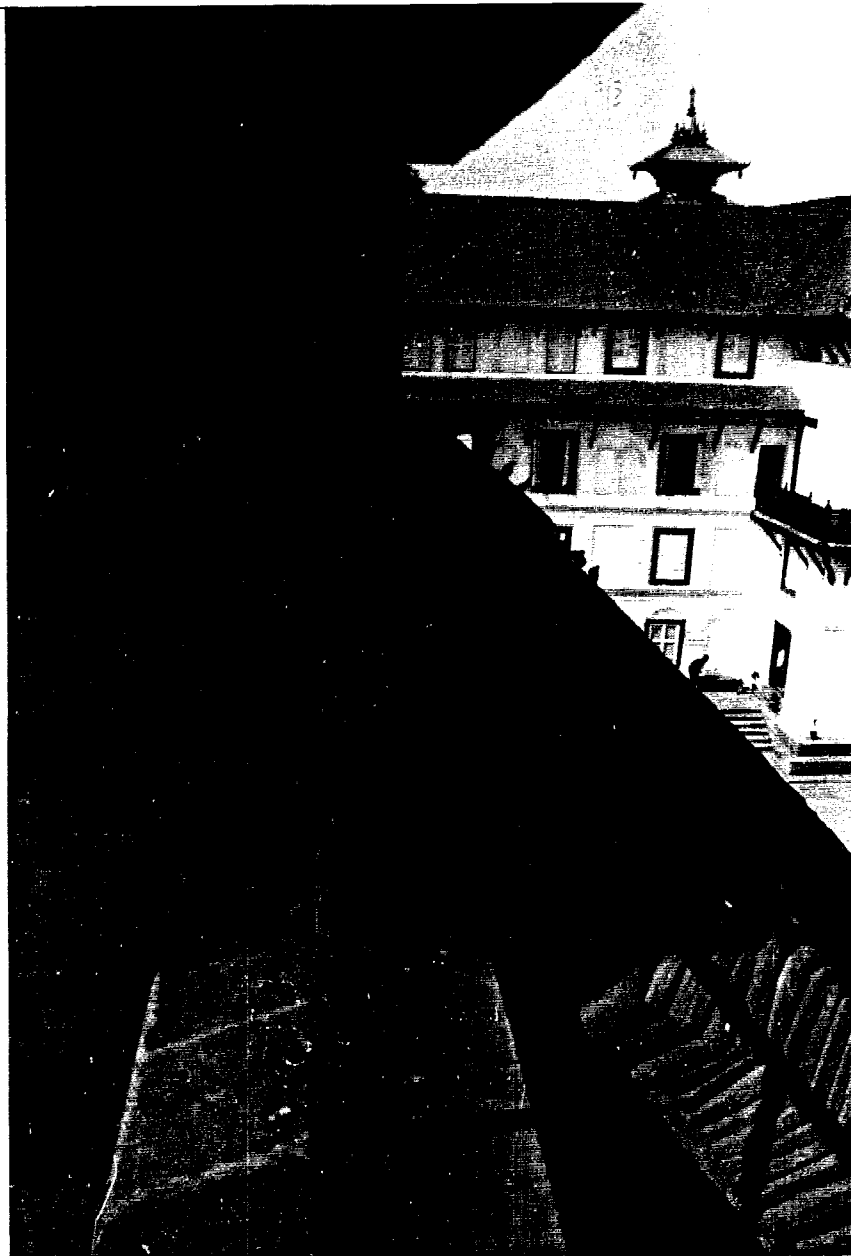
Pl. 2

Monument Zone 1: Kathmandu Darbār Square

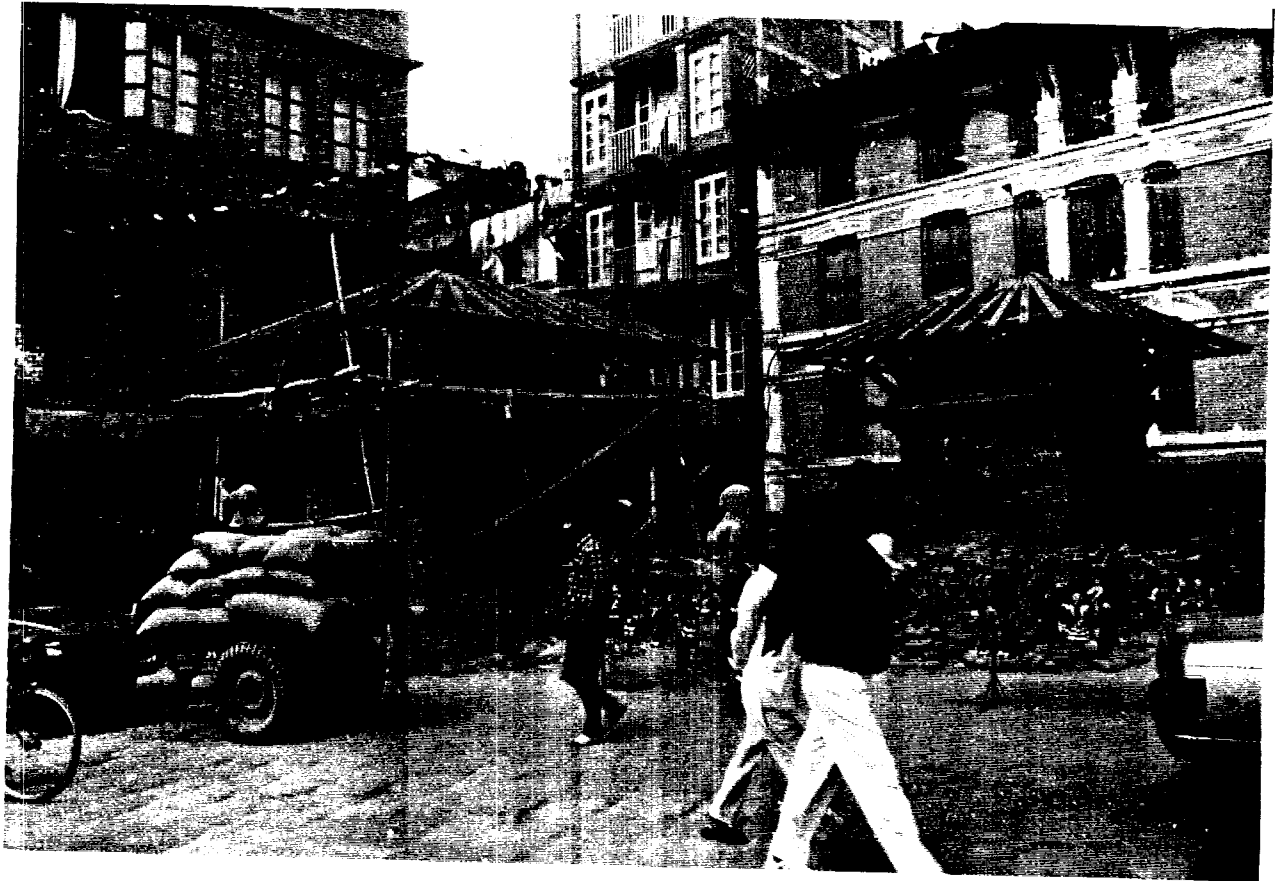
Pl. 4

Domed shrines dedicated to Narayan and Ganesh have been demolished and are being rebuilt to their supposed original forms

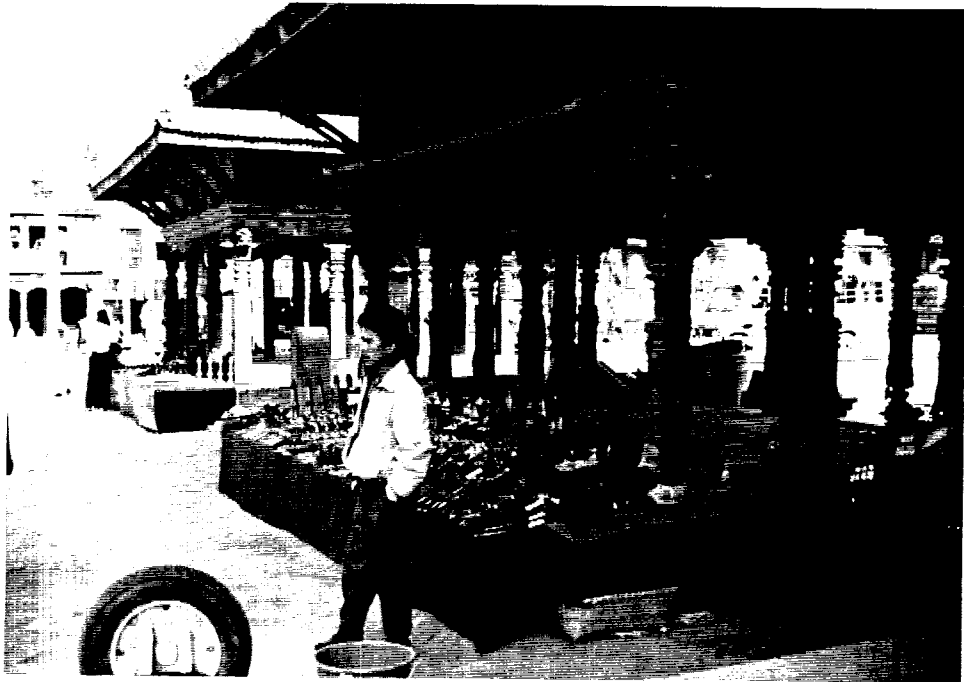
Pl. 5
Kathmandu Valley World Heritage Site
Monument Zone 2: Patan Darbār Square
Unlicensed curio stalls occupying patis outside the palace

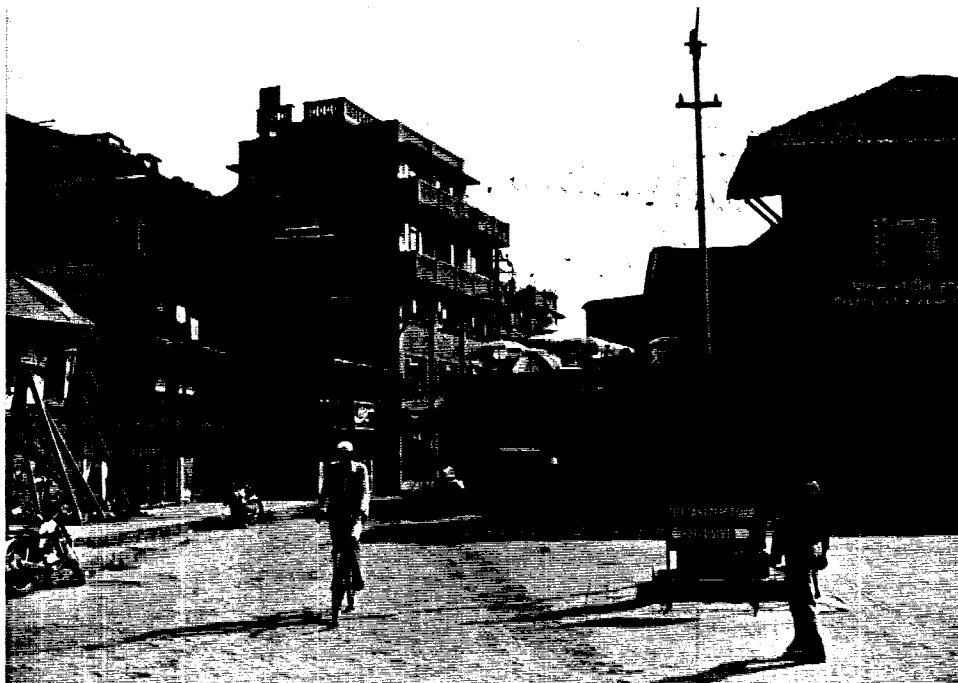
Pl. 6

Intrusive sun umbrellas on cafe roof adjacent to the palace; in the background, a modern concrete building of illegal height

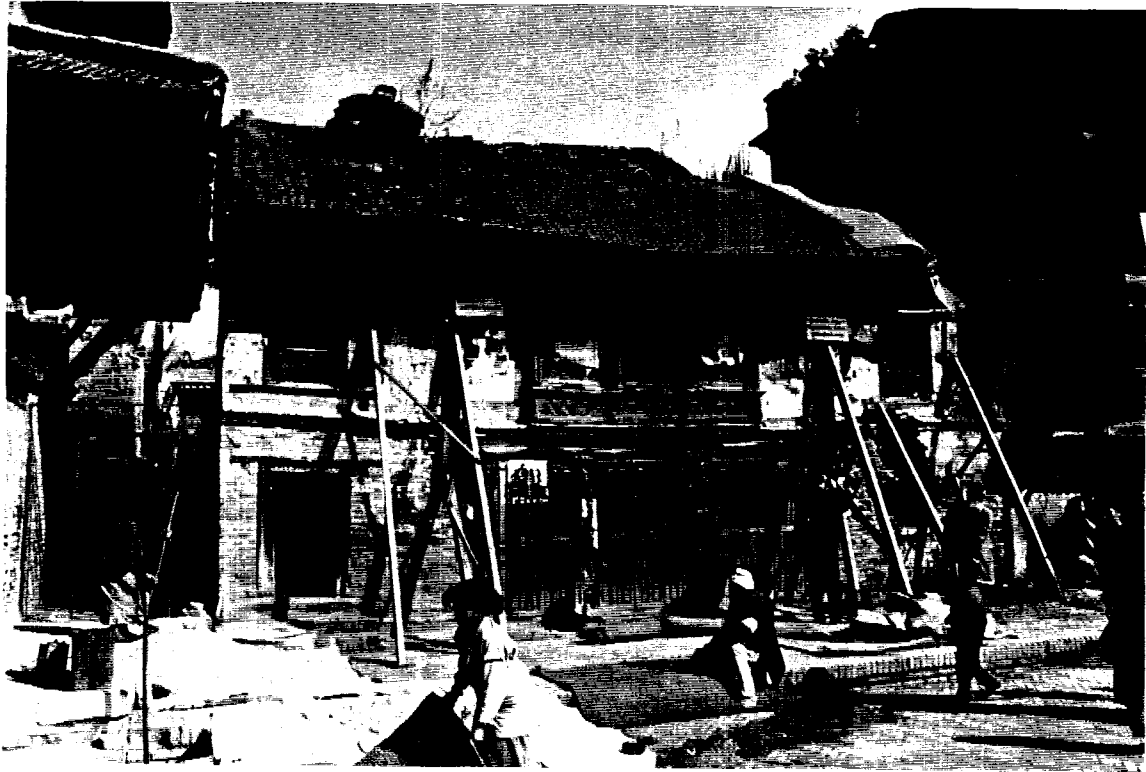
Pl. 7

Thum Baha Narayan temple, half collapsed. It is illustrated in the Protective Inventory (C/P 172) in a complete form, before the traditional buildings behind it had been replaced by the present concrete houses illustrated here

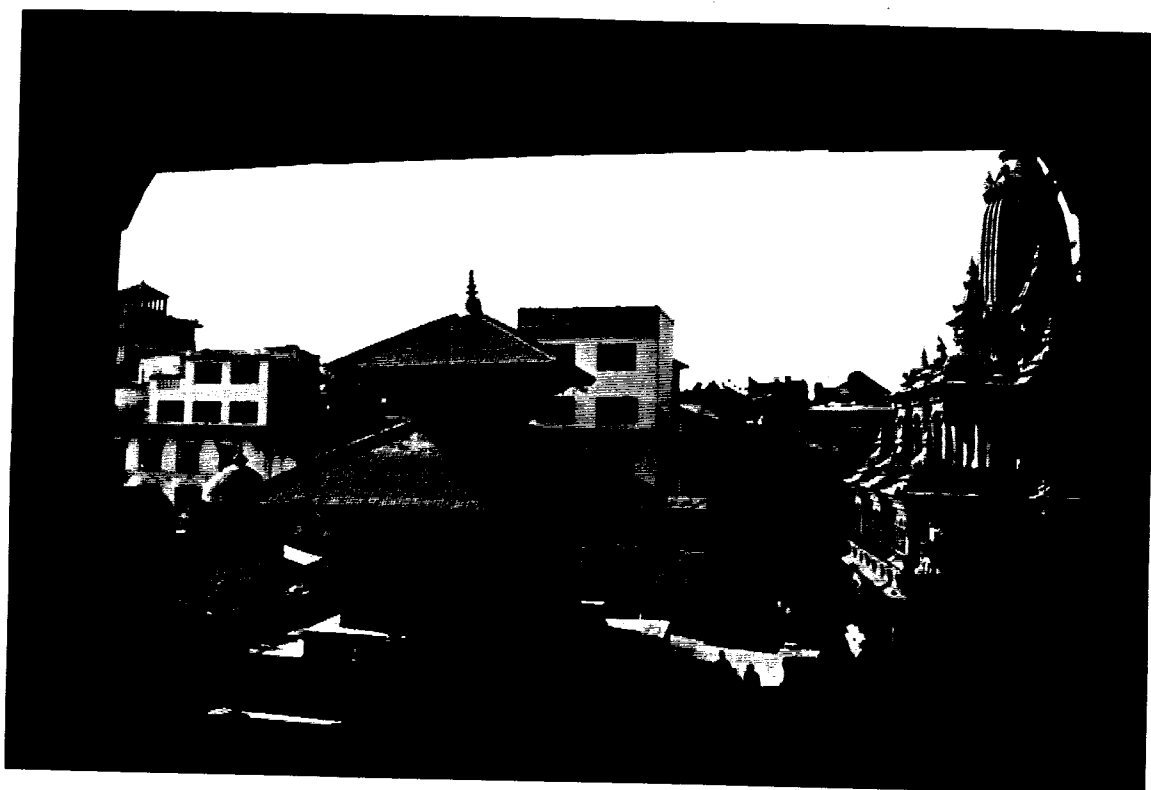
Pl. 9

Rebuilt modern buildings, of illegal height (see Fig. 31), now form the background to the Char Narayan temple, 1565 (on left), and Krishna temple, 1637 (on right)

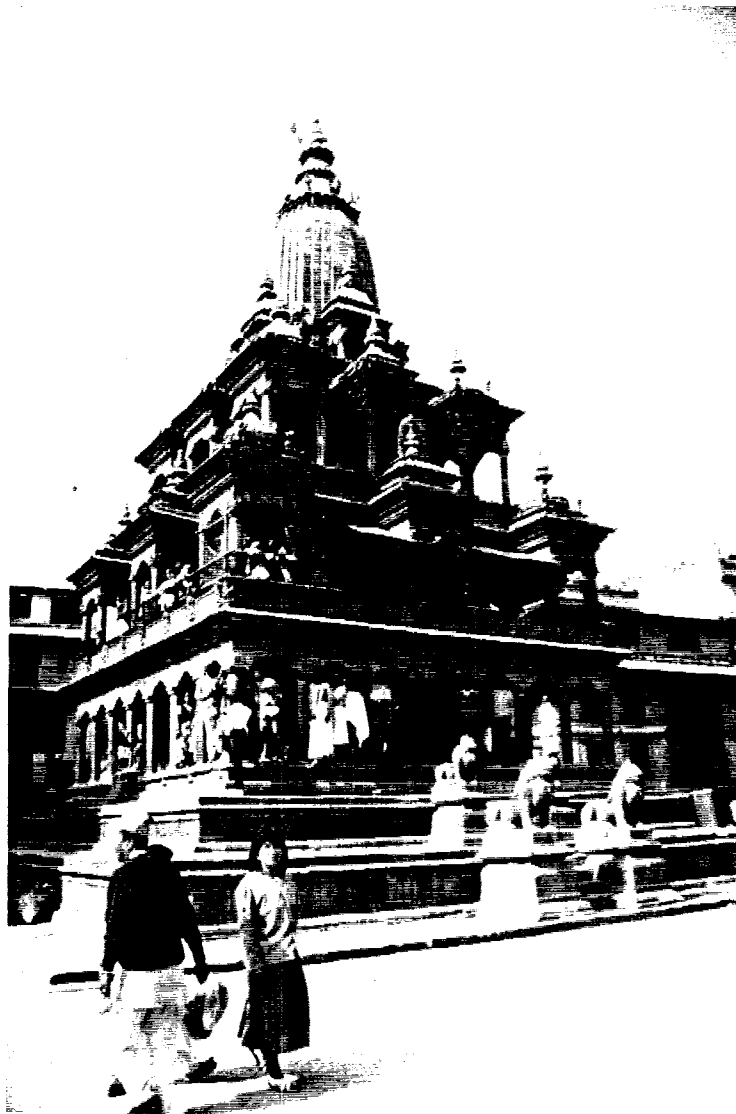
Pl. 10
Kathmandu Valley World Heritage Site
Monument Zone 2: Patan Darbār Square
Krishna temple, 1637

Monument Zone 2: Patan Darbār Square

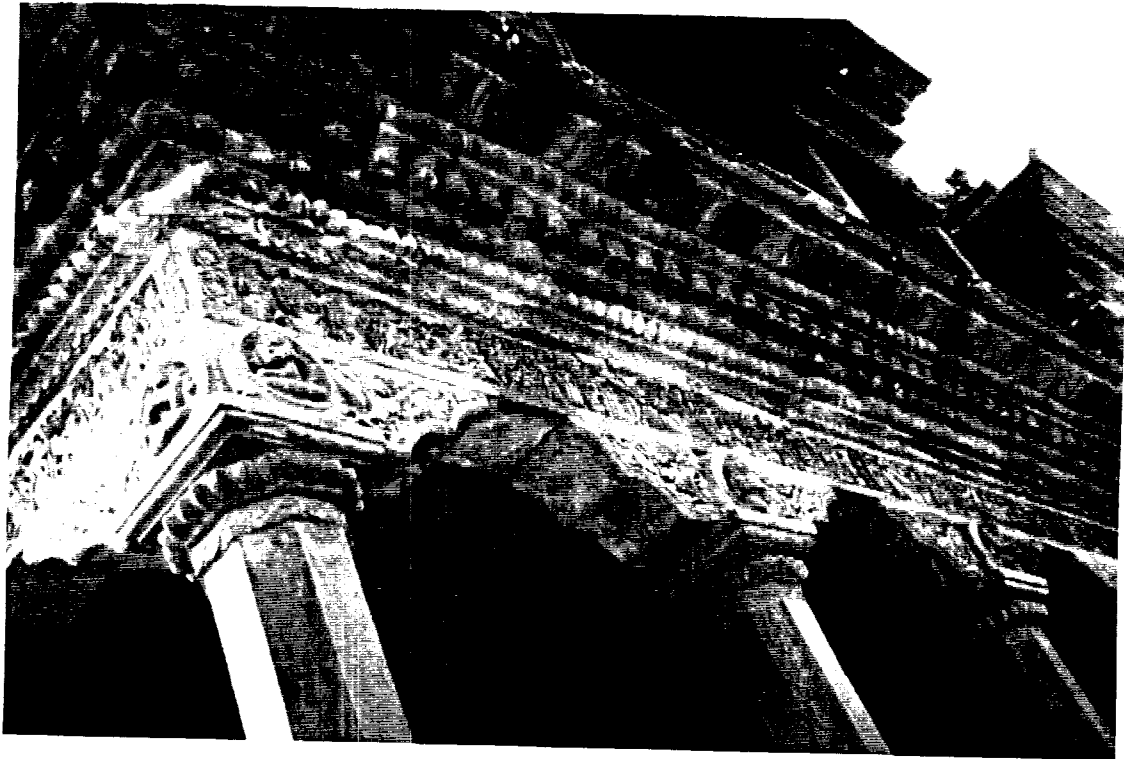
Pl. 11

Efflorescence, possibly caused by salts from cement used in previous repairs, activated by the water thrown on the balcony by the priest, who still lives there, is destroying the surface of the carved stonework

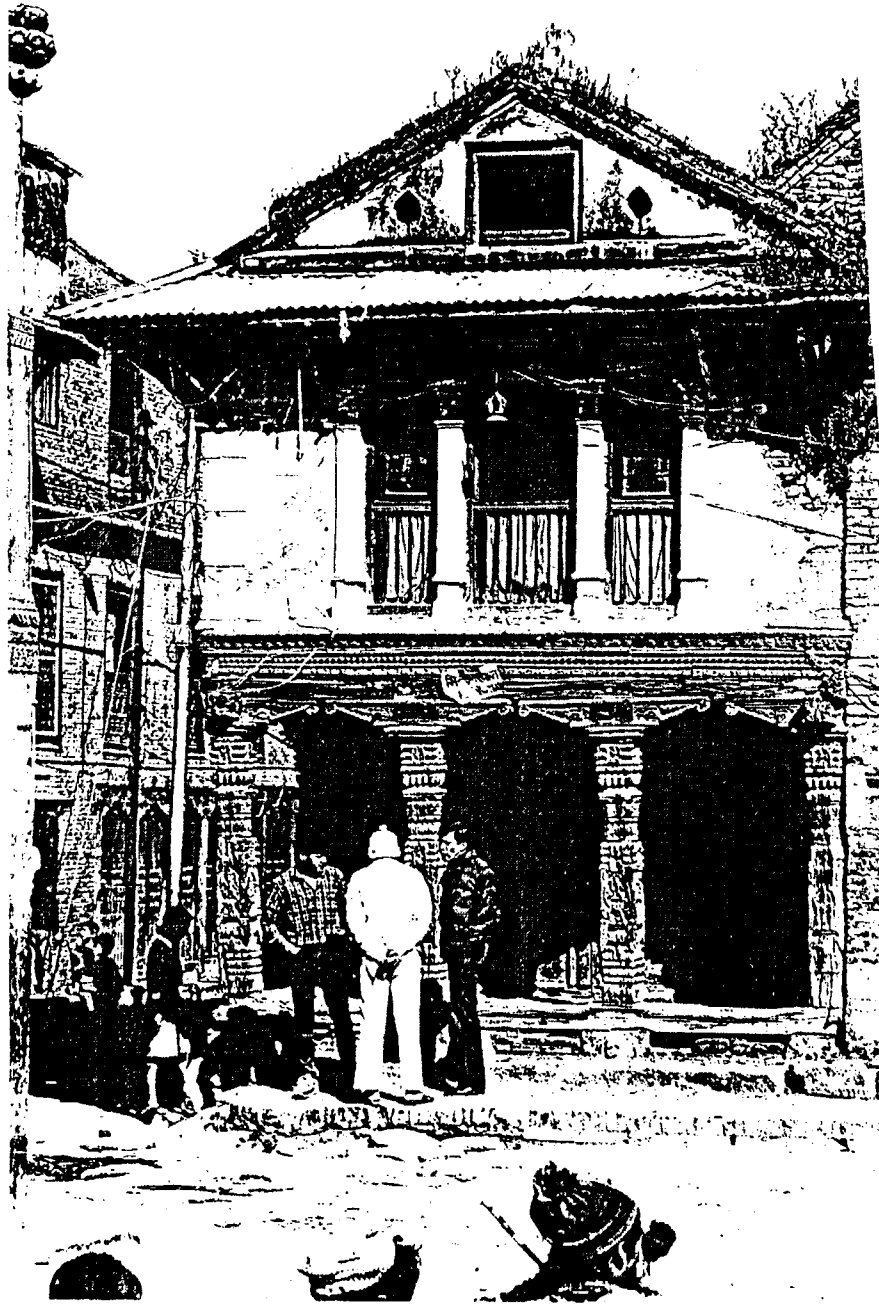
Pl. 12
Kathmandu Valley World Heritage Site
Monument Zone 2: Patan Darbar Square
Sarasvati Pati, photographed before its recent demolition and rebuilding to different dimensions

- 4.3.6 With regard to examples of the demolition of structures within the monument zone, Sarasvati Pati, a 16th-century structure with a 1934 upper storey (see Pl. 12) has been demolished and rebuilt by Patan Chamber of Commerce to a different size, the 18th-century house adjoining it on the north (see Pl. 13) also being demolished. A house beside Ganesh temple, on the northern side of the square, was demolished and rebuilt, albeit incorporating design suggestions from Patan Programme. A small Narayan temple at Olakhu was demolished in 1993 and replaced by a concrete structure of particularly inappropriate design (see Pl. 14).

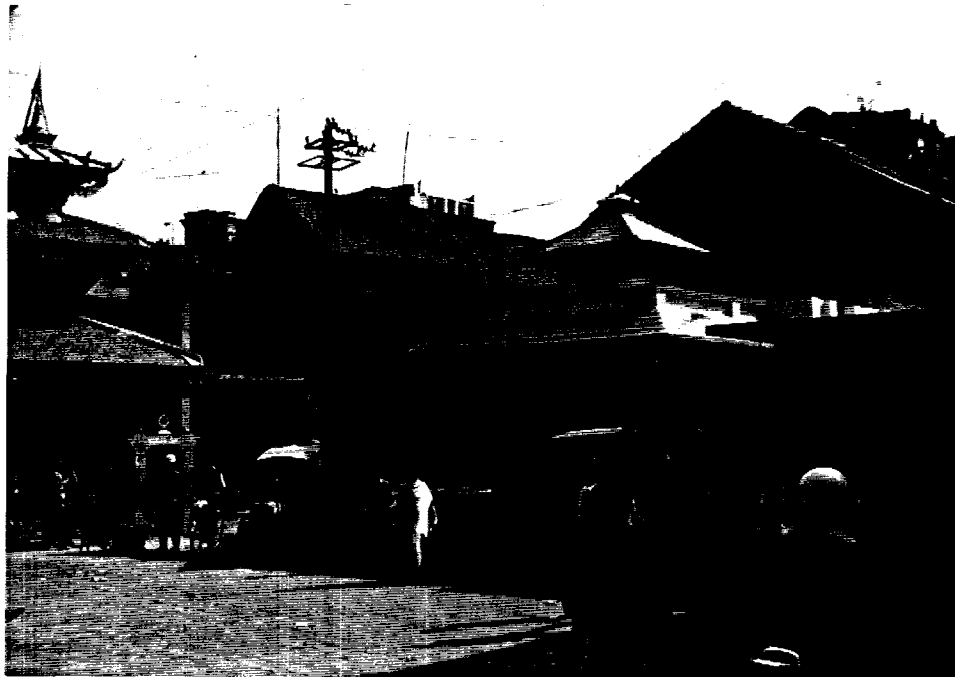
Pl. 14

Monument Zone 2: Patan Darbār Square

18th-century house adjoining the northern gable of Sarasvati Pati, now demolished

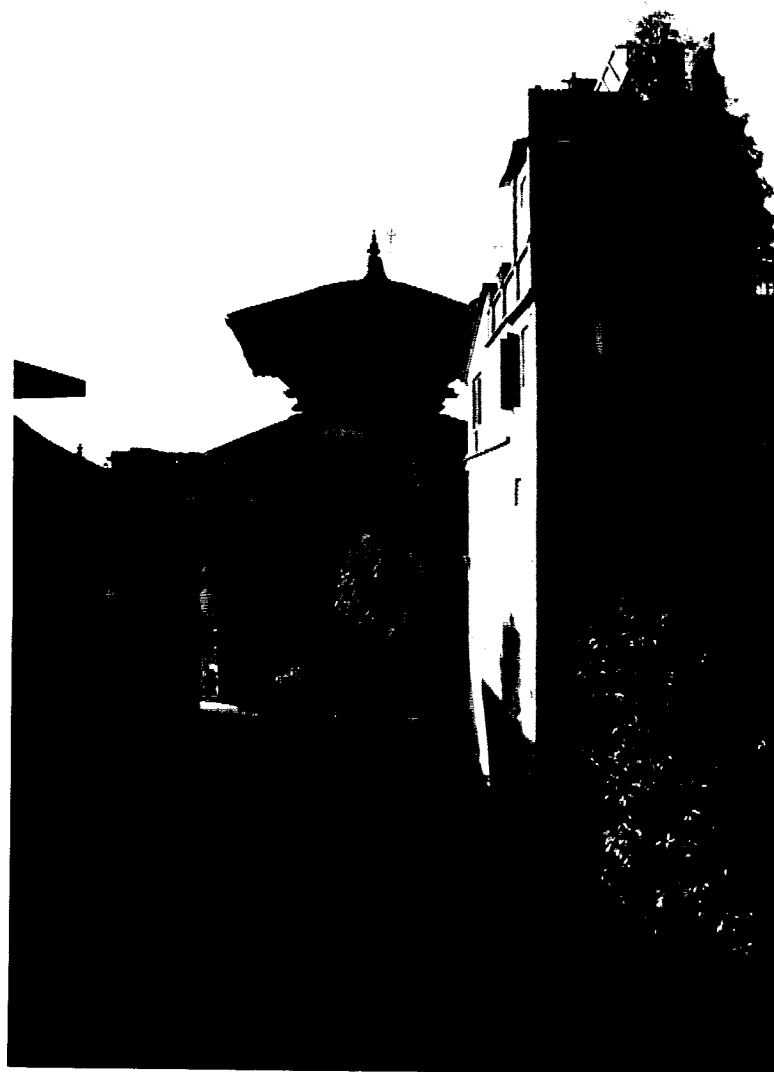
Pl. 15

Monument Zone 2: Patan Darbār Square

Olakhu: the historic Narayan temple which formerly stood on this site was demolished in Spring 1993 and replaced by this inappropriate modern concrete structure

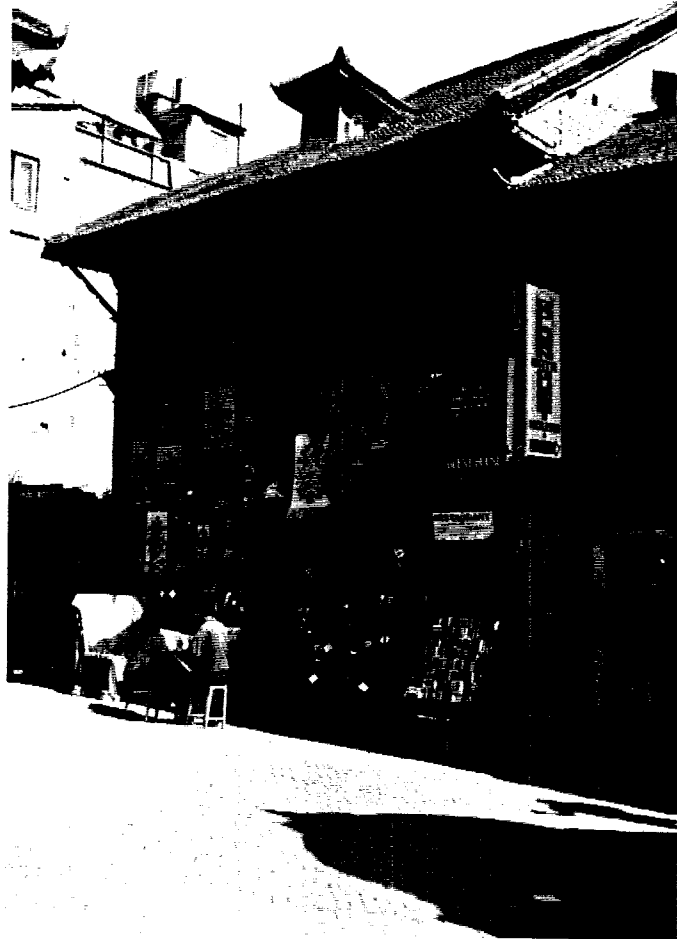
Pl. 16

Monument Zone 3: Bhadgaon (Bhaktapur) Darbār Square

The Shiva Guesthouse towers next to the 15th-century Pashupati temple; illegal additions have been made to this building on a regular basis

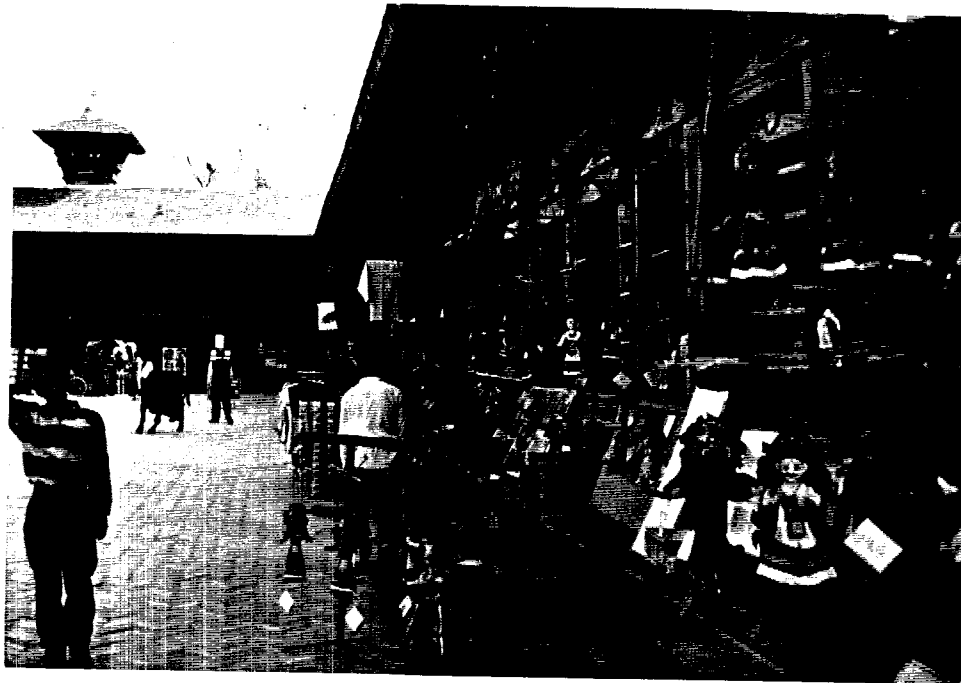
Pl. 17

Monument Zone 3: Bhadgaon (Bhaktapur) Darbār Square

Curios and advertising cover the front of this traditional house next to the Pashupati temple

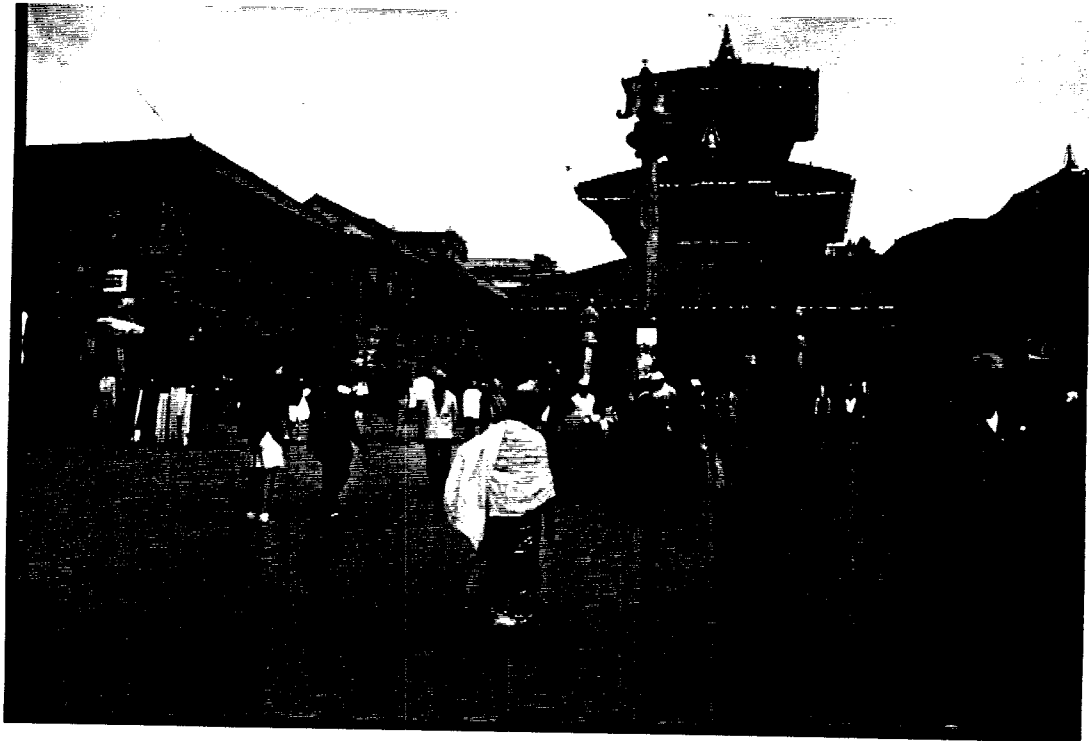
Pl. 18

Monument Zone 3: Bhadgaon (Bhaktapur) Darbār Square

Curio stalls swamp the dharamsalas at the eastern end of the square

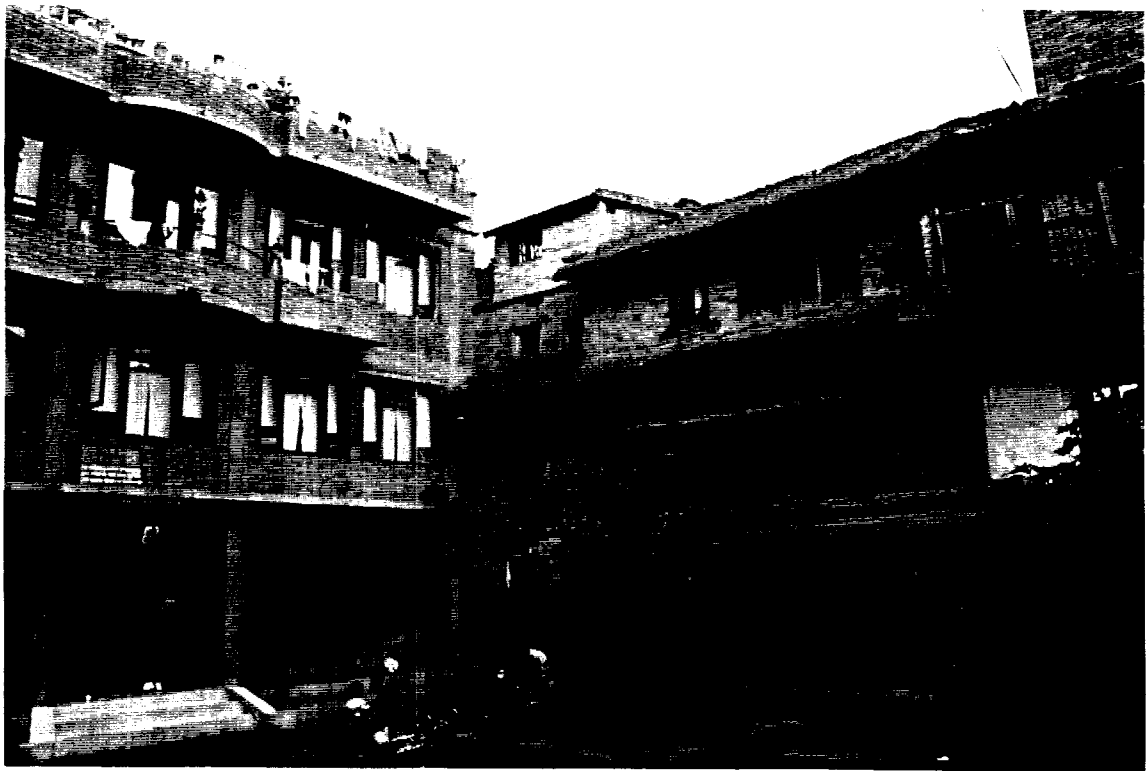
Pl. 19

Part of a historic domestic courtyard (remaining portion on the right) was demolished to build the concrete-framed Golden Gate Guesthouse

- 4.4.5 Demolition has taken place in the Bhaktapur Darbar Square monument zone, as in Kathmandu and Patan. For example, the construction of the concrete-framed Golden Gate Guesthouse in the late 1980s involved the demolition of part of one of the best residential courtyards in the city (see Pl. 19). The Bhairab shrine adjacent to the Municipality building in the Darbar Square was demolished three years ago and rebuilt in modern materials. The Bhaktapur Darbar Square Monument Zone also supplies examples of decay, such as the collapsed and derelict traditional houses to the north east of the palace (see Pl. 20), the important 16th-century stone temple nearby, which is in danger of destruction by tree roots (see Pl. 21) and the royal bath, in the garden behind the palace, where one of the sides partially collapsed during 1993.

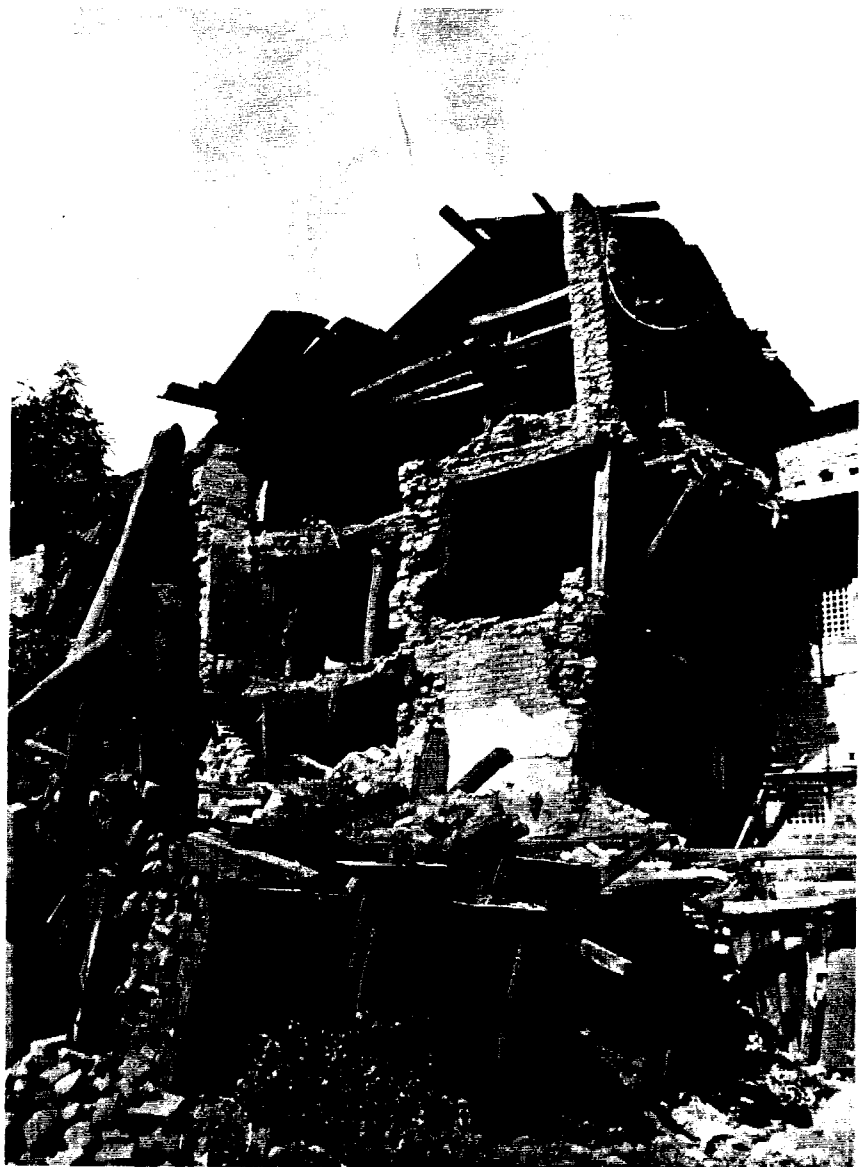
Pl. 20
Kathmandu Valley World Heritage Site
Monument Zone 3: Bhadgaon (Bhaktapur) Darbār Square
Collapsed and derelict traditional houses to the north-east of the palace

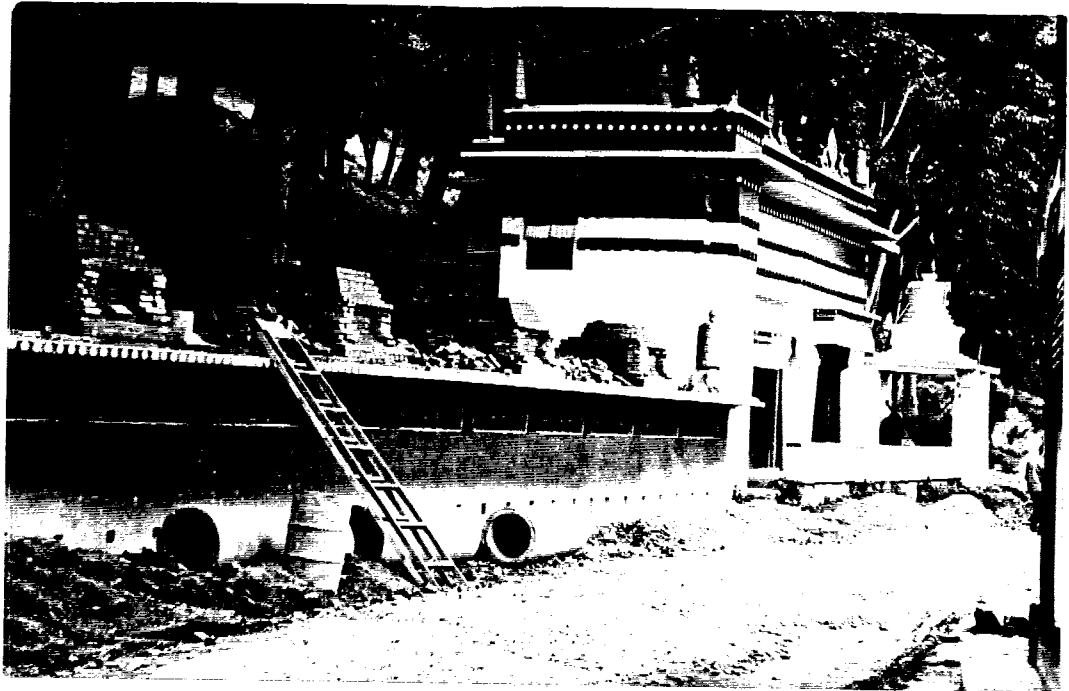
Pl. 22
Kathmandu Valley World Heritage Site
Monument Zone 4: Swayambhu
Uncontrolled new building in the monument zone

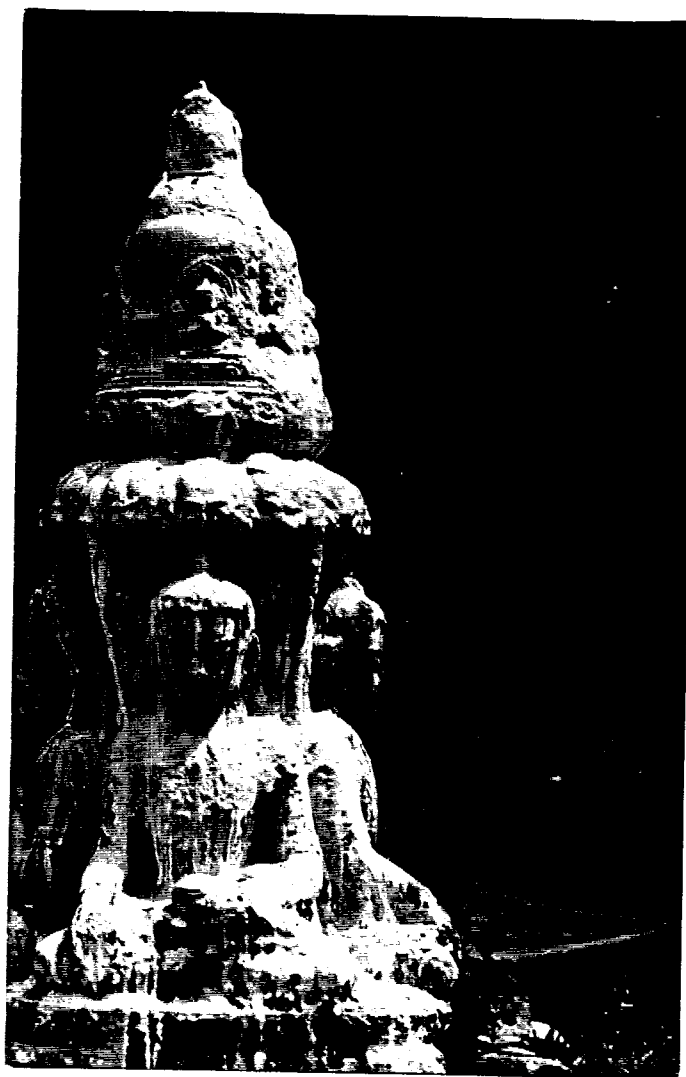
Pl. 23

The damaging practice of pouring whitewash over monuments as an act of worship is not traditional in the Kathmandu Valley and is a recently introduced custom of Tibetan origin. Note the advertisements which form the backdrop to this monument

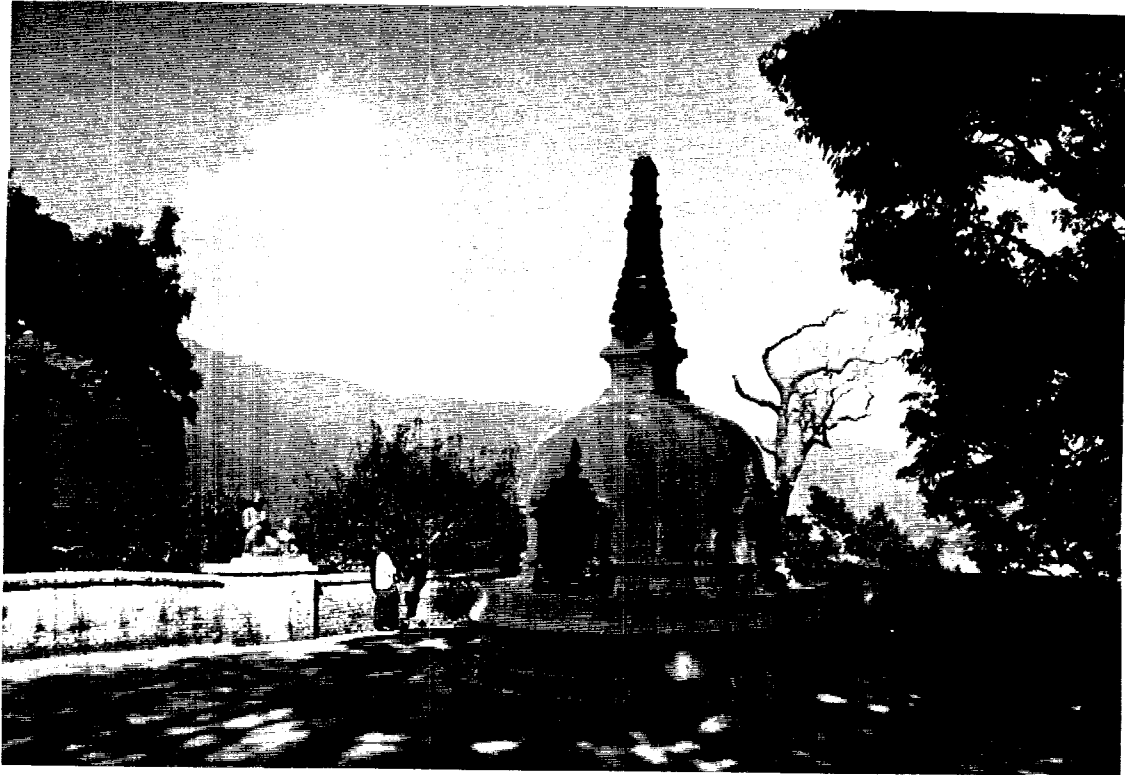
Pl. 24

This historic chaitya has been defaced as a result of its previously unpainted carvings being painted with unsuitable modern enamel paints

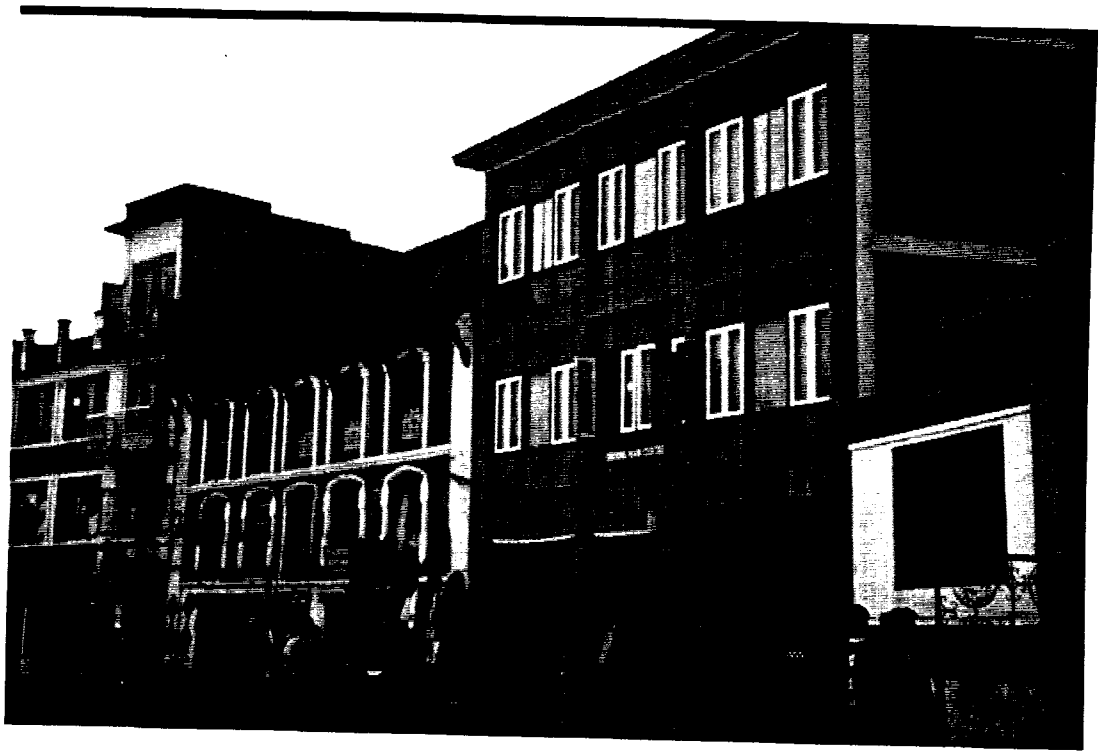
Pl. 28

Traditional houses have been demolished to make way for taller, concrete-framed, buildings

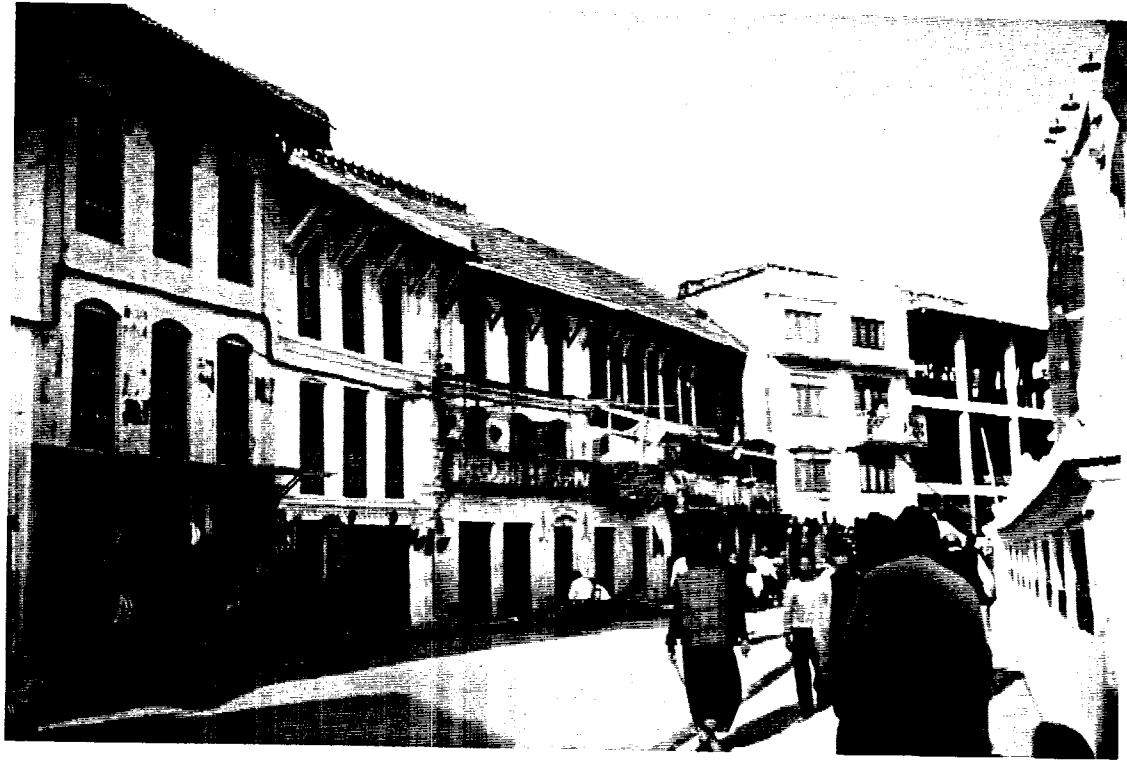
Pl. 29

Monument Zone 5: Baudhanath

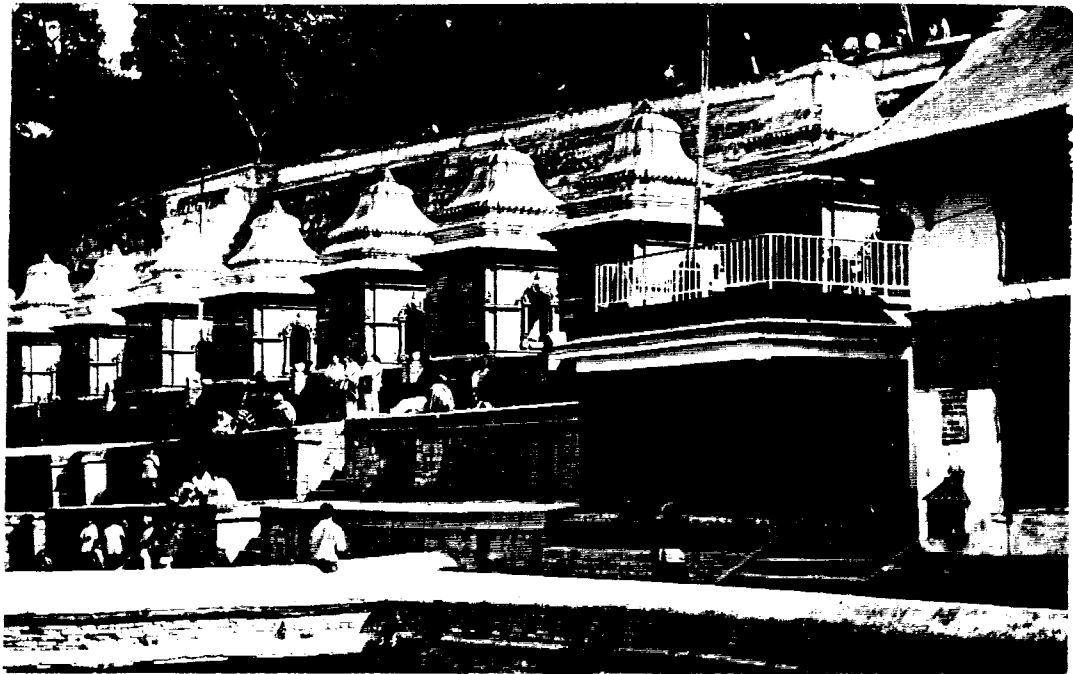
Pl. 34

A historic pati, formerly used by Indian musicians, was demolished to build a new tourist information centre

- 4.7.3 Examples of the demolition of monuments can again be found at Pashupati. On the terrace on the eastern side of the Bagmati river, facing the main temple, a historic pati formerly used by Indian musicians was recently demolished and has been rebuilt (incorporating fragments of historic material) as a tourist information centre (see Pl. 34). In Deopatan, the Dakshina Murti temple was totally demolished prior to restoration; although the new work is to a good standard, complete destruction of the historic fabric was almost certainly unnecessary (see. Pl. 35), and minor repairs would probably have sufficed. The dharamsalas surrounding the large Vishvarupa temple complex are in danger of collapse because of termite infestation of pine beams (see Pl. 36) and a number of adjacent small shrines are falling down.
