KATHMANDU VALLEY

WORLD HERITAGE SITE, NEPAL

Report and Recommendations of The Joint UNESCO/ICOMOS REVIEW MISSION

14 - 30 November 1993

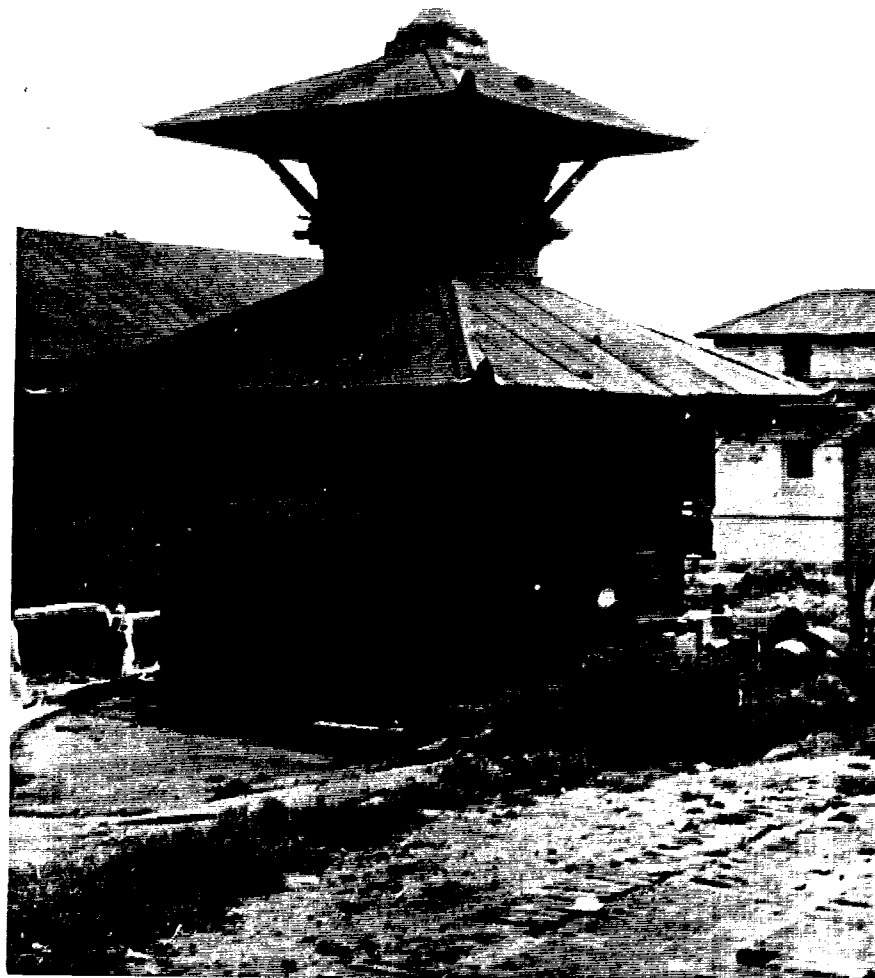
Pl. 35

Deopatan: this official record photograph of the Dakshina Murti temple, taken before work commenced, suggests that total demolition, as carried out, was unnecessary in order to repair the building

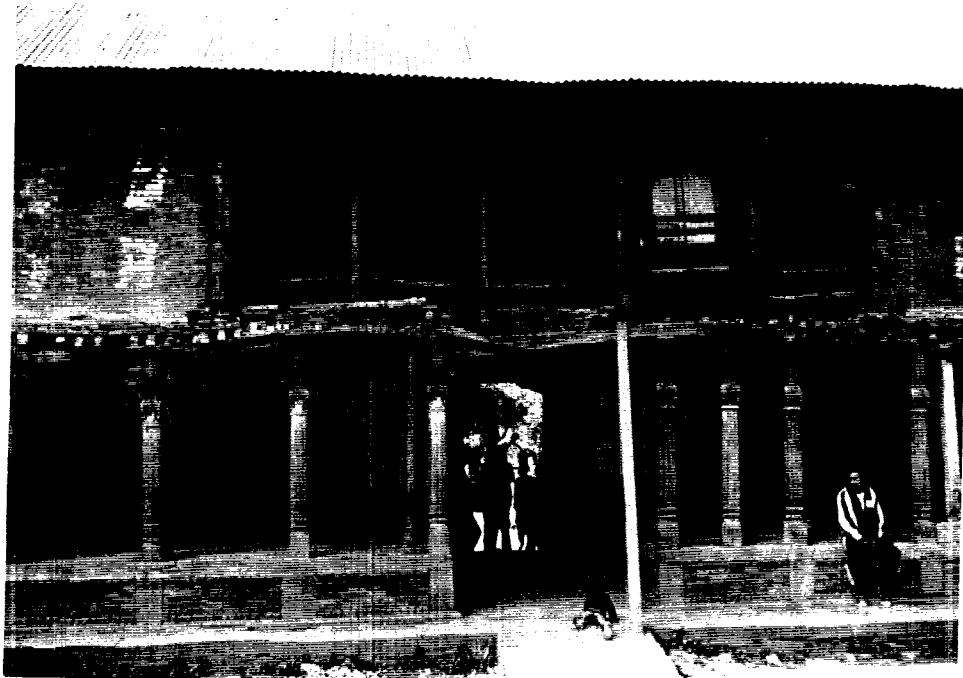
Pl. 36

The dharamsalas surrounding the Vishwarupa temple are in danger of collapse due to termite infestation of pine beams

- 4.7.3 Examples of the demolition of monuments can again be found at Pashupati. On the terrace on the eastern side of the Bagmati river, facing the main temple, a historic pati formerly used by Indian musicians was recently demolished and has been rebuilt (incorporating fragments of historic material) as a tourist information centre (see Pl. 34). In Deopatan, the Dakshina Murti temple was totally demolished prior to restoration; although the new work is to a good standard, complete destruction of the historic fabric was almost certainly unnecessary (see. Pl. 35), and minor repairs would probably have sufficed. The dharamsalas surrounding the large Vishvarupa temple complex are in danger of collapse because of termite infestation of pine beams (see Pl. 36) and a number of adjacent small shrines are falling down.

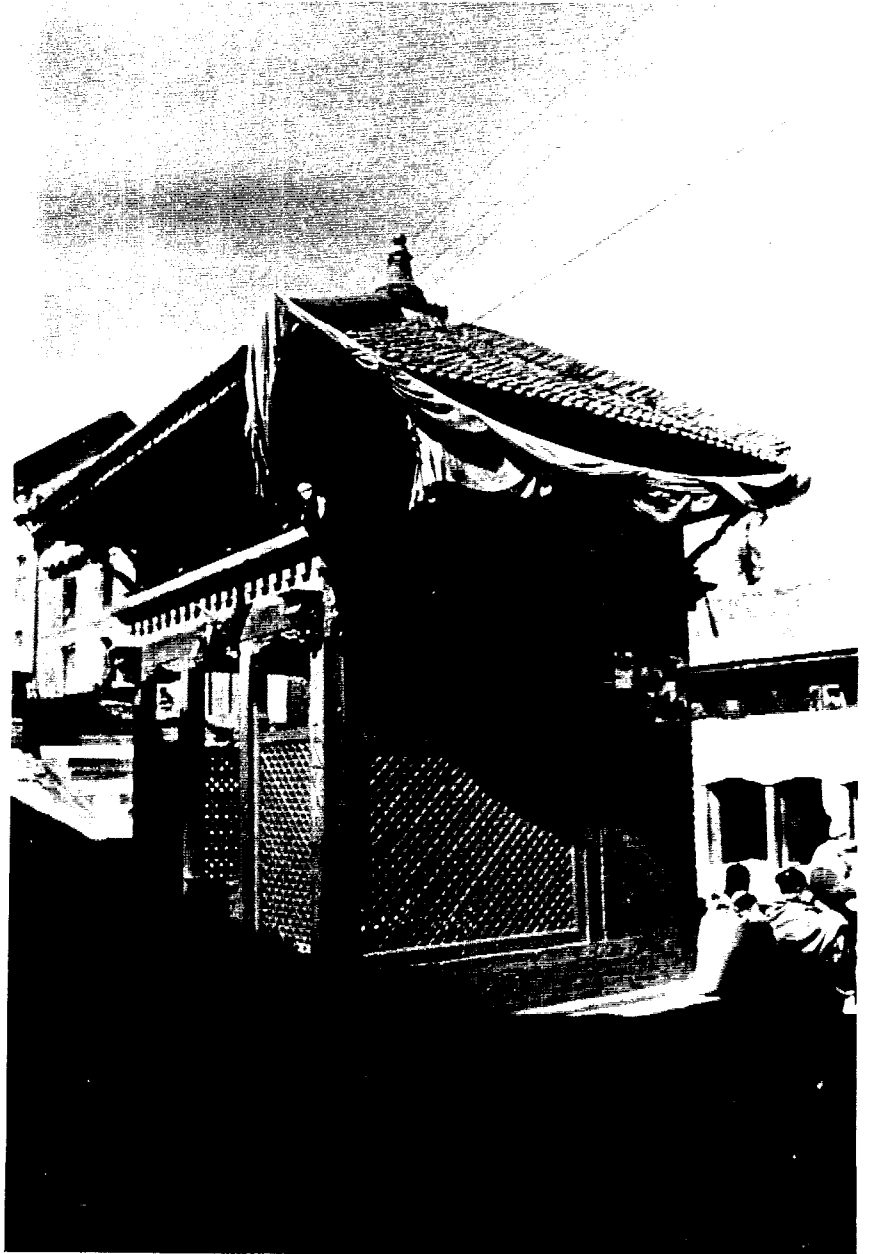
Pl. 37

The Ganesh temple was entirely demolished before being reconstructed in replica, 1988/9, as also was the sattal in the background

- 4.8.3 Considerable work was carried out at Changu Narayan between 1987 and 1989. In the village, the Ganesh Temple was entirely demolished and reconstructed in replica: treatment which was also accorded to the two-storey sattal which faces it across the village street (see Pl. 37), as well as to the L-shaped pati which adjoins the entrance to the temple. Repair work to the monuments inside the temple precinct was generally more conservative, apart from a Bhairab shrine, which had largely collapsed. Many of the sculptures inside the temple courtyard were covered with crude brick arches during the course of this work (see Pl. 38) and crude plastic repairs were carried out on another early sculpture at the site. The roof of the main temple is leaking and allows water to fall on the image within it and there is extensive decay to the brickwork of the surrounding dharamsalas (see Pl. 39).

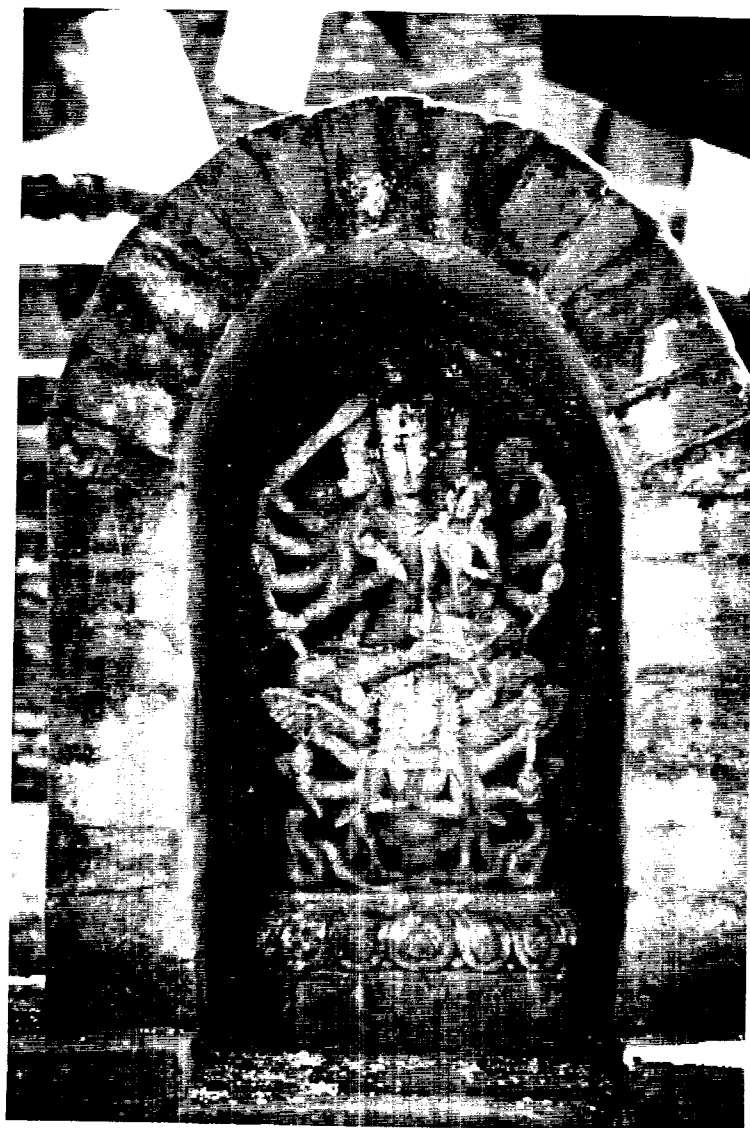
Pl. 38

In common with many of the sculptures in the temple courtyard, this 16th-century image of Mahavishnu (monument V-MZ 9.5 in the Protective Inventory) was covered with a crude brick arch during the works of 1987-89

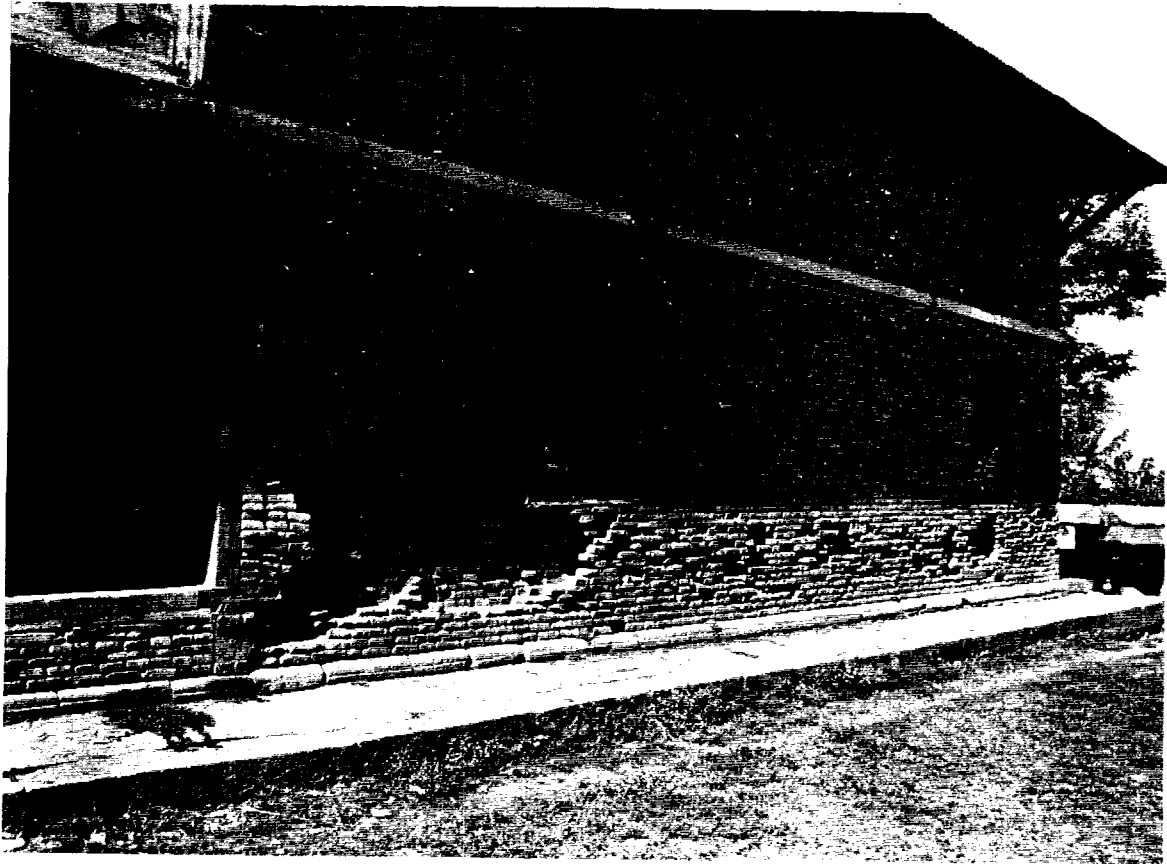
Pl. 39
Kathmandu Valley World Heritage Site
Monument Zone 7: Changu Narayan
Decayed brickwork of the dharamsalas surrounding the temple

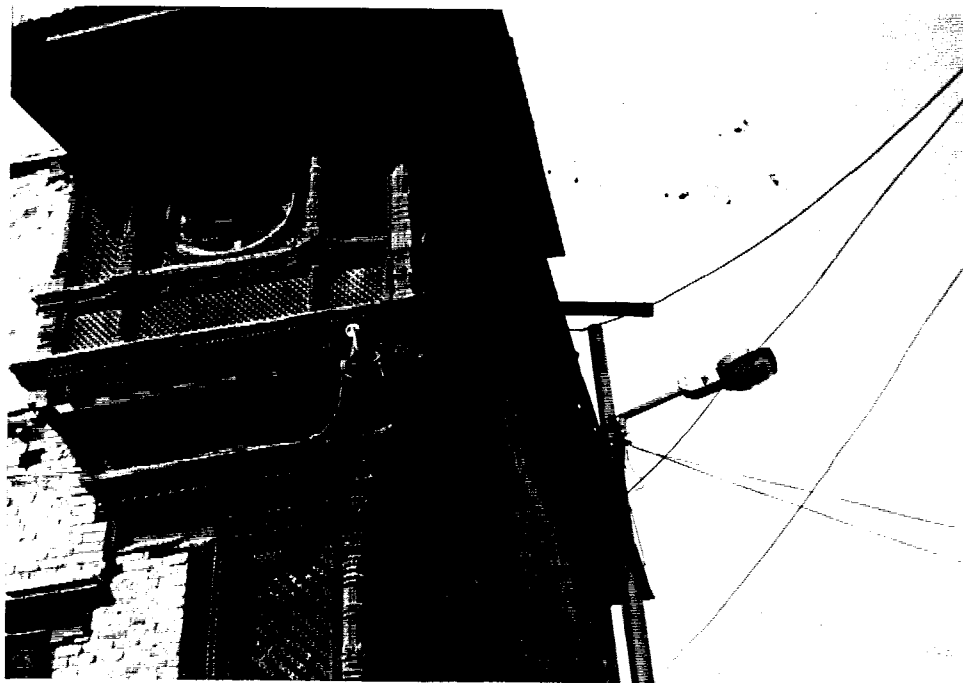
Pl. 44

Sundari Chowk: electrical wiring immediately adjacent to the palace
