# STATE PARTY REPORT

Updating Information for the State of Conservation Of the

Ancient City of Damascus (dossier n 20) (Syrian Arab Republic)

May, 2016

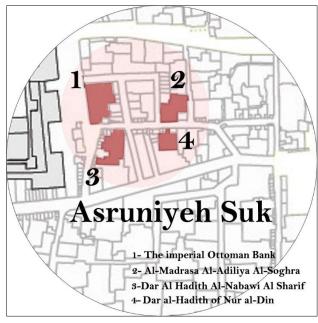
Map of the damaged area marked by red color

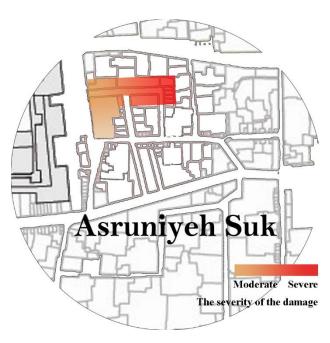
- More than 100 shops damaged.
- Several of the shops 2<sup>nd</sup> floor burnt down and totally destroyed.
- The bank affected by fire, the roof and windows were destroyed, interior walls damaged by fire while the outer facades witnessed minor damage.
- The rest of the Historical Monuments were undamaged.

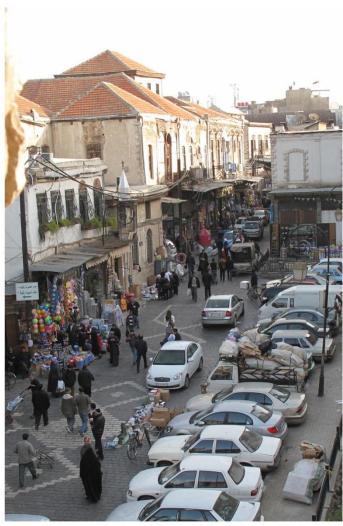
The North Facade - April 2016

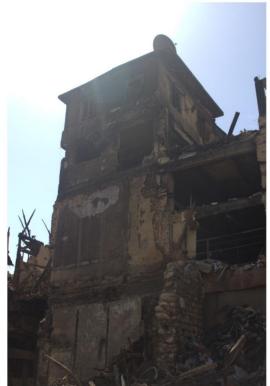
The West Facade - April 2016
