REPORT ON THE
ICOMOS REACTIVE MONITORING MISSION TO THE
AKSUM WORLD HERITAGE PROPERTY (C15)
FEDERAL DEMOCRATIC REPUBLIC OF ETHIOPIA

01 - 06 FEBRUARY 2016

Nicholas Clarke for ICOMOS

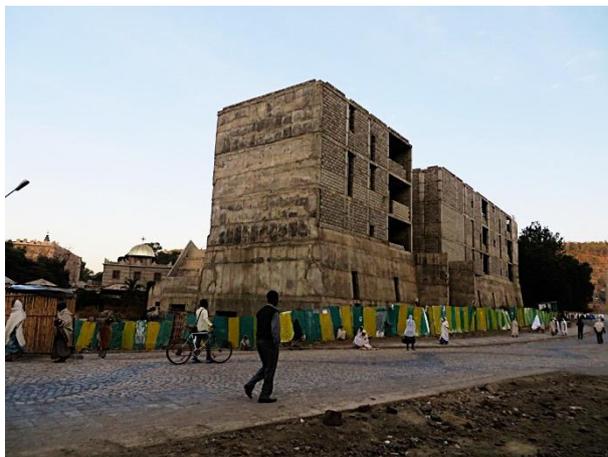
Figure 1. The Church Museum, 2016. (Author)

The urgency of this was confirmed during the visit to Aksum. The incomplete skeleton of the Church Museum, fenced by a temporary corrugate iron sheet fence, has a current temporary high negative visual impact on the property and therefore has a temporary negative impact on the Outstanding Universal Value of the property. This needs to be rectified through completion of the project, while taking in cognizance the recommendations following submission of the minor façade modifications.

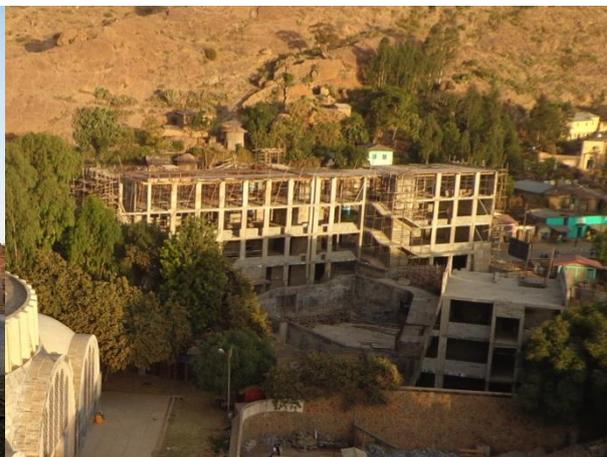
Figure 2. The Church Museum at time of the 2013 Mission (KA Bakker)

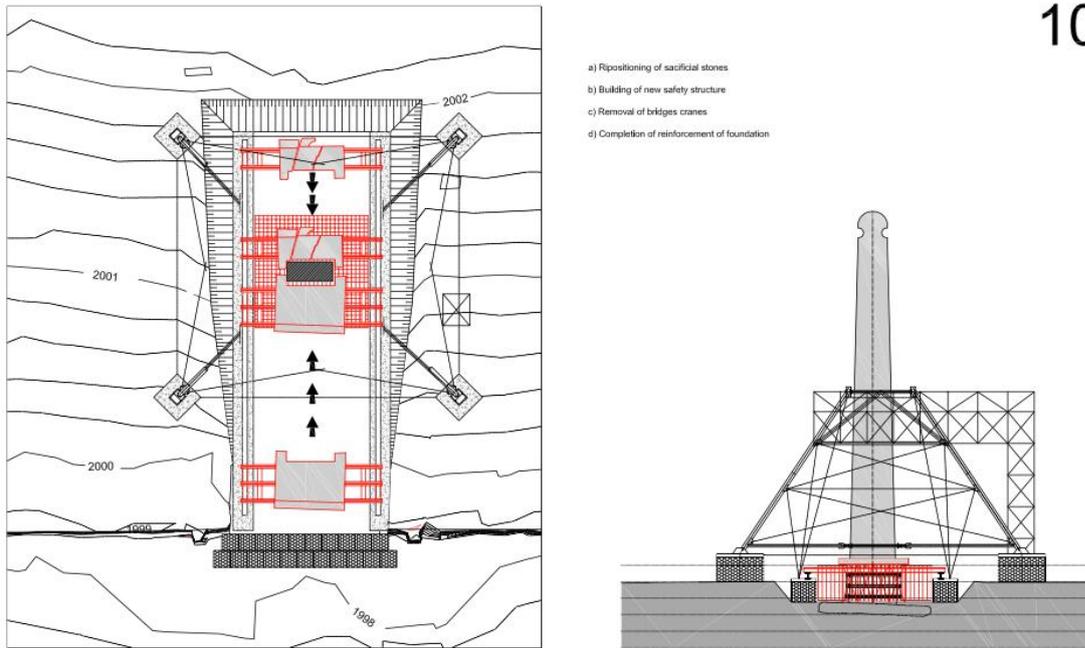
Figure 3. One image from the sequence of steps in the proposed plan for the consolidation of Stela III. The red block at the base of the Stela represents roughly the volume of the proposed concrete footing. (Croci: 2010b, See Annex A.13 for the full sequence of consolidation proposed.)

In the light of the above, and taking into account all the unforeseen negative effects of the carefully planned 'Zero Risk Operation'; of the reconstruction of Stela II, and a review of the 2010 Studio Croci Reports, the Mission recommends that:

- It is important to note that the process of stabilising Stela III will destroy the original near 2000-year old foundation of the Stela and with it the evidence of how ancient Aksumites erected these giant Stelae. Therefore any and all excavation at the site needs to be guided by an archaeologist with knowledge of the Aksumite construction technologies lead any excavations. This included excavations leading to the positioning of temporary shoring/scaffolding and the excavations for the positioning of the new reinforced concrete foundation.

- A relocation plan be designed for the display and interpretation of the basal stones and boulders that form part of the historical foundation of Stela III and will be removed in the process of installing the new foundation. The basal stones removed from the foundation of Stela III have been discarded haphazardly on the Stelae Field, without any interpretation, in cases lying on the site upside-down (Hagos, 2015). This cannot be allowed to happen again.

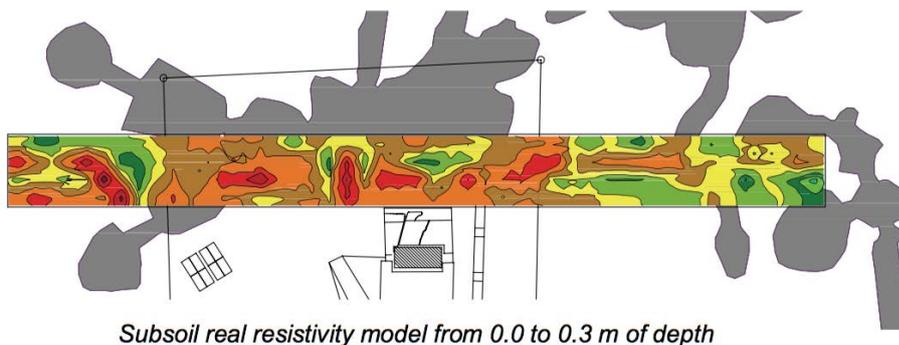
The proposal is not without risk, in the opinion of the Mission. This concern is shared by other specialists such as Hagos who firstly cites the original incline of the Stela, who states that stabilizing Stela III to a vertical position would be a *...reconstruction of a distorted history*. (Hagos, 2015). He also fears for the stability of the adjacent underground tunnels and the stability of the proximate Tomb of the Brick Arches. The positions of these are known. Additional cavities have been detected through a non-invasive geophysical survey, Studio Croci identified the presence of a cavity, possibly a burial chamber 4-5 meters below ground level directly to the north-west of Stela III. In fact the whole area around Stela 3 is riddled with sub-surface cavities, making this area very fragile.

Figure 4. Diagramme from the Studio Croci geotechnical survey report indicating the new cavities proximate to Steal III identified through the geoelectrical tomography survey (Croci: 2010a)

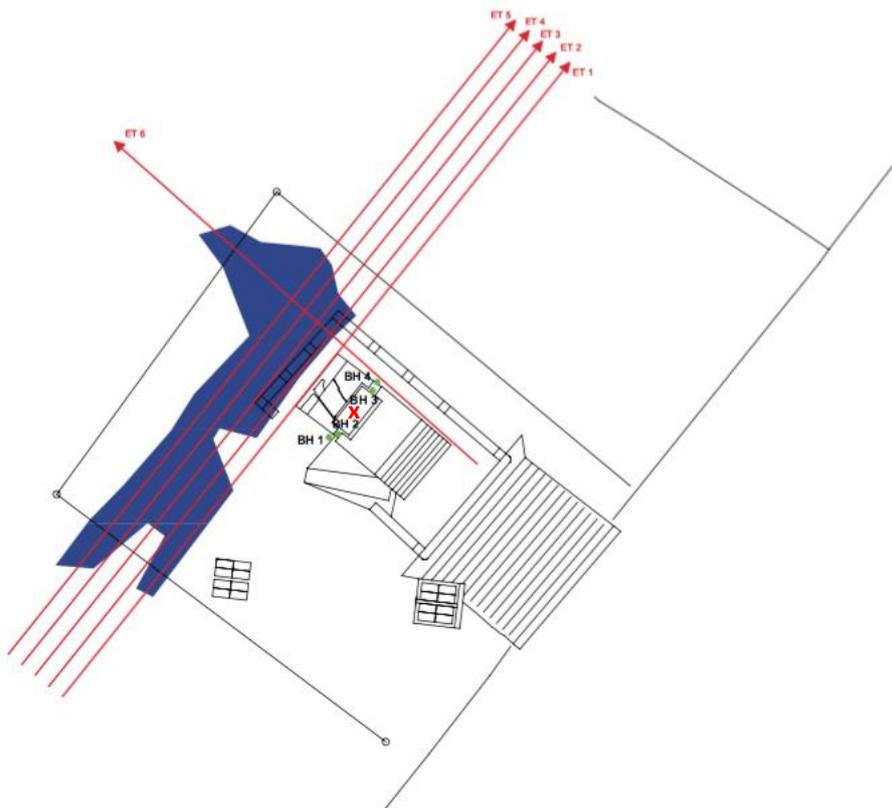
Figure 5. Diagramme from the Studio Croci geotechnical survey report indicating the chambers around Stela III (rectangle, labelled 'x') discovered in the 1980's digs. (Croci: 2010a)

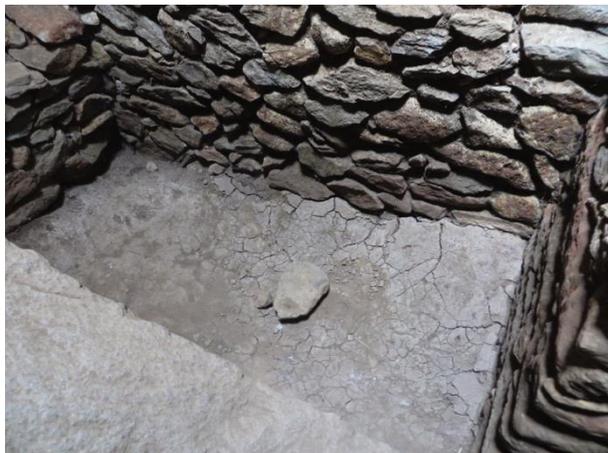
2010 WHC/ICOMOS Reactive Monitoring mission report (page 23) noted that stone shafts that light and ventilate the Mausoleum were constructed as part of the 2005/2006 World Bank Project that also saw the construction of the Archaeological Museum (in their opinion too close to the Stela Field). This has added to the weight the slabs over the central passage need to carry. These shafts were constructed from heavy stone walls, many meters high. These are covered in such a manner that rain enters the Mausoleum, evidence of which was visible throughout. This leads to situations, according to the site manager, where the tomb needs to be closed to visitors during the rainy season. The high retaining walls at the tomb's entrance also recently collapsed, due to structural pressure from the earth over the tombs. This has been reconstructed.

Figure 6. Evidence of rainwater ingress in the end chamber of the Mausoleum. (Author)

It is clear that the Mausoleum requires urgent structural and water proofing intervention. The soil covering the Mausoleum presents a dynamic load, getting heavier during the rainy season when it is saturated, lightening when it dries out. This Mission proposes for consideration a solution to both problems of water ingress and the load on the mausoleum: excavating down from the surface of the Mausoleum, thereby lightening the load, and covering this with a green roof that spans the original pit in which the Mausoleum was installed. Such an approach carries a high risk and careful archaeological and structural investigation would be required before any action is undertaken. In the meantime the structural provisions made by the site manager are welcomed; the situation should receive careful monitoring and, should any additional movement be noticed, additional reversible non-intrusive emergency measures be taken.

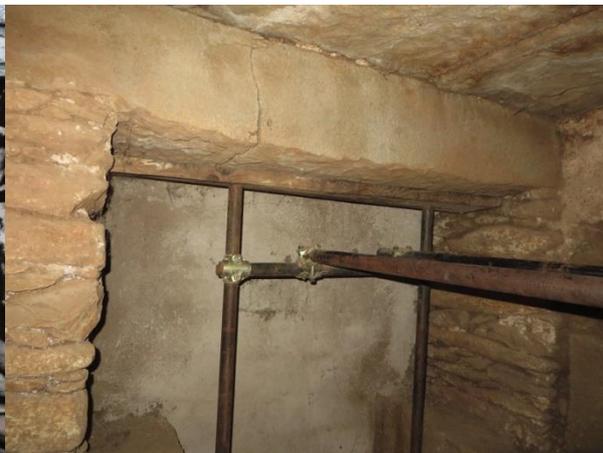
Figure 7. Temporary scaffolding supporting the historically cracked lintels in the Mausoleum. (Author)

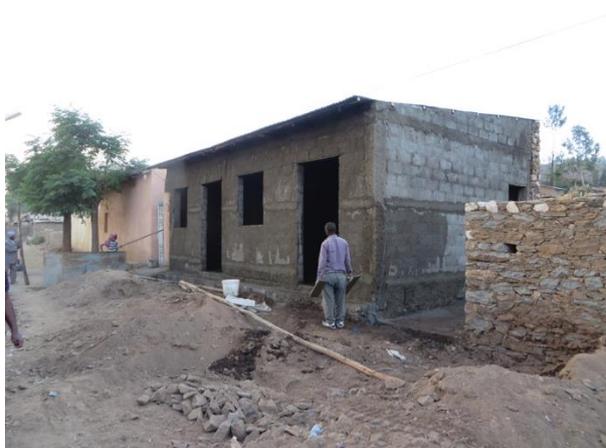
Within the boundaries of the property, new construction is being undertaken adjacent at the Ta'ka Maryam Palace Archaeological site (Figure 1). The Site Management has approved this structure, with a height restriction imposed and an instruction regarding the finishing of the walls of the structure to match adjacent buildings. The roof form, a mono-pitched roof with gable ends, unfortunately does not follow the standard form—a hipped saddle, or pyramid roof—common in its environment, leading to a misfit between the new and extant construction in full view of the archaeological site. And while its materials match the adjacent structures it does not continue the traditions of the vernacular structures that still dominate that environment.

Figure 8. New construction opposite the Ta'ka Maryam archaeological site. (Author)

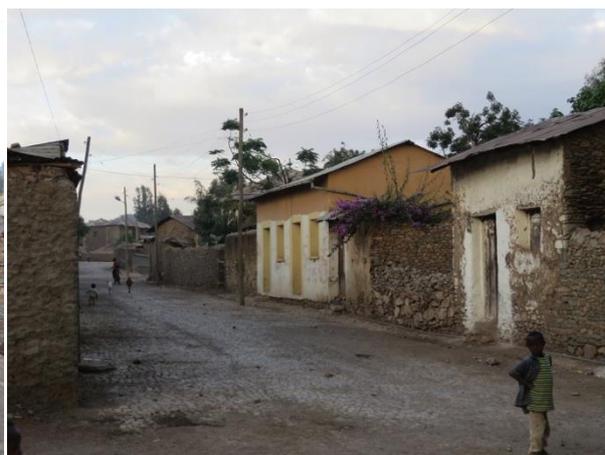
Figure 9. The urban context of the Ta'ka Maryam archaeological site. (Author)

The Mission therefore recommends that clear development guidelines and regulations be developed for both the property and the buffer zone. These should include restoration guidelines for extant vernacular and modern structures, height, form, material and aesthetic coding and guidelines for new construction and be regulated through local or provincial proclamation. Until such guidelines have been reviewed by the World Heritage Centre, all large-scale developments and infrastructure projects should be submitted for review to the World Heritage Centre as per Paragraph 172 of the *Operational Guidelines*.

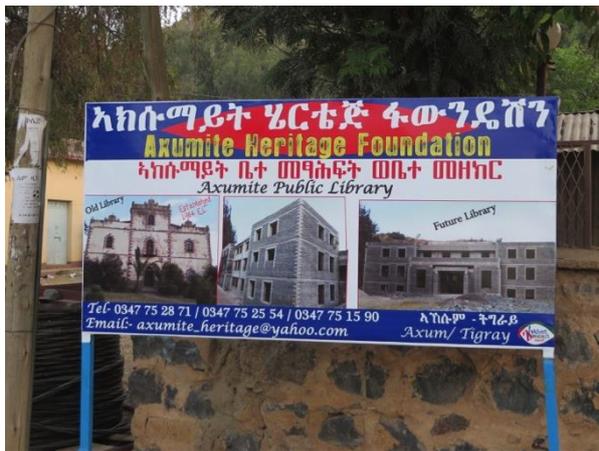
A new three-storey Public Library is under construction at the site of the old Library/ Patriarch's residence by the Aksumite Heritage. The Old Library is to be converted to use as an Ethnographic Museum. The concept of this development is welcomed as it will not only provide library facilities to the community, but could also become a repository for knowledge on Aksum and its ancient civilization, as well as showcasing cultural development of Aksumites over the centuries in the envisaged Museum. Yet this new construction falls within the boundaries of

the Aksum World Heritage property. Its setting, against the hill of Mai Koho, is able to absorb the bulk of this new construction and it is reasonably masked by extant foliage, but it continues the precedent of inappropriate height for new buildings in the property. On enquiry the site manager informed the Mission that the site had been previously archaeologically explored by the late Prof Ziegert who found no noteworthy archaeological residue located here. On the basis of this study approval was given for the project. The location of the library, on the Italian Square is appropriate and the site is out of sight of the Church Compound and main Stelae Field. Yet the fact that such a large development could proceed without approved development guidelines in place; and the absence of reporting, which should have taken place in terms of Paragraph 172 of the *Operational Guidelines*, is worrying.

Figure 10. Notice of the construction of the new Public Library. (Author)

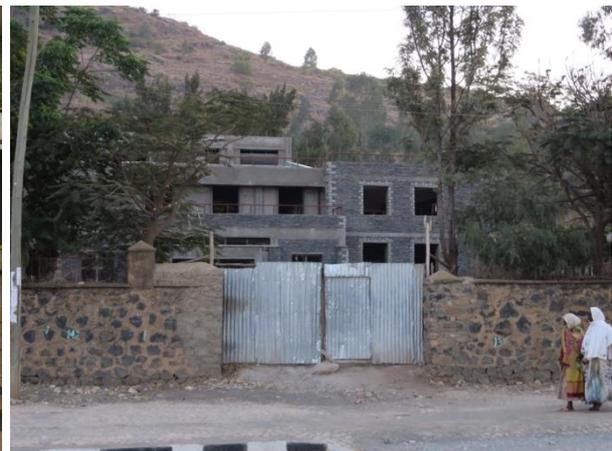
Figure 11. The new Public Library, a three-story building, located against Mai Koho. (Author)

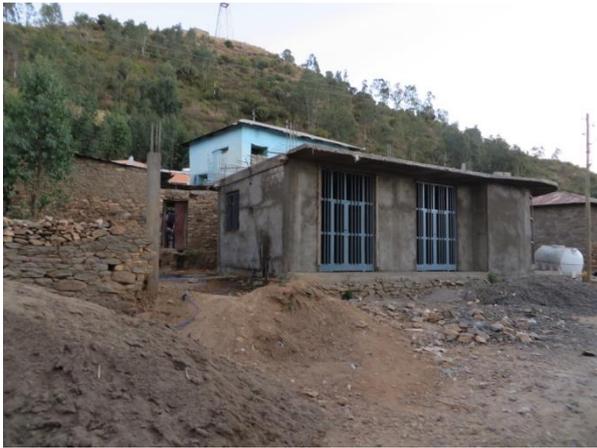
Construction is also taking place in close vicinity to the Tomb of Basen where the clear intention is to construct a contemporary-looking double storey building. On the other side of the Tomb of Basen, a tourist lodge, constructed during 2013, pays lip service to the aesthetic of the ancient Aksumite palaces and the local vernacular, but this is inappropriate due to its pastiche like character and scale of three stories. This is a clear indication that more careful development guidelines and regulations are required.

Figure 12. New double storey construction located adjacent to the Tomb of Basen. (Author)

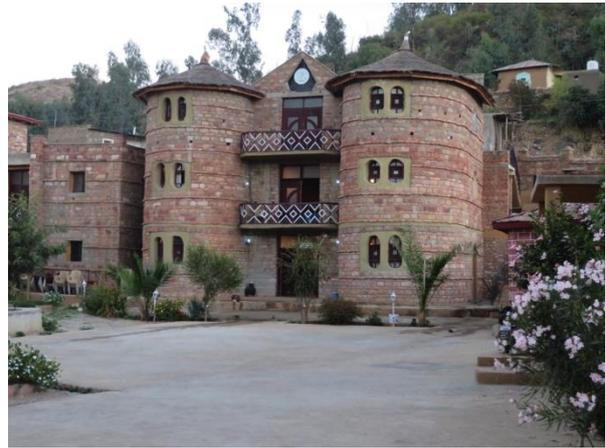
Figure 13. A new tourist lodge constructed close to the Tomb of Basen in a faux traditional style. (Author)

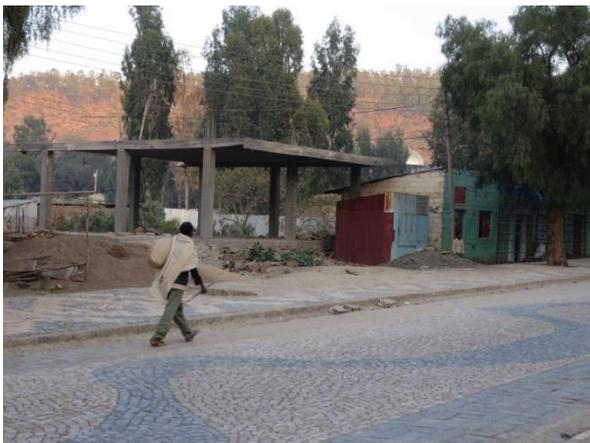
Adjacent to the Church Museum new construction is being undertaken in a highly visible location along the main sight line to the Stelae Field. This development had not been approved by the site management and was subsequently stopped, and a restriction was placed on the height, before approval given for its completion.³ It is unclear what the final aesthetic appearance of this building will be, but it is a point of concern. It also illustrates the knock-on effect of the presence of the Church Museum in the property, also evidenced by other new construction being undertaken on this important route.

Figure 14. New building work adjacent the Church Museum site on the main access way to the Stelae Field. (Author)

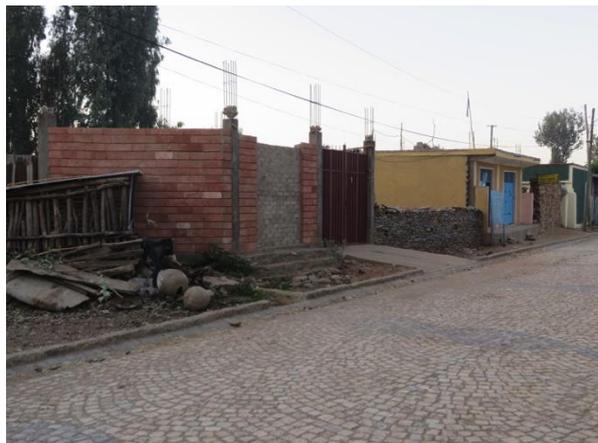
Figure 15. New construction in close proximity to the new Church Museum on the main access to the Stelae Field. (Author)

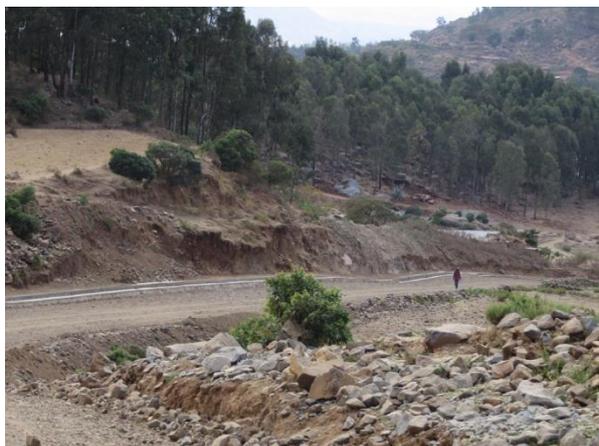
In the developing city of Aksum infrastructure development is not only necessary, but welcomed. The Mission noticed the construction of a large storm water gutter along the road to the Tombs of Kaleb and Gebre Meskel

that required groundwork including grading and digging. The ARCCH Head of the World Heritage office informed the Mission that an Heritage Impact Assessment had been done before approval of the project and that care had been taken to avoid impacting important archaeological sites, such as the known Aksumite Villa located directly adjacent the road. The Mission did not have the opportunity to inspect this HIA and notes that the State Party as standard practice should communicate such HIA's to the World Heritage Centre. In the absence of an approved Management Plan and Development guidelines the Mission recommends extreme caution and proposed that any such future activity be communicated to the World Heritage Centre as a development that could potentially impact the Outstanding Universal Value of the property.

Figure 16. New storm water gutter on the road to the Tombs of Kaleb and Grebe Meskel. (Author)

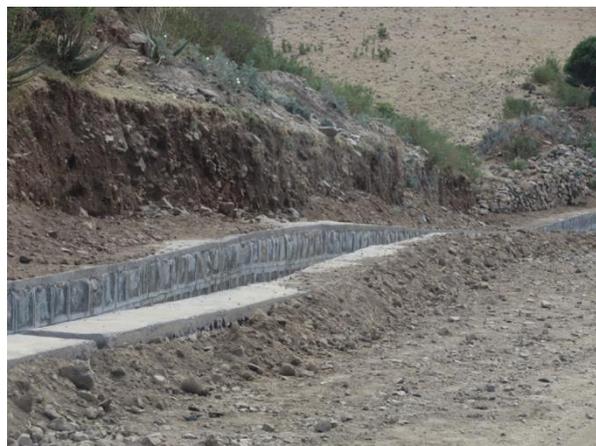
Figure 17. Close-up photograph of the new storm water gutter on the road to the Tombs of Kaleb and Grebe Meskel. (Author)

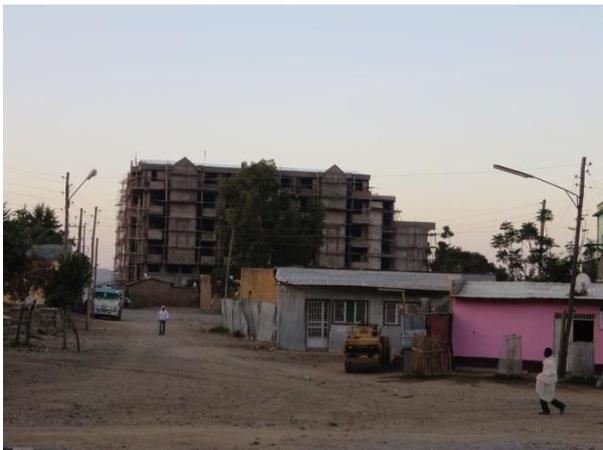
In the buffer zone; a seven-story hotel building is in the process of completion. This is located on the boundary of the buffer zone, and has been under construction since at least early 2013 (it appears on Google Earth photography dated 18 March 2013), therefore predating the delineation of the buffer zone. This fortunately is screened from the Church Compound and the Stelae Field, but has a high visual presence along the lower reaches of the property. It is unknown to the Mission how the façade will be faced, but it is important that this be selected, and if needs be, modulated to limit as far as possible the visibility of the tall structure. It also creates a precedent for further high-rise development in the buffer zone, which cannot be allowed. This building must be seen as an exception, with possible future remedial action through lowering it when the building gets replaced. In other word the current height should not for the bases for future development rights for the property or any others in the buffer zone. This case further illustrates the need for development guidelines and regulations.

Figure 18. New seven-story hotel development located in the buffer zone of the property. (Author)

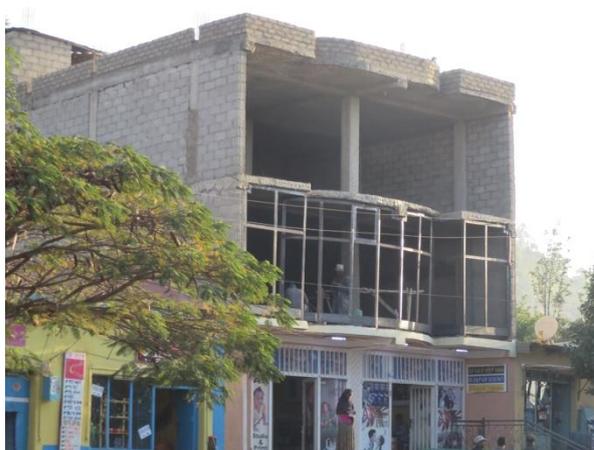
Figure 19. The new commercial construction on the outer edge of the buffer zone on the road to Dungur. (Author)

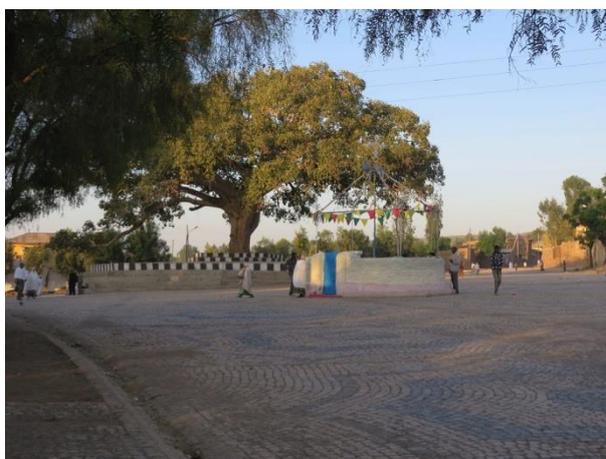
The landscaping programme has certainly altered the character of the property and the buffer zone, especially at the roads leading to the Stela Square, the Stela Square itself, Dearo Piazza (Italian Square) and the Daero Ela Square (Square of the Four Beasts). The provision of built structures to accommodate the Interpretative signage has been undertaken through the project. For this a single design was developed and executed at 22 places in the serial site with varying visual impact and contextual success. The Mission finds that the aesthetic and material finish of the structures constructed for interpretation are not well aligned with the setting of the property and do not contribute to the harmony of the property. This is less pronounced at outlying sites such as at the tombs of Kaleb and Gebre Meskel and the Dungur Place and Stela Field, than in the town of Aksum and especially the Stela Field. These changes can be absorbed by the capacity of the property site and have not markedly negatively altered the attributes that lead to the property being inscribed on the World Heritage List.

Figure 20. Square of the Four Beast, 2016. (Author)

Such a large scale programme certainly had the potential to affect the Outstanding Universal Value of the property (both in relation to the first statement of Outstanding Universal Value and the later Retrospective Statement of Outstanding Universal Value), and the State Party should have notified the World Heritage Centre of their intention to plan and execute the project under Paragraph 172 of the *Operational Guidelines*. At the same time this project, due to its scale and potential to detract from the Outstanding Universal Value of the property, should have been subjected to an Heritage Impact Assessment, according to the ICOMOS *Guidance on Heritage Impact Assessments for Cultural World Heritage Properties* (2011). It also has the potential for setting an unwanted precedent, for instance, for the landscaping of the Church of St Mary of Zion Church compound.

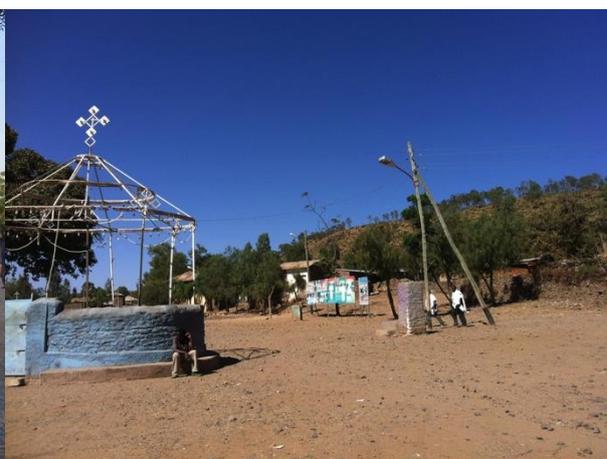
Figure 21. Square of the Four Beast, 2013. (KA Bakker)

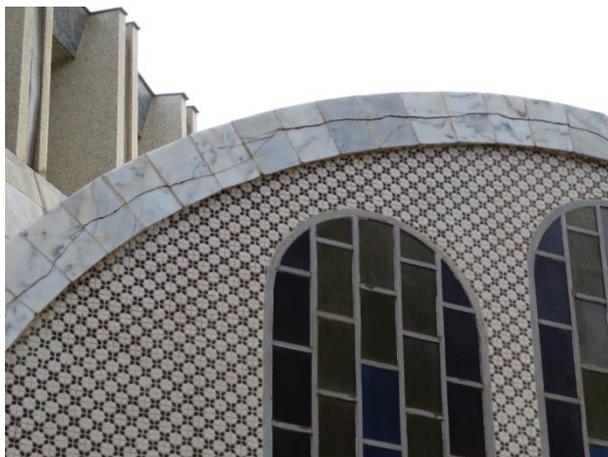
Figure 22. Cracks along the circumferences of the vaulted apses of the 1957 Church of St Mary of Zion. (Author)

This building requires short-term attention, but it must be stressed that this project requires appropriate specialist intervention. Should a proposal be developed to stabilise this structure, such a proposal should be submitted to the World Heritage Centre for review under Paragraph 172 of the *Operational Guidelines*.

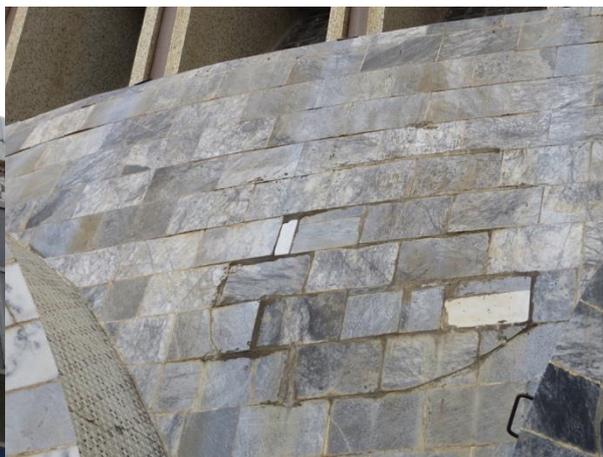
Figure 23. Recent repairs to the lower dome of the Church of St. Mary of Zion. (Author)

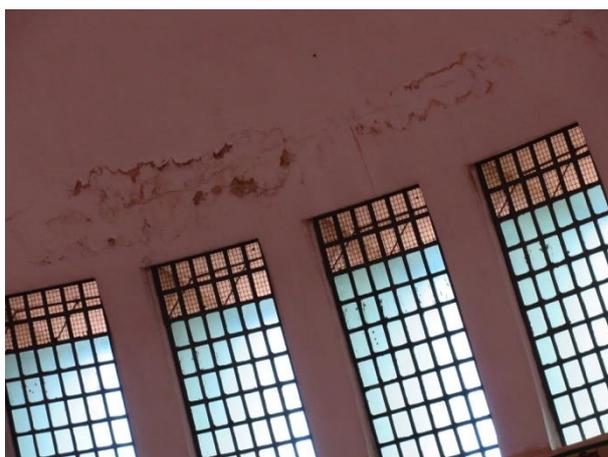
Figure 24. Water damage to the inside of the main dome of the Church of St Mary of Zion (Author)

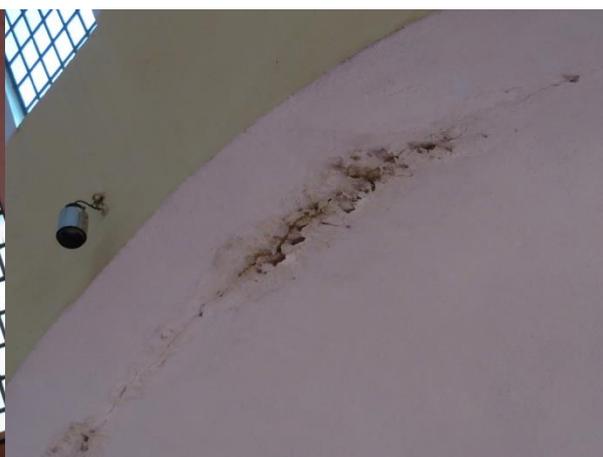
Figure 25. Water damage to the inside of one of the vaulted apses of the Church of St Mary of Zion (Author)
