MISSION REPORT / RAPPORT DE MISSION

Historical Monuments at Makli, Thatta (Pakistan) (C 143) Monuments historiques à Makli, Thatta (Pakistan) (C 143)

19-22 April 2016

REACTIVE MONITORING MISSION TO THE WORLD HERITAGE PROPERTY "THE HISTORICAL MONUMENTS AT MAKLI, THATTA", PAKISTAN

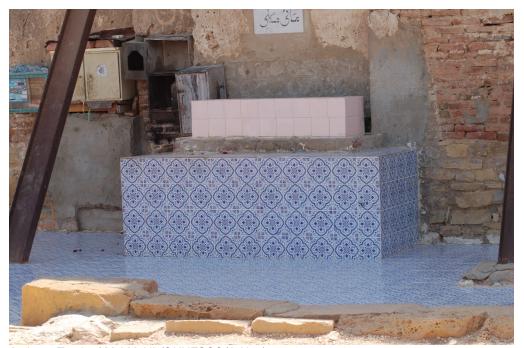
A photo: Tomb of Mai Makli (©UNESCO/J. Han):

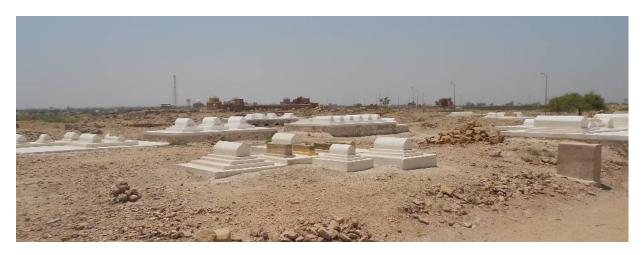
Figure 24. Recently reconstructed and replastered gravesites adjacent to the tomb of Sultan Ibrahim. The reconstruction approach is questionable without adequate documentation of the graves and careful recording of the process and distinguishing of historic fabric and new intervention material. The use of stark white lime wash without addition of aesthetic color tempering to ensure the work is visually compatible with the character of the site is inappropriate. Additionally, if information about these graves and their owners was known, there is no interpretation provided. The allocation of resources to this work is highly questionable given the state of conservation of many far more significant structures within the site of Makli. ©UNESCO/J.Bell

- On the gravesites, individual tombs were reconstructed and plastered in stark white lime without any indication of what portions are original or new interventions (see Fig. 27). Based on the understanding of the Joint Mission, there was no documentation of the condition prior to conservation or during the intervention process. It was also unclear why resources were dedicated to these gravesites when so many monuments of great significance are in critical condition and actively crumbling.
