SAMBOR PREI KUK

Archaeological Site

LANDSCAPE of the Ancient Ishanapura

Annexes of the Request for Inscription on the World Heritage List

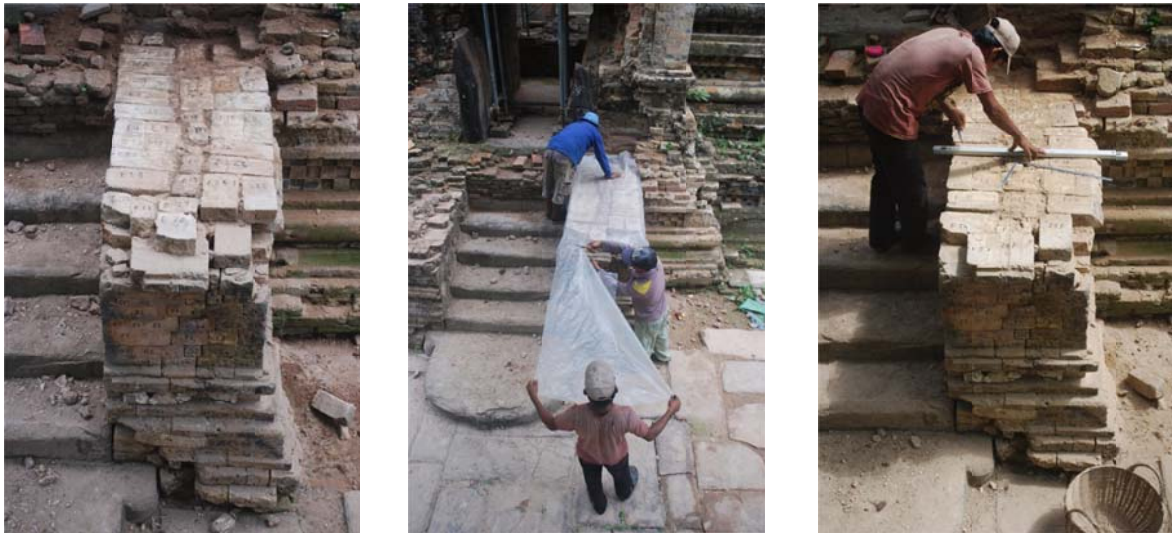
Figure 1, 2, 3 The activities of dismantling work on layer E and F of eastern handrail of south face entrance

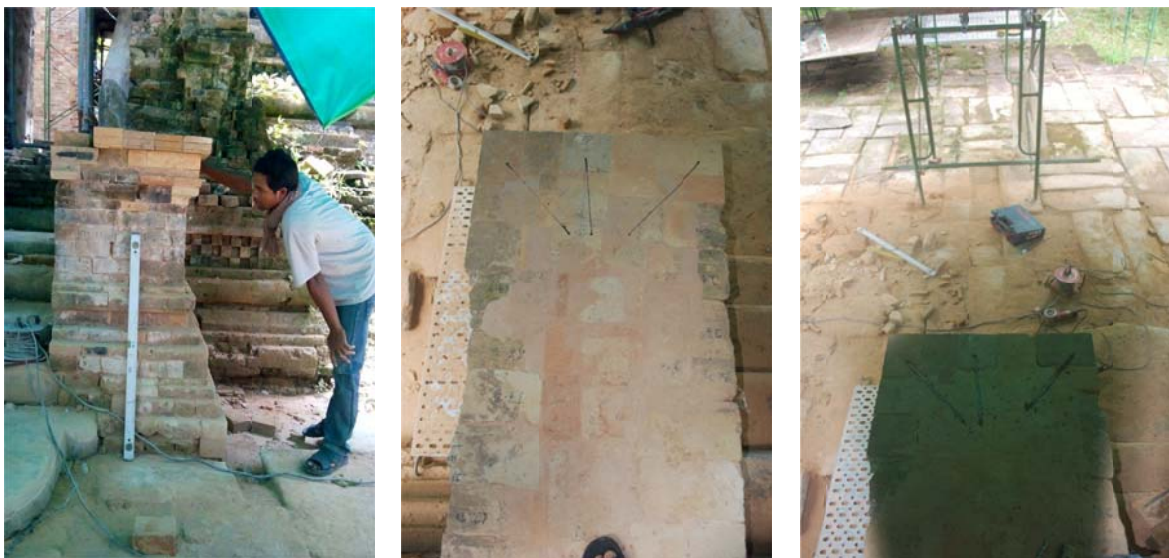
Figure 53, 54, 55 The activities reconstruct and put stainless cramp at layer D

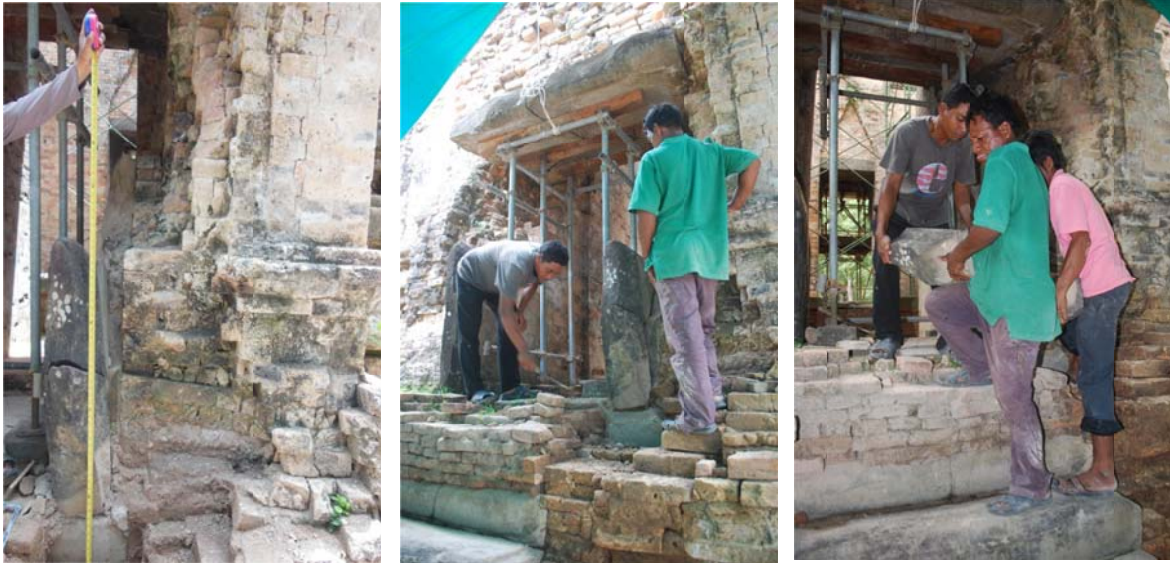
Figure 56, 57, 58 The activities of take record, clearance and move the broken pieces of door frame

Figure 59, 60 The activities reconnect the door frame with stainless pins

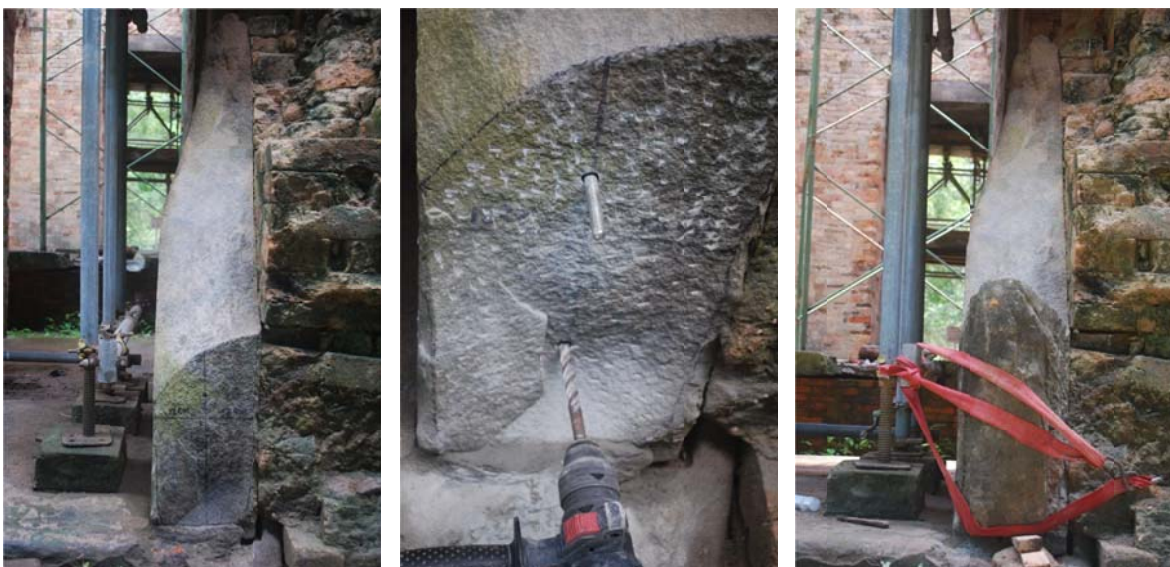
Figure 61, 62, 63 The process of reconnect the door frame

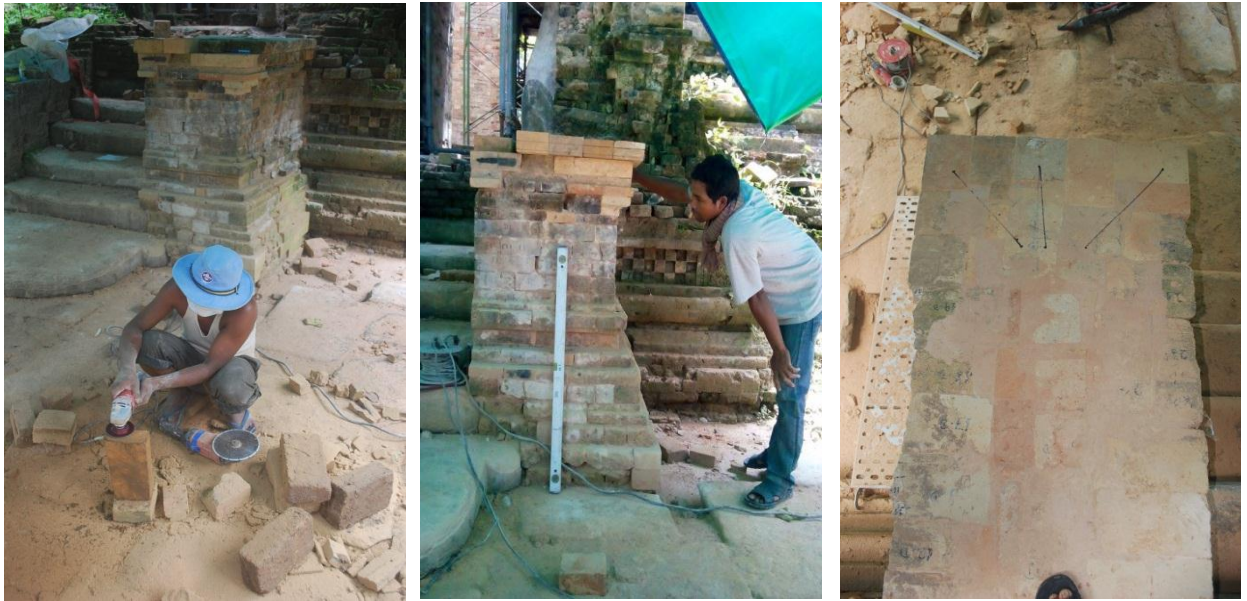
Figures 5.7.5, 5.7.6, 5.7.7 The activities reconstruct and put stainless cramp at layer D

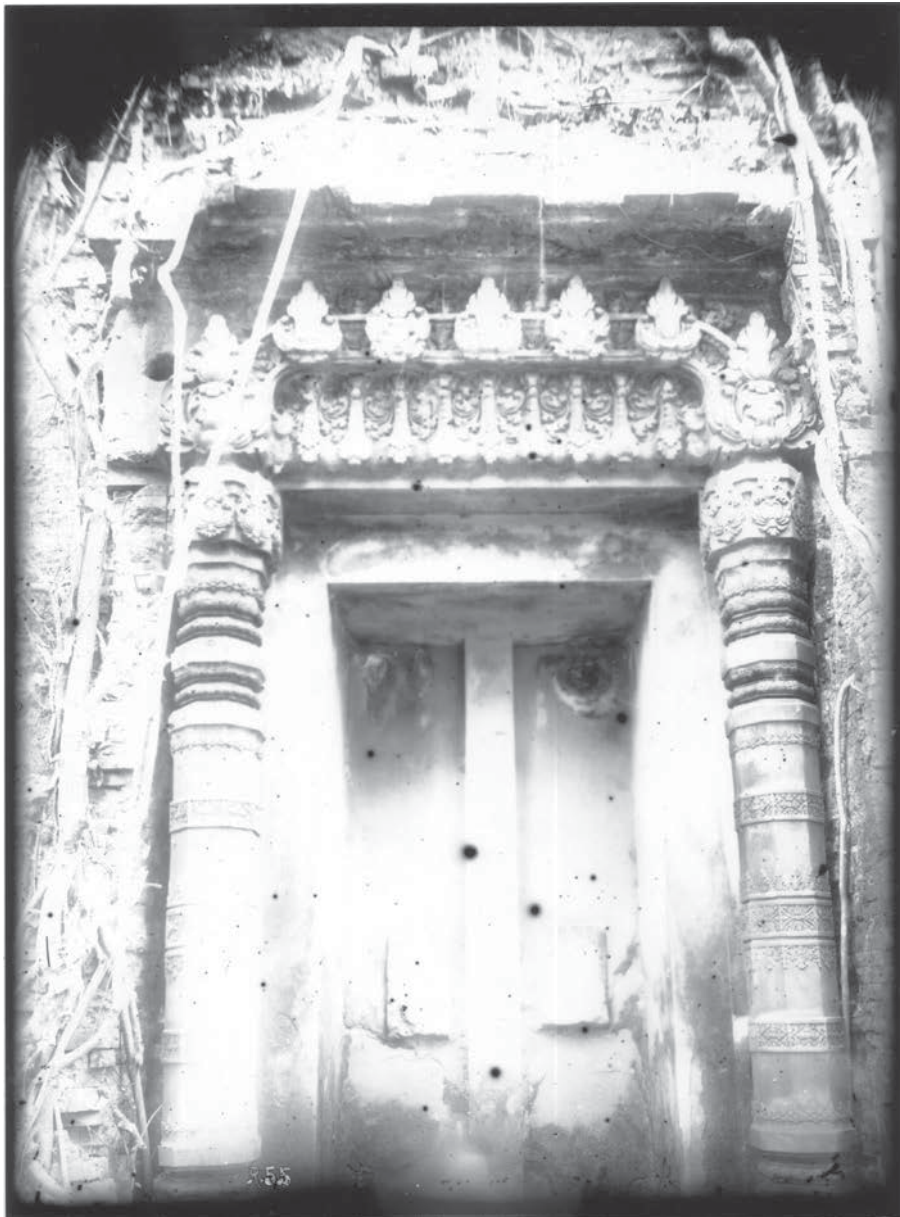
Description : Upper part of the right pilaster remained. Brick wall was tangled with small trees. There was no steel band support for the left broken colonnette.

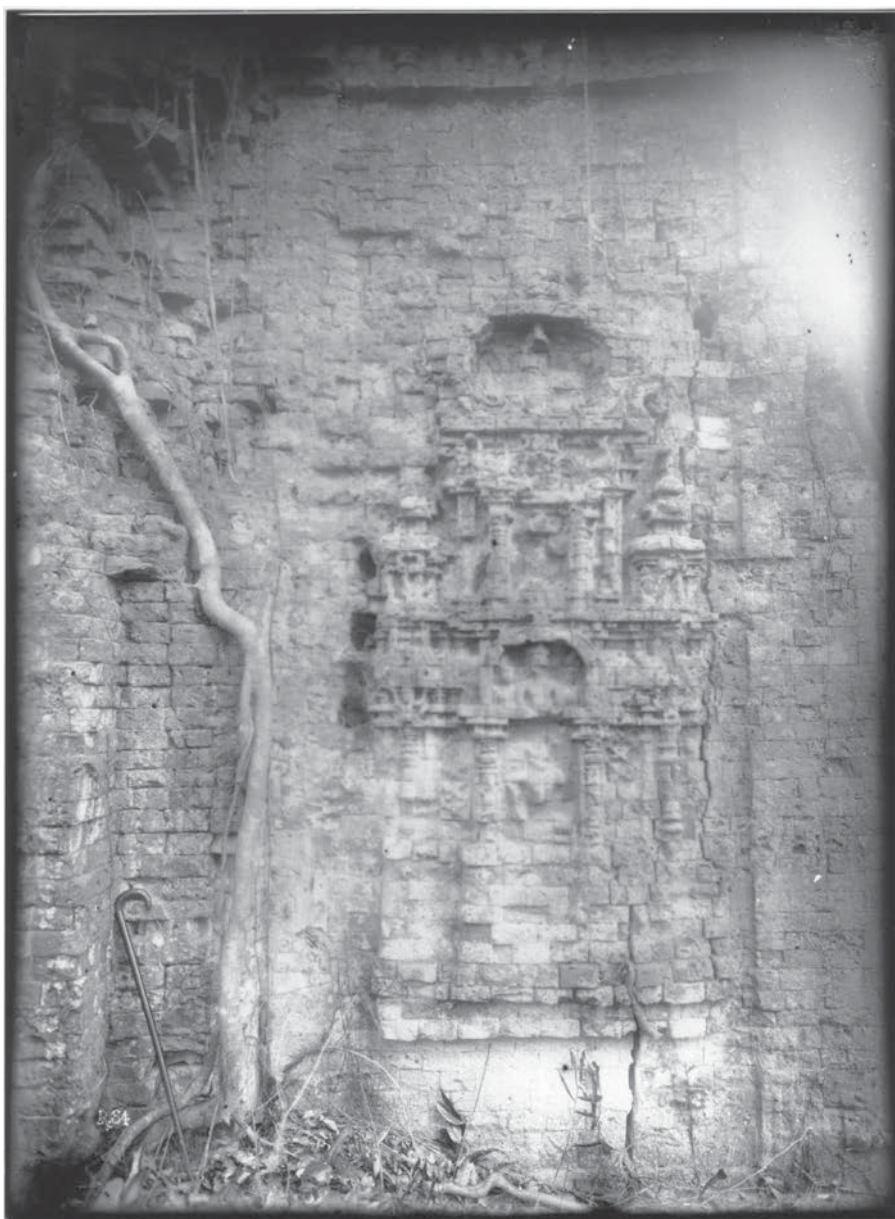
Description : Upper part of the right side pilaster was in better condition than now. Each crack opening was smaller than now. One small tree tangled on left side.

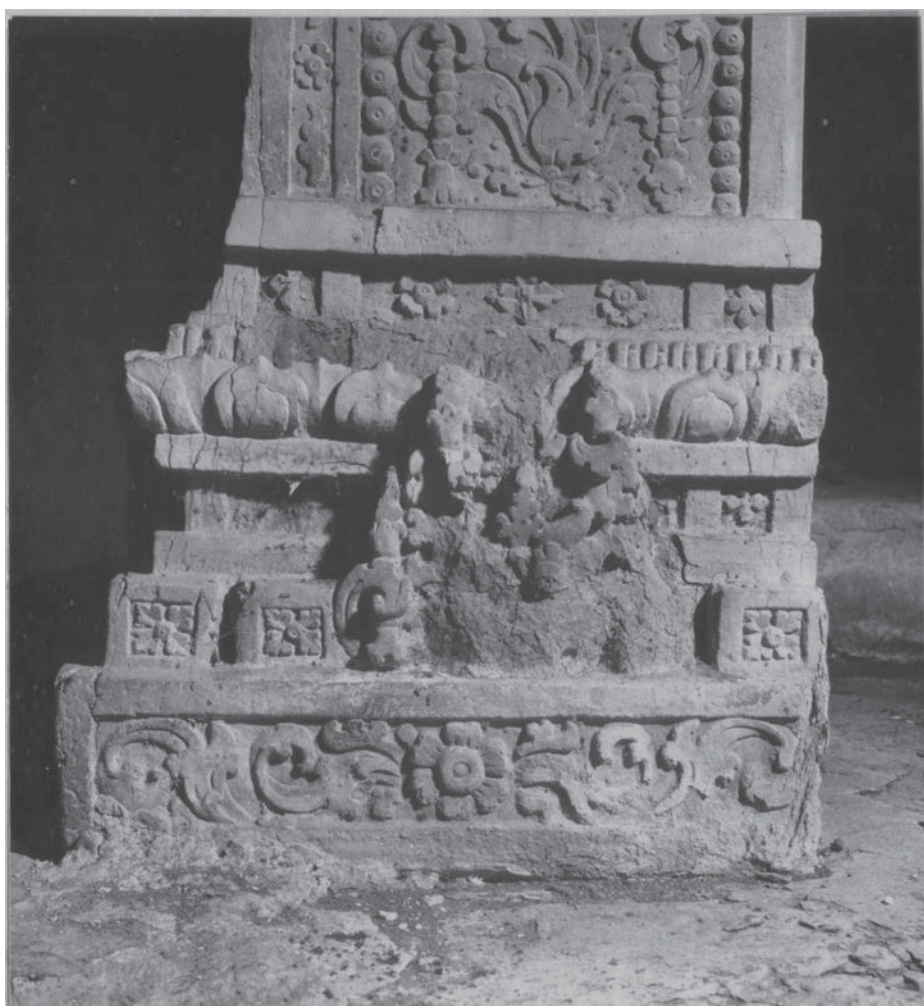
Description : Decoration was in better condition than now (exfoliation of the curved surface progressed after this photograph).

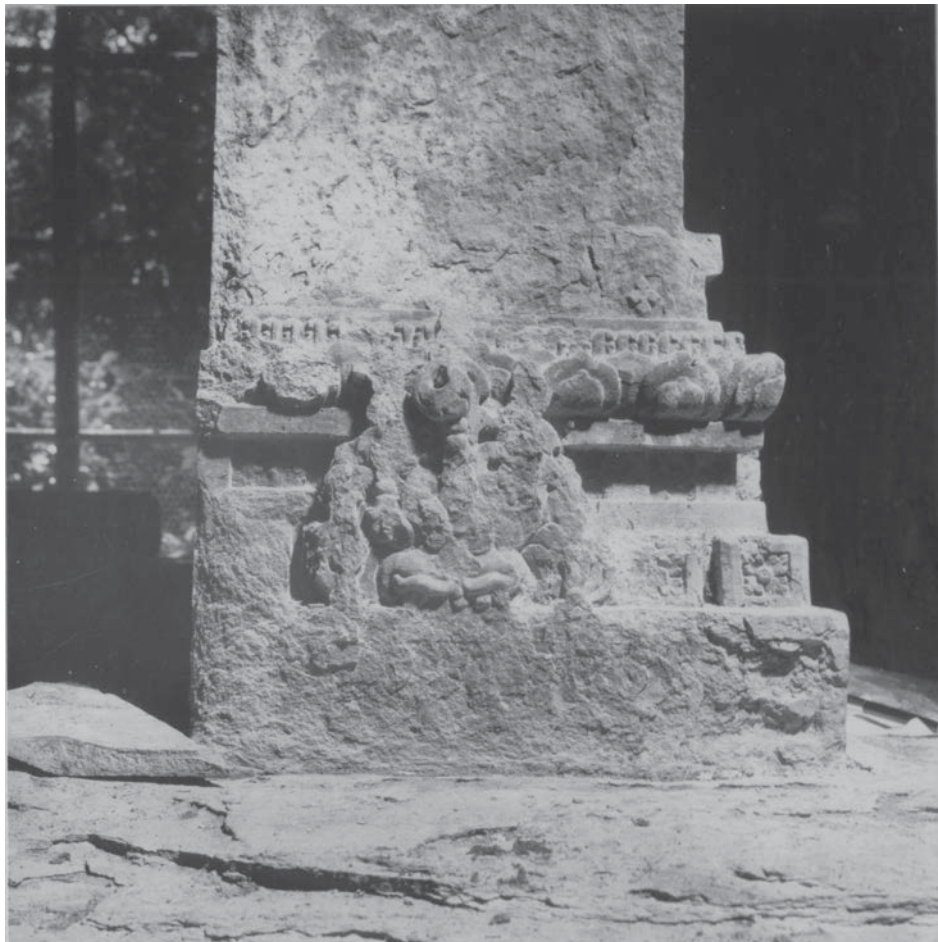
Description : Decorative lotus petal was broken partially after this photograph.

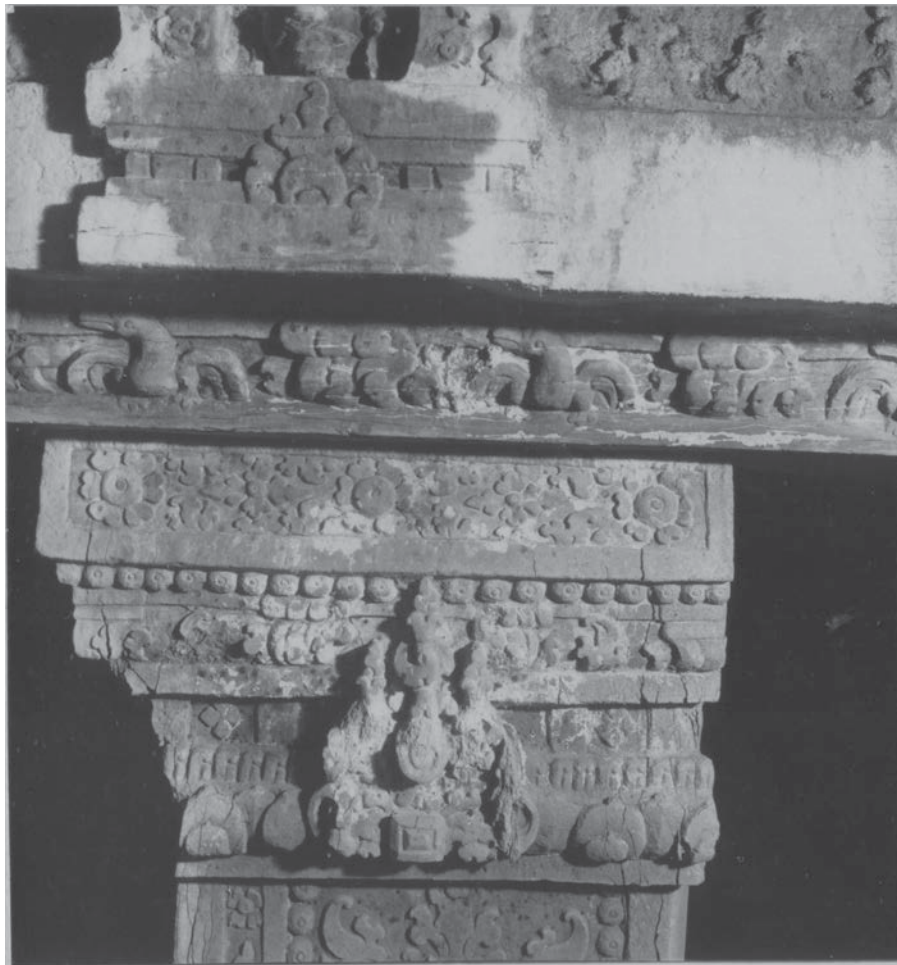
Description : Left side of the head was exfoliated after this photograph. The number of micro crack at canopy element increased.

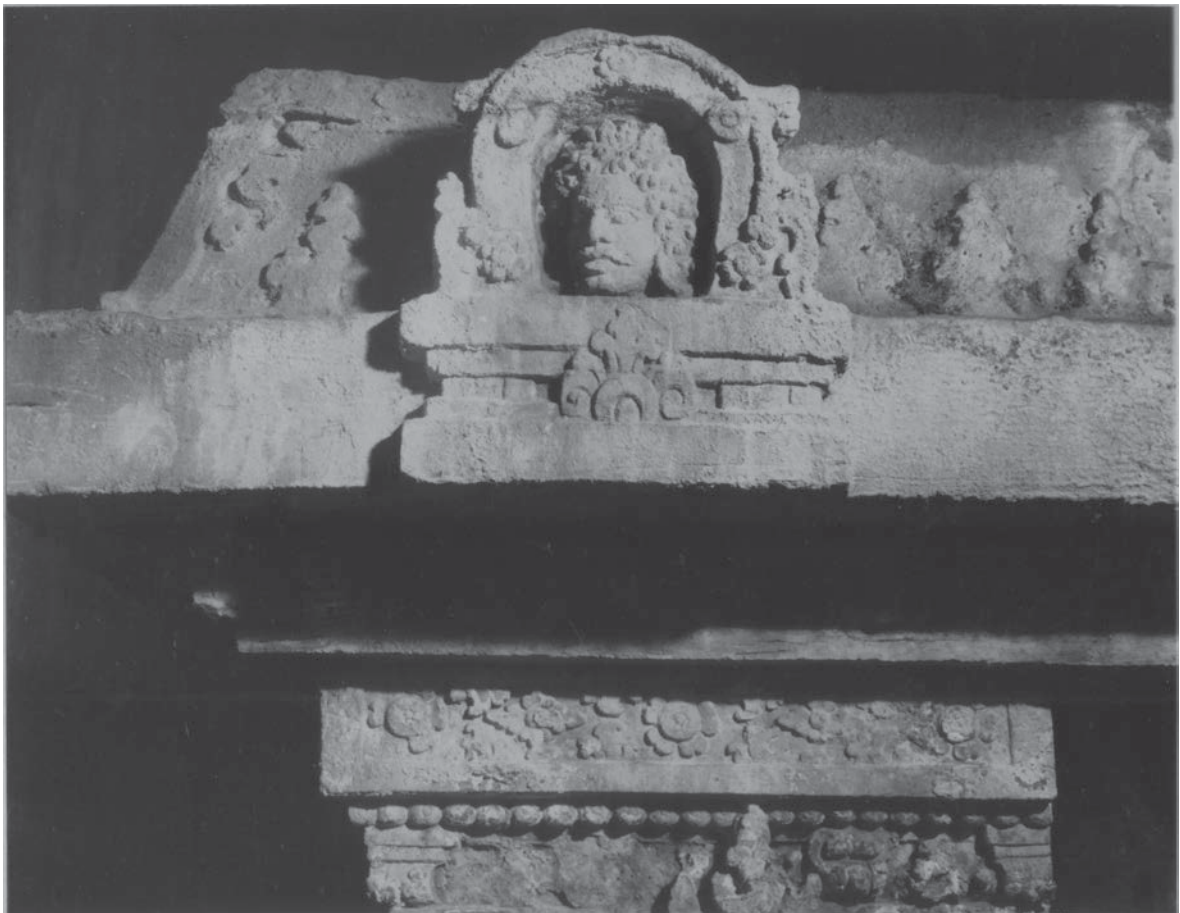
Description : Upper part of the arch and the left side of the base are missing now. Bas-relief on the head of post was exfoliated after this photograph.

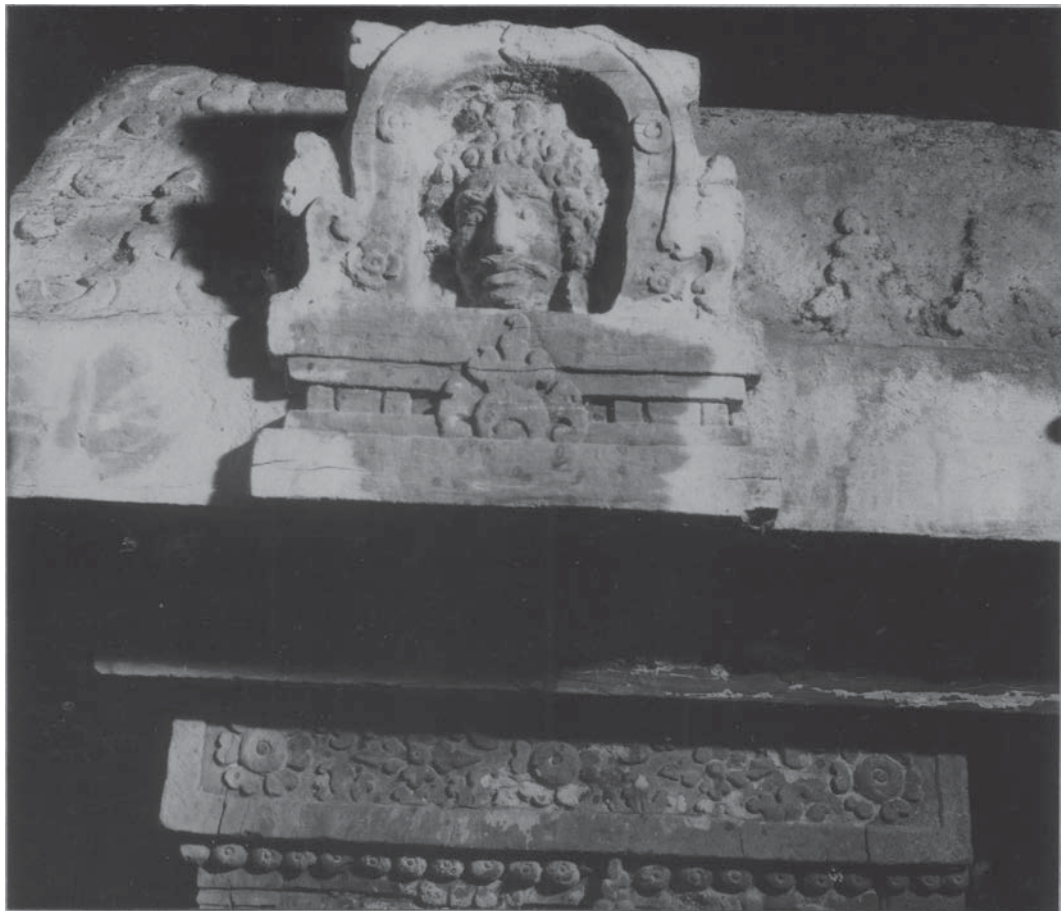
Description : Curved line was clearer than now. Left side of the head is missing after this photograph.

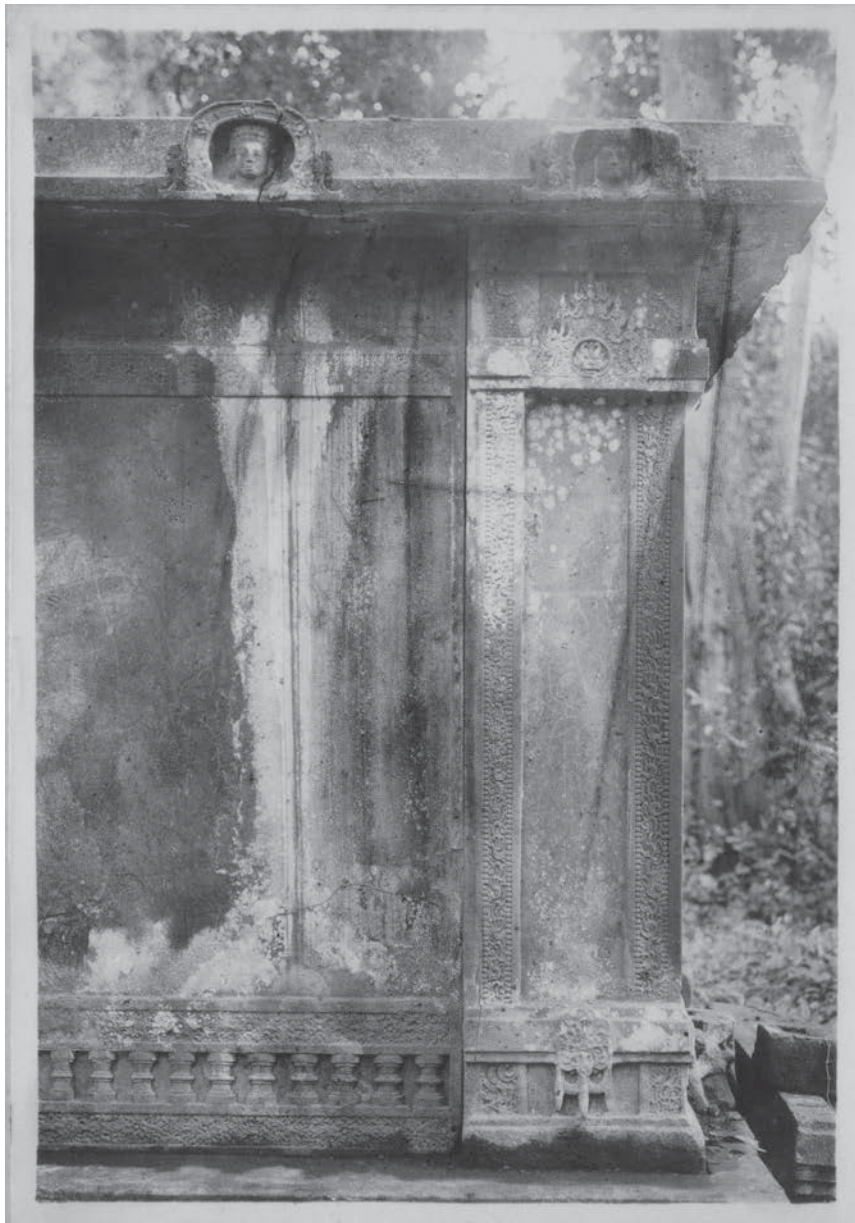
Description : Flat surface of the wall was exfoliated. Some trace of gun shots were added. The edge of the pilaster was chipped off. Central side of the arch (Kudu) is partially missing.

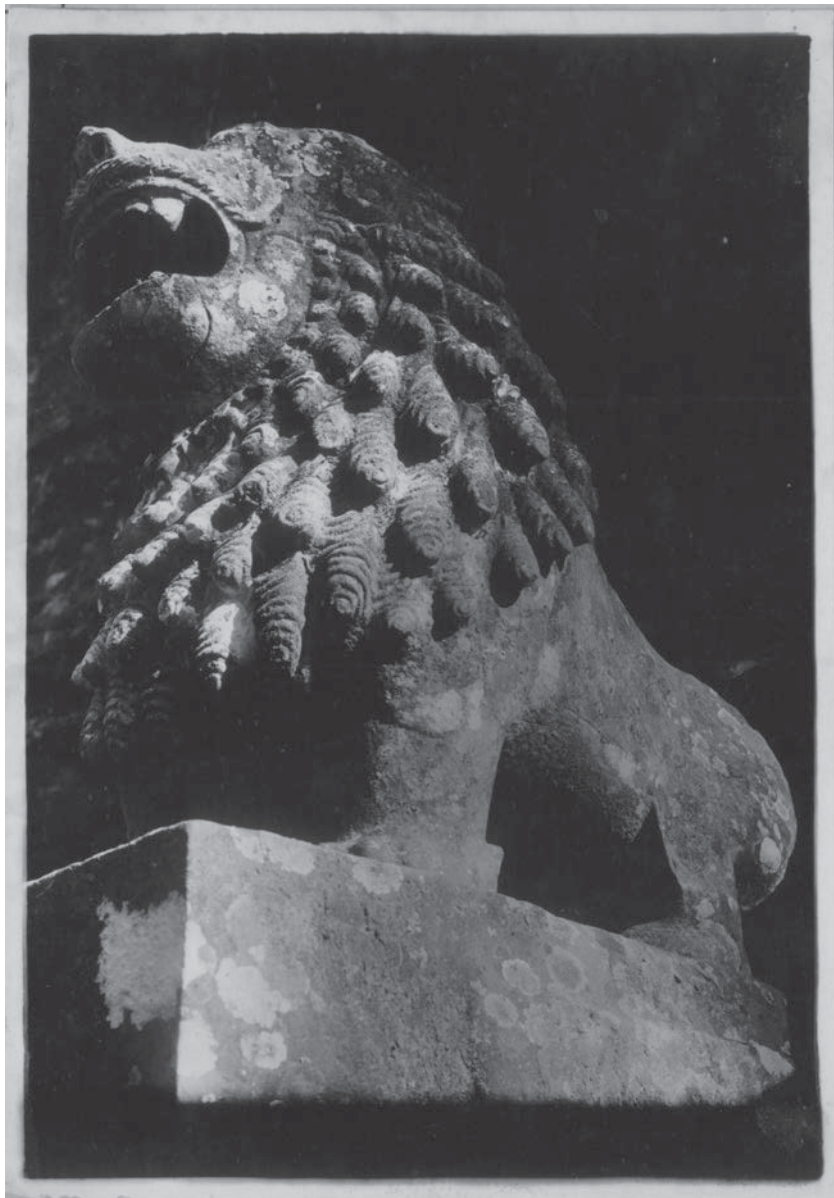
Description : Front and hind leg were repaired by casting mortar. Some parts of the curly hair were chipped off. Corner of the base is missing.

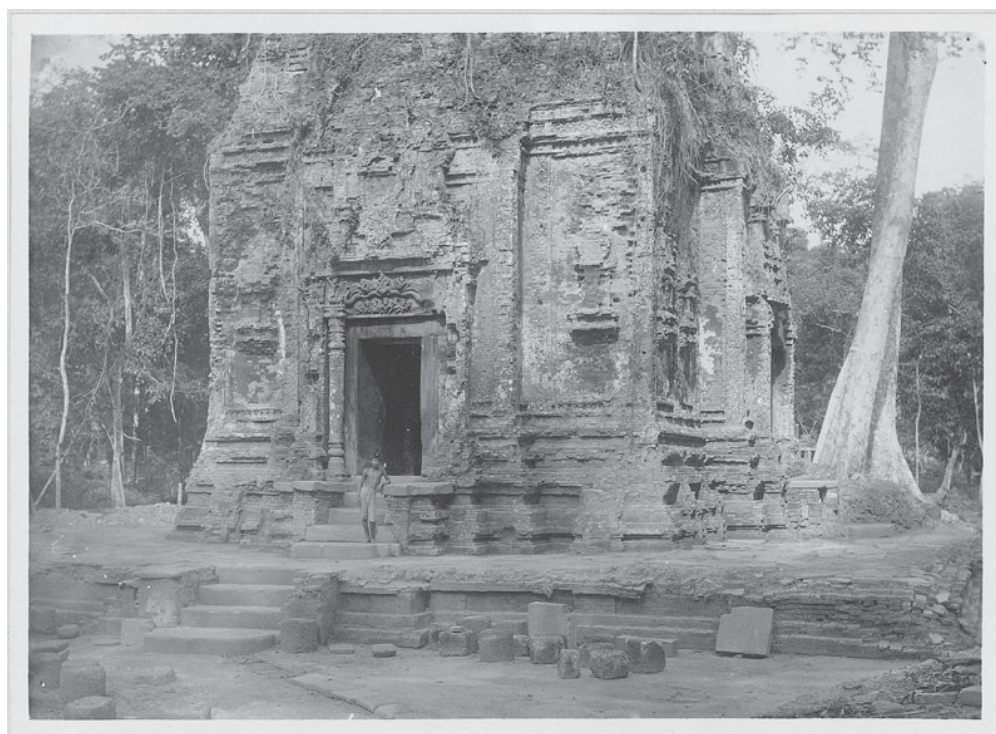
Description : Some sandstone and laterite pieces were surrounding around the terrace. Big trees on the terrace were not removed. Roof was covered with grass and small trees. Accumulation covered platform and terrace were cleared. South side wall of the entrance steps remained in better condition.

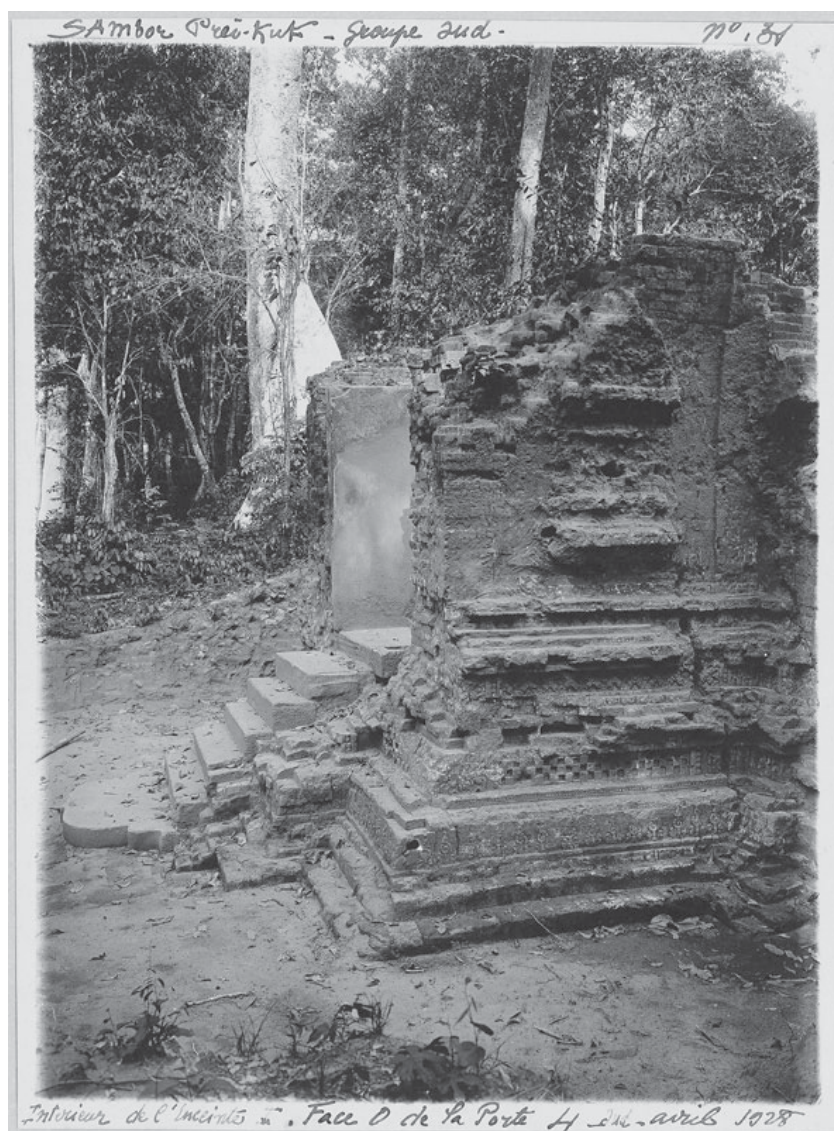
Description : The east side jamb was left standing. The steps was cleared and the moon stone was revealed. Around platform was cleared. The Flying Palace on the west wall remained in better condition. Some trees were not removed.

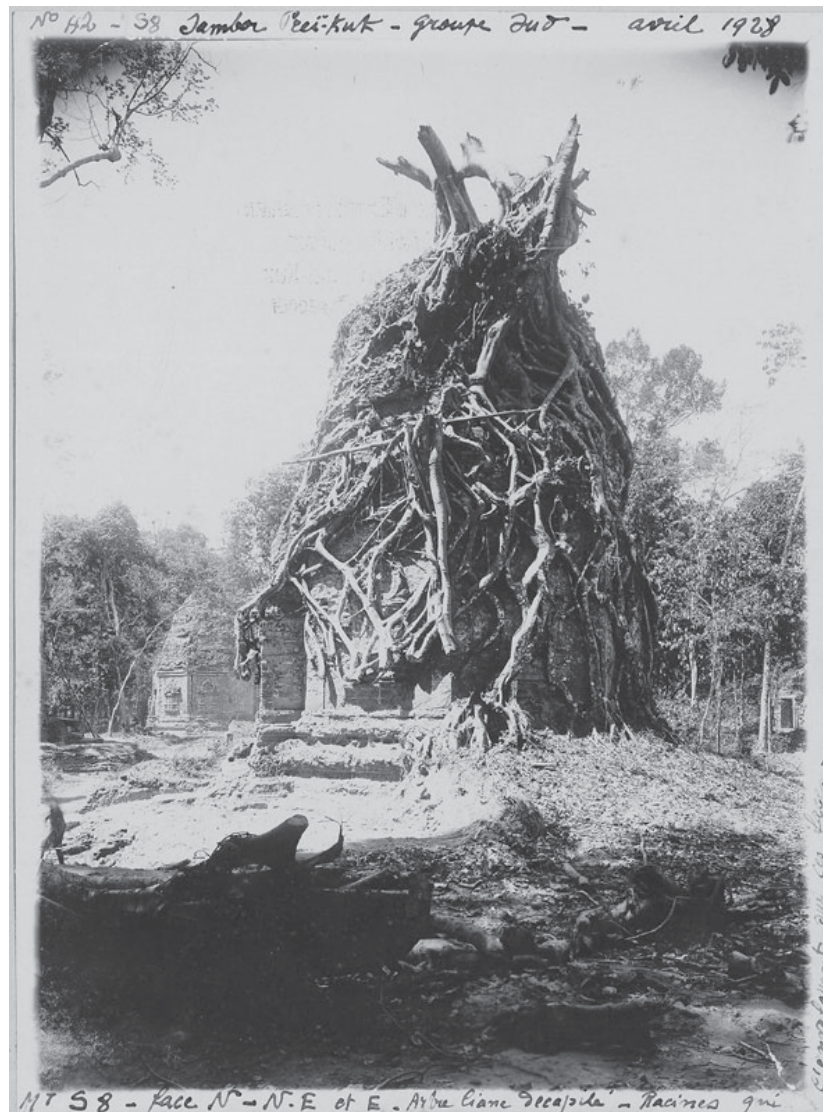
Description : The tower was covered with big roots. Platform was cleared partly. East edge of the front porch remained in better condition.

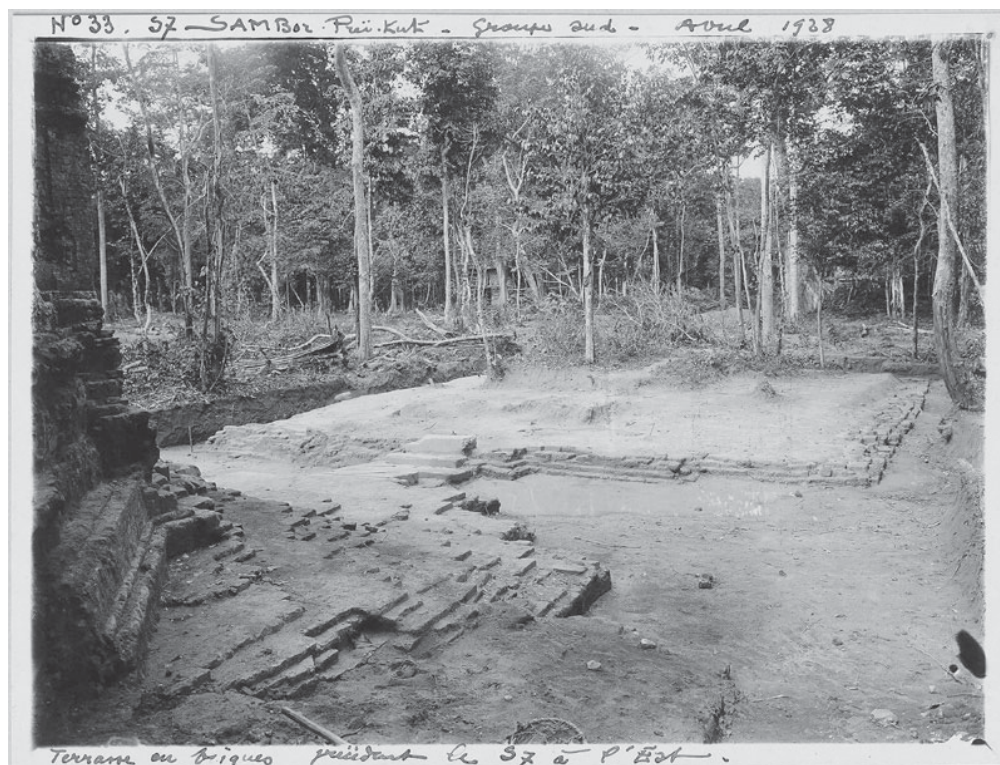
Description : Foundation in front of S7 tower and terrace of S7 Tower were cleared. Rectangular shaped foundation with steps on the west edge was revealed in this photograph. This foundation was buried in the natural soil again.

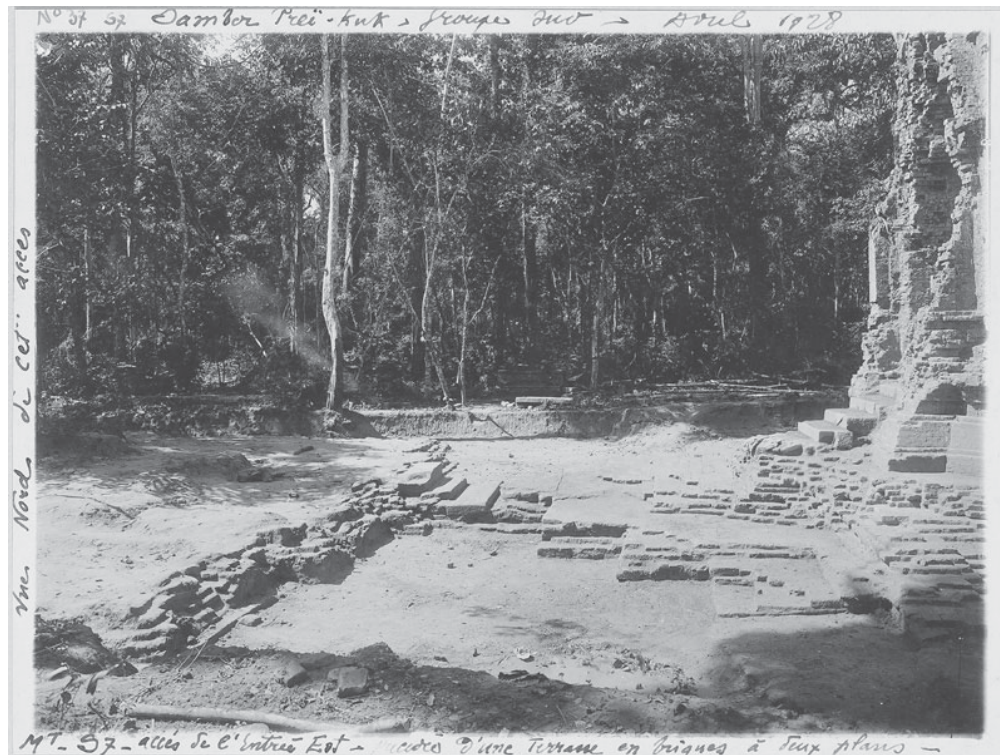
Description : Platform and terrace of N7 tower were revealed. Now these part are buried again. S7 Tower and the foundation in front of S7 Tower were revealed. Same as 0107.

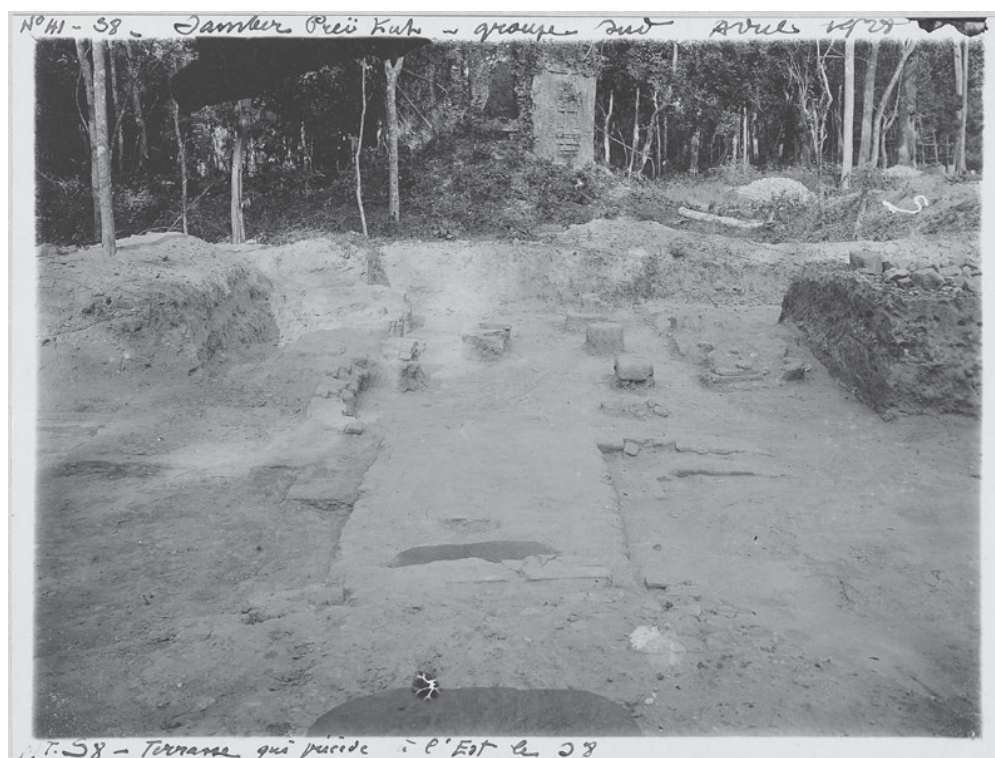
Description : Between S8 Tower and S9 Tower, trace of foundation was confirmed by clearance. This structure was buried again.

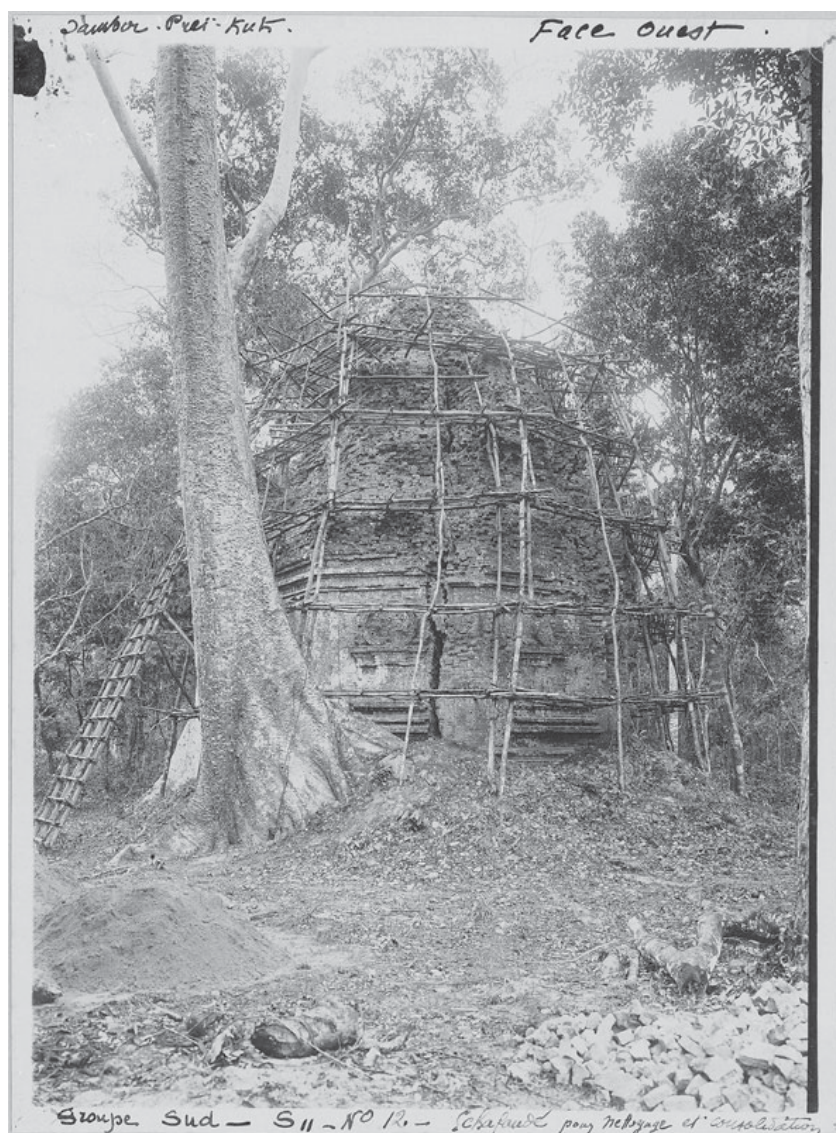
Description : Now crack on the wall is filled up with new bricks. Big tree was not removed.
Tower was surrounded by wooden scaffolding.

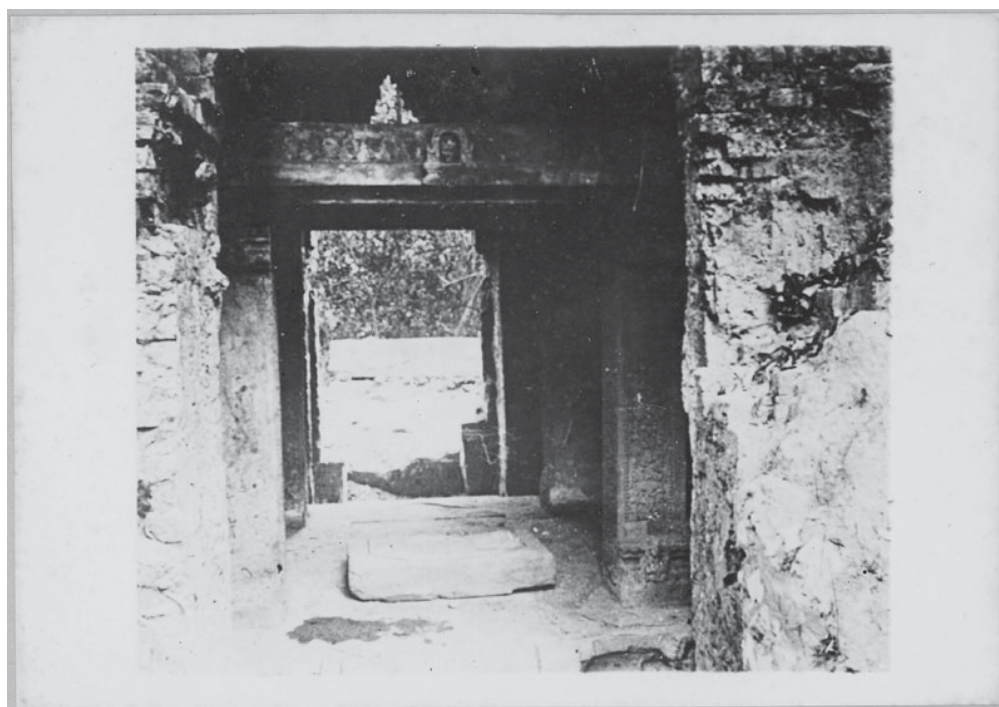
Description : Door frame of the south side was damaged, after this photograph this lacuna was installed new brick masonry.

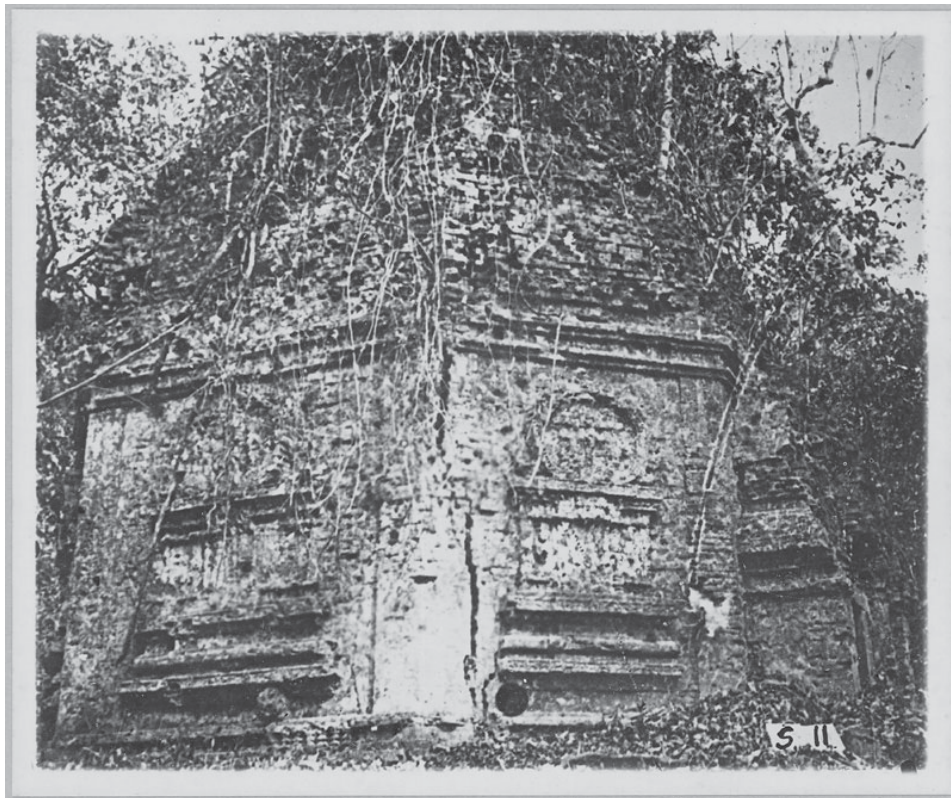
Description : Roof and wall were covered with roots of trees. Crack on the wall was filled up with new bricks after this photograph.

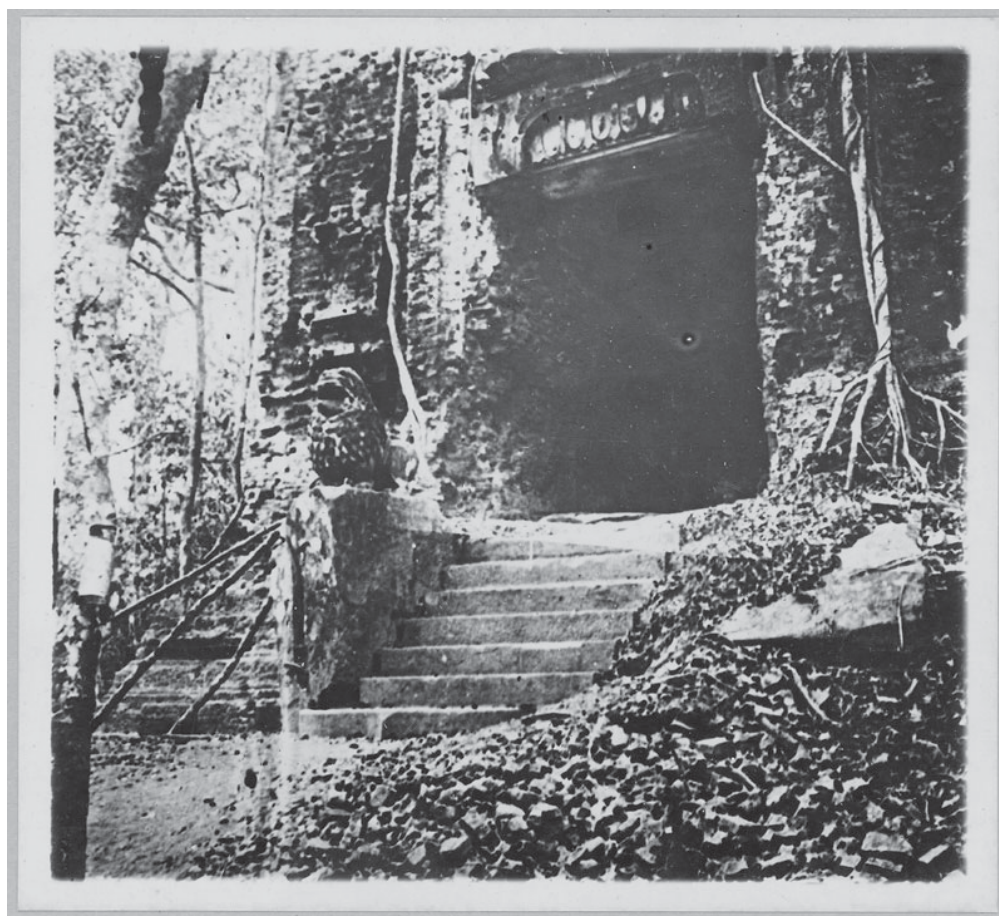
Description : Lion of the left side remained. Right side wall of the steps was broken.

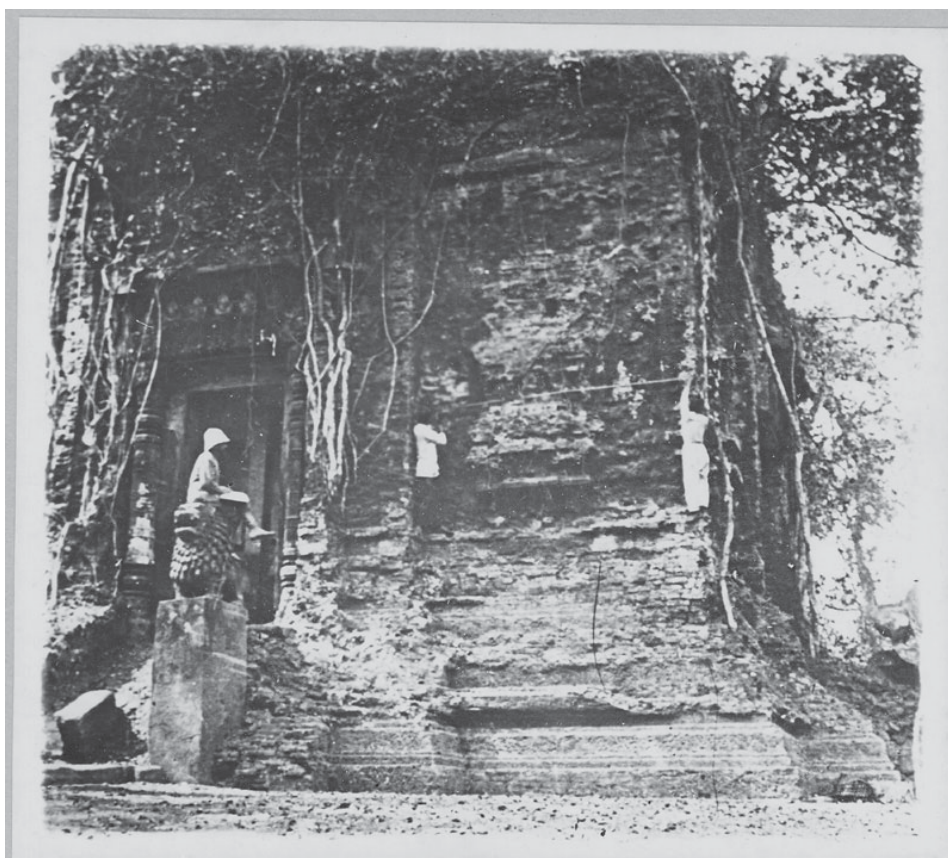
Description : Same angle as 0003. Lion remained. Base of the lion was not deteriorated.
Tower was covered with roots of trees.

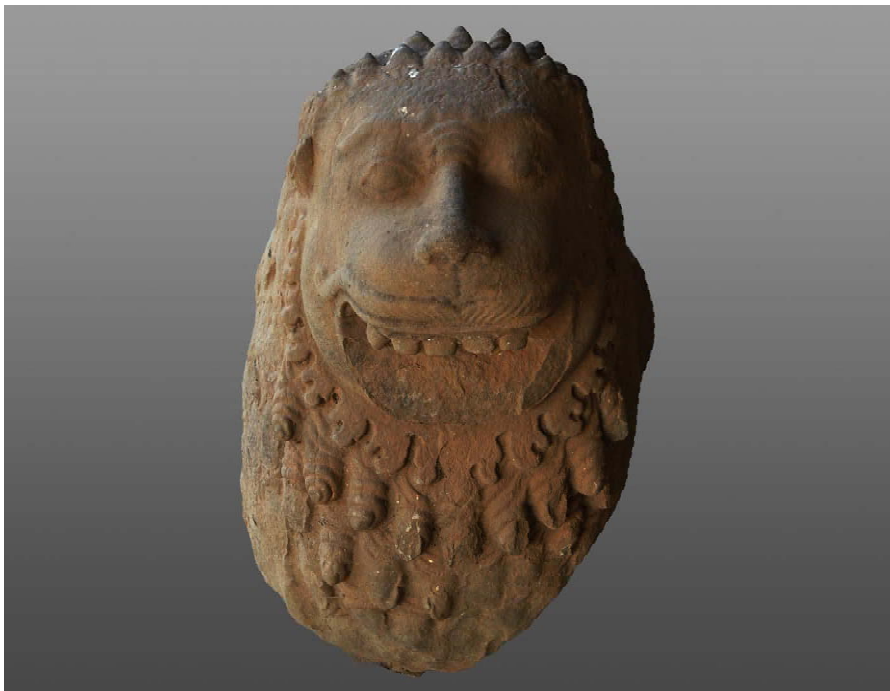
This is a lion statue on the side of step at C1 tower of Prasat Tao. The feet are lost. Mouth is opened with his upper teeth and lower mouth was broken.
