SAMBOR PREI KUK

Archaeological Site

LANDSCAPE of the Ancient Ishanapura

Annexes of the Request for Inscription on the World Heritage List

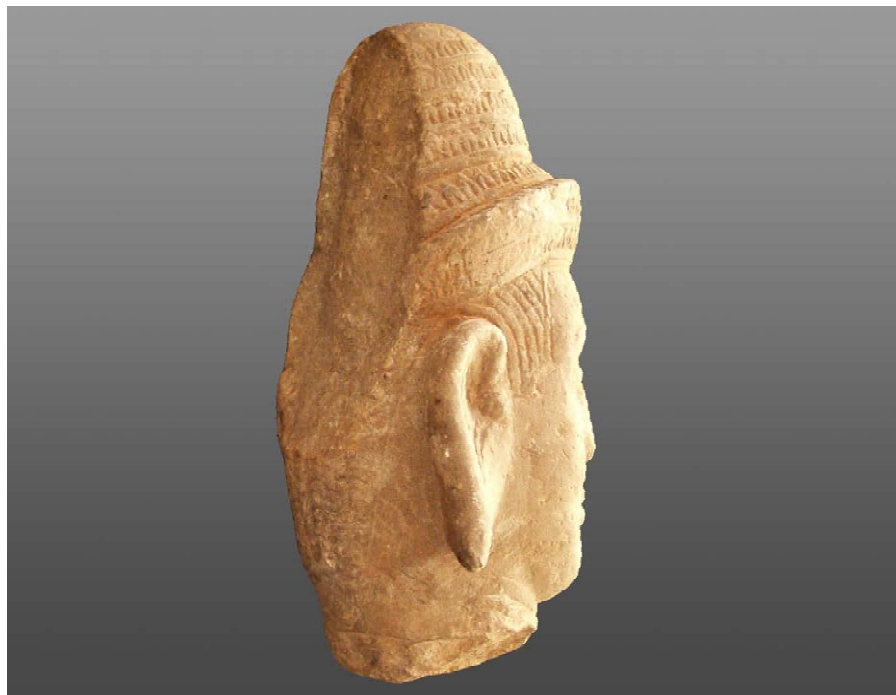
Head of statue fragment. The diadem patterned with two rows of U reversed and the crown ornamented with five tiers row of U reversed too. The back side was broken.

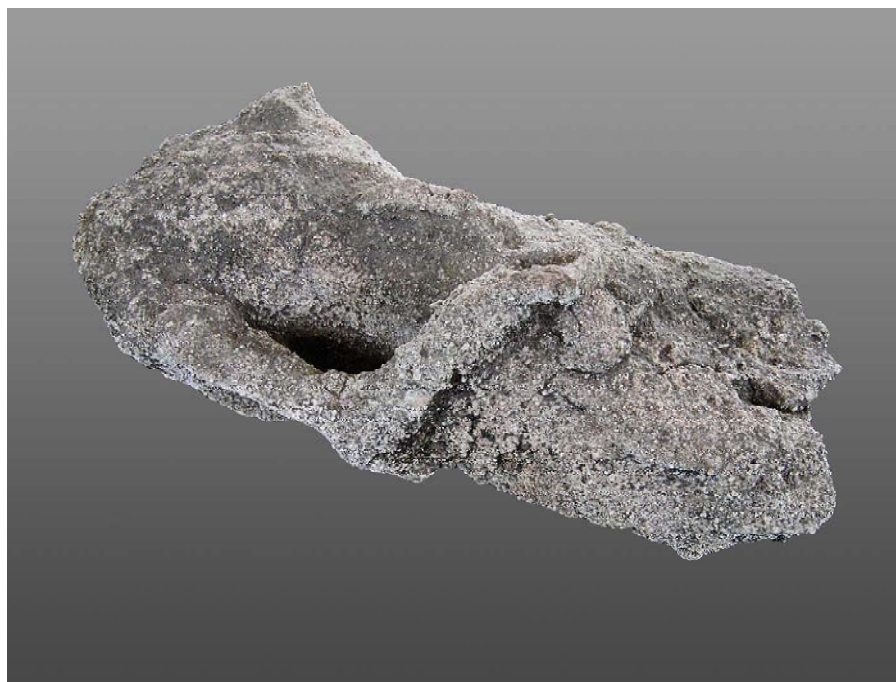
Statue fragment: no head, remained from the shoulder to the thigh, left arm was missed. This figure was decayed.

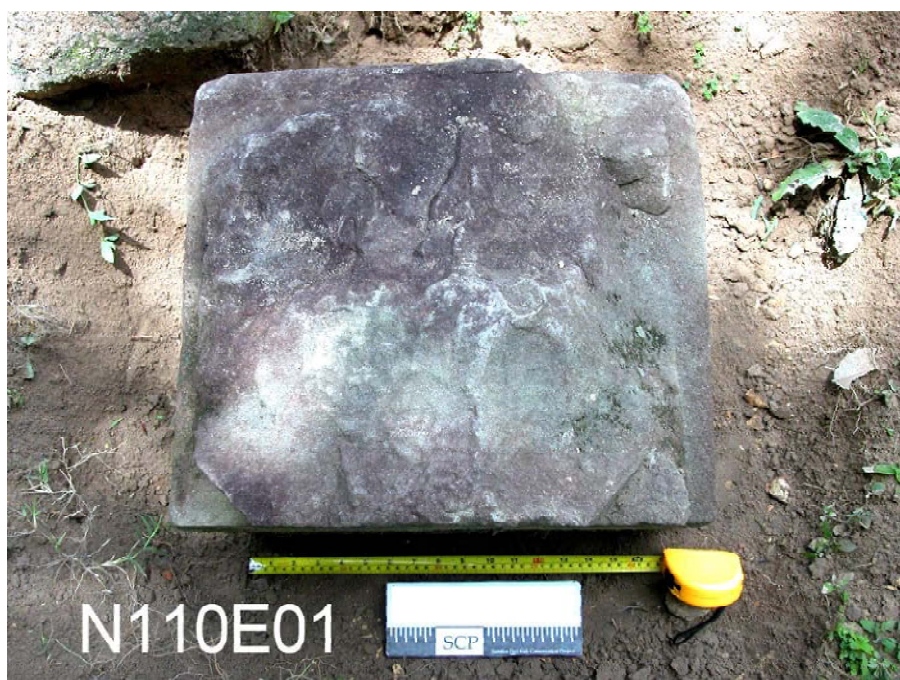
Base of colonnade fragment: is square, three sides ornamented with big foliage surrounded by bead row. On the upper surface was damaged. It is in front of N11. It may be 9 meter from N11 (eastern).

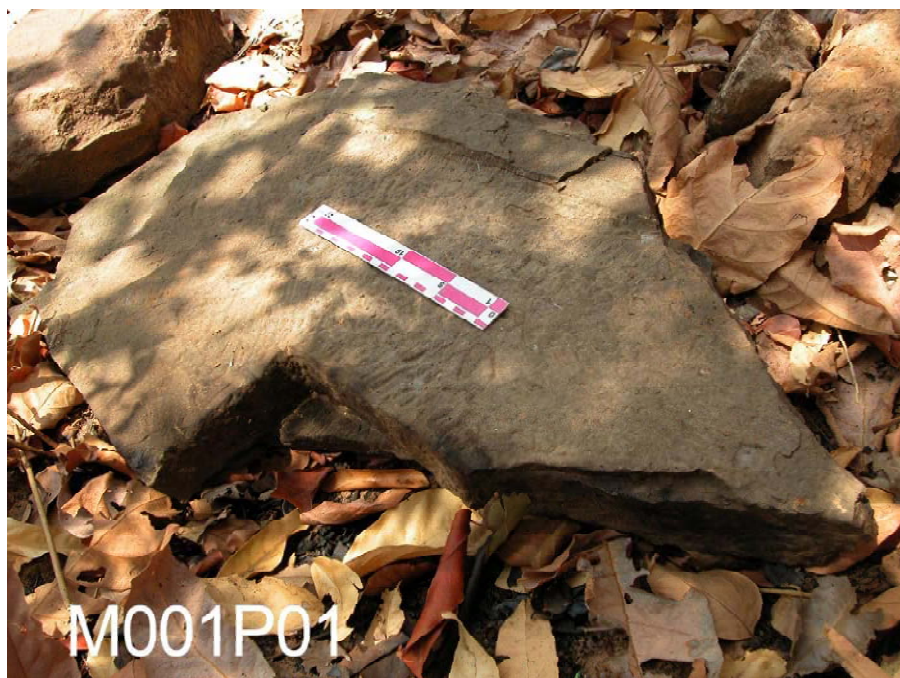
Pedestal fragment: remained 1/4 of the original of its, rectangle hole is at the center. It was decayed.

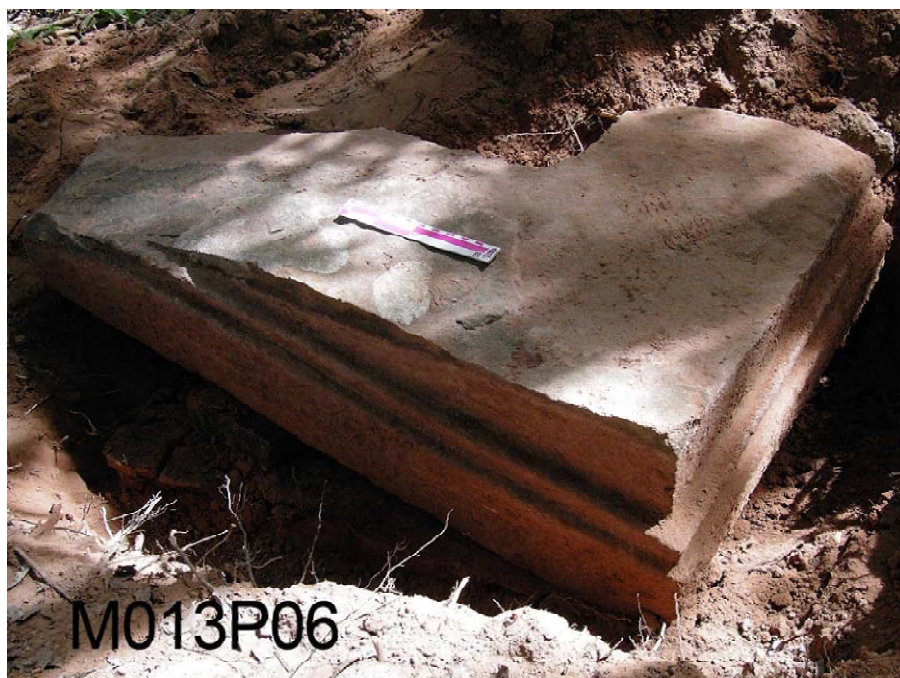
It's rectangular, on the top was damaged. It may be square hole at the center. The edge of the original of pedestal has molding.

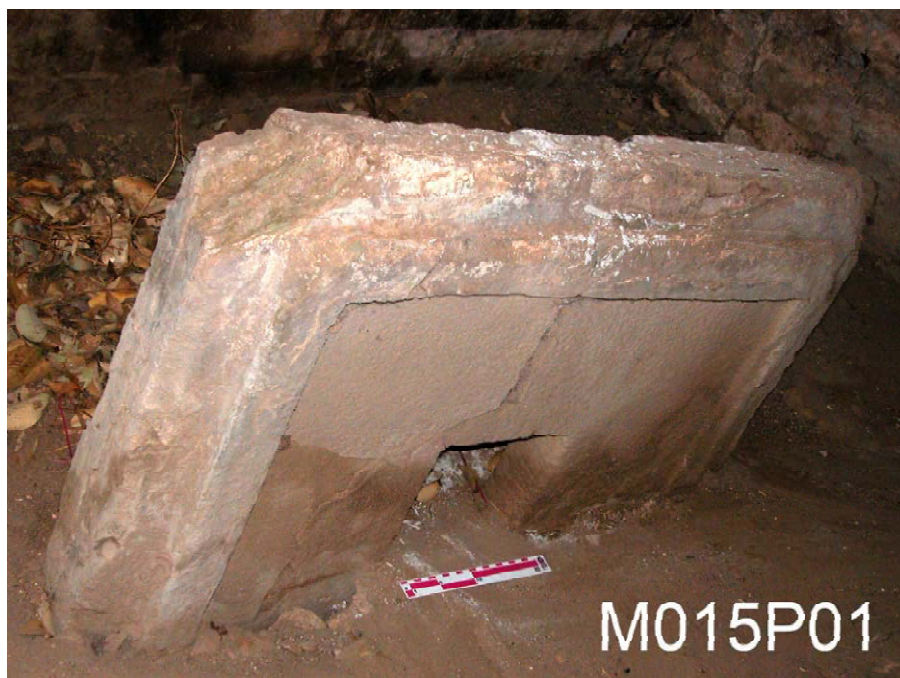
Pedestal is square and hole square is at the center, was decayed and cracked on its. It's in the soil some part.
