**UPDATED STATE OF CONSERVATION REPORT ON
HISTORICAL MONUMENTS AT MAKLI, THATTA SINDH
(PAKISTAN) (C 143) DECISION: 40COM 7B.44**

Historical Monuments at Makli Thatta Sindh (Pakistan) – a World Heritage property

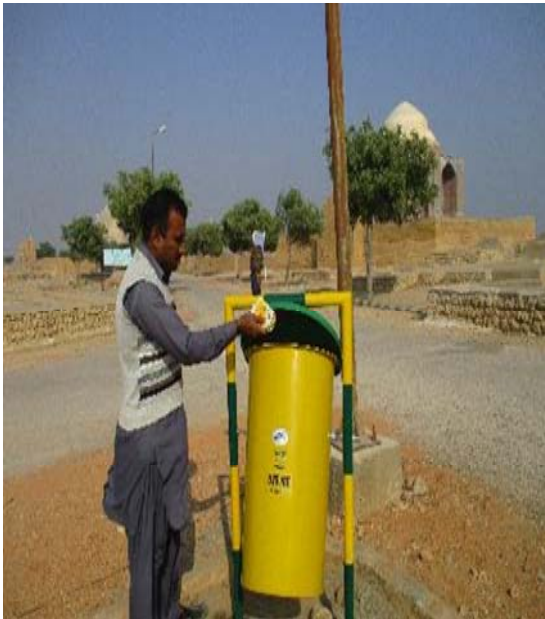
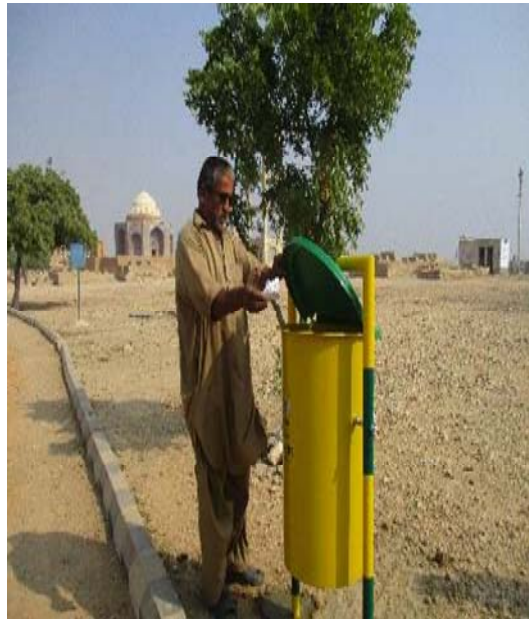
To establish regular trash removal system and remove graffiti

Trash bins have been installed as well as meetings held with those responsible for the shrines. The site has also been cleaned to discourage litter.

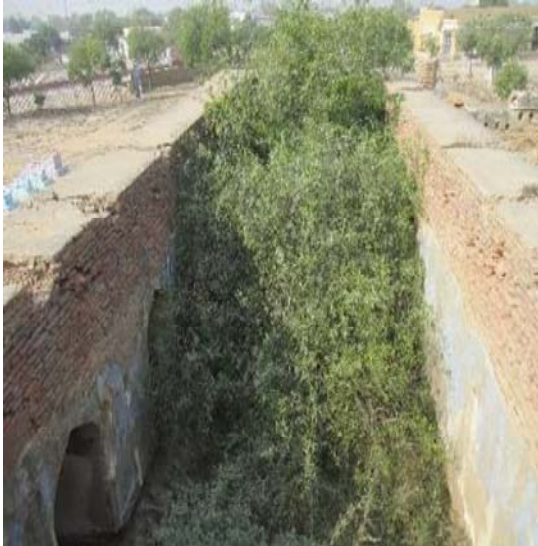
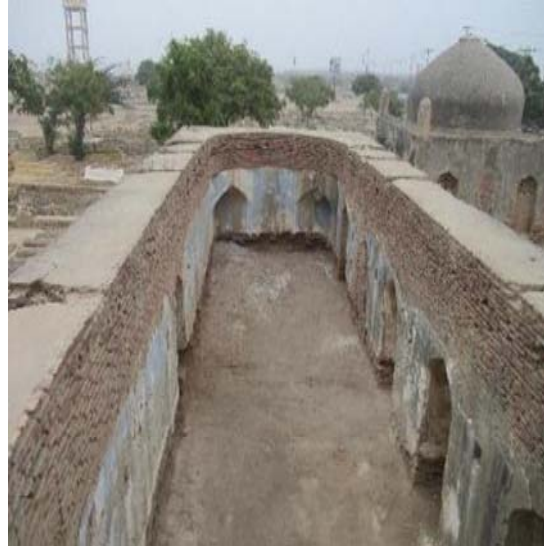
COMPOUND NEAR BUKHARI SHRINE

The vegetation near the compound of Bukhari Shrine has been removed.

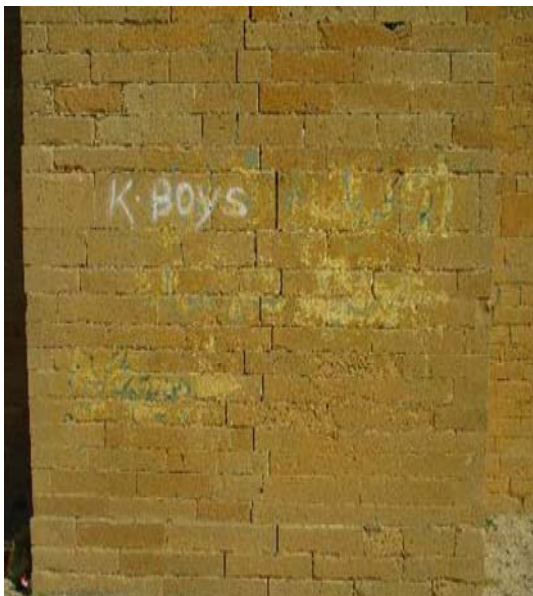
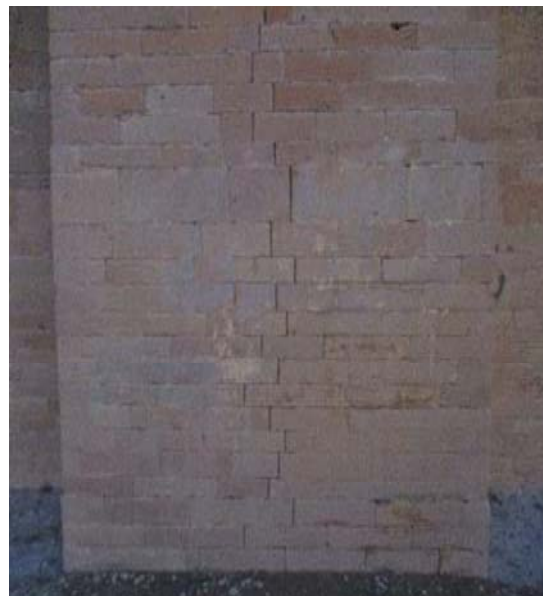
TUGRAL BAIG

Graffiti Removal

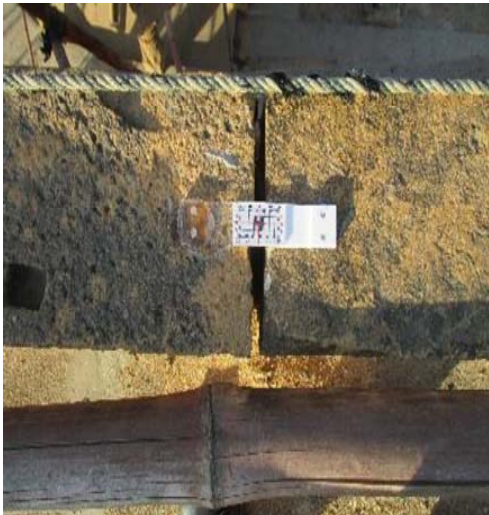
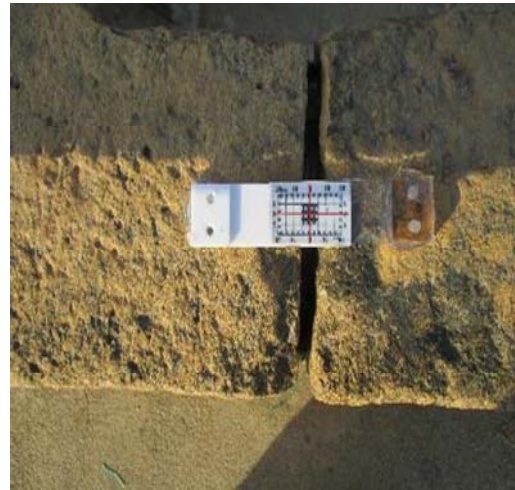
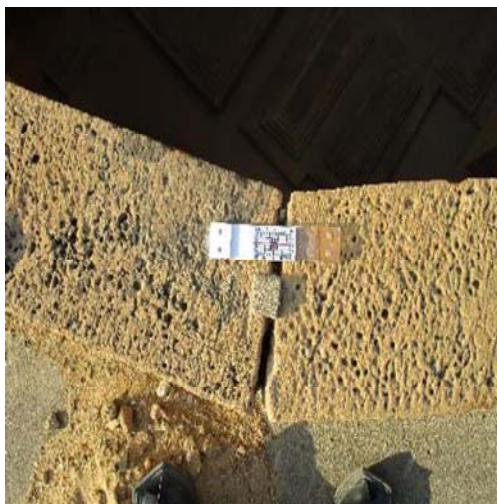
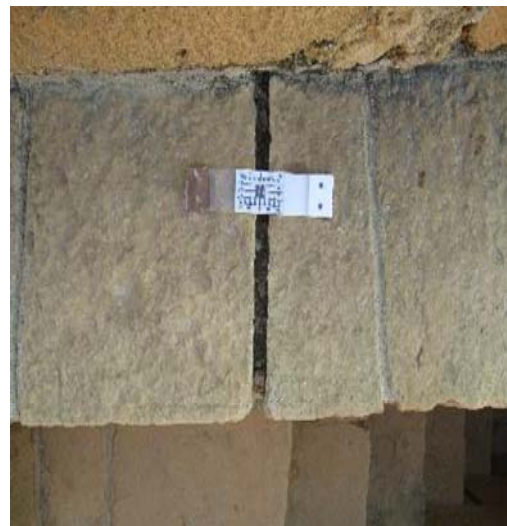
INSTALLATION OF CRACK MONITORS ON JAM NIZAMUDDIN

In addition, vibrating wire crack monitors with data-loggers have been ordered which will measure the movement of the building to 0.01mm. This will allow monitoring during any intervention or subsoil investigation.

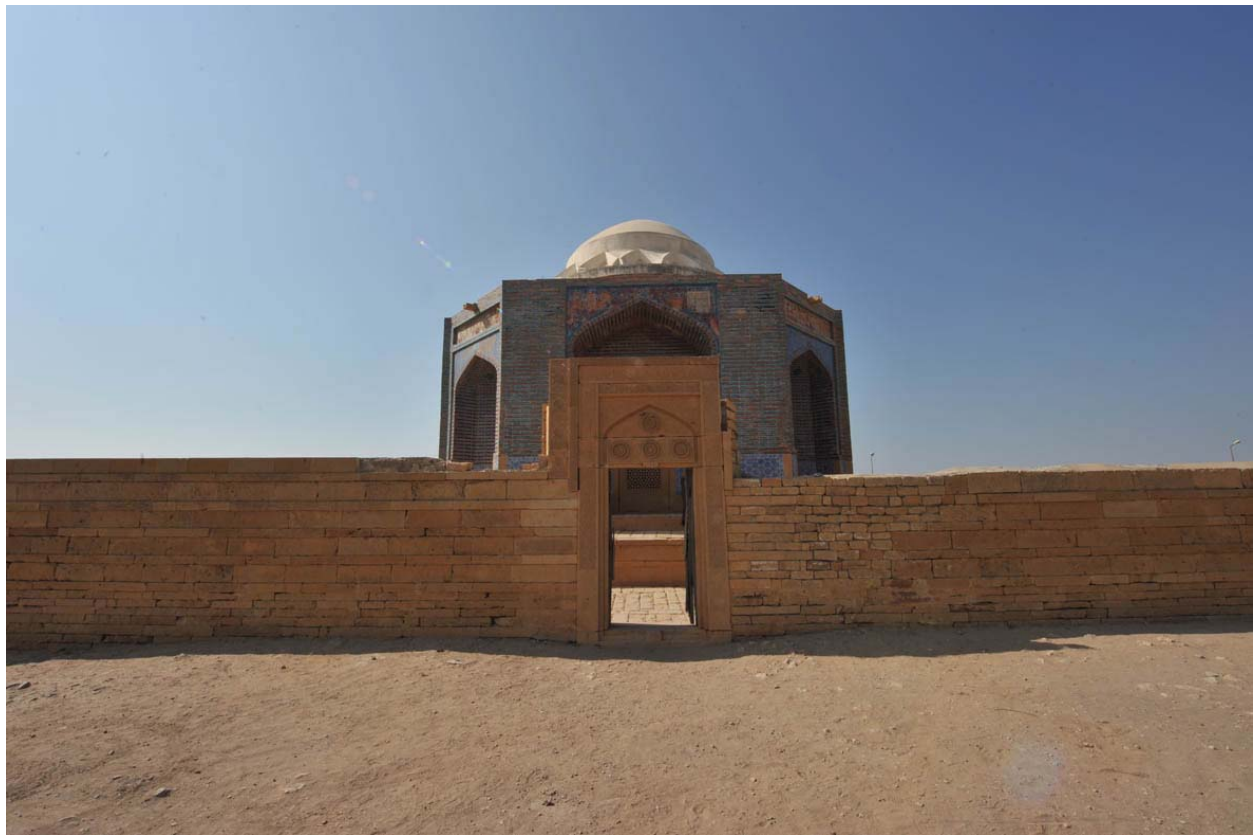
*Figure 2 - Crack monitors were installed at four corners on the roof of the Mirza Jaani Beg Tur Khan Tomb
In order to measure any future movement of the structure*

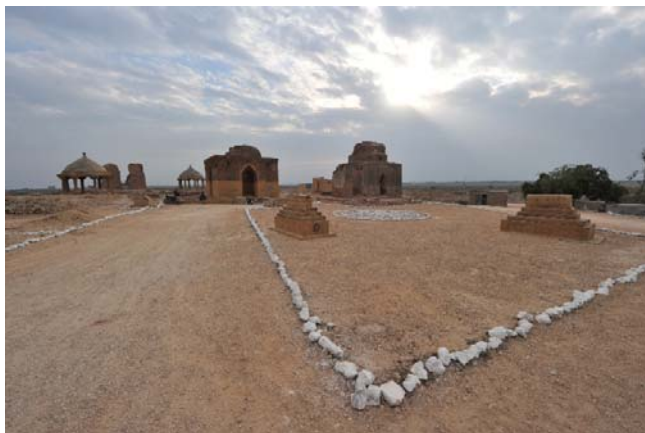
Figure 6 - Group C near Jam Nizamuddin. Vehicular traffic has been managed and automobiles are no longer able to park next to this endangered monument. This approach must be extended throughout the site. These low cost, high impact decisions were discussed in January as being very beneficial to the site not only to control traffic but also to control rubbish and improve appearance.

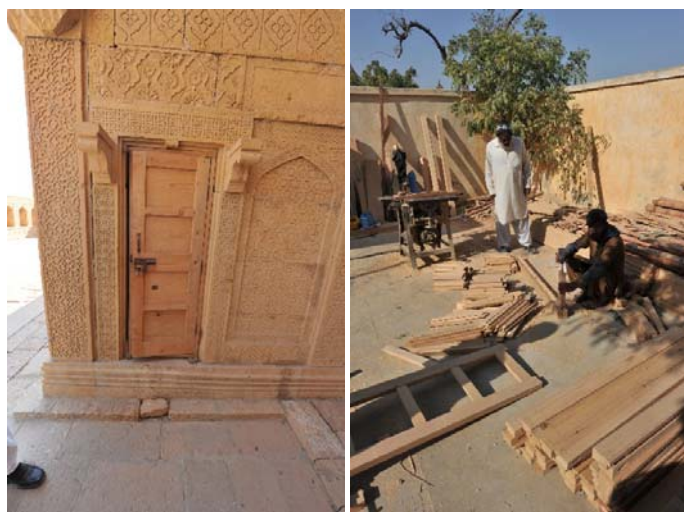
Figure 8 - Temporary door to the upper gallery at Mirza Esa Khan Turkhan (Sani) and the wood workshop on site.

FOLLOWUP – A schedule and routine for the motorcycle patrols is necessary and a check or verification system to ensure they are completing each round. This could be done with a series of sign in sheets distributed throughout the site at each group in secure locations such as the weather station enclosure at Group C. These locations could also serve as rest stops for the guards. The doors to the upper levels of all monuments must be finished and a system of locks installed with a master key for the site manager. These should take precedence over the doors to other structures.

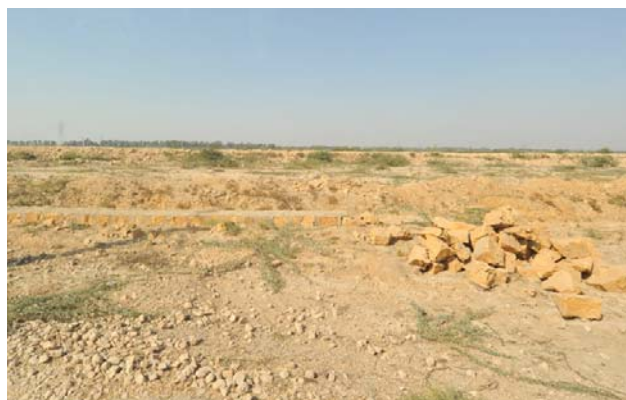
Figure 10 - Although the barrier wall is incomplete the foundation extends near the encroachment along with raw building materials

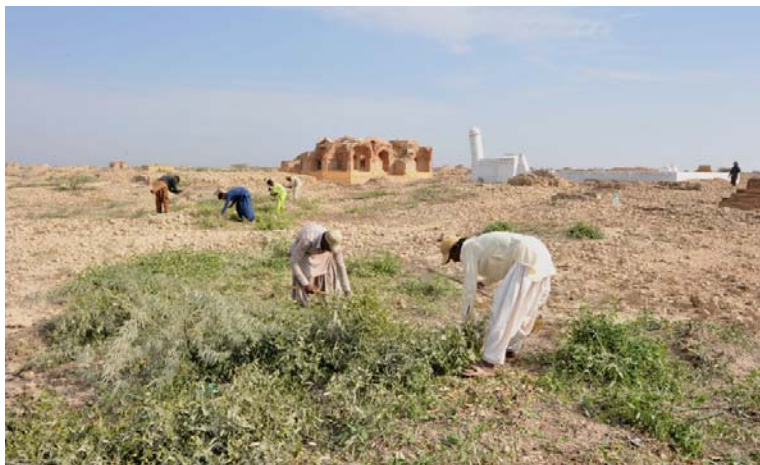
Figure 15 - The site has also been cleaned of rubbish and undergrowth. This helps deter future litter as well as reduce unwanted animals feeding on site. Additional work must be done to establish a method for long-term control of vegetation on site.

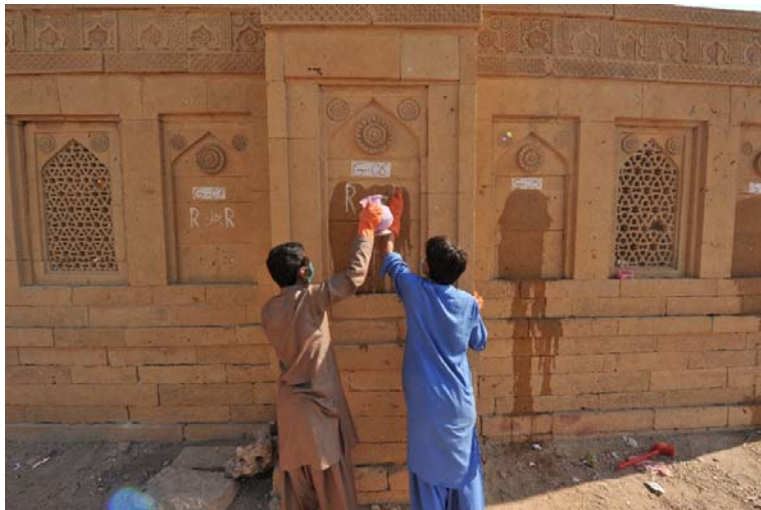
Figure 16 - Graffiti removal on site

Undergrowth as well as litter was removed and this has uncovered previously unknown or undocumented grave markers. The removal of undergrowth will keep windblown litter from collecting on site as well as deter grazing animals from entering the site. There will be further recommendations to keep the undergrowth under control with some form of bio agent. Graffiti removal was also conducted throughout the fall of 2016 and in January, 2017. This involved using distilled water and soft brushes to remove the majority of the graffiti as it was simply chalk. Spray paint graffiti and glued announcements were more difficult and these were removed by vigorous scrubbing with nylon brushes.

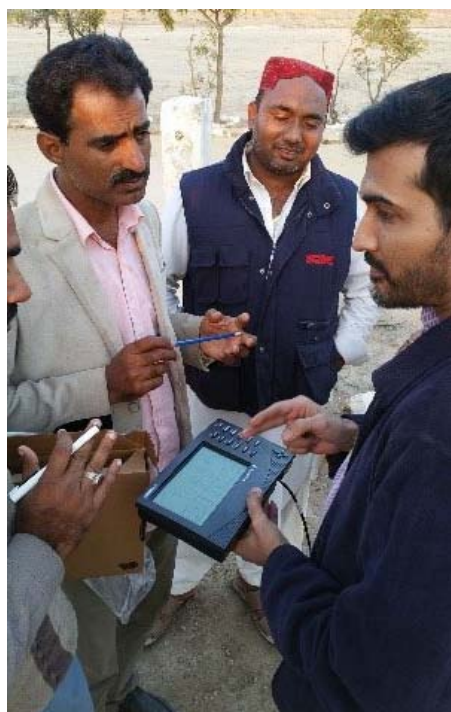
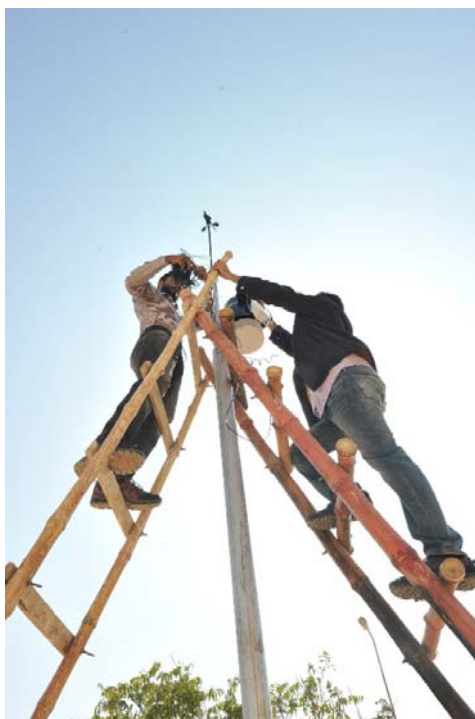
Figure 17 - Training on the use of the weather station. Figure 18 - Installation of one of the three weather station.

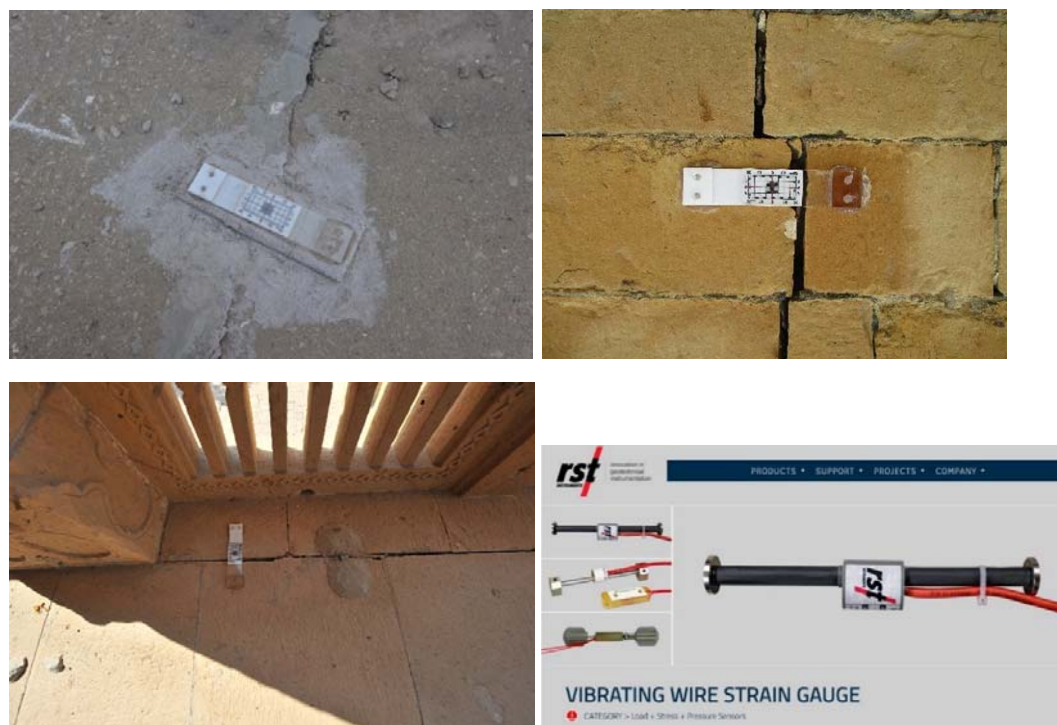
Figure 19 – Existing crack monitors installed at key locations including the Tomb of Mirza Jaani Beg Tur Khan, the Tomb of Mirza Tughral Beg Turkhan, and Mirza Baqui Bag Tur Khan.

FOLLOWUP – These crack monitors are useless unless monitored on a regular basis. This must be in the management plan. There must also be more sensitive crack monitors at Jam Nizamuddin. This is the most critical monument at risk as it is located at the very edge of the bluff and has been actively moving since the British Period. Standard Avongard tell-tale crack monitors are not sufficient in this situation. It is clear that the structure continues to move and there must be an intervention. Therefore it is highly recommended that a more accurate monitoring system be installed such as a vibrating wire strain gauge with an accuracy of .01mm of movement. This is detailed further in the recommendation section.

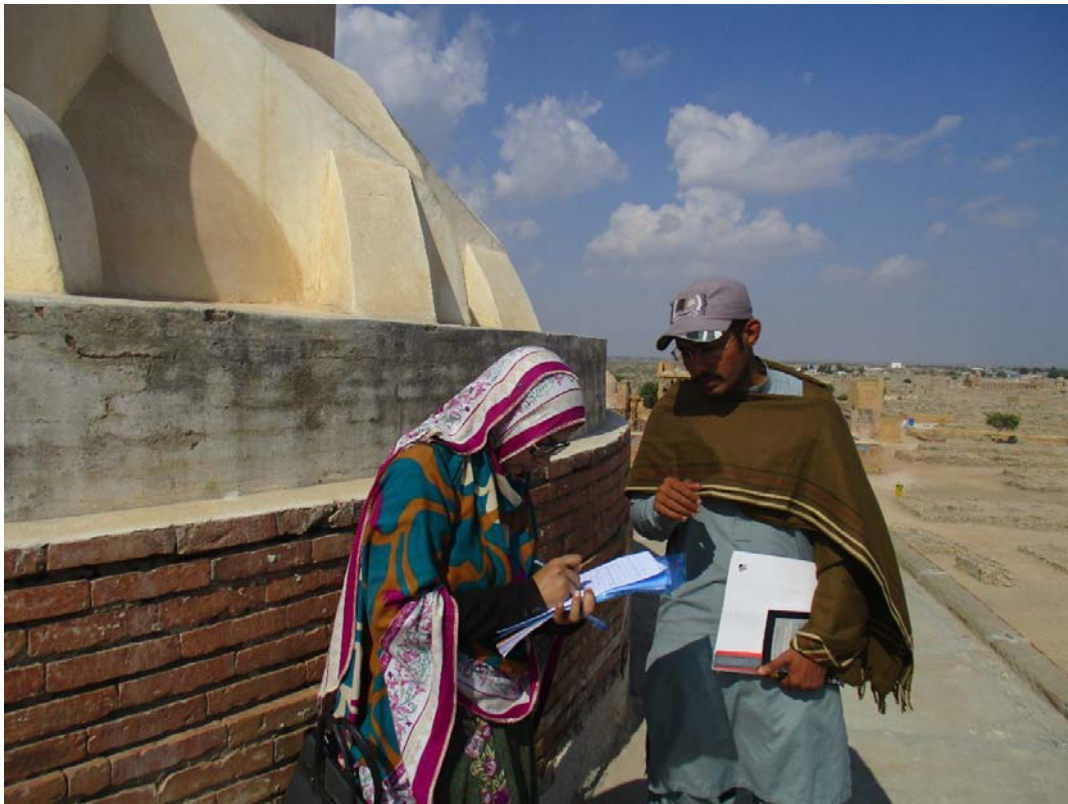
Figure 21 - in January, 2017 five new interns began training at Makli. Here they are learning to monitor the cracks on the top of Jani Baig

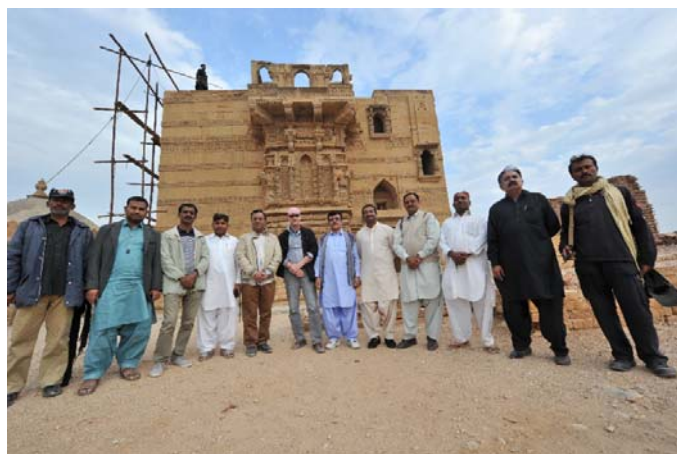
These geotechnical investigation recently got underway at Jam Nizzamuddin in January. Currently there is a small bore hole in progress just to the north of this monument. A report will be forthcoming shortly.

Figure 22 - Geological investigation team at Jam Nizzamuddin in January

FOLLOWUP – This investigation and report is essential. As there are numerous less significant monuments suffering from the same problem. As soon as this report is complete it should be sent to the World Heritage Centre. In addition the Geological Survey of Pakistan has substantial data concerning the geology at a macro scale for Sindh. This information, while not public, should be officially requested. The Survey was contacted during January however there was no reply.

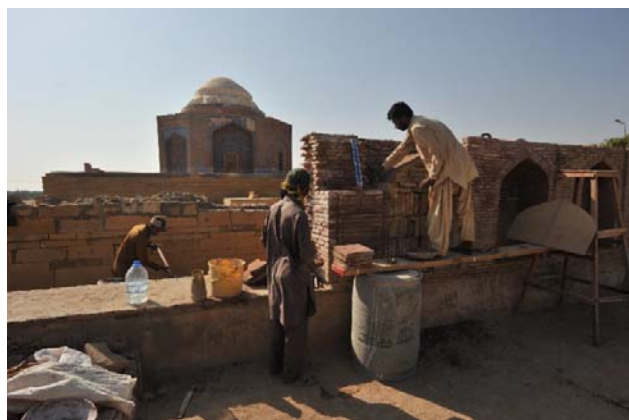
Figure 23 - Consolidation work in progress at the wall south of Mirza Tughral Beg Turkhan

FOLLOWUP – There is a significant amount of work that has been done to stabilize the structures that were at risk. This should continue but with caution. ALL new materials must be tested for compatibility and salt content. During January the management team discussed a field salt test and this is in progress. A simple field test for salts will be sent to the UNESCO office shortly. In addition there should be a more systematic method to document the ongoing work.

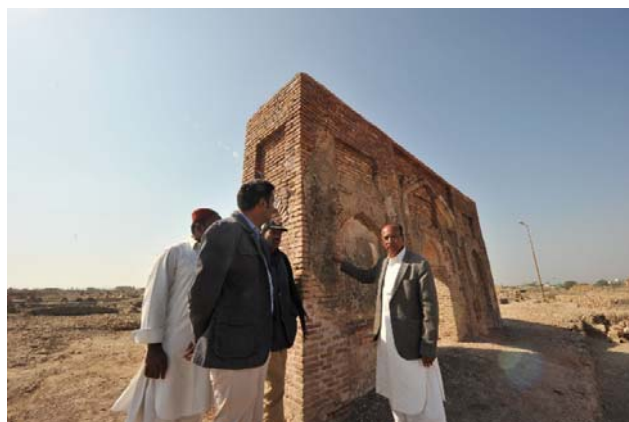
Figure 24 - consolidation of the masonry at Meran Bai (Unknown) Tomb

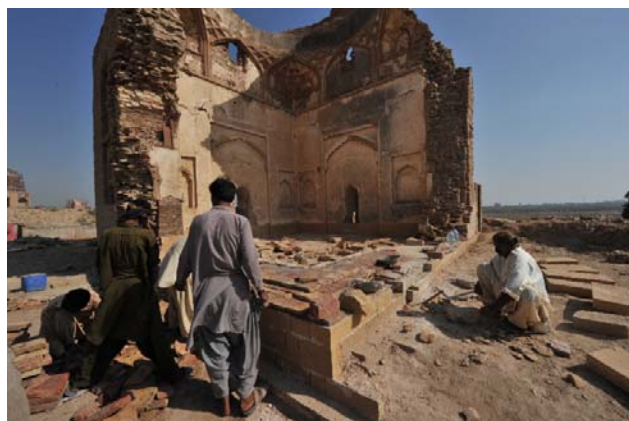
Figure 25 - Emergency structural measures at the Lali Mosque/Tomb

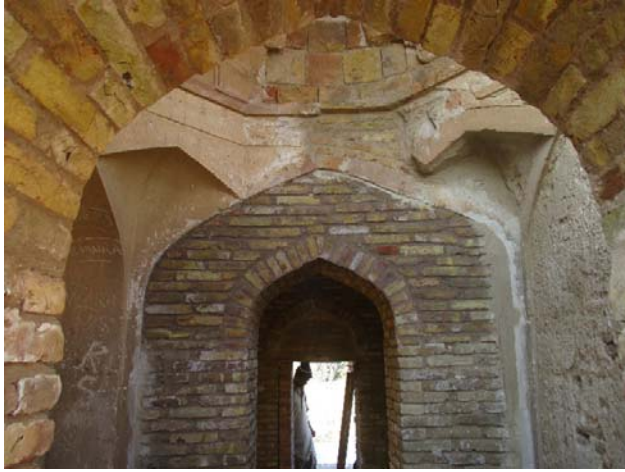
Figure 26 - Shoring under one of the remaining domes at the Lali Mosque / Tomb

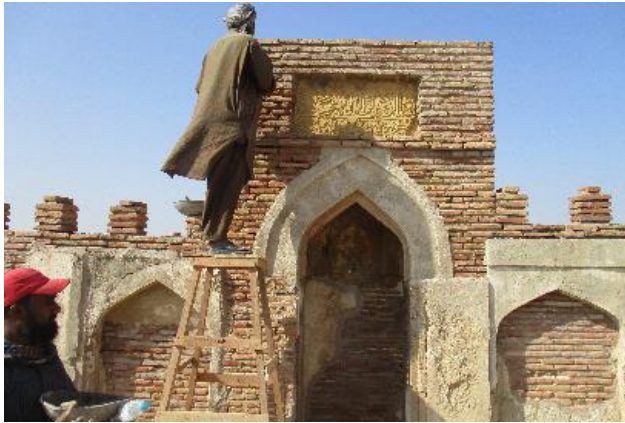
Figure 27 - Consolidation of masonry in place at Ghairat Khan

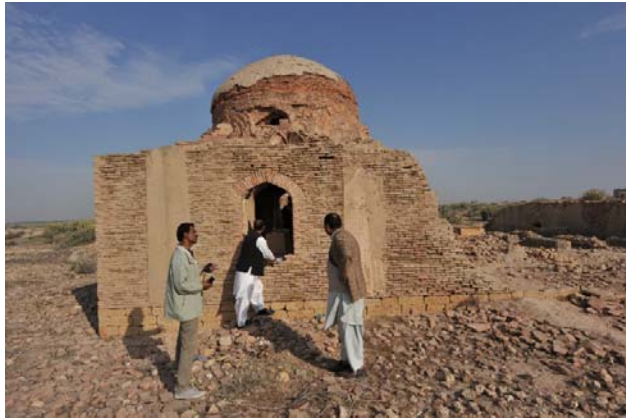
Figure 29 - Inspection at a small unknown tomb with intact dome near the entry gate

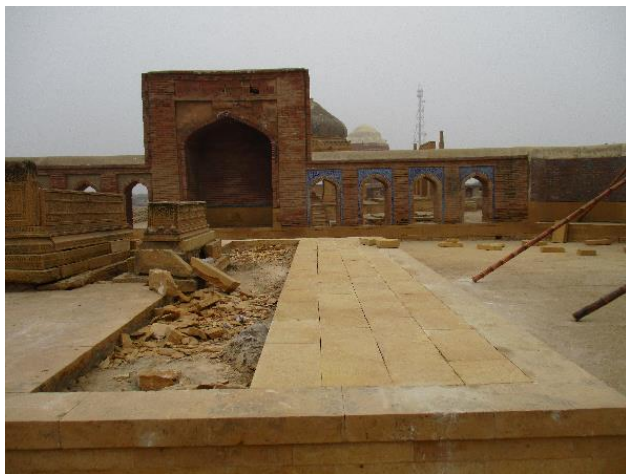
Figure 30 - installation of pavers for water protection at the platform within the Baqi Beg Tomb

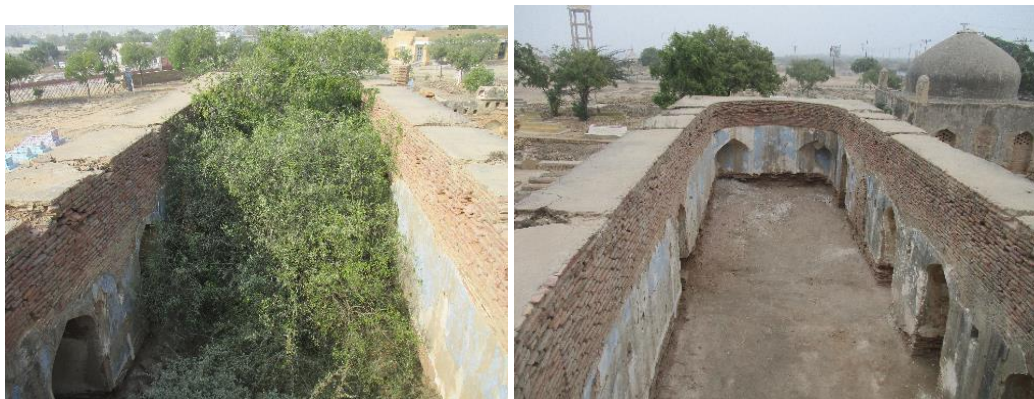
Figure 31 - Before and after images at a minor structure near the main gate. This space could be used to store building materials as there is no evidence of tombs here

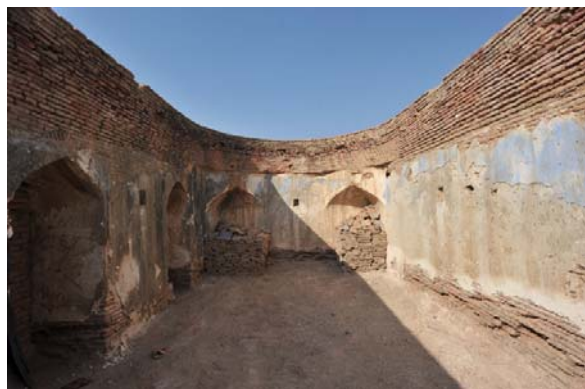
Figure 32 – At the building near the entry some materials and decorative elements are carefully stored on site until conservation works can proceed

FOLLOWUP – There has been significant progress on this topic. However there are still some area of loose decorative material. Within structures and in the open areas. The procedure established in January should become an official part of the provisional management plan. An inventory should eventually be established of these loose materials. They could form a small exhibition at the future visitor centre.

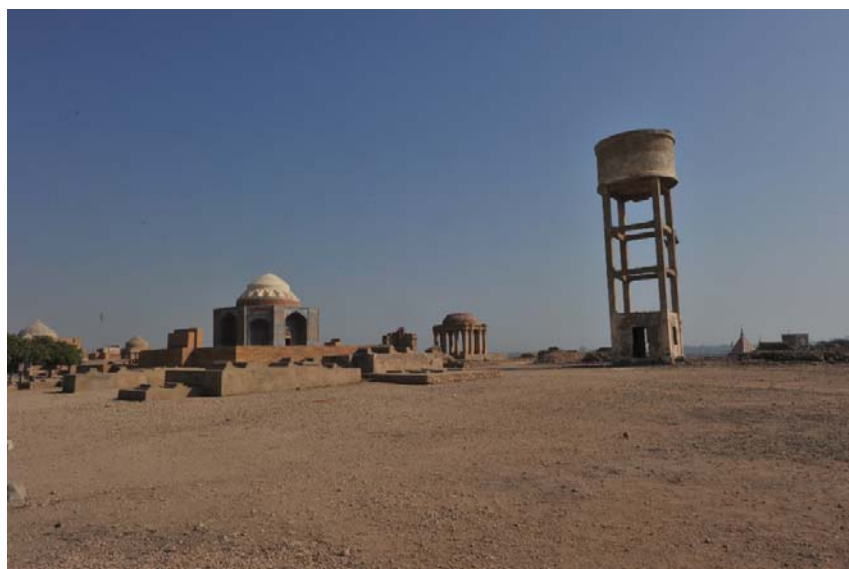
4. Future structures within the buffer zone and 5 year plan for phasing out and relocating. This is being addressed at the ministerial level. Existing structures that are non-contributing have been considered for demolition. This includes the water tower. It currently does not function and will improve the appearance of the site from the entry.

Figure 46 - There are plans to remove the water tower – however after urgent conservation works

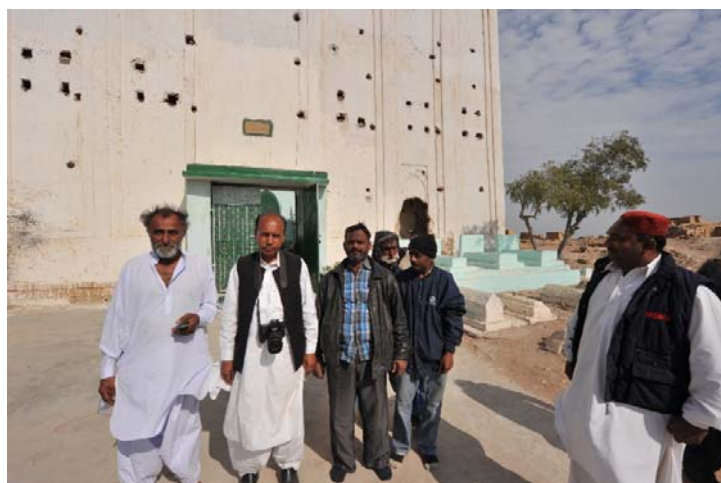
Figure 48 - The current team has met and discussed conservation issues at all of the 12 active shrines within the World Heritage property

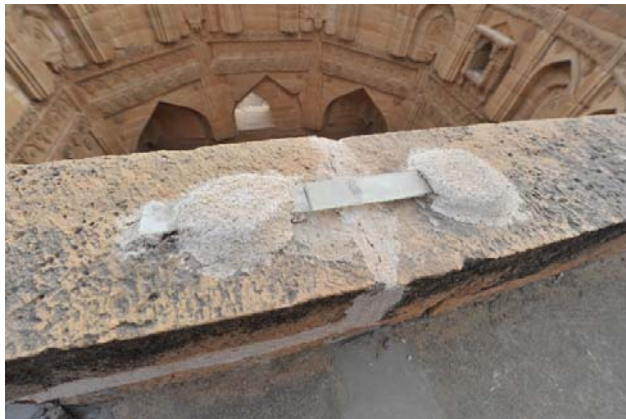
Figure 49 - existing crack monitors show a movement of between 2.3 and 3mm. However it is unclear when this crack monitor was installed

In addition to the geotechnical investigations and crack monitors all cracks in the foundation in the base surrounding the mausoleum **MUST** be sealed to prevent further infiltration of water and control all drainage on site around the structure. This will prevent any undercutting or unseen erosion under this foundation. Consult foundation engineers for designs to stabilize the structure including research into qualified companies in Pakistan that could sensitively install micro pile or other solution to the differential settlement. Eventually extend these geotechnical studies to the entire site.

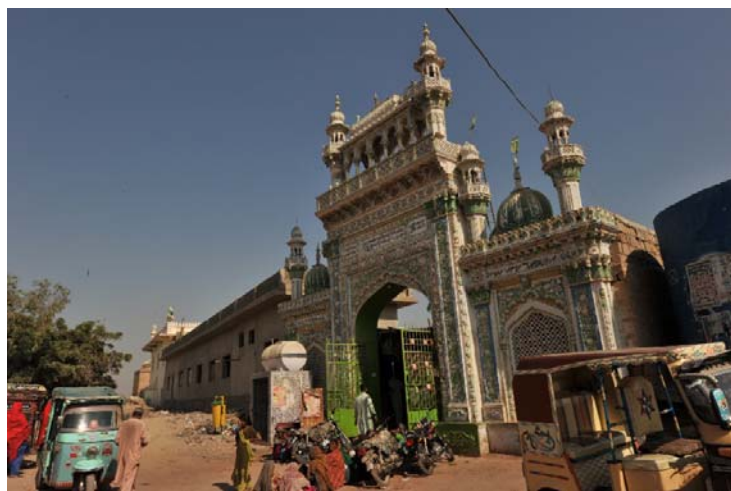
There are a large number of visitor who come to Makli. This number could be in the thousands on Thursday nights or even higher during festivals. However there are no statistics on the number of visitors, frequency of visits, where they go or how they arrive. These numerous visitors have a serious impact on the site and the fragile monuments from their cars to well-worn paths that crisscross the site. They frequently visit the 12 active shrines as well as family tombs. Thus proper visitor management is essential beginning with an education programme for all visitors as to respect to reduce rubbish and graffiti. There must also be some statistics collected to count the number of visitors. This will assist in assigning guards schedule, closing certain monuments at peak periods to reduce impact or conducting outreach programmes. Methods must be investigated for counting visitors including infrared sensors deployed at entrances or through collaboration with a nearby university. In addition private vehicles have a large impact on the site. While the management has already begun to restrict their accessibility on the site more could be done in this respect by further defining paths and roadways. In addition the installation of low cost security cameras and announcements at key points could also reduce the number of issues with graffiti and rubbish. This is being addressed in the larger Master Plan however the team felt it was important to stress in this report.

Figure 50 - The site is heavily used by visitors

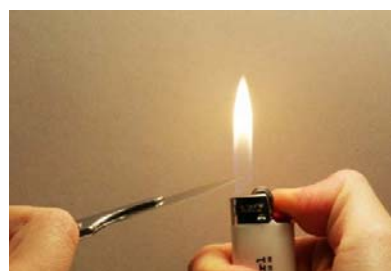
Pick up a small amount of sample material using the tip of the knife blade or scalpel. Hold the knife tip with the sample in the *blue part* of the flame (in order to avoid deposition of soot on the sample and the tool do not hold in the yellow part of the flame).

White biological growth, such as mould, often looks very similar to fluffy salt efflorescence. **Mould burns and becomes black, whereas salt melts or**

bursts Mistakes to avoid:

If the sample is burnt in the yellow part of the flame, it will blacken due to soot deposition, even if it is free of organic material!

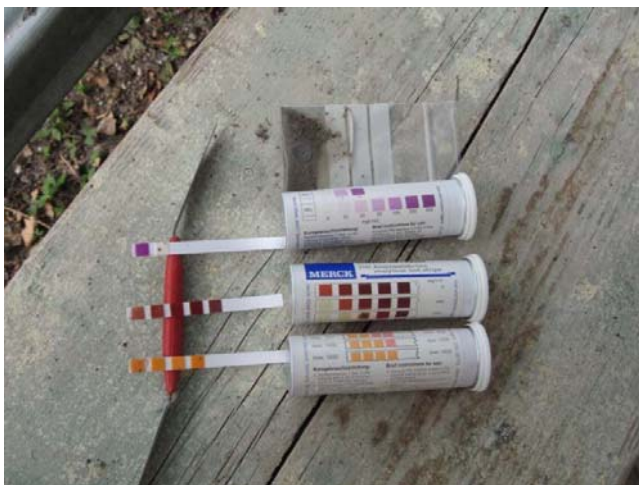
Photo: Christine Bläuer

Merck strips are a quick easy low cost method for indicating the presence of a range dissolved ions. The results are semi-quantitative, but the accuracy of this depends on the dilution used. Therefore in the field they are best used to give a general indication regarding the presence of specific ions. Test strips exist for a range of different ions, however, the detection limit for many of these is quite high.

- Collect a small amount of efflorescence material on the knife point
- Place in central well of a reservoir glass slide; add a few drops of deionised water (dropper bottle) and stir with a glass rod.
- Using a pipette, take up some of the dissolved salt solution (leaving any residue), apply a series of drops to the coloured parts of the Merckstrip,. Wait a few seconds, and then compare indicator strip with the colour guide given on the package. Record the result. *Note:*
- *Chlorides: the detection limit is very high so a very strong solution is needed*
- *Sulphates: the detection limit is very high too. Therefore not really good for gypsum (due to its low solubility) depending on how much water used to dilute sample.*
- *TIP: Merckstrips can be cut in half lengthways to cut costs!*

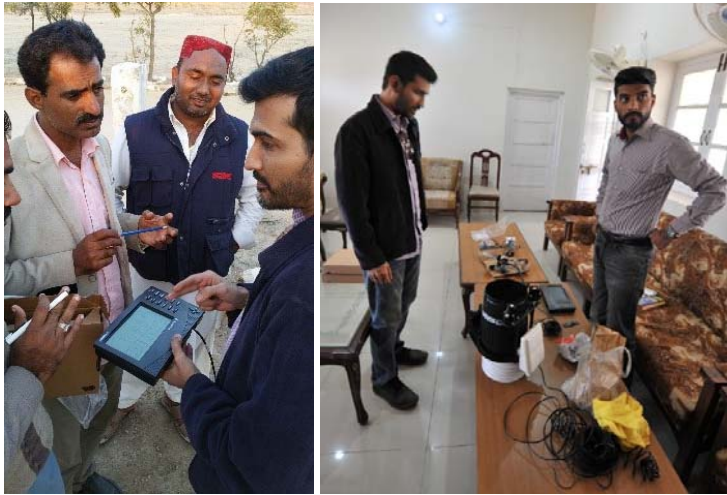
Figure 3 - Installation of the weather station

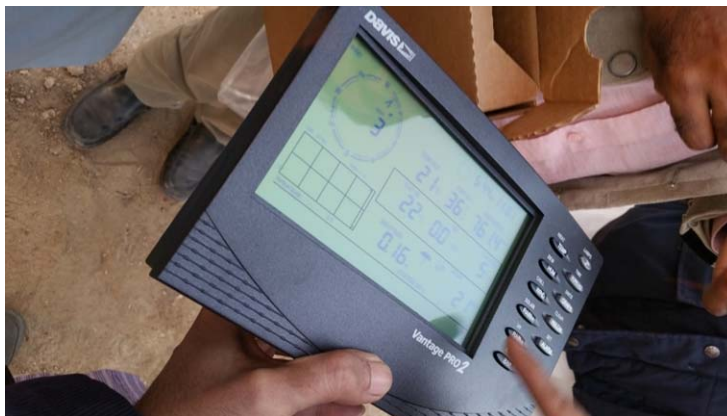
Figure 4 - Description of the weather station panel

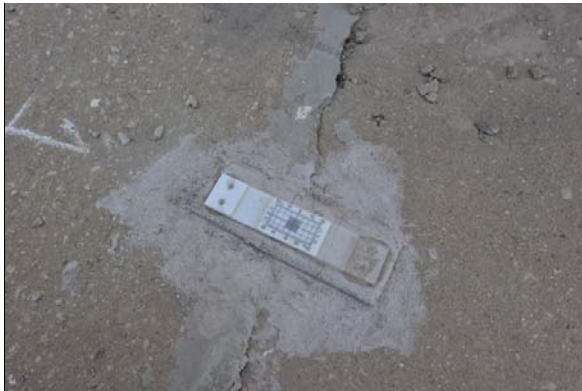
Figure 8 – Existing crack monitor

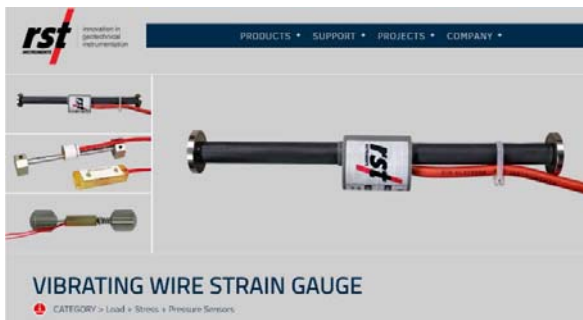
Figure 9 - Vibrating wire strain gauge to very accurately measure movement

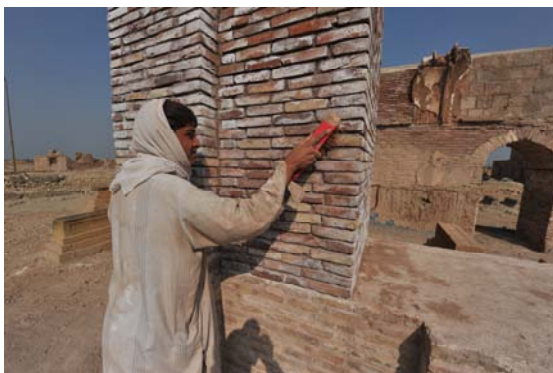
Figure 10 - surface salt removal with a soft nylon brush. Above 1m is the new work and below is a previous intervention

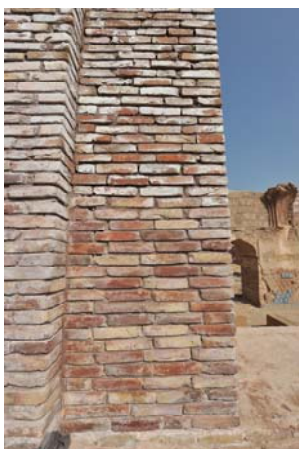
Figure 11 - The surface salt was removed easily

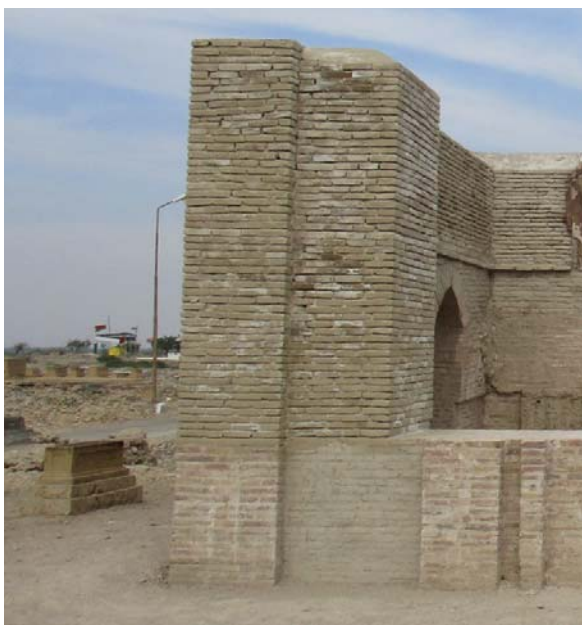
Figure 12 - Meran Bai Tomb after treatment, most salts on the surface following the intervention have been removed however it must be closely monitored. The appearance has been greatly improved.

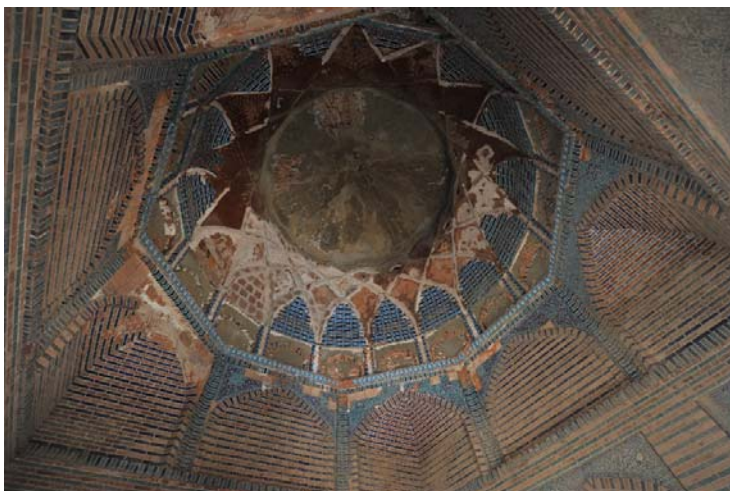
Figure 13 - Other sites were discussed that had past interventions that have introduced salts into the historic structures such as the tomb of Mirza Jaani Beg Tur Khan

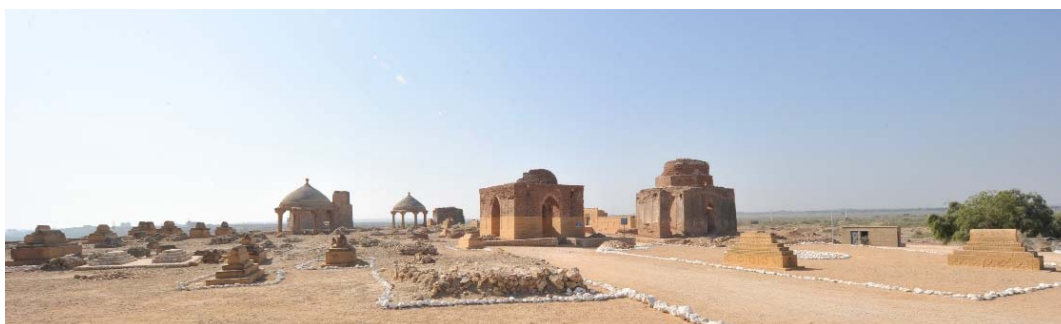
Figure 2 – Local Group C including Jam Nizamuddin Tomb. Keeping the site clear of vegetation, rubbish and control of vehicles is a continuing challenge for a much used place.

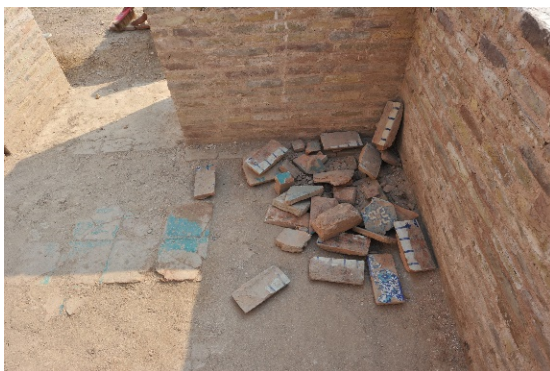
Figure 4 - documentation en-situ of the detached decorative elements

1a – the detached elements must be photographed where they are found before disturbing. It was recognized that this may involve only one photograph or multiple photographs.

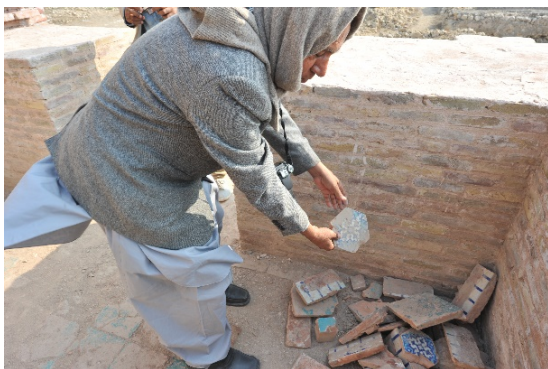
Figure 5 - inspection of individual elements

1c – Each element must be inspected and notes taken as to their description, condition, site, location, etc. A form will be developed to outline these notes.

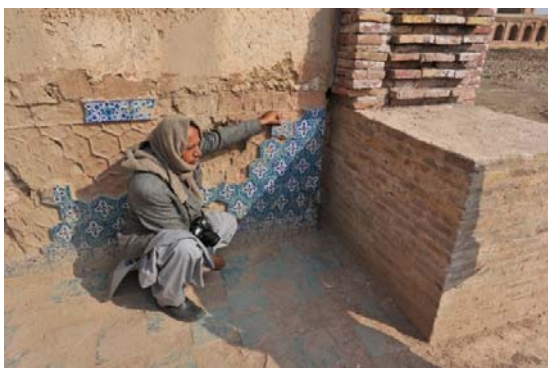
Figure 6 - determination of the detached elements' original location

The detached elements must be compared to the remaining attached elements and documented.

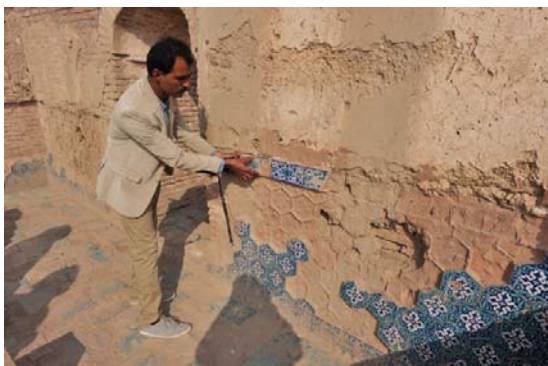
Figure 7 - inspection of remaining elements

2b – the remaining elements must be thoroughly inspected to determine if any are loose or about to become detached. If they are about to become detached then the procedure for semi-detached elements must be followed (part 2 of this report).

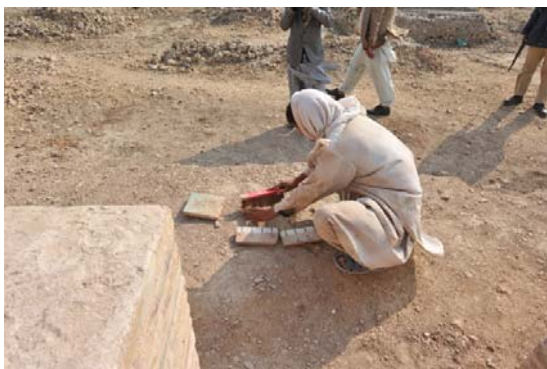
Figure 8 - careful cleaning of each element

Each decorative element must be cleaned, front and back, with a dry soft nylon brush taking care not to detach any remaining glazing.

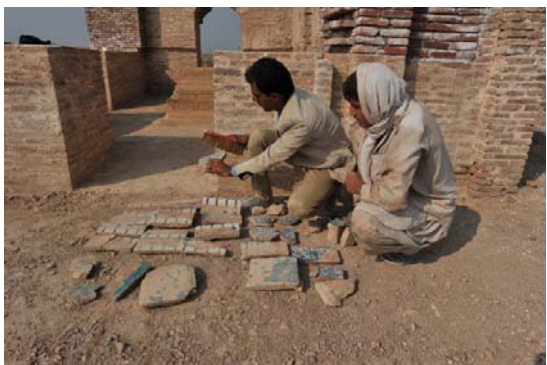
Figure 10 - assigning an index number

STEP 4a – INDEXING – each element will be given a unique code number starting with the name of the monument and a sequential number.

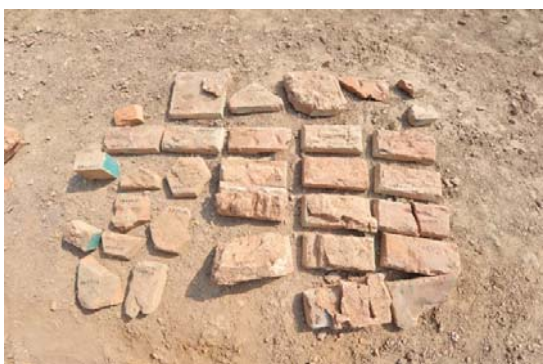
Figure 12 - arrangement for photography

4c – Each element is to be placed face down and photographed with a high resolution camera in order to read the index number.

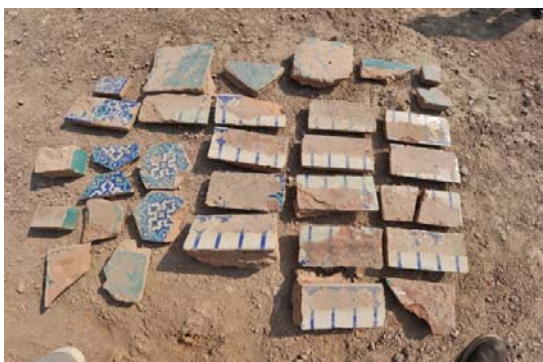
Figure 13 - reversing each element in place for photography of the decorative face

4d – Each element will then be placed decorative face up and photographed again.

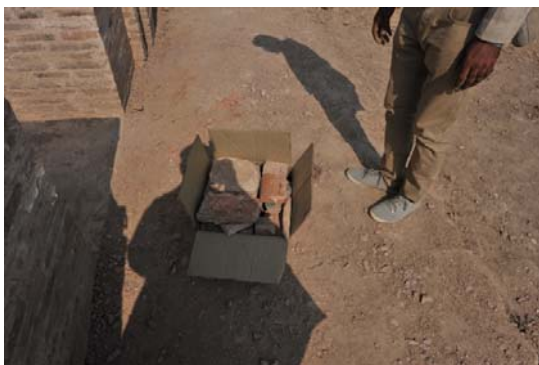
Figure 14 - careful packing and storage at the conservation office

STEP 5 – STORAGE – the elements are then to be placed into a wooden or plastic box carefully and separated with packing material then transported to storage.

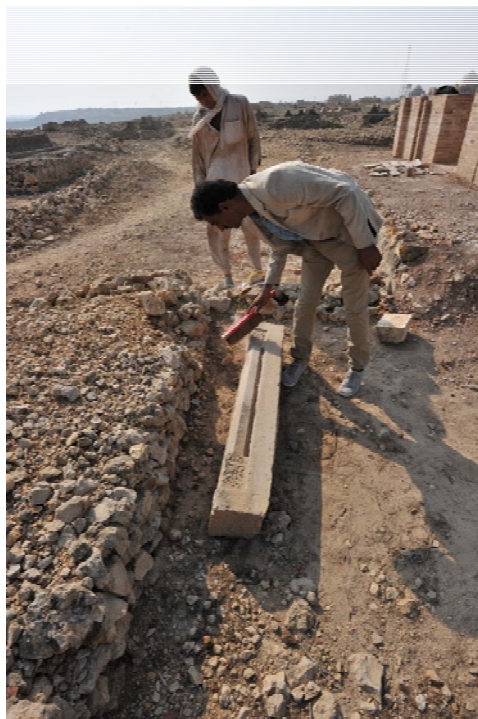
Figure 15 - The same procedure applies to carved stonework

The same procedure above applied for detached decorative architectural elements such as this column from the same site.

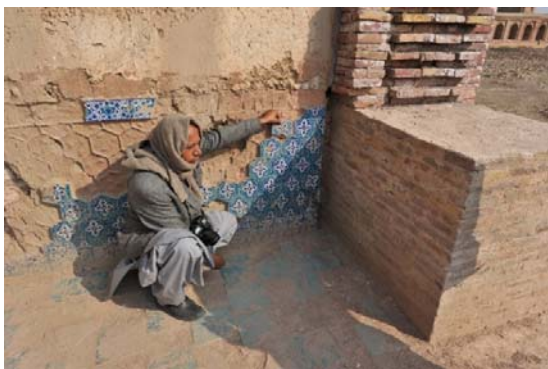
As with the detached decorative elements there was a procedure required for loose elements that are about to become detached.

Figure 16 - inspection of attached decorative elements

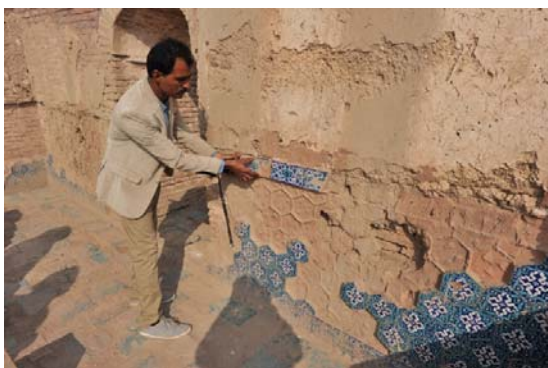
Figure 17 - inspection and consolidation of remaining decorative elements

The detached elements must be compared to the remaining attached elements and documented. The entire decorative surface must also be documented through photography, sketches and notes. These must include the state of condition, written description, name of the inspector, monument and date.

STEP 2 – the remaining elements must be thoroughly inspected to determine if any are loose or about to become detached elements.

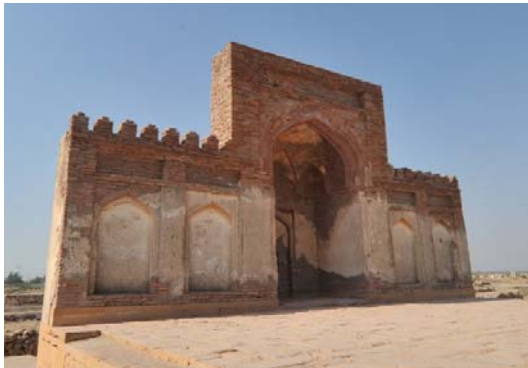
Figure 18 - Unknown tomb Group A - fallen brick capping was replaced

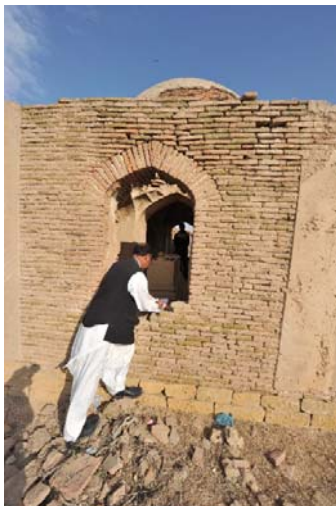
Figure 19 – documentation by photography and notes of original material location

This is a critical step in order to determine the original location of the construction elements. This includes photography of the context and of the fallen elements from multiple angles. It must also be accompanied with copious notes and sketches. Sketches are essential as it is a selective form of documentation and only those elements that are important can be documented.

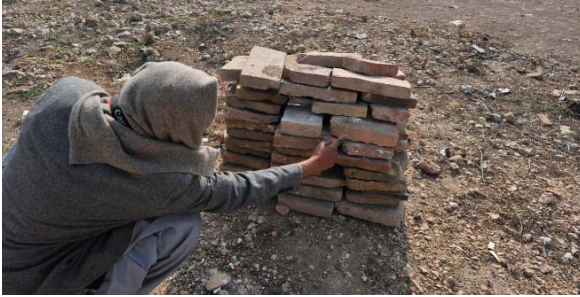
Figure 20 – classification of on site of original building materials in preparation for an intervention

This second step is just a classification and characterization of the building materials and their suitability for anastylosis. This classification determines their original location in the building based on the previous documentation and location, acceptability for reinsertion. In many cases fractured original materials can be used for rubble core walls but this determination must be made on a building by building basis.

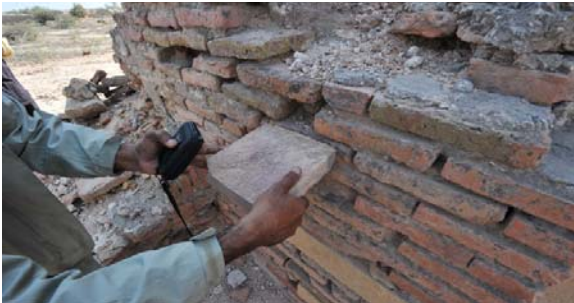
Figure 21 - examination of original en-situ materials and fallen materials
