**UPDATED STATE OF CONSERVATION REPORT ON
HISTORICAL MONUMENTS AT MAKLI, THATTA SINDH
(PAKISTAN) (C 143) DECISION: 40COM 7B.44**

Historical Monuments at Makli Thatta Sindh (Pakistan) – a World Heritage property

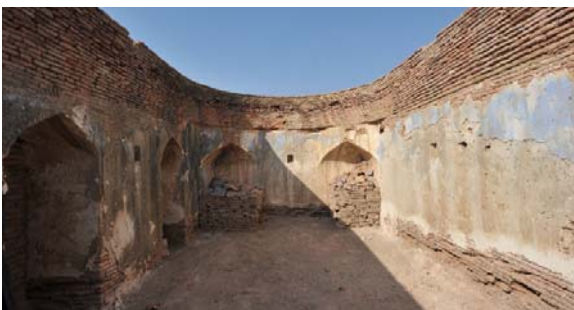
Figure 22 – longer term storage on site or within the structure.

It was determined by the team that these construction elements should be stored on site. This is due to three main reasons. 1) They can be used during upcoming restoration efforts, 2) They are not in great risk of theft and 3) there is limited storage space and the decorative elements must receive priority.

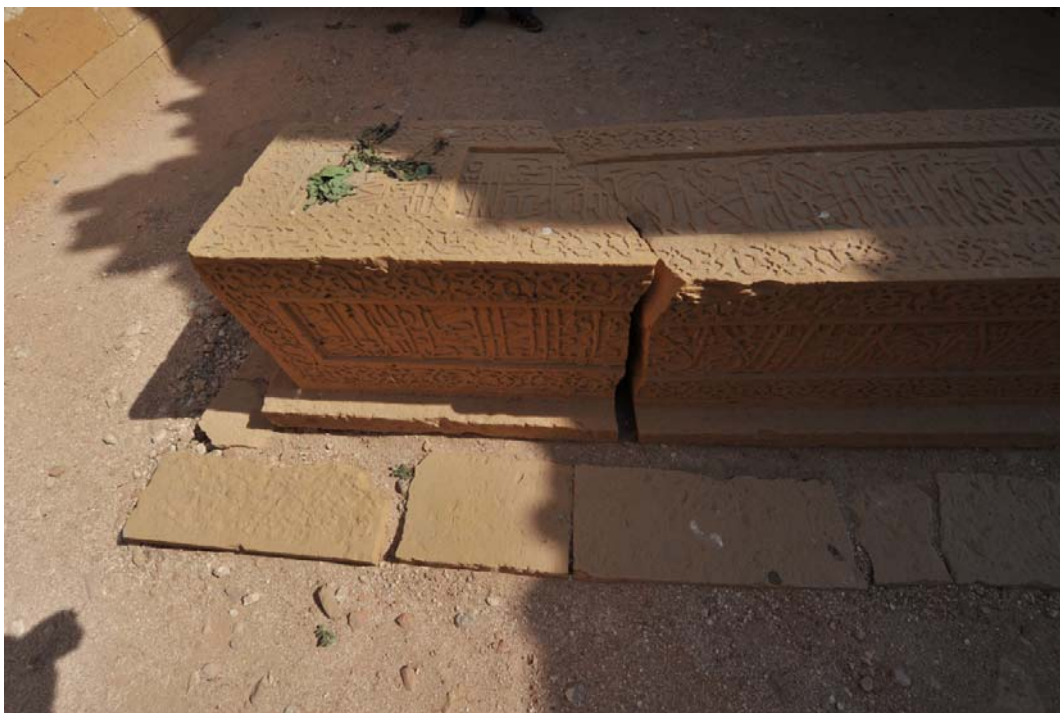
Figure 23 - for some decorative elements it is important to stabilize in place as they tell the story of the history of the tomb. Here the monument was fractured as a result of the dome collapse
