**MISSION REPORT / RAPPORT DE MISSION**

**Kathmandu Valley (Nepal) (C 121bis)  
Vallée de Kathmandu (Népal) (C 121bis)**

**20–25 March 2017**

REPORT ON THE JOINT  
WORLD HERITAGE CENTRE/ICOMOS/ICCROM  
REACTIVE MONITORING MISSION  
TO THE KATHMANDU VALLEY  
(NEPAL, C 121BIS)

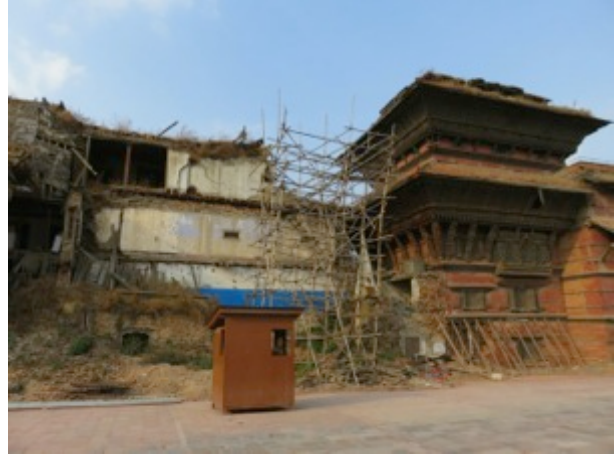
Nine Storey Palace (Basantapur Bhawan).

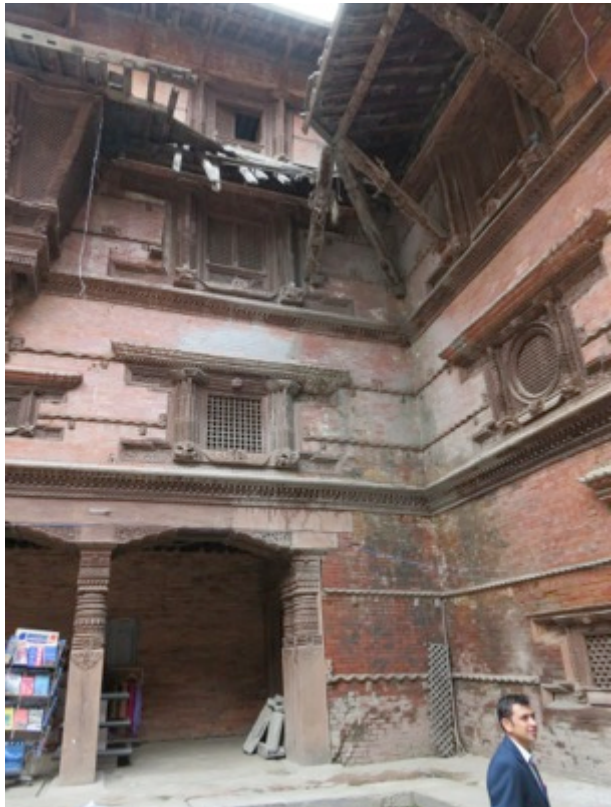
Area of Nine Storey Palace showing signs of deterioration from continued exposure.

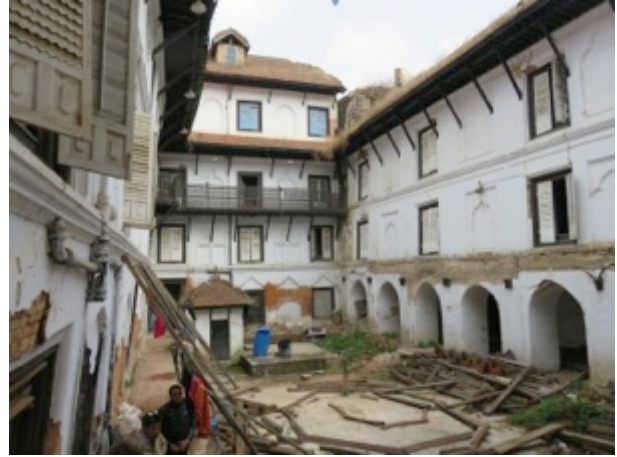
Seriously damaged Rana buildings around Lamo Chowk with shoring – no repair works to date.

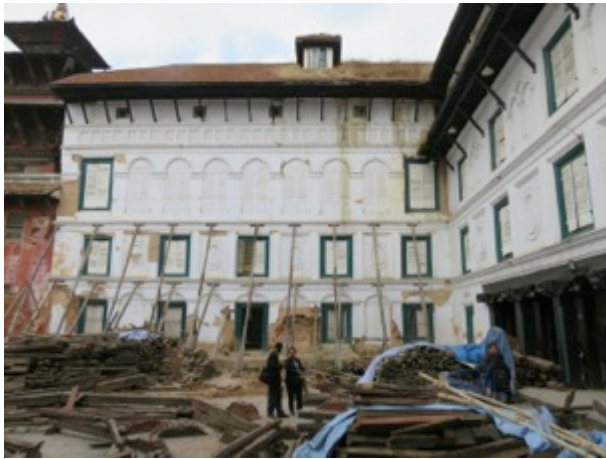
Timber from collapsed temples is stored in Dhak Chowk and is often left uncovered at the end of each work day.

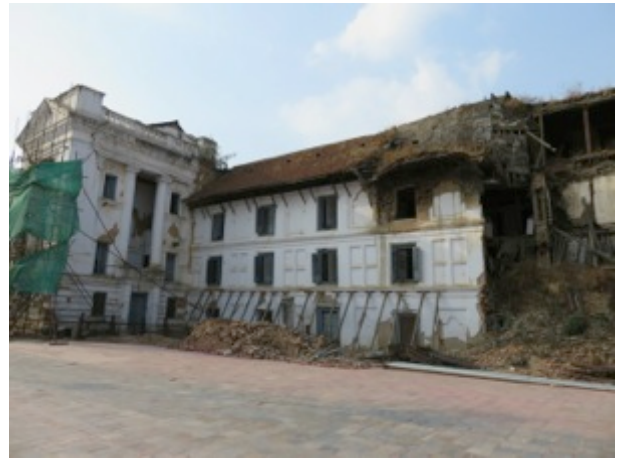
Seriously damaged Rana style wing still exposed to weather. Eastern end of Gaddi Bhaitak on left.

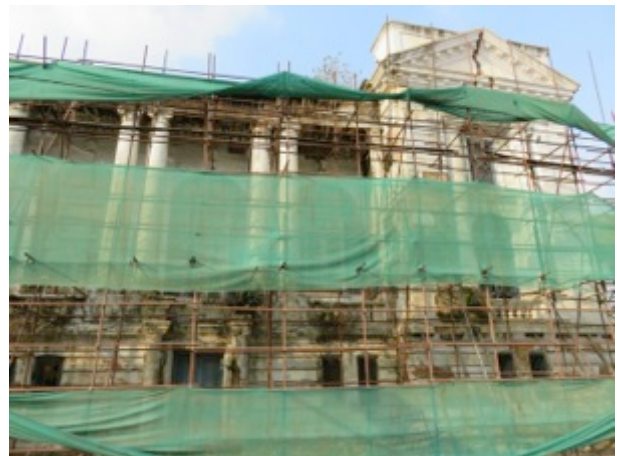
Southern elevation of Gaddi Bhaitak showing severe cracking.

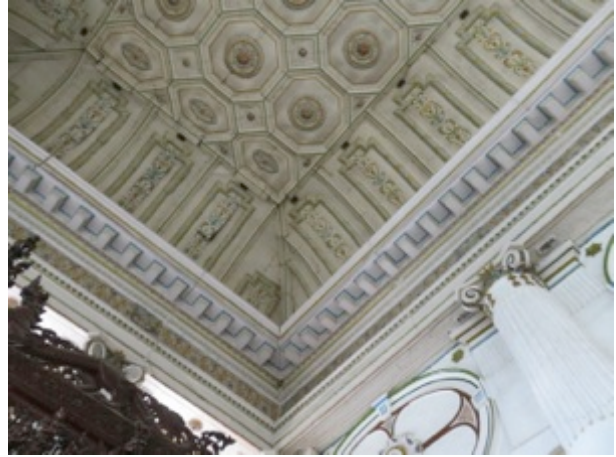
Hand painted, pressed metal ceiling and cornice of Gaddi Bhaitak, starting to detach due to roof damage and exposure to elements.

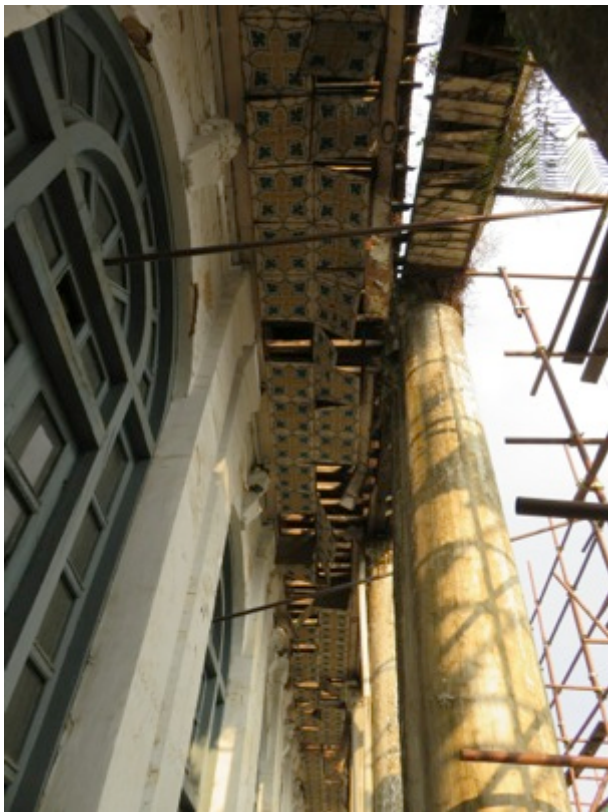
Southern colonnade of Gaddi Bhaitak, showing pressed metal ceiling panels corroding and falling due to lack of weather protection.

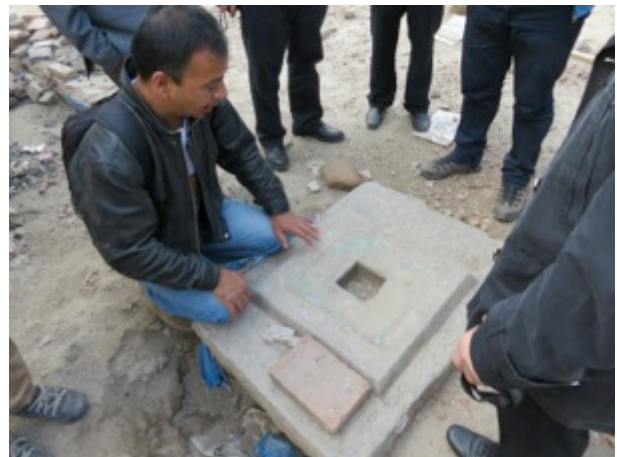
Post that fitted into this stone was not properly prepared in previous c1960s refurbishment. Brick paving had been laid across the top of the stone, between it and the post. Evidence of previous copper flashing to bottom of posts survives on the stones.

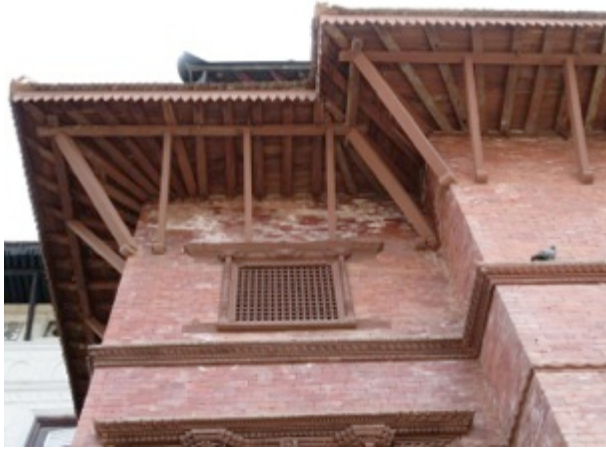
External wall below Degutale Temple has been repaired, but the bricks are showing white efflorescence, believed to be due to chemicals in the clay used in their production

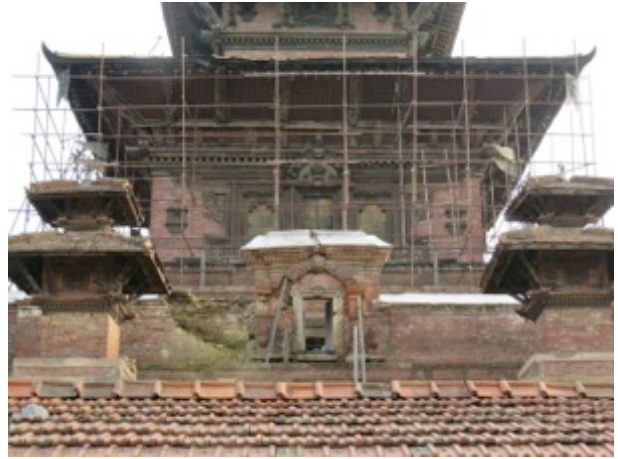
Top of Talegu Bhawani Temple has been repaired, but the walls around its tiered plinth have not been repaired and are deteriorating due to exposure to the weather.

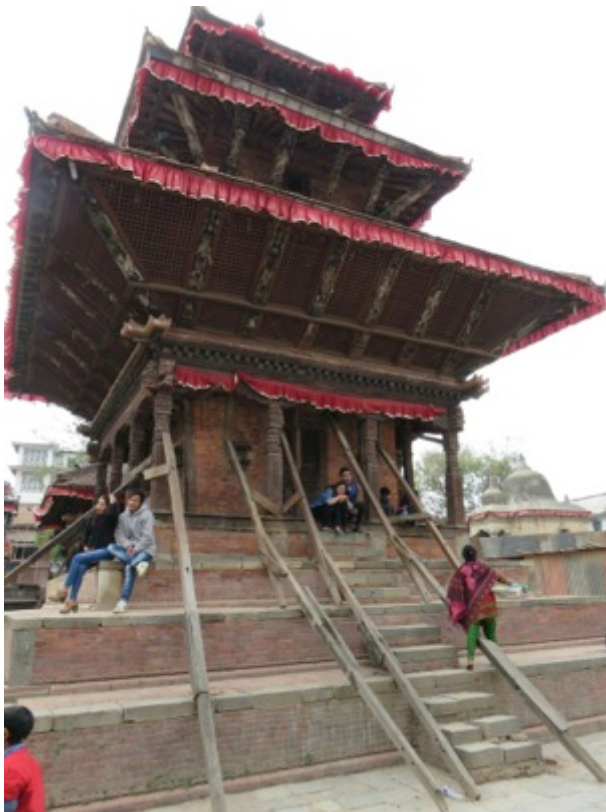
Jagannath Temple has been the subject of archaeological investigations and structural modelling. Photographs taken through holes in walls show that timber posts have rotted at their bases. Person stepping over props that have been installed to stabilise the structure.

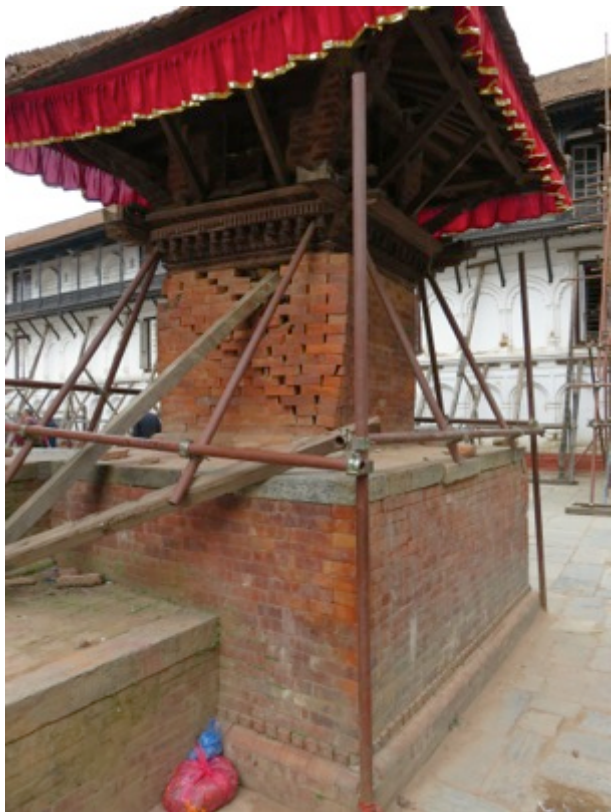
Bricks in corner shrines have moved since 2015 mission. Temporary props appear to also have moved and are no longer supporting the structure.

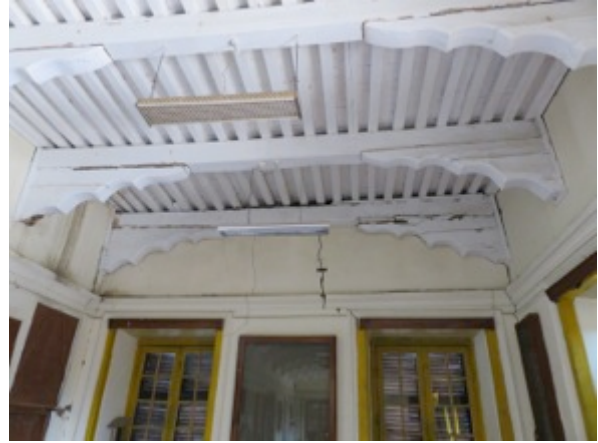
Large timber beams support the ceiling and roof, but are decayed. Cracks in the end wall of the hall are being monitored.

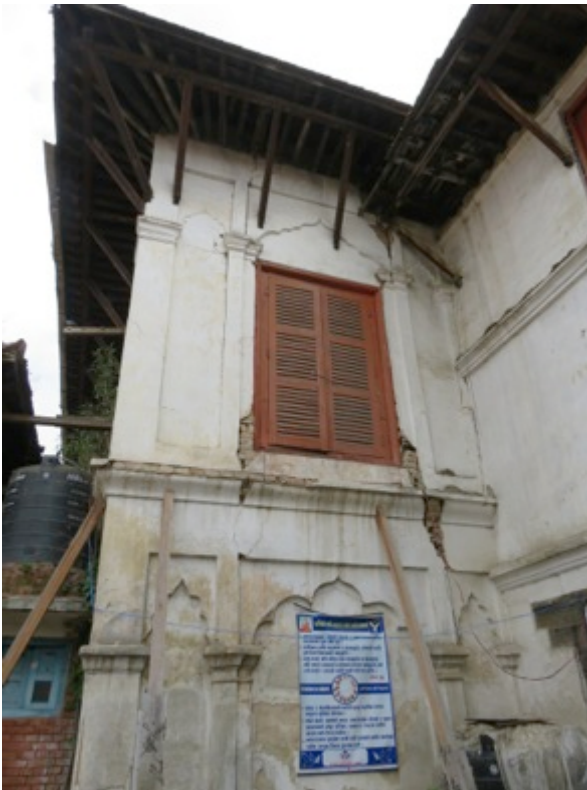
Cracks in end wall of Lal Bhaitak (Rana style wing of former palace, dated 1858).

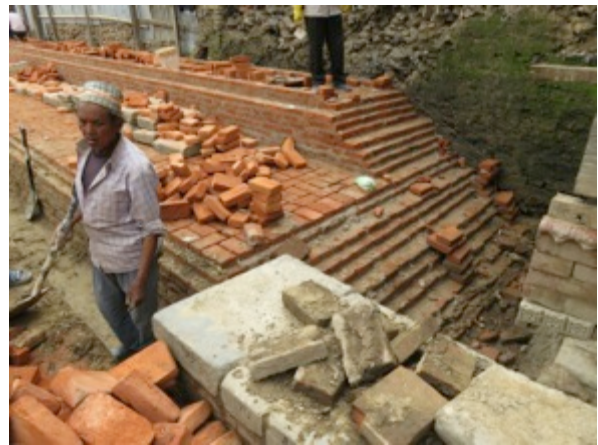
The brick plinth has been replaced in new brick matting with lime, sand and surkhi mortar.

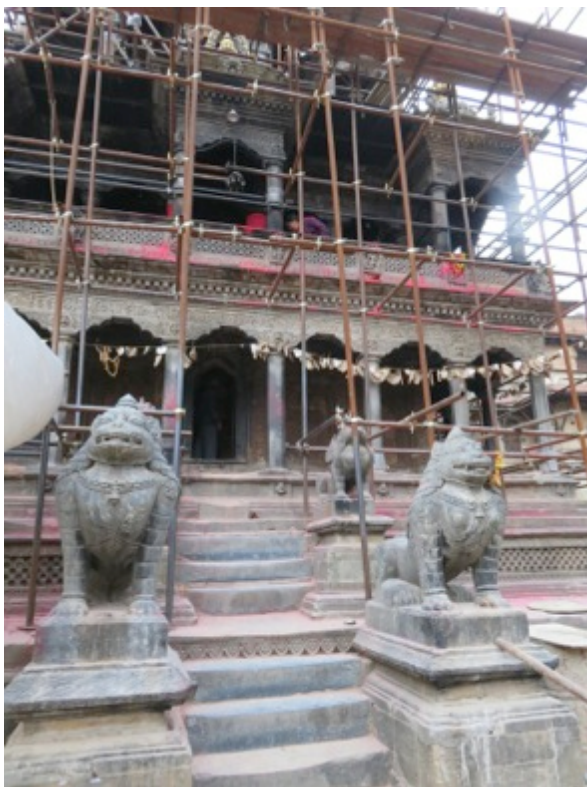
The lower portion of the Krishna Temple remains active, whilst the upper levels are severely damaged.

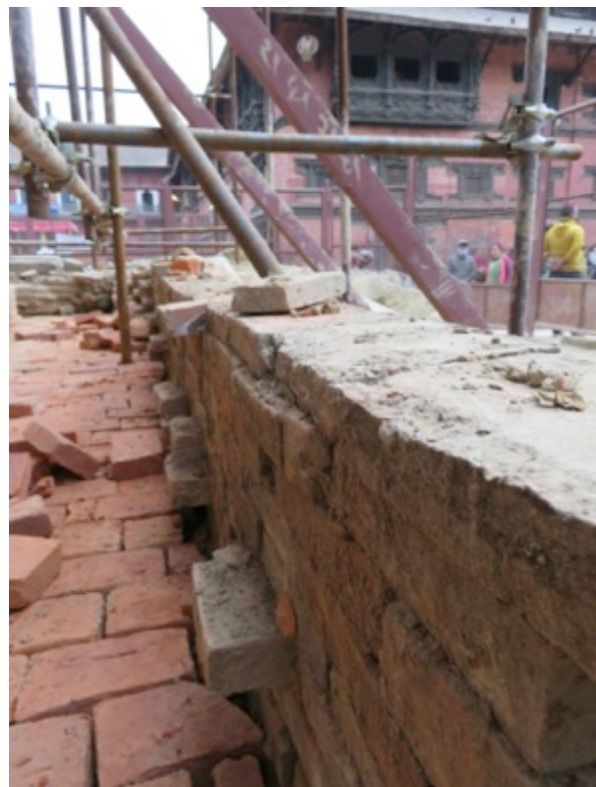
New brick matting being laid within the temple plinth base. New bricks have been designed to bond the external skin to the body of the paving – Bishwanath Temple.

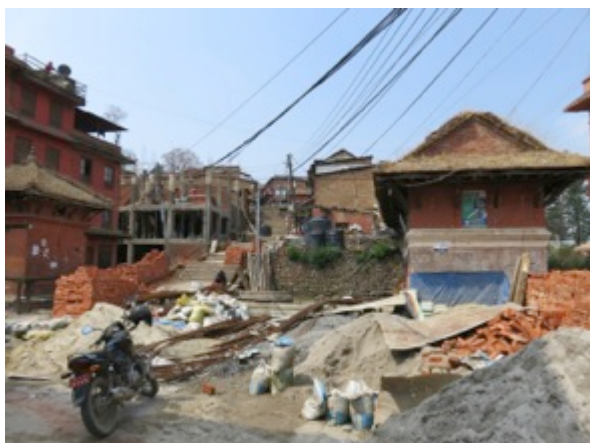
Housing in ancient settlement is being replaced with modern concrete framed structures.

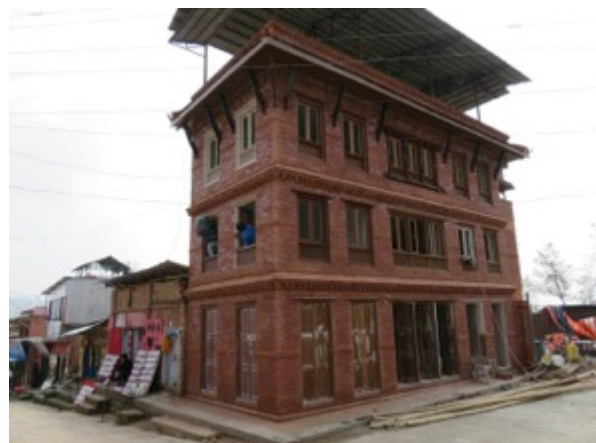
House opposite temple gate rebuilt with a concrete frame and brick cladding. It is one storey higher with a roof top terrace.

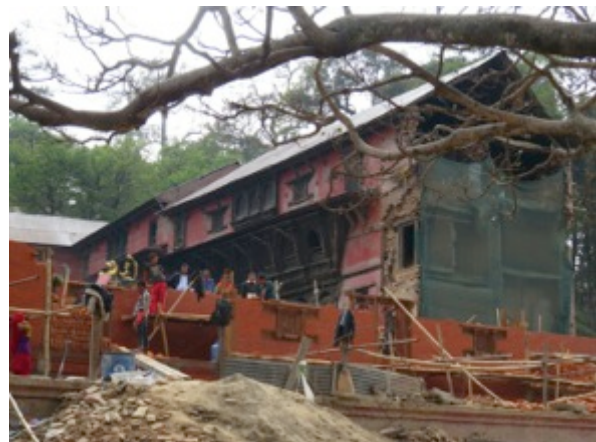
Shree Guhyeshwori Temple and sattal complex – this portion of the sattal in the foreground has been demolished for reconstruction. The adjoining portion (still standing) has not been supported and has suffered additional structural failure.

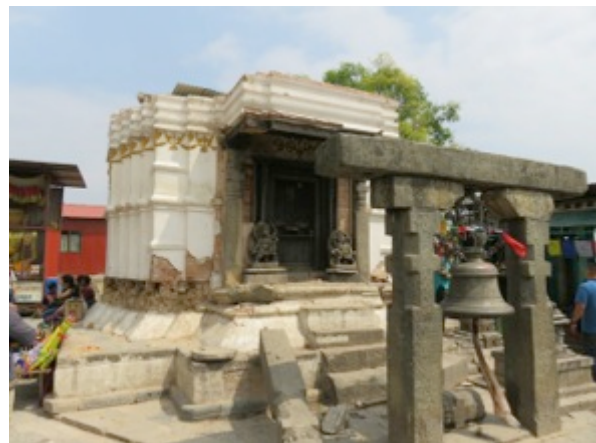
Pratipur has been partially demolished. The upper section is set with lime based mortar, the lower section is set with mud mortar and was damaged during the earthquake.

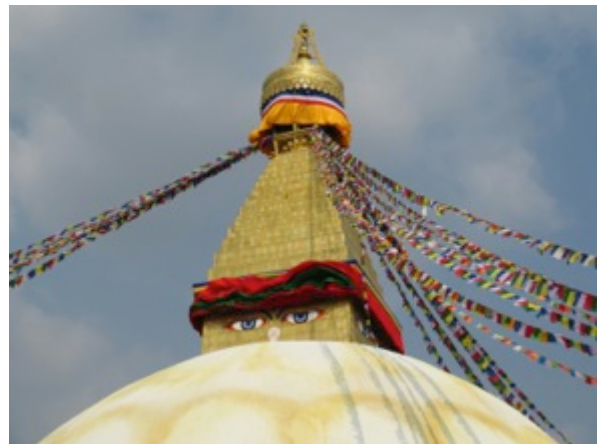
Top of stupa has been reconstructed and the timber framed parasol and gilt metal cladding have been reinstated.
