THIMLICH OHINGA CULTURAL LANDSCAPE

NOMINATION DOSSIER FOR INSCRIPTION ON
THE WORLD HERITAGE LIST

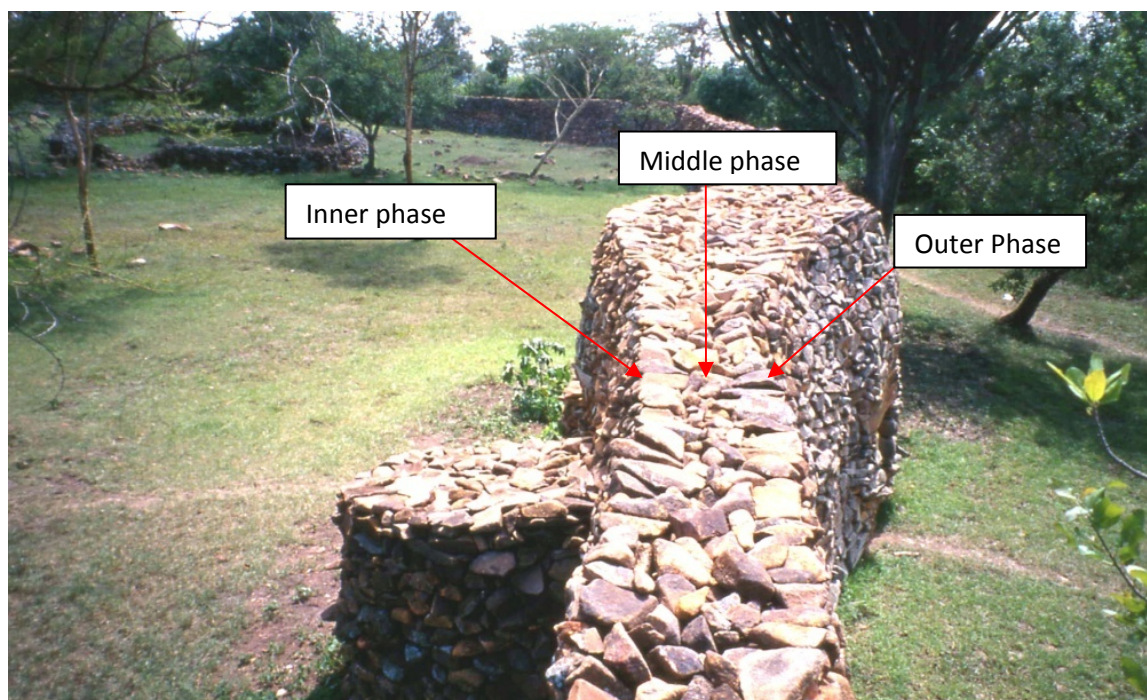
Figure 3: Photo showing the three phase technique

The architectural technique used at the site is a three-phase design where the walls have an outer and inner phase of neatly arranged stones of all shapes and sizes and a middle phase consisting of smaller stones (Figure 4). The middle held together the stones in the inner and outer phases of the walls. Due to lack of distinct shapes of the rocks used, the walls do not exhibit any clear coursing, as is common in modern stone walls or buildings. Stones were placed in an interlocking system that enhanced overall stability without the use of any mortar or cement. The walls range from 1.5 m to 4.2 m in height, with an average thickness of 1 m. The thickness of the walls increase at the entrances from 2 m to 3 m and rectangular slabs were used at the lintels (Onjala 2003).

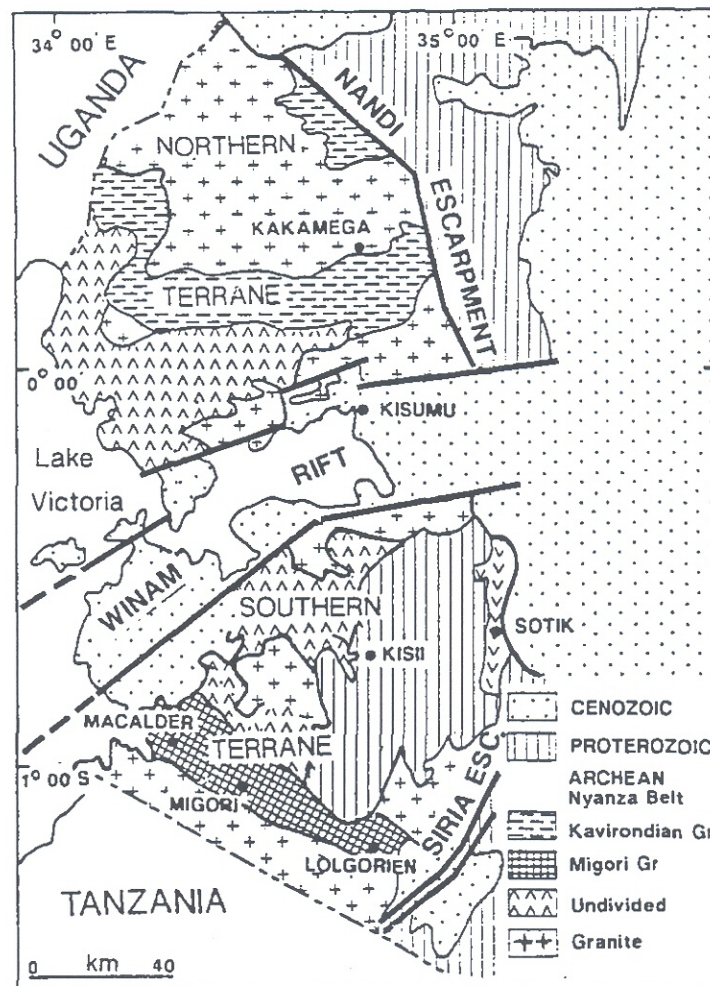
Figure 4: Diagram showing the geology of the Lake Victoria region (source: Ichangi 1990)

There are other rock groups found within the area namely Pleistocene rocks formed as a result of faulting and tilting which took place in the area. There are also alluvial rocks recently owing to

erosion and deposition. Miocene deposits are visible in the form of clays and sand around the Gwasi area. This area is also associated with the Bukoban system or the Kisii series of the Paleozoic times consisting of basalt and quartz rocks. The final group is the Nyanzan basement system of Precambrian times mainly consisting of quartz.

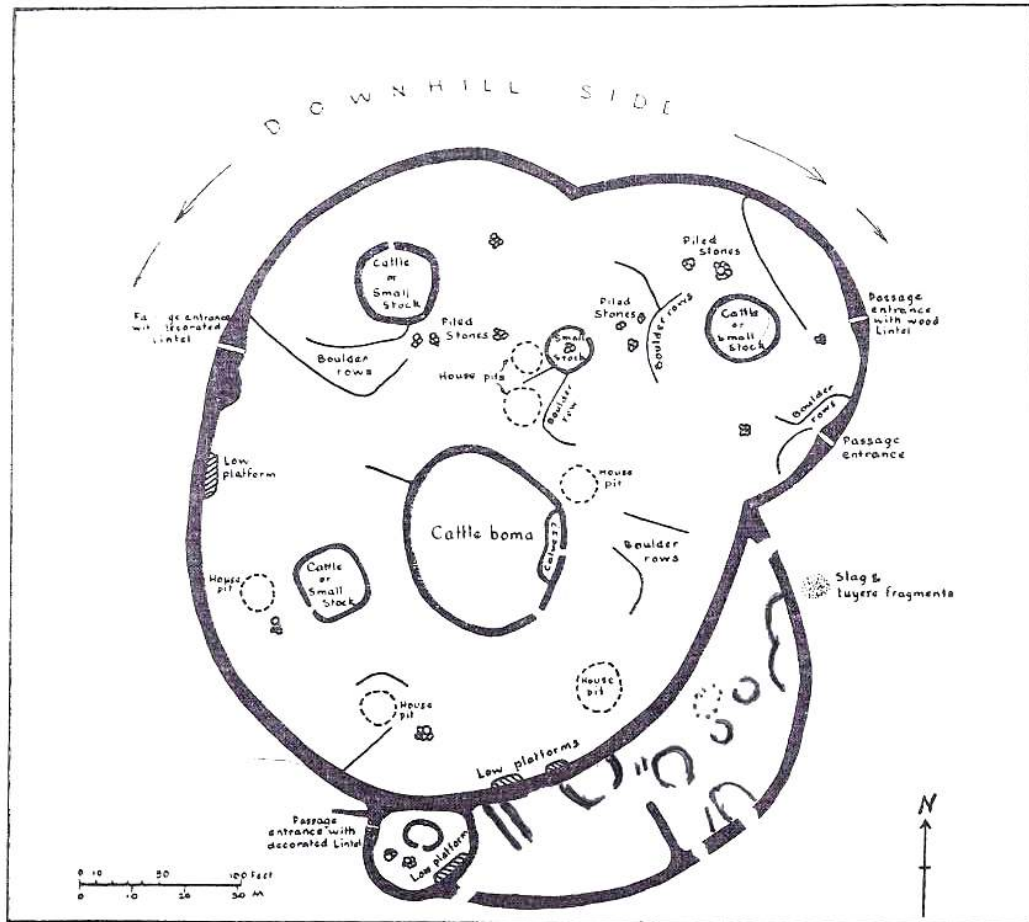
Figure 5: Illustration showing the extension at top right of the main enclosure (*Kochieng*) (source: Lofgren 1967)

Throughout the periods of occupation, the site experienced modification in terms of additional walls, repairs and general maintenance. Additional structures were constructed uphill. These were mainly built by the Kabuoch-Kachieng people. The main enclosure has a demolished wall on the northern side where an extension was built, probably as a response to an increasing population. Enclosures to the main one, especially to the northeast, were also constructed to meet this particular need. (See figure 6).

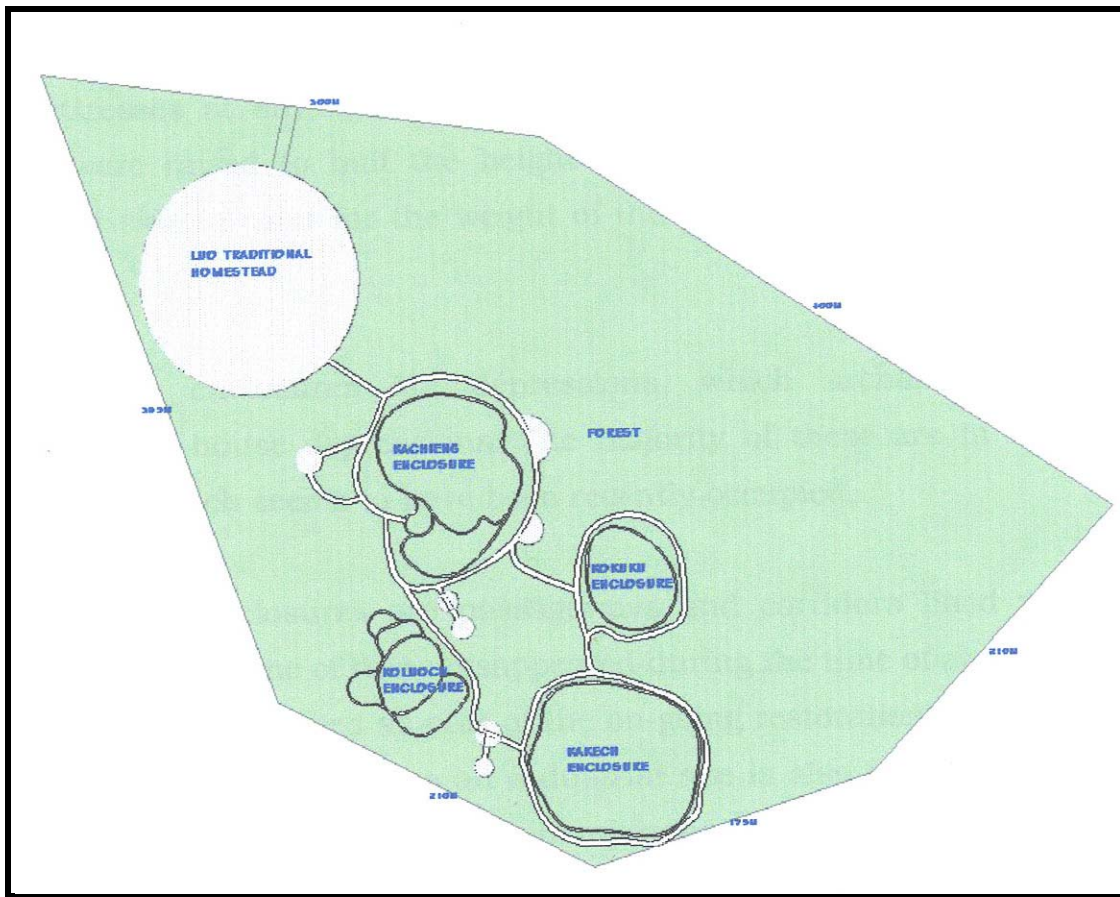
Figure 2 : Site layout showing the distribution of major enclosures at Thimlich Ohinga Cultural Landscape

Within the main structures smaller enclosures, which were used as cattle kraals still exist. The main enclosure called Kochieng has six of these while the others have one each except for the uphill complex, which has two. There are also a couple of tiny structures which were food processing areas. Besides the kraals, the enclosures also contain support heaps or buttresses at strategic sloppy positions to ensure stability. Most of these were raised to half the height of the walls, especially along the downhill side to cater for the weight of the walls relative to the effects of the slope.

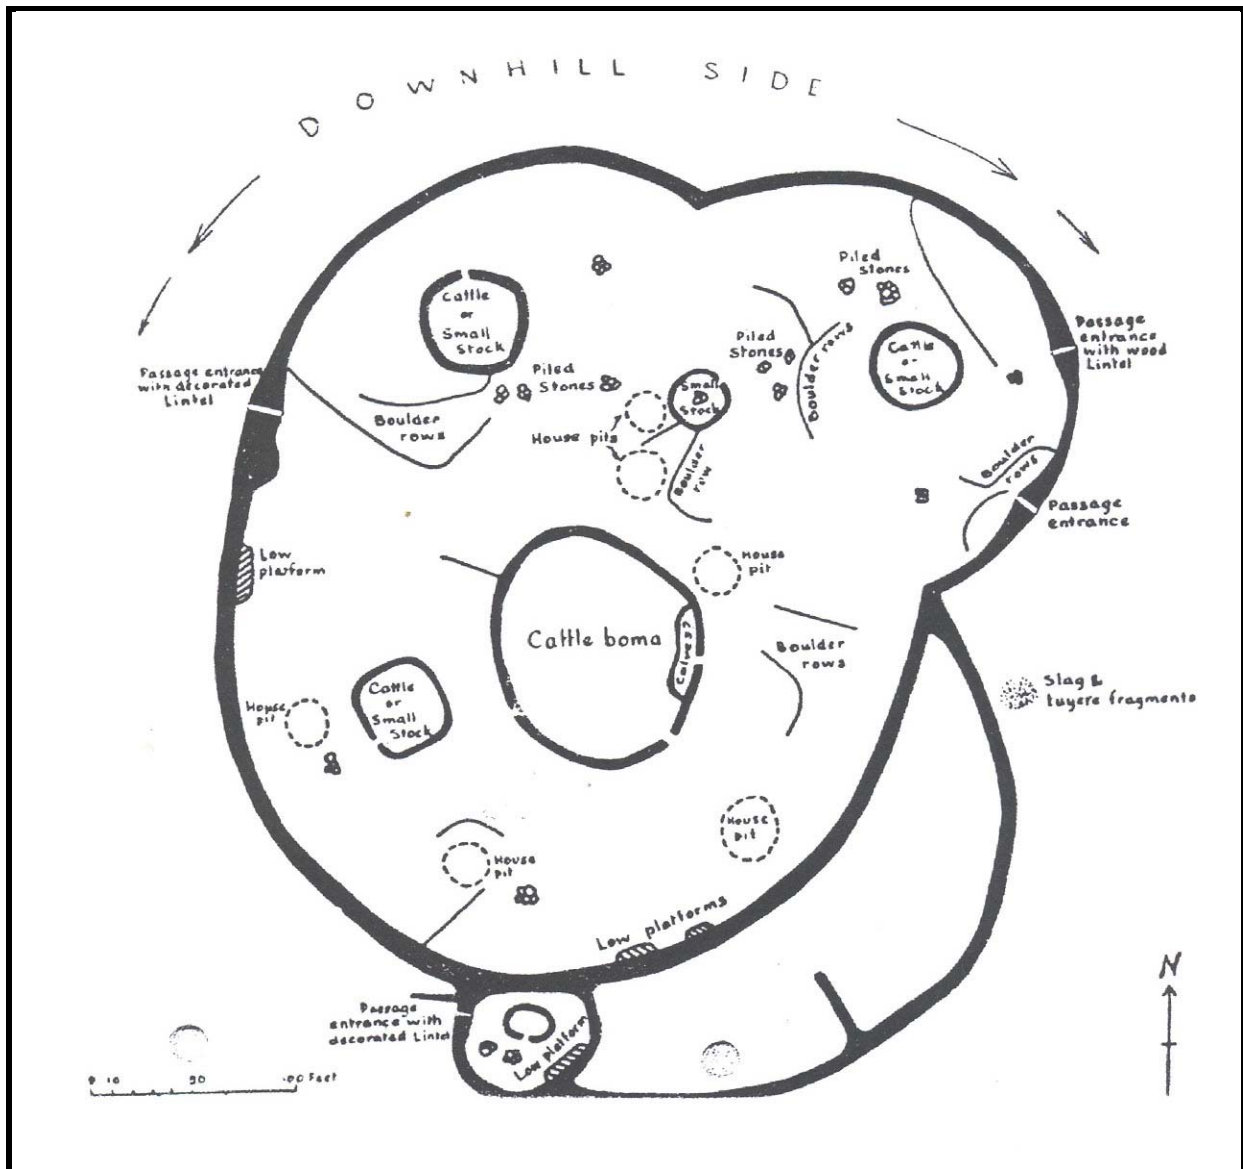
Figure 3 : Layout showing the features at the main enclosure, *Kochieng* (Source:Lofgren 1967)

outside the northeastern wall of the main enclosure. Here, iron smelting and working occurred, as indicated by the presence of a furnace area containing smooth stones, which are the result of iron shaping. Pieces of *tuyere* litter this particular area. Also found in this area is a mound consisting of iron slag and pieces of refuse including broken pottery. An ancient version of the game known today as *Bao* Game, carved on a piece of rock was also found nearby and could indicate that the area was equally used as a leisure spot where games were played. The area is large enough and could have easily accommodated both activities especially if the game was to be played during short resting periods in the course of the iron working process.

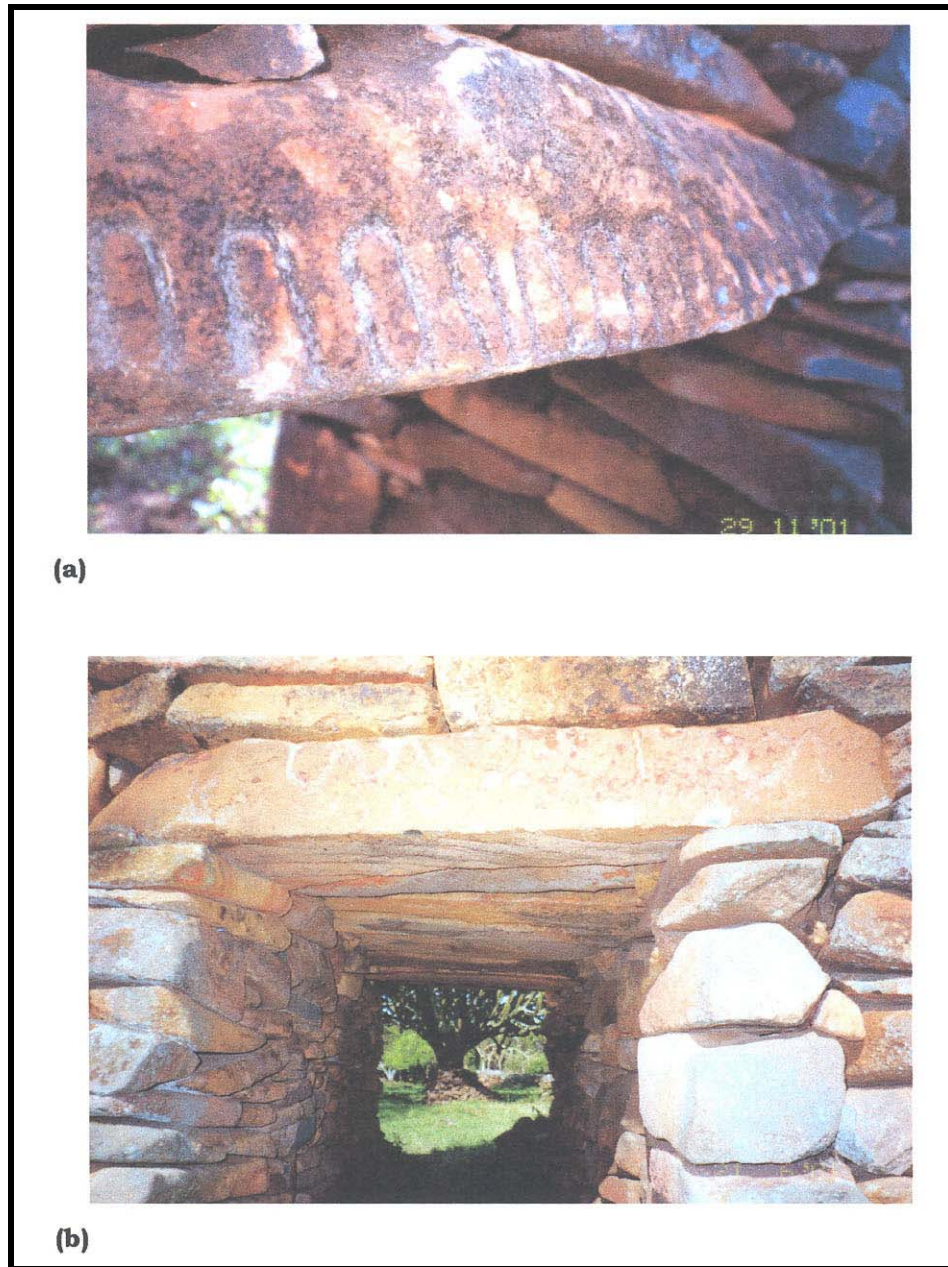
Plate 2 : Details of the gates; (a) decorated lintel at *Kakuku* enclosure and (b) arrangement of stone slabs of uniform size to make the lintel of the gate at the *Kochieng* western entrance. Note also engravings.

In terms of the nature of the walls, these consist of neatly arranged stones of irregular shapes and sizes. The building was done in three phases that ran concurrently. The outer and inner phases of the walls were joined together using a third phase consisting of smaller stones that pressed down the end of the stones of the outer and inner ones. Due to lack of distinct shapes of the rocks used, the walls do not exhibit any course-line, as is common in modern stonewalls. The stones were simply put together through an interlocking system that enhanced stability. No mortar was used in the building of the walls, which range in height from 1.2meter to 4.2meter. The average thickness of the walls is approximately 1meter. The thickness of the walls increases at the entrances to about 2-3meters wide. This was a stability mechanism to create maximum strength at these points, which were constantly in use. Specific slabs or rocks were used at these points.

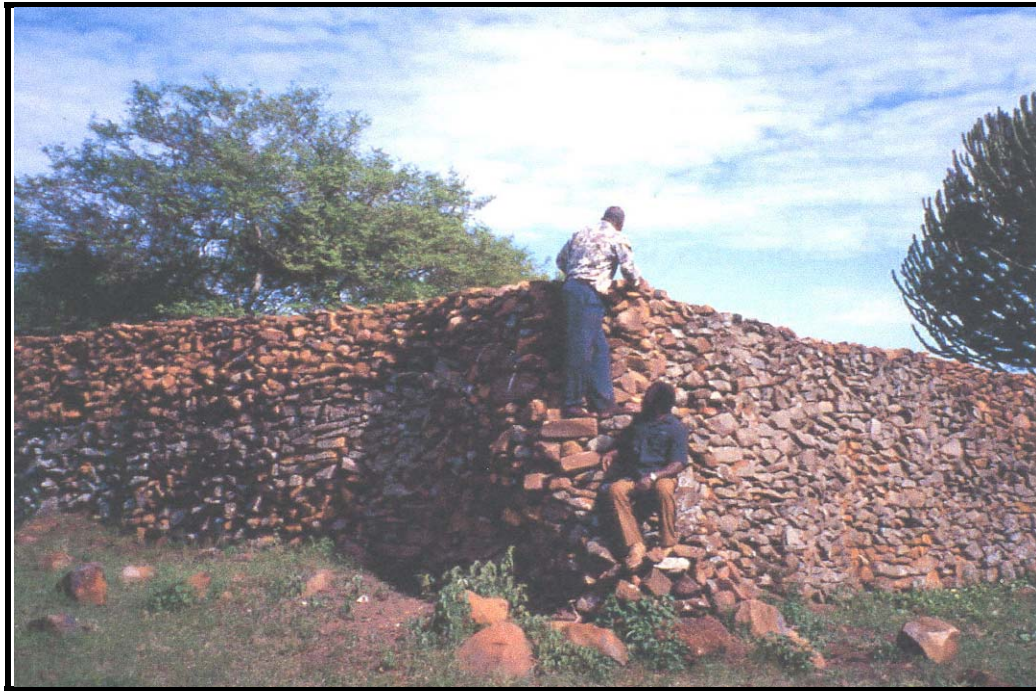
Plate 3 : Wall buttress

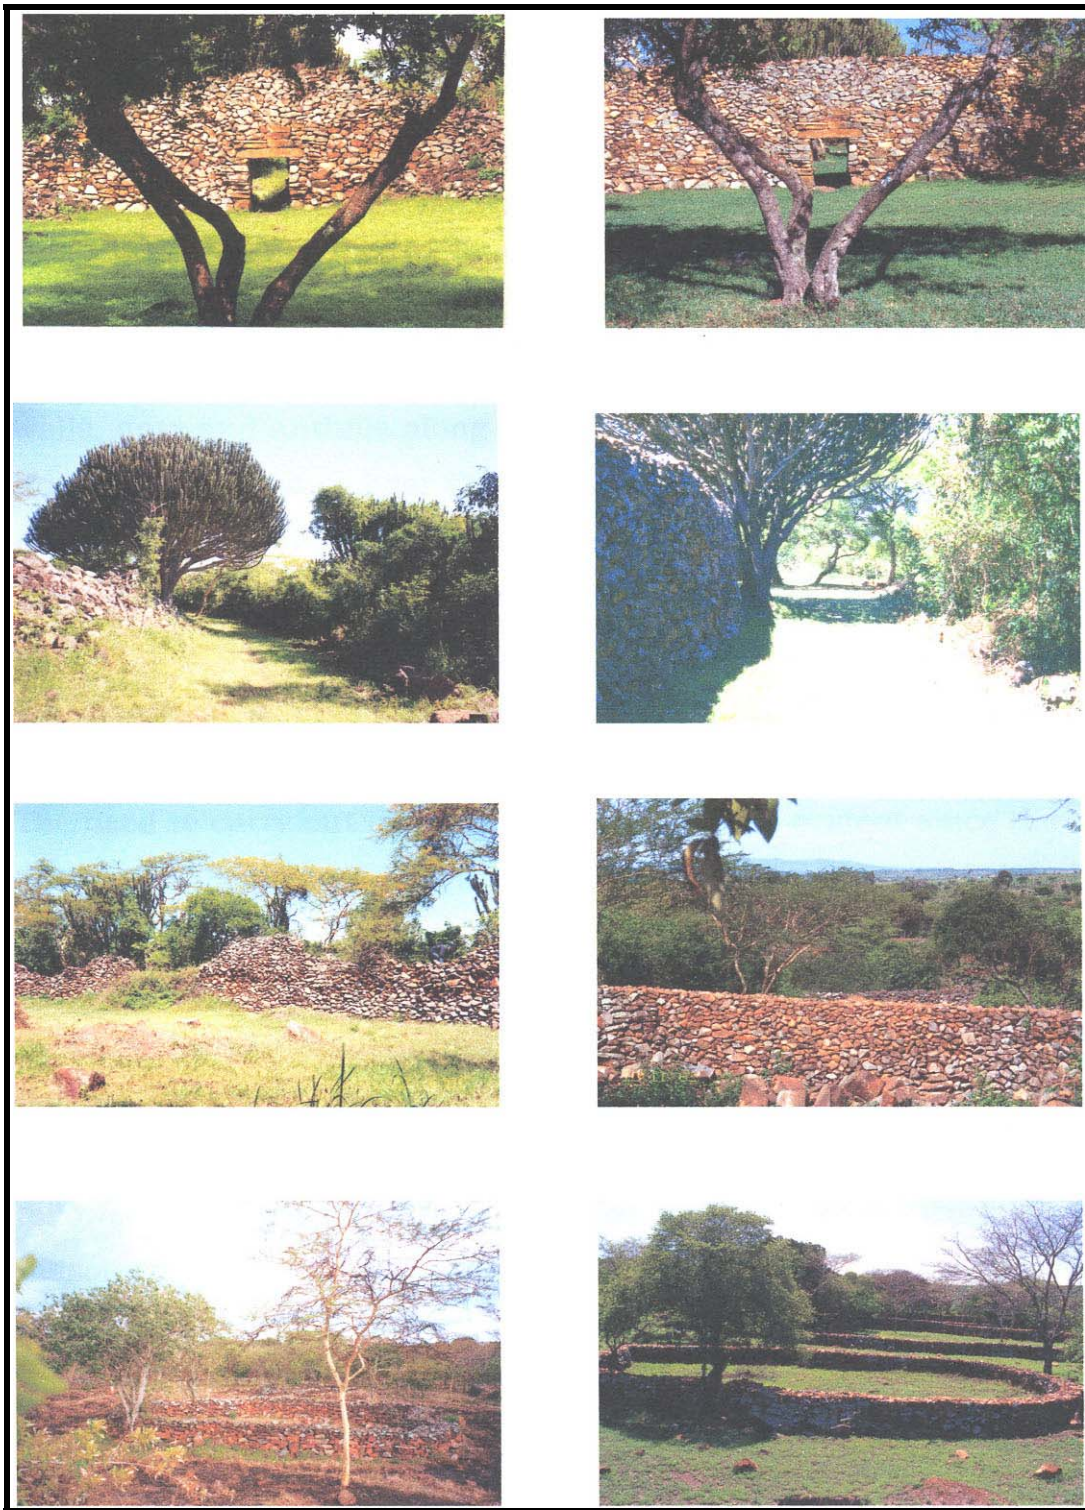
There has been a major change in the state of the walls at the site. Plates 1-8 below show some of these changes and the progress of the restoration work. The major challenge that now remains is the continued maintenance and other conservation practices to ensure stability of the walls.

Plates 6-13 : Condition of the walls before (left) and after restoration work (right)

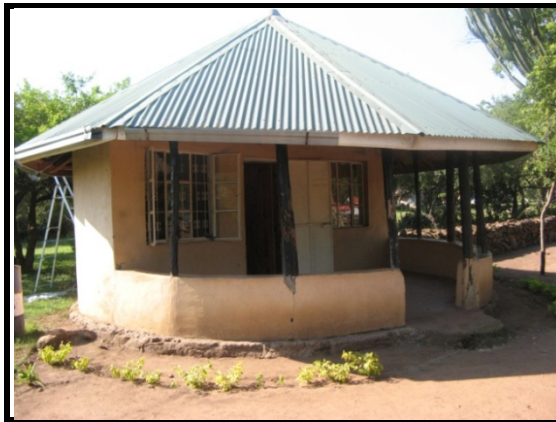
Plate 15: Ticketing office in need of gutters, pole and crack repairs

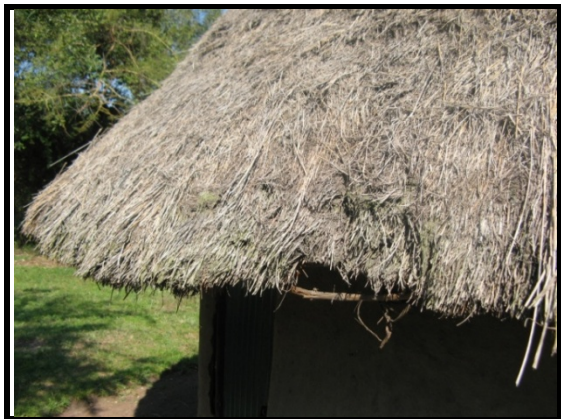
Plate 16: House in need of re-thatching

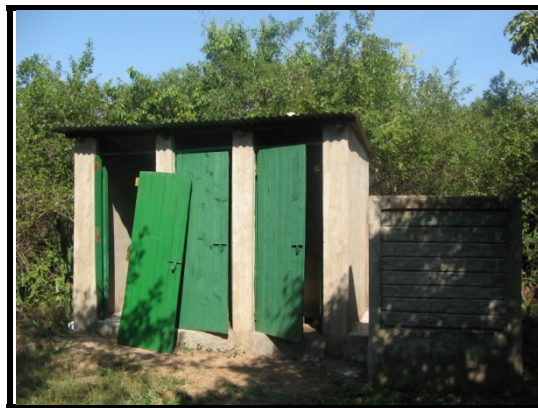
Plate 24 : Toilet door at ablution block in need of repair

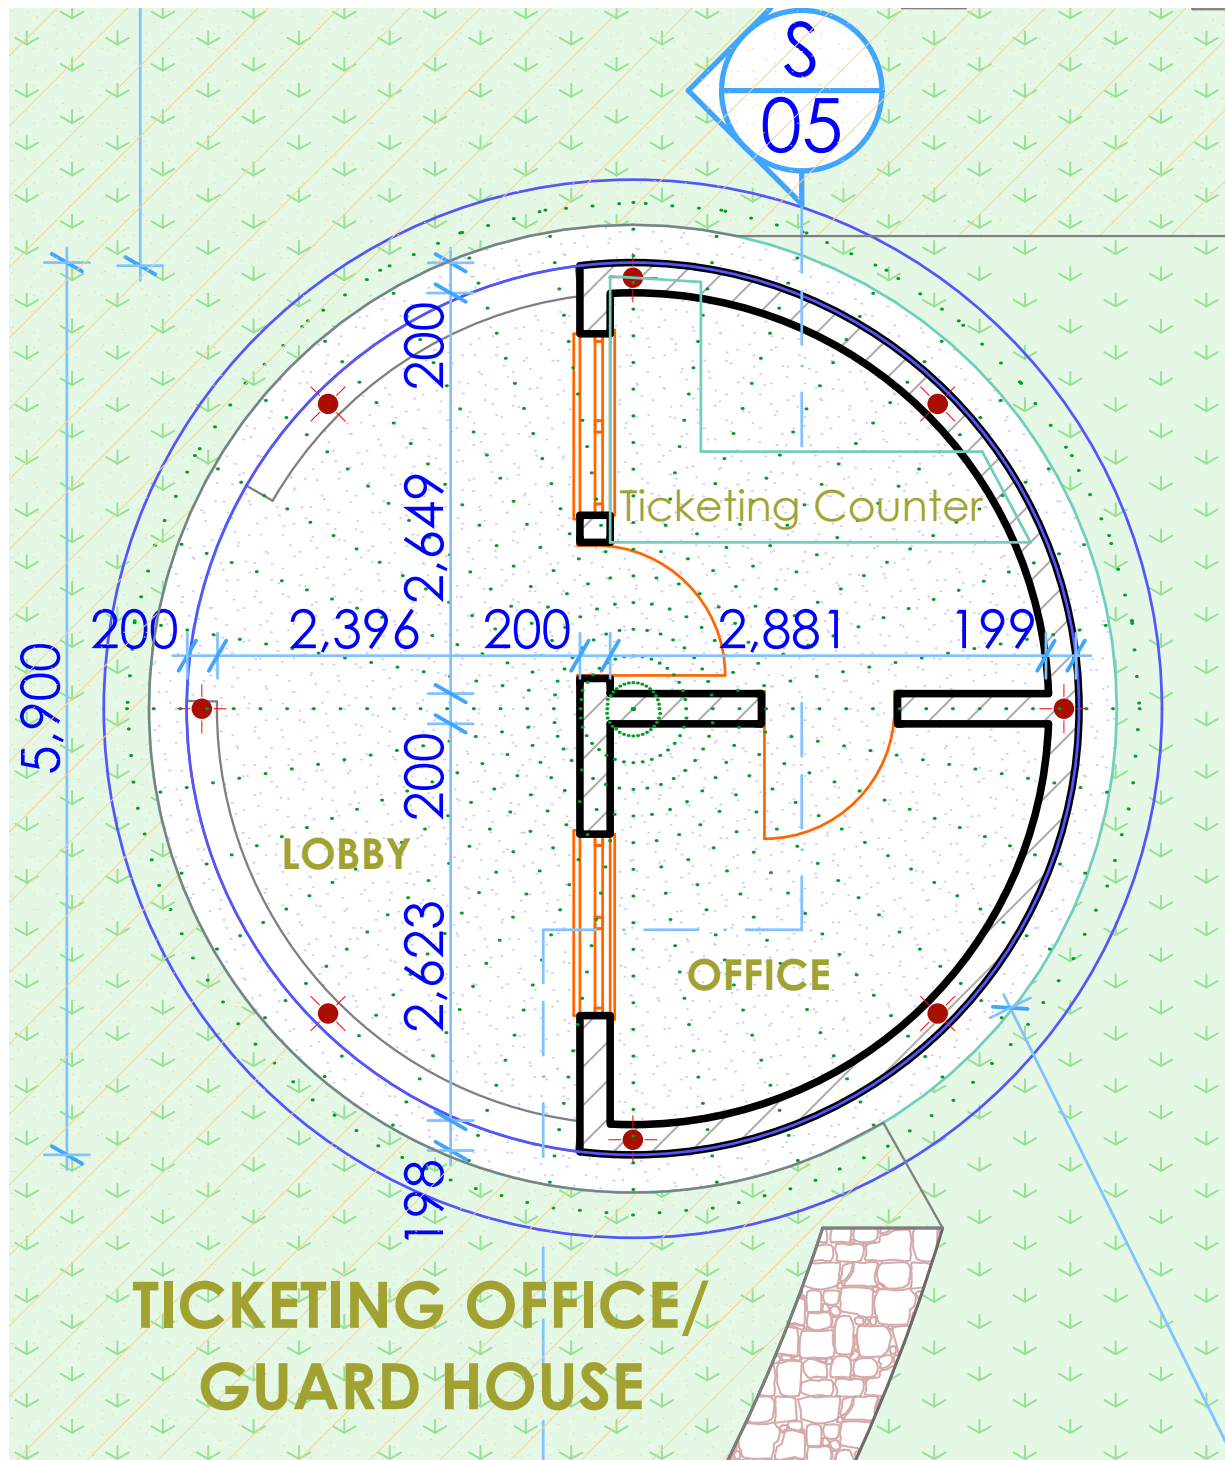
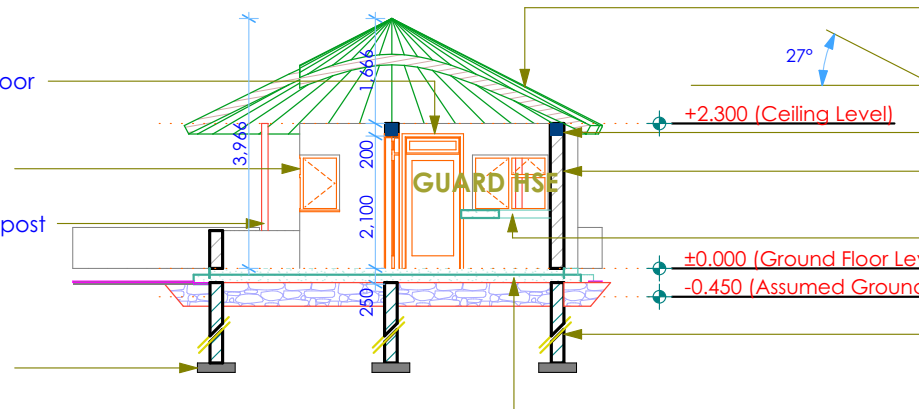
SECTIONAL ELEVATION S/05

ROOF PITCH = 27.0 Degrees

Pre-painted GCI sheets roof covering
on timber trusses

600x200mm thick r.c strip foundation

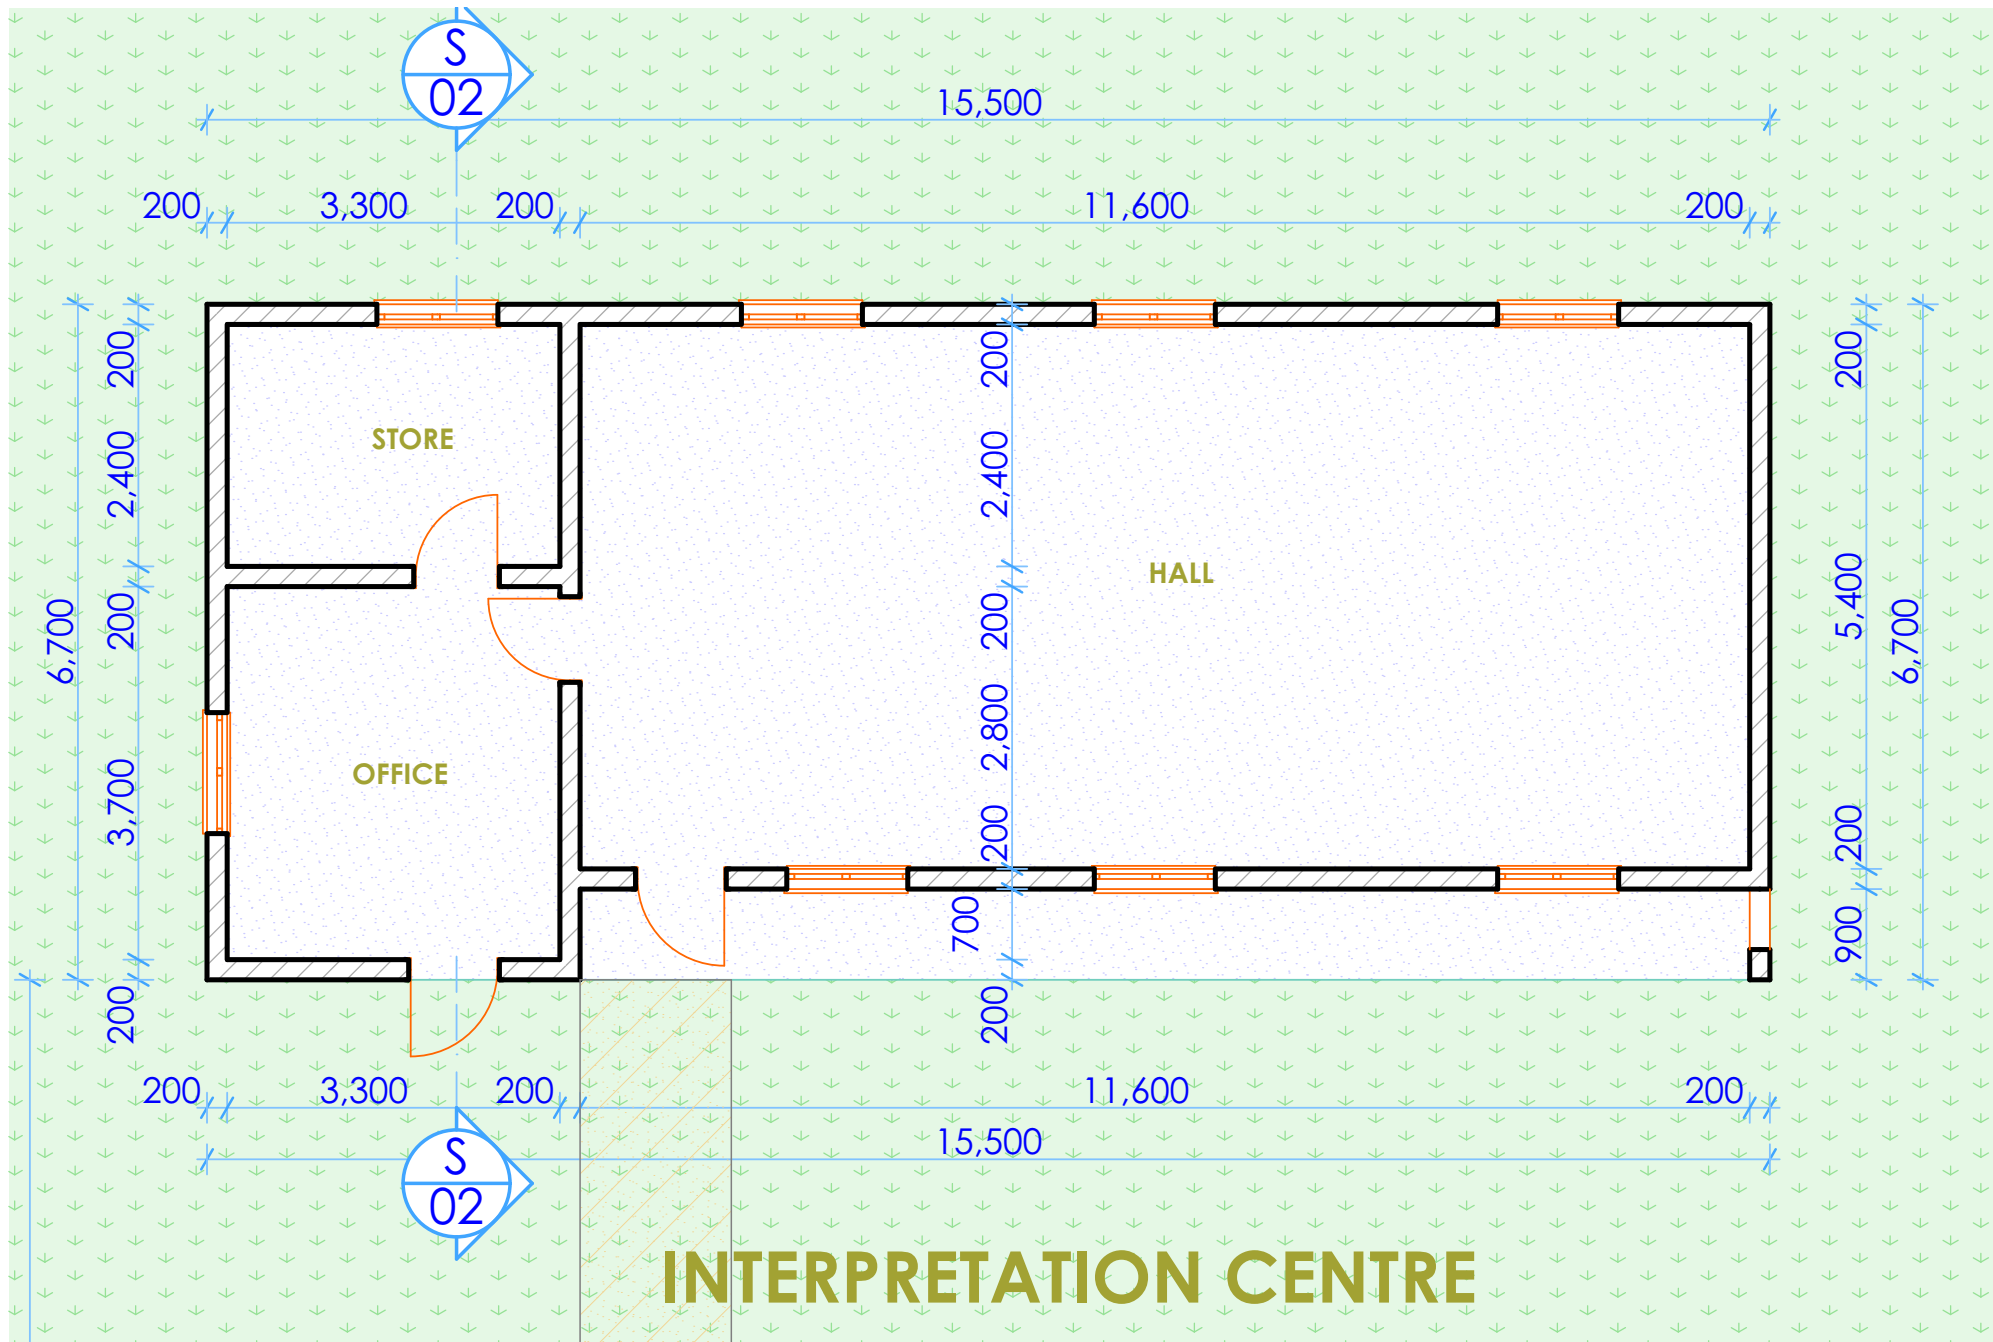
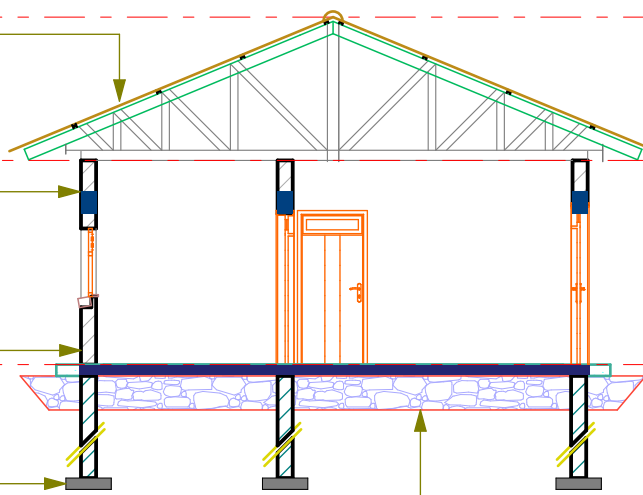
Roof pitch = 25 degrees

Pre-painted galvanised
iron sheets on timber trusses

150mm thick concrete floor slab reinforced with
BRC A142 mesh on 50mm thick blinding
on 300mm well selected and compacted hardcore fill

+4.820 (Roof Level)

+2.850 (Ceiling Level)

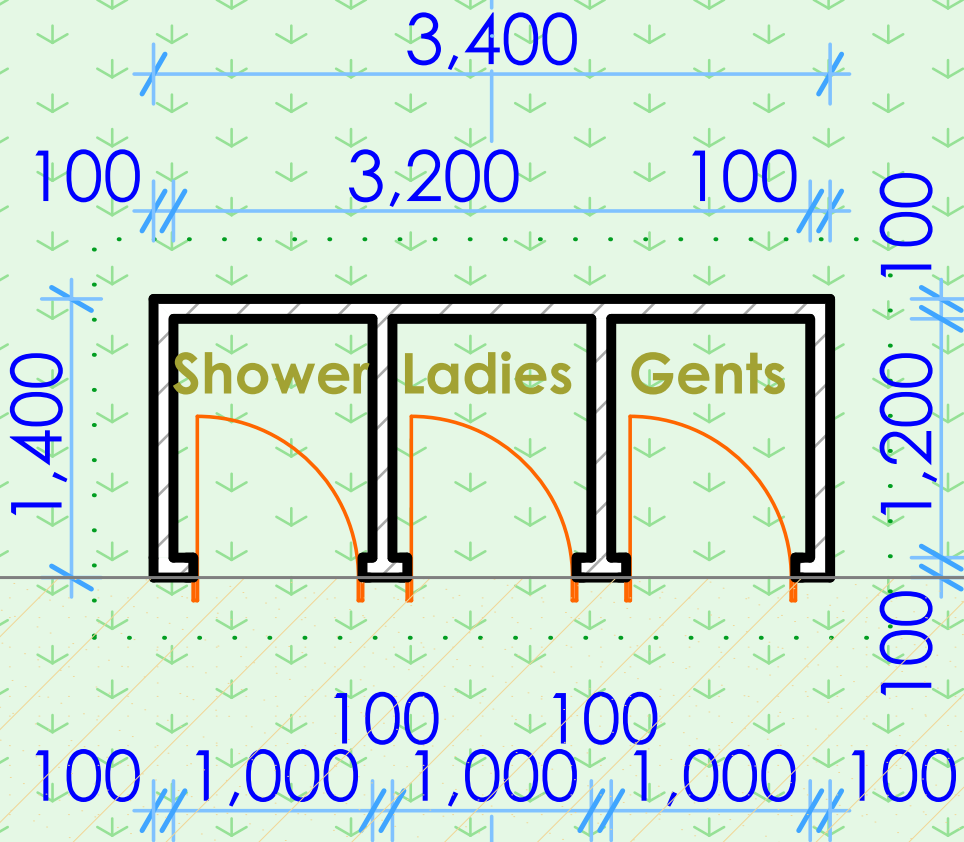
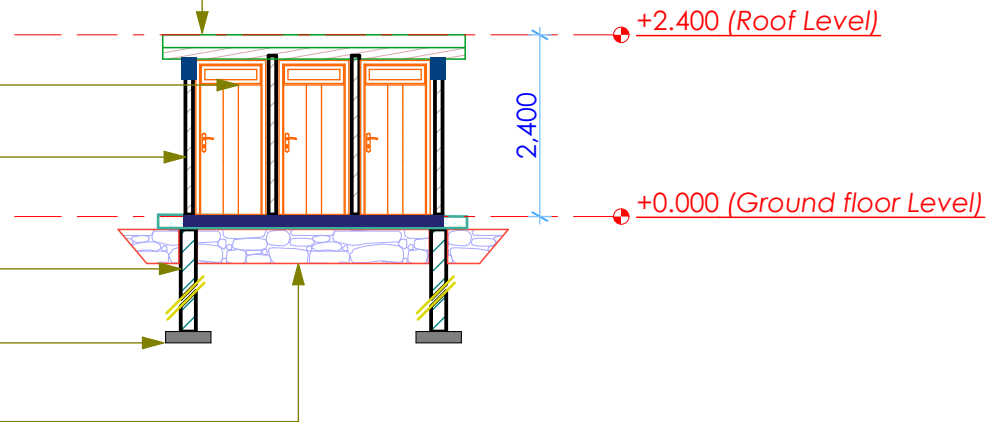
SECTIONAL ELEVATION E/03

150mm thick concrete floor slab reinforced with
BRC A142 mesh on 50mm thick blinding
on 300mm well selected and compacted hardcore fill

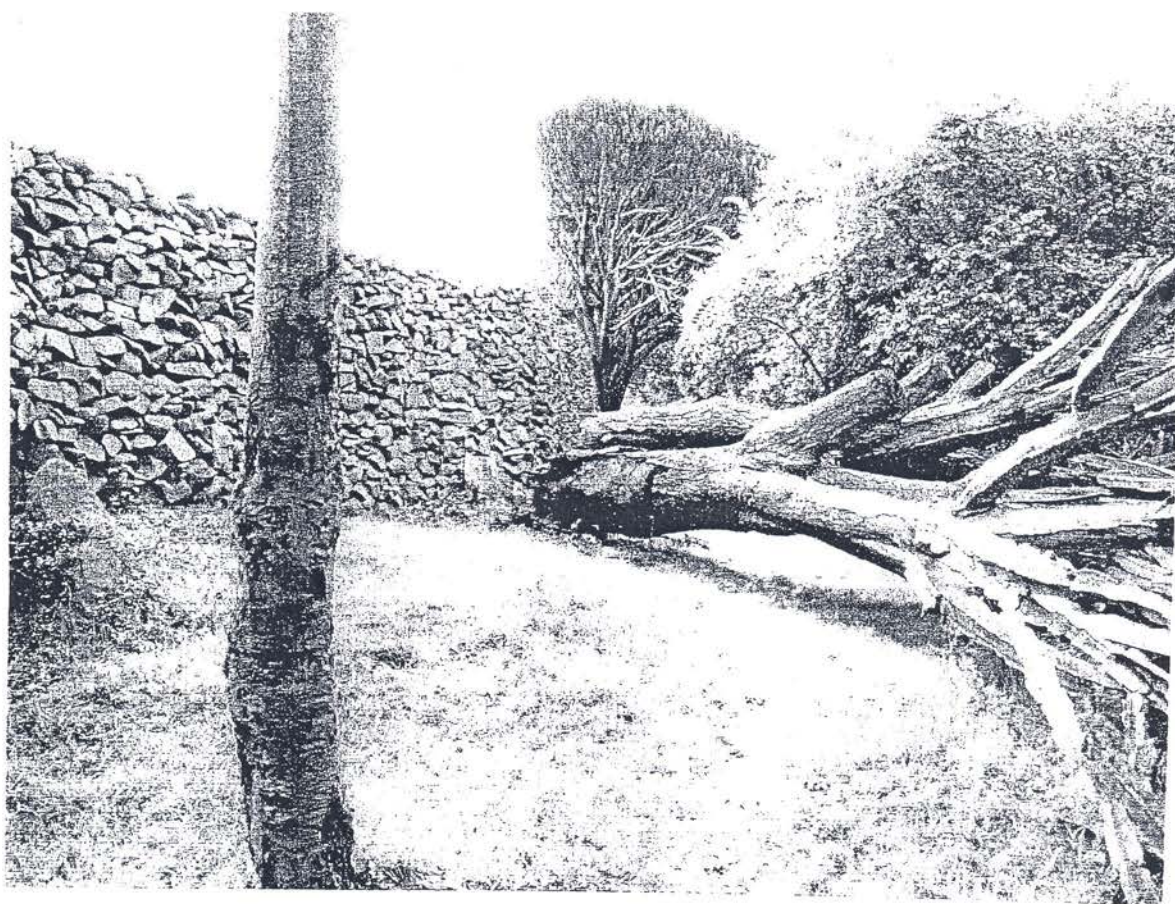
Image 5. Storm-fallen Tree at Thimlich Ohinga; Note Controlled Vegetation around Walls (Photo by Edward M. Luby)

There is a problem of vegetation encroachment. The trees render the walls unsteady and if they remain unchecked they may cause the deterioration of the walls. However, those that tend to grow nearest to the walls are periodically removed as a conservation measure. There is also a problem of the stones on the walls being loosened and falling due to the activities of monkeys. The staffs at the site have been trained to replace them when this occurs.

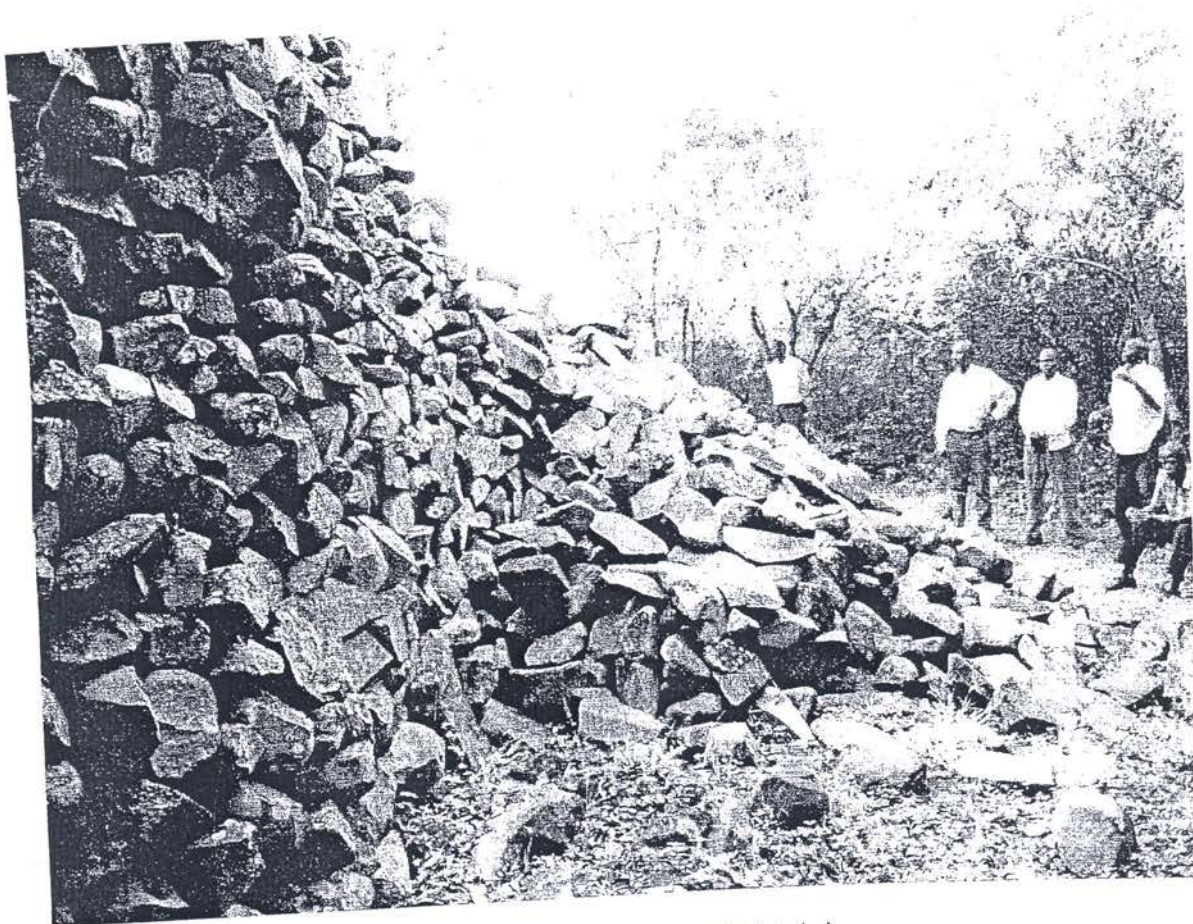
Image 7. Damaged Wall at Thimlich Ohinga (Photo by Edward M. Luby)

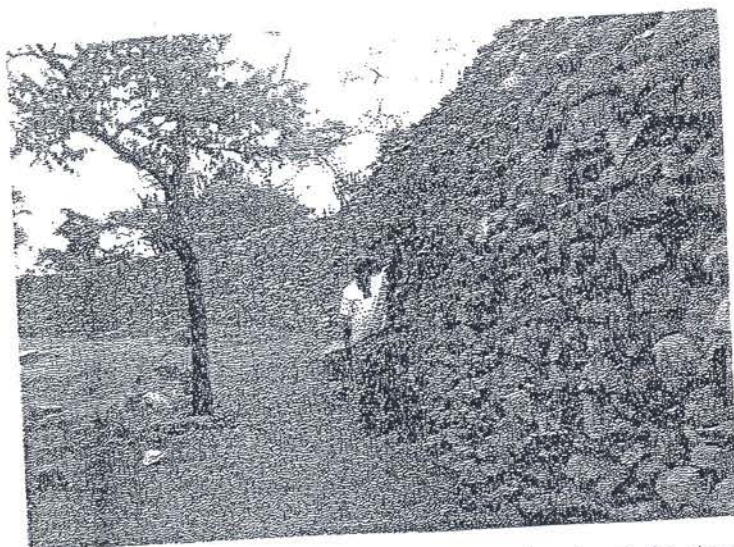
Enclosure wall with buttress. External walls range in height from 0.5–4.2m, with a thickness of 1m. They were made of loose stone without any dressing or mortar, and care must have been taken to ensure their stability.

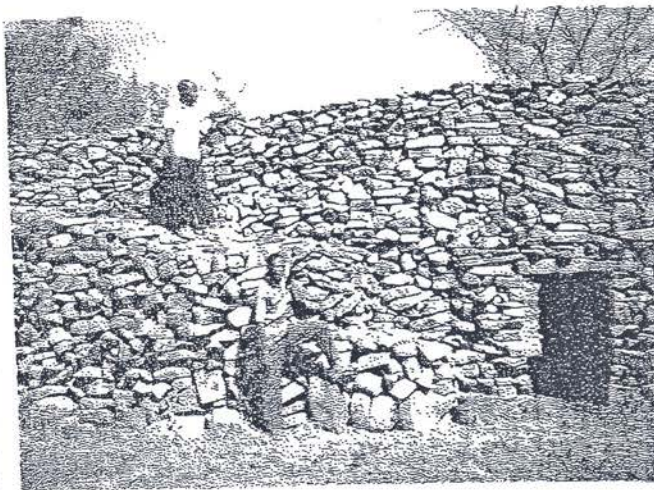
Built for defence: view from inside the enclosure, showing low entrance gate and watchtower. All enclosures are situated on hilltops.

with buttresses, which add to the enclosures' general stability. In Northern Nyanza, architectural features* such as rock pillars, stone linings, natural wall defence utilising the steep face of the hill, and piled rocks constitute the wall of the enclosures.

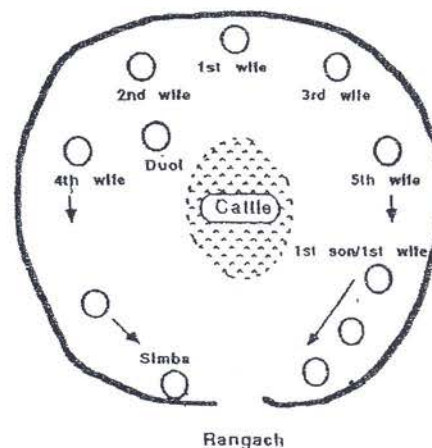
A typical Luo homestead. The layout of traditional Luo homesteads reflects the general organisation of space found in ohingni.

The arrangement of huts in a Luo homestead mirrors that of the stone walled enclosures. The alignment of huts next to the fence conforms in pattern to the circular house depressions within stone walled enclosures such as Thimlich Ohinga. The conformity between the ideal Luo settlement layout and the organisation of space in ohingni is
