Report of the UNESCO/ICOMOS/ICCROM Advisory mission to Rock-Hewn Churches, Lalibela (Ethiopia)

20 – 25 May 2018

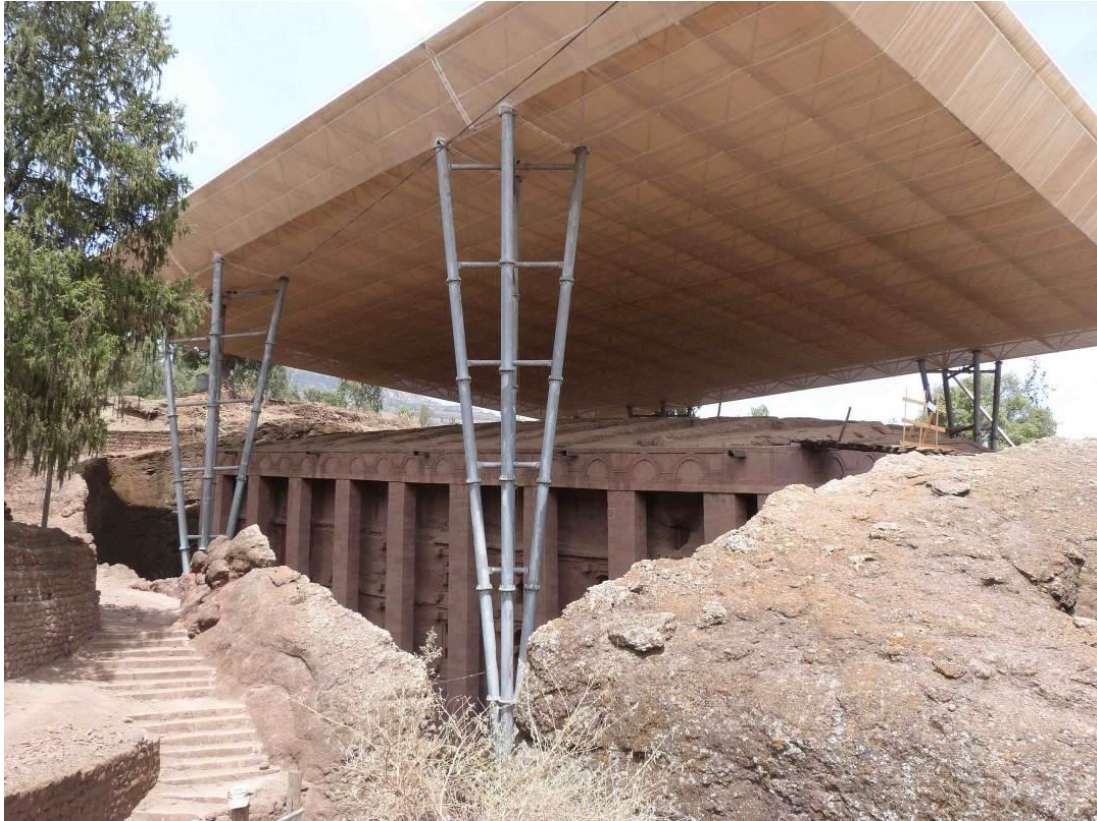
Figure 3 - Modern shelter for Biete Medhane Alem erected in 2007

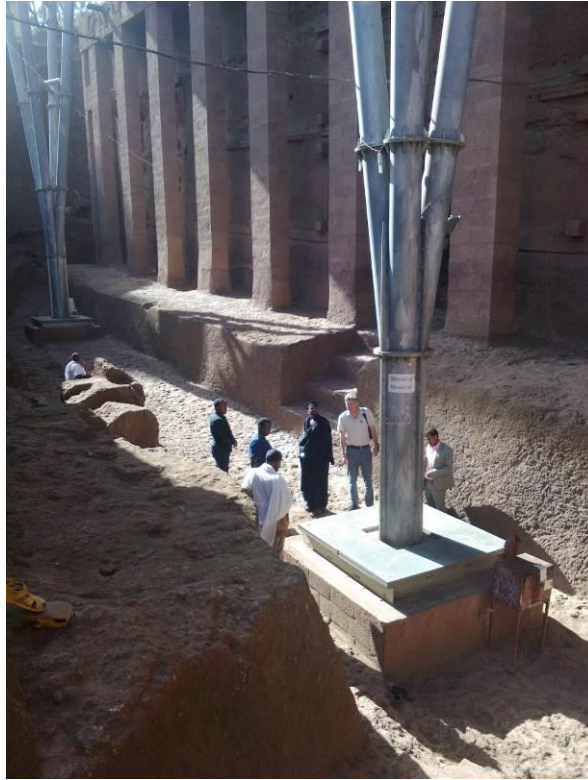
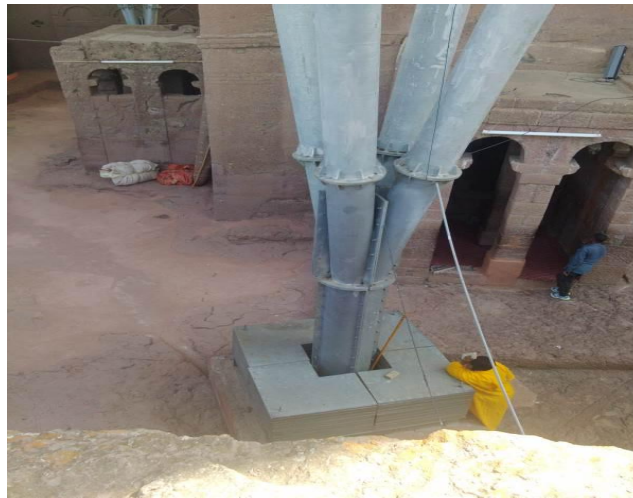
Figure 8 (a/b) – Pylons composed of individual parts bolted together and used to support the shelter construction

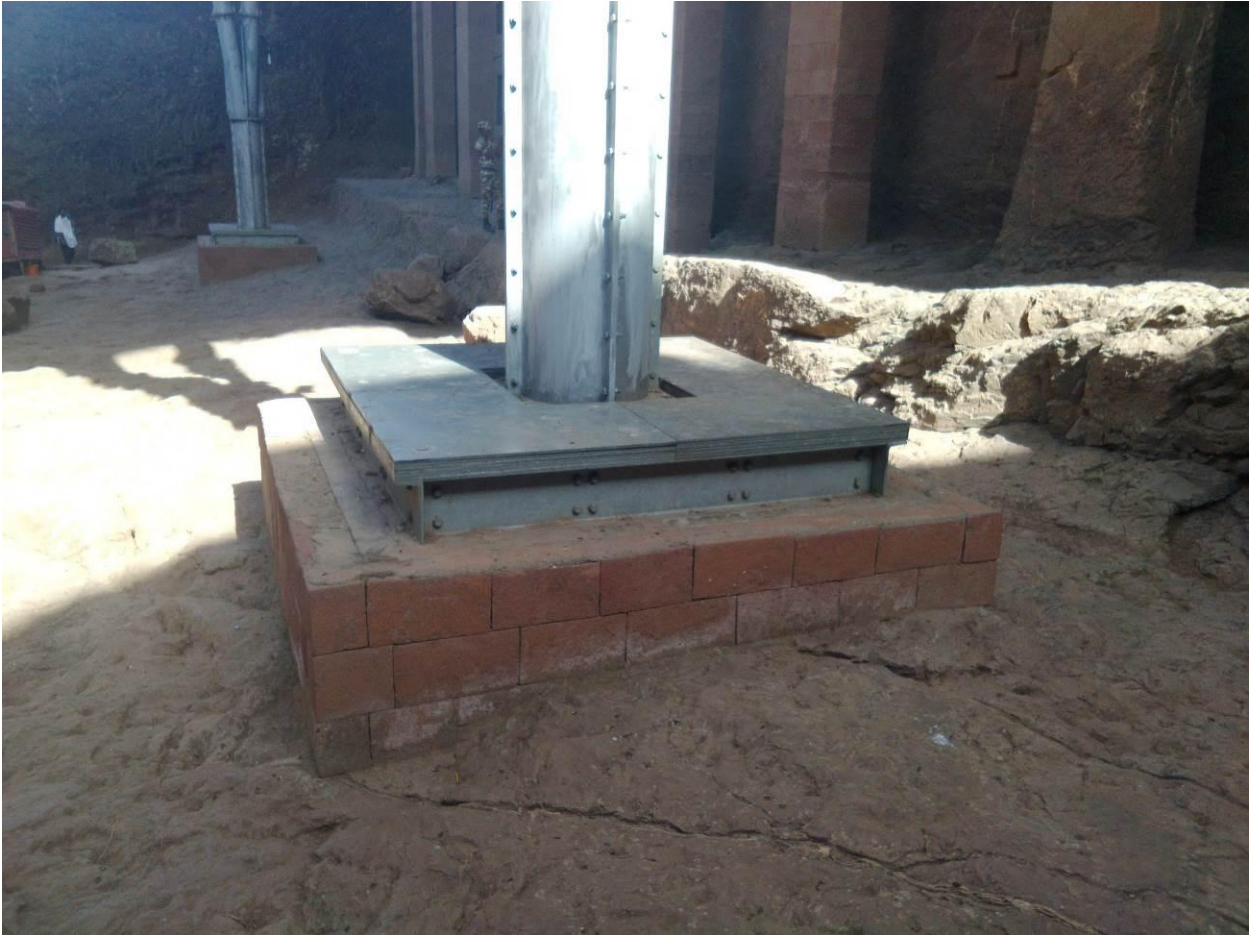
Figure 9 - *Detail of pylon foundation with metal ballast plates*

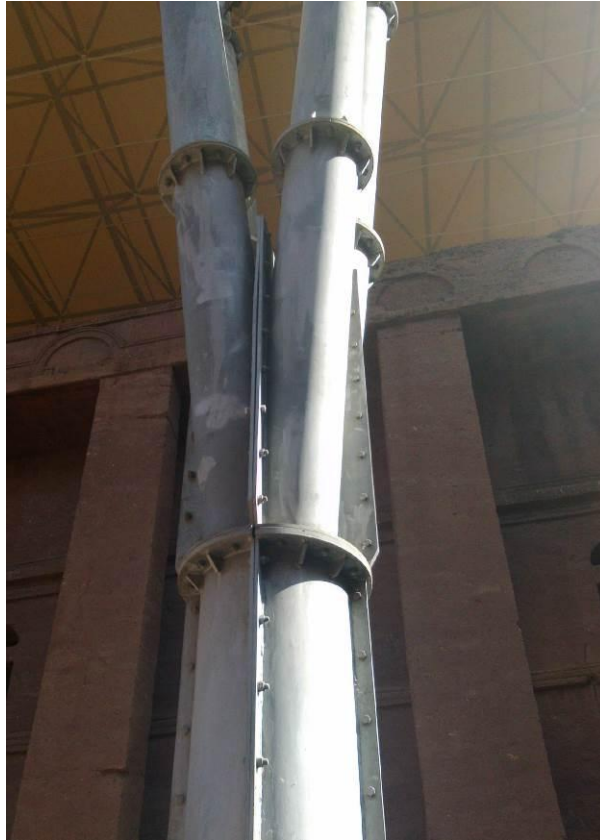
Figure 10 -Upper joint of a pylon at Biete Medhane Alem

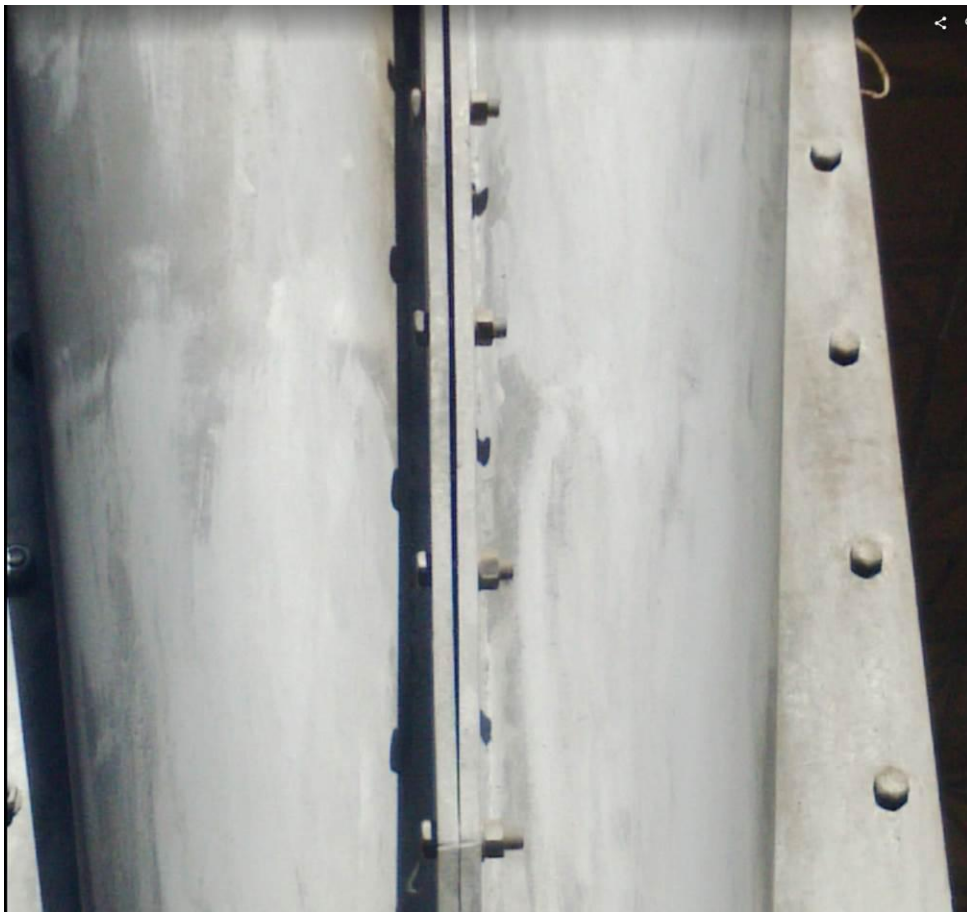
Figure 11 -Detail of upper joint of pylon showing example of the joint opening between individual tube parts

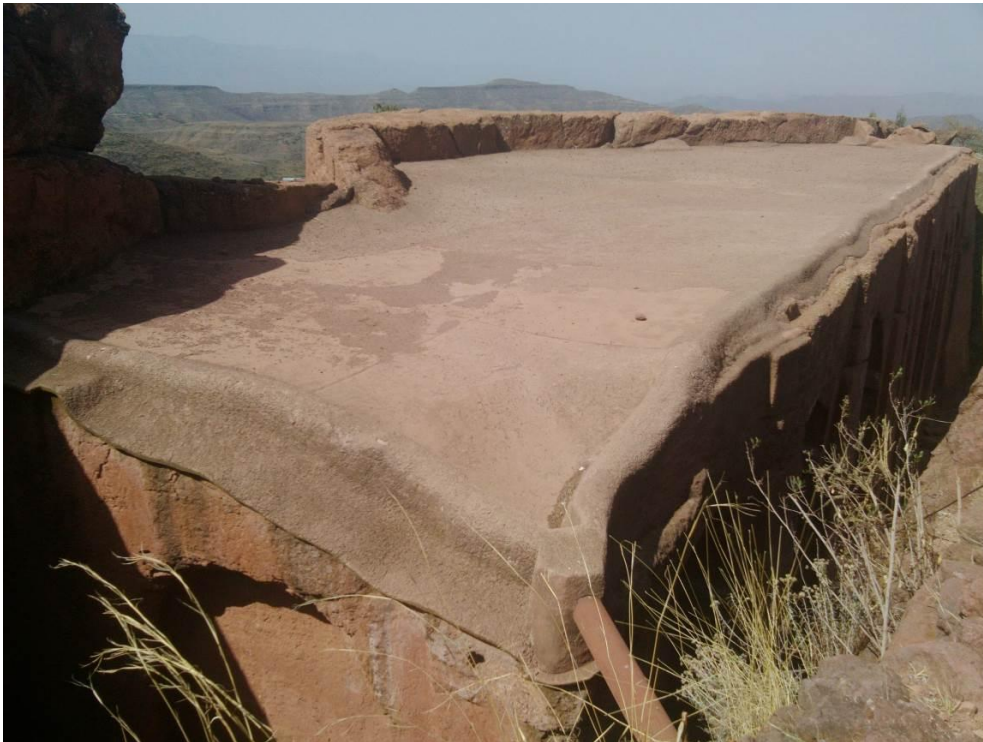
Figure 13 -Roof of Biete Gabriel re-covered as part of the conservation programme of works completed in 2016 by World Monuments Fund and Studio Croci

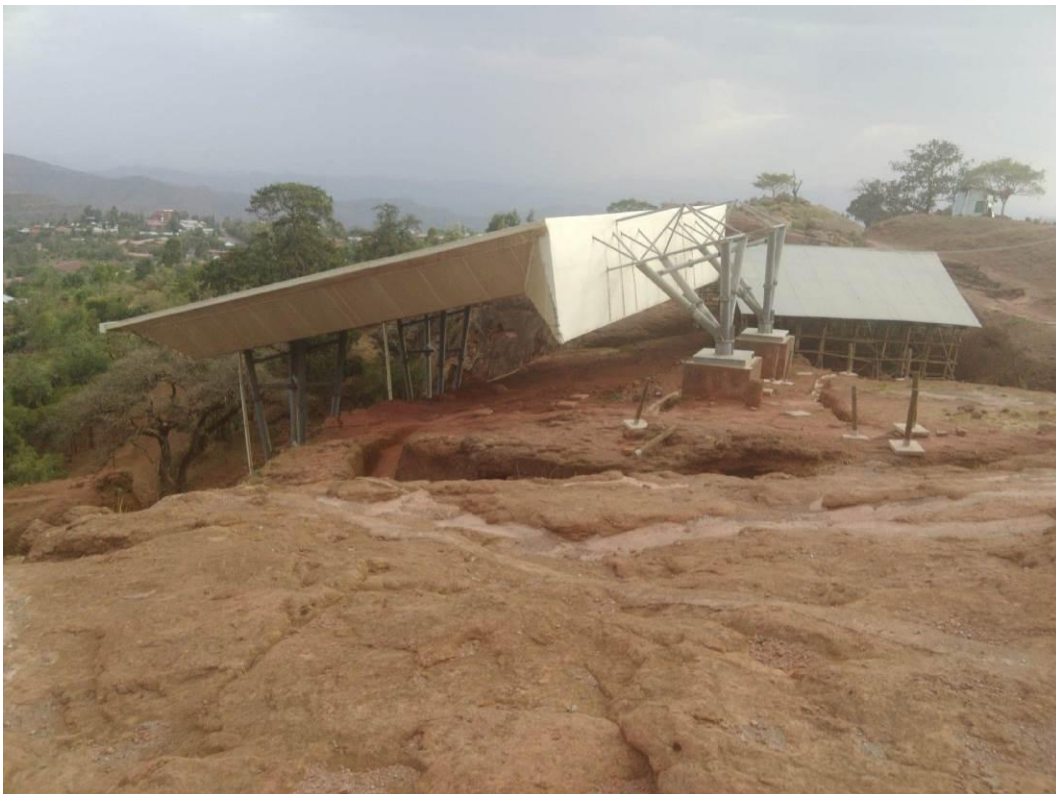
Figure 15 -View of shelter over Biete Libanos from the upper side; note the slope of the topography directing surface waters towards the cliff's edge

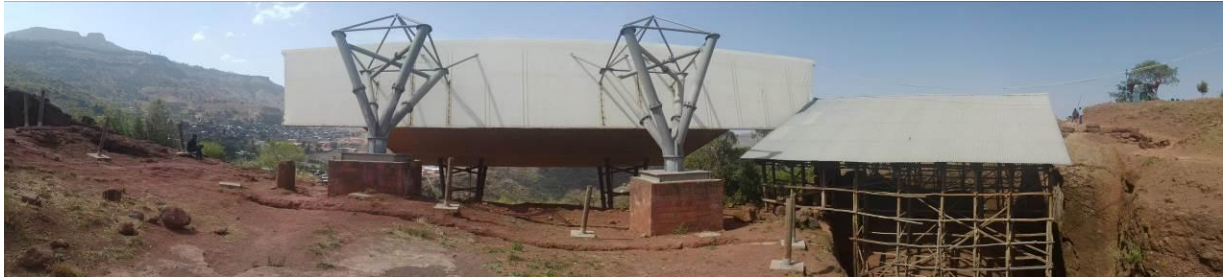
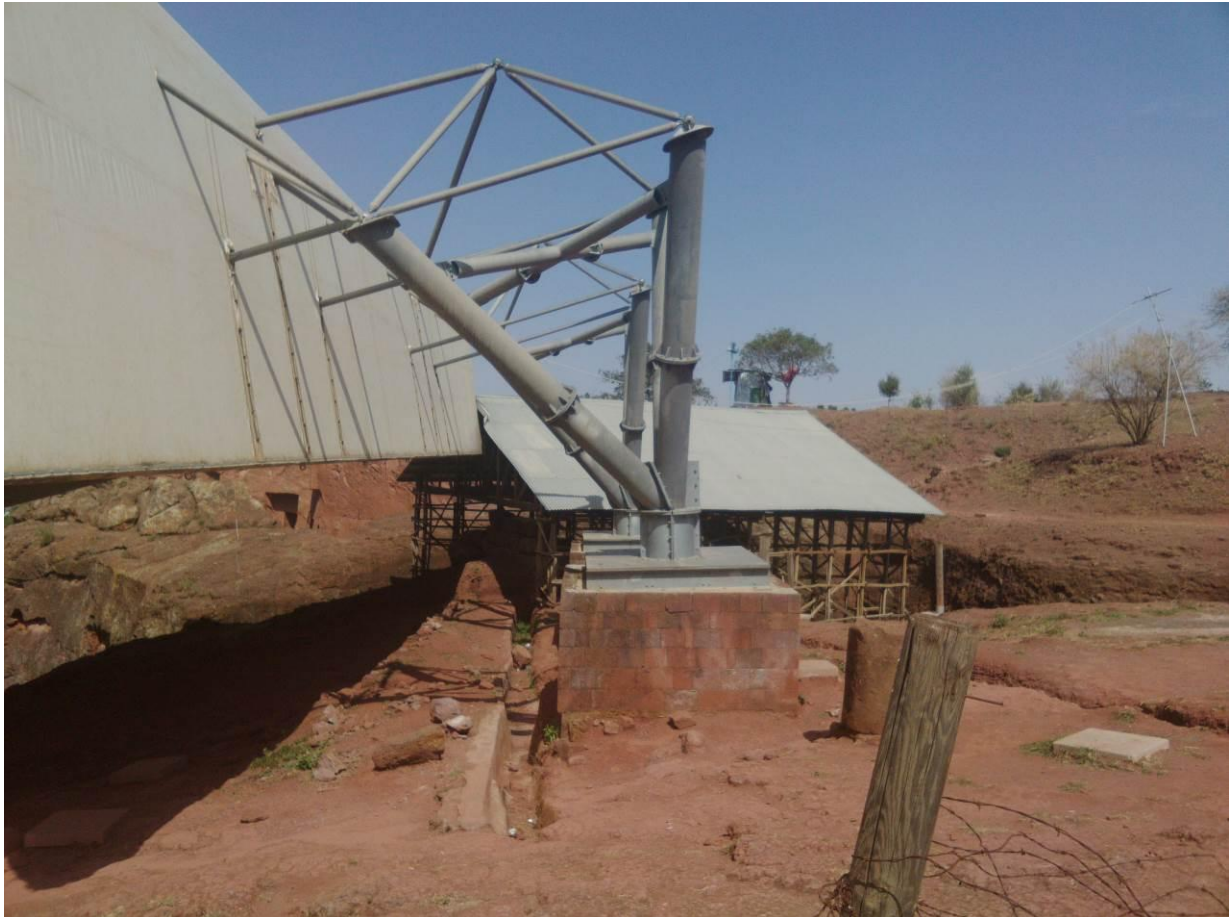
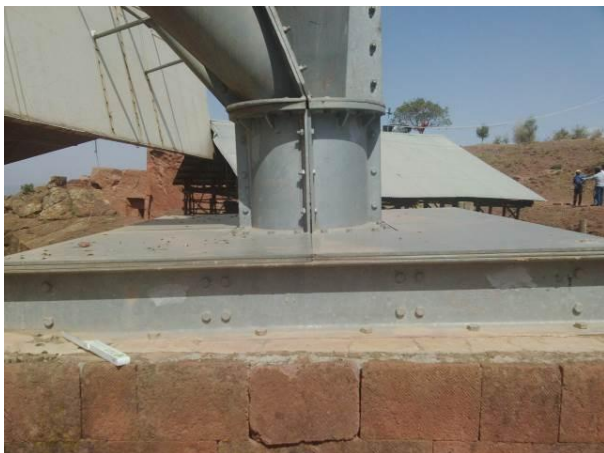
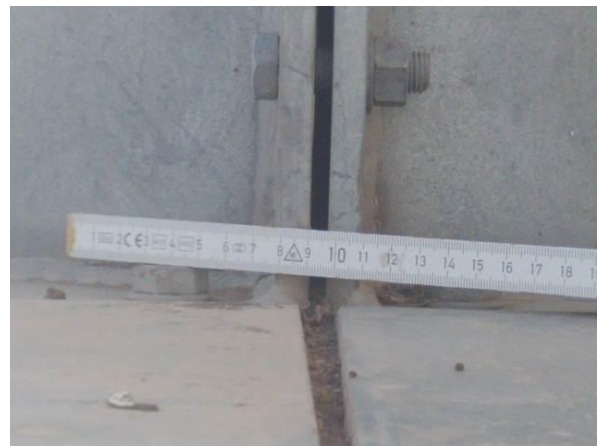
Figure 16 - (a/b/c/d) - View on the upper foundation of the shelter over Biete Abba Libanos from different angles; the roof is too short to properly drain into the (cement) lined channel and conduct of surface water is uncontrolled; some joints of the tuff stone cladding from the concrete foundation are loose, and there is an observable widening of 8mm of base steel-tube element. It is unclear if this widening has occurred during the last ten years or if it has been there from the beginning of the construction phase.

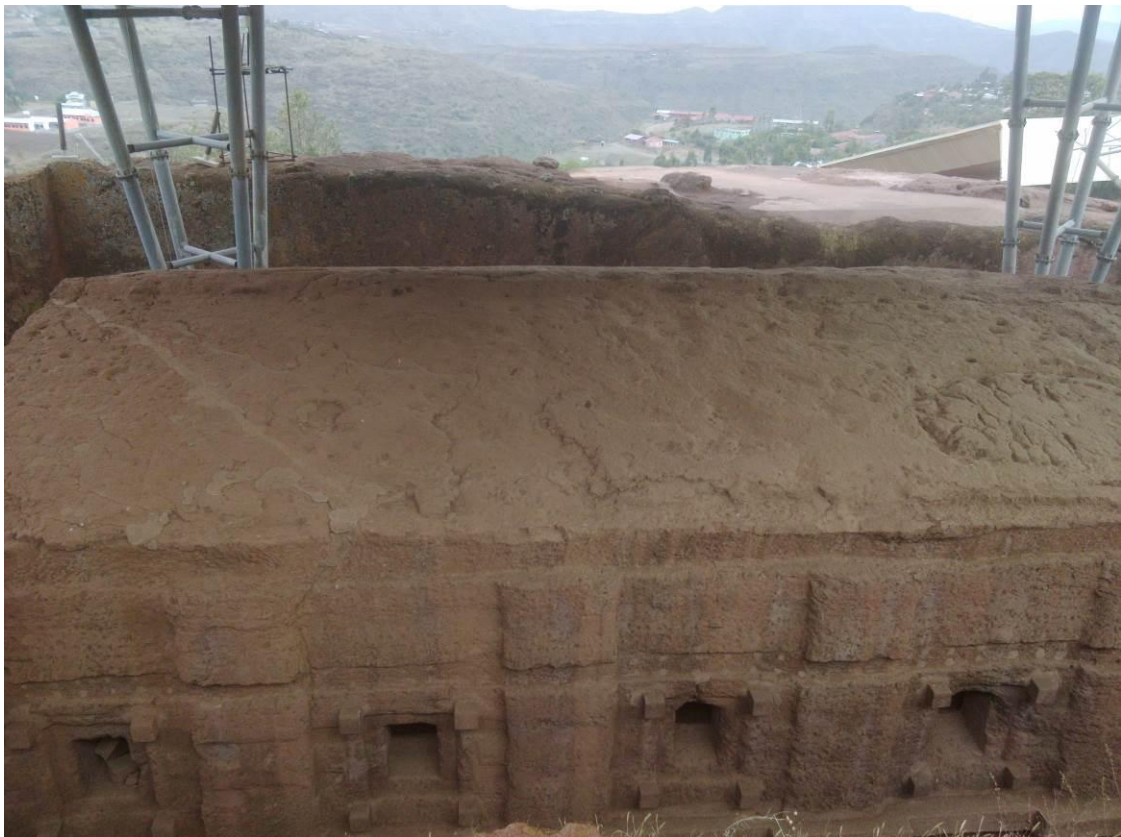
Figure 18 -Detail of roof of Biete Amanuel showing dry, dusted, fragmented surface

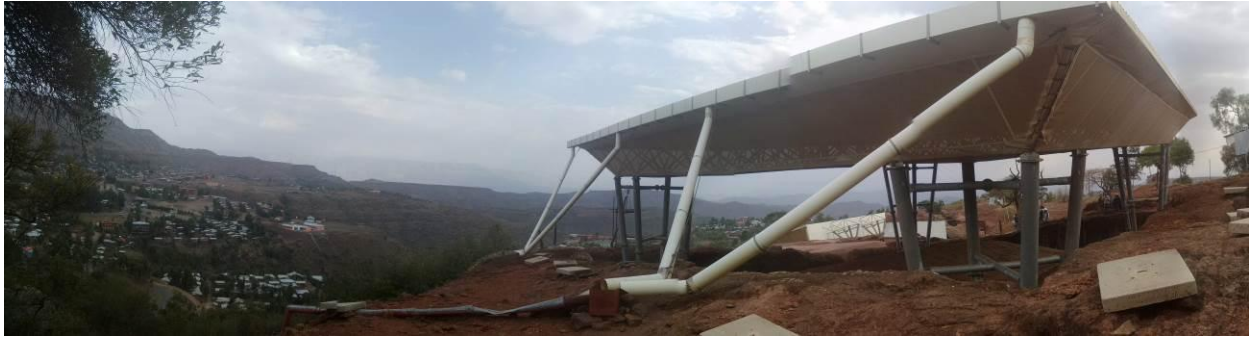
Figure 19 -Unmaintained drainage system from the shelter over Biete Amanuel

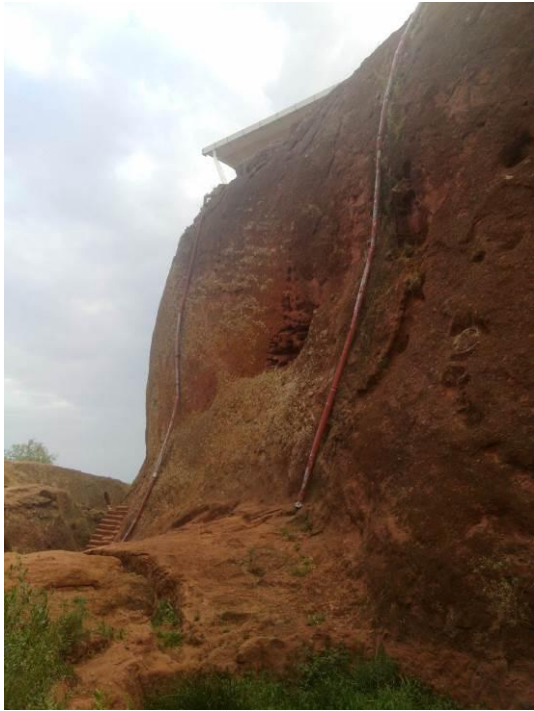
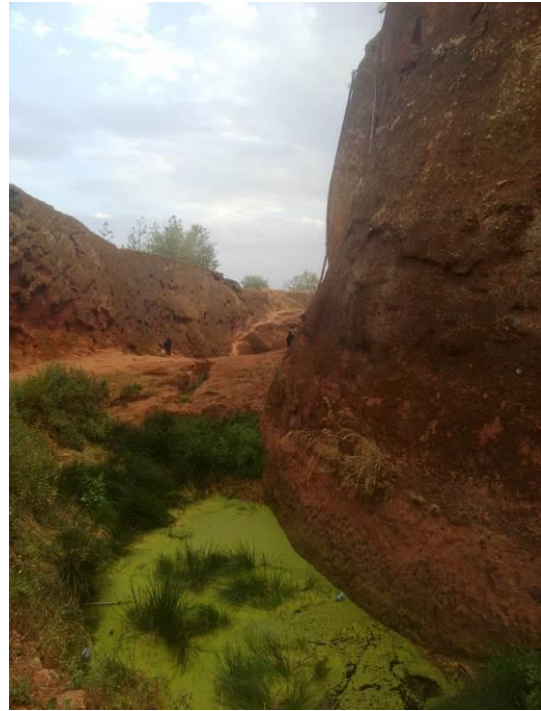
Figure 20 - (a/b) - Water conduct of drainage system from Biete Amanuel and irregular topography of passage ways leading to artificial ponds that do not drain long after rainy season

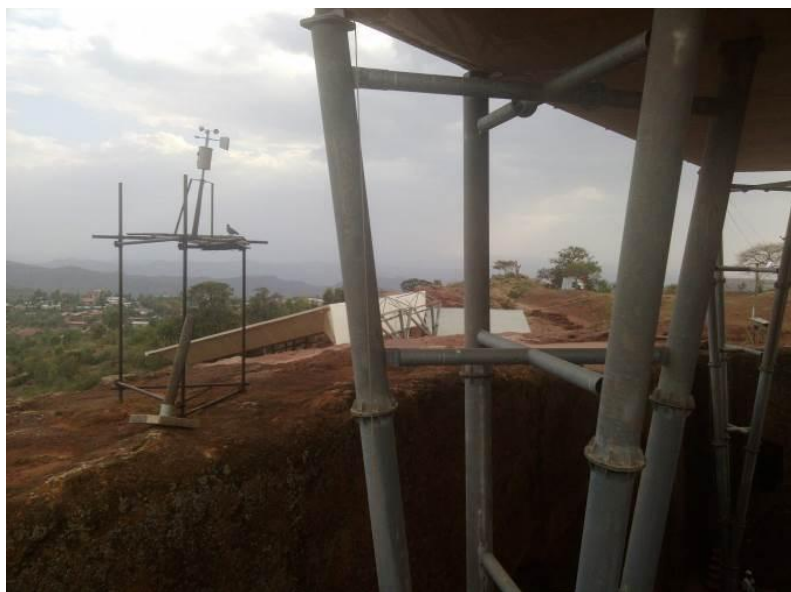
Figure 21 -Weather station not in use and now posing a visitor risk due to rotten planks on which it is mounted

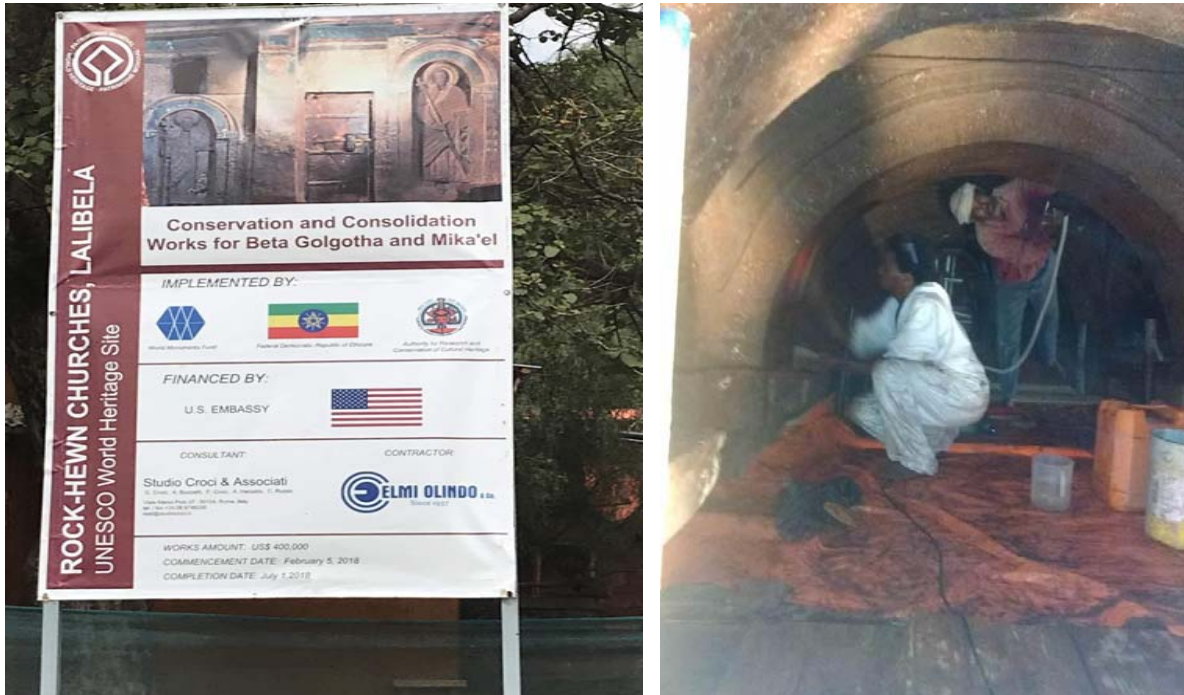
Figure 22 - (a) - Recent conservation work (ongoing) implemented in partnership between Ethiopian authorities and World Monuments Fund and financed by the US Ambassadors Fund – (b) Details of surface cleaning works being carried out as part of the current conservation programme at Biete Golgotha Mikael

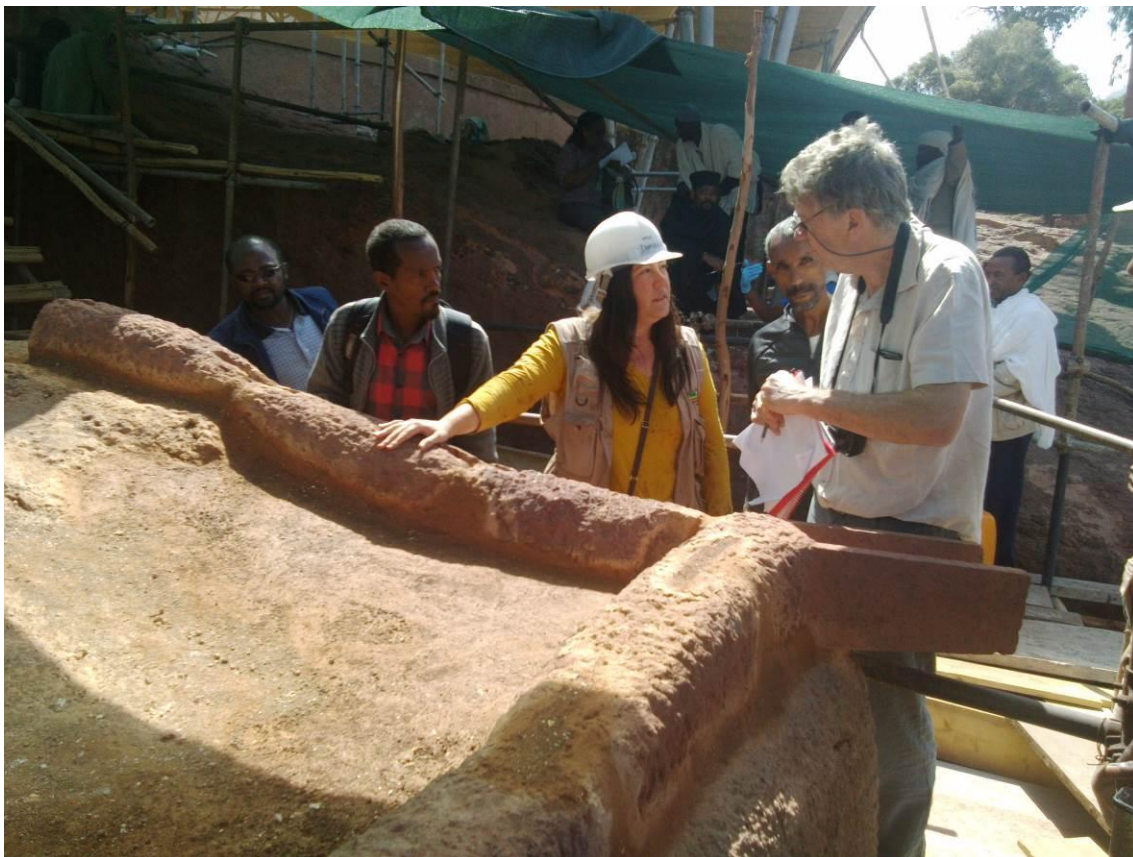
Figure 23 - Example of conservation works on the parapet with newly designed waterspout. During the construction period, all ecclesiastical and decorative elements have to be removed, and the church temporarily deconsecrated to allow secular activities. This process requires considerable time and preparation.

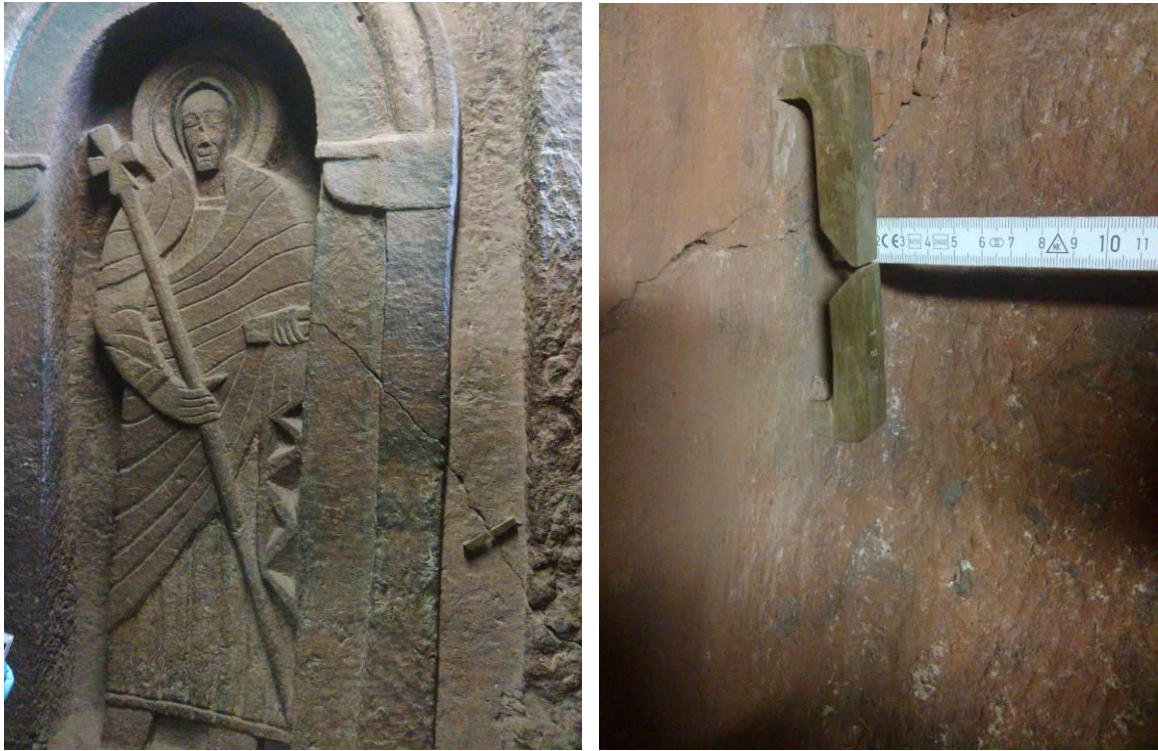
Figure 24 -Carved effigy in Biete Golgotha with one of the Angelini gauges inserted in 1968 to monitor the discontinuity in the rock; all inspected gauges in this area showed deformations of less than 3mm.

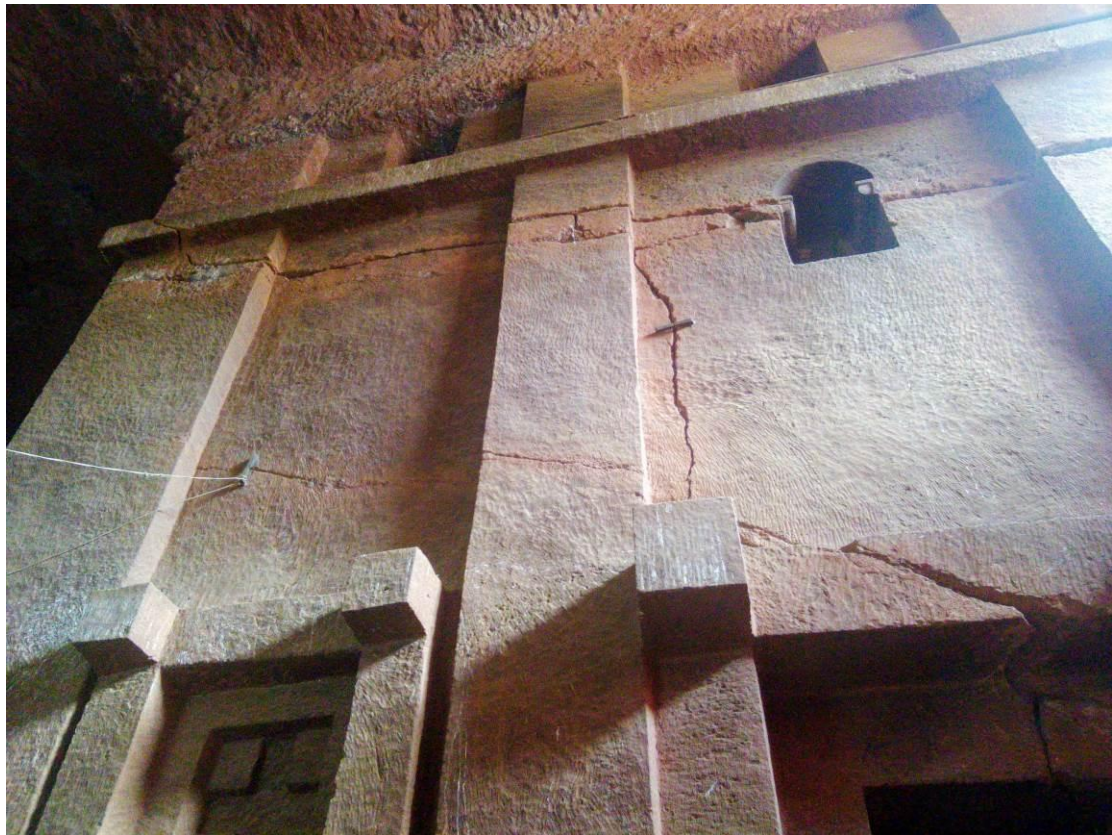
Figure 25 -Rock discontinuities on the side elevation of Biete Abba Libanos; note the gauges installed by Angellini in 1968, most of these gauges require a ladder or some type of simple scaffolding for proper reading.

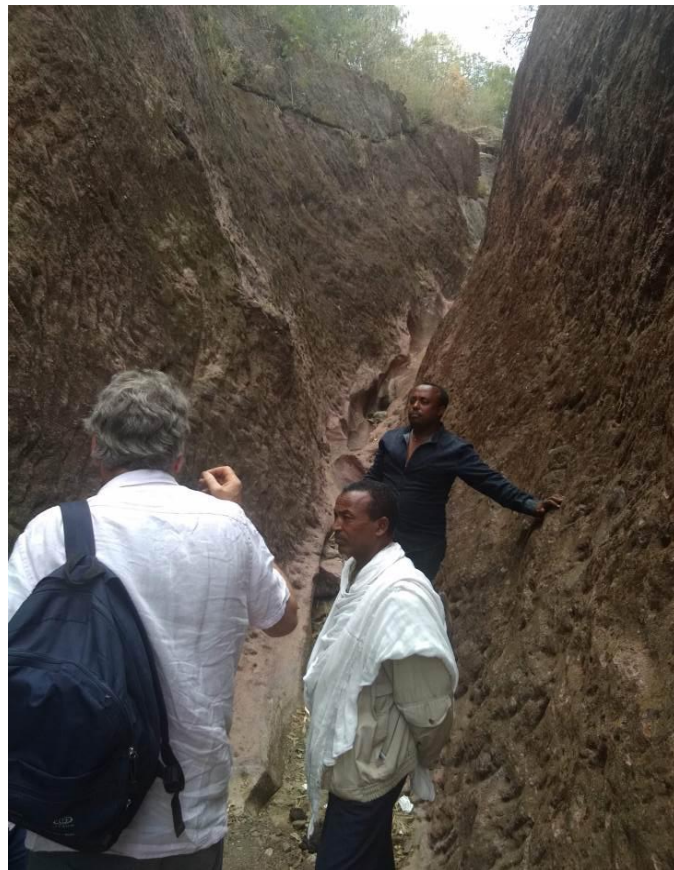
Figure 29 – Experts inspecting the original drainage ditches below Biete Ghiorgis. The function of this system is not fully investigated and understood. Its complete excavation has been suggested in previous reports, resulting in the creation of cavities that capture water in some areas instead of draining it. Excavations of these systems require topographical and archaeological study to evaluate the extent to which the “original” shape (considered to be the native rock bed) is suitable for drainage purposes.

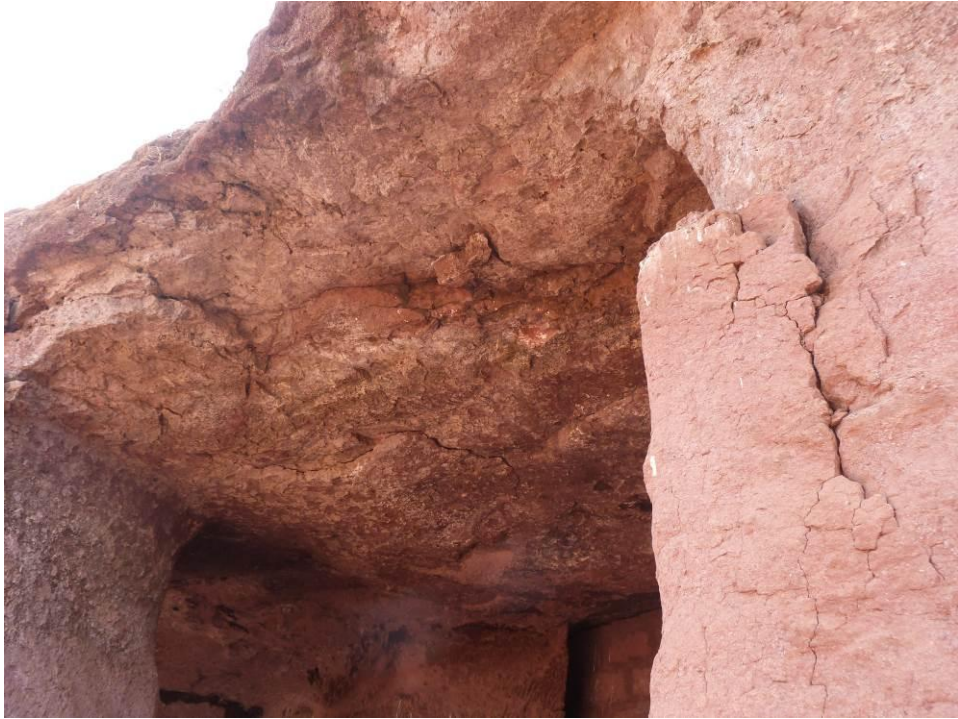
Figure 30 -Example of decayed stone prone to detachment in Biete Mekerios

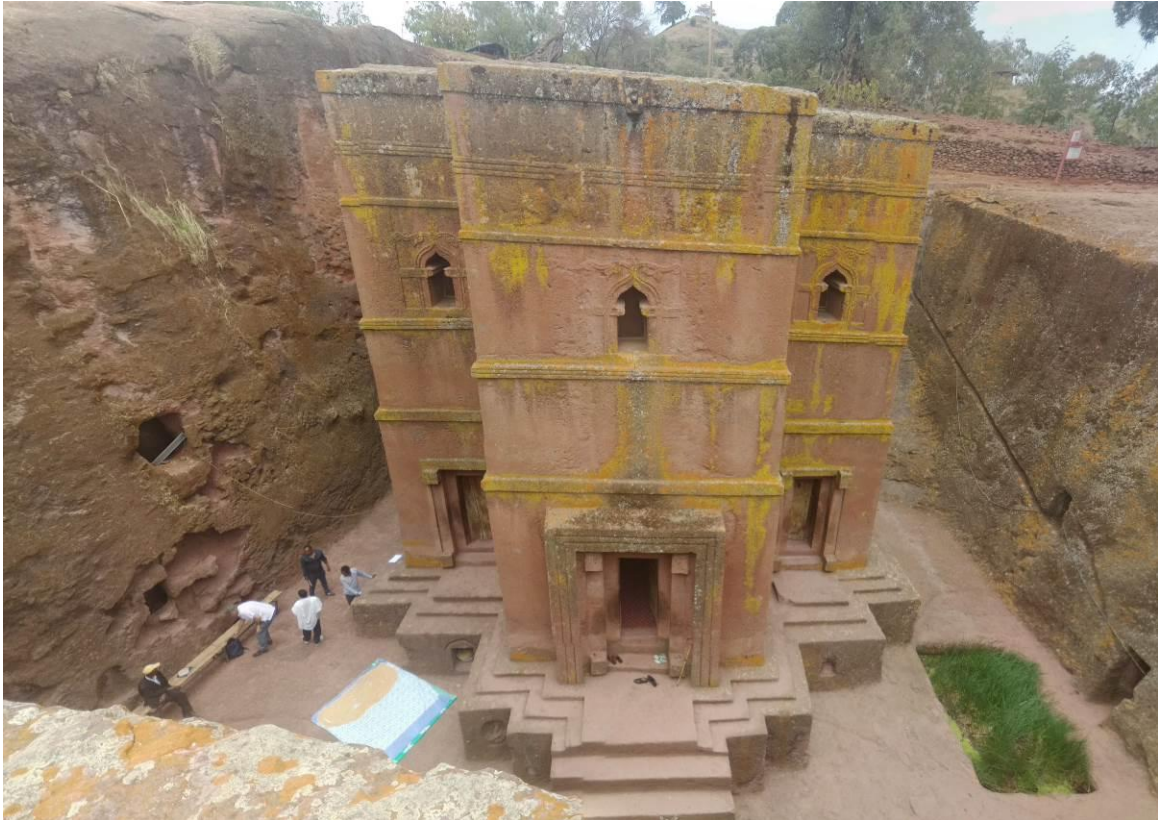
Figure 32 -General view of Biete Ghiorgis most iconic of all eleven churches. *Its state of conservation is remarkably good compared with the other churches*

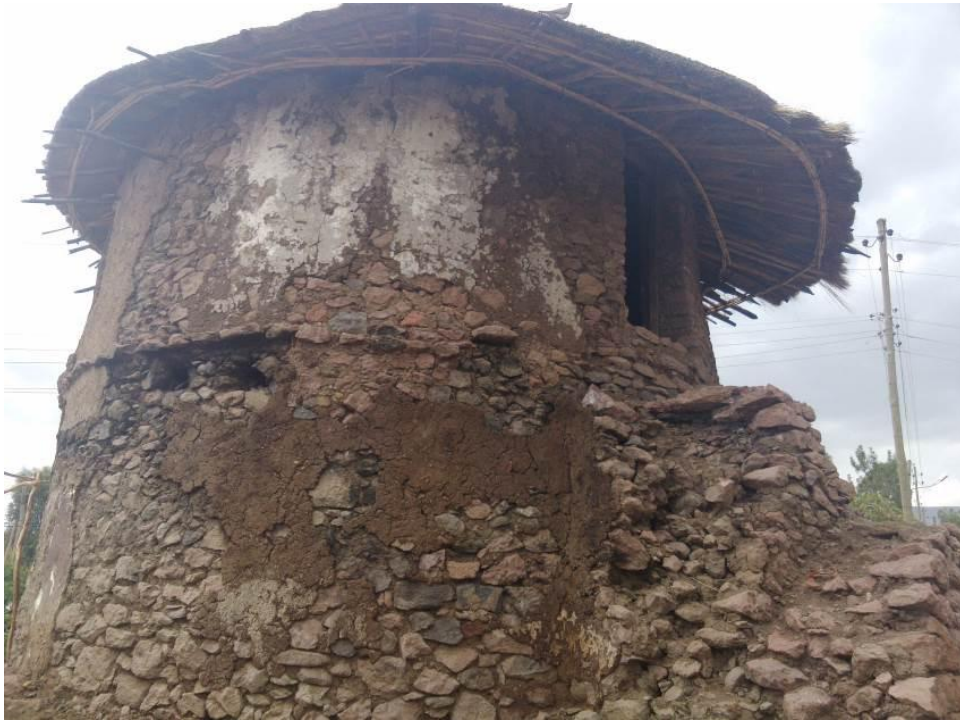
Figure 38 -*Dilapidating traditional "tukul" house construction; a comprehensive survey on the location and condition of the remaining houses is needed.*

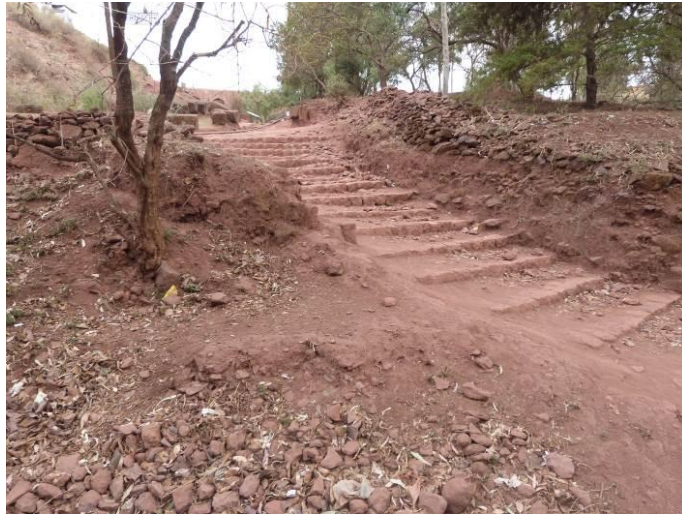
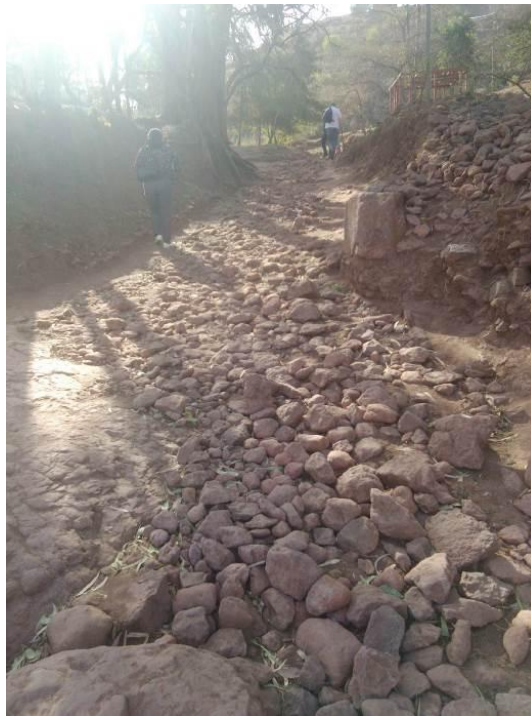
Figure 39 -Steps and pathway built as part of the World Bank project but no longer maintained in large areas
