Historic Ensemble of the Potala Palace, Lhasa (China) (707ter)  
Ensemble historique du Palais du Potala, Lhasa (Chine) (707ter)

REPORT on the joint  
World Heritage Centre/ICOMOS/ICCROM  
Reactive Monitoring Mission  
to the World Heritage Property  
“Historic Ensemble of the Potala Palace,  
Lhasa” (China)

08–14 April 2019

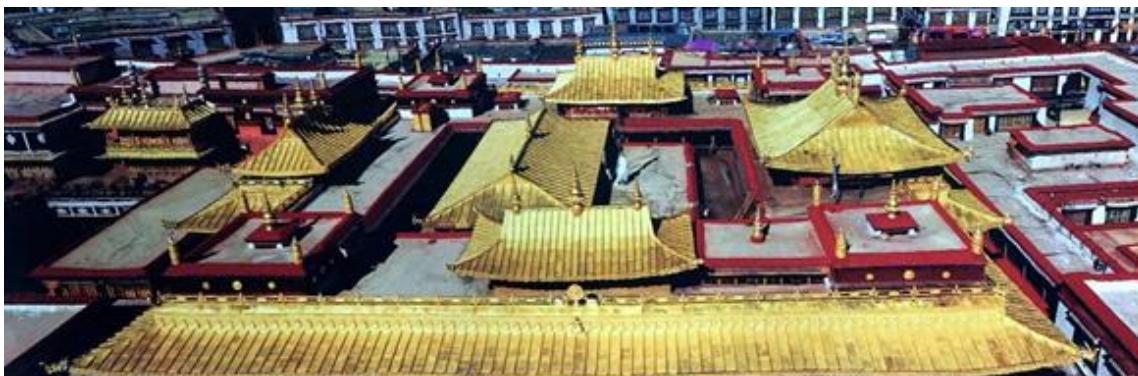
Figure 1 - The Golden Roofs of Jokhang Temple with the Ventilator Chamber at right. Jokhang Temple Management Committee.

The Ventilating Chamber of the Jokhang Temple Monastery is located at roof level (third floor) on the eastern end of the original temple complex, three stories above the 7th-century sanctum containing the Buddha Shakyamuni gilded bronze statue. The Ventilating Chamber is a wood, brick and earthen construction that serves to exhaust air from the interior of the temple. Each of the six major roof constructions at Jokhang is highly decorative, with painted external timber brackets beneath the eaves and gilded copper and/or bronze roof sheathing over wood sarking. The walls are crudely timber-framed, with brick and earth infill and an earth-plaster render. There is a dropped ceiling internally, formed of closely spaced roundwood joists with sawn lumber ceiling boards above them. Air enters the chamber via a small square opening (approximately 1.5m x 1.5m) in the centre of the earth floor and is exhausted from narrow openings immediately beneath the wall plates (above the exterior brackets); these vent into the eaves and are concealed by the decorative roof.

Collectively, the six structures shown in Figure 1 form the ‘Golden Roofs’ of Jokhang Temple. These are highly significant and character-defining aspects of the building (the Ventilating Chamber is the wider roof visible at the right side of the image).

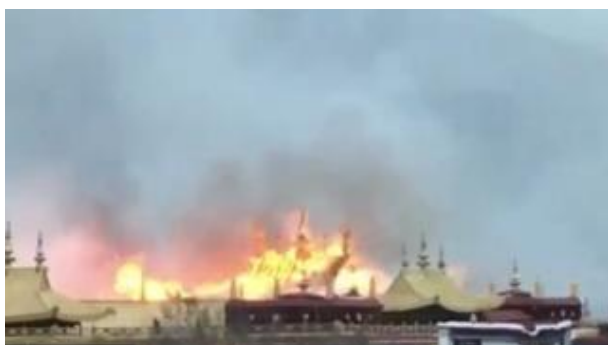
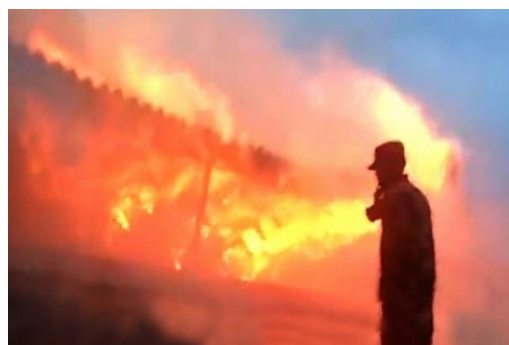
Figure 2 - Fire at Jokhang Temple on the evening of 17 February 2018. Source: Twitter.

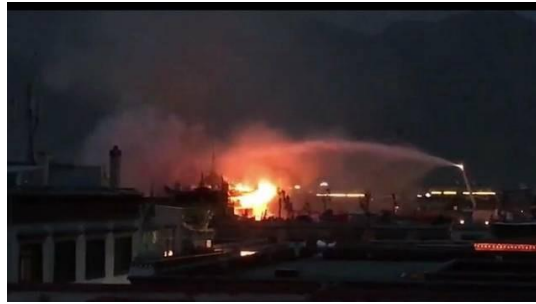
Figure 3 - Aerial firefighting at Jokhang Temple. (NB: sunset on 17th February 2018 was at 19:45.) Source: Twitter.

Images posted on social media suggest the fire burned for several hours and well into the evening (see Figures 3 and 4). Firefighters fought the blaze using a combination of portable extinguishers indoors, and aerial equipment from street level outside (see Figure 4). The fire was extinguished before the morning of 18 February, and fire crews then dismantled the remaining roof structure of the Ventilation Chamber to prevent debris from falling onto the floors below.

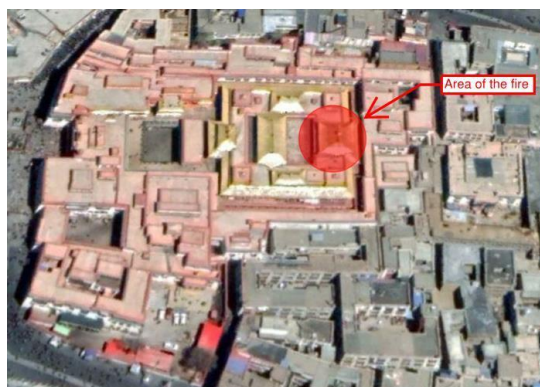
Figure 4 - Aerial view of Jokhang Temple complex showing the area of the fire. Source: Google Earth.

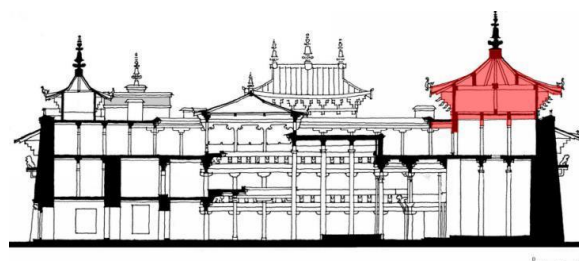
Figure 5 - Section-through Jokhang Temple showing the area of the fire. Base graphic © UNESCO/A. Alexander.

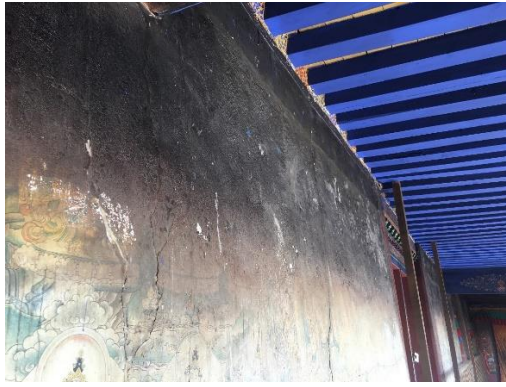
*Figure 6 - Damage to exterior wall murals at the 2nd floor level below the mezzanine, 10 April 2019.*

Heat from the fire caused damage to exterior paintwork, gilded roofing and wall murals in adjacent areas on both the second and third floors. Wall murals and interior finishes within the Ventilating Chamber were destroyed. Exterior murals on the walls of the second floor (under the mezzanine) were seriously damaged. Traditional materials such as earth and brick, used in the construction of the Ventilation Chamber and surrounding areas, helped retard the spread of the fire, while the roof of the ground floor shrine helped to protect the Shakyamuni Buddha from water damage resulting from firefighting. The fire was partial and did not affect the whole architecture, art and belief system of the Jokhang Temple. Thus, the overall impact on the authenticity and the integrity of the temple was minimum. The areas most severely affected by the fire date primarily to the period of major reconstruction in the 1980s. The OUV of Jokhang Temple Monastery is unchanged as a result of the fire and subsequent restoration efforts.

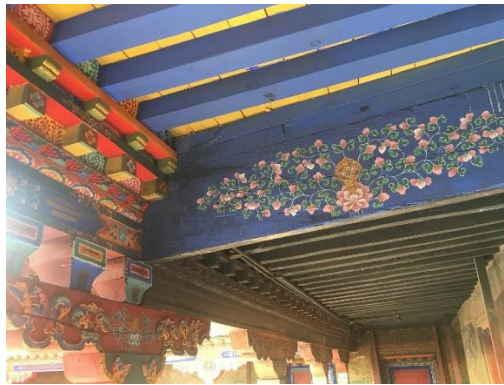
*Figure 7 - Damage to 2nd floor, exterior ceilings beneath the mezzanine, 10 April 2019.*

The fire appears to have burned intensely for several hours, destroying perhaps 80% of the Ventilating Chamber roof and damaging approximately 20% of the eastern ceilings of the second floor (i.e. the undersides of the third-floor mezzanine).

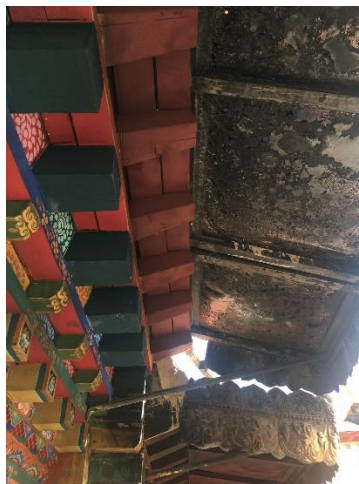
*Figure 8 - Fire damage to the roofing at the eaves of the second-floor mezzanine, immediately below the parapet wall, 10 April 2019. Note the unfinished gilding.*

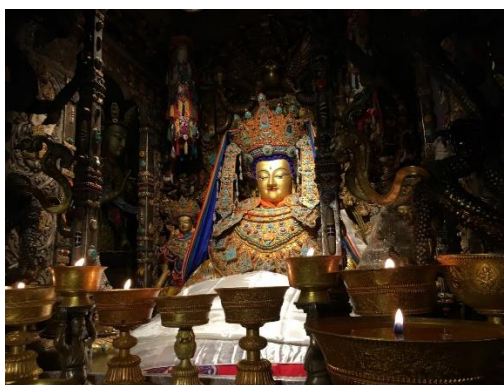
*Figure 9 - Shakyamuni Buddha, protected from the fire three stories above, 10 April 2019.*

- Traditional materials such as earth and brick, used in the construction of the Ventilation Chamber and surrounding areas, helped retard the spread of the fire, while the roof of the ground floor shrine helped to protect the Shakyamuni Buddha from water damage resulting from firefighting.

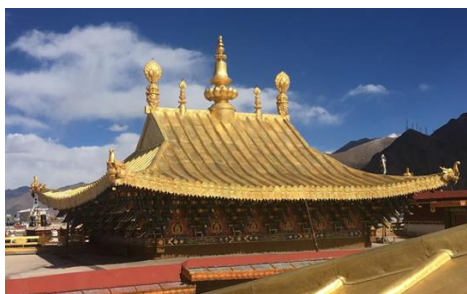
**The Ventilation Chamber** has been substantially restored since the fire on 17 February 2018. According to the report forwarded to the UNESCO World Heritage Centre on 16 March 2018, the Ventilating Chamber and its golden ceiling were restored in 1973 and 1984 (repaired in 2013), and the interior line-drawing murals were painted in the 1980s.

*Figure 10 - Exterior of Ventilator Chamber after substantial restoration, 10 April 2019.*

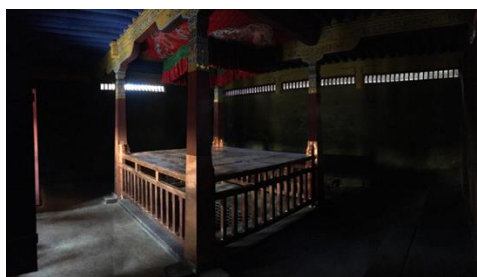
*Figure 11: Interior of the Ventilation Chamber after restoration, 10 April 2019*

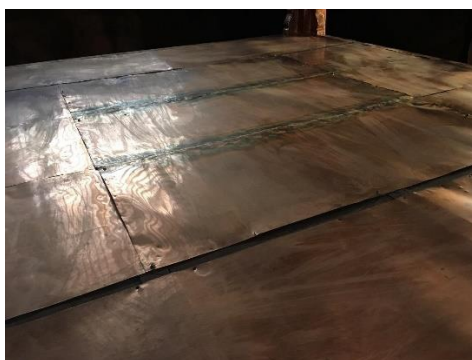
*Figure 12 - Improvements to the fire resistance of the Ventilation Chamber include a new copper hood above the air inlet, 10 April 2019.*

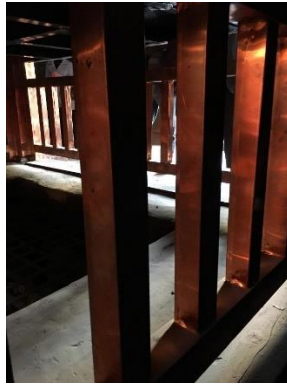
Figure 13 - Wood balustrading around the air inlet has been sheathed in copper, 10 April 2019.

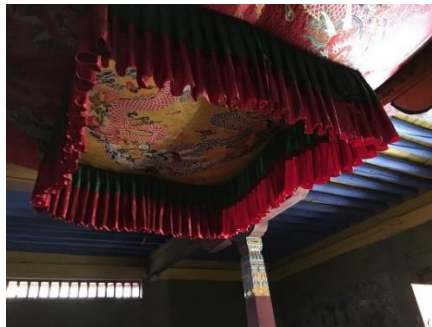
Figure 14 - New awning and decorated ceiling of the Ventilation Chamber, 10 April 2019.

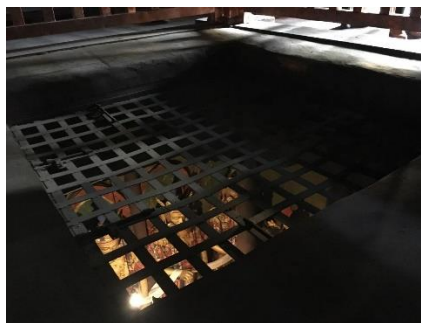
Figure 15 – The original, screened inlet remains in place, 10 April 2019.

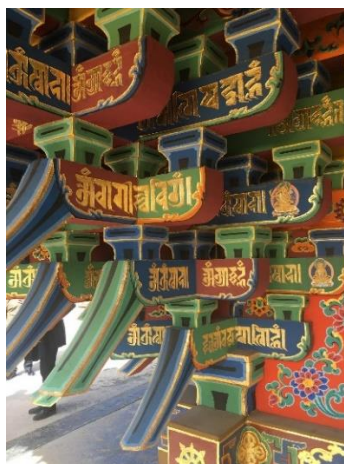
While the quality of the carpentry is good and appears to follow traditional patterns of construction and joinery detailing, the quality of the timber finishes and paintwork varies throughout the structure. Wooden parts appear to have been painted in situ rather than before assembly, resulting in partial coverage; in some areas, the paintwork has been crudely applied owing to the awkward access (see Figure 17).

Figure 16 - The overall quality of the carpentry is good, 10 April 2019.

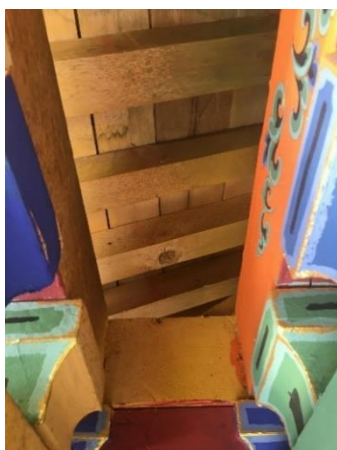
Figure 17 - Painted and unpainted surfaces in the eave spaces, 10 April 2019.

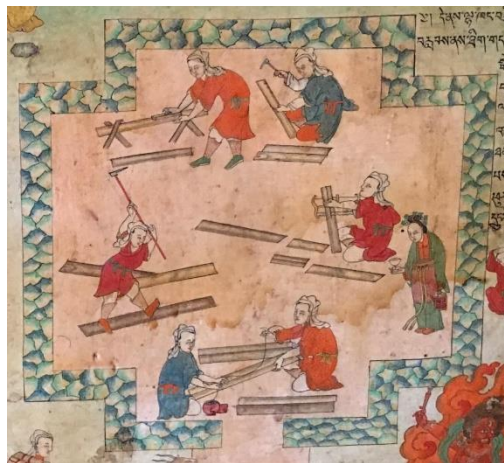
Another consideration is the method of timber conversion used for repairs and reconstruction: the new timbers used to repair the Ventilation Chamber are band-sawn, by contrast to the hewn and adzed finishes of the historic building fabric. The difference to the overall presentation of the work is subtle, but the implication for the preservation of traditional craft/carpentry skills is important: historic timber conversion is only possible through the practice of traditional skills such as hewing and adzing with traditional carpentry tools. Access to these traditional skills (and the traditional hand tools necessary to perform them) becomes particularly important when repairs are made to the primary/structural timber frame because there are many less-decorated parts of the Jokhang temple where it is appropriate to expose the conversion, and where exposed conversion marks contribute to the authenticity of the repairs. Therefore, *ICOMOS Principles for the Preservation of Historic Timber Structures* (2017), Part 14 (c) states that “Any replacement timber should preferably be worked using similar craft methods and tools as the original” (see Figures 18 and 19).

Figure 18 - Carpenters working on the Jokhang Temple, a section of a modern mural (1956-58) at the Norbulingka Summer Palace, 11 April 2019.

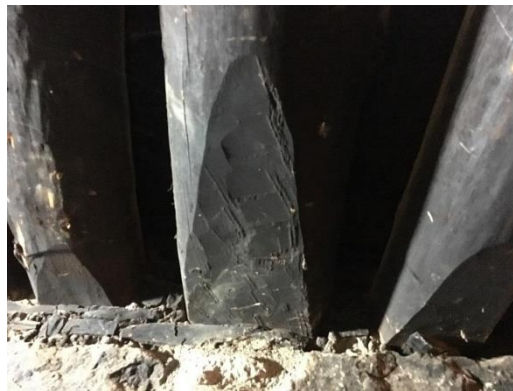
Figure 19 - Adzed joist ends in the foundations of the Potala Palace exhibiting tool markings (witness marks) that match the carpentry tools depicted in the mural at Norbulingka Palace, these being typically narrow width adzes hafted on long handles, 12 April 2019.

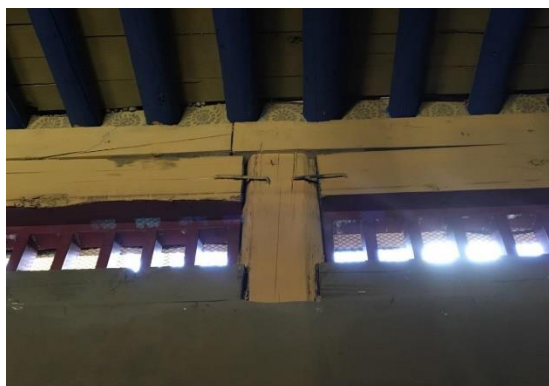
Observations of the repairs and reconstruction support that newer parts of the structure are easily distinguishable from the original, historic parts of the Jokhang Temple complex because of the generally low quality of timber used and the methods of conversion still visible on many timbers (NB, this is consistent throughout the temple). Particularly noticeable are the smaller, more decay-prone elements such as external brackets, rafters and rafter sprockets, joists, sarking boards, etc. which one would expect to be repaired and/or replaced more frequently than the larger, primary elements. Additionally, there are several non-traditional and poor-quality joinery connections visible in the surviving primary timber elements of the Ventilation Cupola, such as the posts to top plate connections shown in Figure 20. Such repairs detract from the authenticity of the building and diminish its structural

*Figure 20 - Non-traditional and poor-quality connection between the post and top plates inside the Ventilation Chamber, formed with vertically aligned butt joints and reinforcing rod staples, 10 April 2019. This connection predates the fire, but the top plates and joists are new.*

performance. As opportunities arise, poor quality modern repairs should be gradually replaced by repairs of these higher standards. Similarly, there are also many examples of high-quality modern repairs throughout the Jokhang Temple Monastery, exemplified by Figure 21. As opportunities arise, these high-quality repairs should serve as examples for future interventions.

- e. As opportunities arise, poor-quality modern repairs should be gradually replaced by high-standard repairs.
  - f. The *ICOMOS Principles for the Preservation of Historic Timber Structures* (2017) should be adopted and implemented for all future timber repairs.

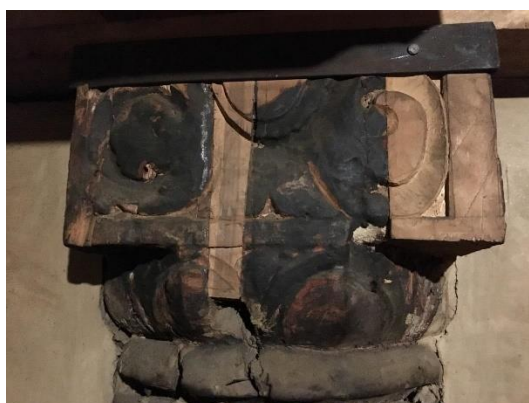
*Figure 21 - High-quality modern repair from elsewhere in Jokhang Temple, 10 April 2019.*

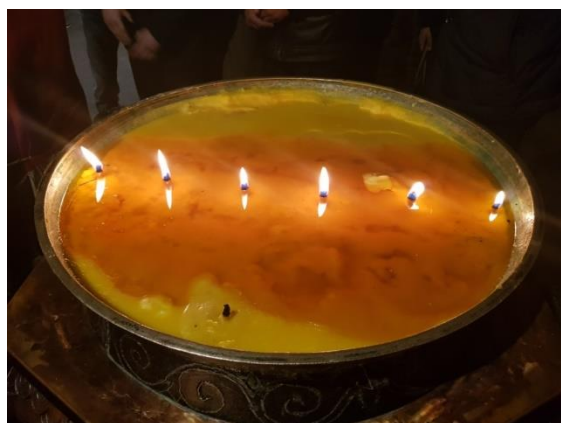
The candles were replaced with soot-low liquid oil, and the amount of lighting decreased significantly compared to 2015, which can be seen as a major improvement in reducing the danger of fire and the soot that damages mural painting within the component sites (Jokhang Temple and Potala Palace).

*Fig. 22 - Lighting of Jokhang Temple & Potala Palace*

In the future, it is necessary to consider a plan to light candles only from the morning prayer time to the evening prayer time and turn them off when the evening prayer is over. The pilgrims and visitors visit the monastery during the day only, thus extinguishing candles at night will not have a negative effect on the temple's religious atmosphere.

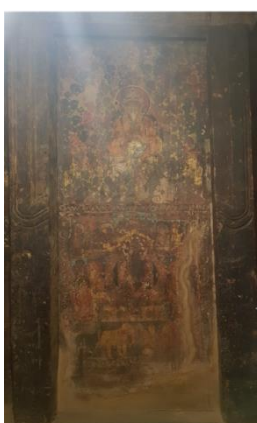
*Fig. 23 – Soot on a mural painting*

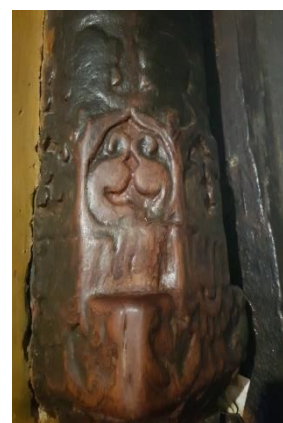
*Fig. 24 – Soot on the wooden craft*

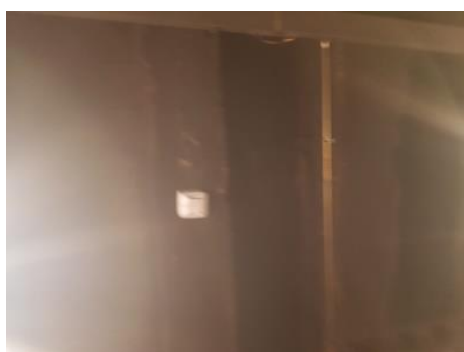
As recommended in the 2015 Reactive Monitoring mission report, an ongoing monitoring system of soil erosion and bedrock conditions has been established. This monitoring system can be seen as the first step for the efficient topography conservation of the Potala Palace. It is necessary to build a long-term database and monitoring measures to assess risks to the traditional structure and materials from hazards related to climate change.

*Fig. 25 – Detector in the basement of Potala Palace*

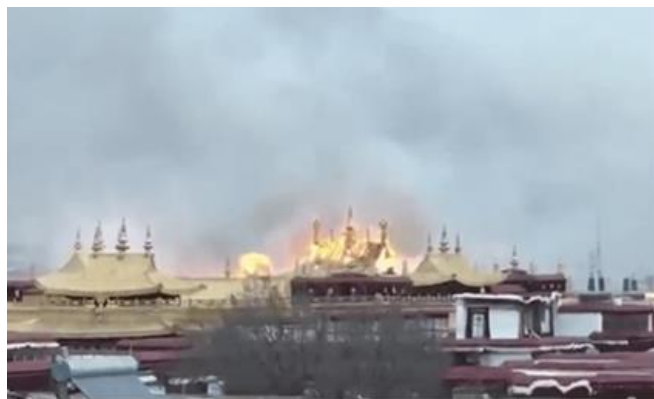
*Figure 26 - Jokhang Temple during the fire in 2019. Source: Twitter.*

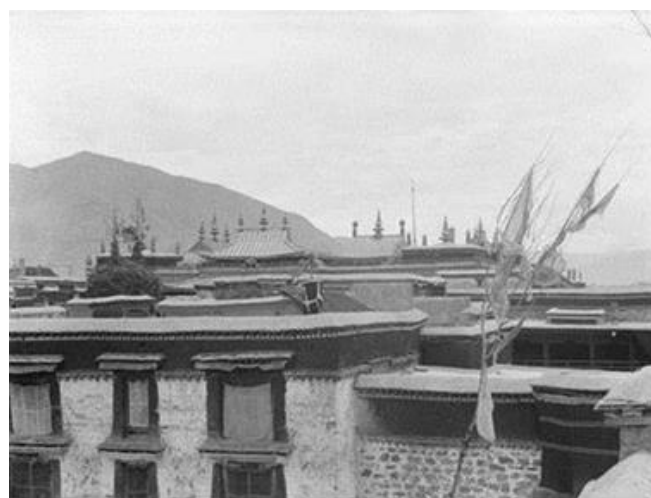
*Figure 27 – Image of the Jokhang Temple made in 1920-21, Pitt Rivers Museum. Note the different roof ornamentation on the ridge of the Ventilation Chamber roof (centre).*

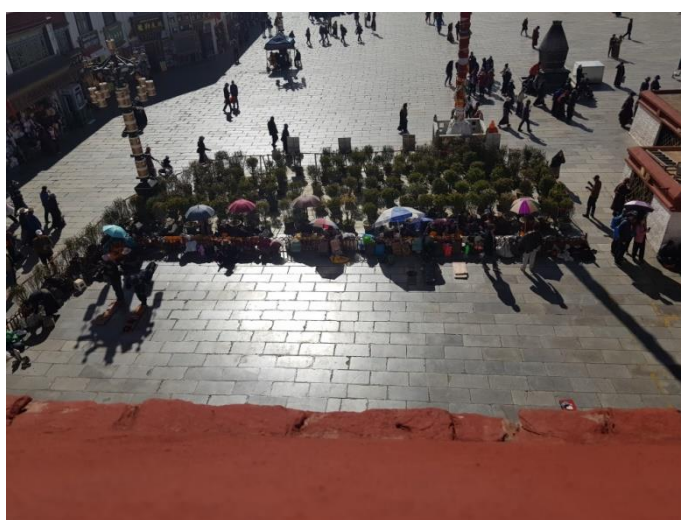
There have been some positive changes to protect the pilgrims' religious activities and to provide a religious environment. Potted plants were placed in front of the Jokhang Temple, giving refuge for pilgrims to worship. A system has been set up to separate the visiting hours for pilgrims and tourists: Jokhang Temple has advised travel agencies to guide massive visitor groups to the temple in the afternoon and avoid the peak visiting times for pilgrims, who normally visit the temple in the morning.

*Figure 29 – Pilgrims place marked by the potted plants in front of Jokhang Temple*

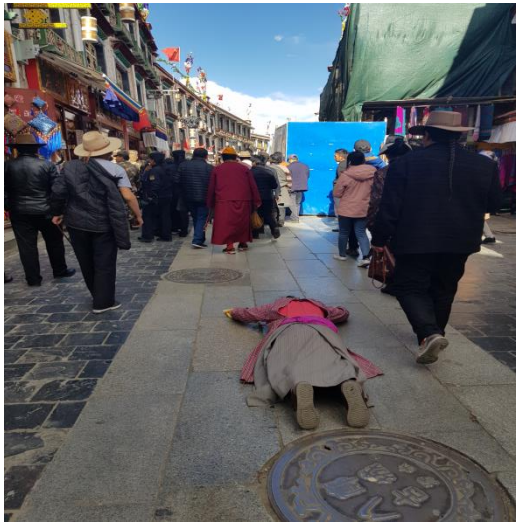
While the route of pilgrims' circumambulation and/or prostrating around Jokhang Temple is identified by the colour of the pavement, some areas are still hampered by tourist traffic (Figure 30). Additionally, pilgrimage routes are only marked around parts of the Jokhang temple and there is poor connectivity with other parts of the complex such as the entrance, as seen in Figure 31. These issues should be corrected.

*Fig. 30 – Tourists share the route used by Pilgrims circumambulating and/or prostrating around the Jokhang Temple*

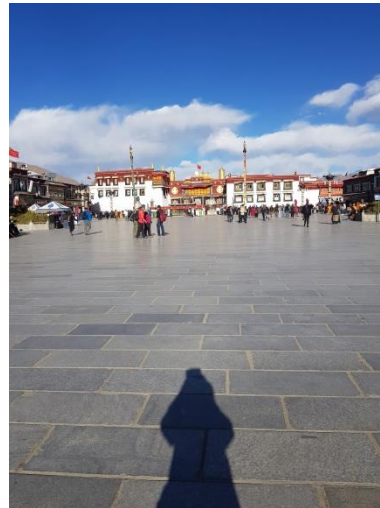
*Fig. 31 – Square in front of the Jokhang Temple, the pilgrim route around the temple needs to be extended to the entrance of the square.*
