Report on the State of Conservation

of the World Heritage Property of Vat Phou and Associated
AncientSettlements within the Champasak Cultural
Landscape

Report

Follow up Champasak Water Suply state Enterprise Project
For Extension of The Water Supply Network
From Dontalat To Champasak Town

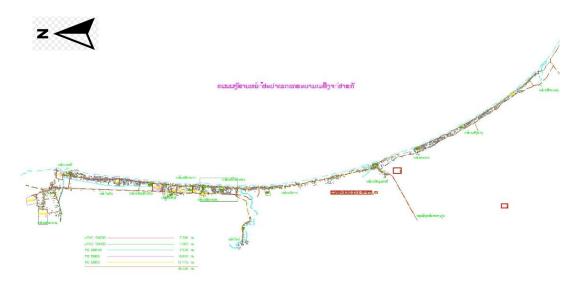
Figure 1 Map of monitoring area. (see annex for high resolution)

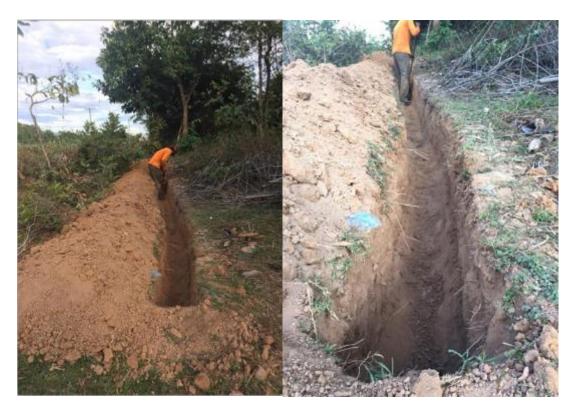
In December 2018 the Water Supply State Enterprise construction team, installed water pipes \varnothing 200mm from the water gate point just close to the last house of Nongvien village at its north, on the south slope of road number 7818, until another water gate in Vat Luangkao at T-Junction of the entrance to Phanon Tai village . Ground digging was also done on the other side of the road, and passed through the second earthworks of ancient city, therefore the protective measures were employed. The channel was dug by the man at its size of 30cm wide and 50-60cm deep for PE pipe \varnothing 200mm (Figure 2 and).

Figure 2 digging process, where it is pass the earthworks of the ancient city at the Nongvien village.

Because the area around Nongvien Village, contains the second earth wall of the ancient city, mitigation measures were undertaken to avoid this feature. The Pipeline was diverted, from directly adjacent to the road number 7818, in order to avoid known archaeological features. The sizes of the excavation was limited to 30 cm in width and the depth to 50-60 cm (PE pipe \varnothing 200 mm was used). The soil layer was found to be a sandy-clay mixed sediment and no heritage structures were detected.

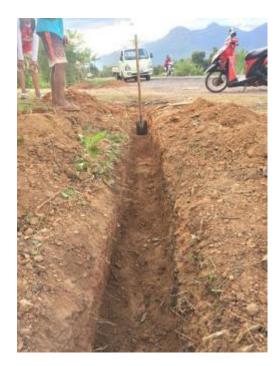
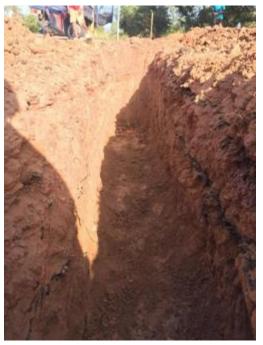
Figure 4 digging process at the archaeological site in Nongvien village.

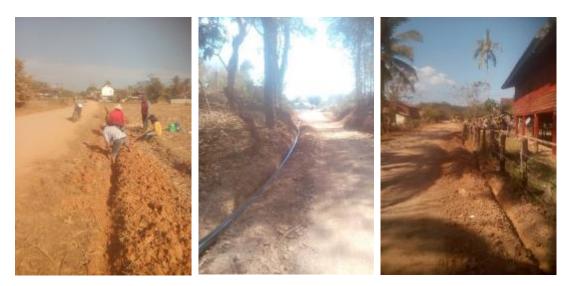
Figure 7 Pipeline installing on the area inner ancient wall and Phanone village.

The installation of pipeline within the area of the inner-city wall, and south Phanon Tai village, was placed adjacent to the slope of the laterite road. To minimise the potential impact to heritage, this excavation was conducted by hand and restricted to 20cm wide and 25-30 cm deep, using PE pipe \emptyset 100mm. No significant heritage was disturbed by this work and building mounds were deliberately avoided. The soil was found to be a predominantly sandy, mixes sediment. Traces of historic building materials were found in the excavations but these were fragmentary and not *in situ*.

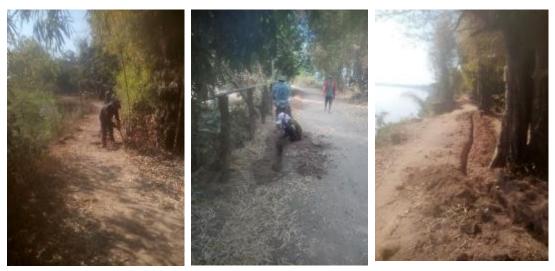
back to Phanon (Figure 8). The size of the excavation was 30 cm wide. The depth was about 30-40 cm, using PE pipe \varnothing 100 mm and PE pipe \varnothing 80 mm.

Figure 8 Pipeline installing from the Sisavang village into south Phanone village along to small road on the Mekong river bank.

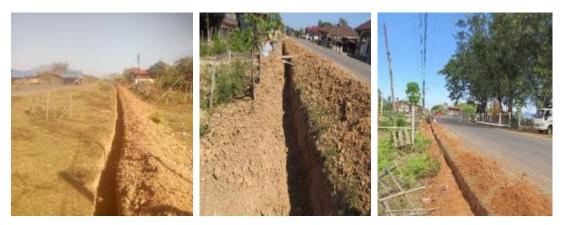
In January 2019 the construction team installed pipelines from the Watergate, along the south of road number 7818 (joints from PE pipe \varnothing 200mm connected to PE pipe \varnothing 80). The excavations started from Vat Louang kao village, progressing along the roadside of 7818 to Vat Sang \mathring{O} . The excavations bypassed the large Buddha statue at Sisumang, some 400 meters then switched to the other side of the road. again, bypass the drained pipe and making two lines on both side of the road, for the south installed PE pipe \varnothing 200mm and PE pipe \varnothing 80-50mm and on the north installed PE pipe \varnothing 100-80. The size of the excavation is 30cm wide, the depth is about 60-70 cm and continued until Vat Muangsen village.

Figure 9 Pipeline installing from the Vat luangkao village, Vat sang oh and Sisumang big Buddha statue.

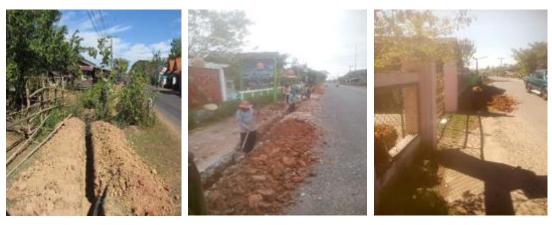
Figure 10 Pipeline installing from Vat That village to Houy Phabang Bridge (digging two lines)

Installing pipeline from Vat Luangkao to Vat That villages involved excavations along both sides of road 7818. The excavation on the west side of the road was 25 cm wide and 30-40 cm deep, using PE pipe \varnothing 100-80 mm. The excavation on the east side of the road was 30 cm wide, to a depth of 60-70 cm, using PE pipe \varnothing 200 mm and \varnothing 100-80 mm. No significant cultural heritage was found along this section of the excavations.

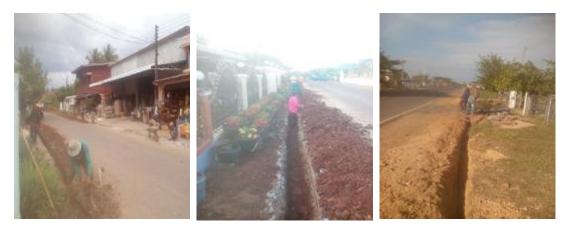
Figure 11 Pipeline installing from the Phon pheang village, Vat lakhone village and roadside 14A. Pipeline installing from Phon pheang village, Vat lakhone village and roadside 14A.

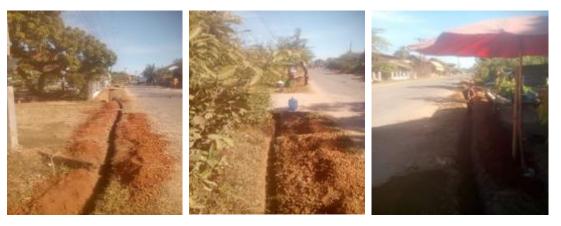
In January and February 2019, the construct team continued to install pipelines from the Water gate PE \varnothing 200mm, along the east side of road number 7818 (joints from PE pipe \varnothing 200mm and reduce to PE pipe \varnothing 150). Starting from the Meuangsen village on the east side of the raod to the crossroad at Phaphin village. Channel's lines were dug on both sides of the road, putting PE pipe \varnothing 150-50mm on the east with the channel's size of 30cm wide and 60-70cm deep, on west side of the road putting PE pipe \varnothing 100-80mm with the dimension of channel 25cm wide and 30-40cm deep. Then continued putting PE pipe \varnothing 100-80mm from the crossroad at Phaphin to the road 14A, until Phanthakham village outside of UNESCO zone and finished in Phaphin Noy village.

Figure 13 Pipeline installing from the Vat Meuangseanh village into Phoxay village

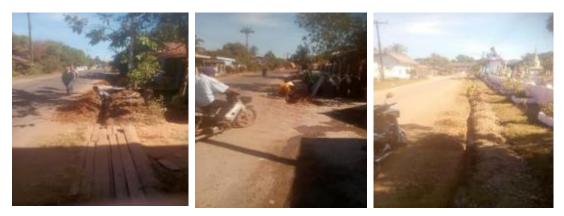
Figure 14 Pipeline installing from the Phoxay village into Phaphine village.

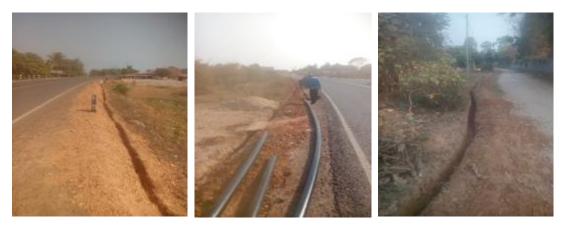
Figure 15 Pipeline installing from the Phanthakham village into small Phaphine village.

No significant cultural heritage was located during this section of the work. Some large unaltered sandstone blocks were found opposite the school at Phaphin village, these appeared similar to natural blocks that are occasionally used as building material, but if this had been the case, the blocks were now not *in situ* (they overlaid a metal sheet). The blocks had most recently been used as part of a culvert and as a structural part of the existing road, they were not excavated for further examination.
