SITE NAME: Kronborg Castle

SUBMISSION FOR NOMINATION ON
THE WORLD HERITAGE LIST

Name of country Denmark
List drawn up by ICOMOS DK
Date September 1, 1993

Kronborg Castle

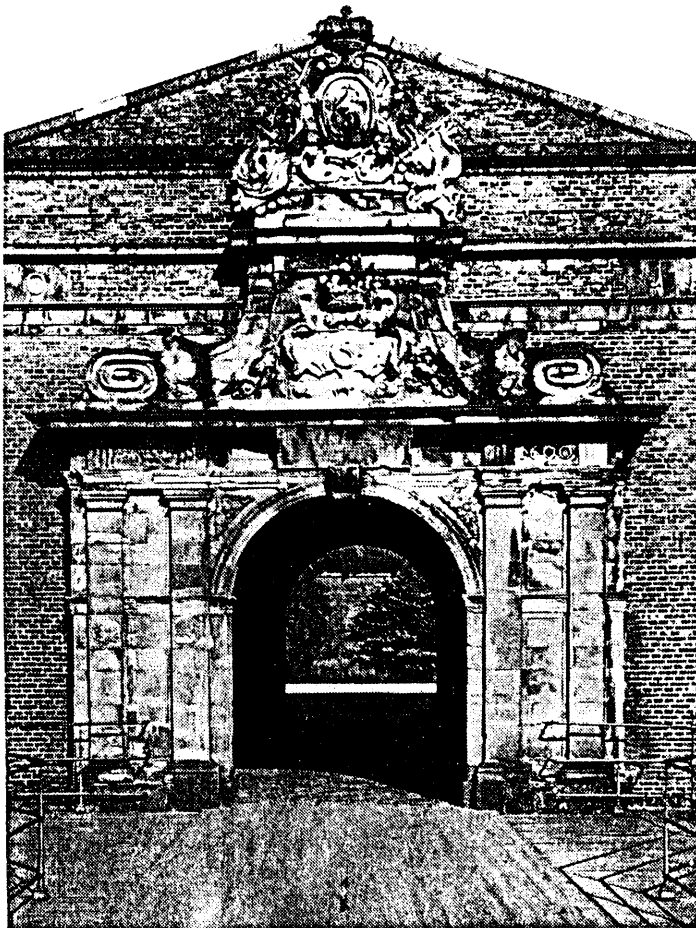
The Crownwork Gate. On a tablet above the entrance is an inscription by Thomas Kingo: If honoured the barrier will raise and through the arch you pass to meet the crowned castle's gaze!

The gate bears the date 1690 although it has since undergone alterations and the present façade is from 1733. The tablet above the gateway is inscribed with a poem by Thomas Kingo.

The cobblestones here are only 1½ metres over sea-level, and the sea has been known to flood the terrain at high water, forcing people to sail through the gateway by boat in order to reach the Castle.

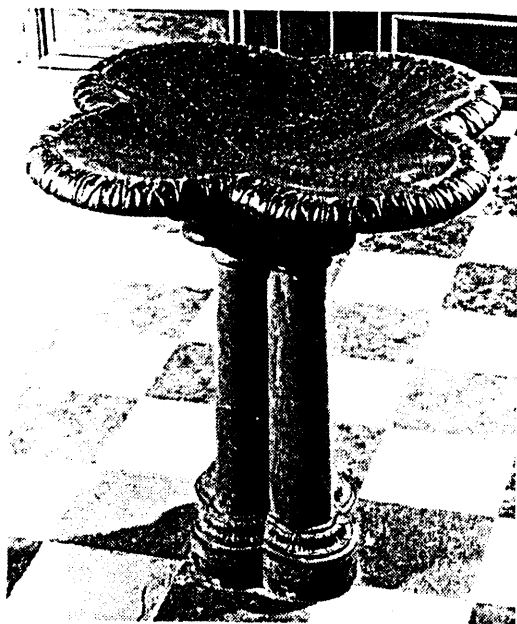
Baptismal font in the Chapel.

The baptismal font reached the Chapel in 1843. The pedestal made in 1842-43 is of marble; the shallow bowl is of Egyptian porphyry, a rock imported into Rome in great quantities at the time of the Roman Empire. The Tuscan Duke, Ferdinand I of the House of Medici established a porphyry workshop in 1588 where stonemasons dressed this hard rock. All porphyry that could be salvaged from Roman ruins was brought to the Medici court in Florence. Some of the porphyry objects appear to have reached the French court at the Louvre in Paris where Catherine of Medici, and later, Maria of Medici, both were Queens of France. In 1762 Egyptian porphyry was collected from the Louvre for *Frederikskirken* in Copenhagen, and the curiously shallow bowl was transported further to Kronborg Castle.

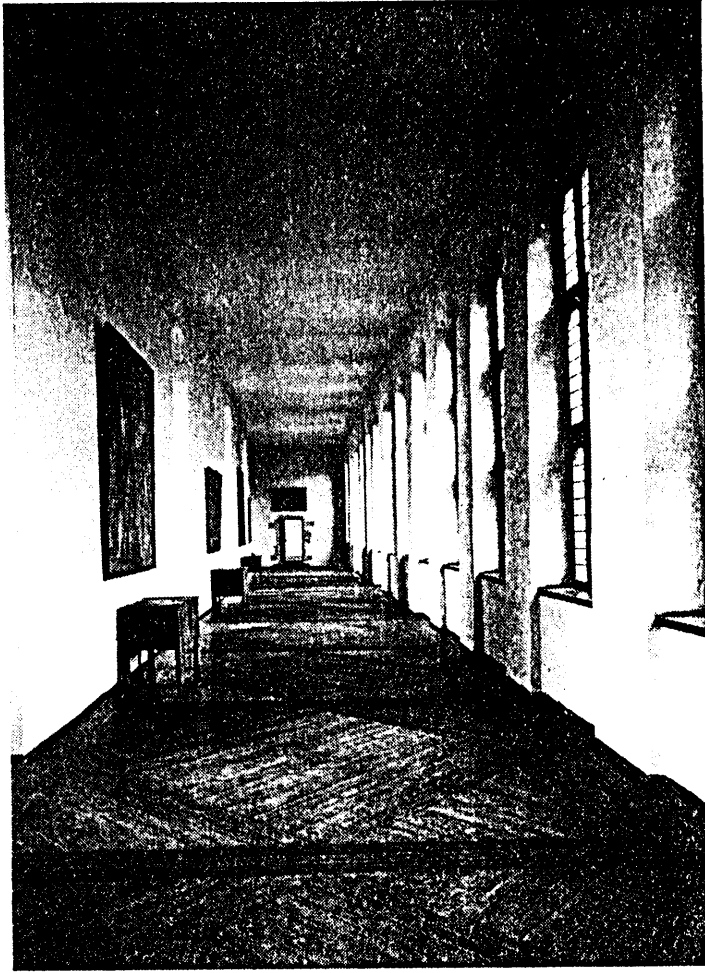
The Queen's Long Gallery on the top floor of the East Wing.

The top floor of the East Wing was arranged as a Long Gallery in 1583 through which Queen

Sophie passed on her way to the Banqueting Hall in the South Wing. It was decorated with paintings. Among the portraits mentioned is one of Queen Elizabeth I of England. After the fire of 1629 Christian IV had the Long Gallery restored. He died in 1648, and within a hundred years it was divided into two floors. In 1785 it was turned into a barracks for part of the Castle garrison. It was not restored to its original state until 1928.

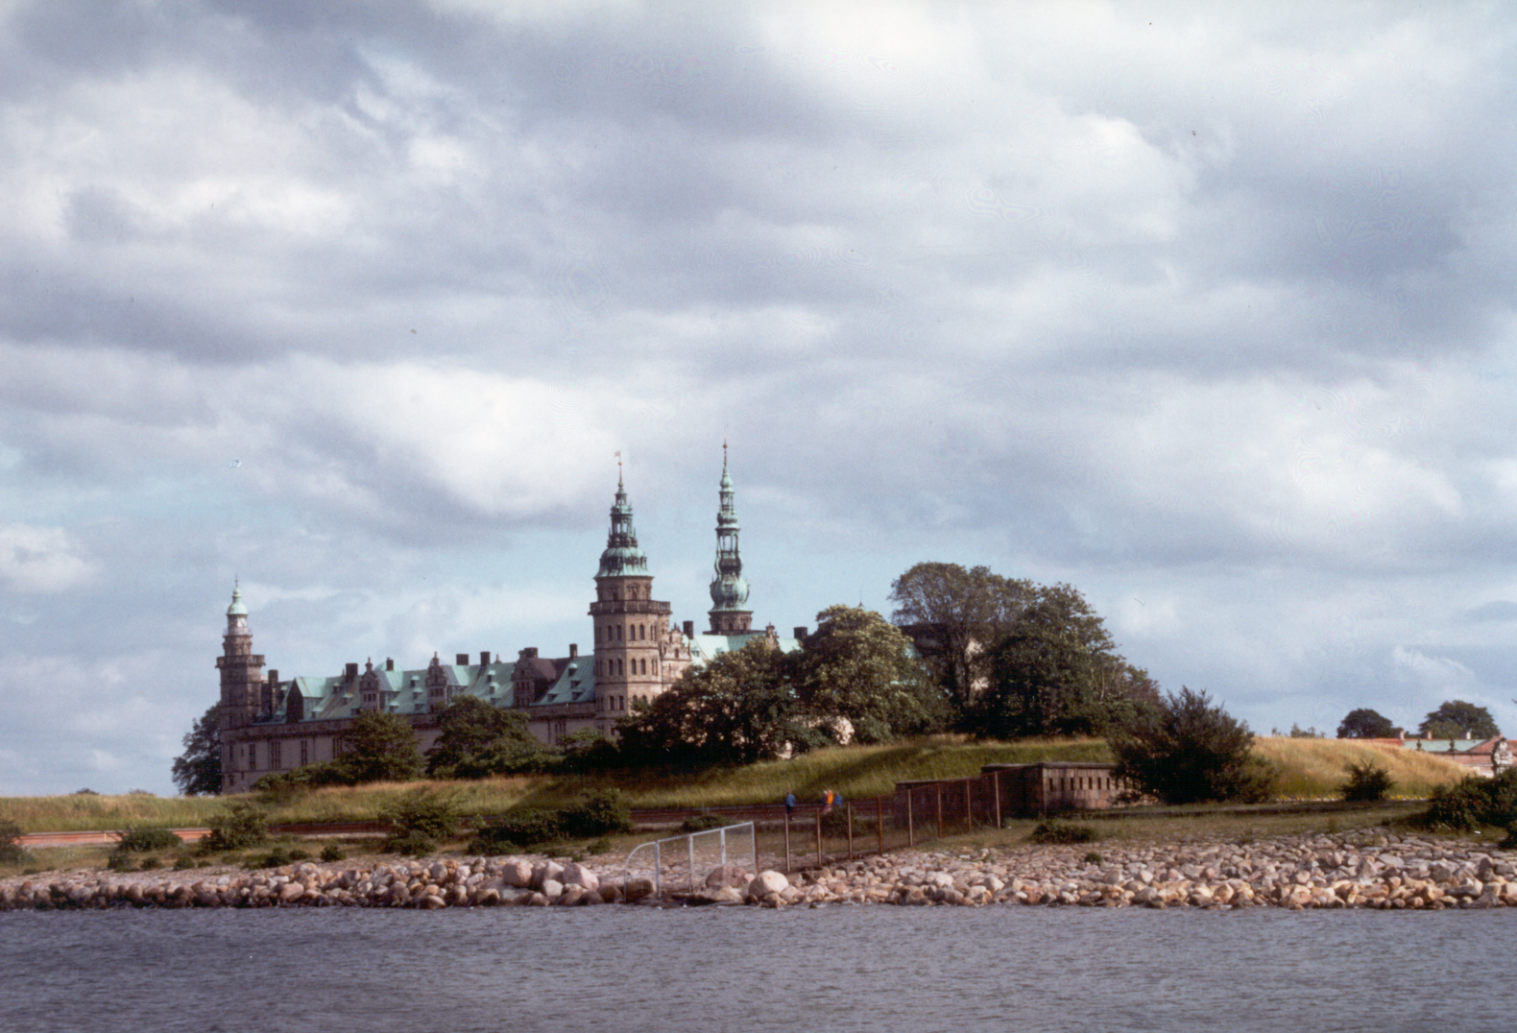
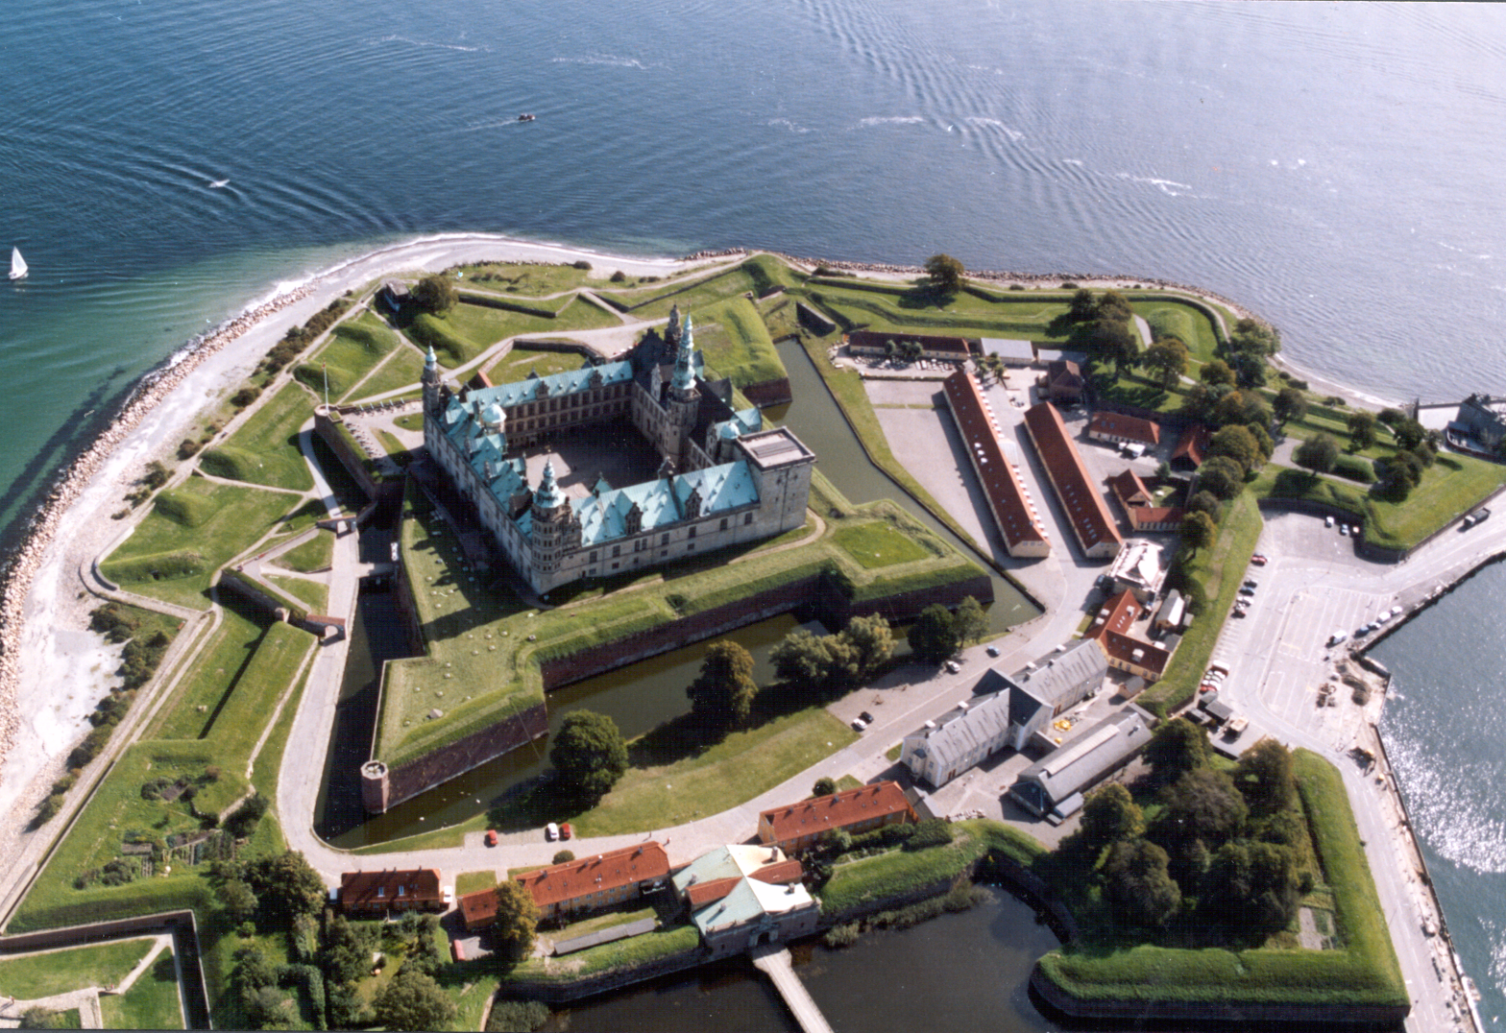
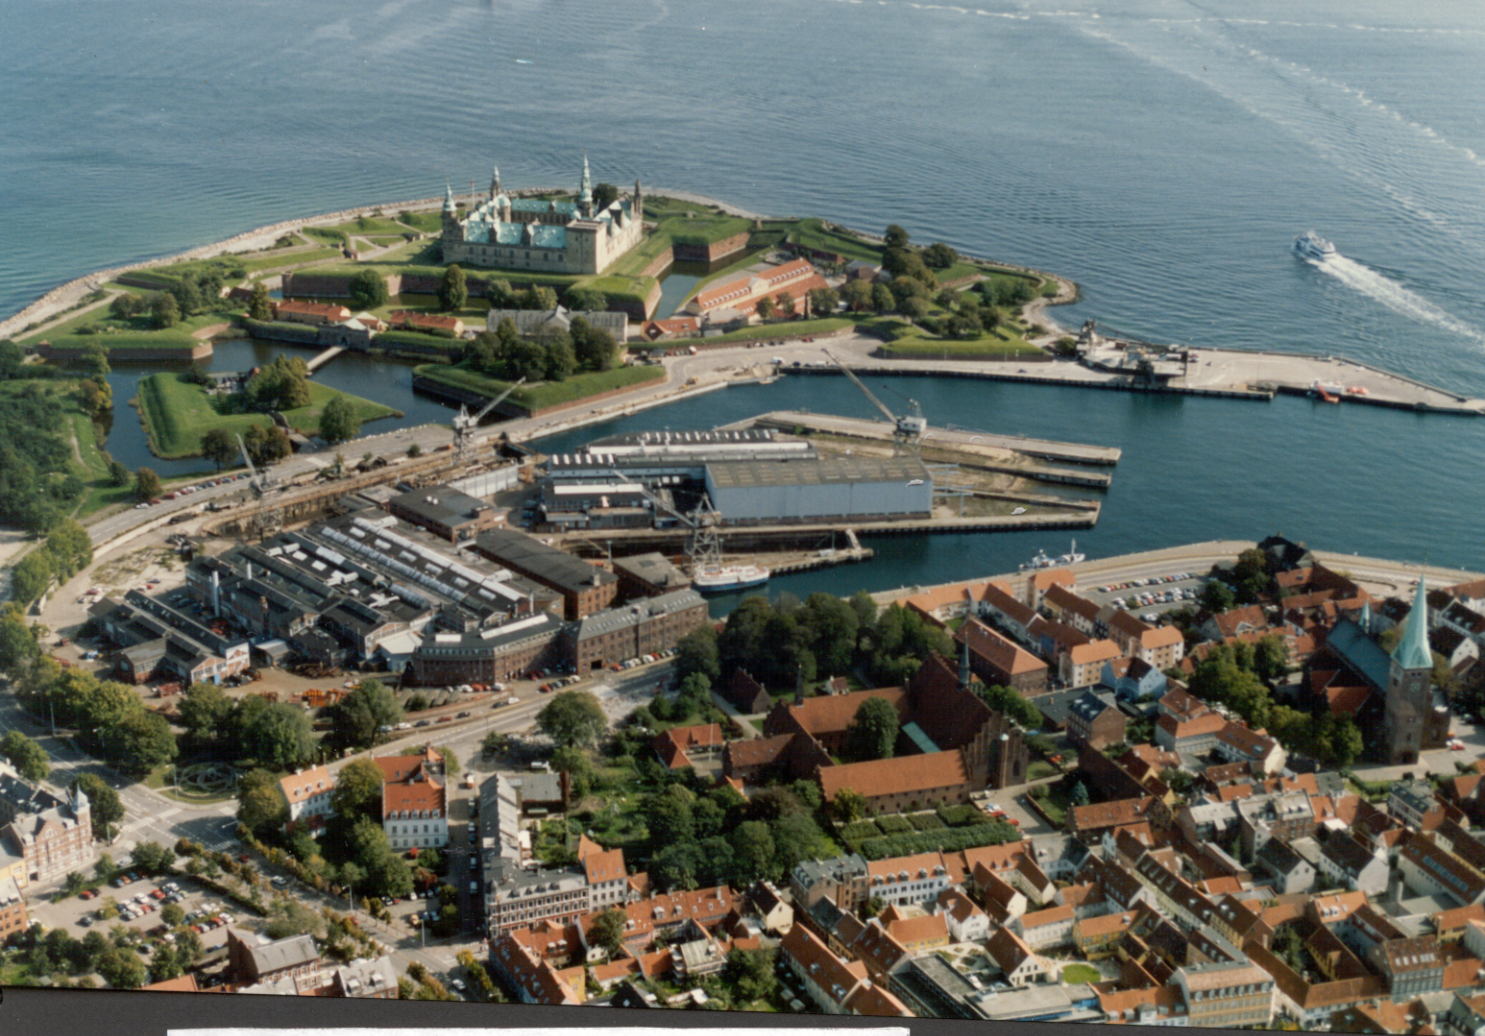
Area between Kronborg and the town of Elsinore with closed down shipyard buildings.

At the time of the original nomination in 1993/94, the area between the old town of Helsingør and the Castle was occupied by the buildings and installations of a former shipyard which had recently closed down. On the recommendation of ICOMOS, the Bureau of the World Heritage Committee, at its 18th Session in Paris in July 1994, deferred further consideration of this nomination until a satisfactory programme had been adopted by the Danish authorities for the removal of the major part of the disused shipyard and the landscaping of the area.
