JOINT UNESCO(WHC)/ICOMOS/ICCROM EXPERT MISSION REPORT  
/ RAPPORT DE MISSION CONJOINTE DES EXPERTS DE L'UNESCO  
(CPM) ET DE L'ICOMOS ET DE L'ICCROM

KREMLIN AND RED SQUARE IN MOSCOW /  
LE KREMLIN ET LA PLACE ROUGE A MOSCOU

6 – 14 December 2007 / 6 -14 décembre 2007

**REPORT OF THE JOINT UNESCO-ICOMOS-ICCROM REACTIVE MONITORING  
MISSION  
TO KREMLIN AND RED SQUARE IN MOSCOW**

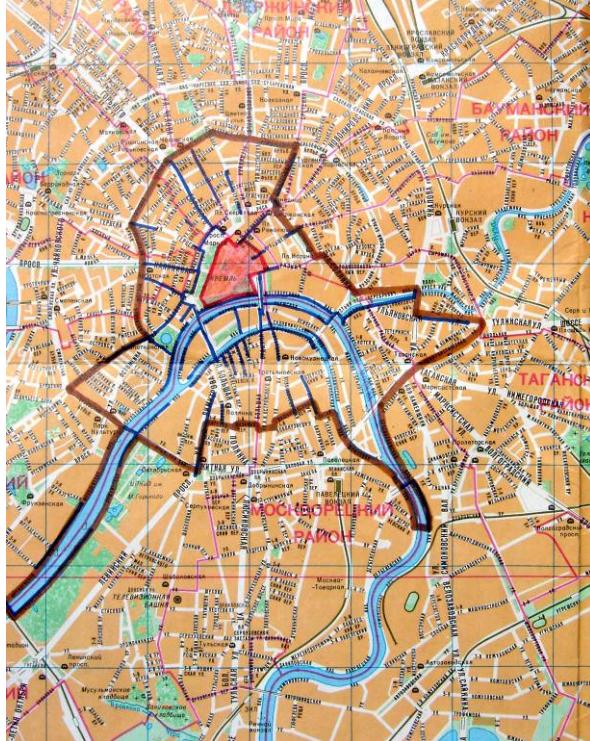
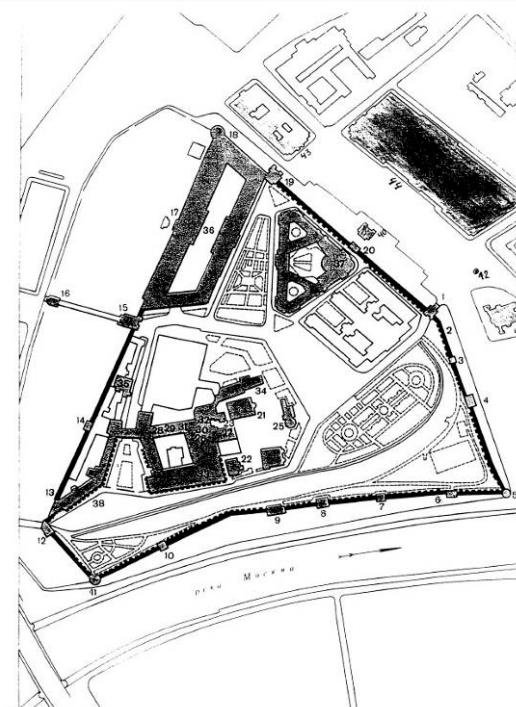
The inventory of the nomination files indicates that the boundary of the World Heritage site of the Kremlin and Red Square, Moscow is represented by the following maps, submitted with the nomination in 1989.

Moscow map with project of Kremlin and Red Square preservation/conservation areas. MOCKBA [MOSCOW] scale 1:38,000.	Sketch-map of monuments placed on territory of the Kremlin

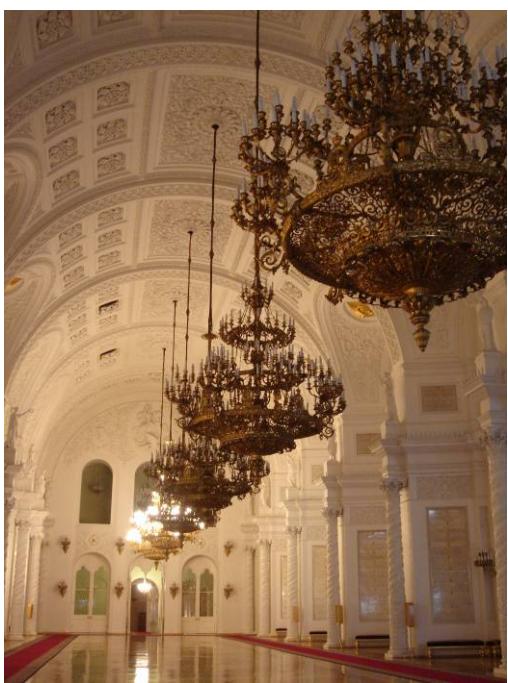
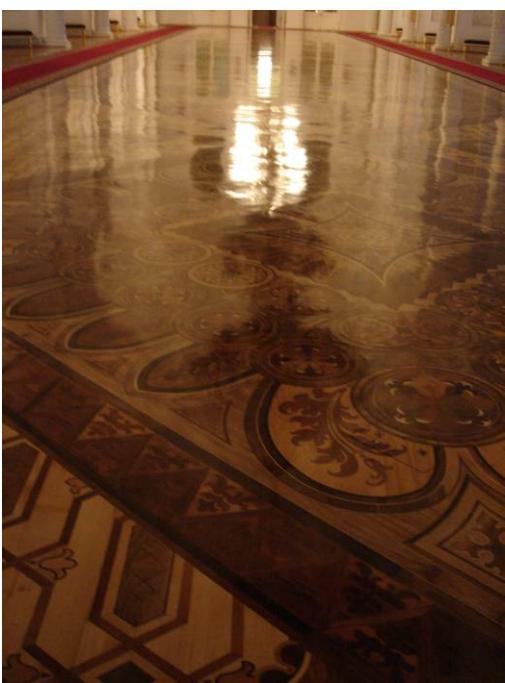
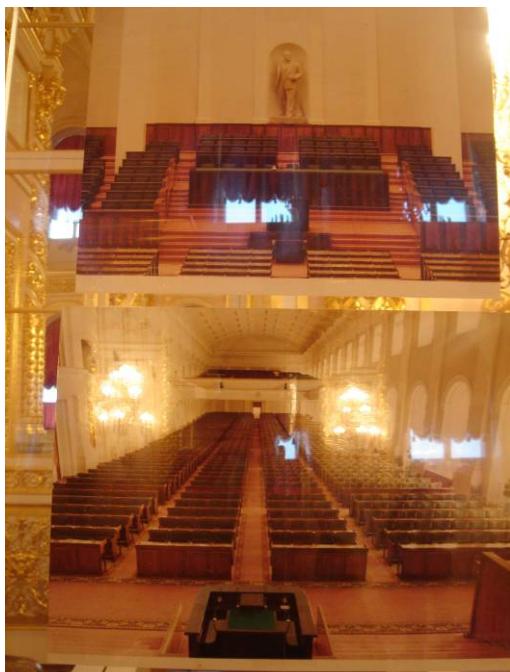
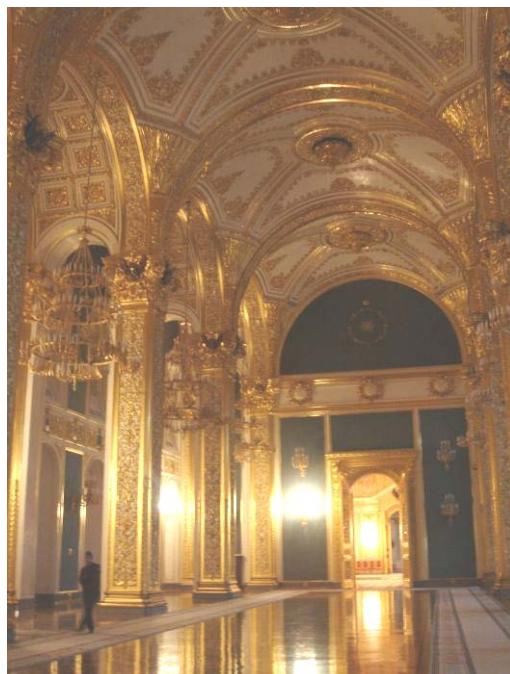
- A l'étage se trouvent les grands espaces de réception (photos 37 à 43), dont certains, transformés dans les années restaurés à grands frais à la fin du XX<sup>e</sup> siècle (1995-1998).
- L'Armurerie conçue par Konstantin TON et édifiée de 1844 à 1851, reçoit d'importantes collections d'armes, de carrosses, de costumes, d'orfèvrerie et de mobilier.

La restitution des salles de réception du Grand Palais est spectaculaire, et malgré la disparition d'un témoin historique majeur (salle du Soviet Suprême) qu'un ensemble de photos rappelle, on ne peut manquer d'être très impressionné par le résultat. La restauration "à neuf" appelle une nécessaire patine, pour une intégration plus « naturelle » dans les espaces historiques.

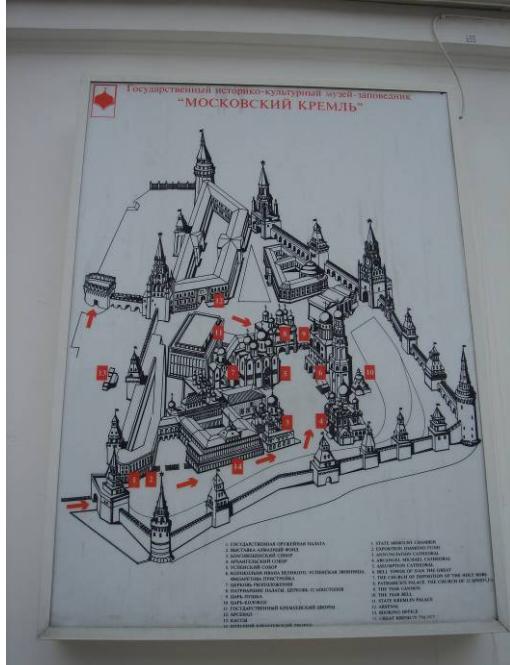
43

L'ensemble de la Citadelle (photo 43) est entouré d'une enceinte constituée de courtines bâties en maçonnerie de briques rouges (photo 44), flanquées de près d'une vingtaine de tours, et globalement en bon état.

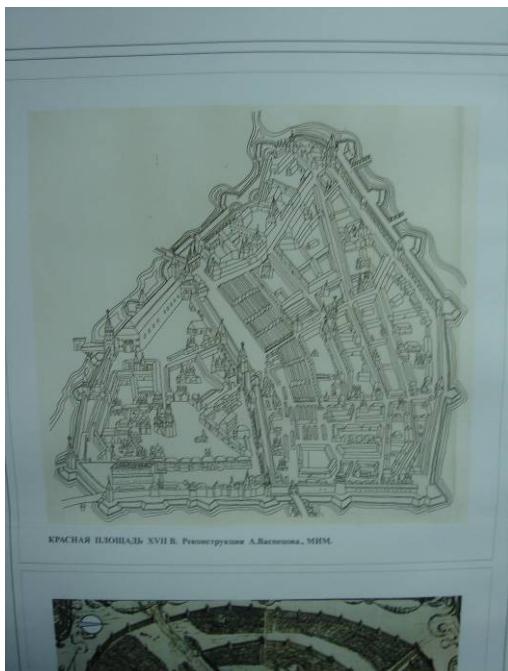
КРАСНАЯ ПЛОЩАДЬ XVII в. Реконструкция А.Василева. МИМ.

La Place Rouge borde la Citadelle du Kremlin à l'Ouest ; sur des plans anciens (XVII<sup>ème</sup>) elle est occupée sur tout le côté Ouest d'entrepôts (photo 52), appelés TORGS, construits en bois, et dont les multiples incendies seraient à l'origine du nom de place « Rouge ». Ceux-ci furent remplacés au XIX<sup>e</sup>s. par des bâtiments maçonnés avec cours intérieures (photos 52 à 54).

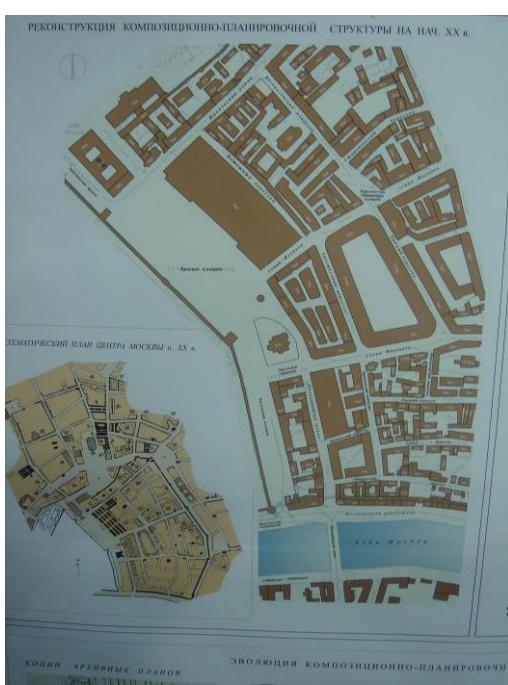
54

КОПИЯ АРХЕОЛОГИЧЕСКИХ ПЛАНОВ  
Эволюция композиционно-планировочной структуры на нач. ХХ в.

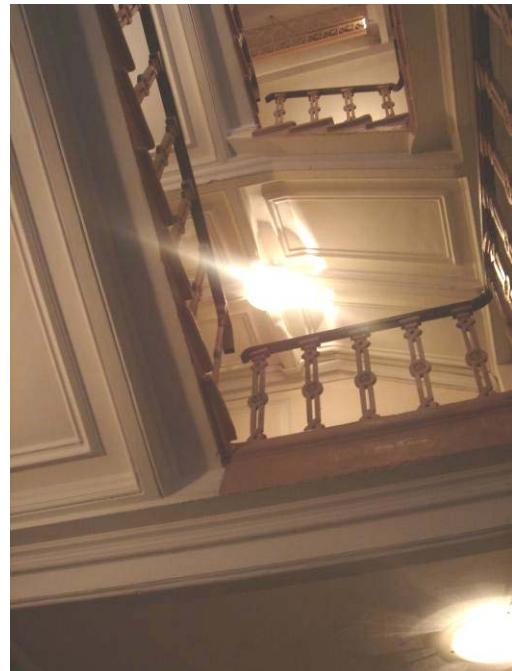
**65**

Les bâtiments périphériques sont destinés à être conservés : les façades et toitures, les murs intérieurs porteurs, les planchers et les escaliers ( photo 65). Les décors anciens sont rares (salle en comble photos 65, 66) ; les décors actuels néo-classiques dateraient de l'époque soviétique (photos 68, 69).

Ces bâtiments vont faire l'objet, sans plus de précision, de consolidations de fondations par pieux forés à 12m de profondeur. Des sondages effectués jusqu'à -15m ont identifié un sol composé principalement de sable, et la présence de la nappe phréatique à -15m. Les résultats ne sont pas communiqués. Une seconde campagne à -50m est annoncée.
