Cascades Female Factory
South Hobart

Conservation Management Plan

Prepared for
Tasmanian Department of Environment, Parks, Heritage and the Arts

April 2008

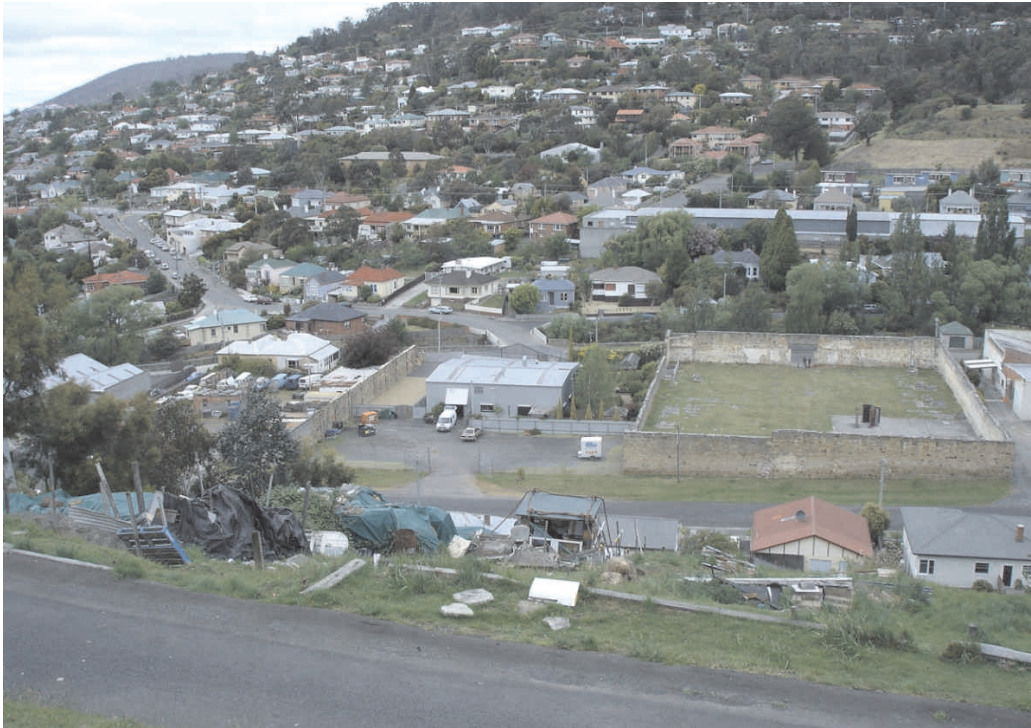
Figure 2 Elements of the former Cascades Female Factory, viewed from the north, with (from left to right) Yards 4, 3 (centre picture) and 1.

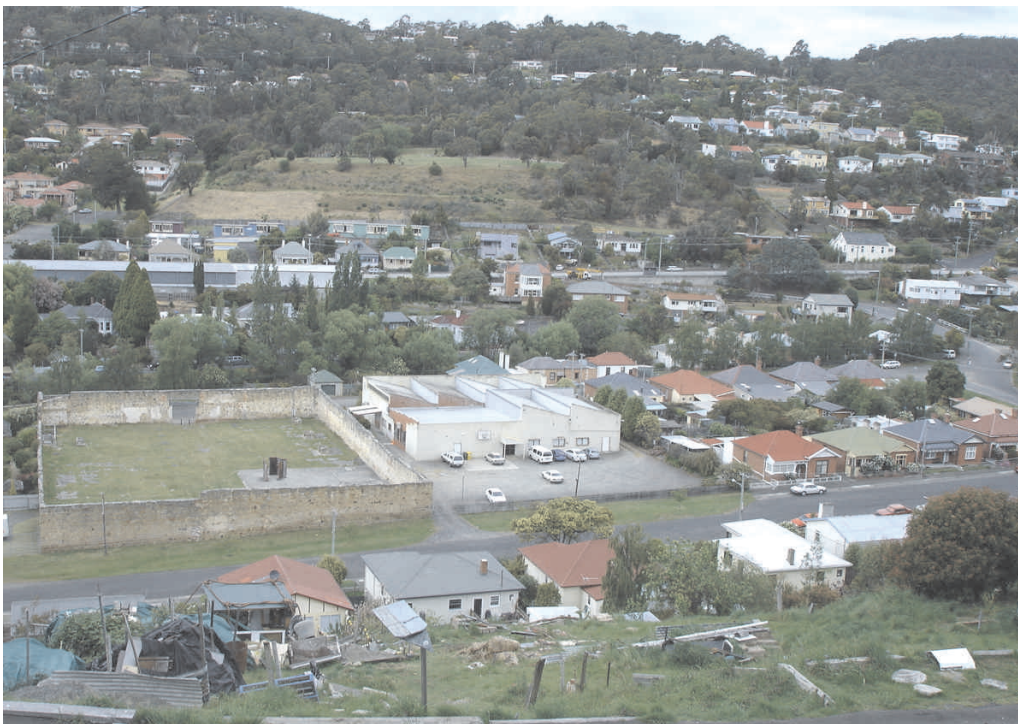
Figure 3 Elements of the former Cascades Female Factory, viewed from the north, with (from left to right) Yards 1, 2 (centre picture) and 5.

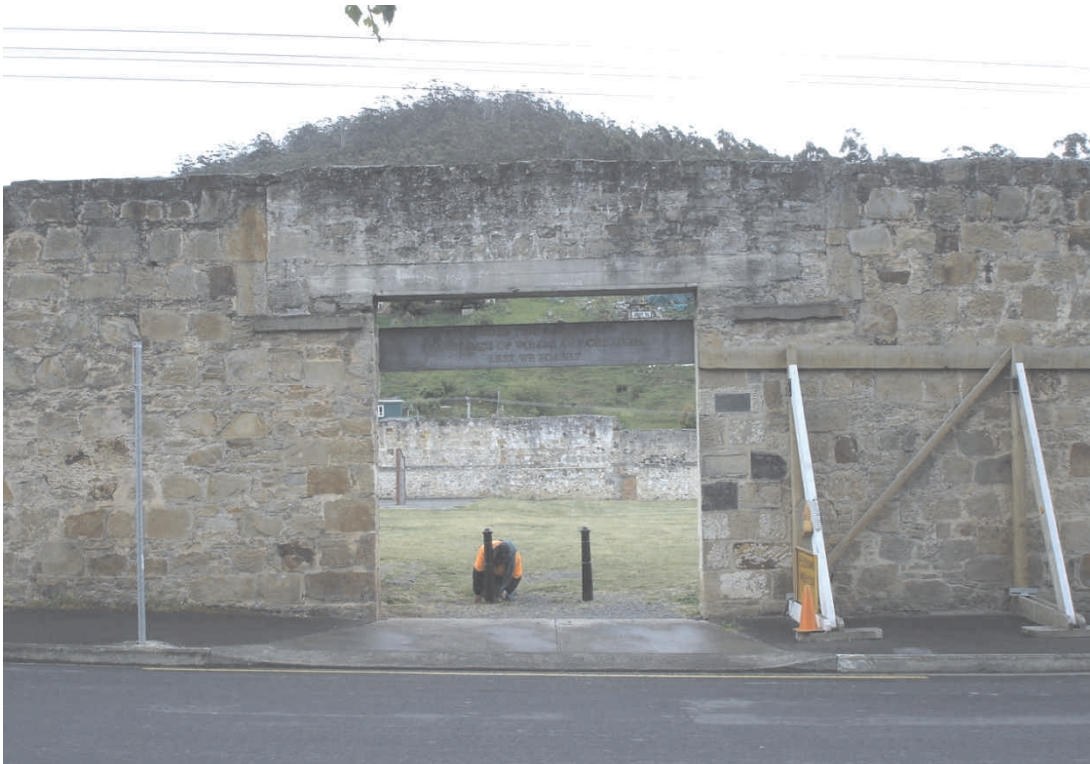
Figure 4 Entrance to Yard 1, Degraeves Street (south elevation).

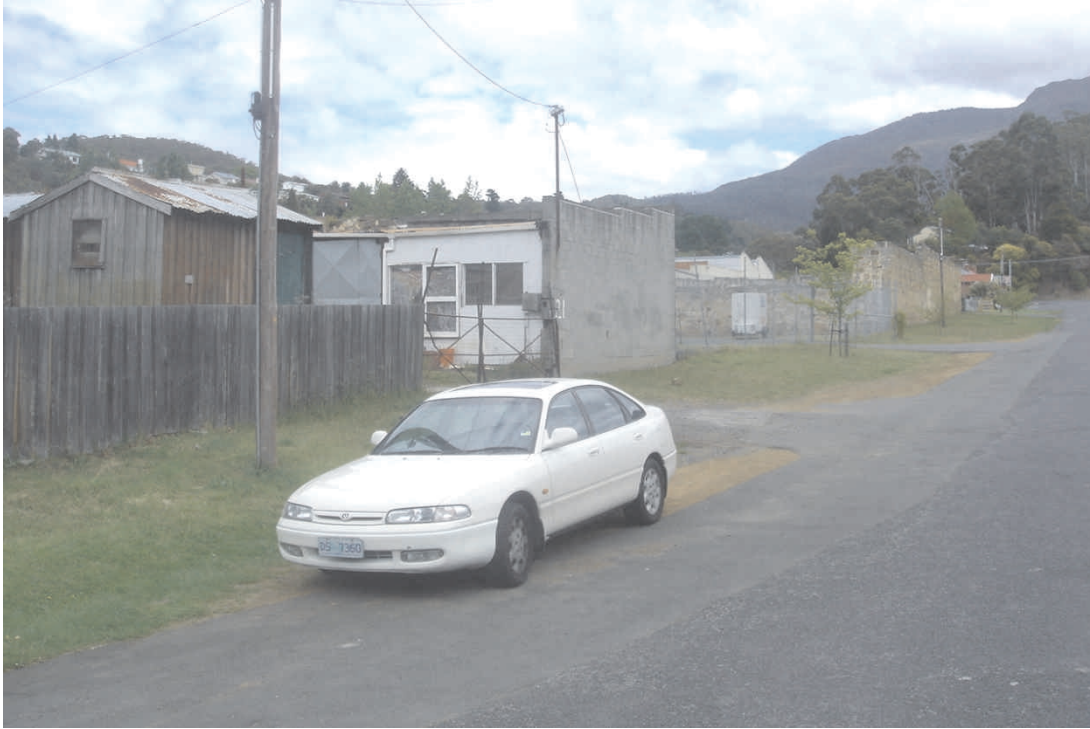
Figure 5 View of rears of former yards on Syme Street (north sides of properties) looking west (from left to right) Yards 4, 3 and 1 (walled yard in distance).

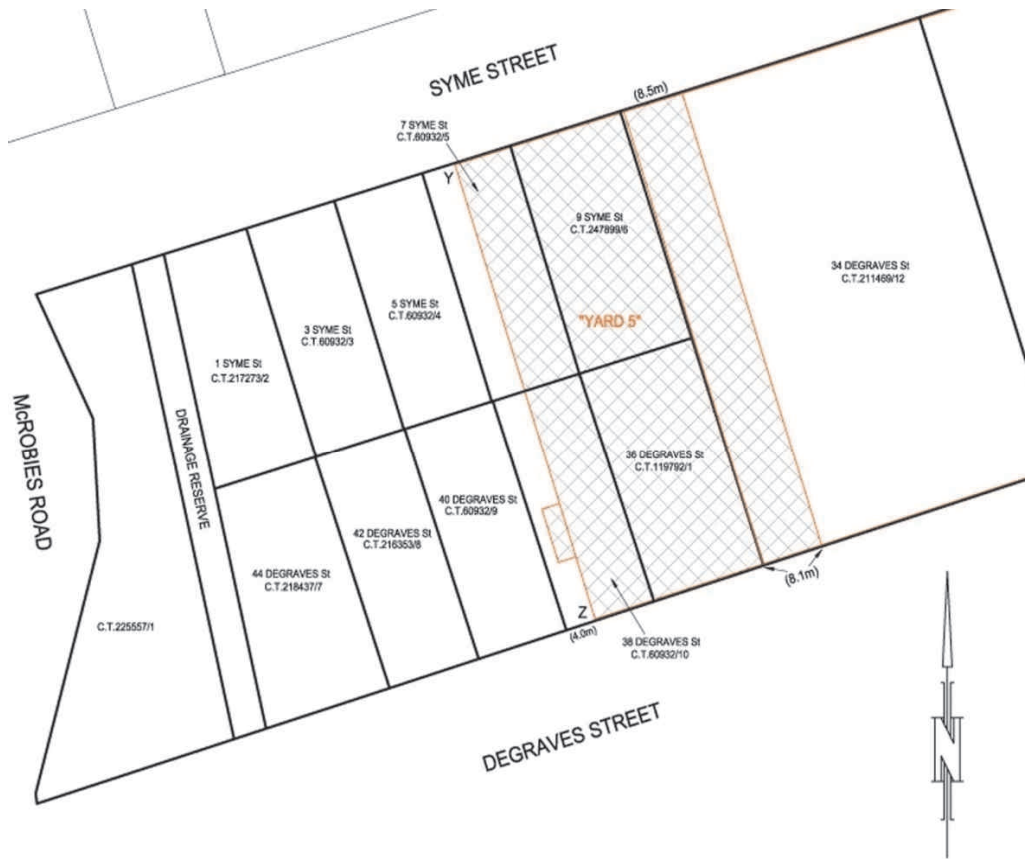
Figure 16 2007 survey plan prepared by Rogerson & Birch Surveyors for Heritage Tasmania, indicating Yard 5 boundary extending east into Yard 2.
Source: provided by Heritage Tasmania.

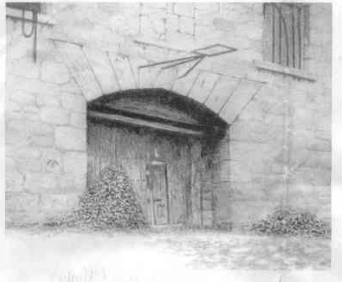
02	<p>Yard 1 perimeter wall</p> <p>A 60 x 41.5 metre wide enclosure wall surrounding the distillery building was originally built in c1824 but subsequently enlarged in c1829 as part of the Yard 1 re-fit. Today, the wall varies in height from 3.5 to 5.5 metres between its eastern and southern aspects. Constituent fabric consists of lime mortared ashlar/rubble sandstone with occasional brick or concrete block patching.</p>	<p>Surviving extant fabric</p>

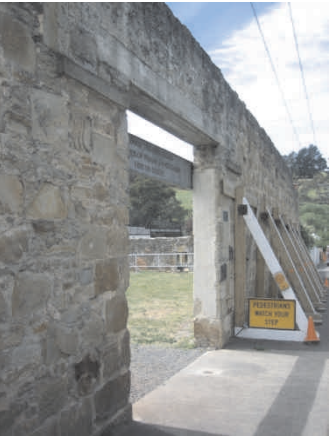
03	<p>Original distillery building</p> <p>10 x 15 metre long rectangular building erected in centre of Yard 1. This structure was reputedly the original distillery building erected by Thomas Lowes in c1824 but subsequently re-used as part of Yard 1 infrastructure until its demolition some time in the mid 19th century.</p>	<p>Potential surviving sub-surface footing and deposits</p>

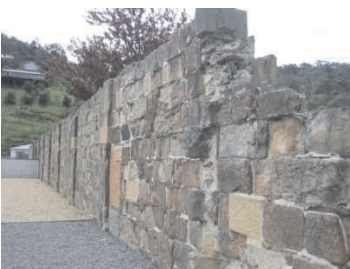
No.	Yard 3 Description	Context condition	Historic diagram/ photograph
33	<p>Yard 3 perimeter wall</p> <p>A 60 x 45 metre wide enclosure wall surrounding Yard 3 infrastructure was built when the yard was first laid out between c1842-1845. Today only the eastern and western walls survive to a general height of 4.5 metres. Constituent fabric consists of lime mortared ashlar/rubble sandstone with occasional brick or concrete block patching.</p>	Extant walls with patching

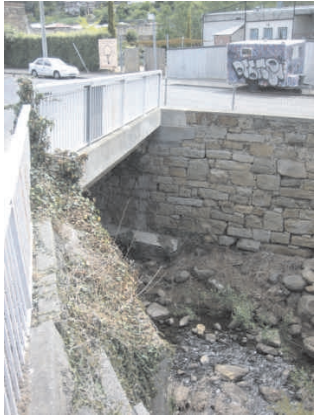
No	Associated Elements Description	Context condition	Historic diagram/ photograph
	<p>housing which occupies the site today.</p> <p>[The plan at right is the Cascades Factory, Hobart - Allotments on Reserve c.1859.¹²⁰]</p>		
75	<p>Degraves St. bridge and rivulet stone work</p> <p>A bridge was erected over the Hobart Rivulet south of Yard 3 near the Factory's opening in the late 1820s. It remained the principal means of access to the site until its closure in the 1890s. The bridge has subsequently been upgraded.</p>	Remnant stone work comprising abutments

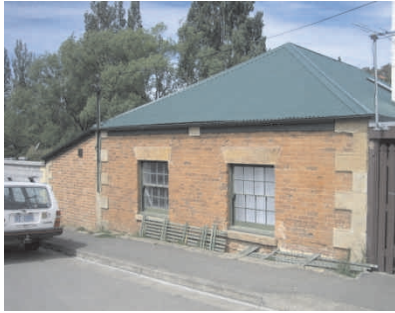
No	Associated Elements Description	Context condition	Historic diagram/ photograph
79	<p>Cottage (17 Degrares St)</p> <p>A building at this location appears in J. S. Prout's 1845 drawing of the Cascades area. It is assumed that this and neighbouring structures were used as staff quarters by the Female Factory facility. After that site's closure, this cottage along with the others was auctioned by the Crown.</p>	Extant structure

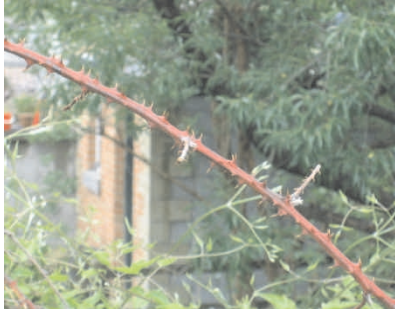
80	<p>Shed (17 Degrares St)</p> <p>A building at this location appears in J. S. Prout's 1845 drawing of the Cascades area. It is assumed that this and neighbouring structures were used as staff quarters by the Female Factory facility. After that site's closure, this property along with the others was auctioned by the Crown. Timber sheds in garden identified as out buildings for staff quarters</p>	Extant structure

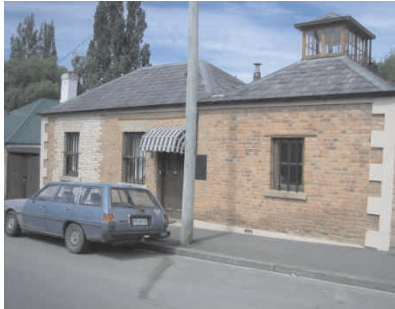
81	<p>Cottage (19 Degrares St)</p> <p>This structure first appears in plans dated 1859 and may therefore be related to the construction of Yards 4 and/or 5. It is assumed that this and neighbouring structures were used as staff quarters by the Female Factory facility. After that site's closure, this property along with the others was auctioned by the Crown.</p>	Extant structure

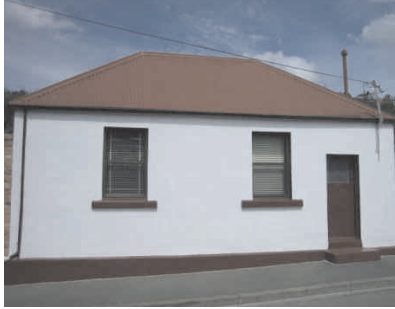
82	<p>Cottage (21 Degrares St)</p> <p>This structure first appears in plans dated 1892 and was auctioned along with the neighbouring cottages and Female Factory grounds in 1904. It is assumed that this and neighbouring structures were used as staff quarters by the Female Factory facility.</p>	Extant structure

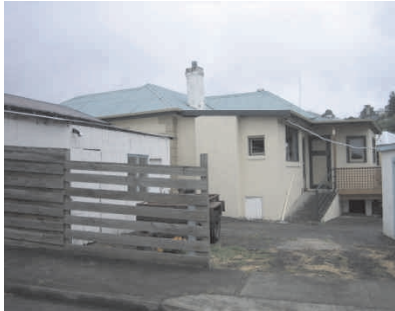
No	Associated Elements Description	Context condition	Historic diagram/ photograph
83	<p>Hope cottage (31 Apsley St)</p> <p>This structure first appears in plans dated 1859 and may therefore be related to the construction of Yards 4 and/or 5. It was named 'Hope Cottage' in 1896 when it became part of the Home of Mercy which operated out of Yard 4. The building was offered for sale by the Crown in 1904 along with the other parts of the Female Factory property.</p>	Extant structure

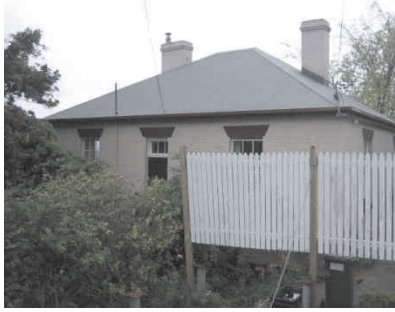
84	<p>Superintendents cottage (3 Apsley St)</p> <p>This house is rumoured to have housed the Superintendent of the Female Factory in c1840 and was described as such when it was offered for sale in 1990.</p>	Extant structure

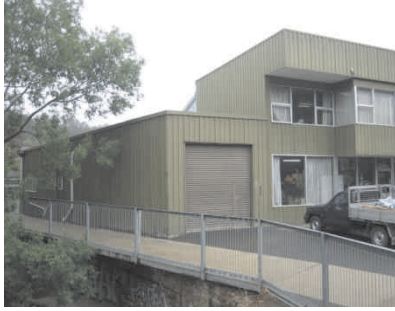
85	<p>Home of Mercy site</p> <p>This structure first appears in plans dated 1859 and may therefore be related to the construction of Yards 4 and/or 5. It was later occupied as part of the Home of Mercy which operated out of Yard 4. The building was offered for sale by the Crown in 1904 along with the other parts of the Female Factory property.</p> <p>This building survived until c.1970 when it was demolished and a new factory was built on the site.</p>	Surviving sub-surface footing?

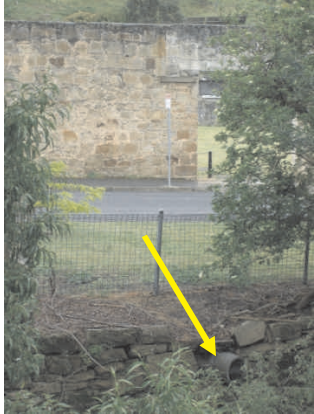
No	Associated Elements Description	Context condition	Historic diagram/ photograph
86	<p>Yard 3 underground storm water piping system</p> <p>Sandstone/masonry lined storm water drainage network from Yard 1 and/or 2 discharging into Hobart Rivulet. A similar better documented system is recorded in Yard 3 and appears as feature 38.</p>	Surviving sub-surface archaeological feature

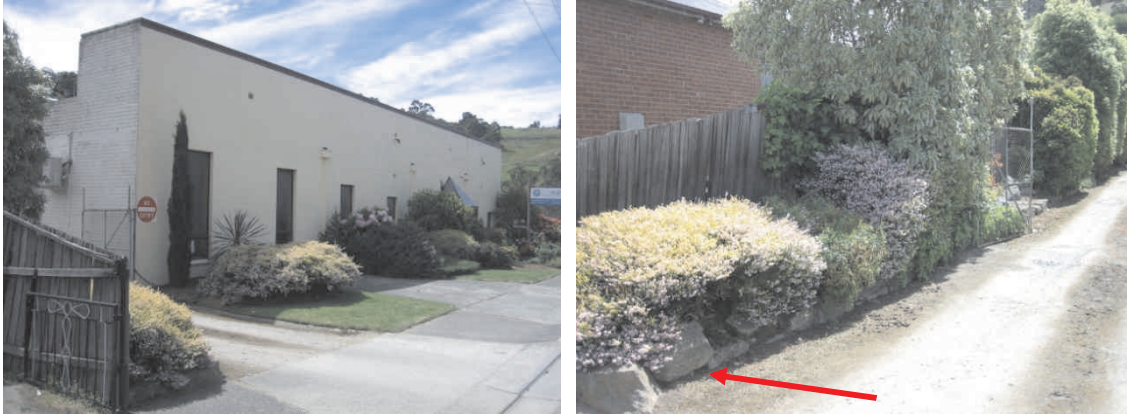
Figure 20 Current views of the church building and the western driveway boundary of the church property. Note the in situ sandstone wall footing running the length of the driveway.

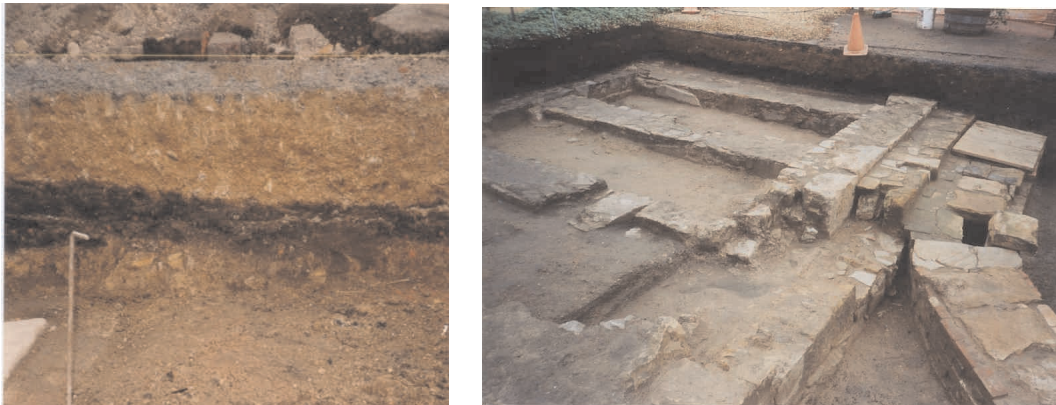
Figure 21 Views showing depth of overburden/fill and resulting solitary apartment footings from test excavations in Yard 3.

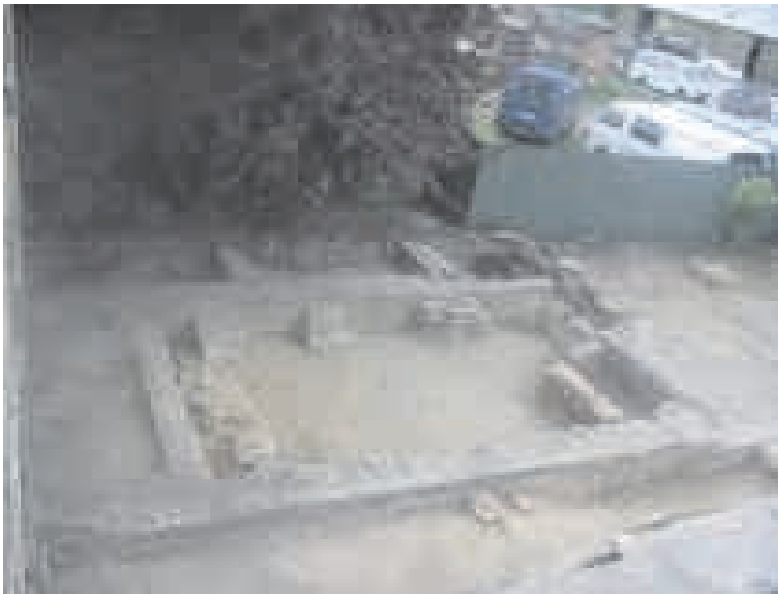
Figure 23 View of Yard 4 South excavation prior to backfilling. Note intact Cookhouse and Nursery footings striking north (top of picture) beneath property boundary.

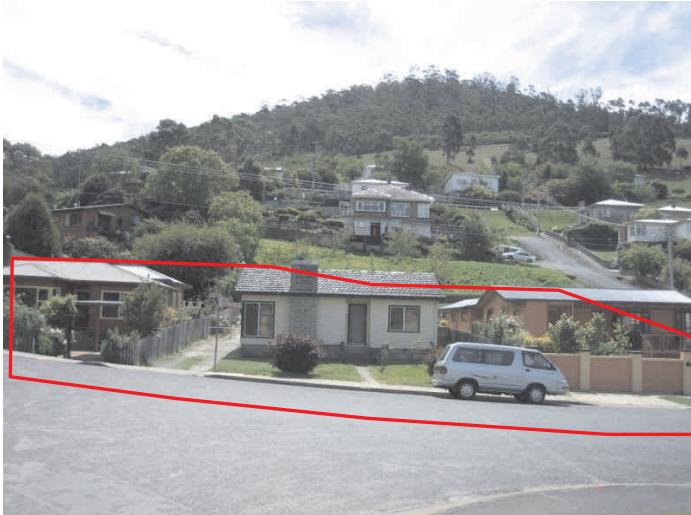
Figure 25 Northerly view showing housing allotments formerly comprising Female Factory cemetery site (bounded by red line).

Certainly the latter activity would suggest that no disinterment program was undertaken prior to the cemetery's closure. Given that the cemetery was deemed to be full when it closed in 1876, many burials should still remain *in situ* beneath the back yards of the houses there. As such, the archaeological potential of this site is still deemed to be HIGH.

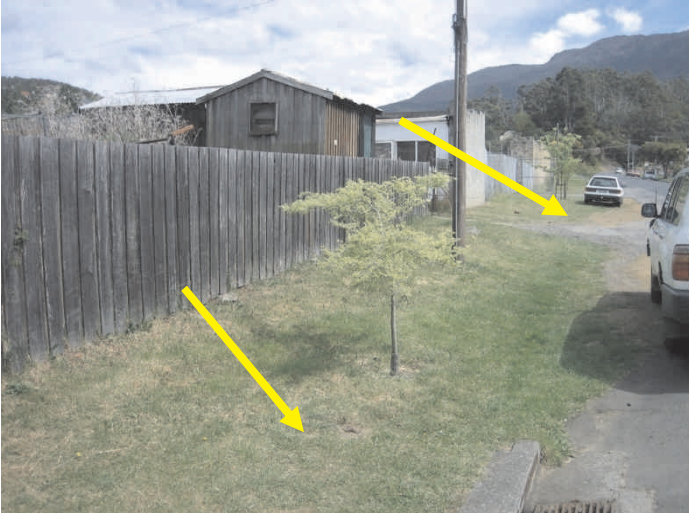
Figure 26 Westerly view along Syme Street showing grassed roadside verge where Yard 4 toilets and Yard 2 cesspool respectively were situated.

Some minor infrastructure related to the various Female Factory yards, which may also have been associated with the later use of the site, was situated beyond the perimeter walls, including cesspits, toilets and gardens. Some structural vestiges of these might possibly survive on the road-side verges. However, given their modesty of construction, the overall archaeological potential for these features/localities is deemed to be LOW.

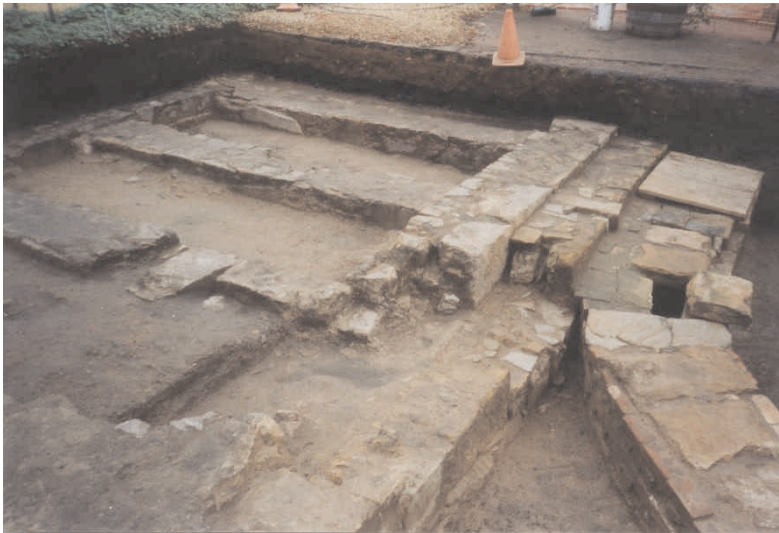
Figure 31 View of Yard 3 excavation undertaken by Kostoglou (2002). This image shows exposed footings shortly after excavation.

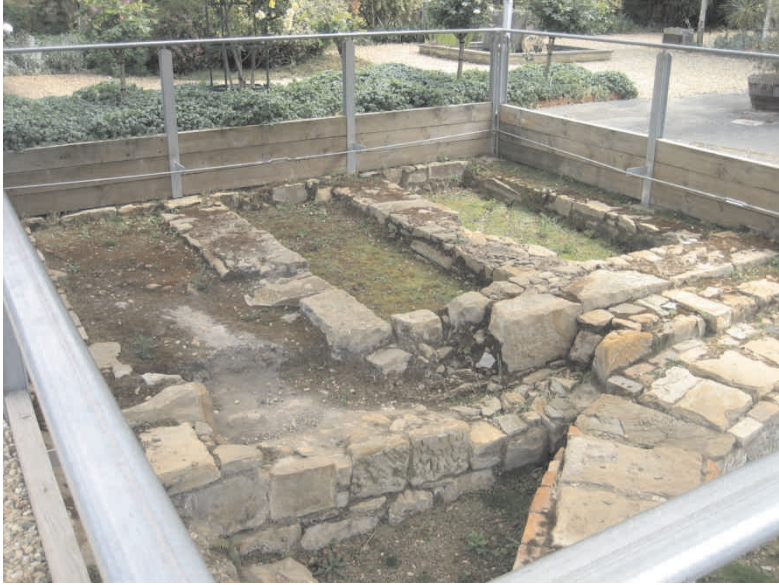
Figure 32 This image shows the same view today. Note vegetation encroachment and mortar deterioration both due to excessive rainwater.
