Woolmers Estate

Longford, Tasmania

Conservation Management Plan

Date:
Revised –9th January 2008

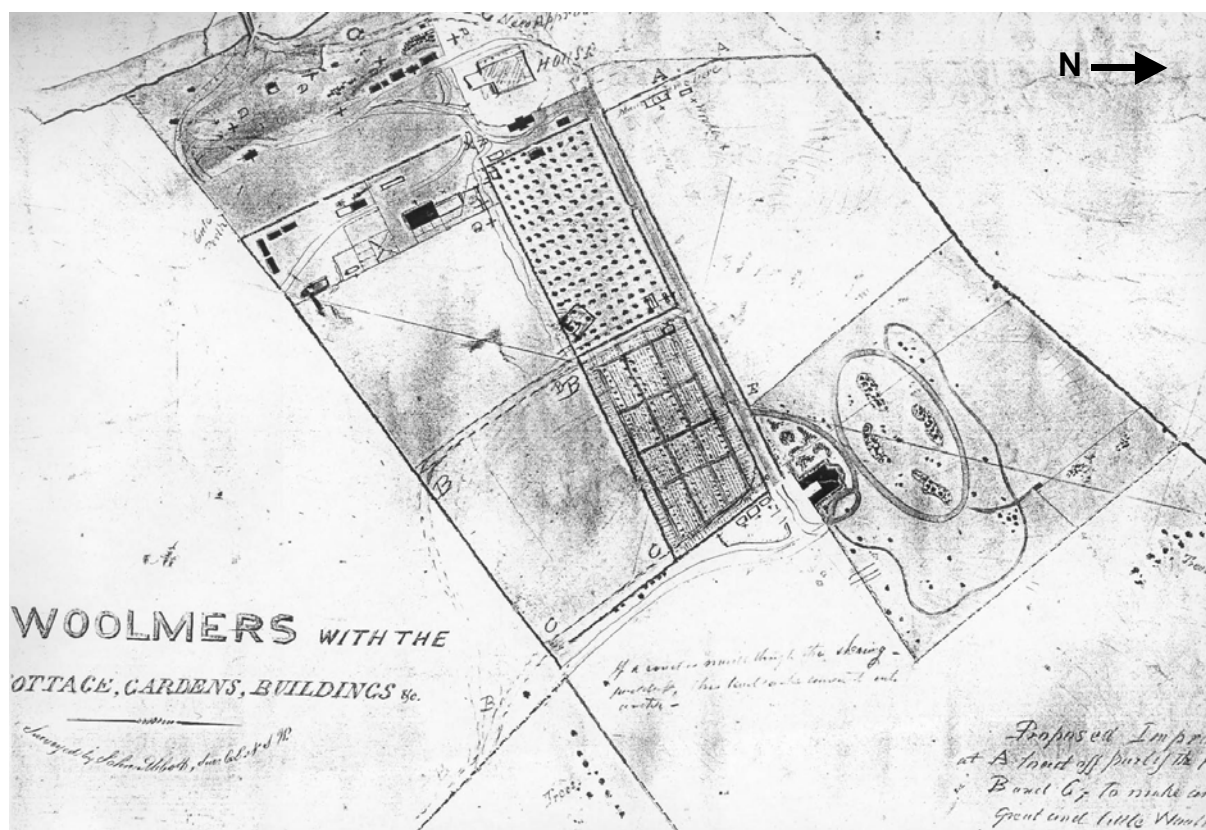
Figure 2. 1: 1840s plan of Woolmers showing the main house, Woolmers Cottage, the outbuildings, and the layout of drives, gardens, and the orchard.
(Source: Woolmers Collection)

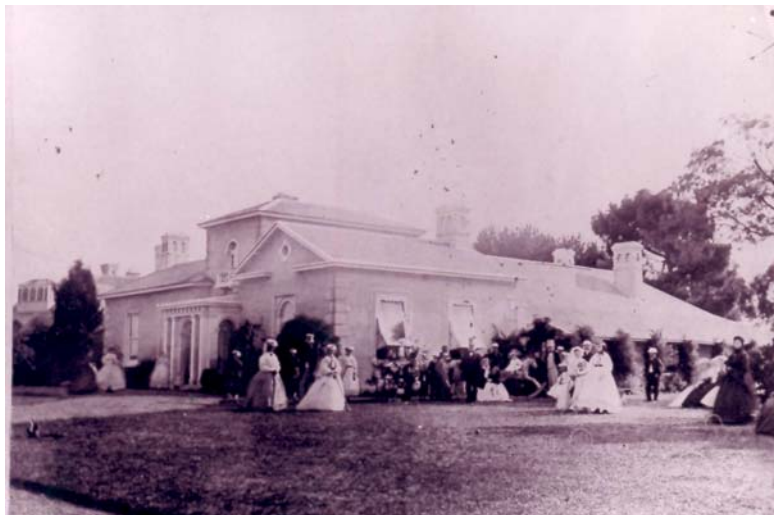
Figure 2. 3: The main house at Woolmers following the 1845 Italianate style additions by William Archer. The original unaltered section of the house is to the right. Undated photograph, possibly taken to coincide with the visit of the Duke of Edinburgh to Woolmers in 1868.
(Source: Woolmers Collection)

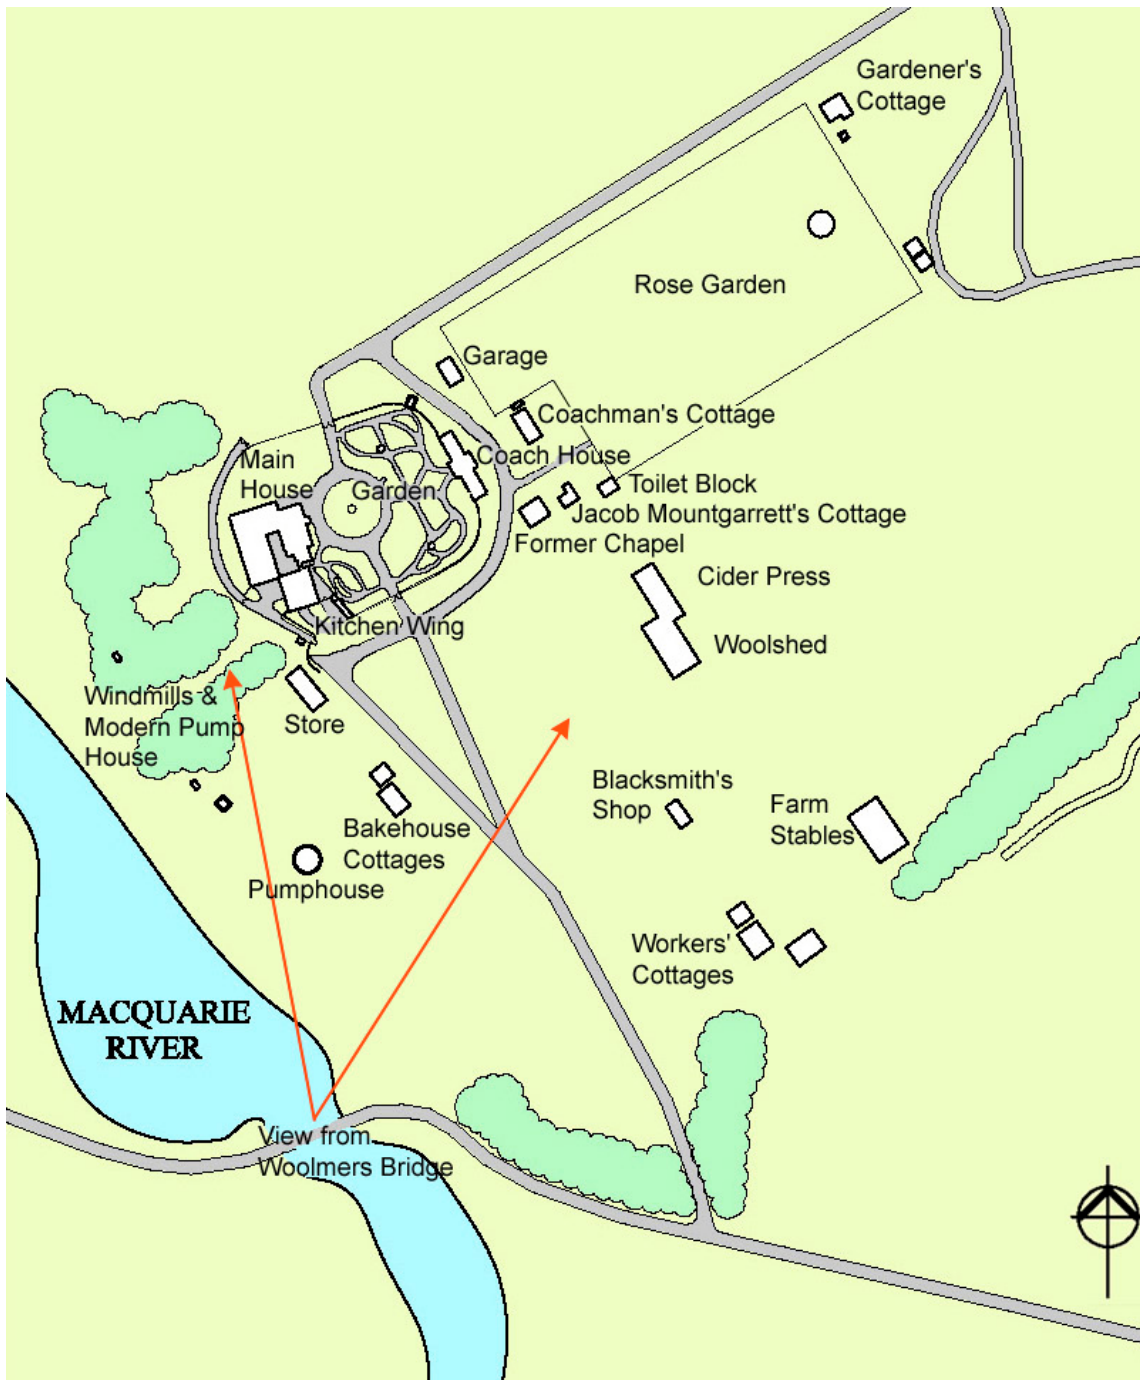
Figure 3. 6: Diagram showing views from Woolmers Bridge.

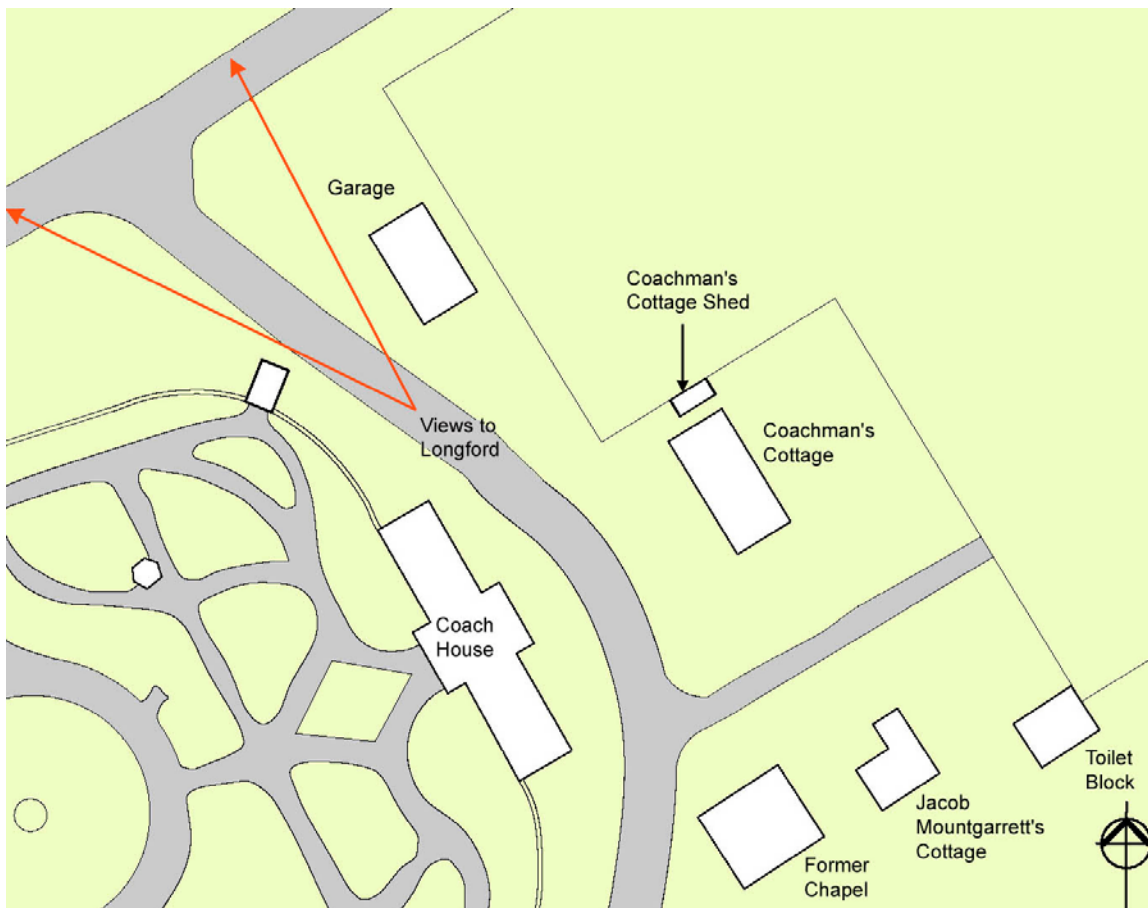
Figure 3. 9: Diagram showing views from the Coach House Precinct.

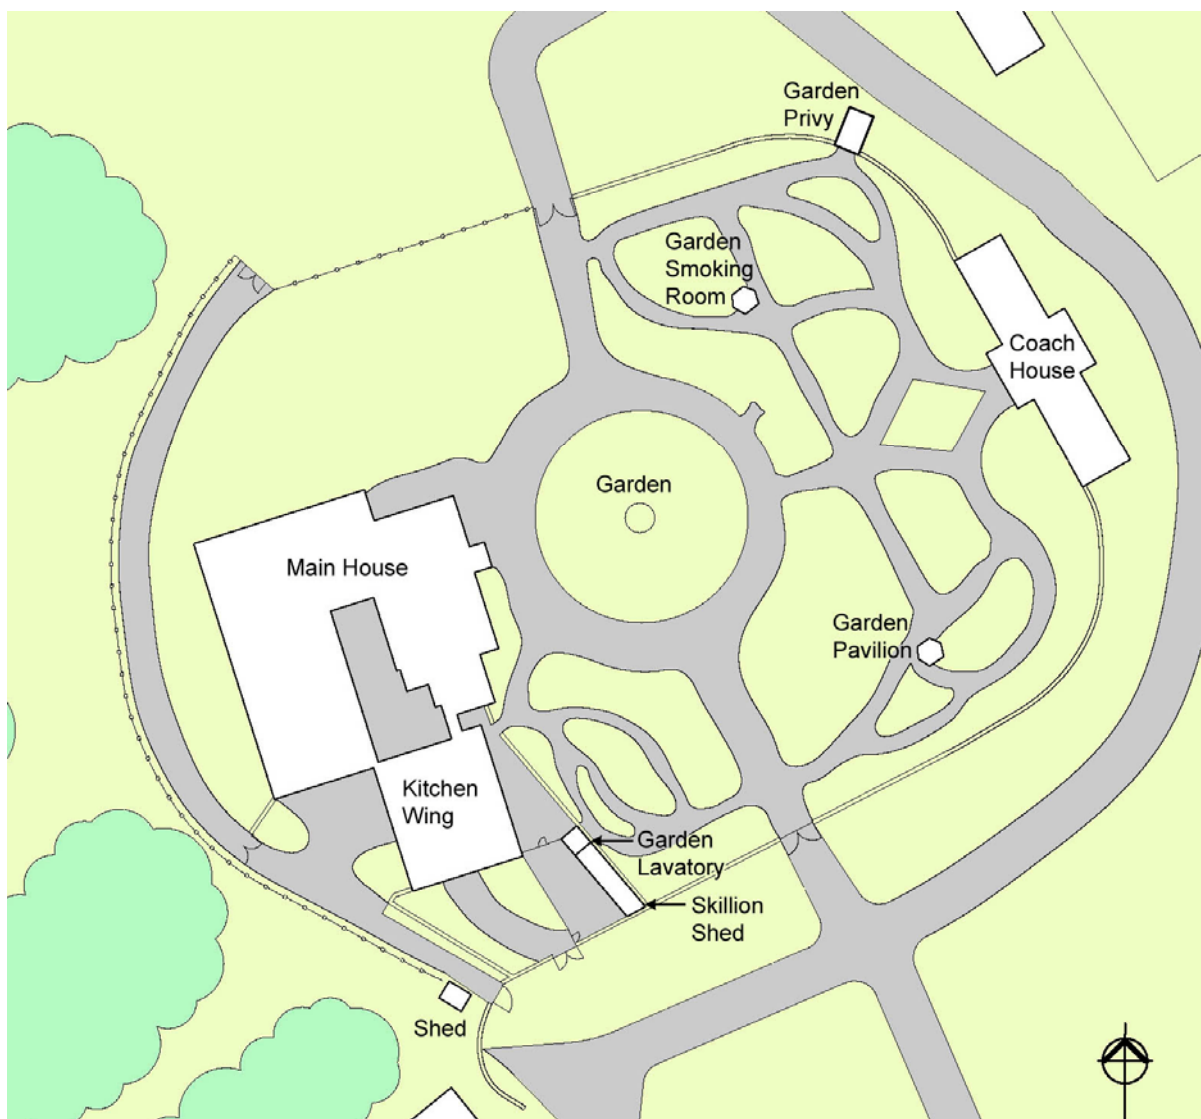
Figure 3. 14: Building and features in the House Precinct.

The main house precinct is located in the north-west corner of the site and contains the main house, kitchen wing buildings (including the shed and skillion shed), the garden and associated garden structures. The curved garden wall clearly separates the main house precinct from the remainder of the site.

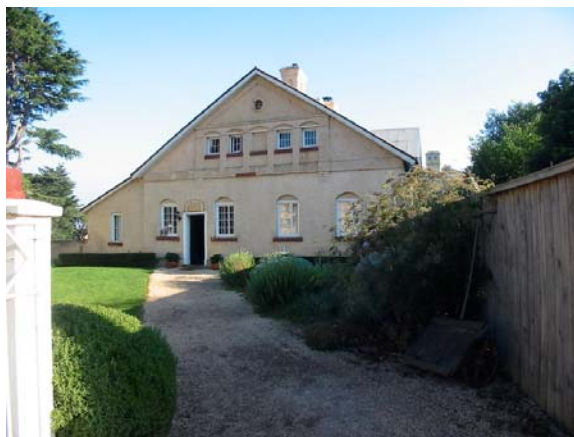
Figure 3.16: Kitchen Wing

The **kitchen wing**, built in 1847, continues the Italianate themes of the main house. It is a two-storey building, built of brick, with a roughcast finish and a gabled corrugated iron roof. The facades facing the garden and outbuildings are more elaborate with decorative recessed arches on the first and ground floors. The building also features elaborate Italianate chimneys and a pyramidal roofed skylight. The kitchen wing building is located to the south of the main house and forms the fourth wall of the central courtyard. The garden wall also encloses an area to the south and west of the kitchen wing forming a kitchen garden front.

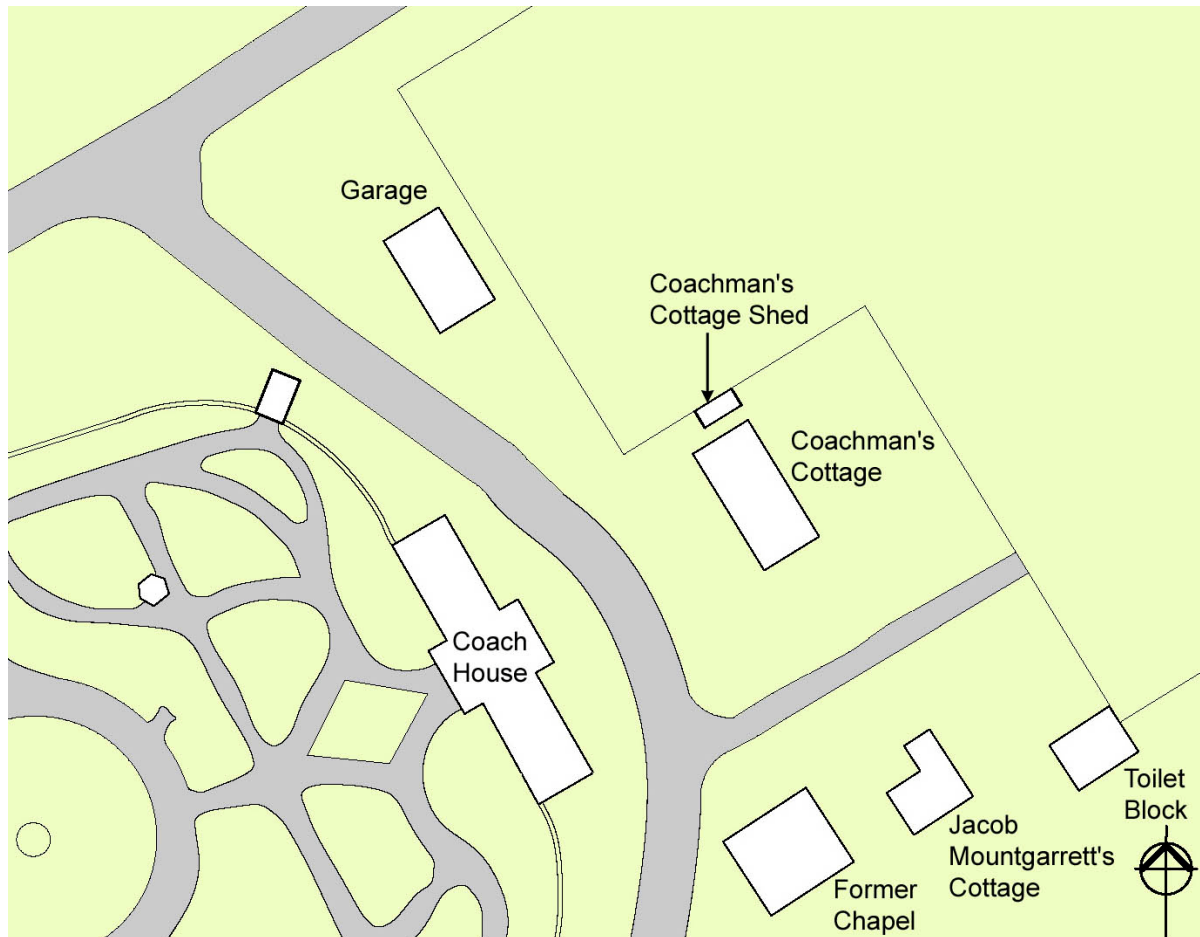
Figure 3. 20: Building and features in the Coach House Precinct.

The coach house precinct is located to the east of the main house precinct and contains the coach house, coachman's cottage, garage, coachman's cottage shed, former chapel, Jacob Mountgarrett's cottage and the new lavatory block. It is bounded by the drive leading from Pashanger Road to the main house via Woolmers Cottage to the north, the curved garden wall to the west and the rose garden to the east.

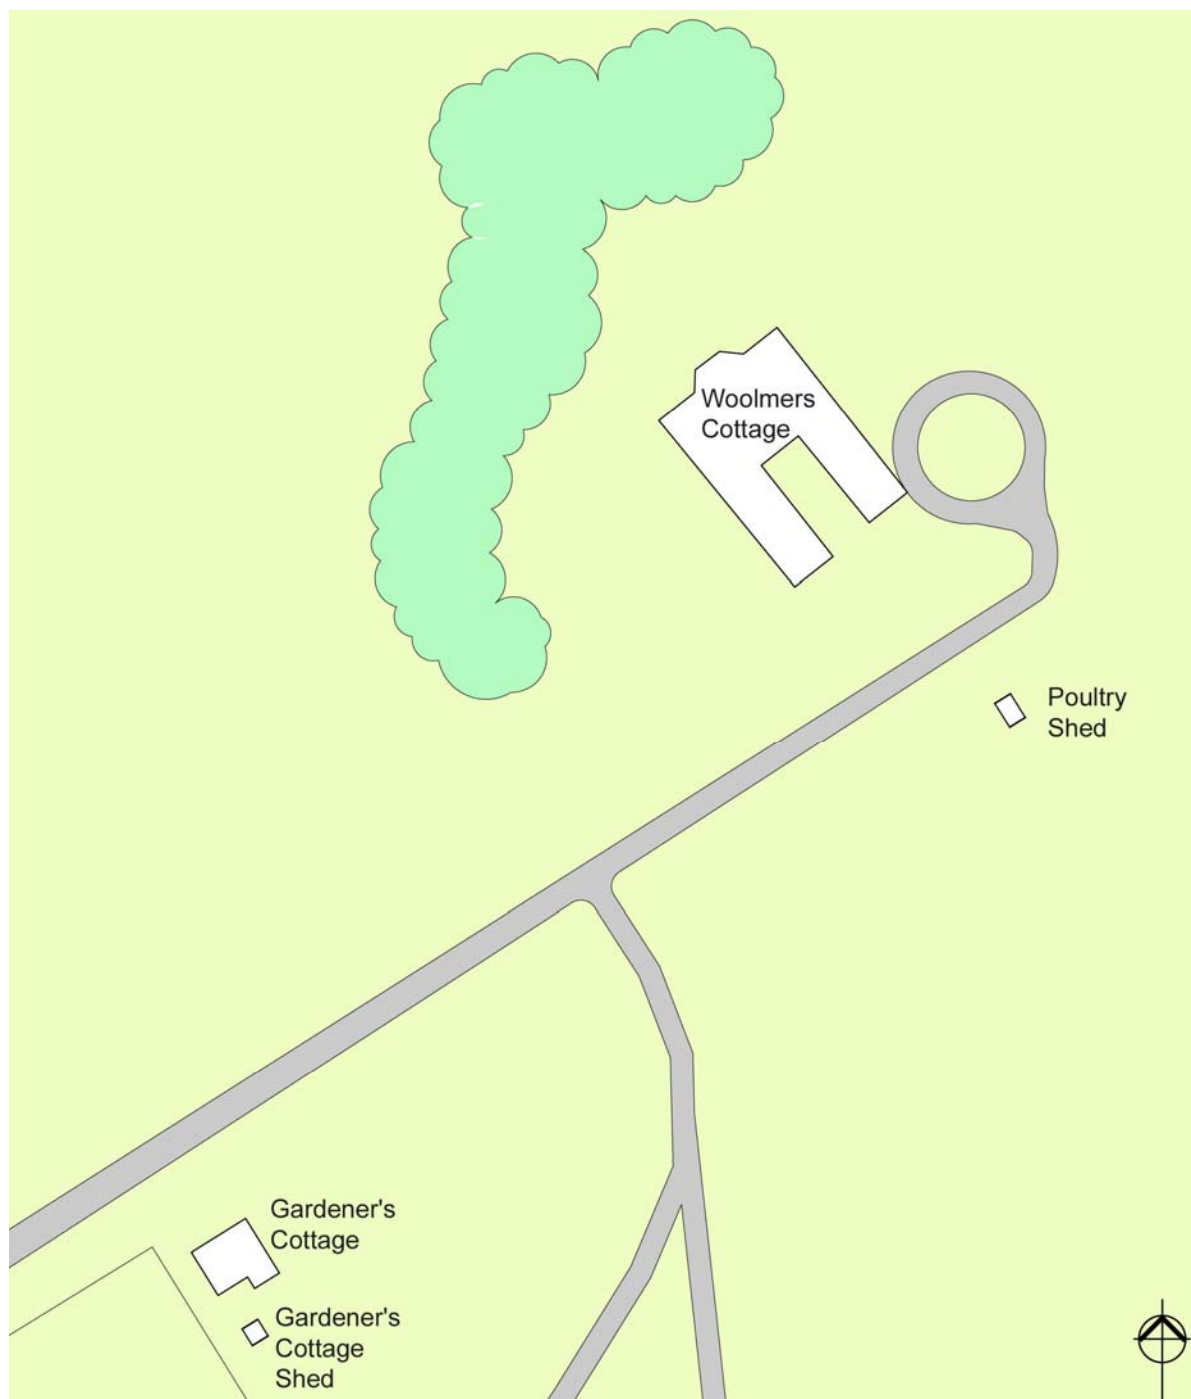
Figure 3. 28: Buildings and features in the Cottage Precinct.

This precinct is defined so as to include both Woolmers Cottage and the gardener's cottage.

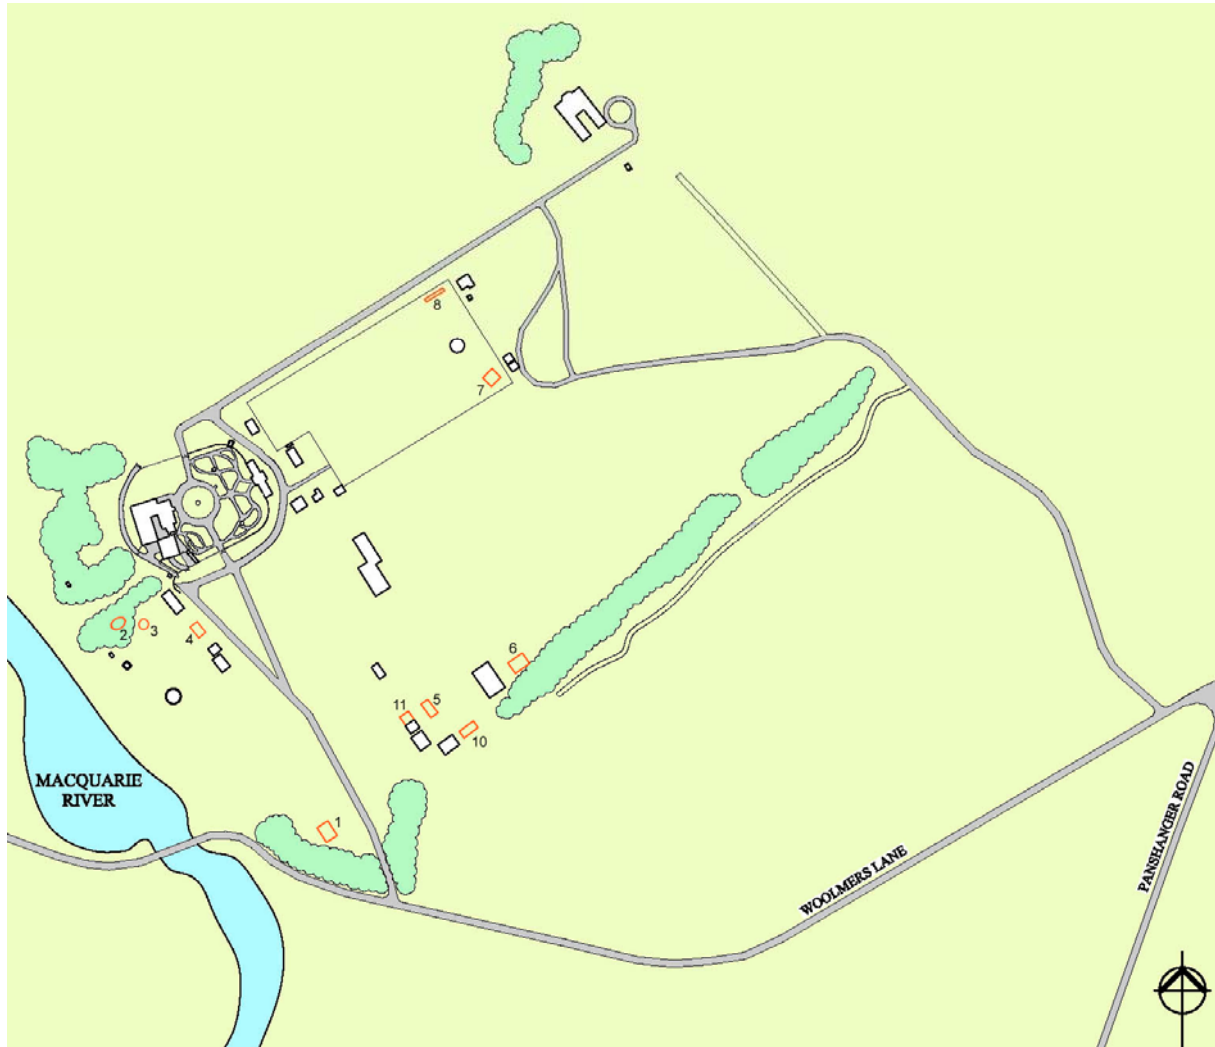
Figure 3. 46: Diagram showing location of known former structures

See Figure 3. 46 below for the location of known former structures at Woolmers.

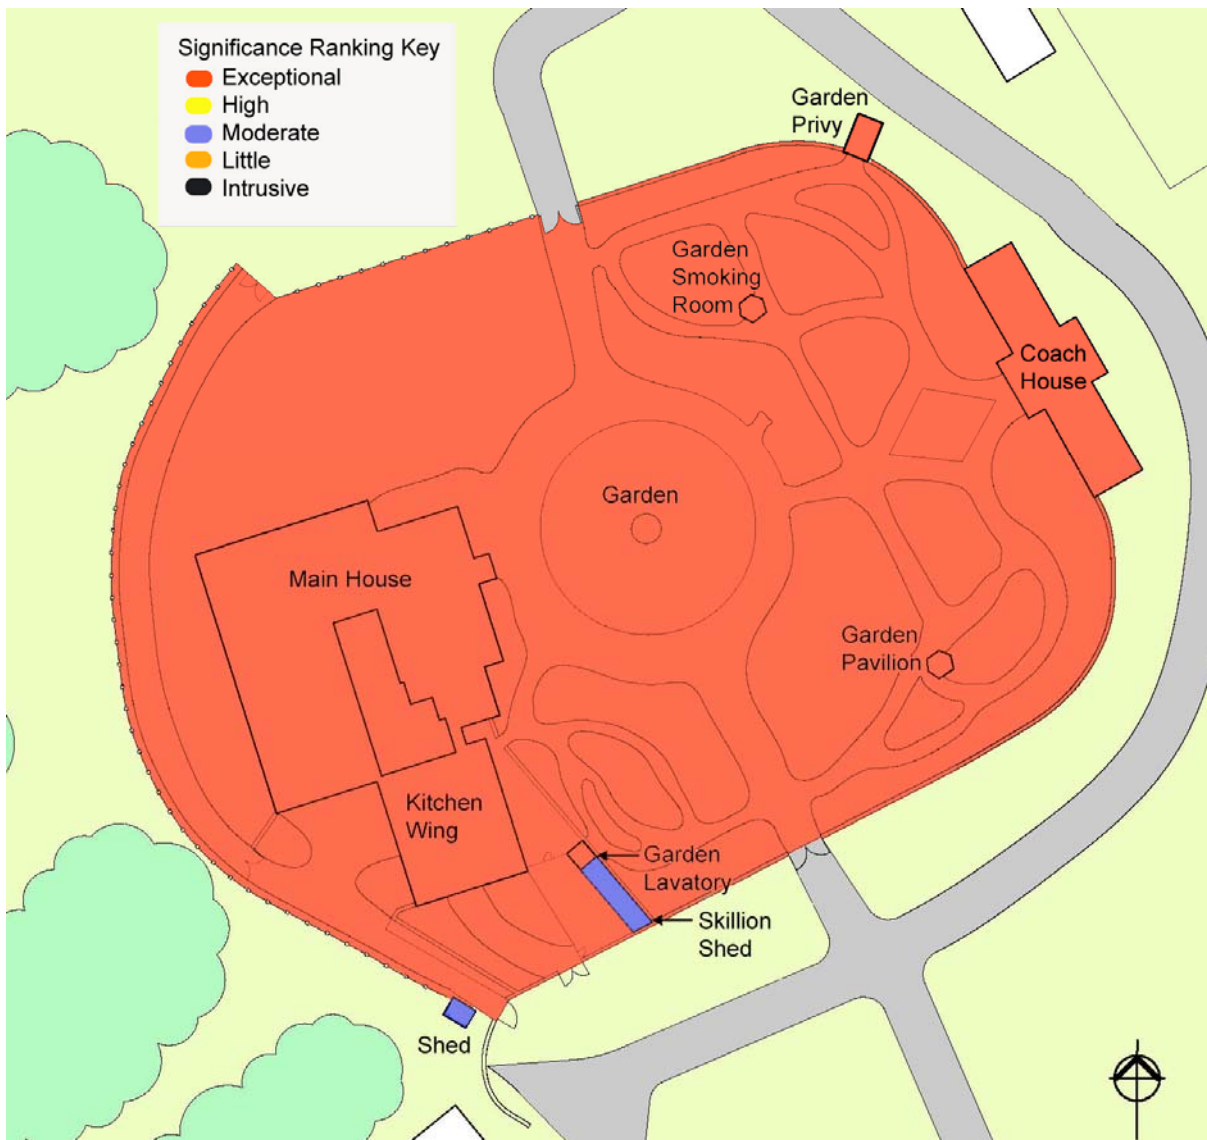
Figure 5. 2: Significance ranking of individual buildings and features within the House Precinct.

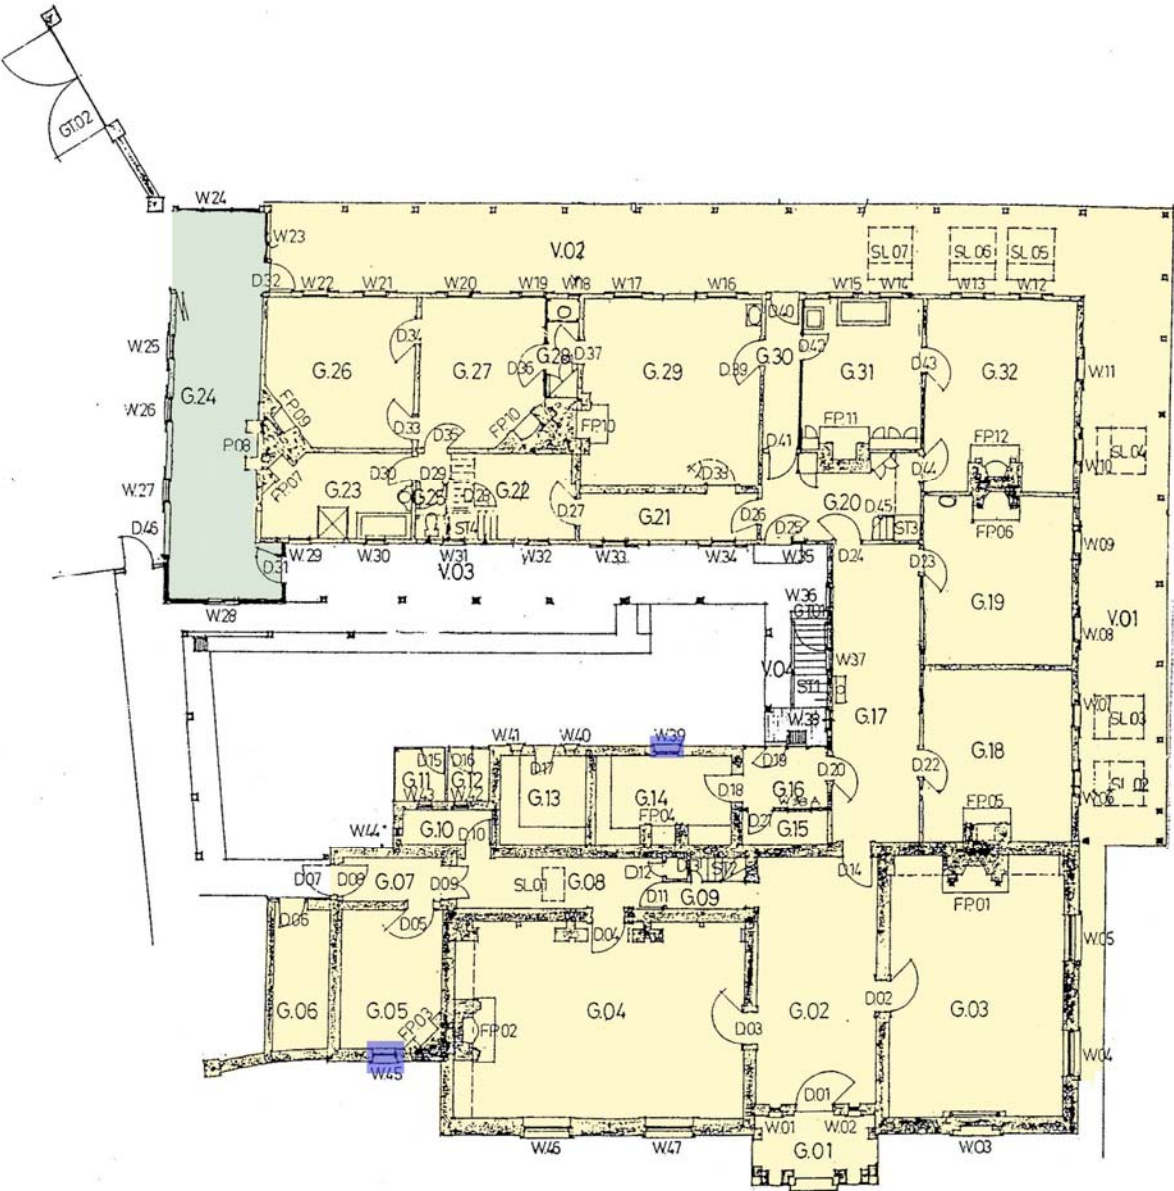
Ground floor plan of Main House showing significance ranking of interior spaces

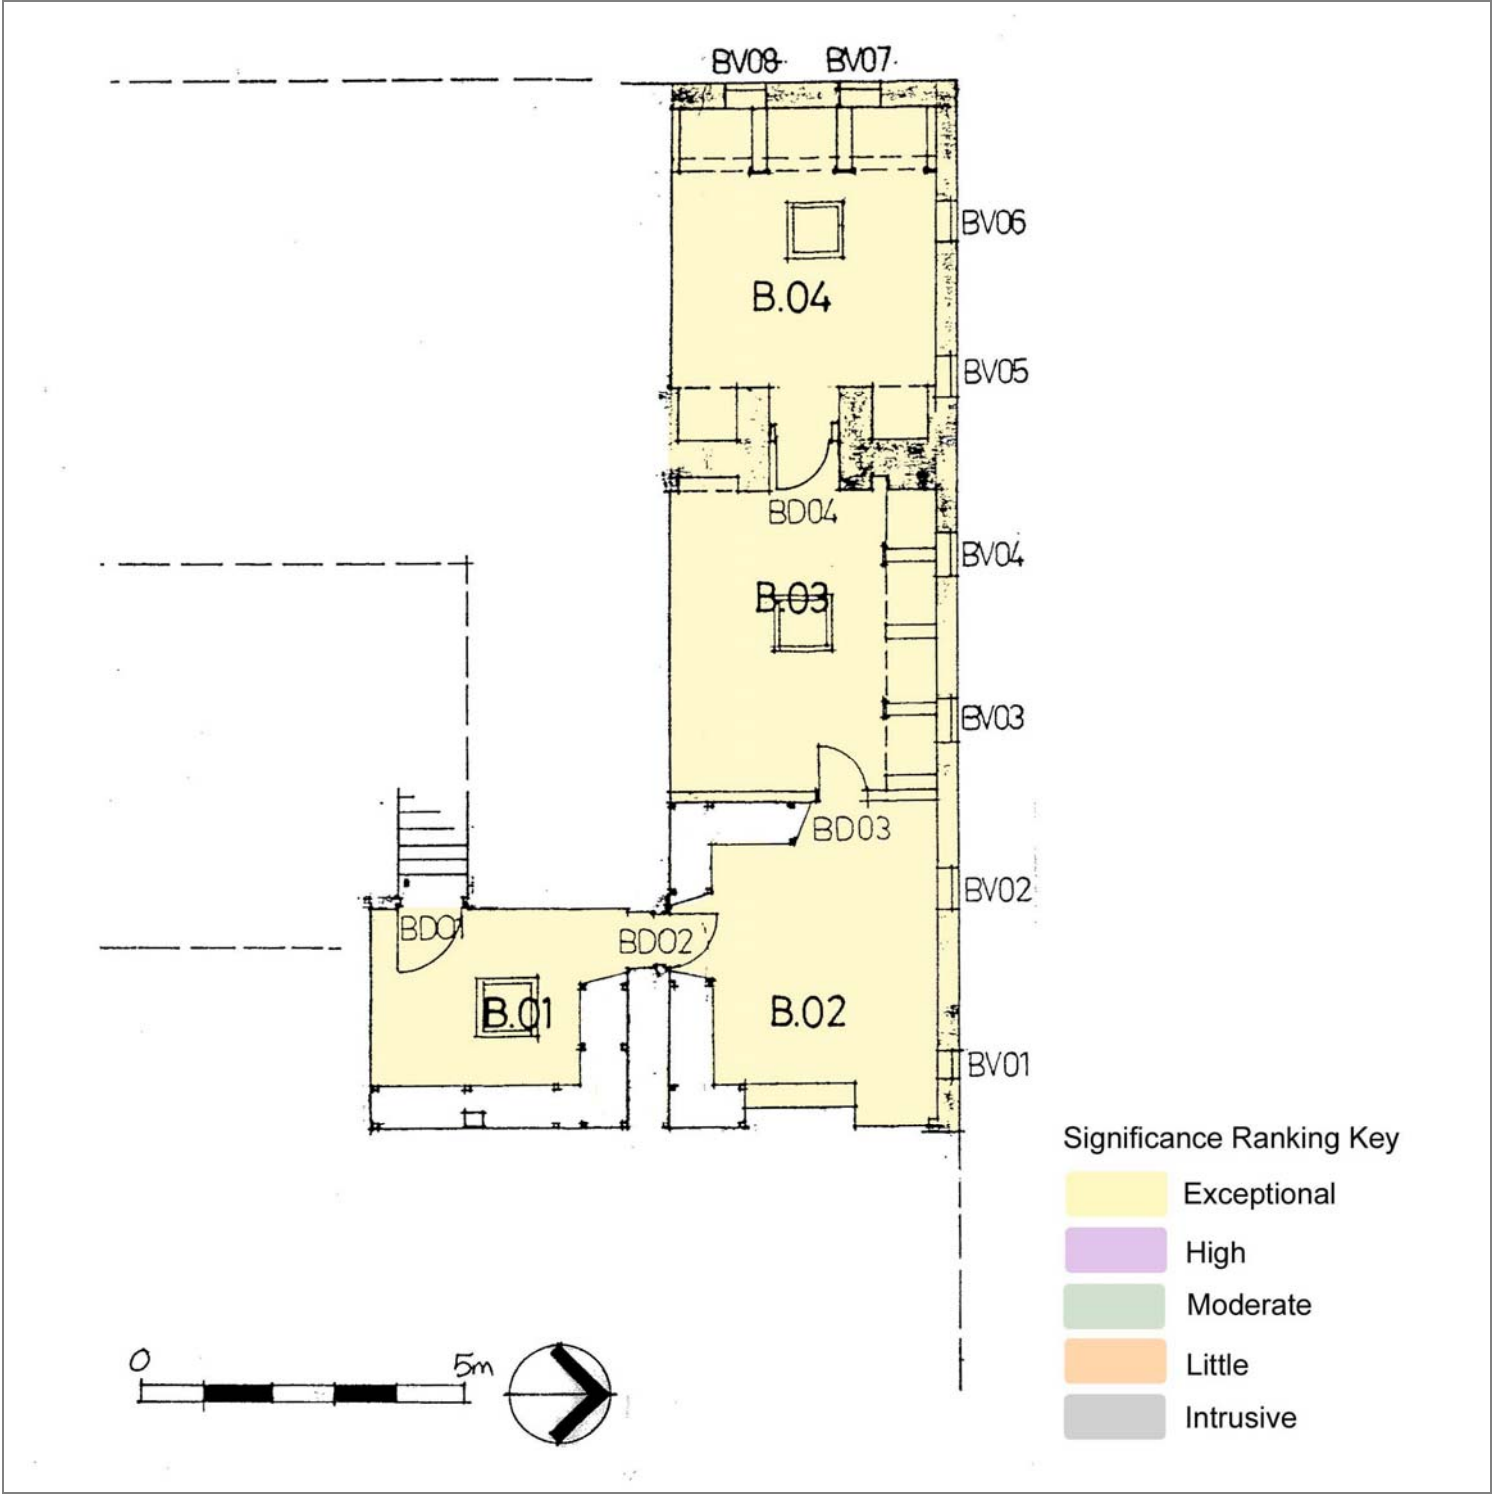
Basement floor plan of Main House showing significance ranking of interior spaces

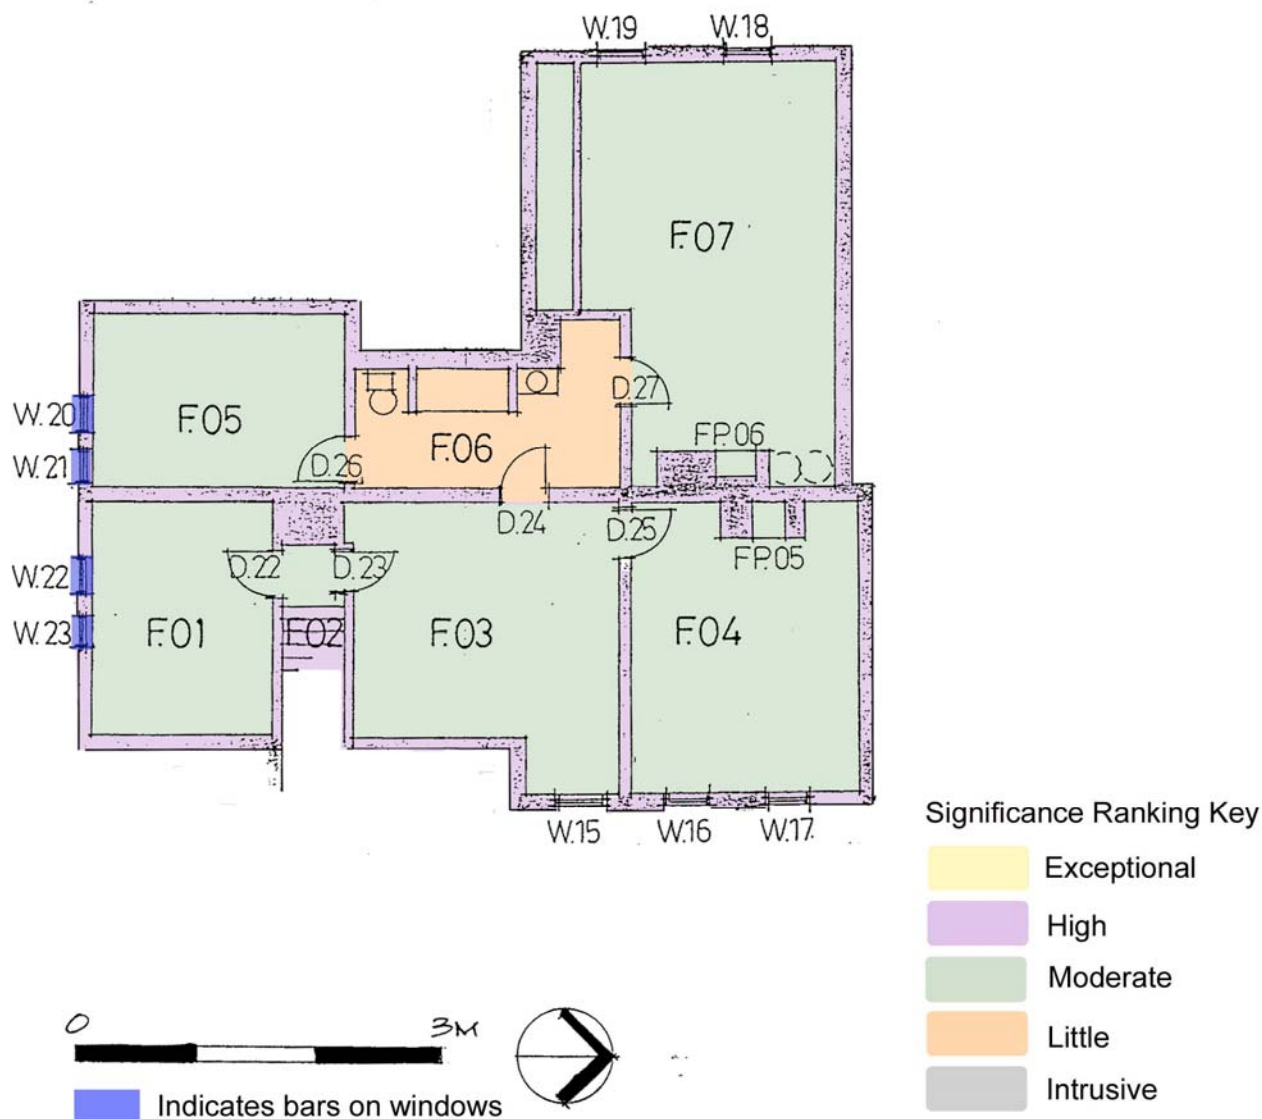
First floor plan of Kitchen Wing Buildings showing significance ranking of interior spaces

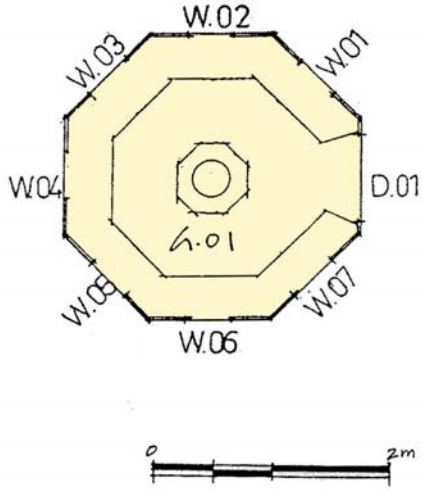
<p>Ground floor plan of Garden Pavilion showing significance ranking of interior spaces</p>

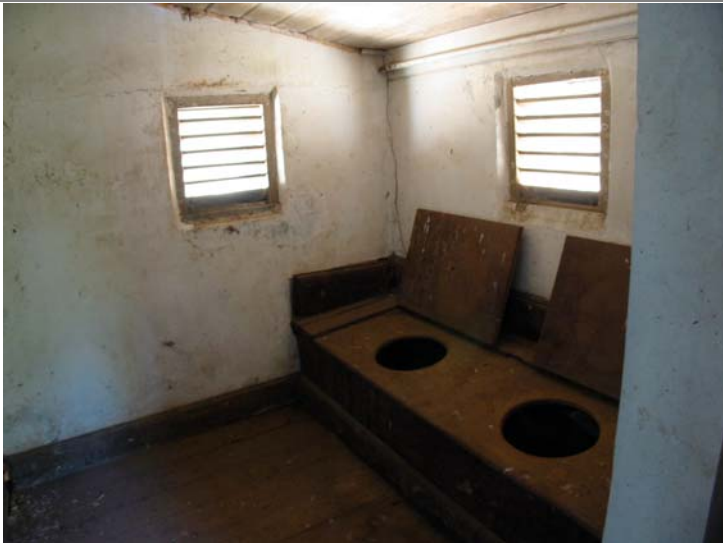
Garden Privy with double thunderbox		
HISTORY					
Historical Notes:		The garden privy was built 1845, contemporary with the garden wall. It is largely intact with its double thunderbox. In the 1890s the garden lavatories were recalled to be “so deep and dangerous that no women or children were allowed to visit them.” (“A Tasmanian Childhood” memoirs Dorothy Mona Halkerston nee Kermode, AOT)			
Key Date:		1845 (Items marked O are original to this date)	Abbreviations:		O = Key date M = Modern (Post 1942)
					N =19 th Century E = Early 20 th Century
PHYSICAL DESCRIPTION					
Exterior:		Roof: Morewood and Rogers tiles, O; no gutter Walls: painted face brick, parapets to north, east, west, small opening to south side to empty pan, O Other feature: timber cleats on east wall for tie rods Condition: fair Significance ranking: exceptional

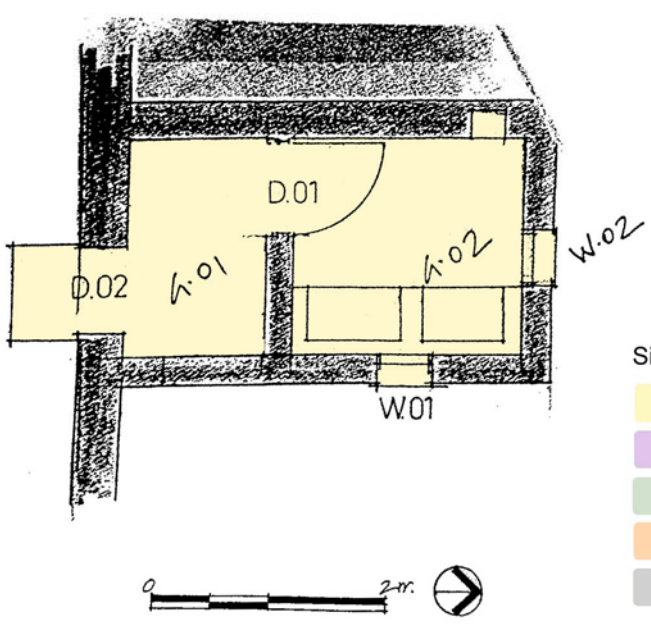
<p>Ground floor plan of Garden Privy showing significance ranking of interior spaces</p>

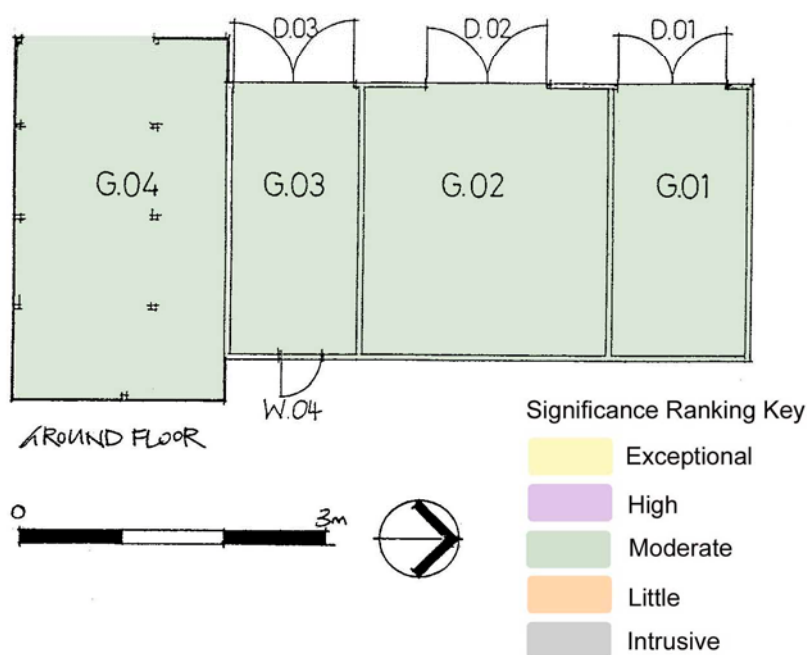
Ground floor plan of Garage showing significance ranking of interior spaces

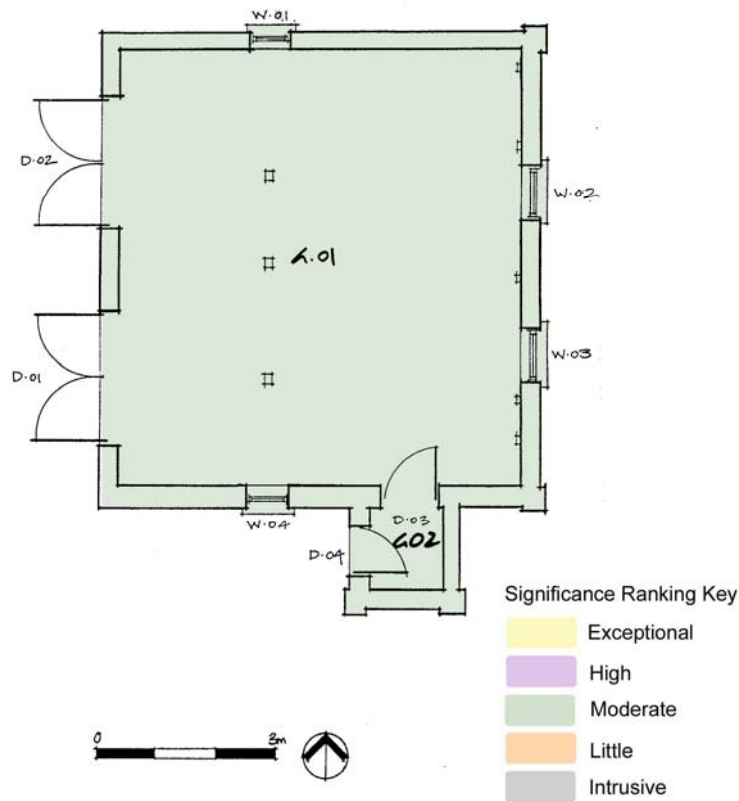
Ground floor plan of Former Chapel showing significance ranking of interior spaces

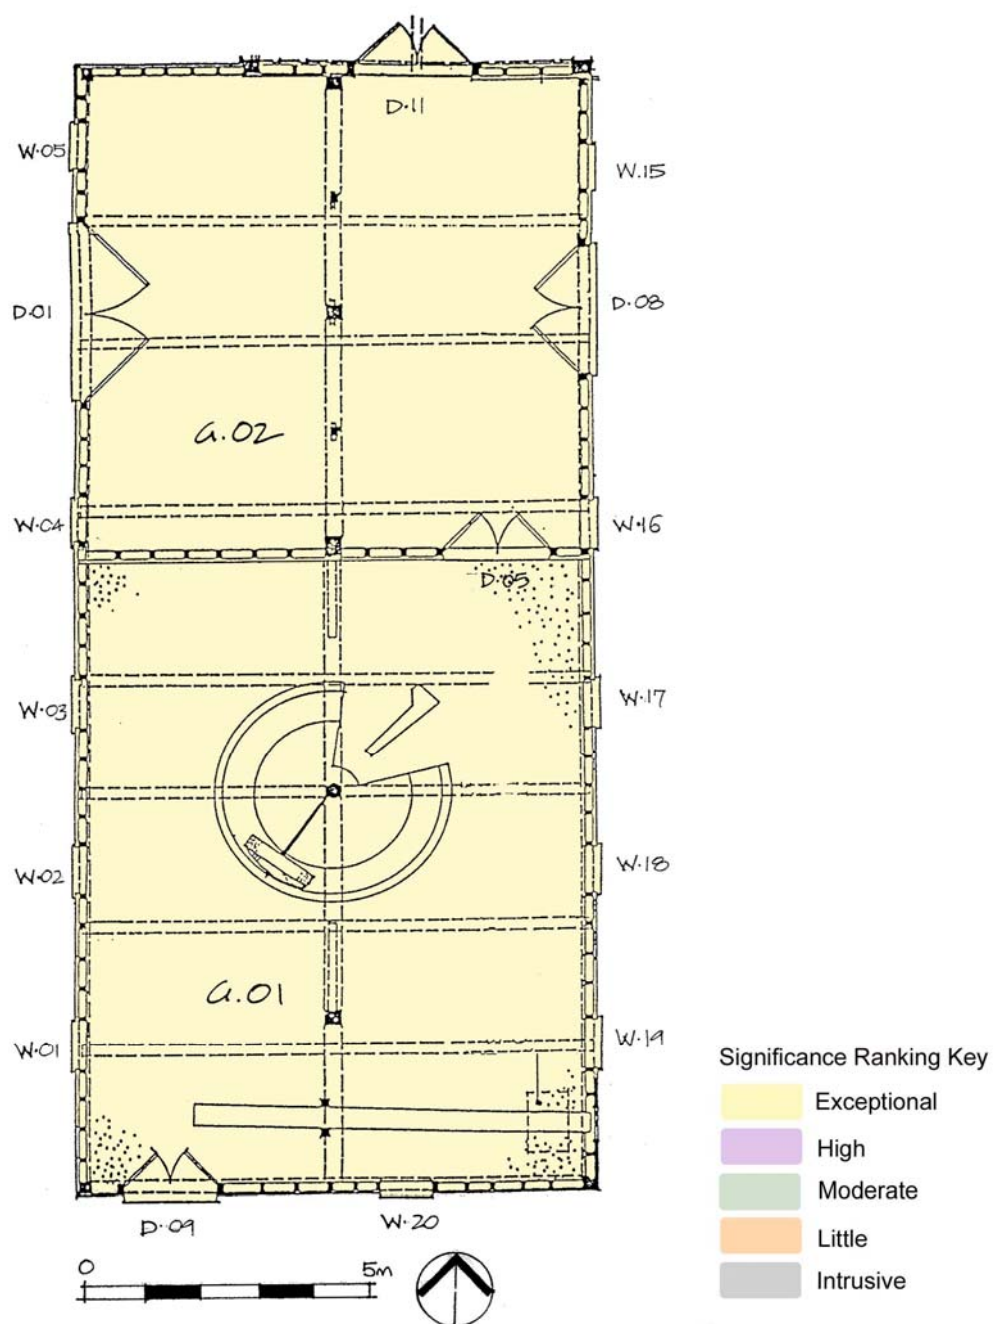
Ground floor plan of Cider Press showing significance ranking of interior spaces

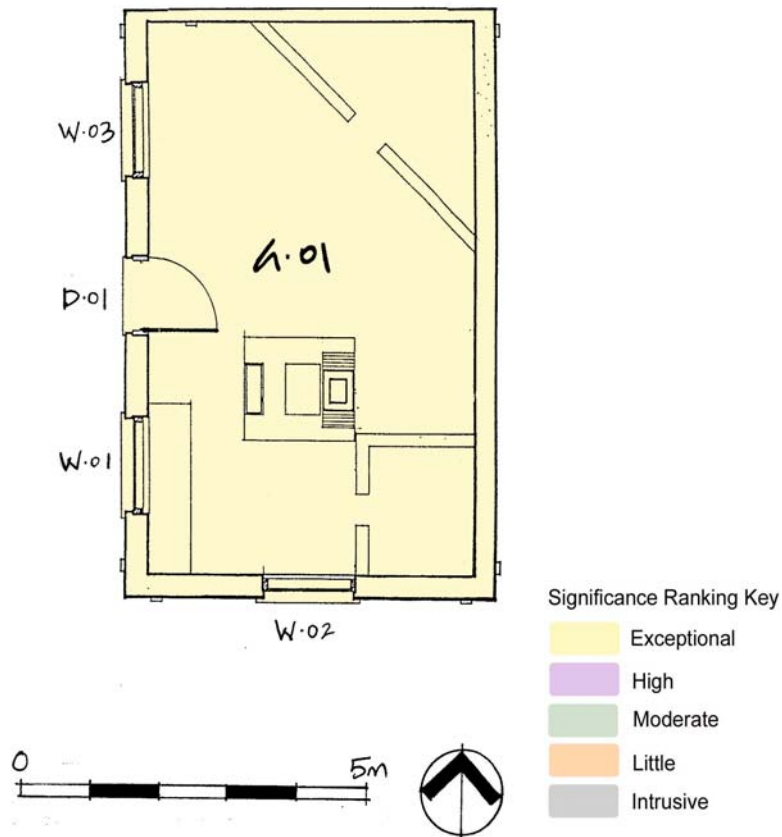
Ground floor plan of Blacksmith's Shop showing significance ranking of interior spaces

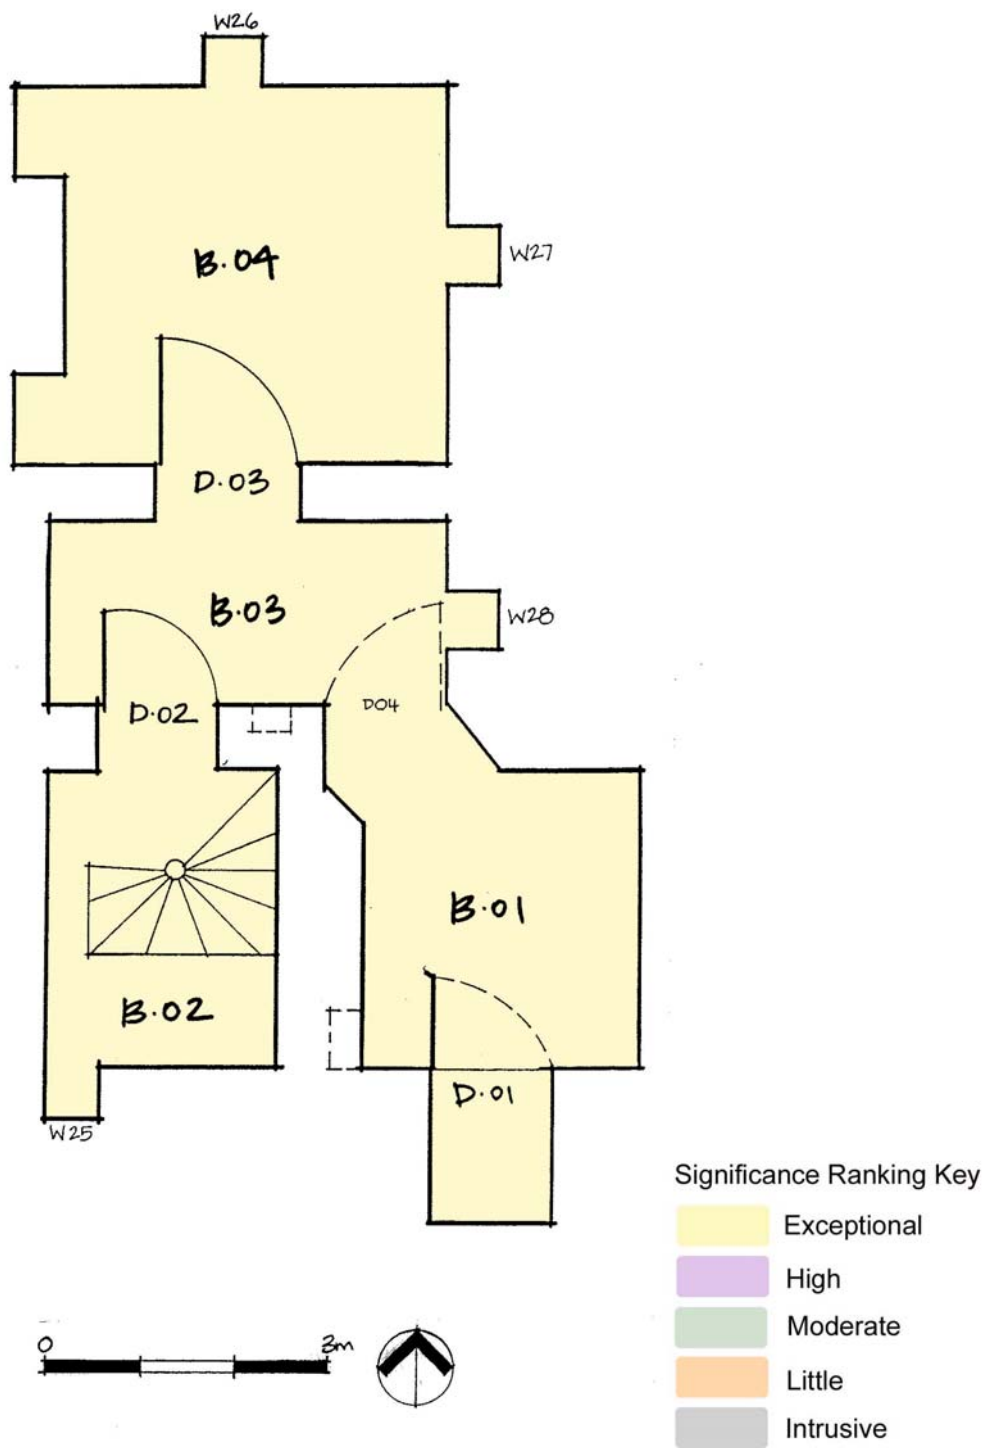
Basement plan of Woolmers Cottage showing significance ranking of interior spaces
